Poul Henningsens Plads

**KBM 3842, Udenbys Klædebo Kvarter, Skt. Jakobs Sogn,
Sokkelund Herred, Københavns Amt**

Kulturstyrelsen j.nr.: 2010-7.24.02/KBM-0015

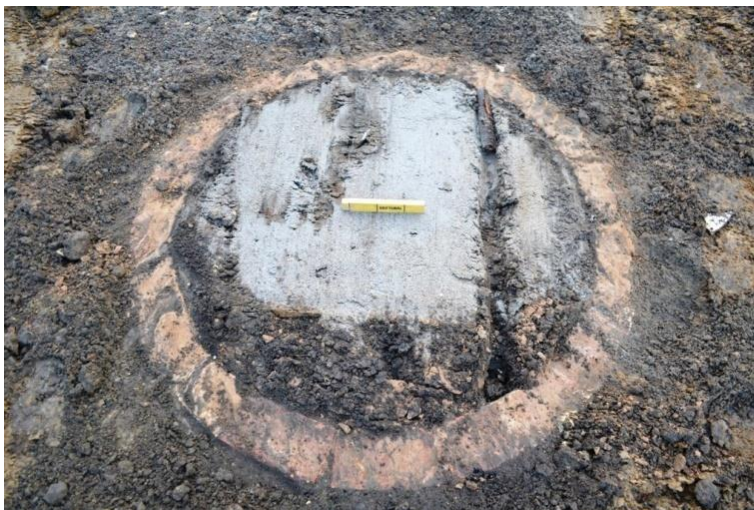
Figure 10. Brick well S1039.

The top of a brick-lined well or cistern was found (S1039) in the northern part of the plot. Machine excavation stopped approximately on the well's upper preserved surface, but time pressure and practical considerations did not allow for excavation and documentation of the well fill (S1151). Therefore, only the uppermost parts were examined.

Yellow, curved bricks had been laid in successive courses and made up a circle measuring approximately 1,20 m in external diameter (Figure 10). Brick size was 21.5 x 12 x 5 cm. No mortar was used between the bricks. The well was filled with grayish brown clayish silt sand and it may be an abandoned well, which was later used as a cistern.

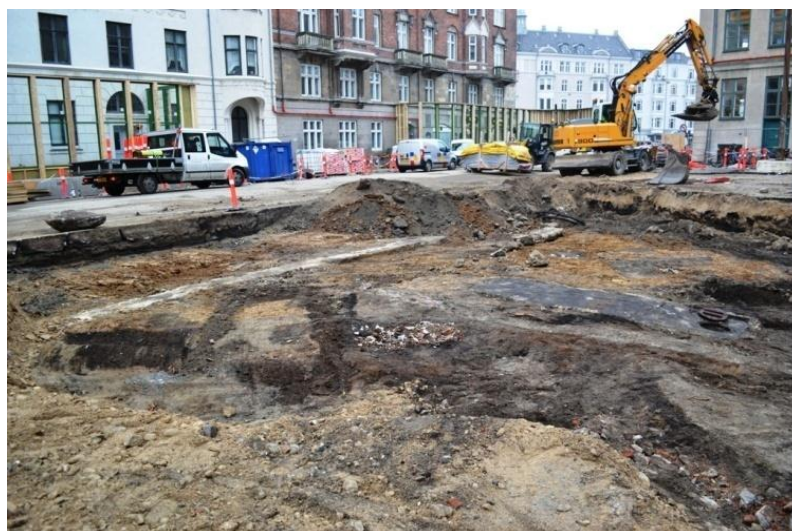
Figure 11. Foundation wall S1056, the mortared floor S1008 and an accumulation of ceramics and other household debris (S1012).

The building was divided into a northern part that functioned as stalls, and a southern part that was a garage for automobiles. Remaining sections of the foundation wall show that the building was 9.65 meter wide and at least 42.5 meter long. The floor area in the southern part would have measured 200 m². It included a small separate room in which a section of the original mortared floor was preserved (S1008). The floor featured a possible oil drain, which was covered with a wooden lid (Figs. 12 & 13).

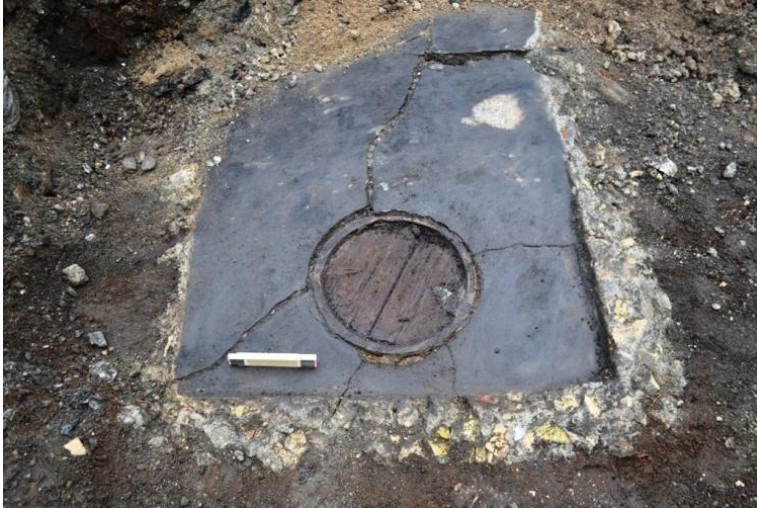
Figure 12. Floor drain in the car garage covered by wooden lid (S1008).

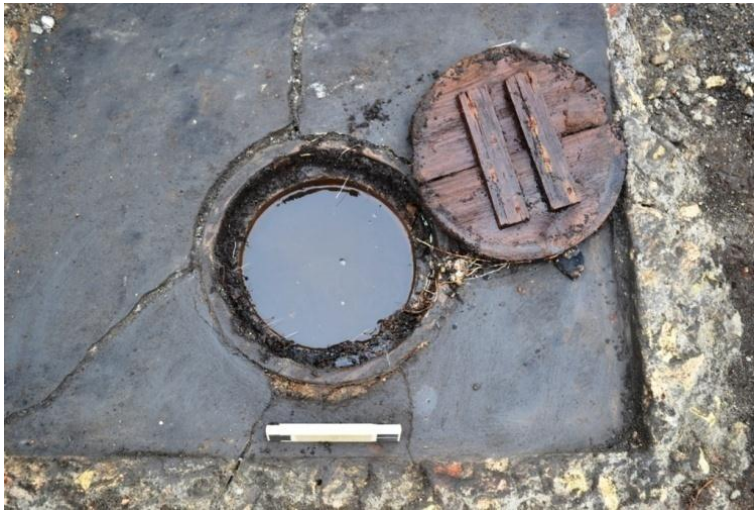
Figure 13. The wooden cover lifted (S1008).

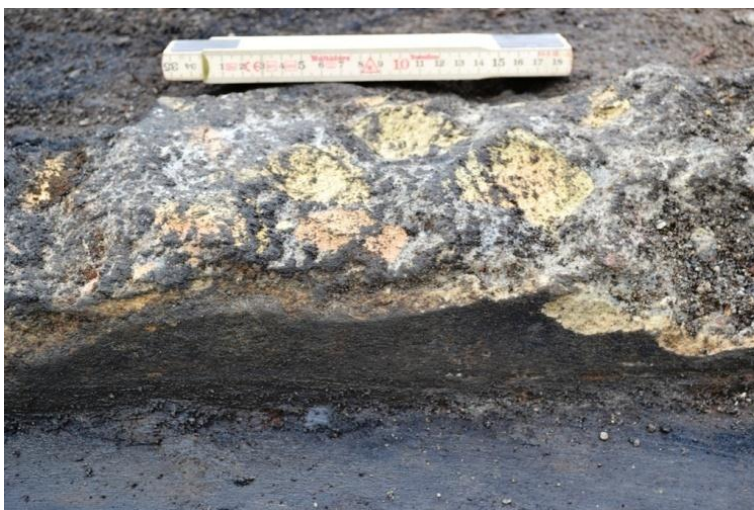
Figure 14. A layer of mortar covered the floor and extended up the crushed-brick mortared walls (S1008).

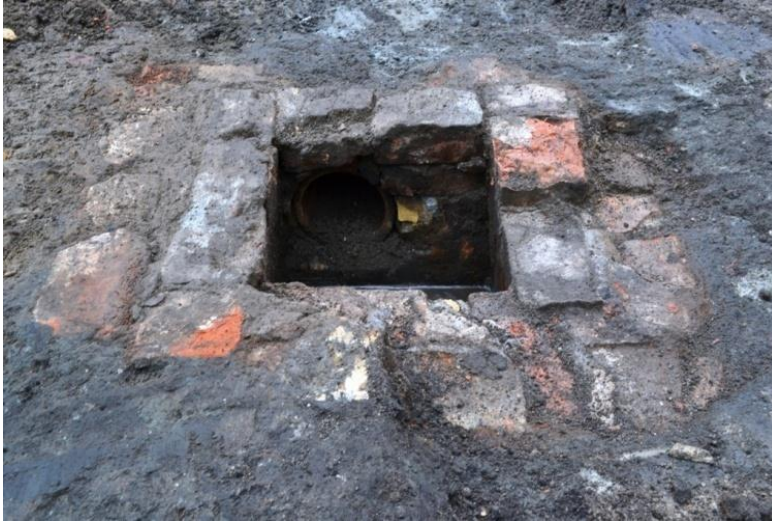
Figure 15. This stone-built catch basin at the south end of the stalls / garage along Reersøgade was used to collect downspout water from the building and release it to the sewer system (S1508). The pipe visible inside the basin would have removed the discharges.

At the south end of Building 1 an external catch basin was found, which was used for collecting downspout water from the building and releasing it to the sewer system (S1508). A pipe inside the basin would have removed the discharges (fig. 15). The building was demolished only in 1959 and the building and the rest of the structures on the compound is still visible on a map from Stadsconductørens Direktorat from 1954¹³.

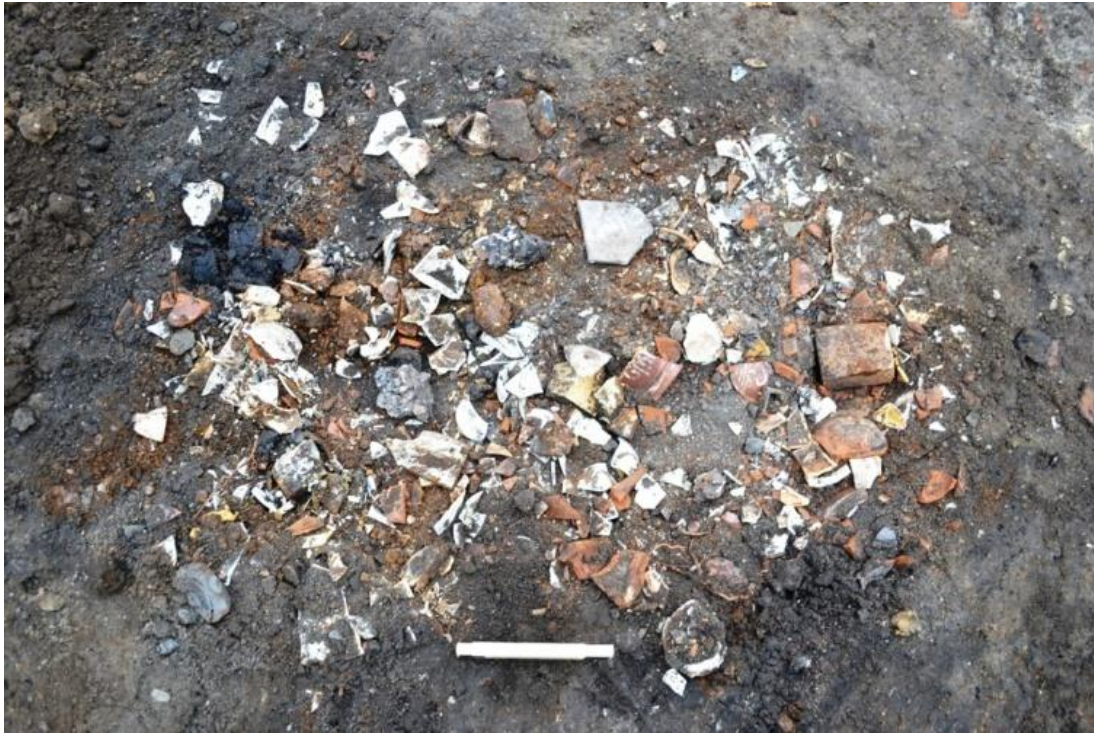
Figure 16. Dump (S1012) of ceramic sherds, glass and other household objects below Building 1.

A dump deposit of limited extent consisted of a densely packed accumulation of household debris, particularly fragmented ceramic material (S1012). In order to obtain a date for this deposit, it was sampled in its entirety. Analysis of the finds places the deposit between the second half of the 19th century and the early 20th century.
