7.2. Phase 2. The Renaissance Stone Harbour, 1570s-1620s

Phase 2 is the shortest phase on the Gammel Strand Metro Cityring project and lasts approximately fifty years, from the 1570s to the 1620s. In Denmark it spans part of the early Renaissance and middle Renaissance periods (Early Post-medieval period internationally). This phase was dated using a mixture of finds analysis and historical records; dendrochronology was used to date some of the structures.

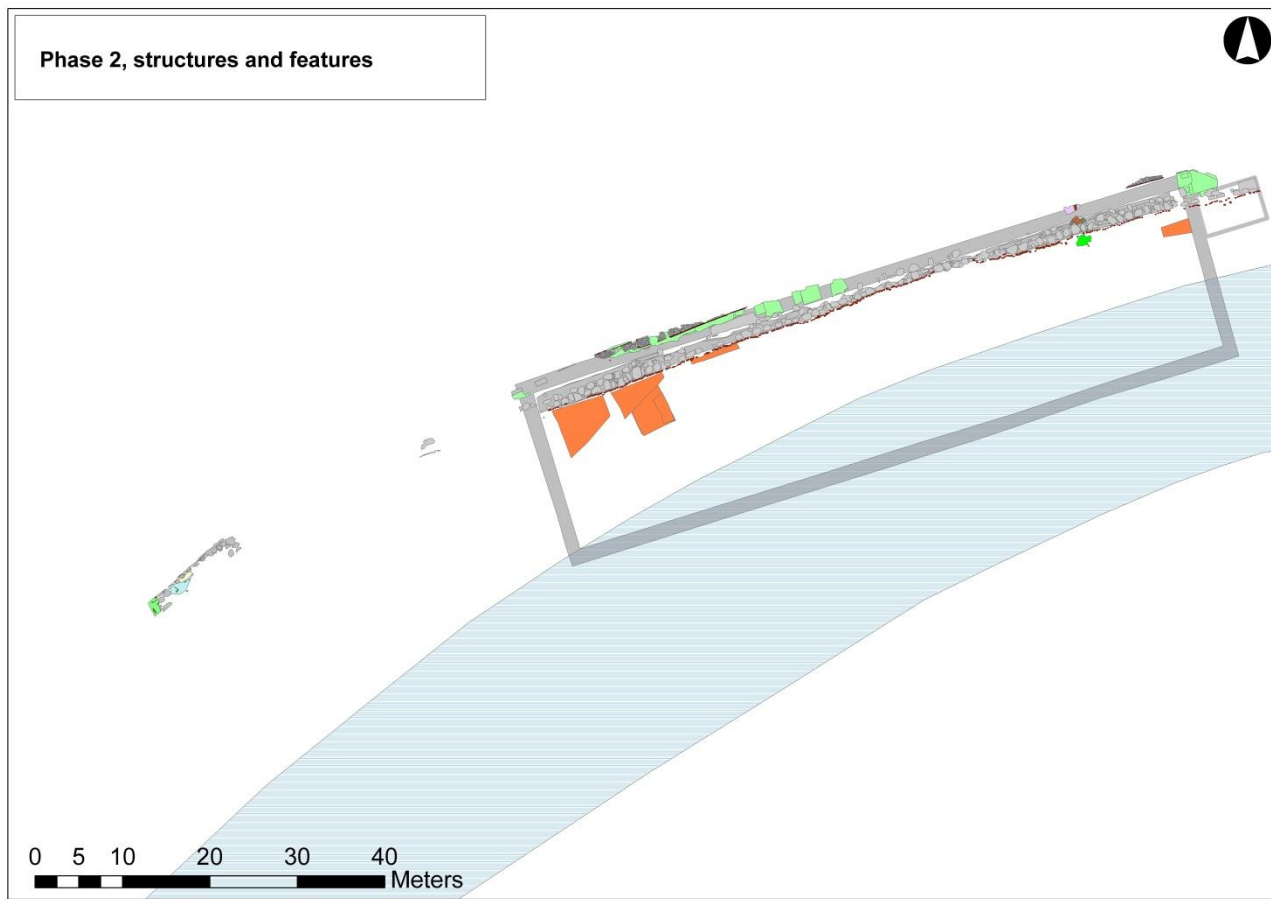
Fig. 58 Plan of Phase 2 structures and features (see also A3 version in Appendix B)

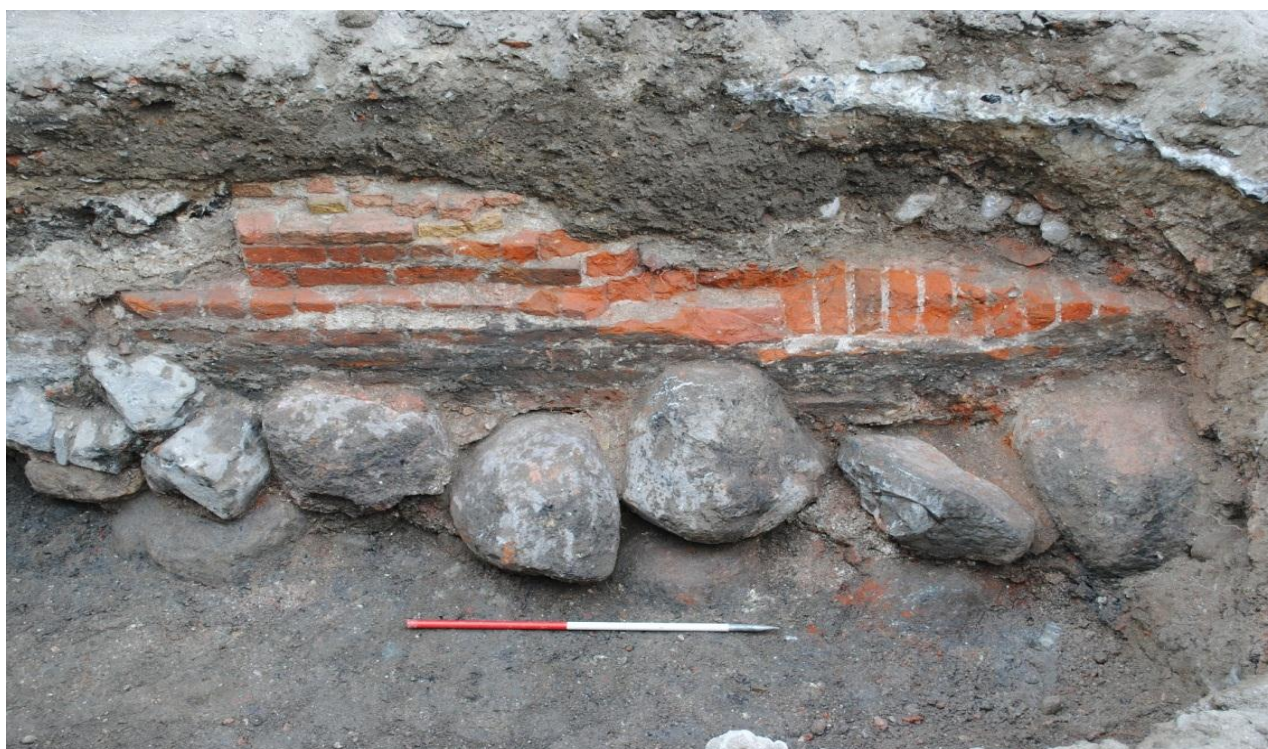
Fig. 60 Northern foundation wall SG220. Comprises lower course (SS4298), upper course (SS4350) and overlying brick structure (SS4453) C07_20100729_0318

The extant northern wall comprised a series of foundations and wall parts orientated NE-SW. The lowest layer was stone boulder foundation SS4298, measuring 7.5 m long by 0.78 m wide (partially exposed), with each stone boulder measuring between 0.5 m by 1 m by 0.3 m. No construction cut was seen. Overlying the stone boulders SS4298 was SD4377, a deposit comprising mortar, sand and clay, perhaps representing the decomposition of mortar, and containing a single residual Late Medieval fragment of redware. This in turn, was overlain by SS4350, another foundation layer of 13 stone boulders which was the base for brick wall SS4453.

Wall SS4453 comprised seven courses of *munkesten* brick, and three courses of irregular sized brick. The wall was not fully exposed due to the location of the trench, but the exposed area measured 6.5 m long by 0.36 m wide and 0.8 m high. The brick sizes were divided into two groups, which were located in two different areas of the build (Olesen and Bork-Pedersen 2012, 119-121). The seven lowest courses of brick comprised *munkesten* brick. The lowest course was highly irregular in form, and was laid and mortared in a style simply to provide a flat base for the upper courses. The second course was laid as a running/stretcher style bond; while the third course featured in header bond. The third course also formed a 1 skin thick cornice; a decorative feature at the eastern end of the wall. The next four courses were irregular in form, but from closer analysis, both cup bond running/stretcher bonds were observed. The three upper courses comprised bricks which were described as a typical Renaissance size (Christian IV-type) brick with a light red or yellow firing, and dated to c.1600. The upper 3 courses contained both red and yellow bricks in the building, and comprised either part of a door frame or perhaps a window frame.

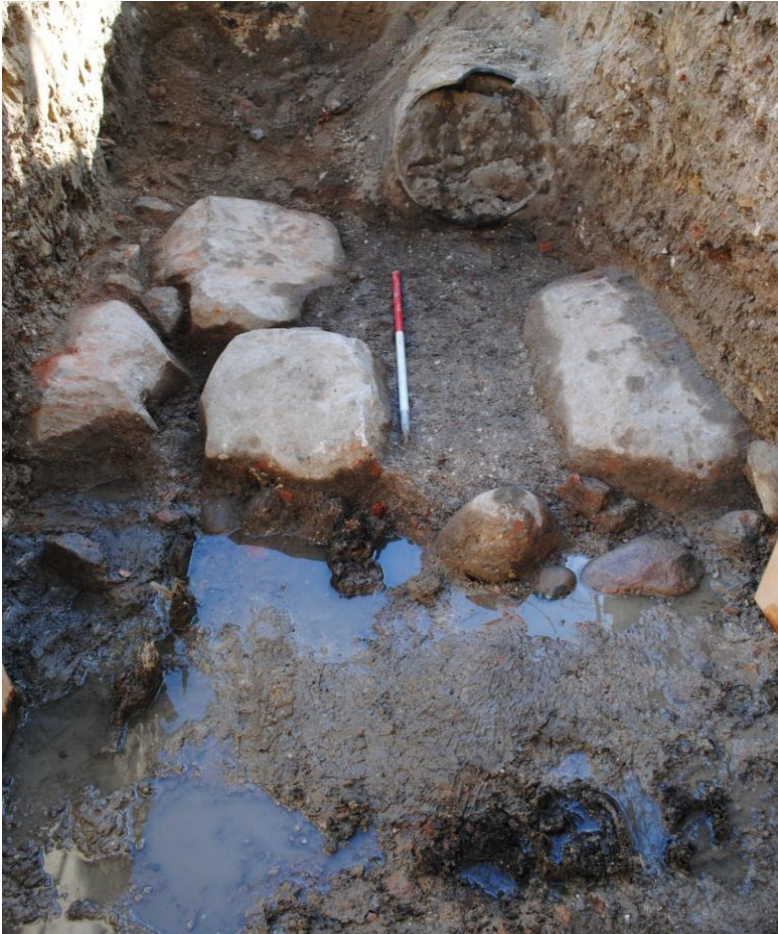
Fig. 61 Western foundation wall SS4075, G218 of Valkendorf's *Vejerhus*.
Looking NE. C07_20100726_0296

The western foundation wall SG218 comprised a line of stone boulders, SS4075 (SG320) measuring 1.92 m by 1.8 m wide, and orientated NNW-SSE. It contained only 4 large stones (at 0.89 m by 0.66 m by 0.3 m) and 3 smaller stones (0.3 m by 0.3 m by 0.2 m). No construction cut was observed. It had been heavily truncated by modern disturbance which removed the upper courses. The form of the foundation was identical to SS4298 from SG220 and SS4703 (SG219) and represented firm foundations of a many storeyed structure evidenced by the substantial width of the foundations.

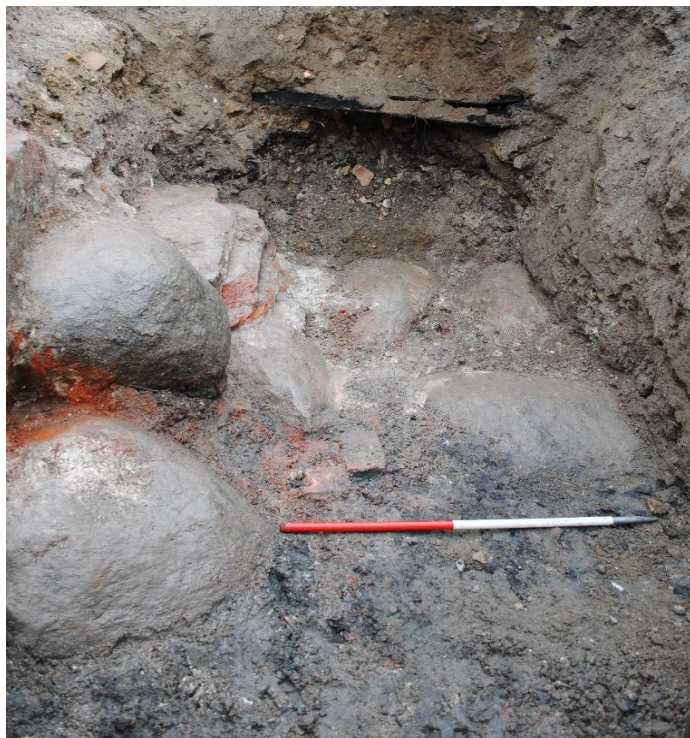
Fig. 62 Wall SS4017, SG219. On the left side of the photo is part of wall SS4298 of wall SG220. Looking NW. C07_20100730_0330

of stone boulders, registered as SS4703 and measured 1.5 m long by 1.7 m wide by 0.3 m thick. Stone foundation wall SS4703 was heavily truncated with only 4 large stones remaining (at 0.6 m by 0.5 m by 0.3 m), and was set on a NNW-SSE orientation. No construction cut was observed. The wall was heavily truncated by a modern gas pipe, presumably laid down in the 20th Century.

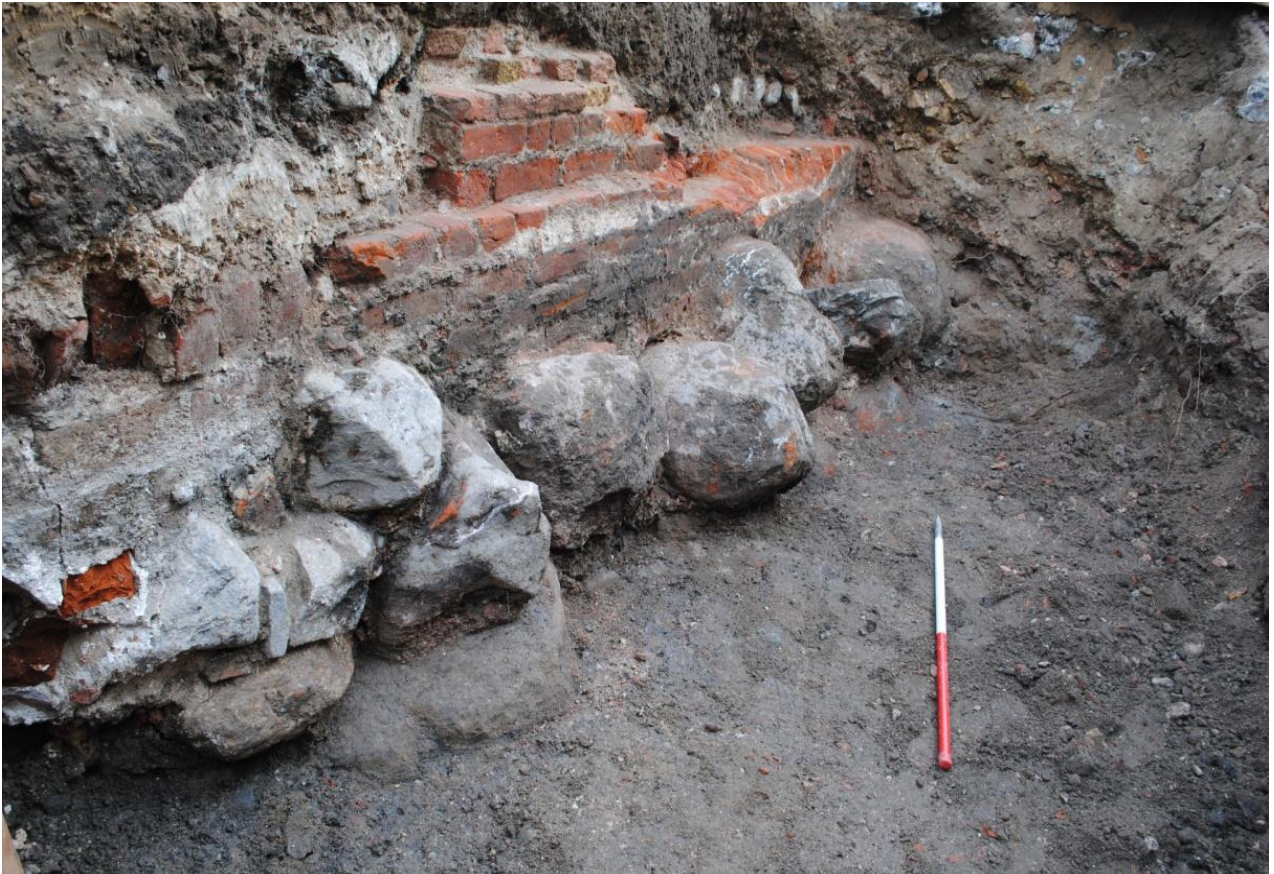
Fig. 63 Northern foundation wall SG220 looking northeast. C07_20100729_0321

The five uppermost courses (two *munkesten* and the three upper courses of red and yellow Renaissance brick) were truncated, while the underlying courses extend beyond the eastern edge of the excavation. It has been suggested that the wall terminus contains rabbeted bricks in order to form either an access way or doorway which related to a major entry point in the northern wall, as shown on the 1683 map.

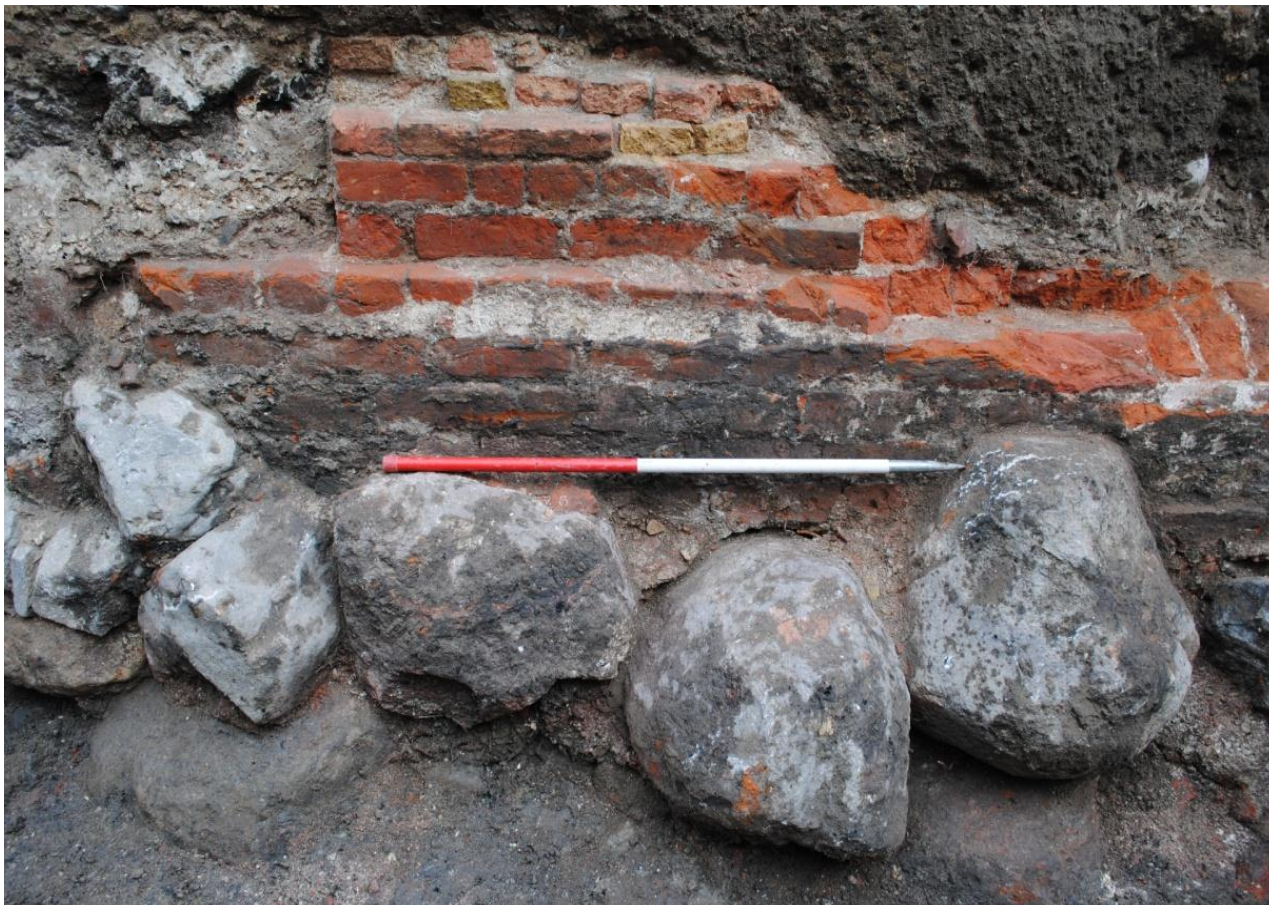
Fig. 64 Northern foundation wall SG220. Indication of a window frame in the upper left corner of the photo. C07_20100729_0322

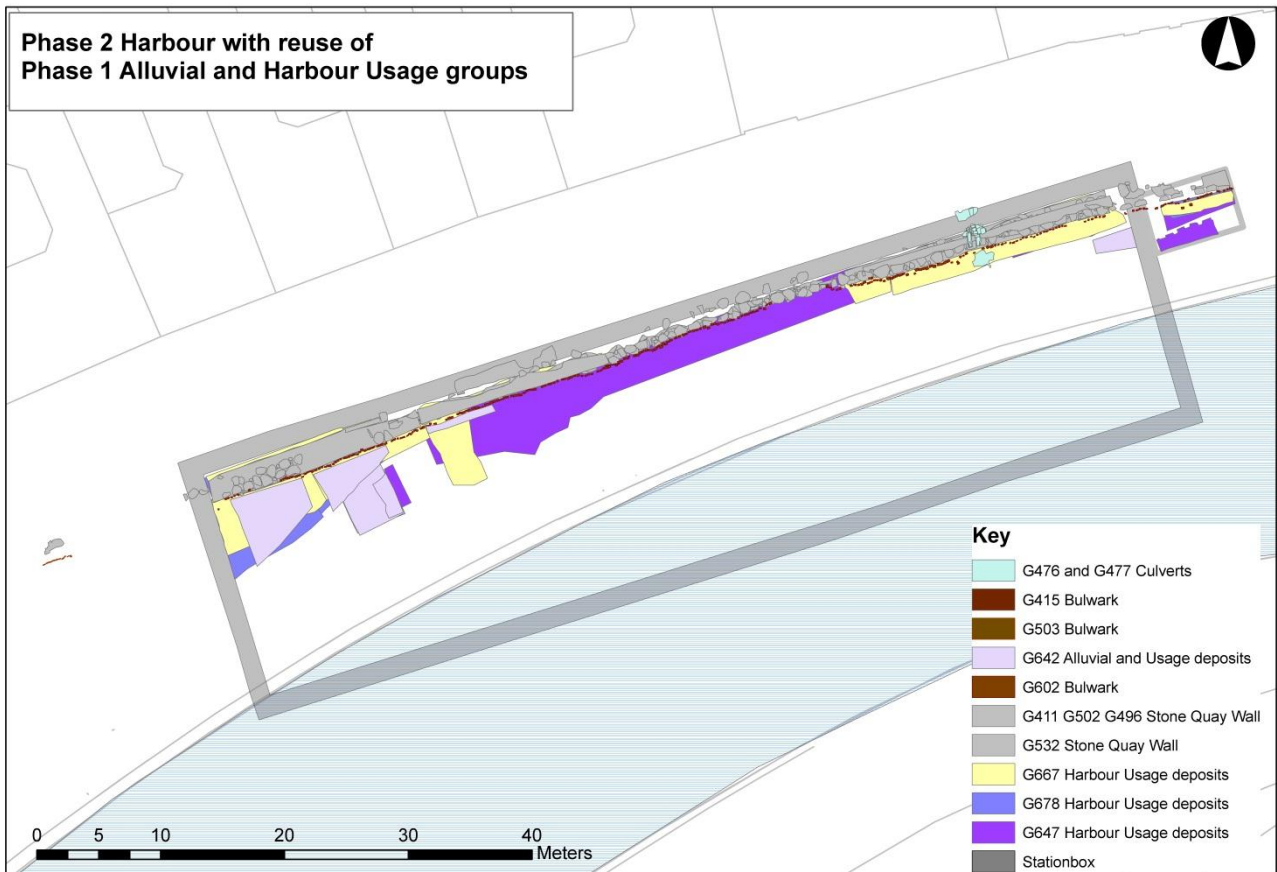
Fig. 65 Plan of harbour wall G532, bulwarks G602, G503 and G415 and the harbour deposits, featuring the re-use of Phase 1 groups G647, G678 and Phase 2 alluvial group G642.

The stone harbour wall, G532, stretches for 88 m through the Guide Wall trench and Main Excavations, as shown in Fig.65. Historical records state that it was constructed by 1583 (Nielsen 1872, nr. 363, 542) and it was in use until the 1690s when the new wooden harbour was constructed. In the western area the stone harbour was in use until the 1630s when a new wooden reclamation box and then wooden harbour front was constructed. Here, at the western end of the Main Excavation trench, the upper reaches of the wall were demolished and a new harbour constructed southwards. This process will be discussed in Chapter 7.3.

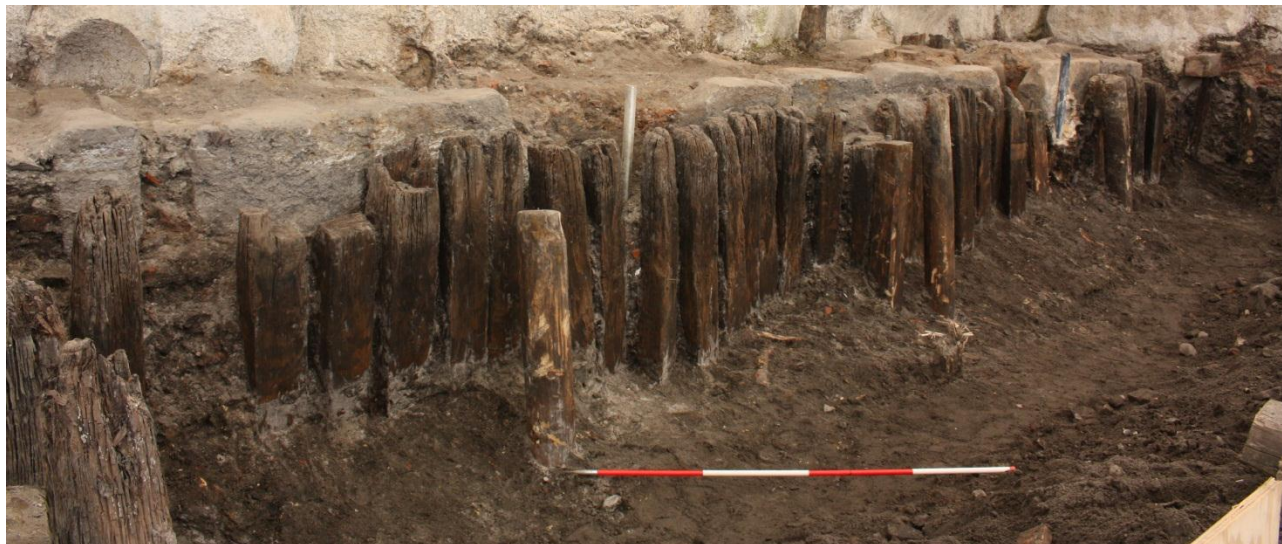
Fig. 66 Photo of harbour wall group G532 and bulwarks group 602. Located at the eastern end of the Main Excavation looking NE. C03_20140602_10517.

The whole post line/bulwark was linear in shape, constructed on a southwest-north east orientation, which was slightly different in orientation to the later harbours on site. The bulwark was spread over the whole 86 m of the Main Excavation and Stairway trench, although there were sections where later truncation had removed some of the posts.

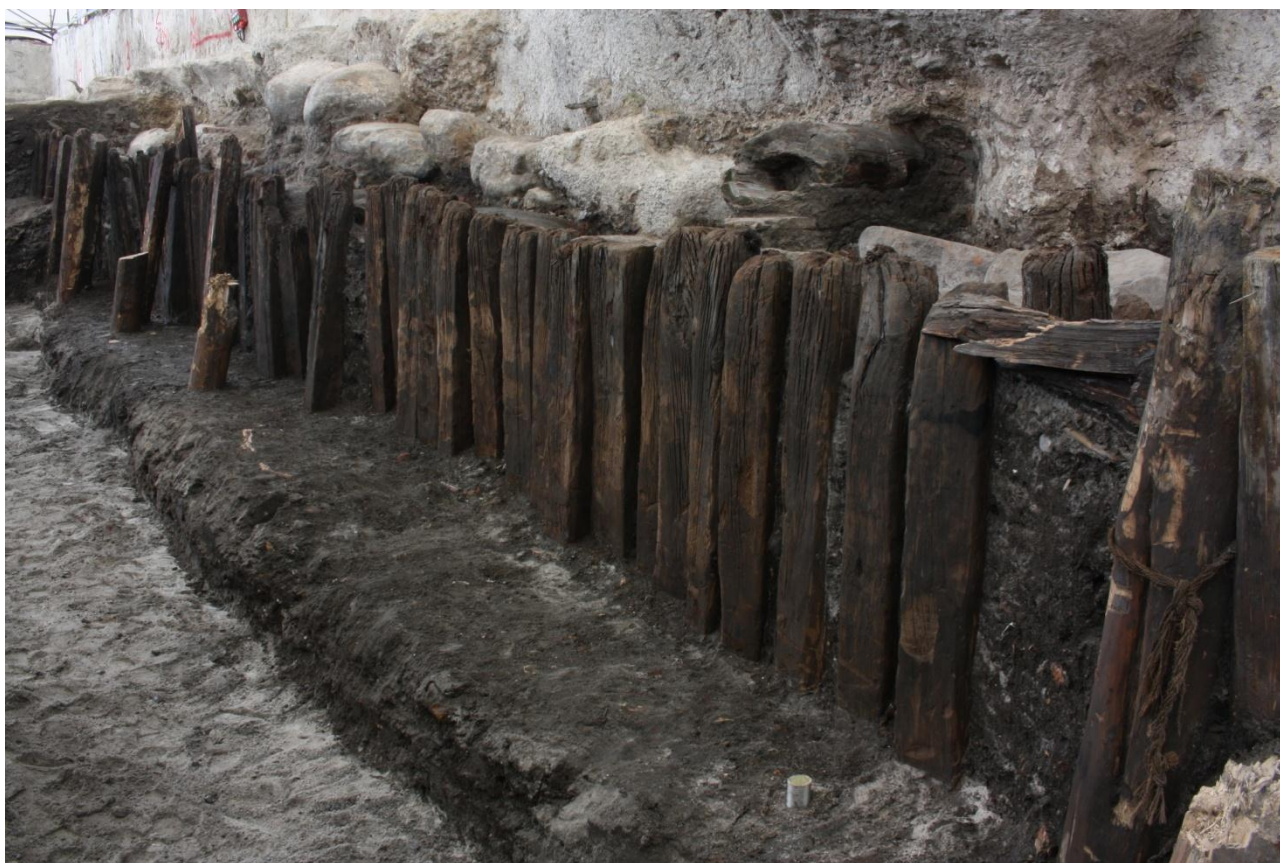
Fig. 67 Photo of central section of harbour wall G532 with bulwark G602 in front. Looking NW.C03_20140611_10788

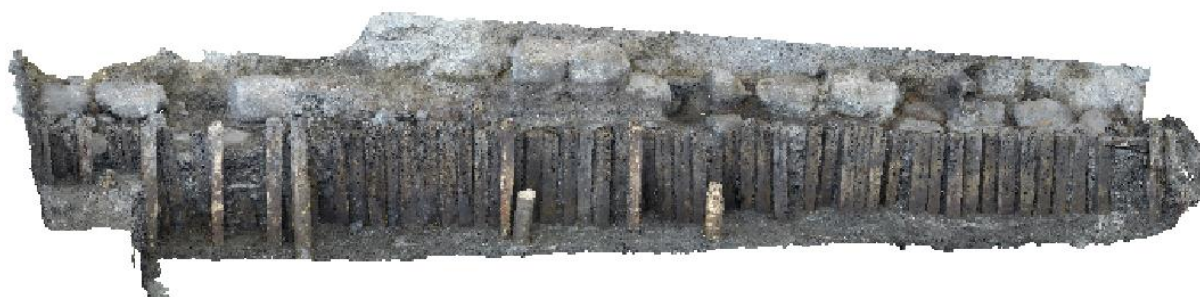
Fig. 68 The central area of wall G532 and bulwark G602. Photo rendering in 3D. Museum of Copenhagen

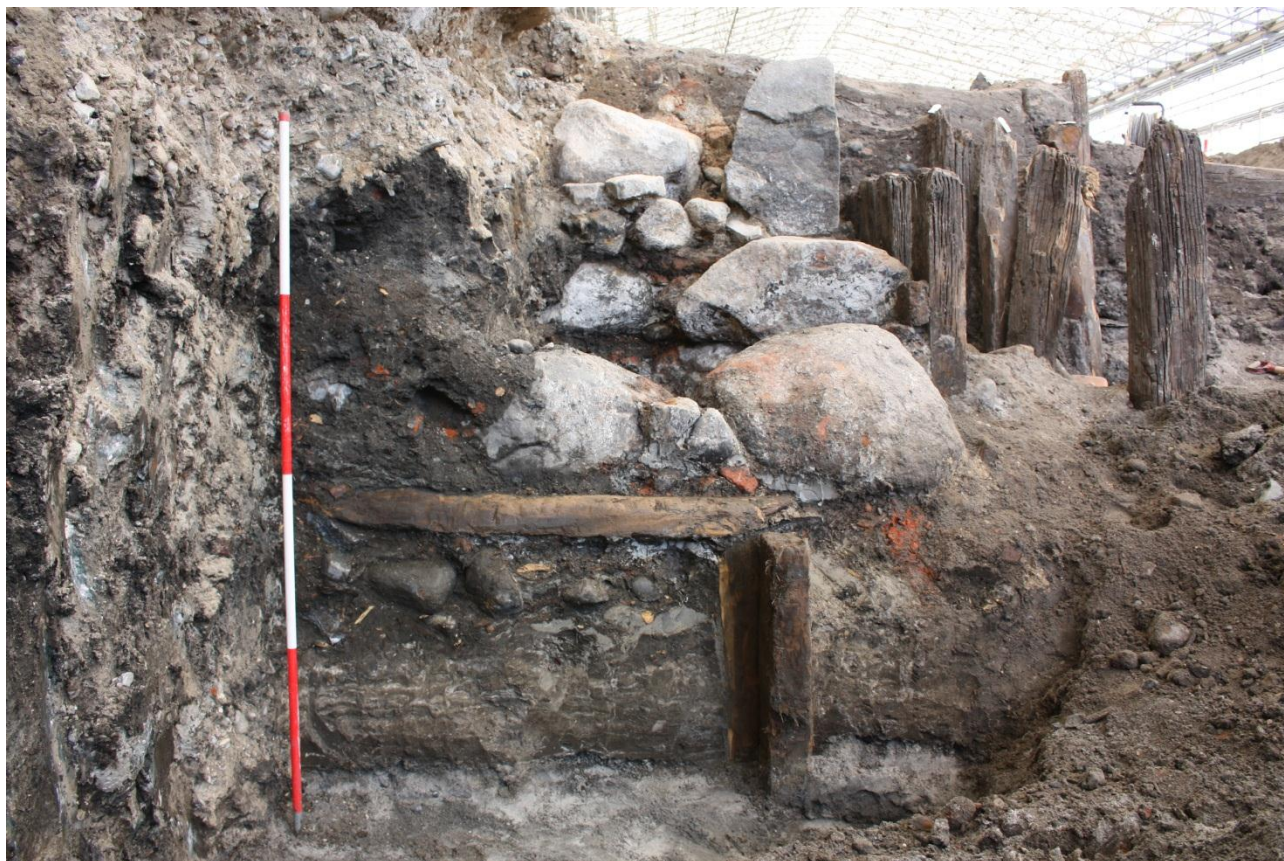
Fig. 70 Photo showing the west facing section of wall G532. Note that the rear of the wall has been truncated, as had the top of the wall by later activity. The Late Medieval harbour bulwark G656 has been cut or snapped with the upper part of the post horizontally placed on a north-south orientation C03_20140630_11307.

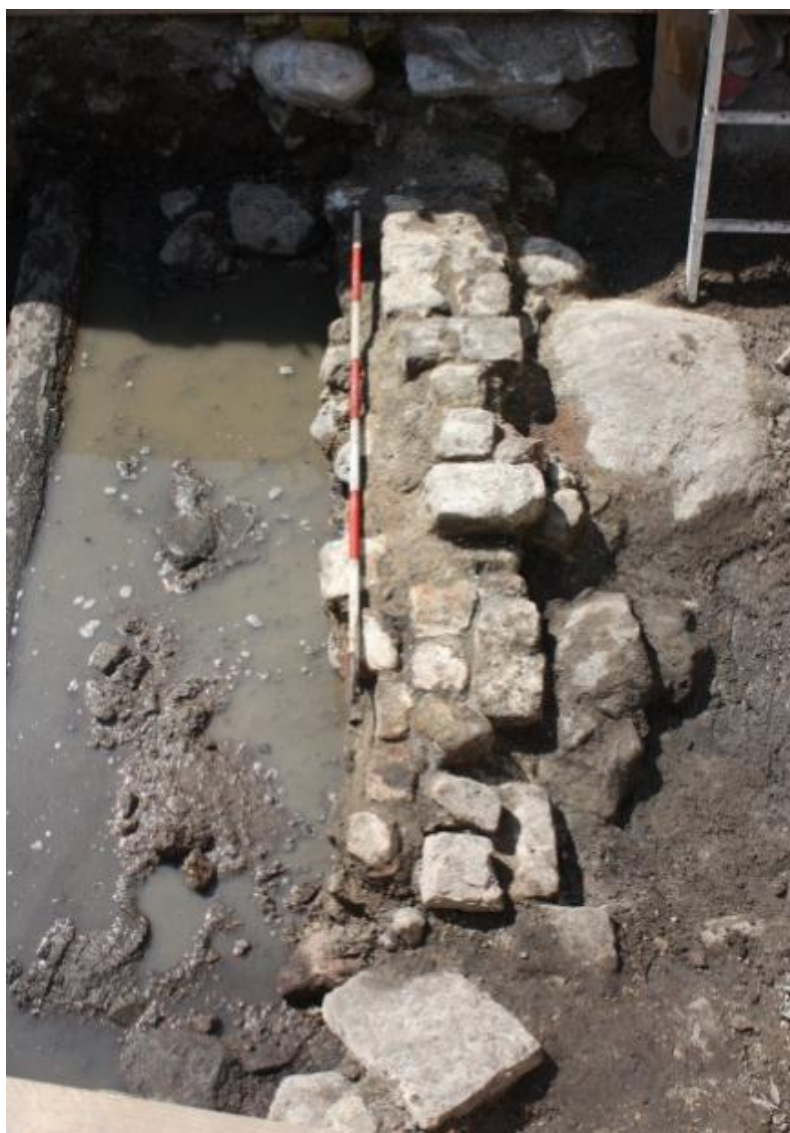
The next phase of construction was the addition of an extra layer of stone wall, SS40775. This part of the wall would have been visible above ground after construction and faced out across the harbour unlike SS42368 which was hidden from view below ground. Structure SS40775 comprised a line of rectangular shaped facing stones, dressed on three sides and located along the southern side of the wall. Forming the northern side or rear of the wall were some large stones, SS45336. In between these two parts there was a

rubble or brick core, SS42332, all of this was held together by a lime rich mortar. This section or part of the wall contained some differential construction techniques which are described in the next few paragraphs relating to the various sections.

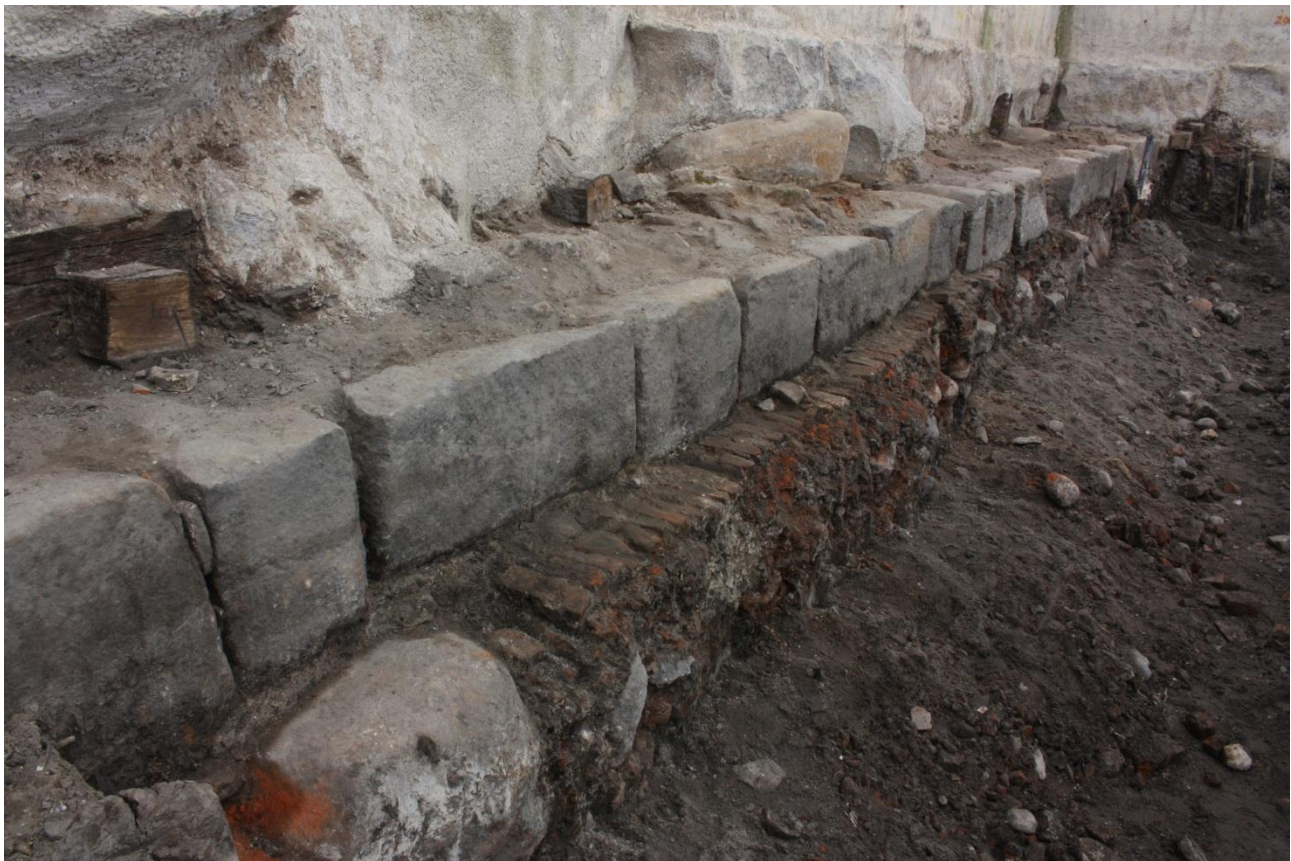
Fig. 72 Photo of eastern end of wall G532 after bulwark G602 was removed Photo shows the different construction methodology to areas in the centre and west. C03_20140613_10888

Even though the preservation of the wall differed, it was clear that there were various styles of construction along its breadth. This is shown in the photo Fig. 72.

At the eastern end of the trench, two different construction techniques were found. The central eastern area featured a dark hard mortar, SD43364 overlying the foundation stones SD42368, measuring 7.2 m long and 0.5 m wide. Set within the mortar was brick structure SS56008, comprising a mixture of placed or set bricks. They were joined together by a mixture of grey blue mortar with straw and a yellow, clay rich mortar. Within this deposit and structure were two redware sherds and a fragment of a German stoneware jug which post-date the 1550s. The bricks were overlain by a line of faced stones, SS40775. The stones were sub rectangular in shape with a cropped or faced side and a rough back measuring approximately 0.67 m by 0.43 m by 0.7 m thick. This part of the wall continued for 19 m.

Adjacent to this area and at the far eastern end of the trench was a slightly different construction technique. Overlying the large foundation stones, SS42368 was a large bedding deposit, SS42208. The deposit comprised broken bricks and stones mixed with mortar and spread over an area 23 m long. It was overlain by a roughly laid brick and stone surface/foundation, held together by an excessive amount of yellow mortar. This served also as a base for the front facing stones SS40775.

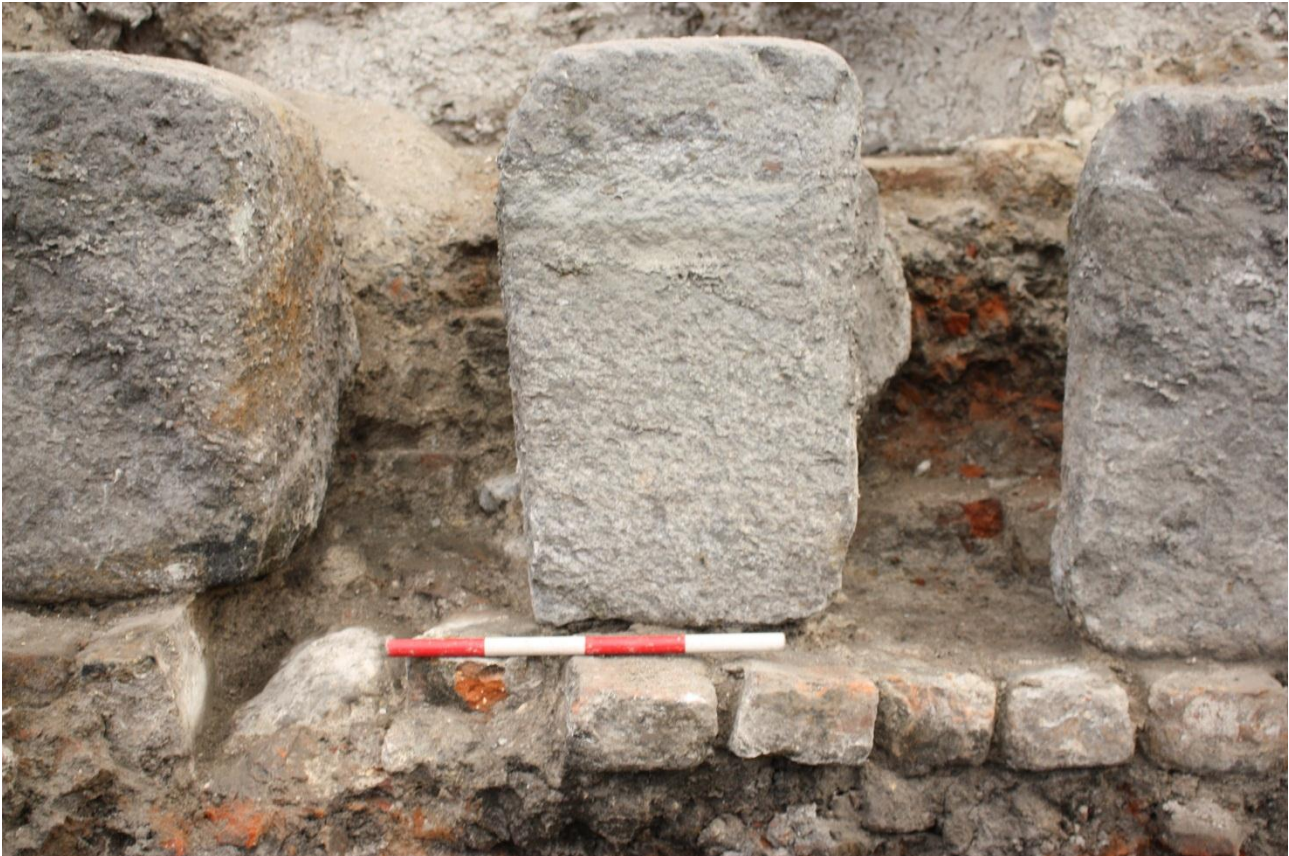
Fig. 73 Photo documentation of the culvert SG477 southern face. Looking north. C03_20140613_10891

The culvert consisted of two rectangular channels formed by leaving gaps between large facing stones with the centre stone placed on its side (see Fig.73 and Fig.74 for more detail). The culvert may have been constructed by the movement of the stone block, and reusing the red and cream mortar at the bottom of the stone as the new base. Laid within was the new wooden culvert, ST16935, which led through the harbour wall group G532. The culvert was seen in phases of the excavation (2012 and 2014) and re-recorded in the post excavation phase when it was seen that the two individual culverts were one large culvert.

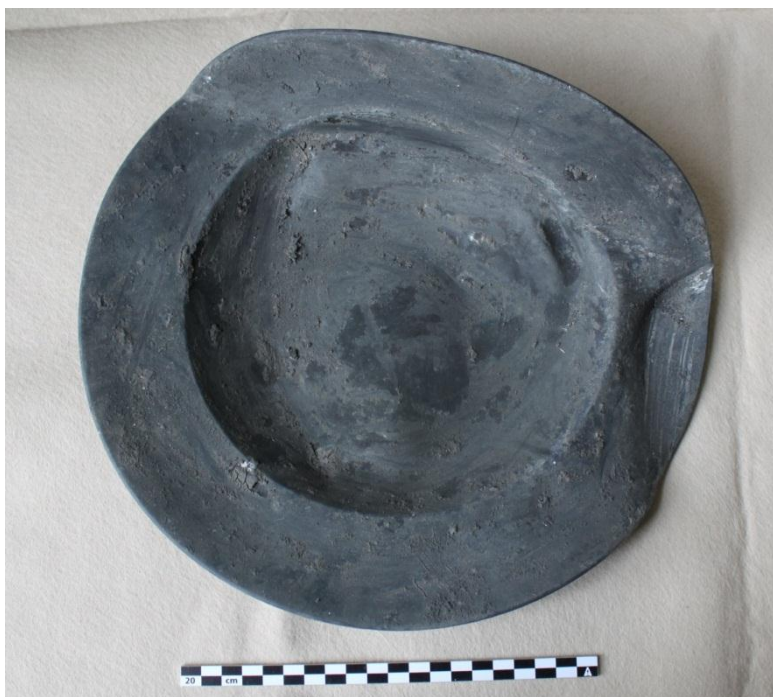
Fig. 78 Pewter plate FO 212784, SD55010, G642, pre conservation. Museum of Copenhagen

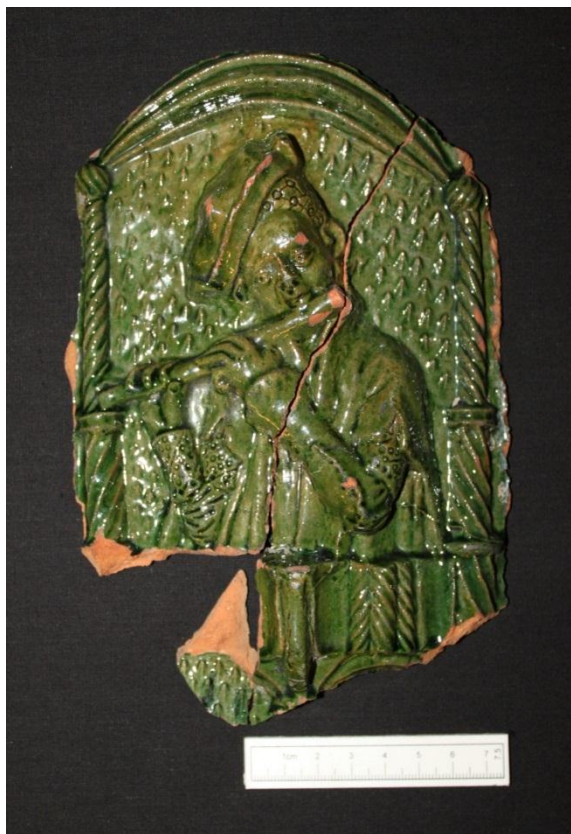
Fig. 80 Stove tile with a boy playing the flute. A Germanic mould on Sjælland fabric dating to 1480s. FO202816, SD12455, Group G435. Museum of Copenhagen.

The group underlies the road bedding group G434. The group finds assemblage consisted of a fairly large quantity of urban waste, which was only expected with the group measuring 40.3 m by 1.8 m by 0.5 m thick. Finds such as ceramics, clay pipes, animal bones and bone **Special Finds** were prevalent. From SD12455, stove tile FO202816 was a very interesting find as it comprised a Germanic type flute player motif moulded onto a *Sjælland* fabric, the design dated to the 1480s and exemplifies the use of foreign ideas with Danish materials (David Gaimster pers. com). Personal finds are represented by decorative artefacts such as bone beads (FO203257) and amber beads (FO203259).

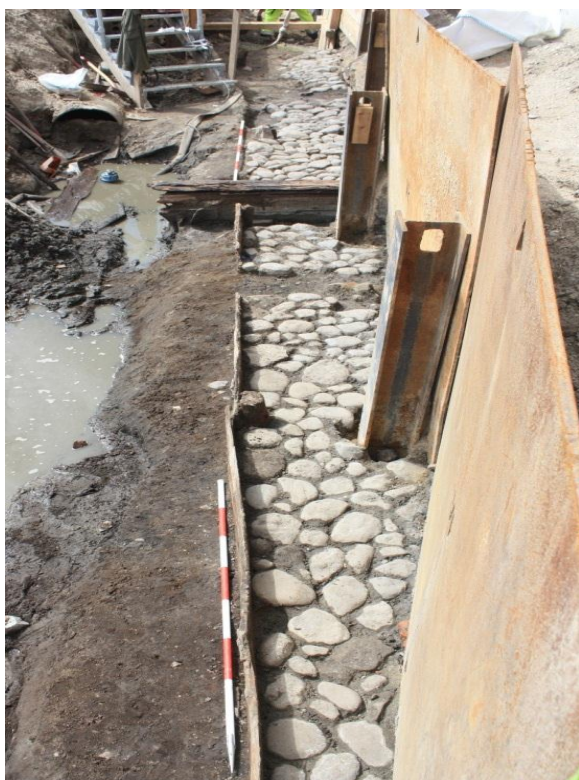
Fig. 81 Working photo of Road Group 430 looking SW in Trench 1 of the Guide Wall trench. The photo comprises road deposit 11789 at rear and road deposit 10493 in foreground. C03_20120723_5083

Group G430 comprised three cobbled stone surfaces, SS11789 in Trench 1, SS10493 in Trench 2A and SS14909 in Trench 3. The road is orientated NE-SW and continues into the northern section of the Guide Wall trench. The cobbled stone road comprised many unfinished stones measuring on average 0.2 m by 0.2 m by 0.1 m that were tightly compacted together. The road was built within similar construction cuts in the three exposed areas. The stone surface was held in place by planks to the north and south which were laid horizontally on their side. A series of stakes were then driven into the ground vertically to the north and south of the planks to keep them in position.

In Trench 1, road surface SS11789 was found to measure 15 m long by 1 m wide and was laid within cuts SC10413 and SC11286, along with many stakes and planks. This is illustrated in Fig. 82. Cut SC10413 comprised the southern plank system ST9691, ST10421; stakes ST10430, ST11340, ST11346, ST11396, and ST11278, ST11286, ST11930, ST11934 and stone surface SS11789. The sides were two planks thick with each plank system comprising many fragments or were possible replacement planks. The northern road plank system ST11934 was truncated by the trench shoring and no cut was seen. Road surface SS10493 merges into surface SS11789 and is bounded to the south by plank ST10421. The road surfaces were covered by manure deposits SD11309 and G10244 from Group G429 from Phase 4 suggesting the end of use of the road, and that it was only in use in Phases 2 and 3.
