## 7.3. Phase 3. The Late Renaissance Global Harbourside, 1630s-1680s

### 7.3.1. Summary

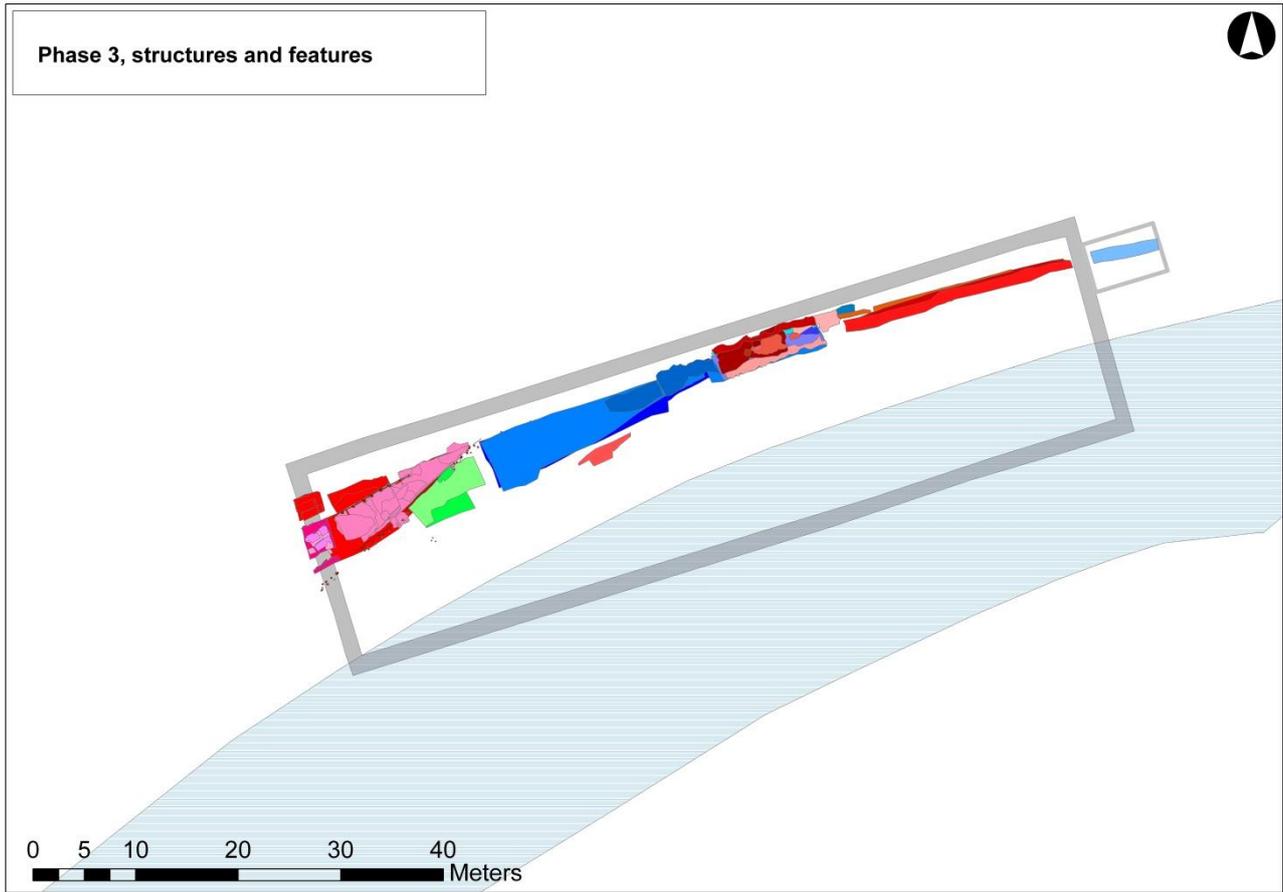
Fig. 84 Plan showing all Phase 3 structures and features (See also A3 plan in Appendix C)

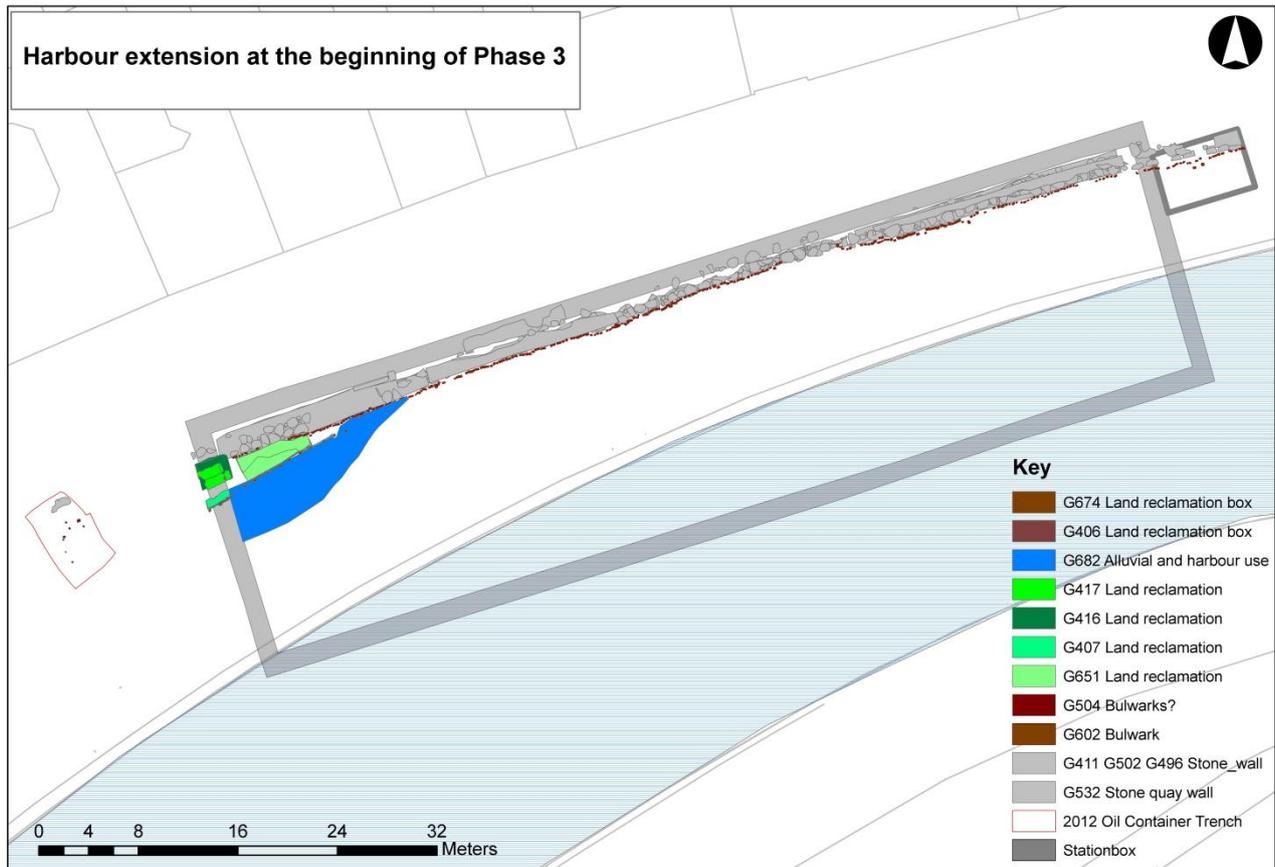
Fig. 85 Plan showing activity in Phase 3 in the mid 1620s.

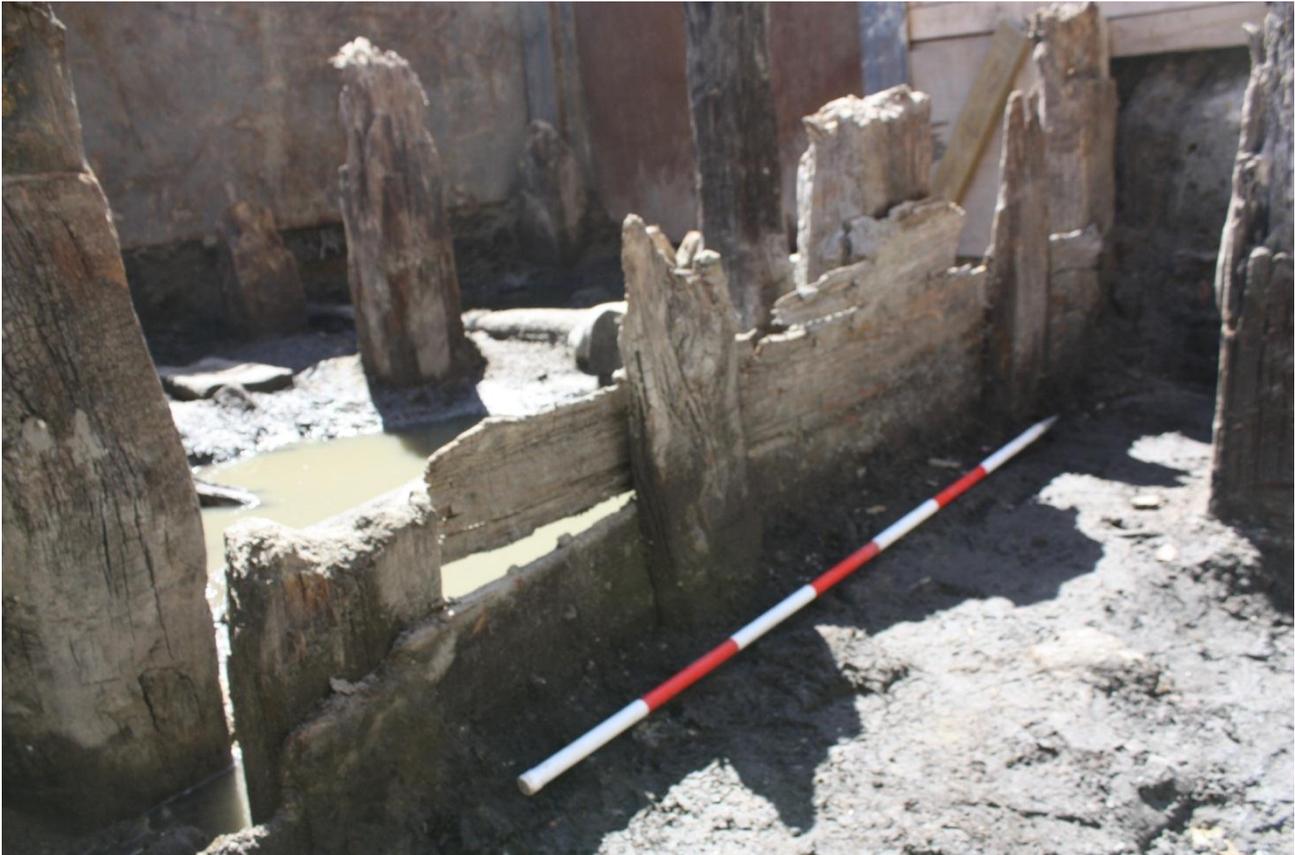
Fig. 86 Photo of reclamation fence G406, looking SW. Guide Wall excavation 2012. C03\_20120725\_5207

The top of the western section of the fence, G406, was uncovered at 0.8 m OD. It measured 2.72 m by 0.75 m and was exposed to the depth of 0.6 m. The group comprised 5 posts and a horizontal plank to form the fence. The posts were vertically set, and were registered as ST9194, ST9199, ST9203, ST10470 and ST12266. They were located on the south side of a horizontal plank wall, ST9334. The plank wall, ST9334, comprises 3 planks on top of each other. Only one vertical post, ST9199, was able to be removed, and measured 2.66 m long. It was rectangular in cross section, and tapered to a point. The post was curved, perhaps through construction or by driving it into the ground. The edges were bevelled and it was quite worn. Many samples were taken for dendrochronology from posts and planks in G406, but no dates were able to be obtained.

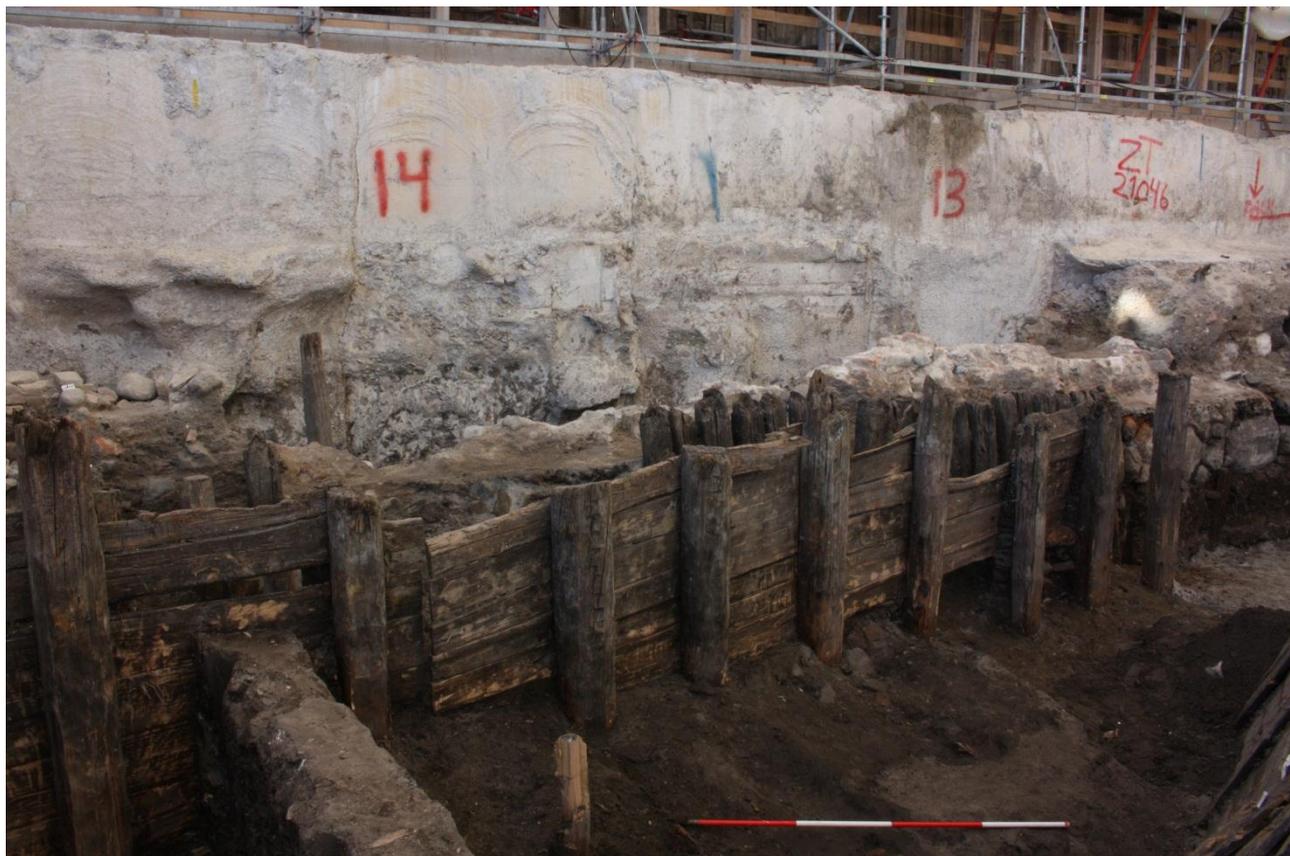
Fig. 87 Reclamation Fence G674, Looking N-W. Note, the bulwark was constructed in two different parts, and that bulwark G602 may have been removed to build this structure. C03\_20140624\_11187

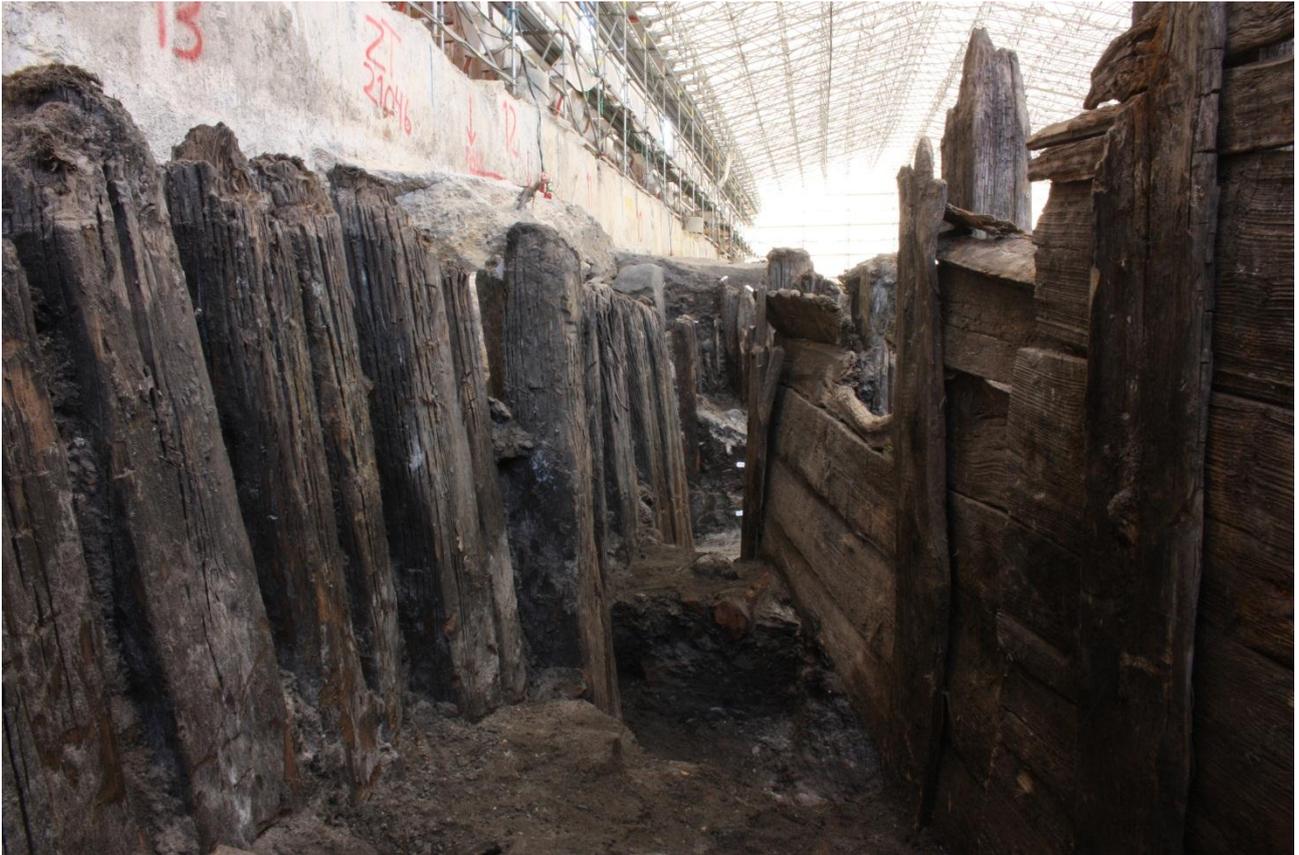
Fig. 88 Working photo of the excavation between G602 and G674 looking NE. Note the majority of the backfill has been removed. C03\_20140624\_11196.

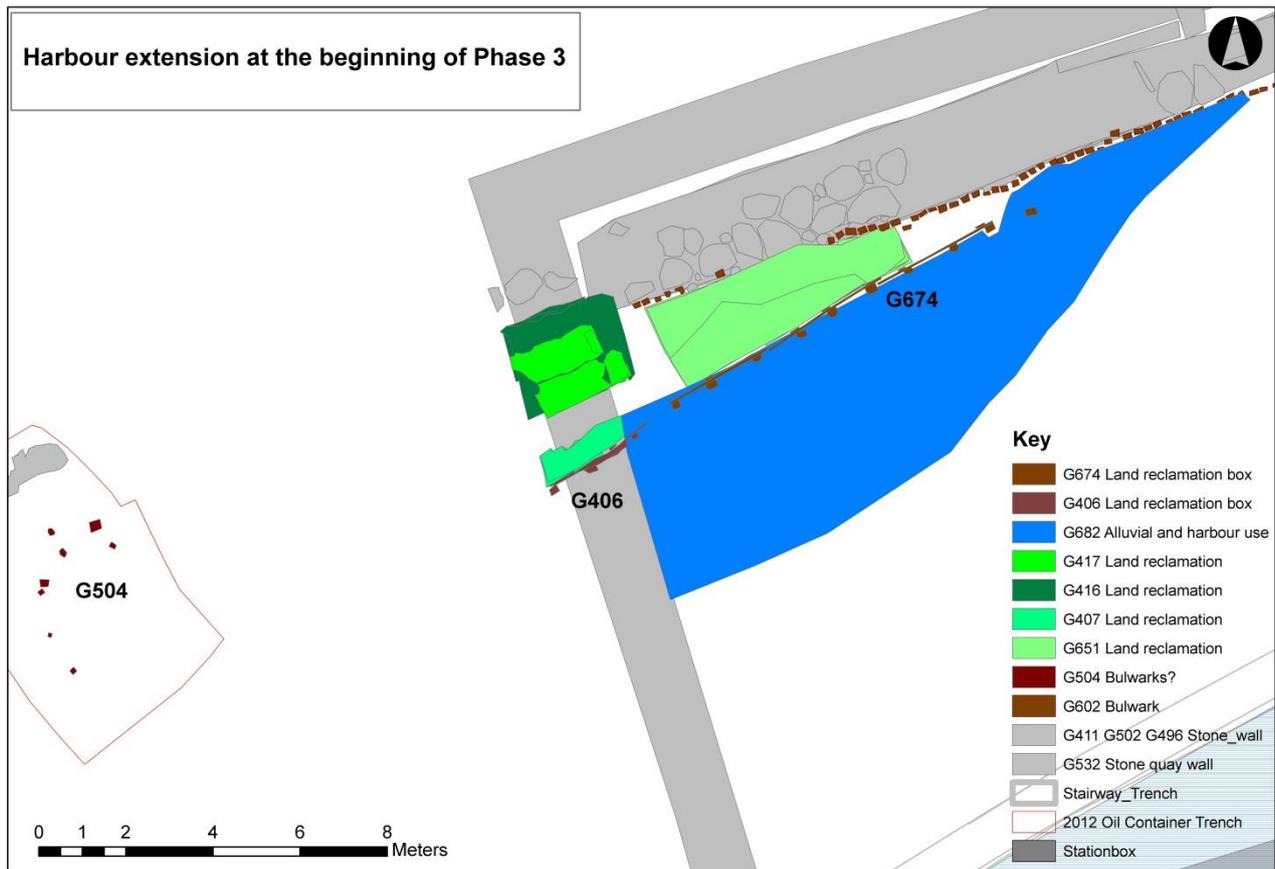
Fig. 89 Close up of the harbour extension at the western part the Main Excavation trench and the Oil Container trench at the beginning of Phase 3.

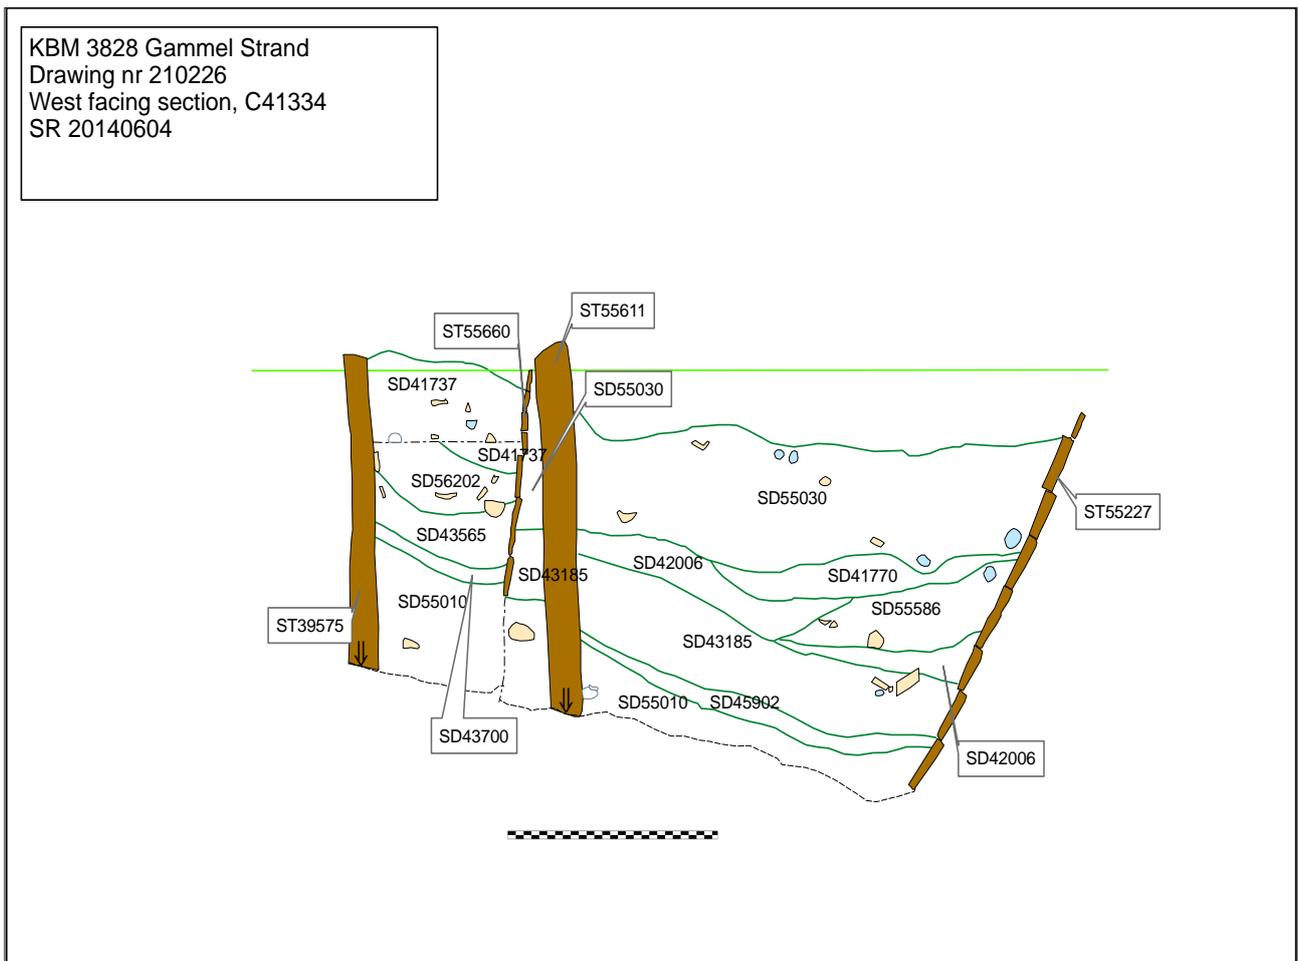
Fig. 90 West facing section of bulwark G674, represented by post ST55611 and bulwark G648, represented by planks and ST55227. Corresponding backfill deposits for those bulwarks in that area are shown. Drawing number 210226. Scale bar 1 metre.

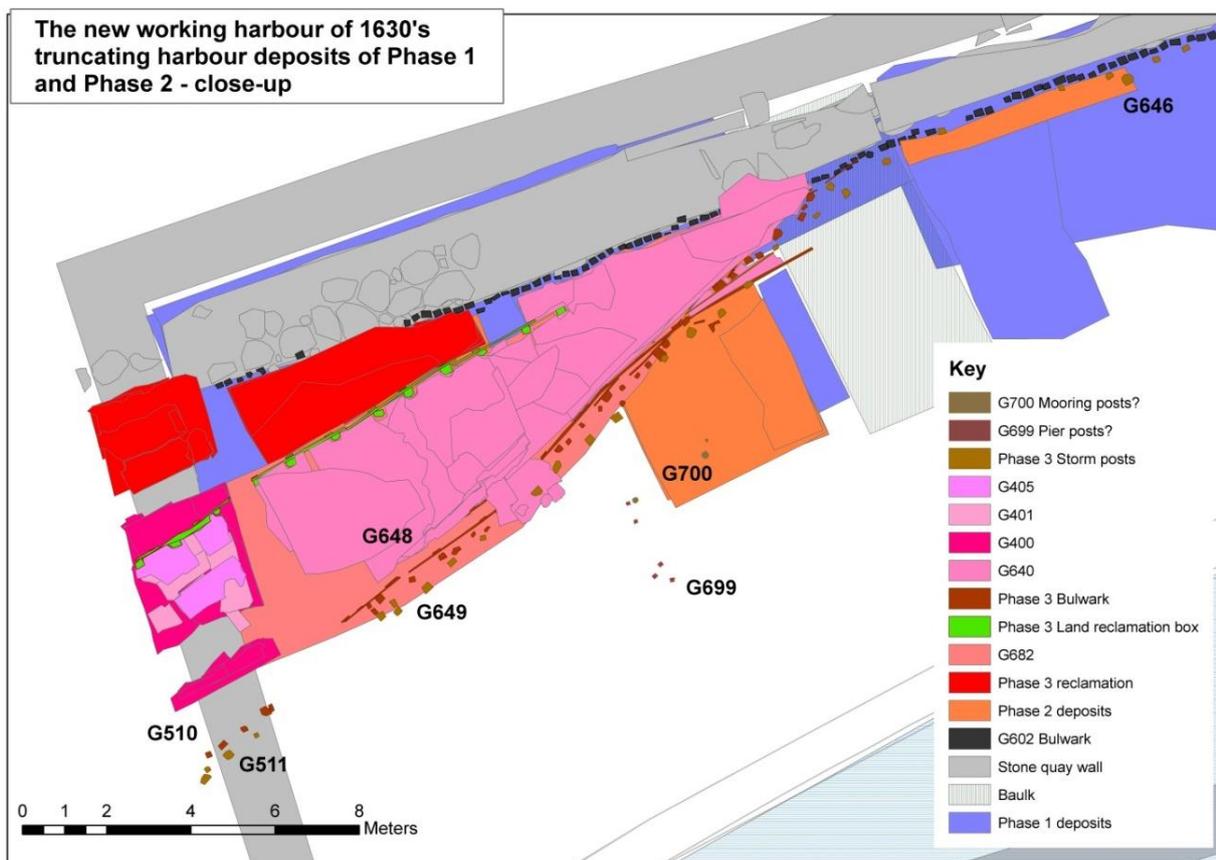
Fig. 93 Plan of the 1630s new working harbour G648, with associated deposits.

The next major phase of activity in the western area of the Main Excavation was the creation of the new harbourside (Fig.93). South of bulwarks G406 and G674, a new harbour front supplanted the short-lived bulwark/reclamation fence. The total bulwark measured 21 m long by approximately 1.1 m wide by 1.4 m high. It was located, at the greatest extent, 4.5 m south from bulwarks G406 and G674 (and 7 m south from wall G532), and orientated on a NE-SW orientation, reaching harbour wall G532 at the NE terminus. The posts were mostly made from oak, the planking from pine, and the vertical planking from spruce and pine. The wood was mainly felled between the years 1618-1626 with the oak coming from *Sjælland, Skåne* or *Hålland* or Norway, the pine from the middle Baltic (*Gotland* or other areas of E. Sweden), but the source of the spruce is unknown. There was clear evidence of repair in certain areas, which would have occurred sometime between 1640 and 1690, when the bulwark was in use.

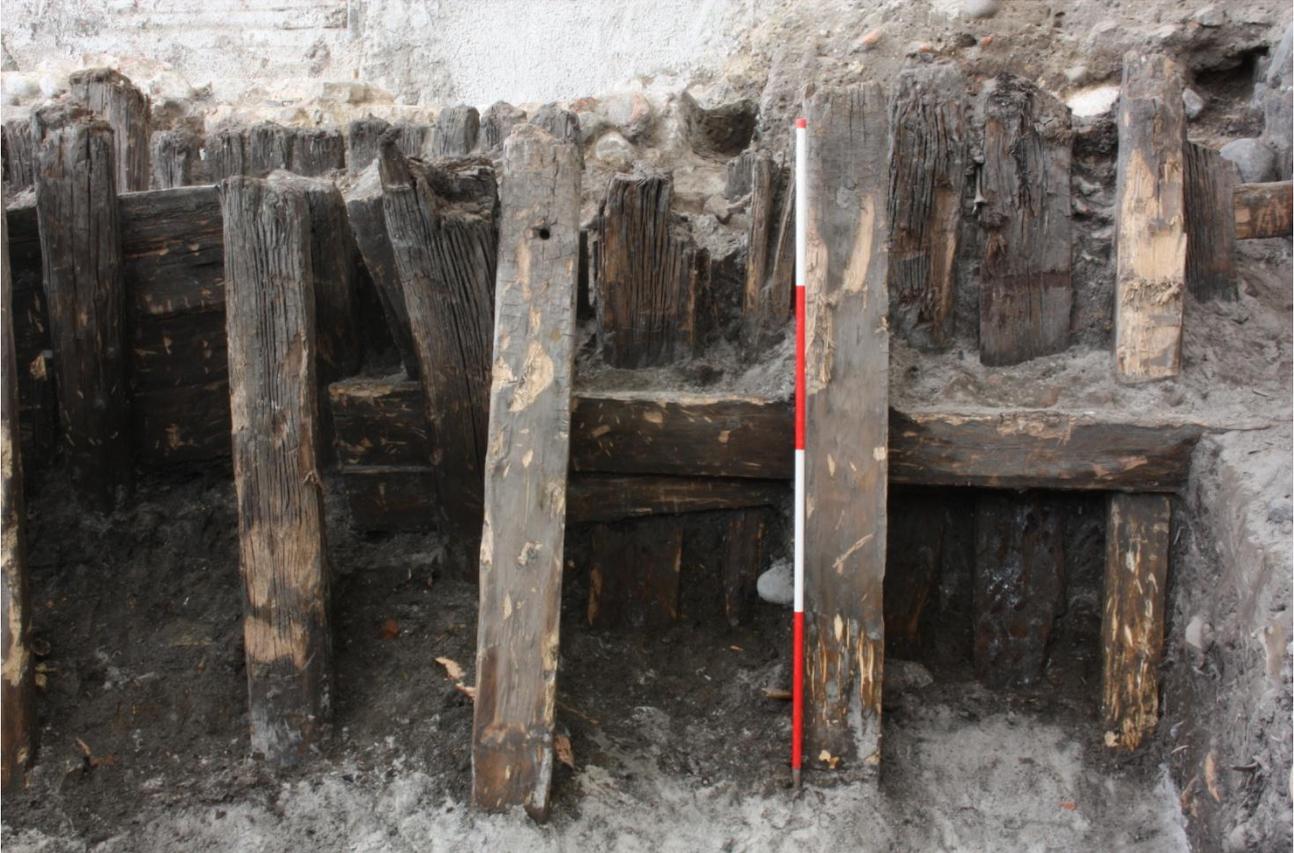
Fig. 94 Close up of harbour bulwark G648 next to the baulk. The photo is centered on an area of repair shown by horizontal plank ST41884 and three vertically set planks (ST39435, ST39413, ST55582) used as the plank's support. The photo is looking N. C03\_20140613\_10920

From the excavation it was seen that the eastern part of the bulwark had to be replaced. This was attempted by adding a replacement section. This section comprised a new horizontal plank, and three support planks. The horizontal plank, ST41884, was fashioned from pine and measured 3.44 m long. It was kept in position by three new support planks, ST39435, ST39413, ST55582, different to the usual post type of support. These plank type posts measured 1.6 to 1 m long by 0.15 m to 0.2 m wide and 0.13 m thick. They were pushed into the ground and slanted northwards against plank ST41884. The tree, which was

used for the post ST34913, was felled in the spring/summer of 1662 suggesting the repair occurred in the latter stages of Phase 3. This dating fits in well with the dendrochronology of bulwark G648 and storm posts G646 as it was located in-between these two different structural groups. Plank ST55582 may be added to the support and repair planks, but it had collapsed just south of the bulwark, collapsing into the Phase 3 harbour area.

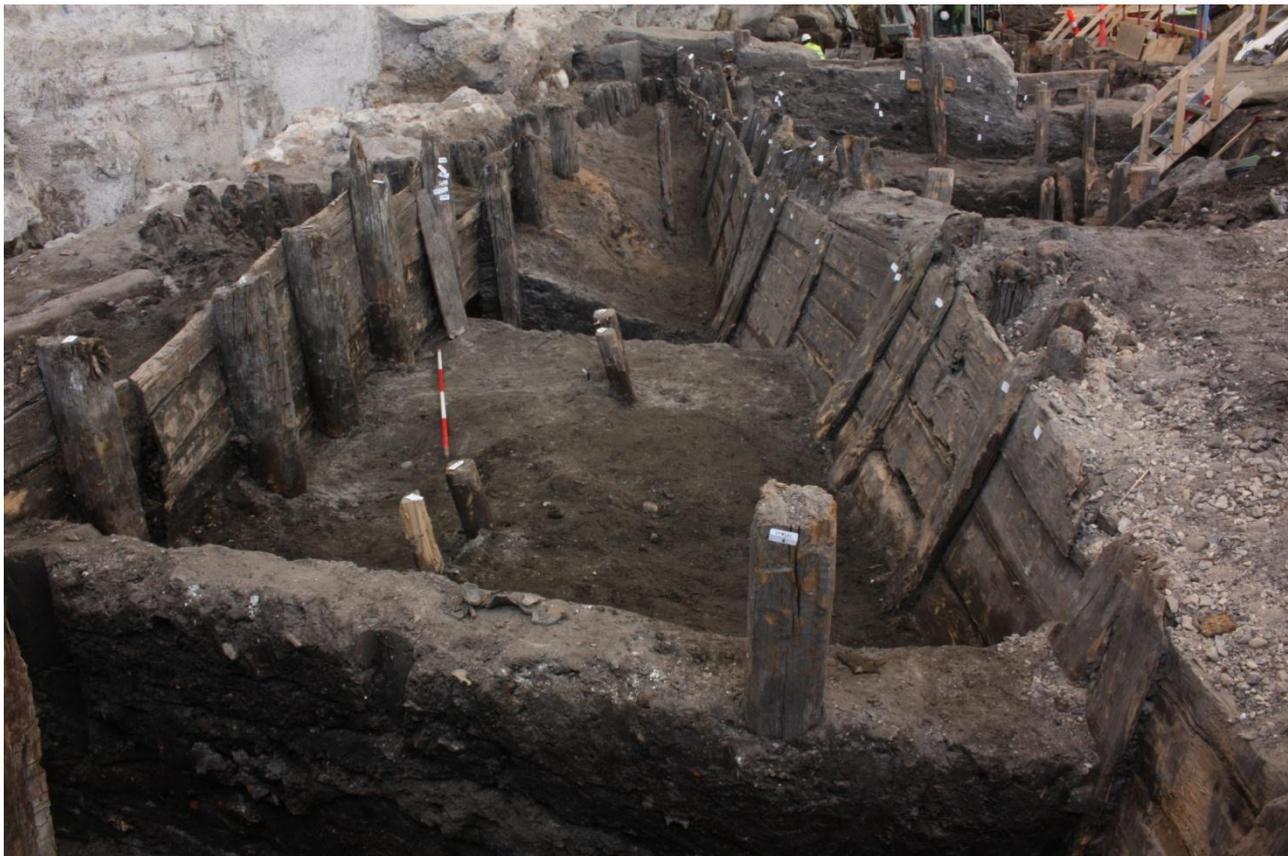
Fig. 95 Harbour wall G532 to the far left of photo, Bulwarks G674 near left, backfill group G640 centre and bulwark G648 right of photo. Looking NW. C03\_20140616\_10952

Bulwark G648 comprised a total of thirty-six vertical posts, seven horizontal timber planking structures, and five planks and posts added later for repair. The dimensions of G648 were 16.67 m long by 1.1 m wide by 1.36 m high and it was located at the levels of 0.14 m to -0.3 m OD. The vertical posts averaged between 3.5 m long by 0.2 m by 0.2 m, whilst the vertical planks were, shorter at approximately 2 m, sharing the other dimensions. They were fashioned from oak, boxed heart style, fairly rectangular in shape with one flat and one pointed terminus. They were usually pushed into alluvial deposits from Group G642 rather than having a whole purposely dug for them. When uncovered most were still vertical, but some had warped or were now at an angle due to the weight of the harbour to the north.

The horizontal planking structures were fashioned from pine. They were between 1 m and 2 m long by 0.1 m thick and 0.2 m wide. They were set behind the vertical posts, attached by nails, and placed or added in layers. Leaning into these planks were support posts, positioned at an angle. The support posts were fashioned from oak and spruce, with oak being the dominant type.

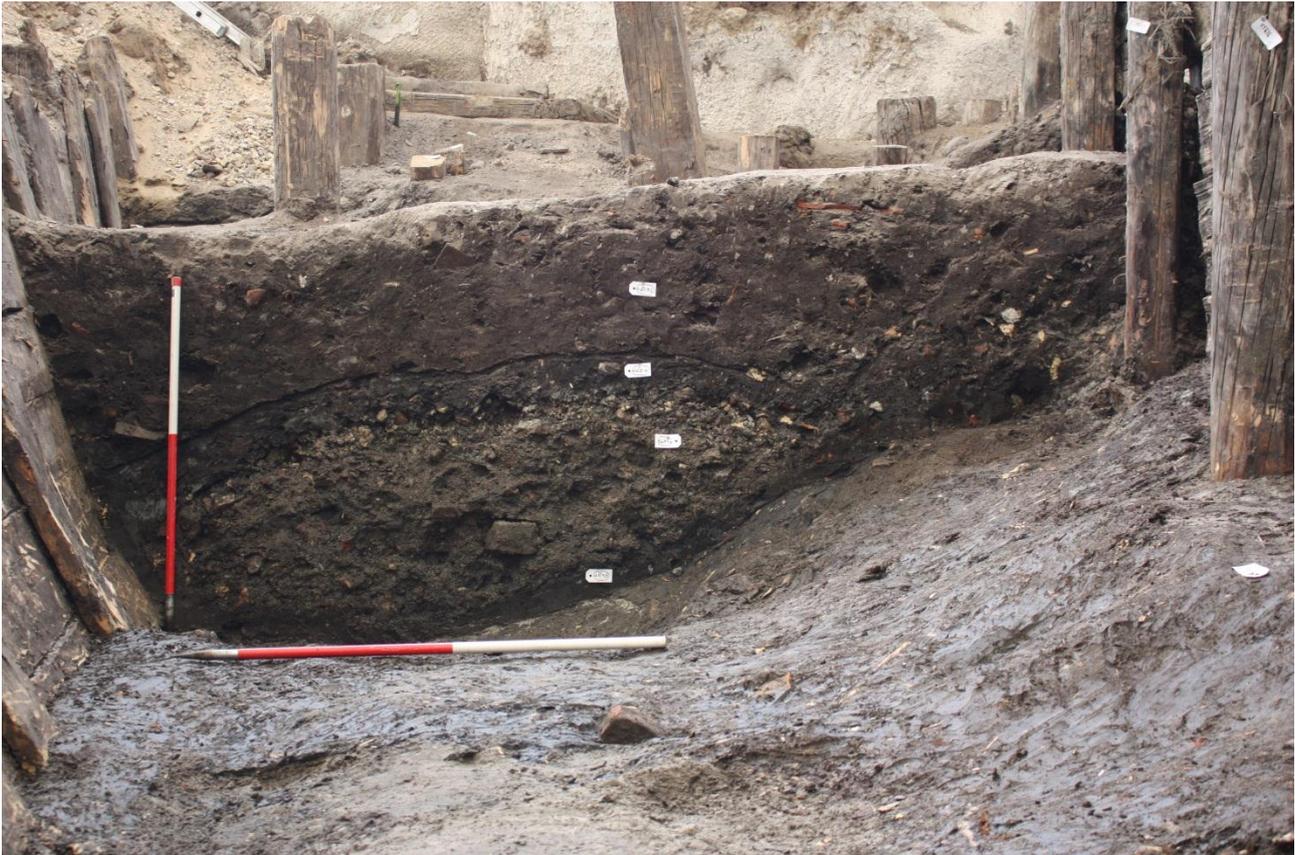
Fig. 97 Working photo of Section of G640, looking SW. The section reveals the mixture of the various types of urban waste. C03\_20140625\_11246.

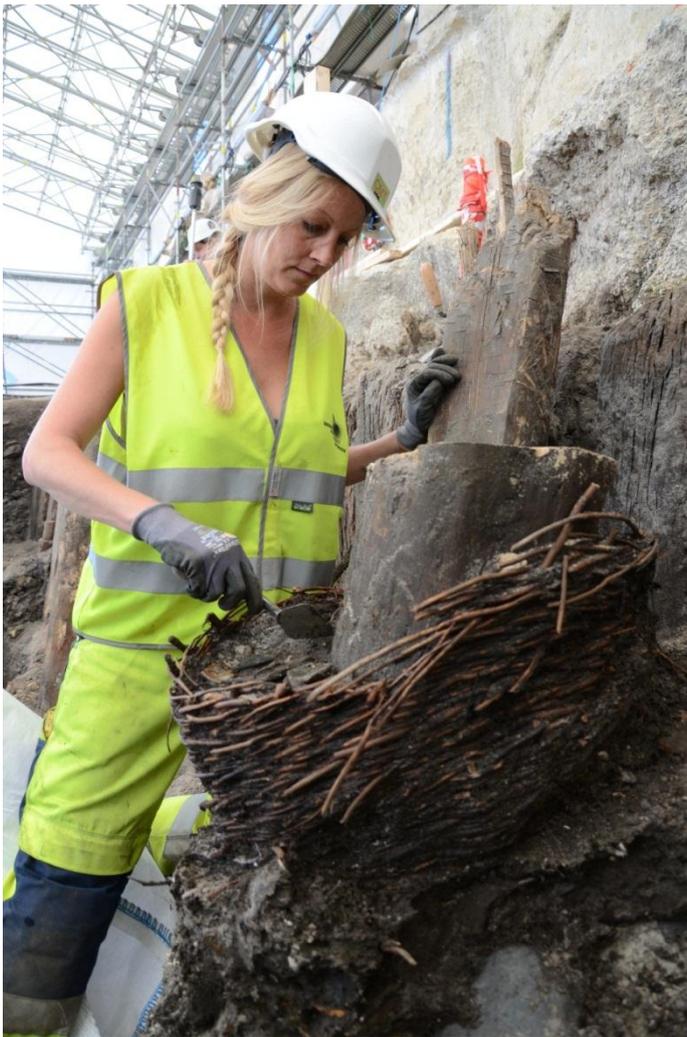
**Fig. 102 Storm Post ST34393 (G646) with wicker fish basket F0219487, G646. The upper part of the post had been recently removed to help excavation. Photo: K. K. Tayanin**

The posts were mainly rectangular shaped with a pointed tip and in good condition due to the preservation conditions. Post ST34393 comprised a fish basket fashioned from wicker, F0219487, which was later attached to the post. It is believed that the basket represents storage of caught fish, rather than a fish trap.

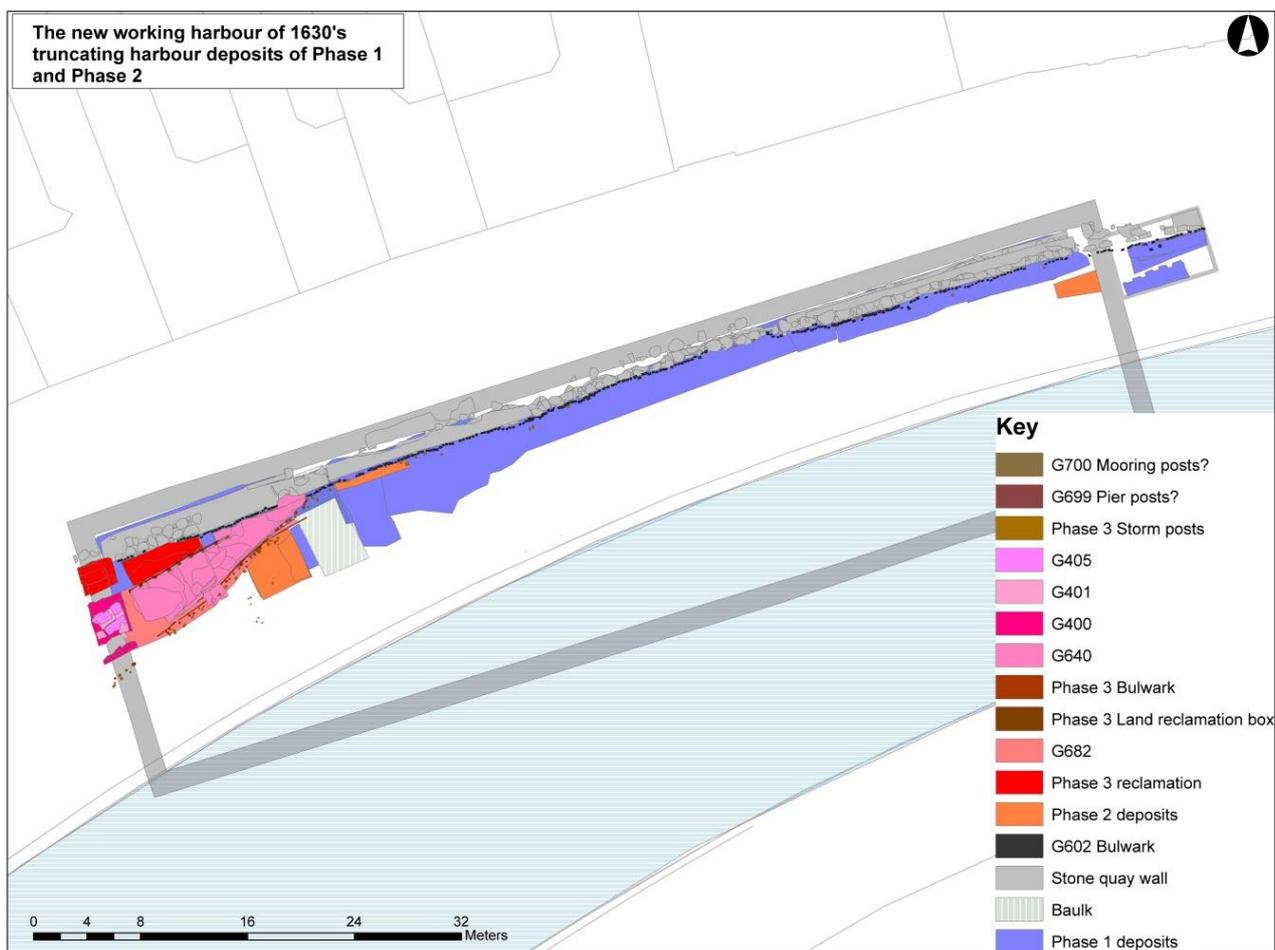
Fig. 103 Plan showing harbour activity from 1620s-1650s. Note the re-use of Phase 1 and Phase 2 deposits at the harbour base due to harbour dredging. Fig 103

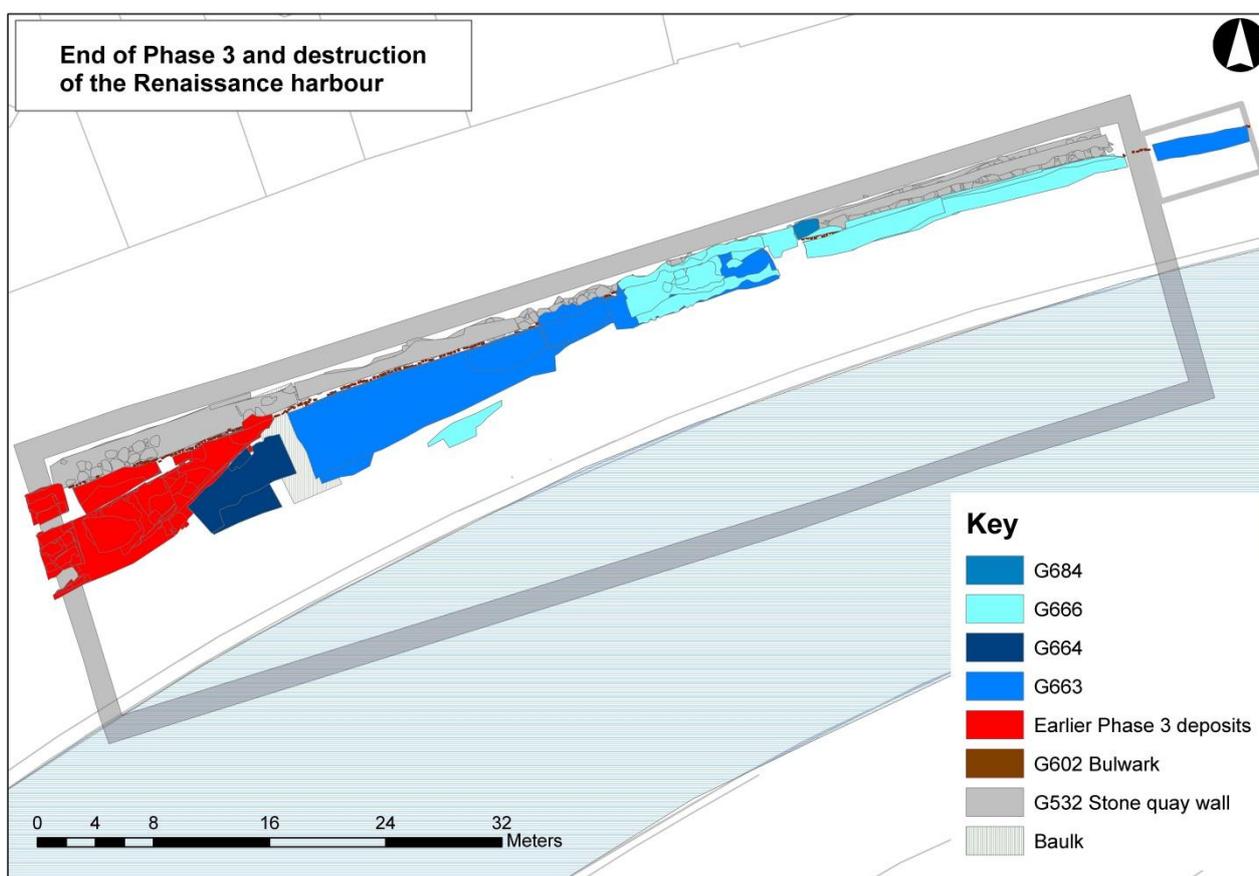
Fig. 104 Plan showing the end of Phase 3 and the destruction of the Renaissance harbour.

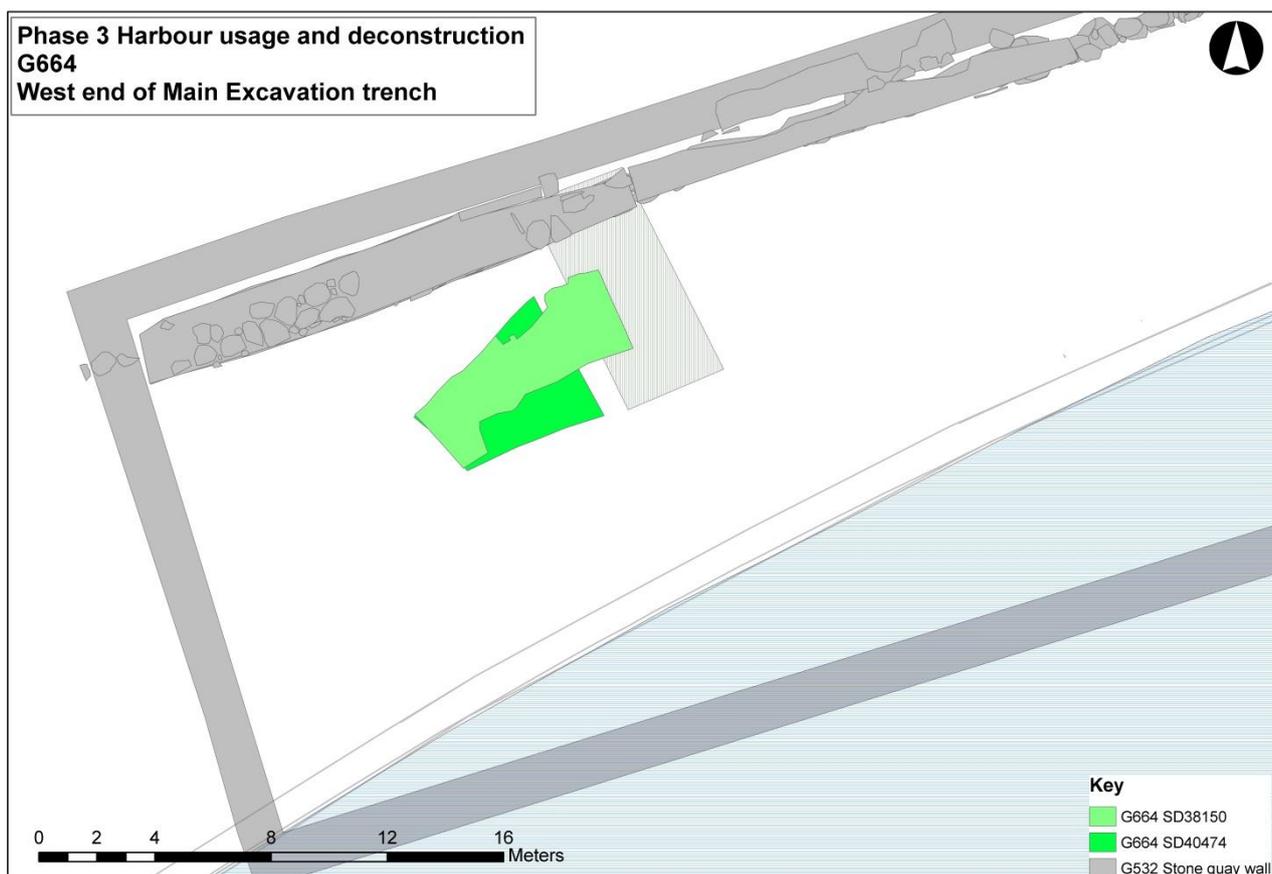
Fig. 105 Plan of G664 and the deposits within the group

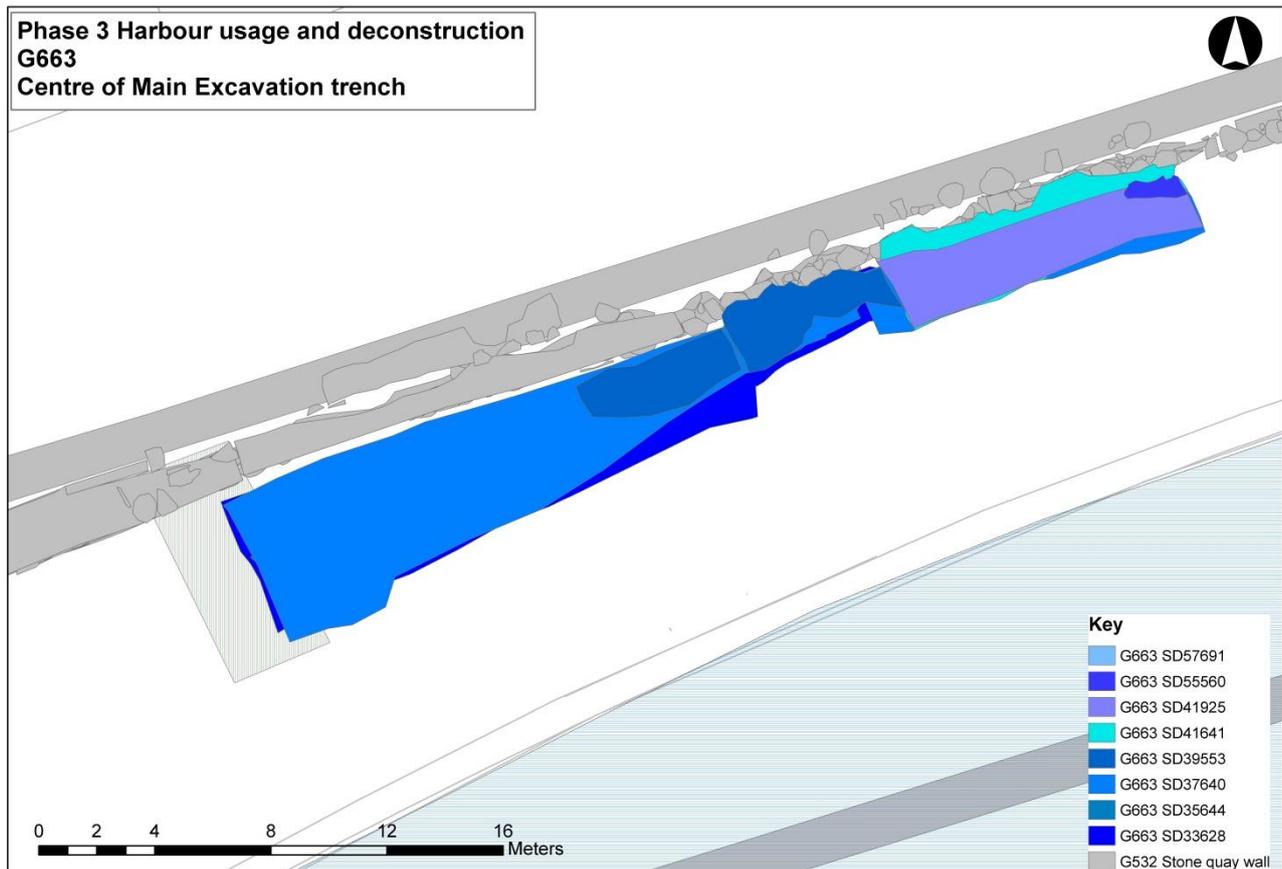
Fig. 111 Plan showing the contexts within G663, Main Excavation trench.

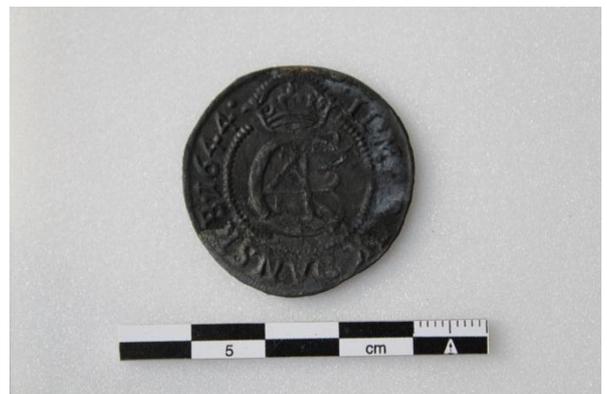
Fig. 115 FO 212520 Christian IV coin. Photo of Obverse with minting date of 1644, pre conservation. Museum of Copenhagen.

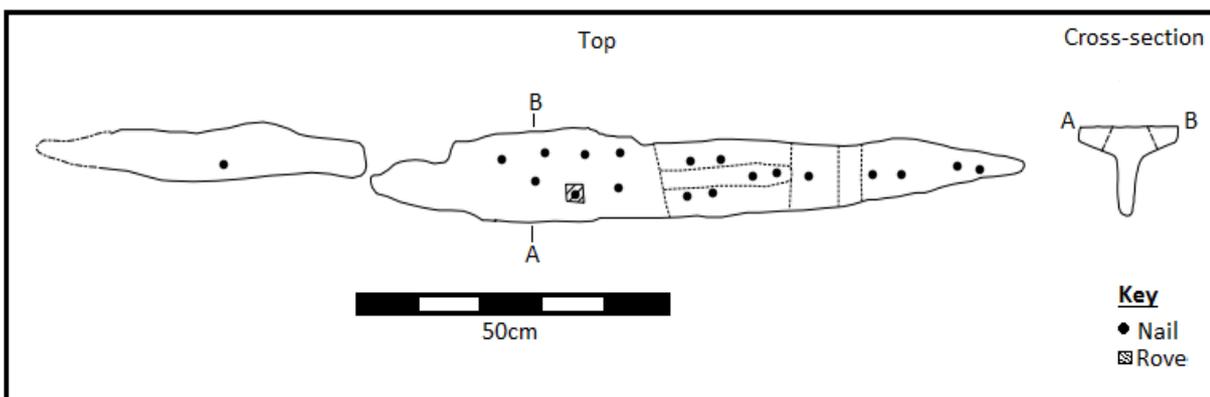
Fig. 116 FO218893 Reconstructed keel. Dashes on cross-section show angle of nails. SD37640, G663. Drawing by G. Dickinson.

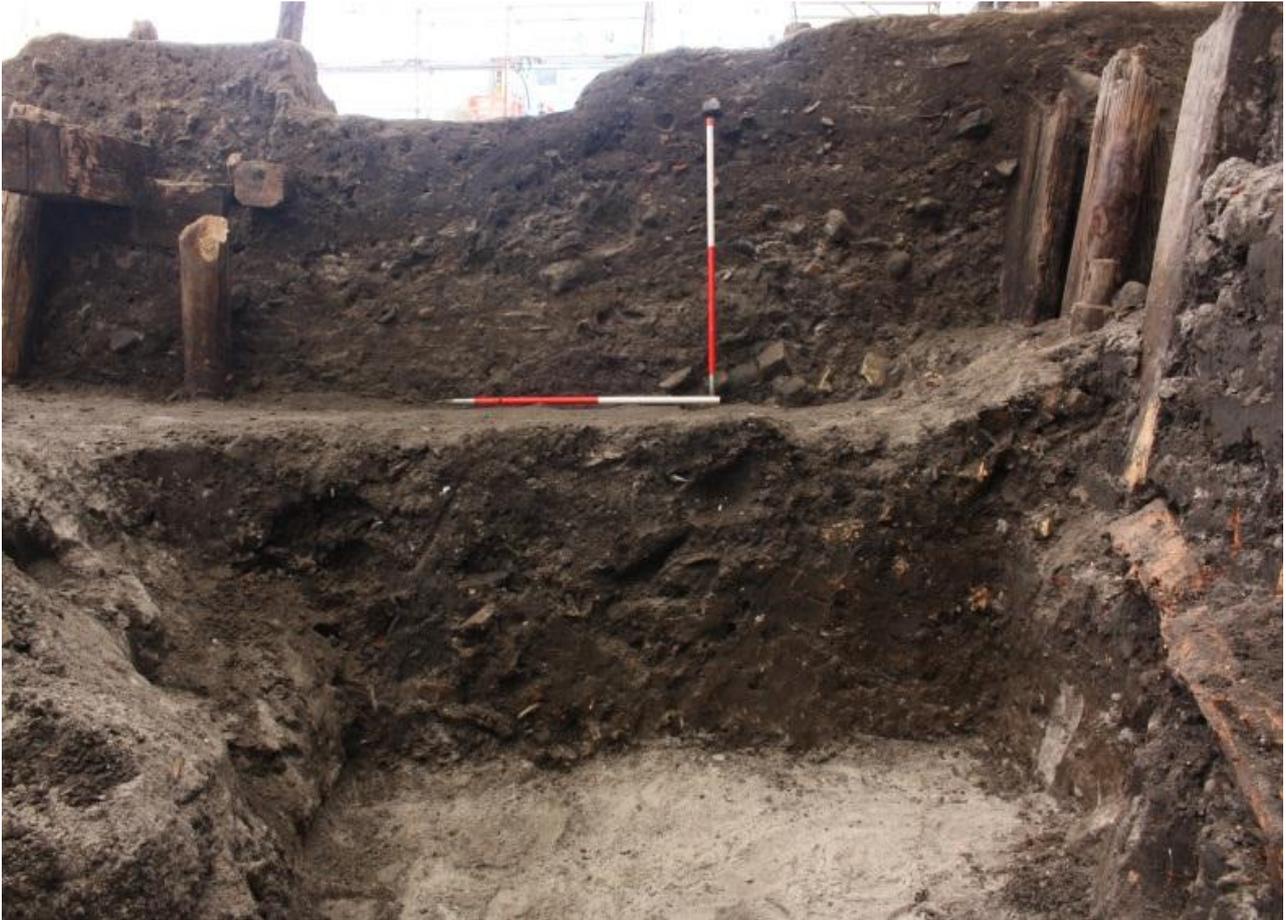
**Fig. 119 Photo of SD33628 with the baulk at the central western part of the Main Excavation, Group 663. Looking NW. C03\_20140521\_10334**

Deposit SD33628 represented a large dumping action in the central and western areas. The deposit was 24 m long by 6 m wide with an organic and silt matrix comprising material that may have come directly from a dumping site within the city. It comprised a large assemblage of clay pipes from the Netherlands with a few pipes from England. Glass was also well represented with various tablewares retrieved as well as window glass and medicine bottles. Unusually, the amount of ceramic vessels was low in the deposit. The average date pointed to the late 17<sup>th</sup> Century from these finds.

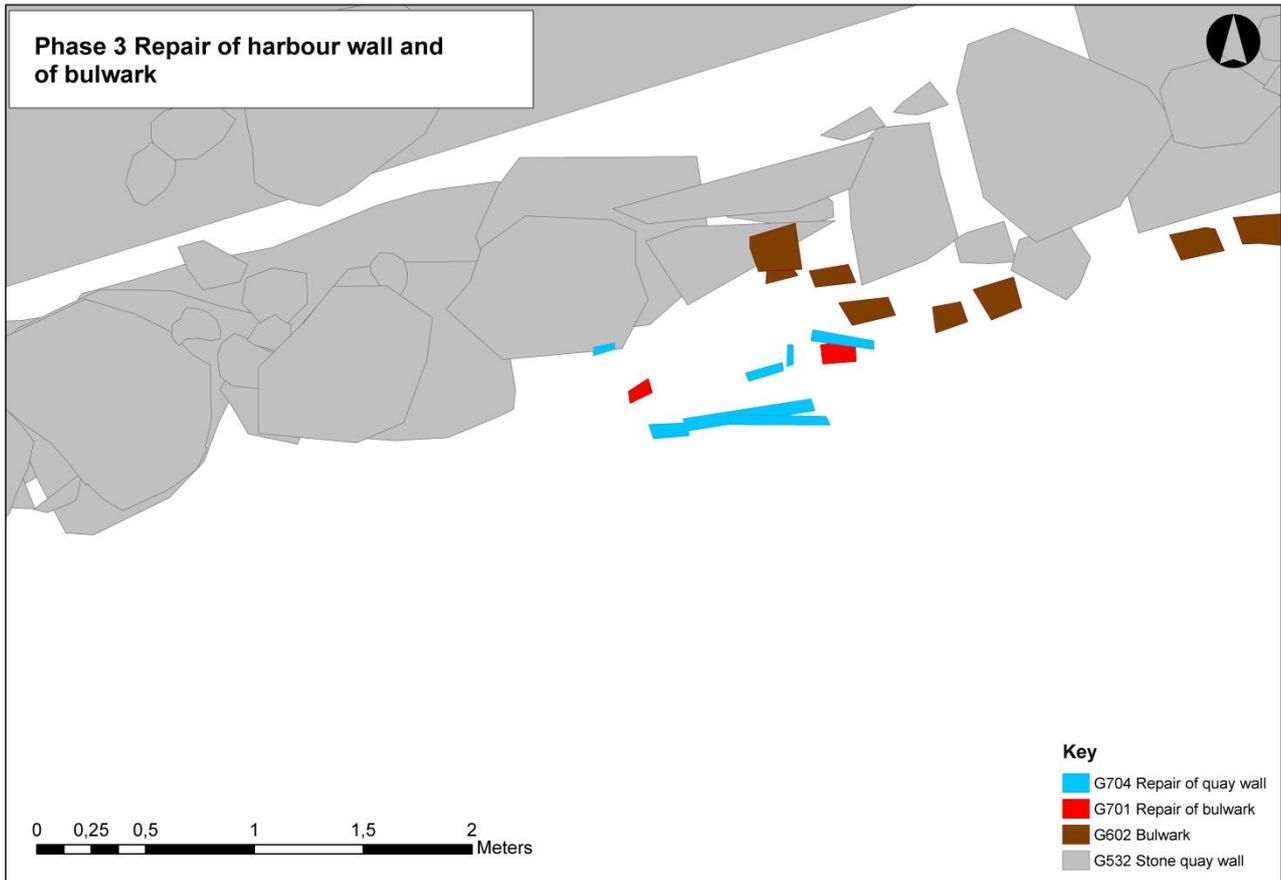
Fig. 123 Plan showing activity linked to groups G701, G704 which may suggest repair of wall G532 and bulwark G602.

Within the Main Excavation trench, evidence of repair of the harbourside was seen with groups G704 and G701. Post group G704 was a collection of planks functioning as a repair of Phase 2 wall group G532, whilst SG701 was the replacement of Phase 2 group G602.
