## 7.3. Phase 3. The Late Renaissance Global Harbourside, 1630s-1680s

### 7.3.1. Summary

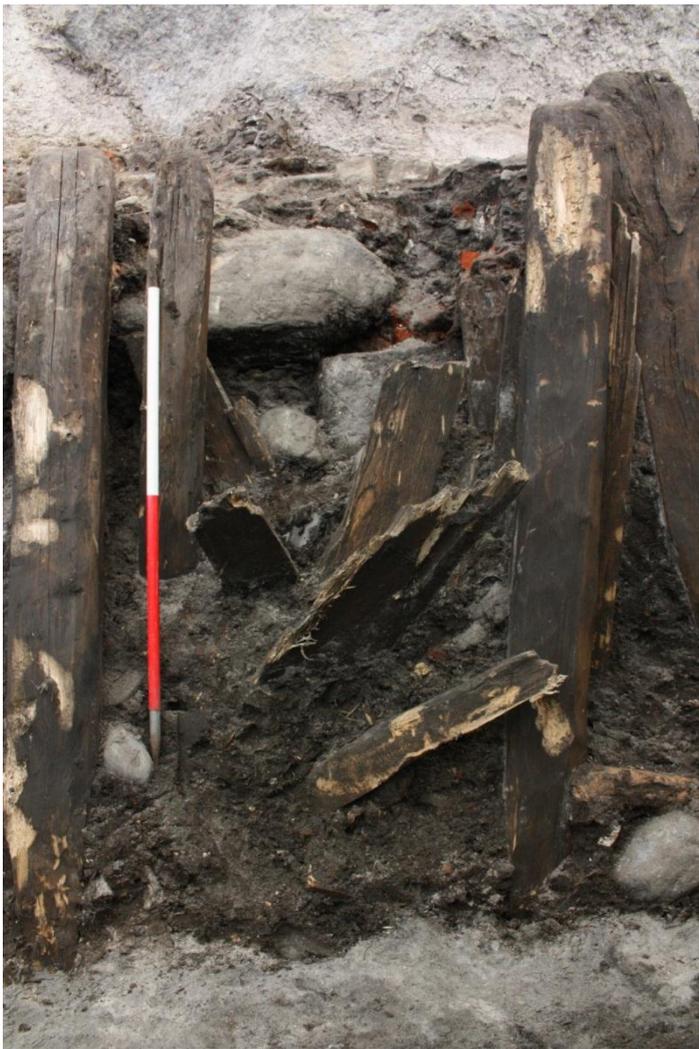
**Fig. 124 Collapsed remains of plank wall repair G704 with storm posts G701 either side. Original truncated wall G532 at rear of photo. C03\_20140618\_11043**

Group G704 comprised six planks placed directly in front of the wall G532, which was highly truncated in this area. The dimensions of this area, where the group was located, measured 1.28 m long by 1 m wide by 1 m high with various truncated wooden planks at c.1 m long. It appears that the wall was damaged after G646, the storm post group, was inserted into the ground. From the dating of the finds and the overlying dump deposits, this would have occurred between the mid 1640s and the 1680s when the various deposits from G663 were inserted into the harbour area. The planks were up to 1 m long and 0.15 m wide, tangentially set, appeared much worn in comparison with the surrounding wood, and was suggested by the archaeologists to have been reused. The difference in quality of the stone wall and differential style suggests uncontrolled maintenance and lack of care of the facility.

earlier G602. This area was then further backfilled and covered over at the end of Phase 3 and beginning of Phase 4. It is not known what caused the plank G704 and repair posts G701 to collapse, but within the soil deposit SD55560, cannonball or grenade FO212798 was found (as seen in Fig.125). This deposit overlay the planks, posts and lower soil deposit SD41925, and arguably the impact of the cannonball smashed the wall, posts and planks and led to the partial creation of SD55560, which then continued to be formed in the later 1600s.

The wall here comprised very few facing stones and was thus poorer in quality than other sections of G532. Damage in this area seems to have led to the original stones being removed and the plank wall being constructed. After the planks were inserted G701 was created. Group G701 comprised two posts, ST45220 and ST45216 pushed through usage deposit SD41925 of G663. This differed to the hundreds of posts from G602 which were pushed through Late Medieval deposits.

It is believed that at some point in antiquity, perhaps in the mid-late 1600s, that the plank repair G704 collapsed and posts from G701 were pushed away, hence their discovery at different angles to other posts from the

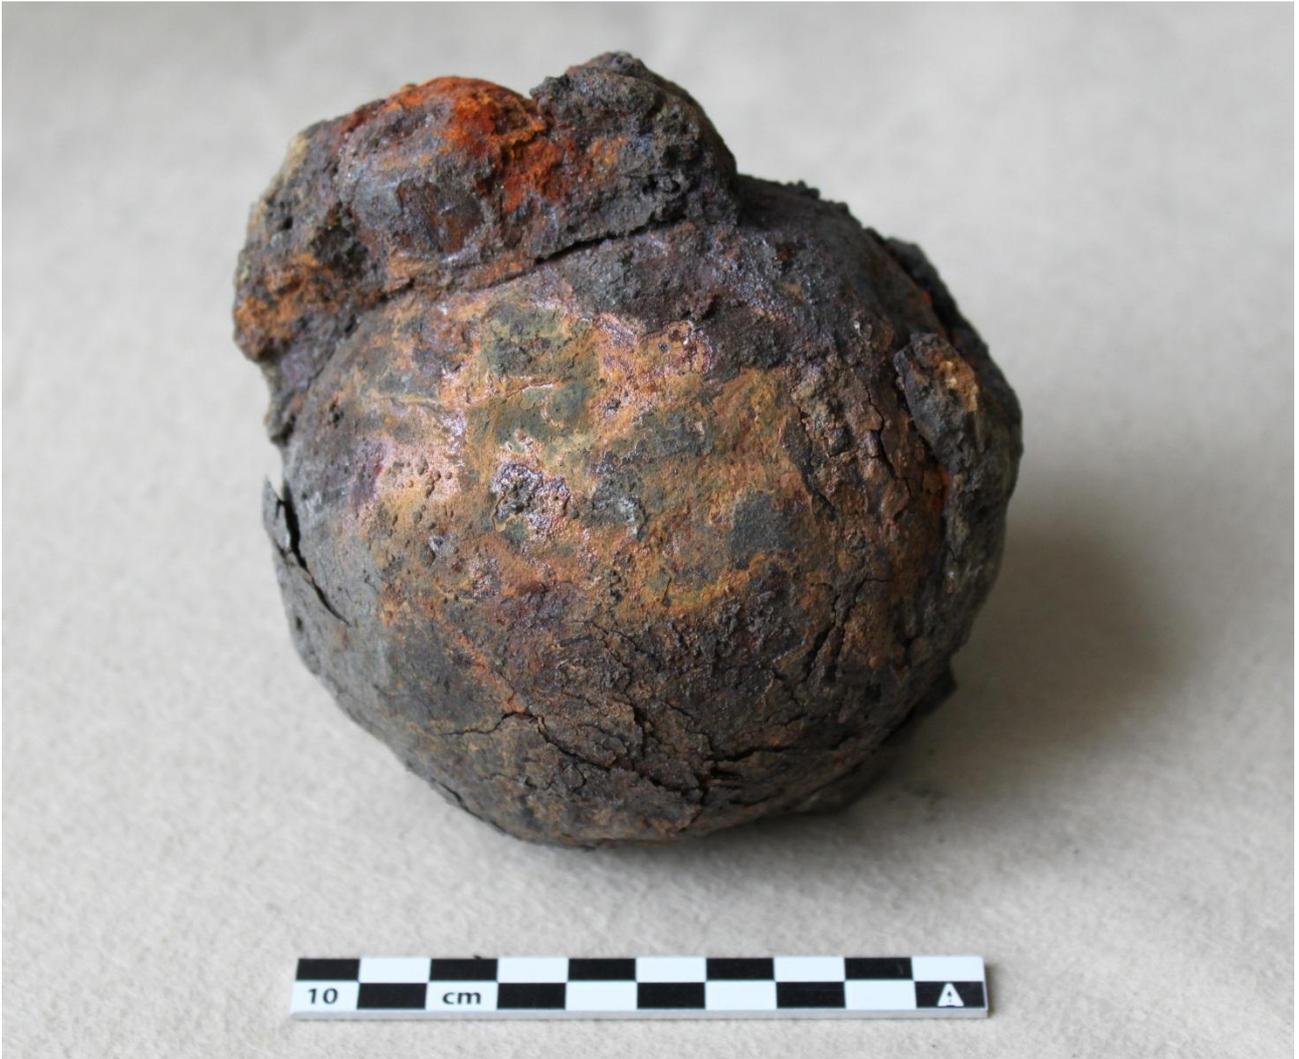
Fig. 125 Iron cannonball FO 212798, from SD55590, G663. Pre-conservation photo. Museum of Copenhagen.

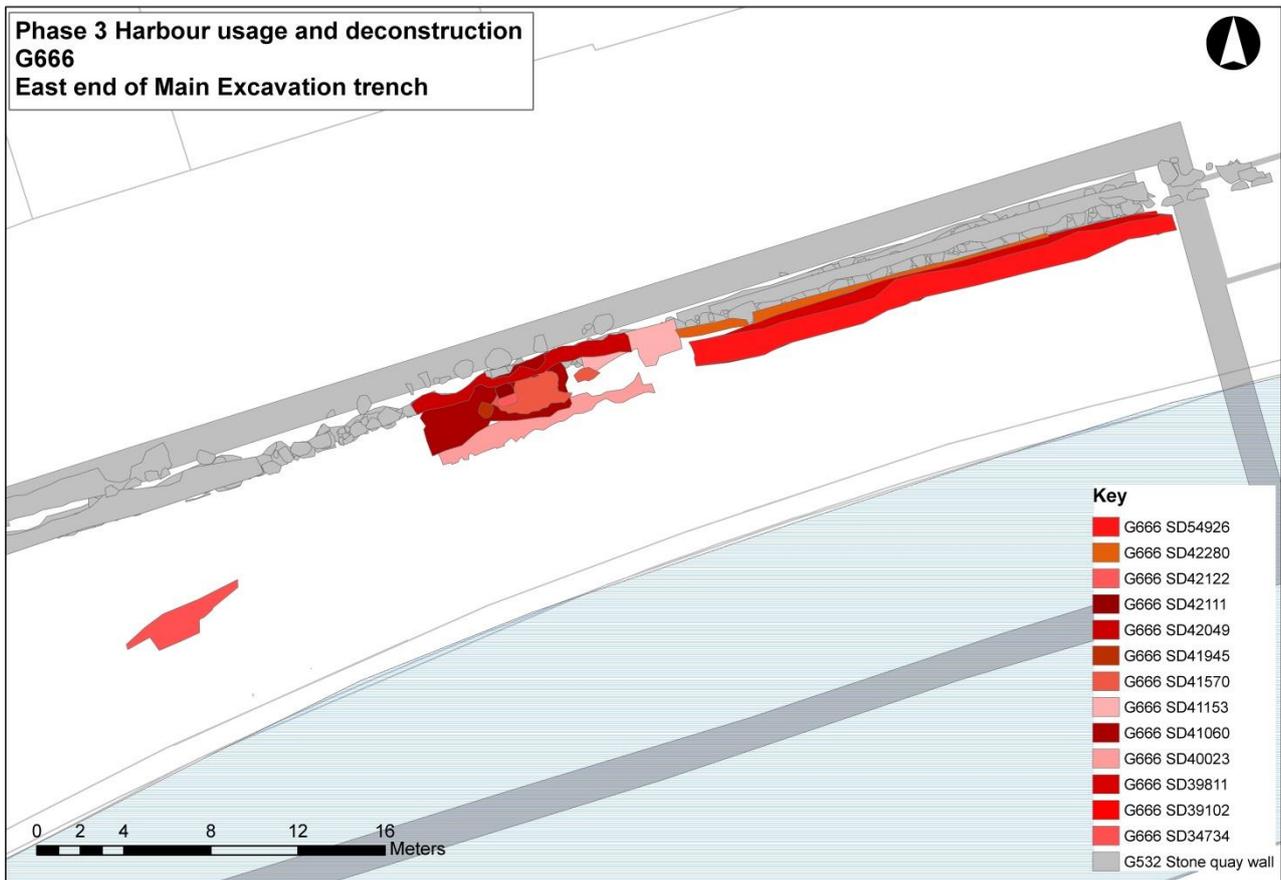
Fig. 126 Plan showing destruction group G666, and their contexts.

Group G666 comprised thirteen deposits. The group was a mixture of urban dump deposits within the harbour and the demolition of wall group G532 in the form of mortar dumps, brick dumps and foundation stones, merging with construction activity with reclamation layers for Phase 4. This phase dates from the mid 1600s until the late 1600s. The deposits were either found south of the wall G532 or physically above the remains of former wall G532. The group was located in the central and eastern areas of the Main Excavation trench and measured 59.85 m by 3.89 m by 1.5 m to 2 m deep, with highest points of the groups between c. 0.1 m OD to the north, to -1.2 m OD in the south, reflecting the slope of the landscape and tipping style of the dumping procedure.

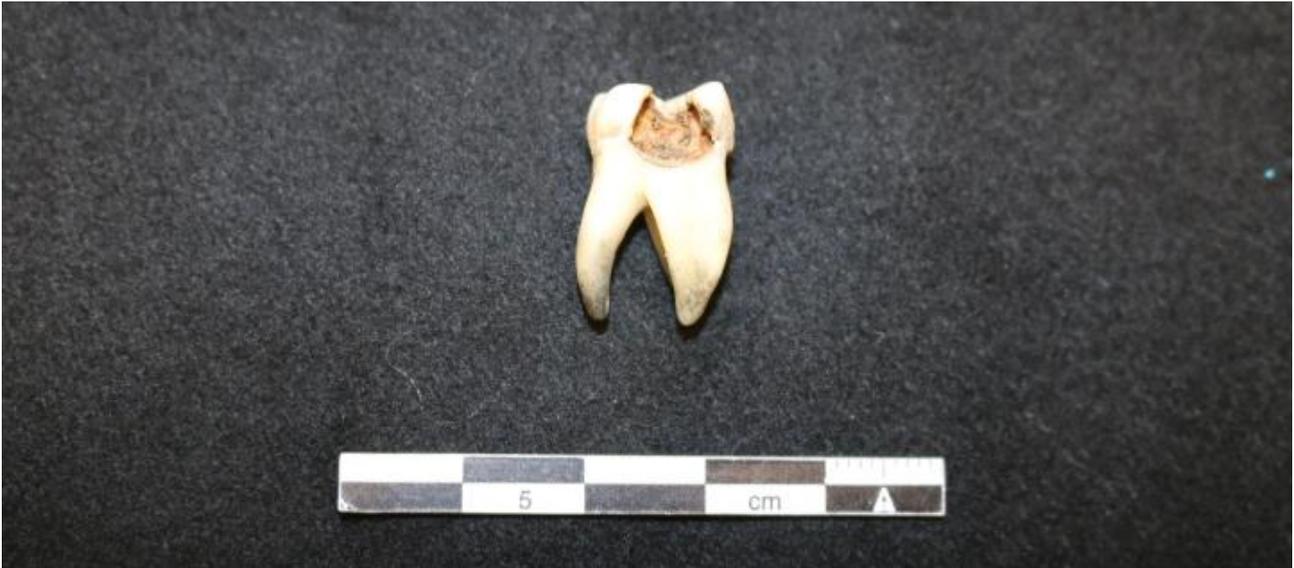
Fig. 127 Human molar, FO214734, SD39811, G666. Evidence of tooth decay in the late 17<sup>th</sup> Century. Museum of Copenhagen.

Deposit SD54926 was overlain by a rubble and sand rich layer, SD39811. The layer was again packed with finds of urban waste and measured 13 m by 1.3 m by 0.7 m thick. Amongst the finds was a human molar FO214734, most likely removed and then discarded due to the large cavity caused by decay (see Fig.127). Deposit SD39811 was overlain by a more organic deposit, SD39102, with roughly the same measurements.
