## 7.4. Phase 4. The Administration Harbour, 1690s-1820s

### 7.4.2. Introduction

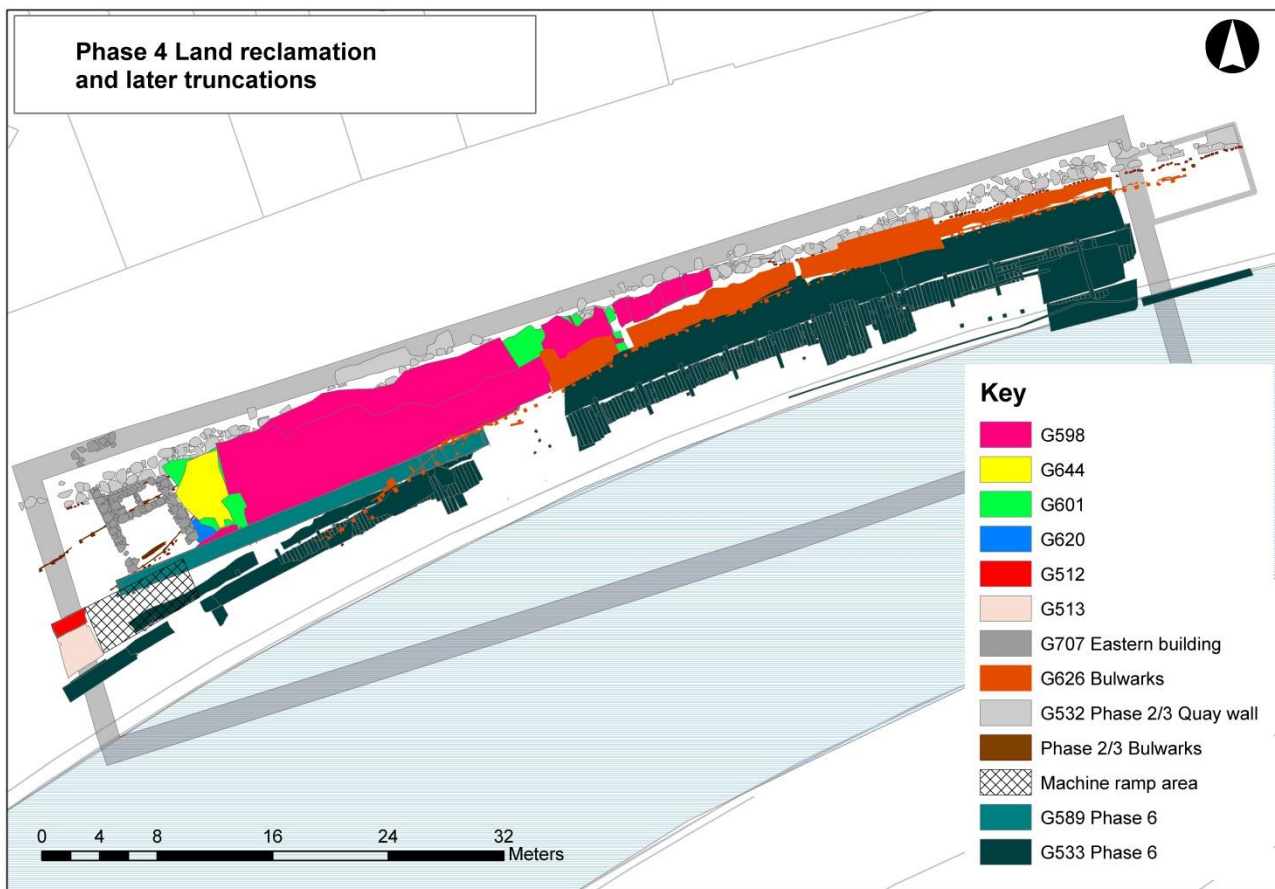
Fig. 142 Phase 4 land reclamation and later truncations

The distribution of deposits interpreted and grouped as land reclamation layers is not evenly spread, when seen in plan (see Fig. 134 and Fig. 142). In the westernmost end of the excavation area, the area between the western Guide Wall trenches and G620 is empty in terms of land reclamation layers. This is due to circumstances, of which one is the fact that the area was partly not excavated as it was used as a ramp for facilitating the access of the machine into the trench. The machine ramp was of course placed at the limit of the excavation and hence the area south of the ramp was outside the excavation area. The construction of the eastern building, G707 (see sub-chapter 7.4.3.6.) would have truncated and possibly removed some of the upper land reclamation layers. This would have produced a gap north of the machine ramp, while the construction of the large Phase 6 structures, G589 and G533 also removed considerable amounts of land reclamation material. Another factor is that there were difficulties in differing between land reclamation layers and former usage/activity layers, as well as between land reclamation and levelling layers.
