7.4.3.2. Land ties

7.4.3.2.1. Introduction

7.4.3.2.2. Groups interpreted as Phase 4A land ties

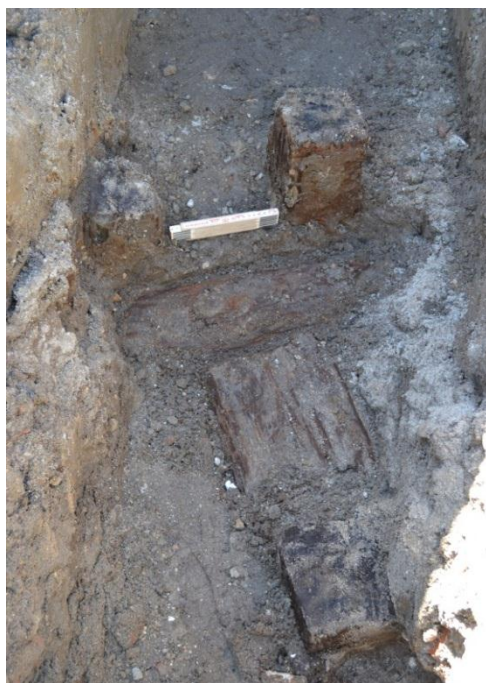
Fig. 144 Land tie G524. Looking SSE. C115_1282

On the NW side of the two posts, a stretcher beam, ST9009 was placed horizontally up against the posts and with the same orientation. Only 0.6 m of its length was exposed, but the beam seemed to be approximately 0.2 m wide. On the top of the beam some corroded iron indicates the presence of an iron nail or spike, possibly fixing the stretcher beam to the underlying anchor beam. It is not certain that the anchor beam was seen due to the excavation depth limit, but on the NW side of the stretcher beam a piece of NW-SE oriented horizontal plank (ST9017) was recorded. Because of the depth limit, the timber could

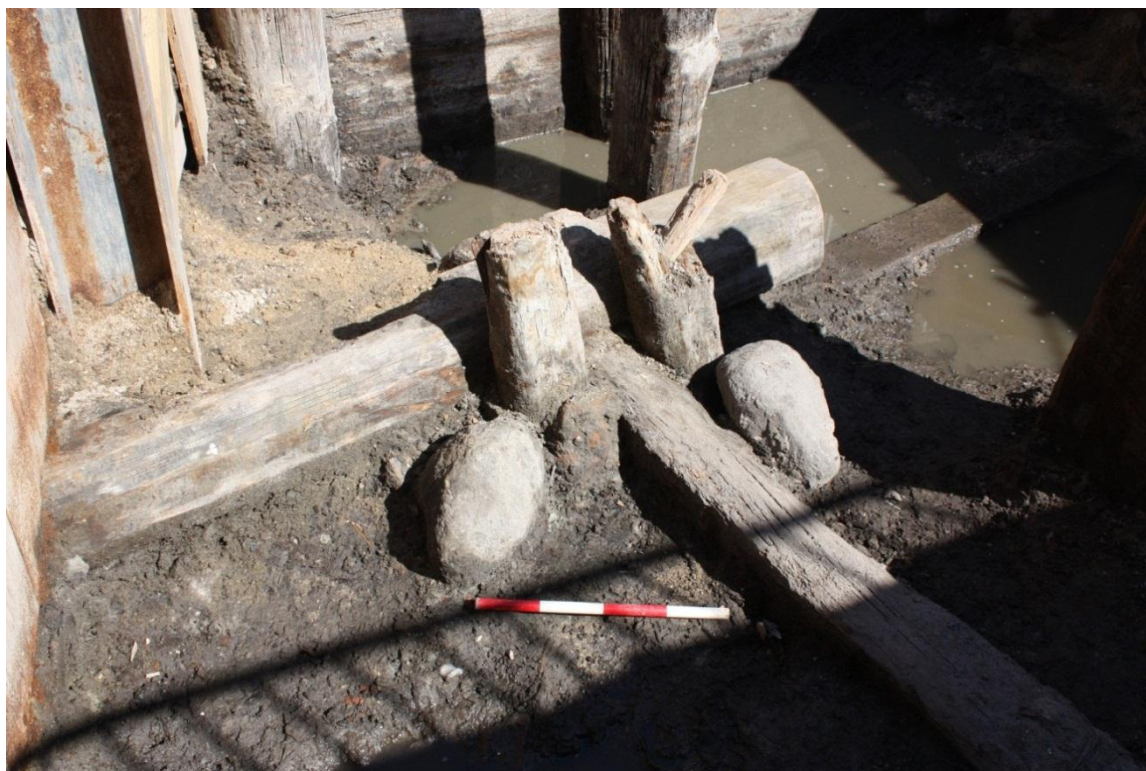
Fig. 145 G404 excavated during the 2012 Guide Wall excavations. Looking north. C03_20120725_5172

The group comprised horizontal beams, ST11566 placed on top of deposits SD11056 and SD11477 (G405, Phase 4 land reclamation). ST11566 measured 3.1 m by 0.19 m and lay on a NE-SW orientation. It was only exposed and measured due to periodic tidal flooding. The beam was attached to horizontal beam ST10790 lying above on a NW-SE orientation and measuring 3.1 m by 0.2 m by 0.14 m. The southern extension of beam ST10790 was later surveyed as ST19300. Beam ST10790/ST19300 had joints (not fully documented), indicating that the timber was not initially made for this purpose, or it had been transported in a way that had necessitated these joints. Secured by nails from above was horizontal beam ST10459 measuring 1.36 m by 0.25 m by 0.18 m, on the same orientation as ST11566. Beams ST10459 and ST11566 were kept in position by vertical posts ST9361 and ST9365. Post ST9361 was exposed to a height of 0.46 m and measured 0.14 m by 0.12 m in cross section. Post ST9365 was pulled from the soil to be measured fully. The post was sharpened to a point, measuring 2.15 m long by 0.15 by 0.13 m in cross section. The vertical posts were secured in their location by boulders SS12277 and SS12270, each roughly 0.3 m by 0.2 m by 0.2 m in size. East of ST10790 was another horizontal beam, surveyed as ST10785, which was seen as linked to this land tie, but truncated by later actions.

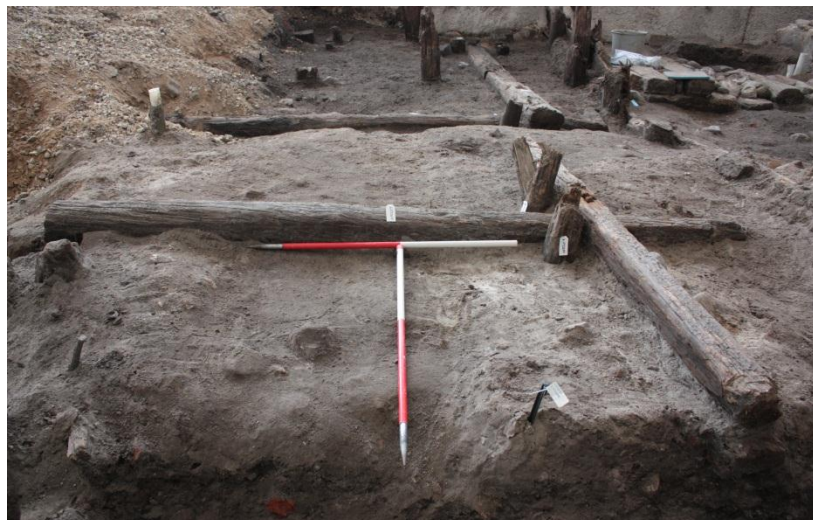
Fig. 148 Western parts of G641. Looking WSW from truncation SC33573. C02_20140508_9310

This group was excavated during the 2014 Main Excavation. G641 consisted of a lower stretcher beam, surveyed as ST36921 and ST37652 on the western and eastern side of the truncation SC33573 (construction

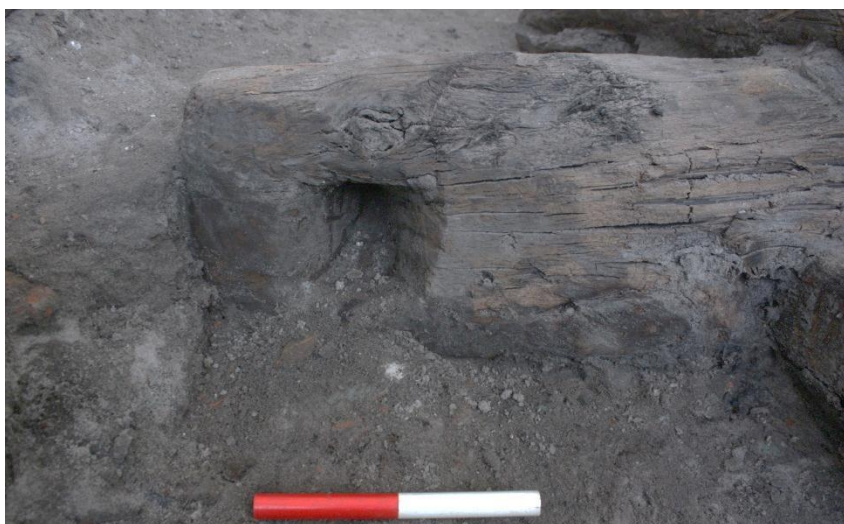
Fig. 149 ST 53643 (G641). Tapered mortise in north end. Looking E.
C03_20140508_10123

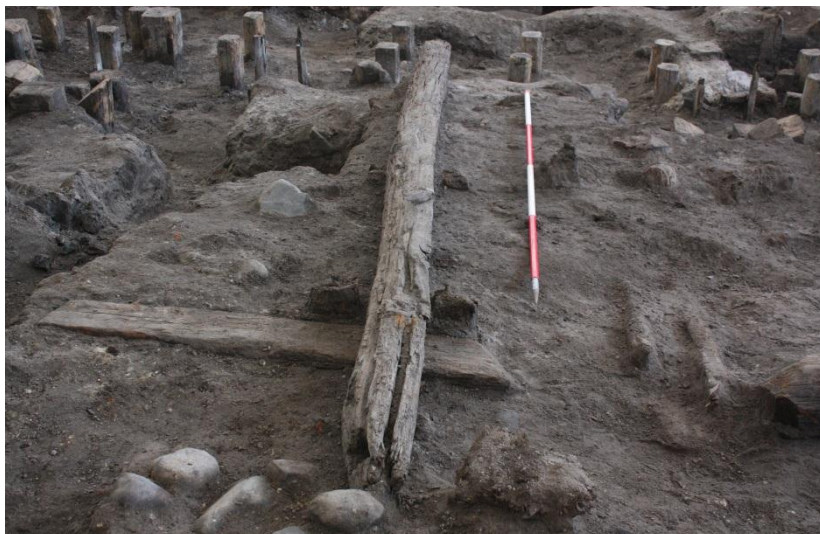
Fig. 150 G652, land tie. Looking SSE. C03_20140508_10127

G652 is interpreted as part of a land tie structure. The documented timbers probably represent the rear, western part of a larger land tie system, possibly including (parts of) G653, which was found east of G652. The land tie would have extended further south, possibly consisting of a middle stretcher and a front stretcher, to meet with a bulwark structure, for which the land tie had its purpose. However, the southern parts would have been truncated by later activity and the assumed bulwark structure (the westerly continuation of SG604) could possibly be located south of the excavation area.

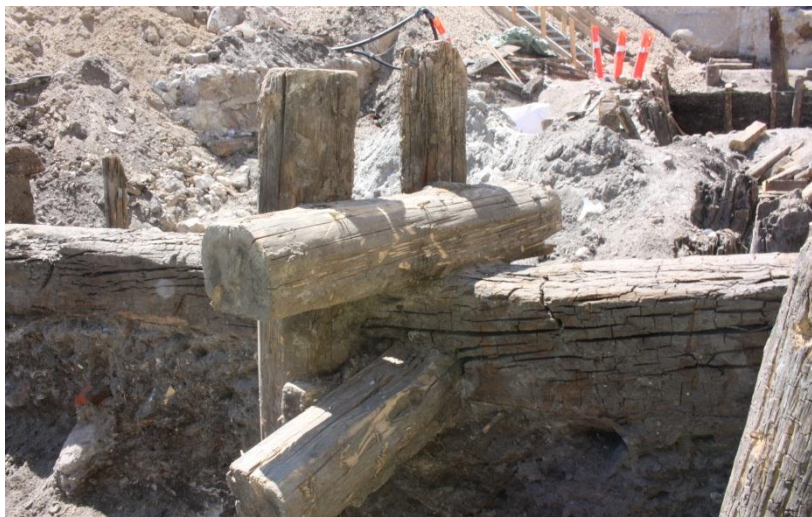
Fig. 151 G653, anchor beam ST47244, with unsurveyed vertical posts and upper and lower rear stretchers, ST53544 and ST39289. Looking SW. C03_20140711_11544

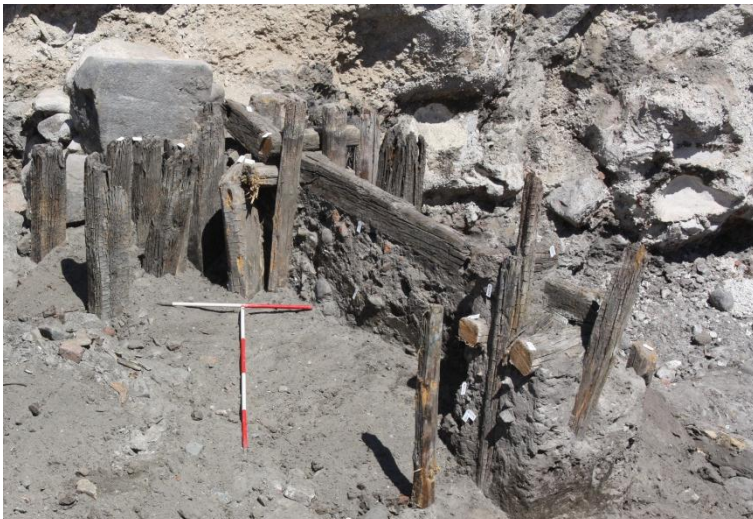
Fig. 152 G653, land tie. Looking NNE. C03_20140711_11538 (cropped)

ST37340 was ST39289, surveyed east of the truncation, SC53909, but hardly any information about this timber was recorded. It seems, however to have extended into the baulk and continued under the anchor beam, ST47244 (see Fig. 152). Both the anchor beam and the surrounding timbers were only partly recorded once the baulk was broken down.

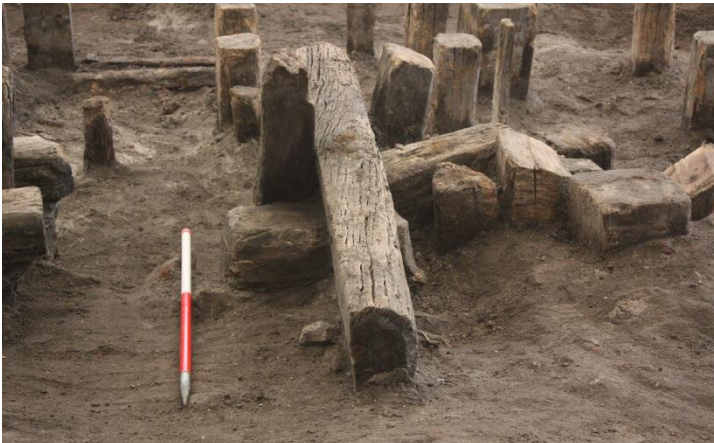
Fig. 153 G639 land tie. Looking S. C03_20140508_10143

G639 comprises two parallel stretcher beams, ST53581 and ST53588, which were both lower stretchers, as the anchor beam, ST53575, was placed above them. The northernmost of the stretchers, ST53581 was a

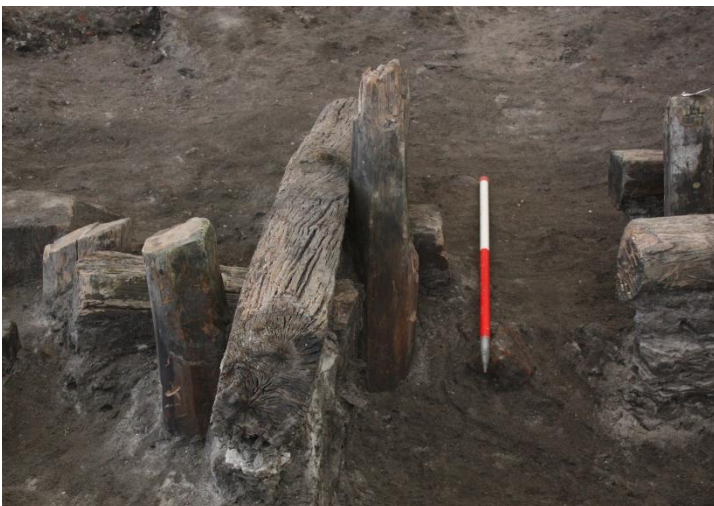
Fig. 154 G639 land tie. Looking N. C03_20140508_10147

Above the two stretcher beams, anchor beam ST53575 was placed in a NNW-SSE orientation. It was attached to the underlying ST53581 by a large iron nail or spike. Two halving lap joints are mentioned, but not fully recorded and it is not clear if these were structural parts of the land tie, or indications of reuse. It was noted that the anchor beam was more worn than the other elements of G639, which could be an

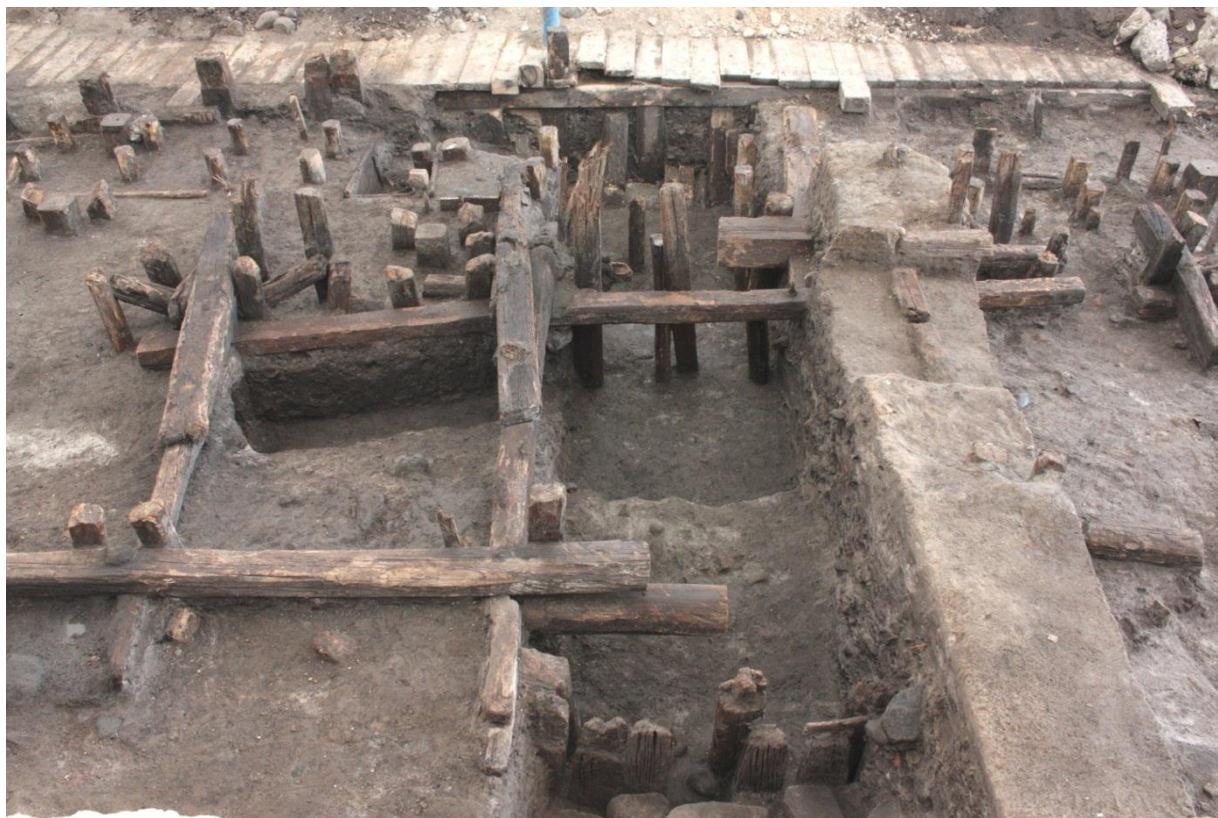
Fig. 156 15 G601, western parts of the land tie and the baulk. Looking SSE. C02_20140507_9187

G601 comprises a lower, rear stretcher, ST36724, which was a 6.47 m long pine beam, NE-SW orientated (with a slight deviation towards ENE-WSW). The beam was rectangular to square in cross section, with slightly rounded corners and was made from a boxed heart timber cut.

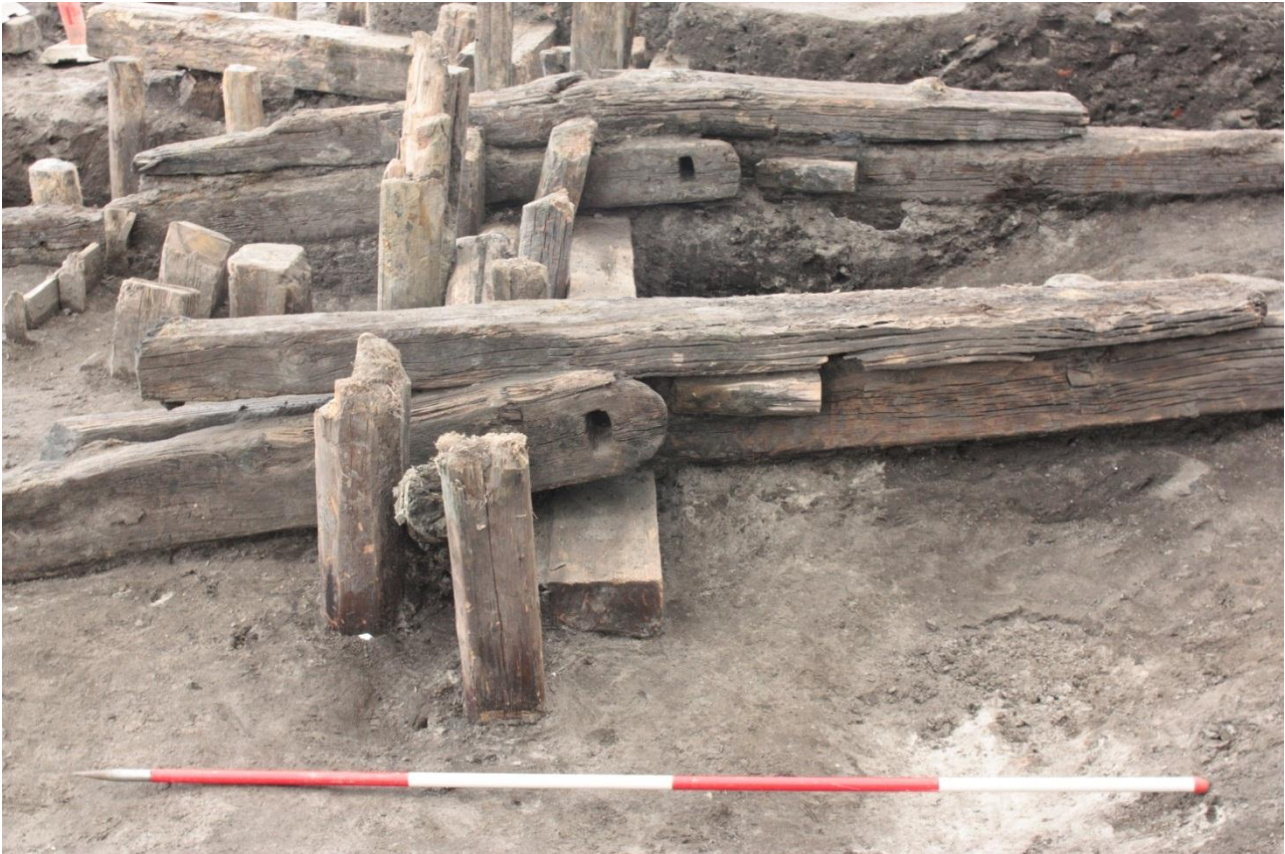
Fig. 157 G601 eastern parts. Looking SW. C02_20140508_9278

Approximately 1.8 m east of the anchor beam ST36630 was another anchor beam. The beam had been broken in two in antiquity, and the northern end had been registered as ST36609 while the rest was registered as ST36570. In total this beam was approximately 4.6 m long and made from oak. The northern end was tapered and had a mortise near the tip as seen on a lot of other Phase 4 land tie anchor beams. On the southeastern side of ST36570 was a (not surveyed) wedge shaped attachment, similar to ST36657 (see photo C02_20140508_9278). South of this attachment, another anchor beam, ST36684 was placed against the southeastern side of ST36570. Like the other anchor beams ST36684, was made of oak and bore the same traces of reuse. Like ST34081, ST36684 extended under the later quay structure, G589, and the south end of the beam was split, probably from a large nail having been hammered into it. On top of the middle

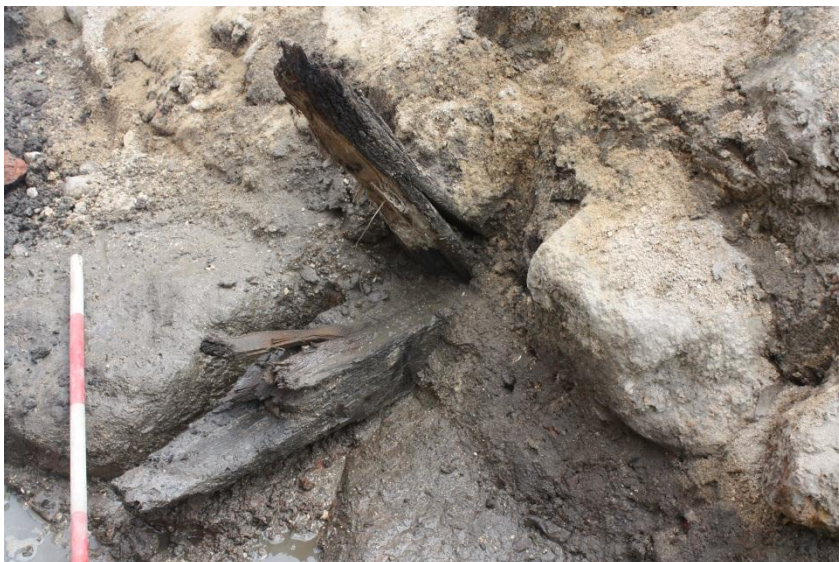
Fig. 158 ST10224 (G609) excavated during the 2012 Guide Wall excavation. Looking SE. C03_07092012_4776

Between the two posts, ST35944 and ST35940, was an anchor beam, the north end of which was surveyed as ST10224 in the 2012 Guide Wall excavation. The southern extension of this was recorded as ST37481. From photos it appears that the northern end of ST10224 was tapered in the same way as many other anchor beams from this phase (e.g. G676, G641, G653 etc.), but it was not possible to see if there had been a mortise near the tip.

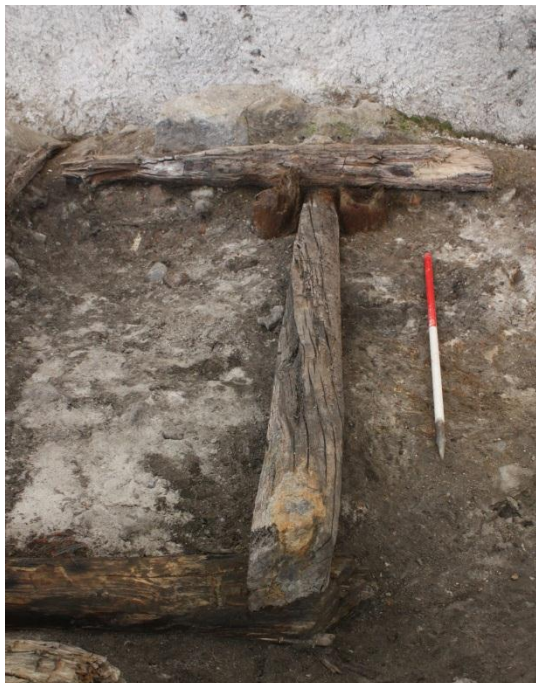
Fig. 159 G609 land tie. Looking NNW.
C03_20140508_10165 (cropped)

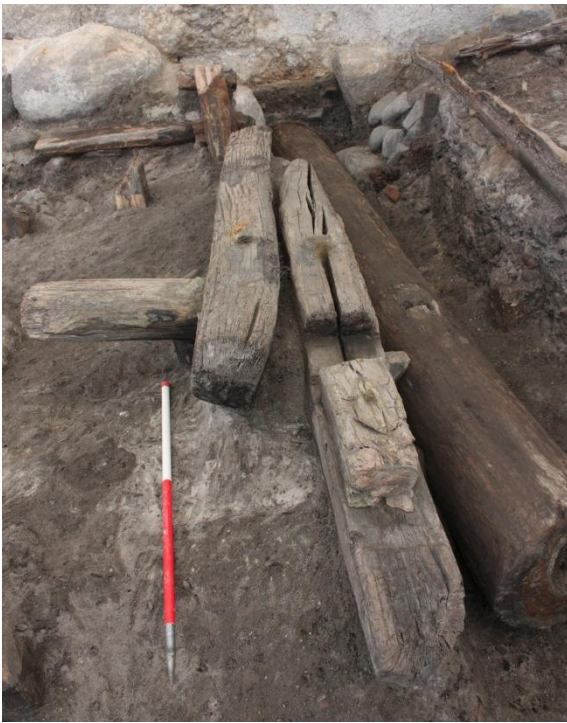
Fig. 160 G611 land tie, Looking NNW.
C02_20140509_9317

G611 comprised a vertical post, ST37584, which was driven into the ground (though exactly from which level/deposit is not clear). The post was circular in cross section (whole), but only approximately 0.13 m in diameter. On top of the post, but not fixed to it, was a stretcher beam, ST36602. The stretcher was 1.2 m long and ENE-WSW oriented, with a slight deviation towards E-W, and thus slightly different from the orientation of the stretcher beams in the land tie west of it (G601). The stretcher was preserved at an angle of approximately 35 degrees to the horizontal, possibly due to the disturbance from a wooden gutter (G231, Phase 5) immediately to the east of G611. It is plausible that ST36602 continued – if not as the same

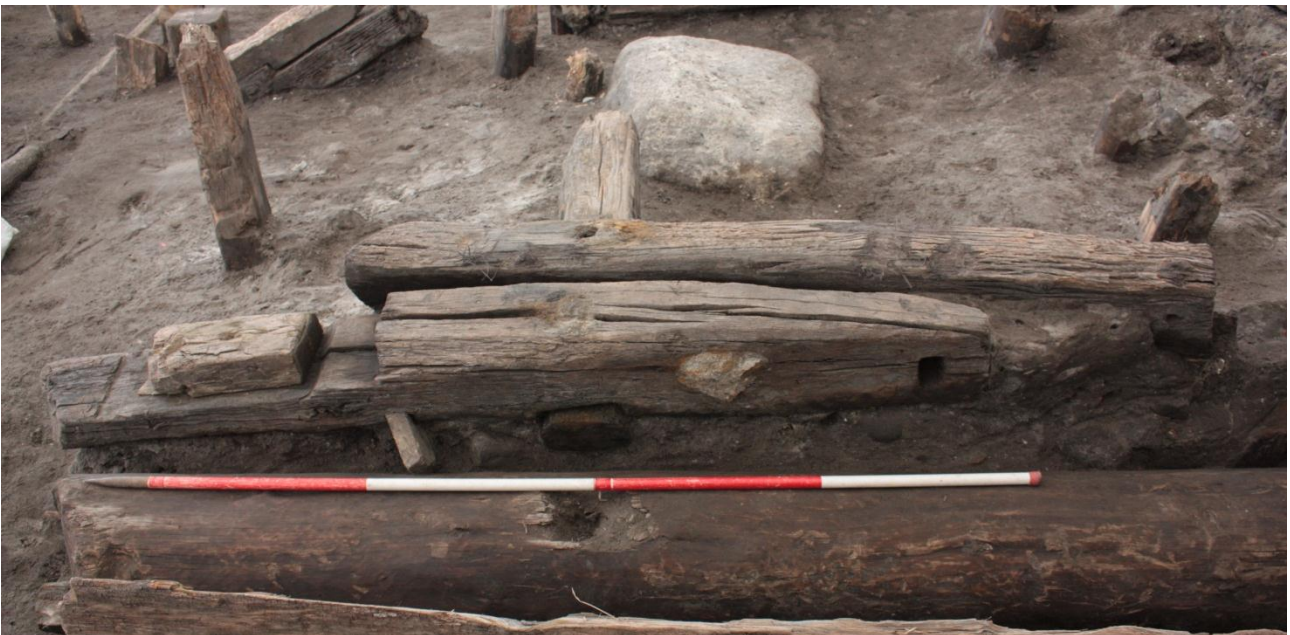
Fig. 161 G611 land tie. Looking WSW.

idea that these two groups are actually the same. The other anchor beam, ST34541 was tapered at the north end and had a mortise piercing the tip as seen on many of the other land ties east of this. The southern end of the beam was truncated by the construction cut, SC24648, for a later gas pipe (G574, Phase 6). The southern half of the preserved beam was more or less half sectioned as a stepped lap joint or scarf and on top of this rested a smaller, truncated beam, ST34537, on the same alignment as ST34541. This

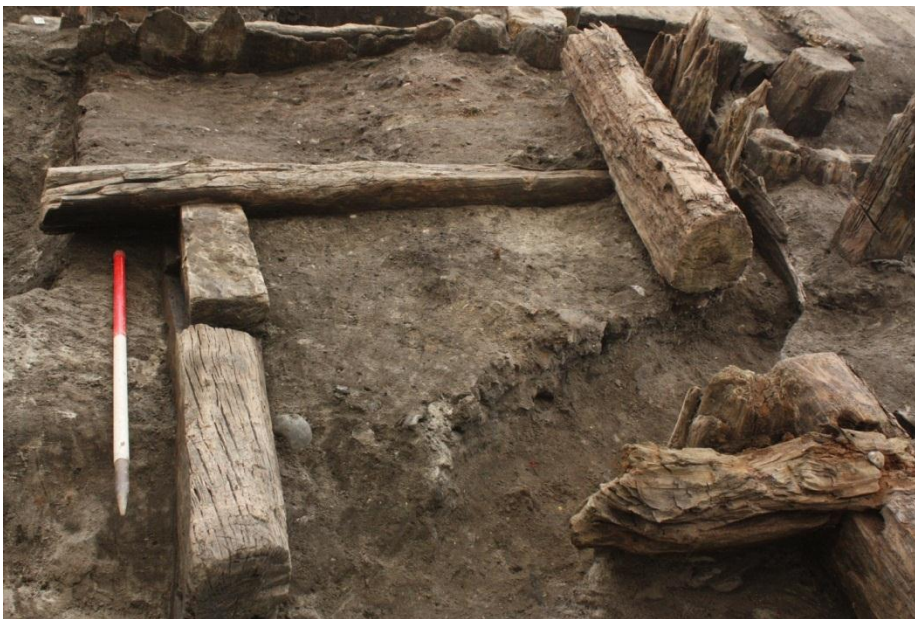
Fig. 162 G608 land tie. Looking S. C03_20140508_10179

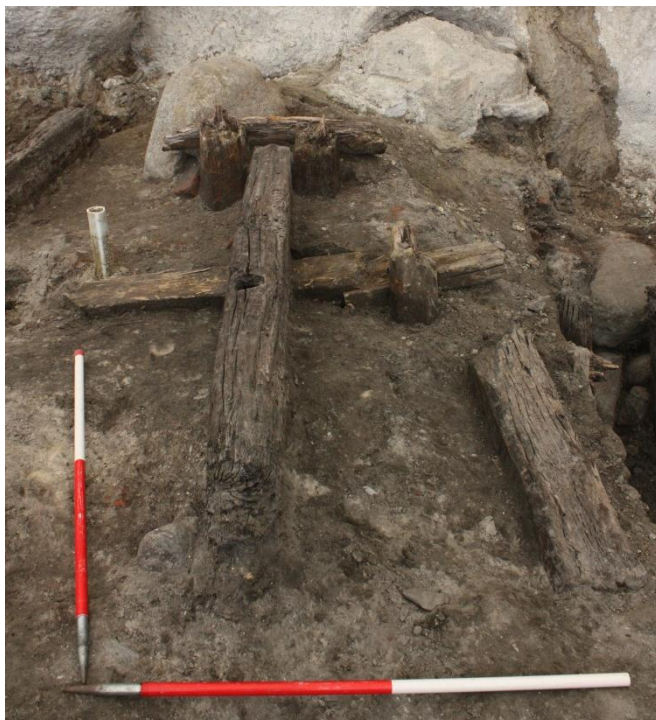
Fig. 163 G603 land tie. Looking NNW. C03_20140512_10221 (cropped)

G603 comprised a lower stretcher beam, ST35864, which was found in perfect alignment with the middle stretcher beams in G609 and G611. It is not clear if the beam was truncated in the east end, but the eastern extension seems to correspond with the edge of the cut, SC22123 (G582, Phase 4 deconstruction). The western end of the beam seems a bit truncated or damaged, but it is not clear what caused this. The beam was preserved at 1.57 m length and was rectangular in cross section, 0.22 m wide and 0.1 m thick. On the south side of the beam, a post, ST23992, was recorded and between the beam and the post, a wedge (ST35872) was seen.

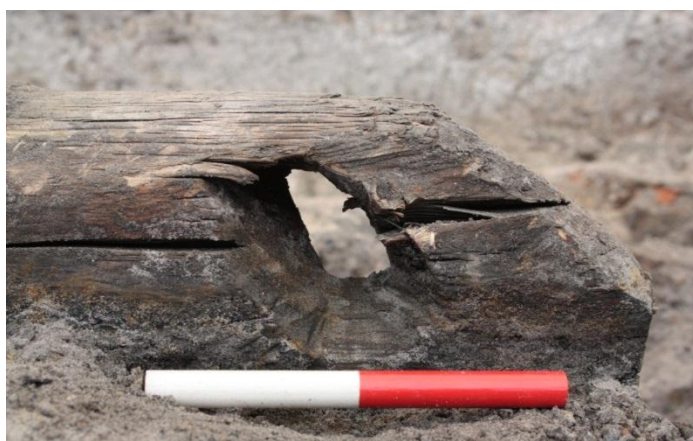
Fig. 166 ST37865, east end with mortise. Looking N. C02_20140602_9595

Parallel to the rear stretcher beams, but recorded approximately 2.5 m SSE of ST9612 was an ENE-WSW oriented stretcher beam, ST37865. This was made of a halved timber cut and has a semi-circular cross section, 0.15-0.16 m wide. The beam was preserved at 4.5 m length, and did not seem to be truncated. The eastern end was tapered and a mortise very much like the ones seen on anchor beams in G676, G641, G601 etc. was present, indicating either reuse or a special function, e.g. for placing the timber.

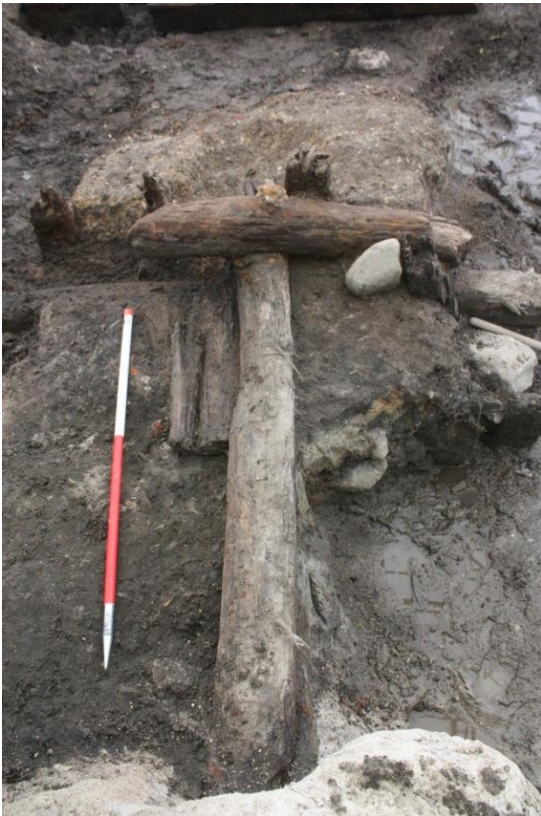
Fig. 167 G552 westernmost part (southern end not excavated). Looking SSE. C03_20140303_8540

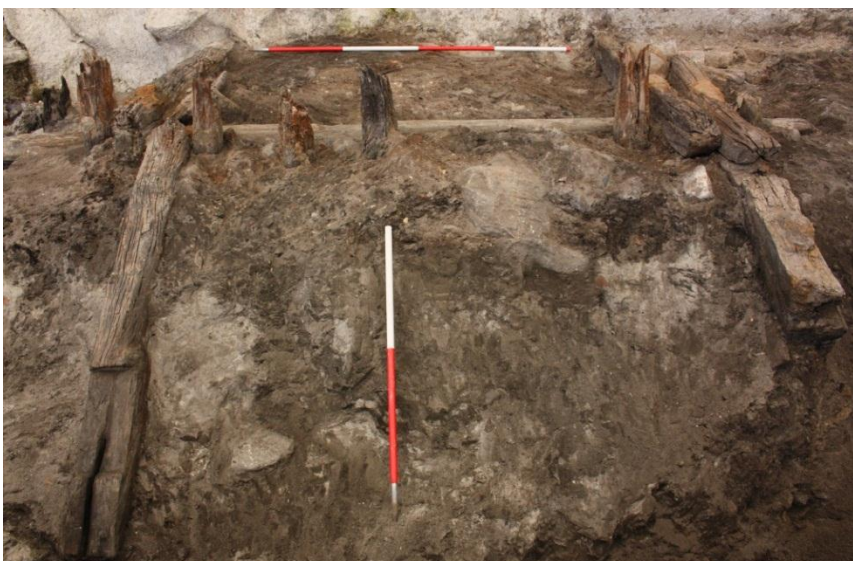
Fig. 168 G552 western parts. Looking NNW. C03_20140527_10453

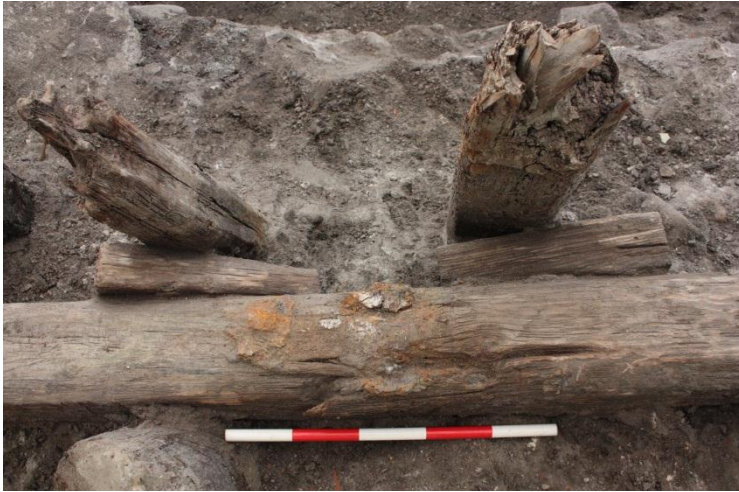
Fig. 169 G552 western part. Posts ST21304 and ST21308 with wedges ST40352 and ST40357. Looking SSE. C02_20140602_9594

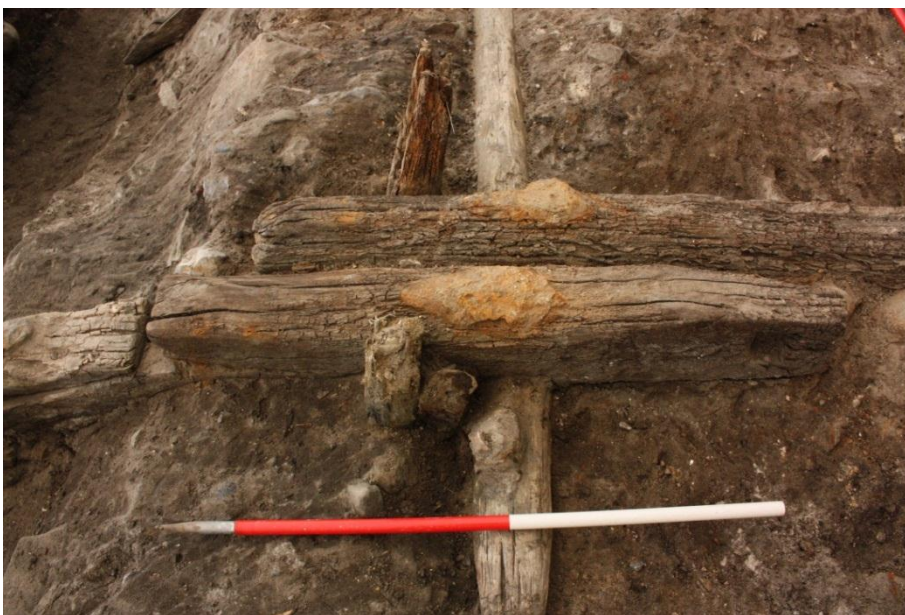
Fig. 170 G552. Anchor beams ST39251 and ST37886. Looking WSW. C03_20140527_10454

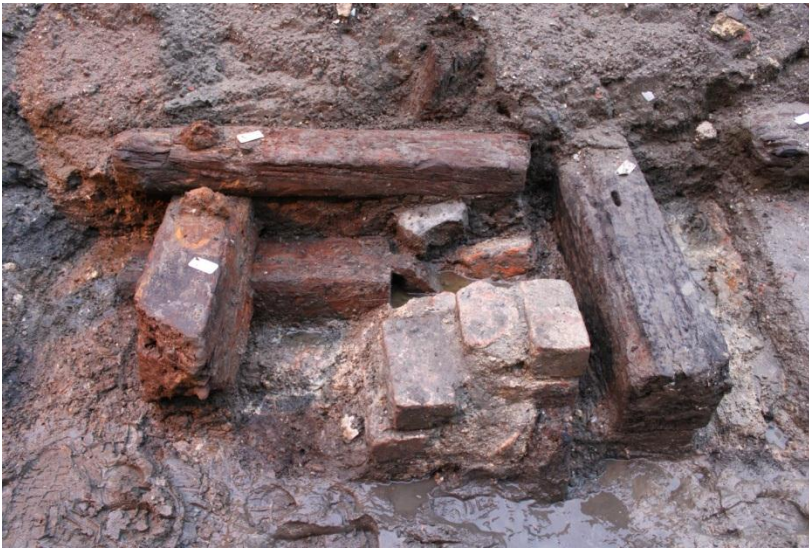
Fig. 174 G462 (and parts of G455 and later G456), excavated during the 2012 Guide Wall excavation. Looking S. C19_20120927_3963

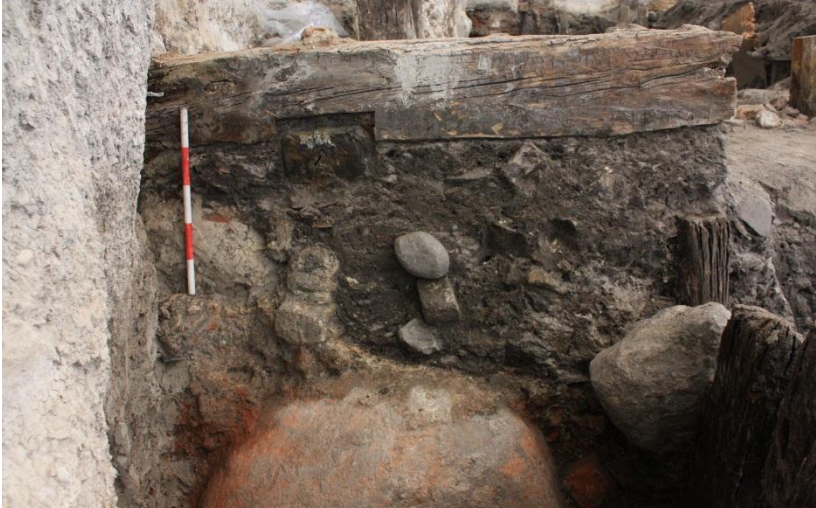
Fig. 175 ST21659 (G455) joined to underlying stretcher beam, ST46303 (G460). Looking E. C02_20140624_10033

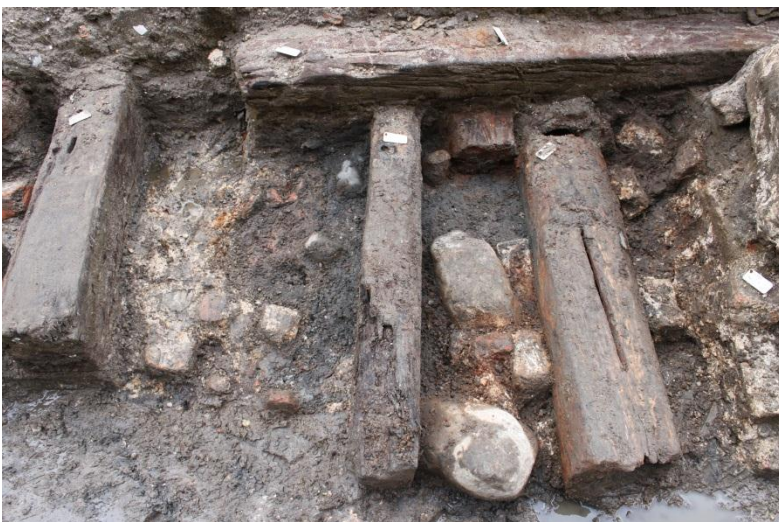
Fig. 176 G455 stretcher overlying former land tie G460 and drain pipe G459. Looking S. C19_20120927_3991

The group, G455, can be interpreted as parts of a repair of the land ties G460 and G462. The repair was probably necessary after the drain pipes, G459 and G464 had cut through the G460 and G462 stretchers. After only a few years of use, the repair was then truncated – and replaced – by the Phase 4B land tie, G456.

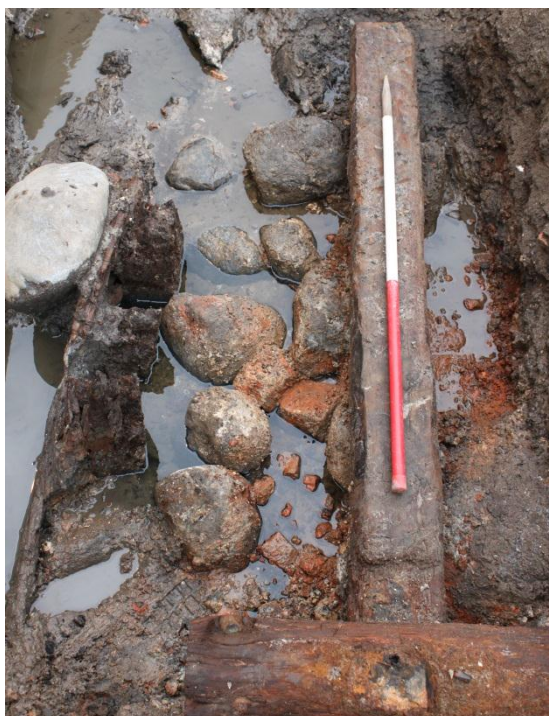
Fig. 178 Stretcher, ST16818 with possible halving lap and iron nail from earlier anchor beam? Looking E. C19_20120925_3952 (cropped)

Within the construction cut was a pine stretcher beam, surveyed as two different timbers, ST16818 and ST16875, due to truncations by Phase 4B land tie G465. West of these beams was a third fragment of a beam, ST18231. This beam did not seem to be placed within a cut, but was probably the western extension of ST16818 on the western side of the truncation caused by Phase 4B land tie G463. It is plausible that this beam is also identical to the stretcher beam ST17495 in G462, excavated immediately west of G468 (on the western side of the truncation made by the construction cut for drain pipe, G464) as they all match in level, alignment and type of timber cut. Leaving the G462 beam out, the stretcher in G468 was originally at least 4.95 m long. The eastern end of ST16875 did not seem to be truncated but had what looked like an inscription “D X D” carved into it. This part of the beam was collected as a find (FO202950). The middle part of the stretcher, ST16818 had an anchor beam, belonging with the (repair?) land tie, G466, fixed to it. However, immediately east of where this anchor beam crossed the stretcher, remains of iron as well as a possible halving lap may indicate that a former anchor beam, belonging with G468 had been placed here.

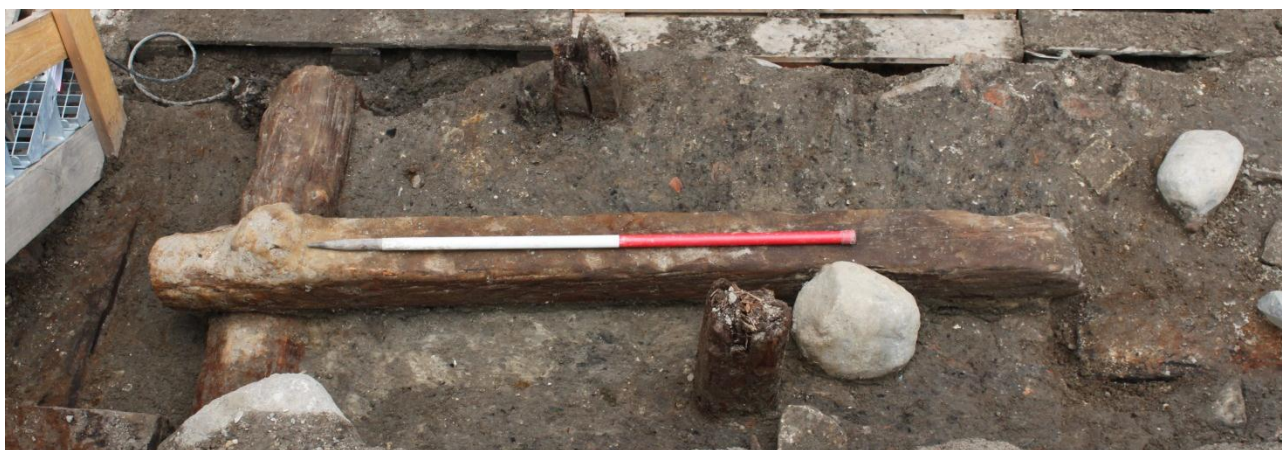
Fig. 179 G466, west end, anchor beam ST14214 and stretcher ST14187. Looking NNW. C19_20120827_3750 (cropped)

The anchor beam ST14214 was NNW-SSE oriented and preserved at 1.27 m length. It was made from a boxed heart timber cut and the cross section was rectangular with rounded corners, 0.21 m by 0.24 m. ST14214 seemed placed secondarily, but directly on top of underlying stretcher beam ST16818 of G468, but it is not clear if ST14214 was in any way fixed to ST16818. It was suggested that ST14214 was actually reused from the underlying land tie, G468, as the halving lap and nail hole found on ST16818 immediately east of where ST14214 now crossed it, seemed to match traces found on ST14214.

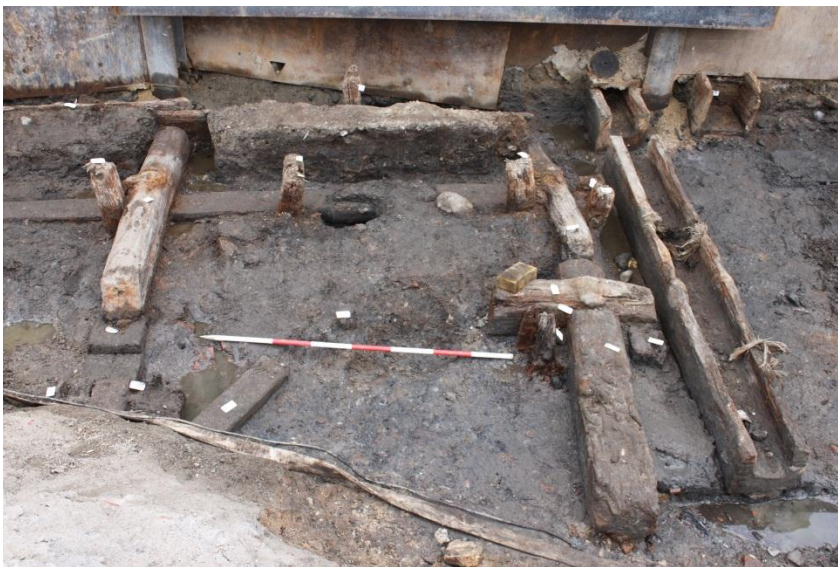
Fig. 183 Parts of land tie G484 (upper stretcher removed). Looking N. C19_20120907_3875

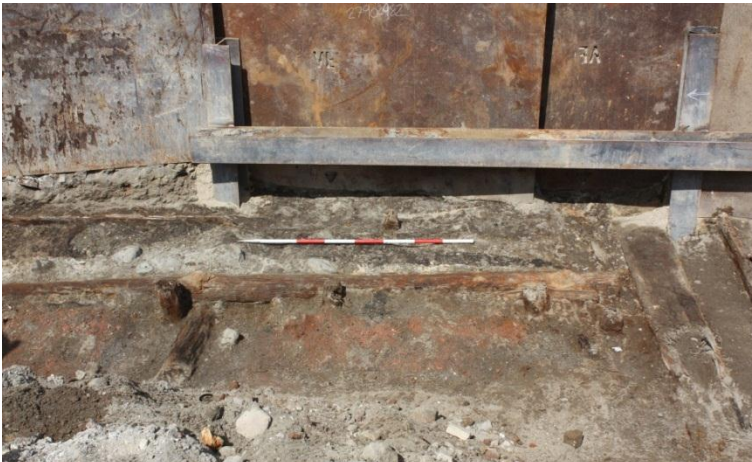
Fig. 184 Upper parts of land tie G484, Looking NNW. C03_20120820_5329

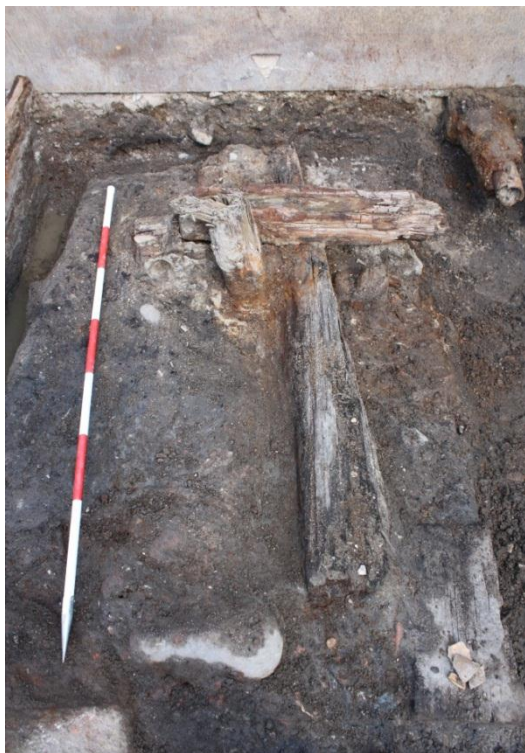
Fig. 186 Land tie G493, Looking NNW.
C03_20120822_5363

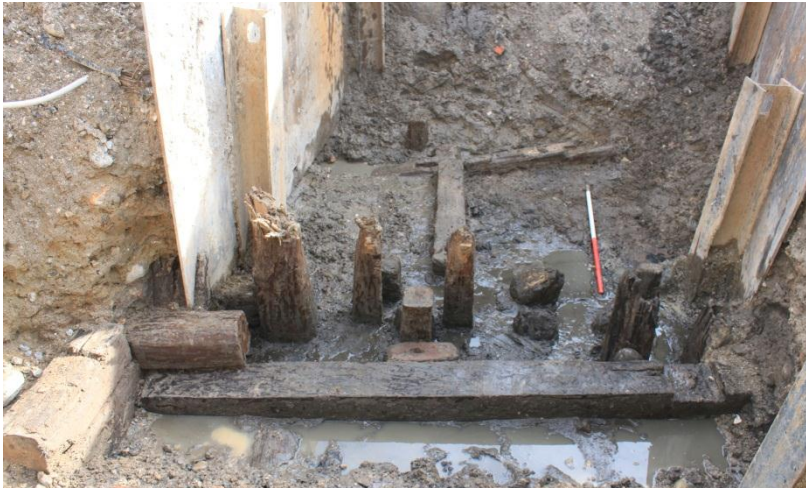
Fig. 191 Land tie G508 excavated in Trench 4/ZT19000. Looking SSE. C19_20121017_4229

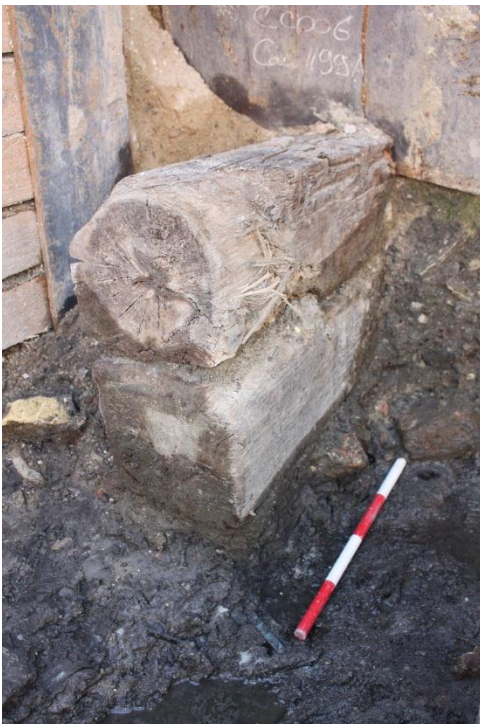
Fig. 192 ST9349 in land tie G508. NNW end, excavated in June 2012. Looking SE. C03_20120724_5098

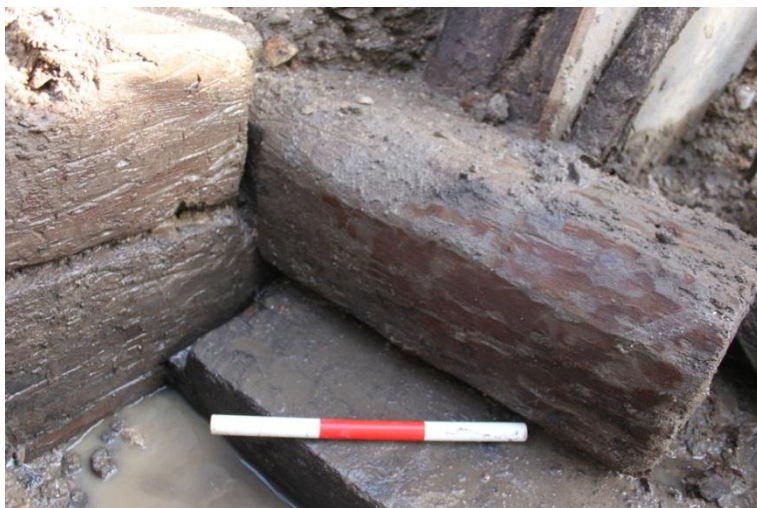
Fig. 193 Land tie G508, beams at ENE end. Looking ESE.
C19_20121016_4220

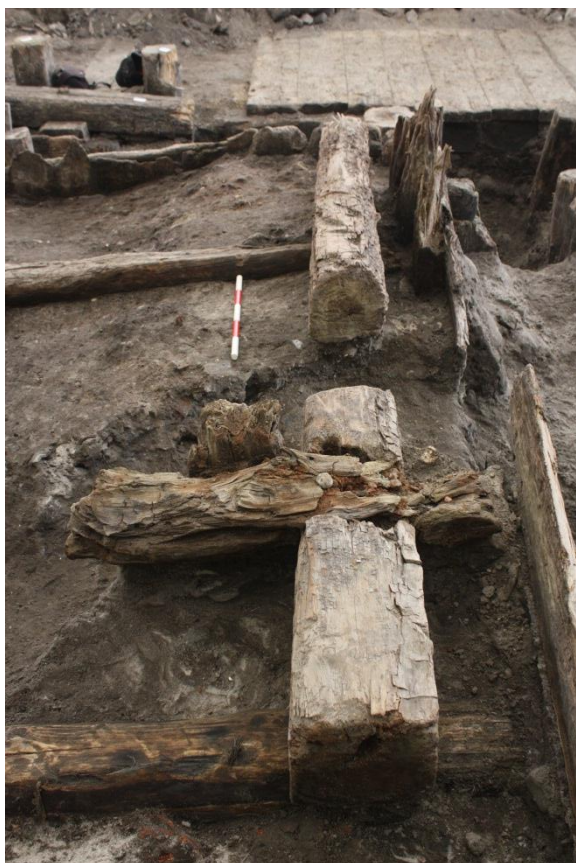
Fig. 194 Land tie G705 Looking SSE.
C03_20140508_10174

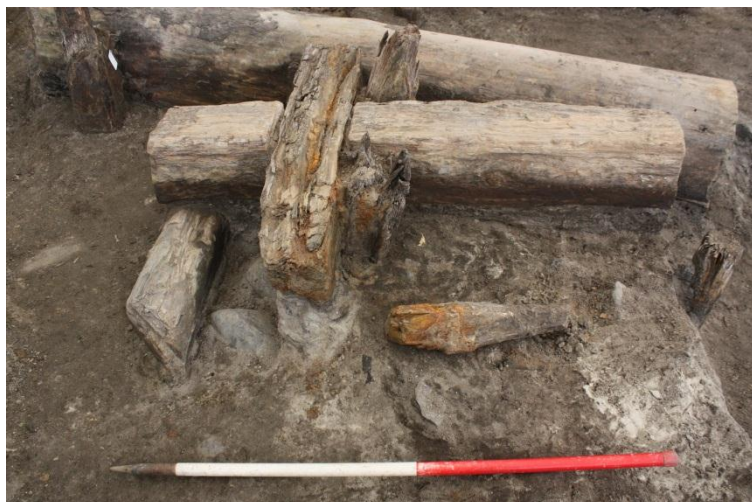
Fig. 195 Land tie, G610 Looking NE. C03_20140508_10186

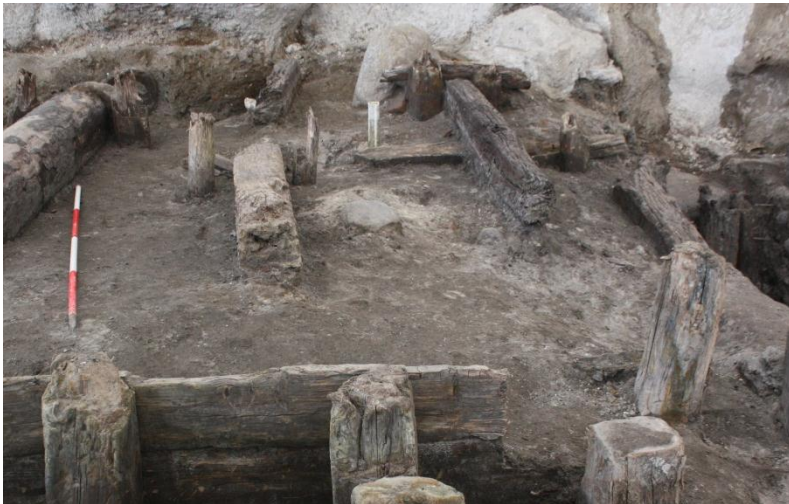
Fig. 196 Land tie G616, Looking N. C03_20140512_10215 (cropped)

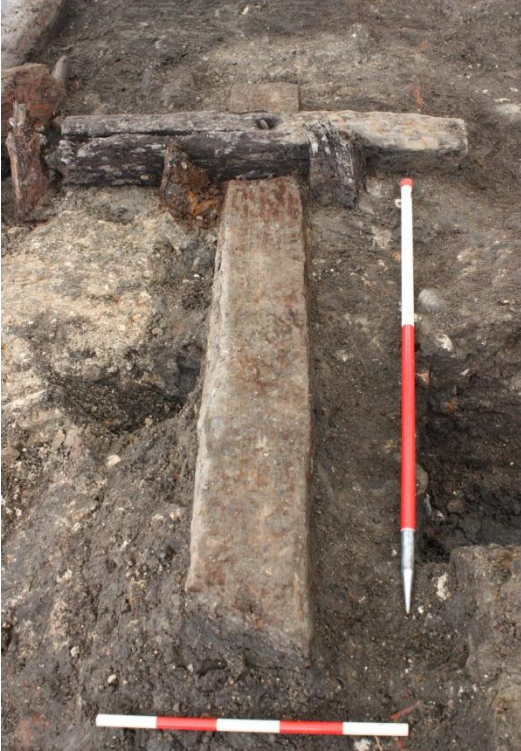
Fig. 198 G553. Looking NNW. C02_20140228_8305

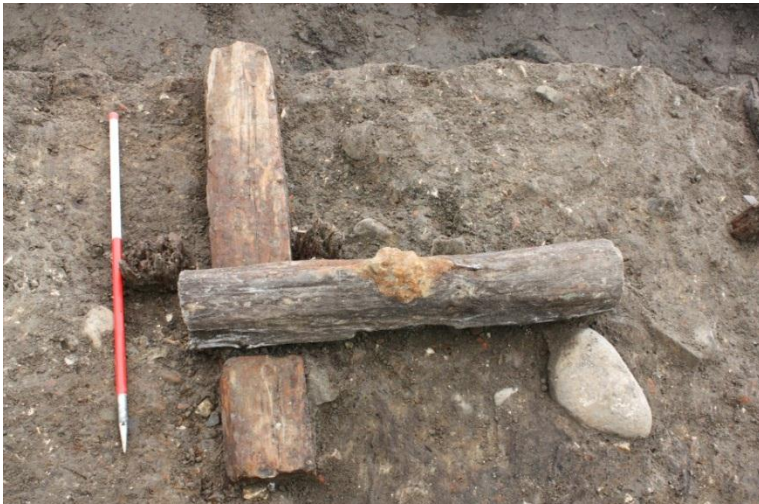
Fig. 199 G554 land tie. Looking SSE. C02_20140303_8358

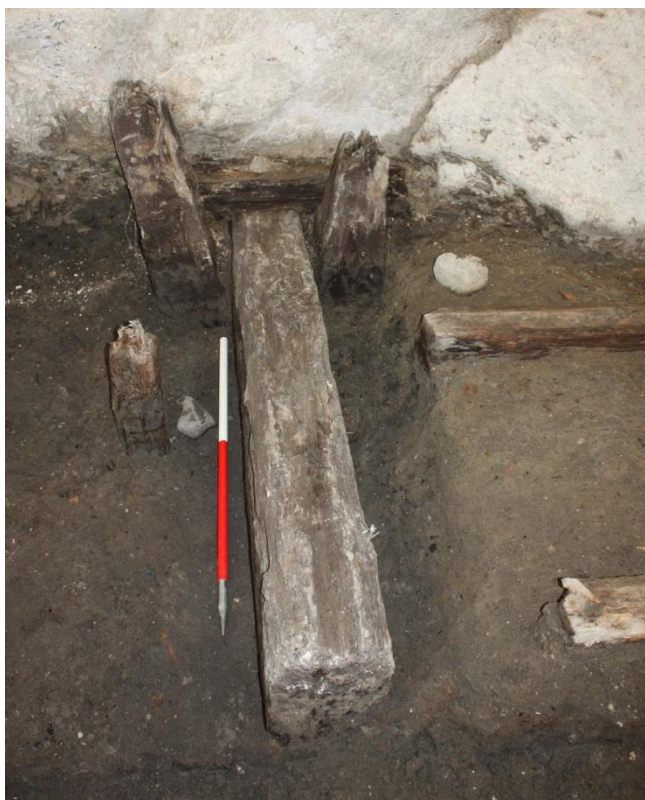
Fig. 200 Land tie G531 extending SSE from under the Guide Wall. Looking NNW. C02_20140304_8394

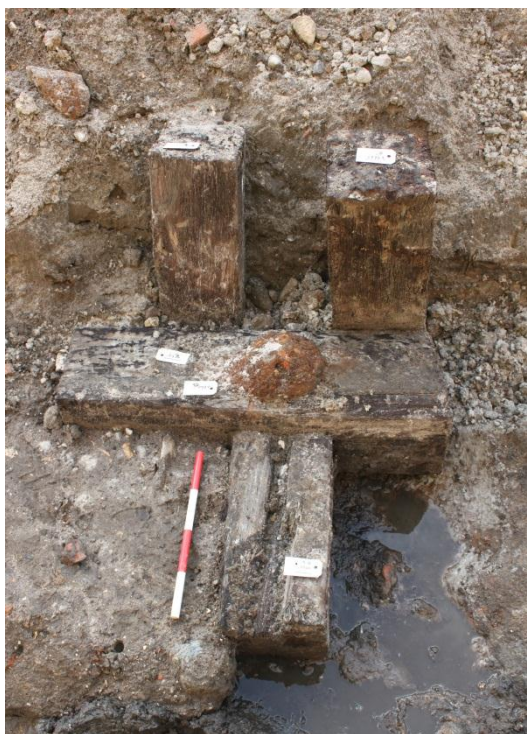
Fig. 204 Land tie G530, northern part as excavated in 2012. Looking SSE. C19_20121001_4007

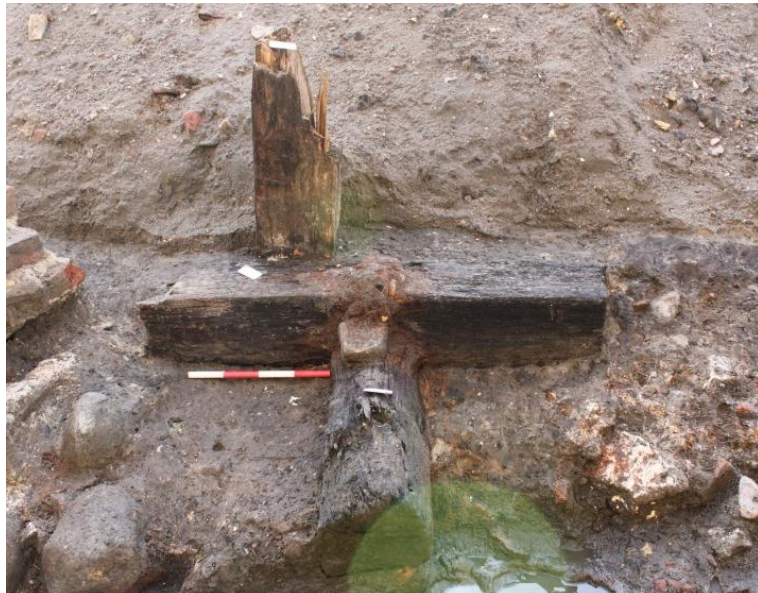
Fig. 205 Land tie G454, excavated in 2012 Guide Wall excavation. Looking SSE. C19_20120925_3949
