7.4.3.2. Land ties

7.4.3.2.1. Introduction

7.4.3.2.2. Groups interpreted as Phase 4A land ties

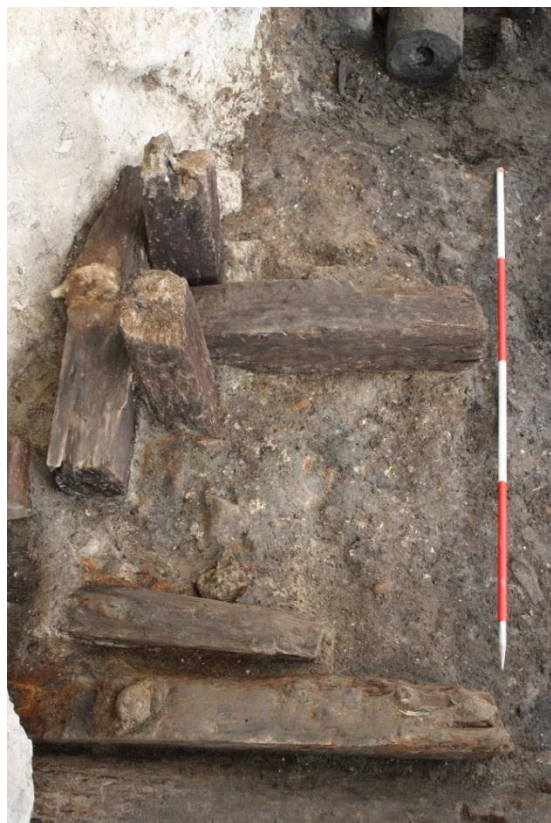
Fig. 207 Land tie G456, excavated during the Main Excavation. Looking ENE. C02_20140310_8469

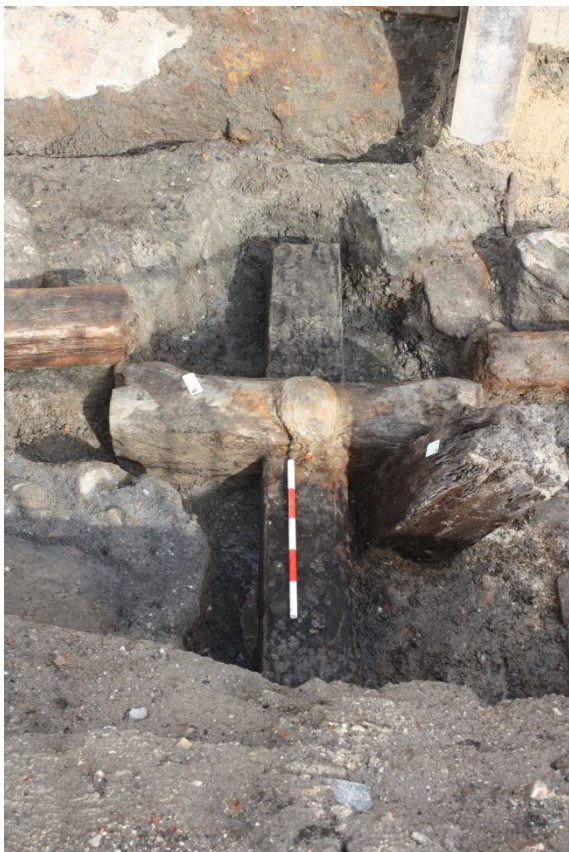
Fig. 209 Land tie G472, north-western side. Looking NNW. C03_20120830_5459

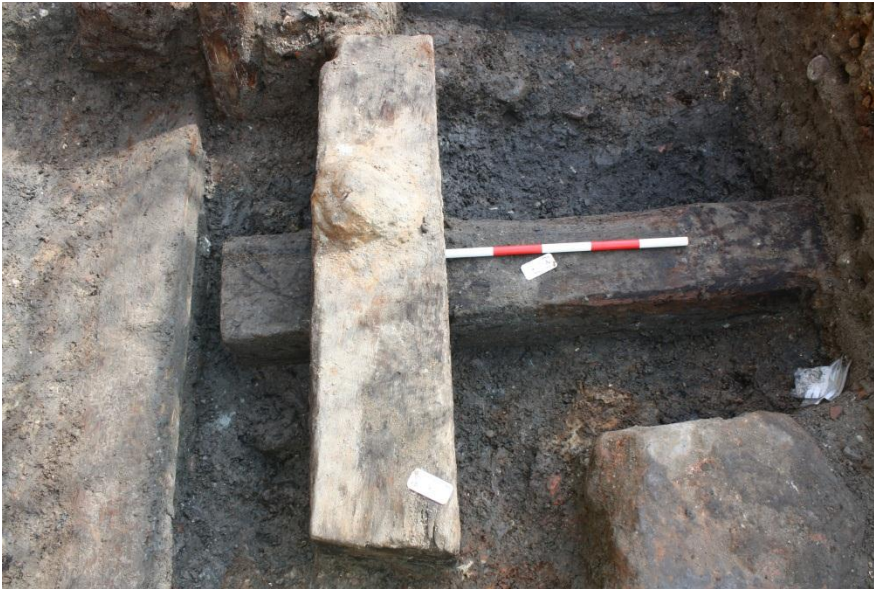
Fig. 210 Land tie, G472, north-eastern part. Looking ENE. C03_20120830_5461

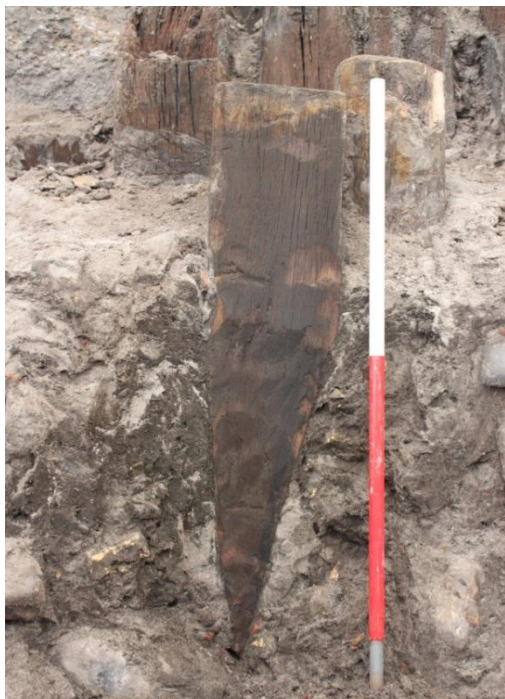
Fig. 211 ST38414 in land tie G472. Looking NNW. C02_20140527_9548

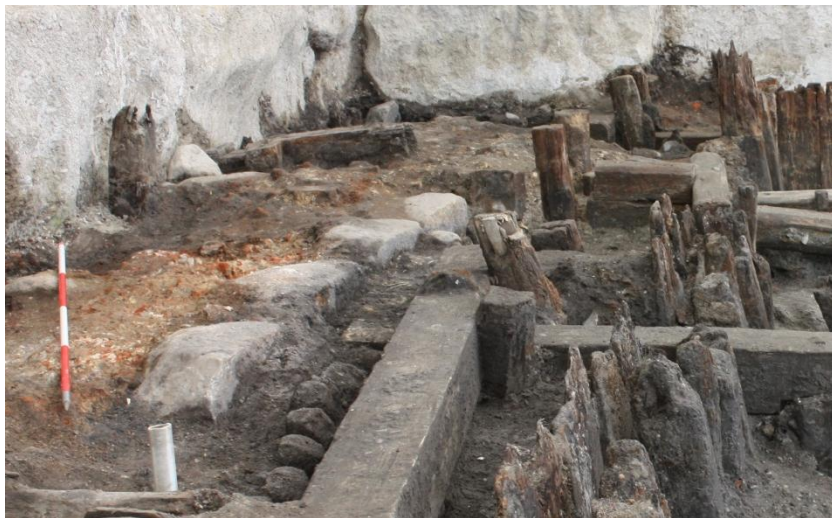
Fig. 212 Post ST51244 - possibly originally a support post in Phase 4 land tie G479, but reused in Phase 5 land tie, G632. Looking NE. C02_20140404_8855

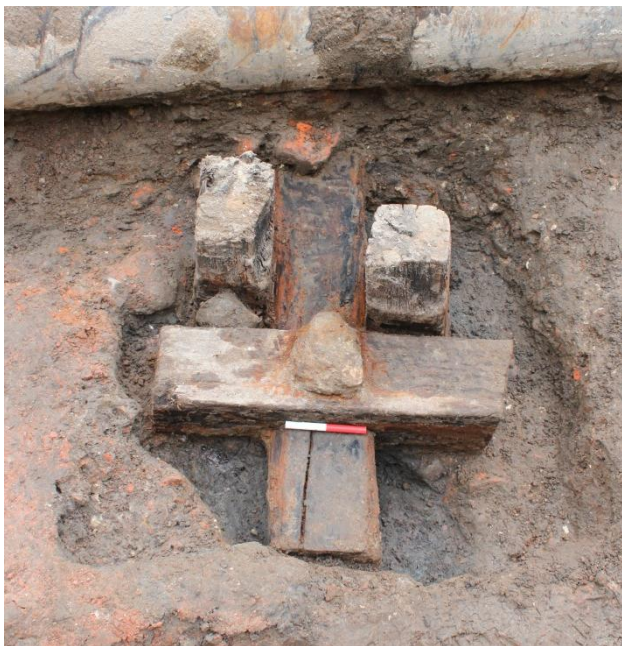
Fig. 213 Land tie G481 excavated during the 2012 Guide Wall excavation. Looking SSE. C19_20120830_3836 (cropped)

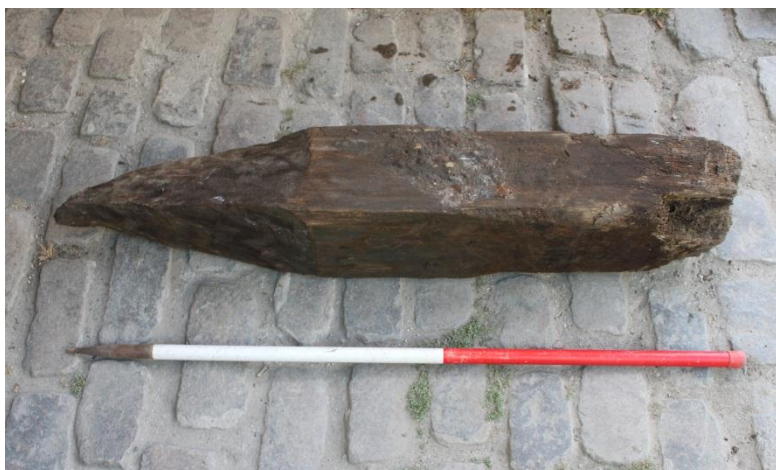
Fig. 214 ST14099, G481, taken out of situ. The tip of the driven in post is bend. C19_20120906_3856

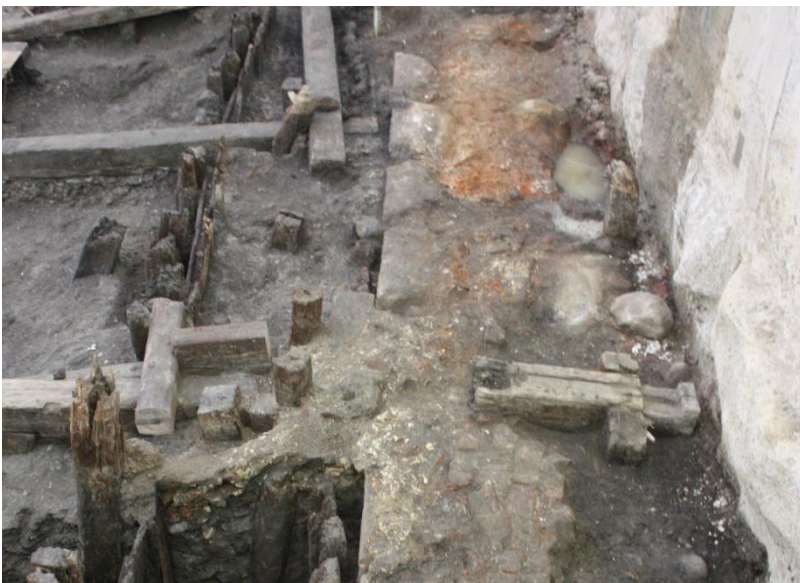
Fig. 215 Land tie G487 as seen in the 2014 Main Excavation. Looking W. C02_20140407_8867 (cropped)
