### 7.4.3.3. Bulwarks

#### 7.4.3.3.1 Introduction

Table 43 Groups and sub-groups related to Phase 4 bulwarks

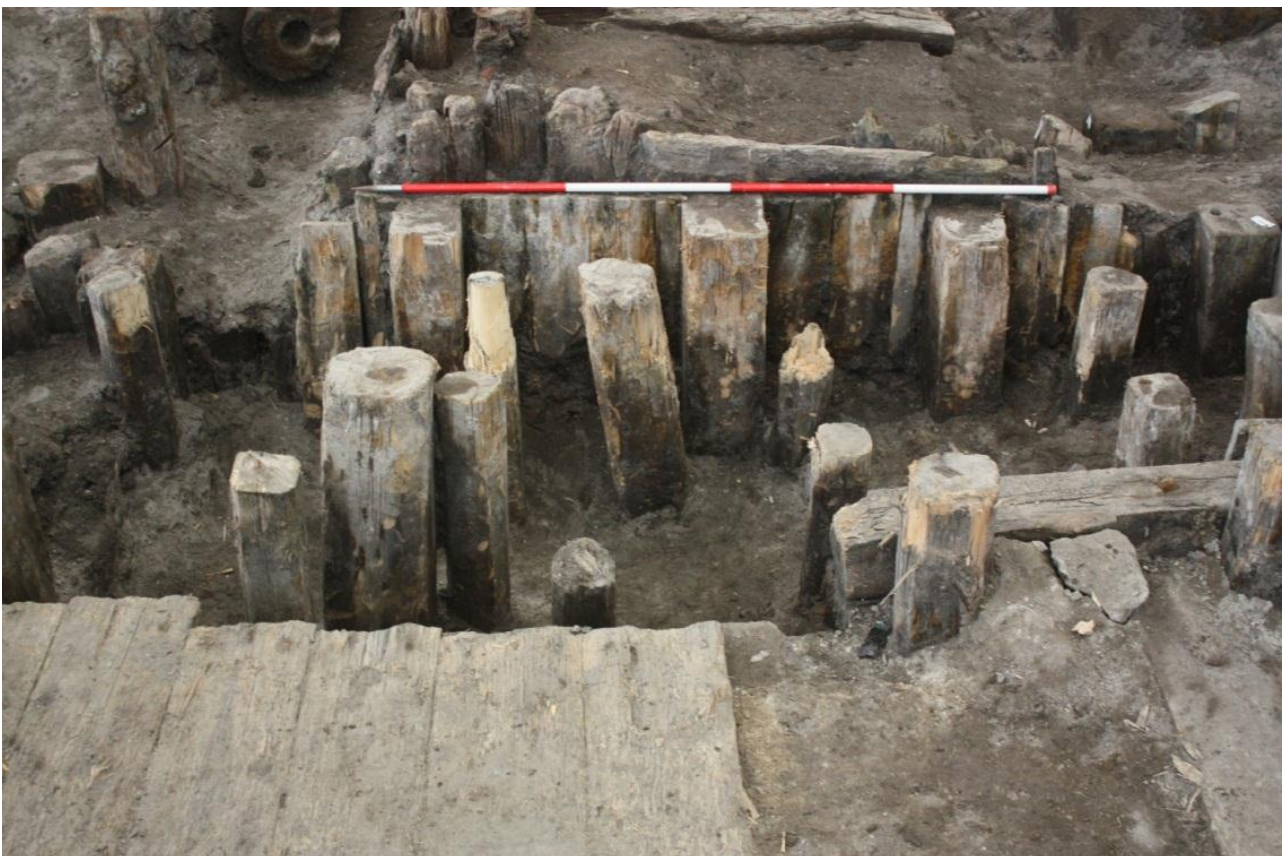
Fig. 220 A section of the bulwark, showing storm posts ST53905 and ST53897 and bulwark posts ST53901, ST53893 and ST53889 with the later shoring/planking ST37030 in between. Behind this, batten plank ST37023 and additional bulwark posts ST36017, ST36022 and ST36027 are seen. Looking NNW. C03\_20140512\_10237

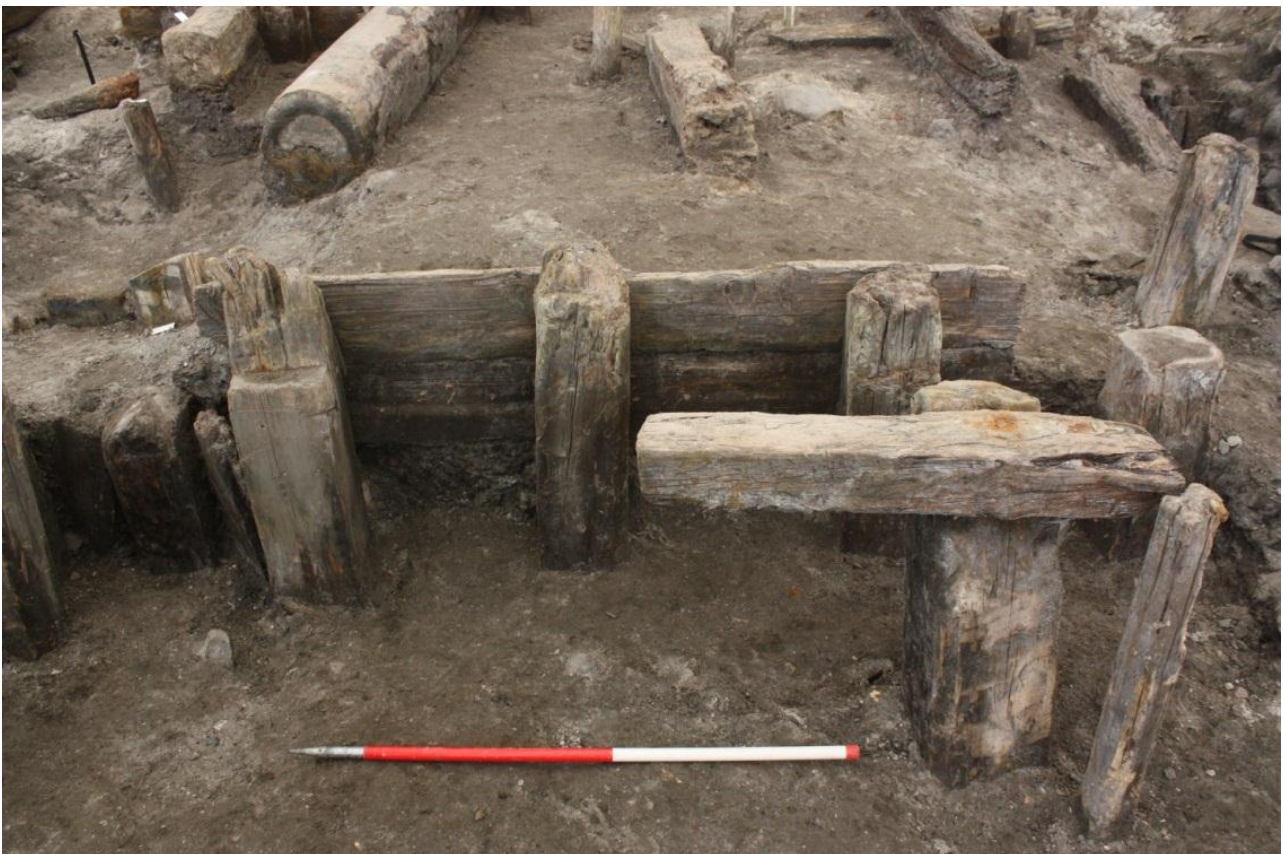
Fig. 221 Bulwark posts ST36270, ST36266 and ST36262 with batten planks ST36999 (the upper plank removed). In the foreground storm post ST36258 with attached beam ST36991. Looking NNW. C03\_20140512\_10223.

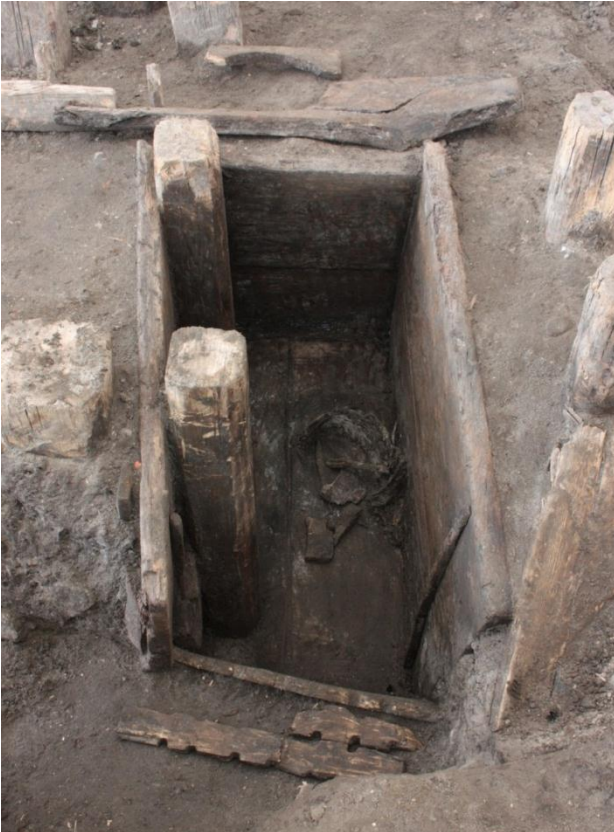
Fig. 222 SG618 seen towards NNW. Loose timber parts placed next to the box. C02\_20140513\_9378 (cropped)

The main part of SG618 was a rectangular, box-shaped timber structure consisting of a plank base, plank walls and a lid. The base was not surveyed, but seemed to comprise two large planks placed horizontally next to each other. Placed on top of the base planks was a set of plank walls on the western, northern and eastern side, ST35468. The planks of these walls were all made of oak and each approximately 0.4 m wide and 0.04-0.05 m thick and set on edge on top of each other in two courses. The western and eastern wall was placed against the two ends of the northern wall and kept in place with large nails. The surveyed top-levels of the plank walls were approximately OD – 0.50 m at the north end and – 0.65 m at the south end. The length of the whole structure (NNW-SSE) was 1.28 m and the width approximately 0.78 m. The depth of the plank walls was recorded as 0.8 m. Inside the box was a set of wooden strips (0.02 by 0.05 m in cross section and 0.78 m long) placed vertically, near the south end of the western and eastern walls respectively. The purpose of these was not completely clear but they may have kept either the lid (see below) in place or facilitated that the south side of the structure could be slid up and down to enable the box to be emptied for its contents. On the outside of the box six planks were described as keeping the box structure in place – two on each of the western, northern and eastern sides.

The south side of the structure was constructed from planks of which the upper parts contained a large number of holes drilled into it. The holes were circular and approximately 0.03 m in diameter. This upper part of the structure was truncated by later activities and the plank fragments, ST36860, were found *ex situ* in the inner fill of the structure, SD36137, while the lower part, with no drilled holes, seemed to be intact but not surveyed. Though it is not completely clear how the box structure was related to the bulwark, SG604, it seems that the south side of the box is in alignment with the bulwark planking of SG604, which could indicate that the two structures are interrelated.

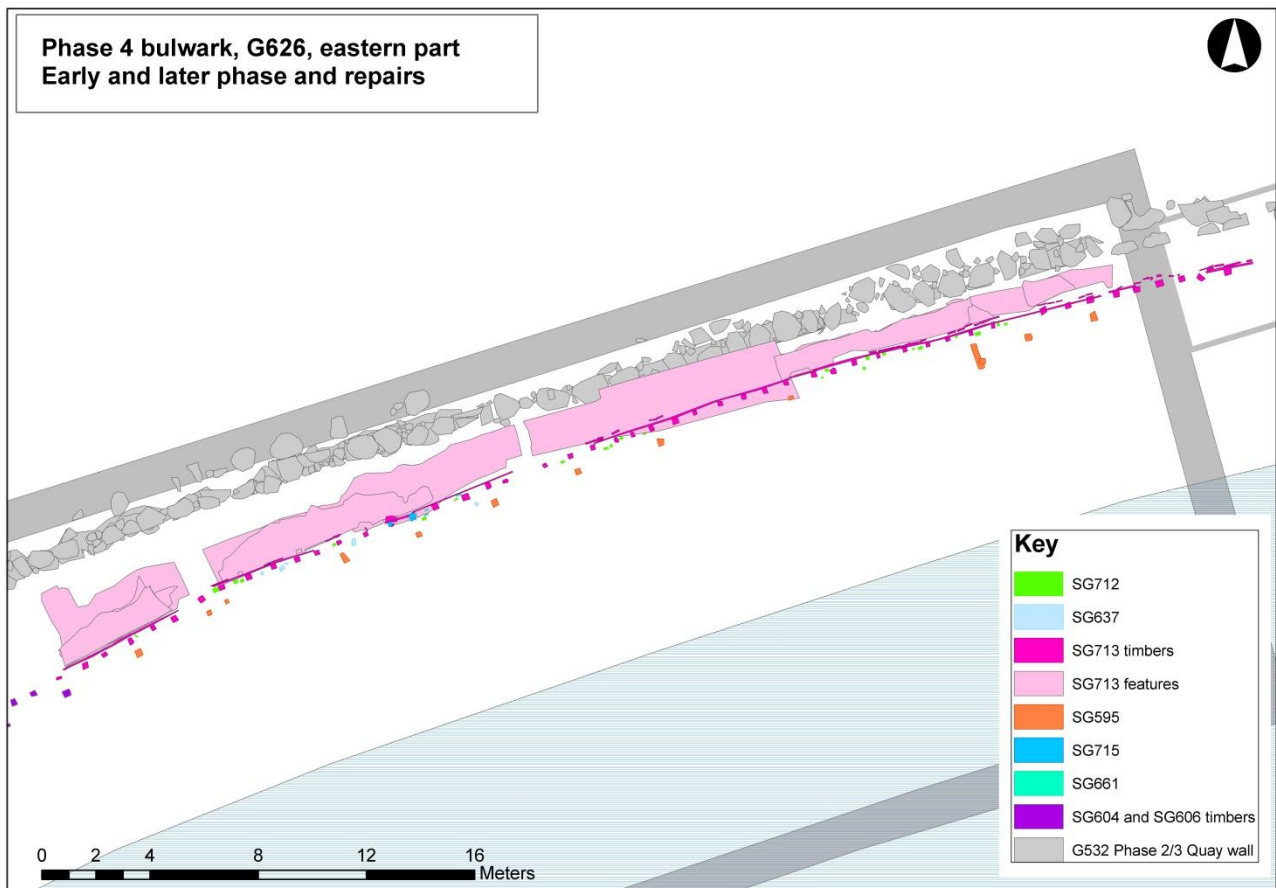
Fig. 224 Plan of Phase 4 bulwarks, G626, eastern parts. Early and later construction phases and repairs

The eastern part of the bulwark consisted of more than one construction phase. The earliest phase, SG712 was almost invisible and comprised the sub-group SG637 of deconstructed posts, along with a number of bulwark posts. The later construction phase, SG713, differed, and instead comprised a large construction/repair cut, 50 evenly dispersed bulwark posts as well as horizontal and vertical planking on the north side of the bulwark posts.

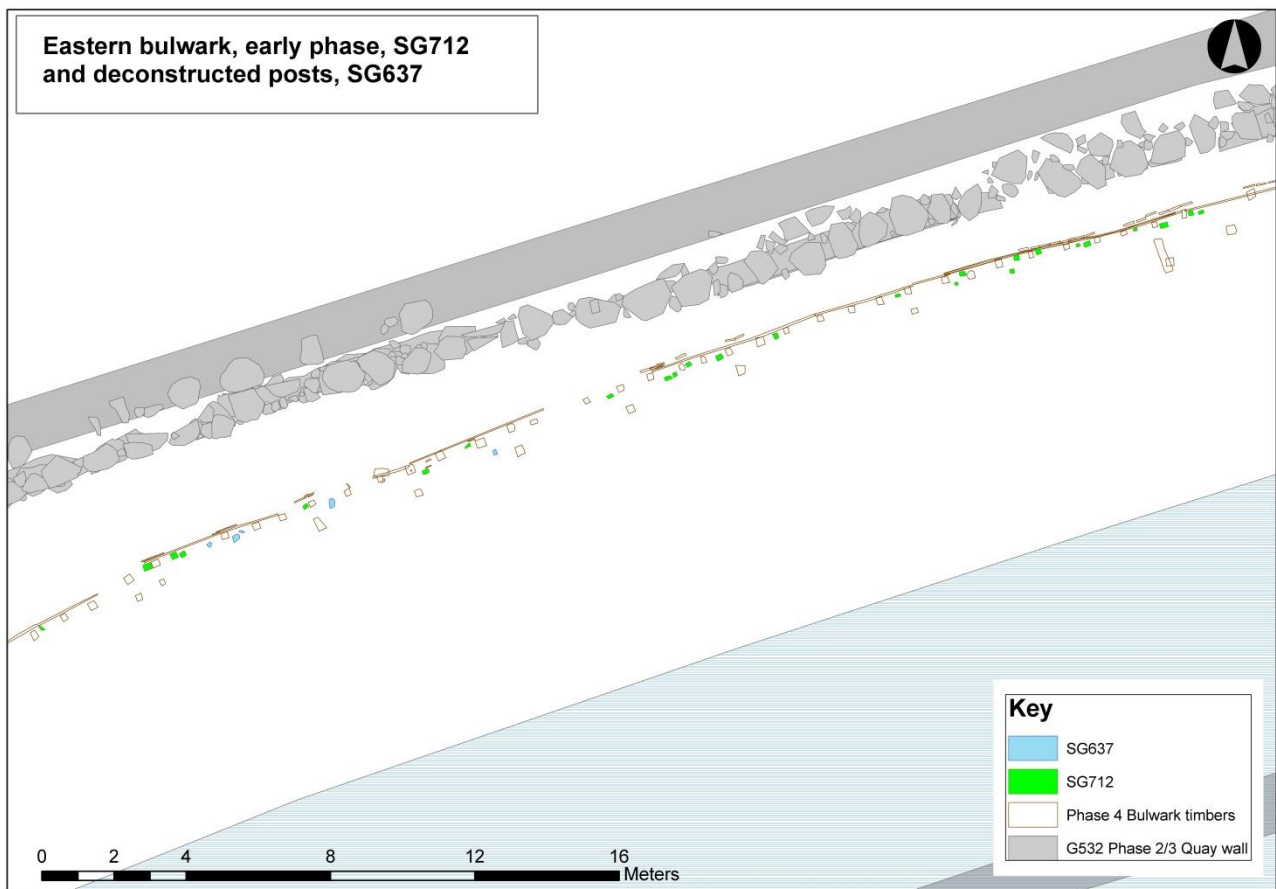
**Fig. 225 Plan of Phase 4 eastern bulwark, early building phase, SG712 and SG637**

The posts in SG712 were stout posts with square cross sections, made from boxed heart cut timbers. The posts were approximately 0.19-0.22 m in cross section. Some of the posts were recorded as soft and worn or having old breaks, but mostly the condition was good. Where the length of the posts was recorded, these were preserved at lengths ranging from 2.1 m to 4.3 m. The bottoms of the posts were tapered to facilitate the driving of the posts into the ground. In one instance, the taper measured 1.4 m long (ST35625), whereas the majority measured approximately 0.45 m long. From the species analysis carried out in connection with the dendrochronological analysis, the posts related to SG712 were from both pine and oak, but there was no visible pattern.

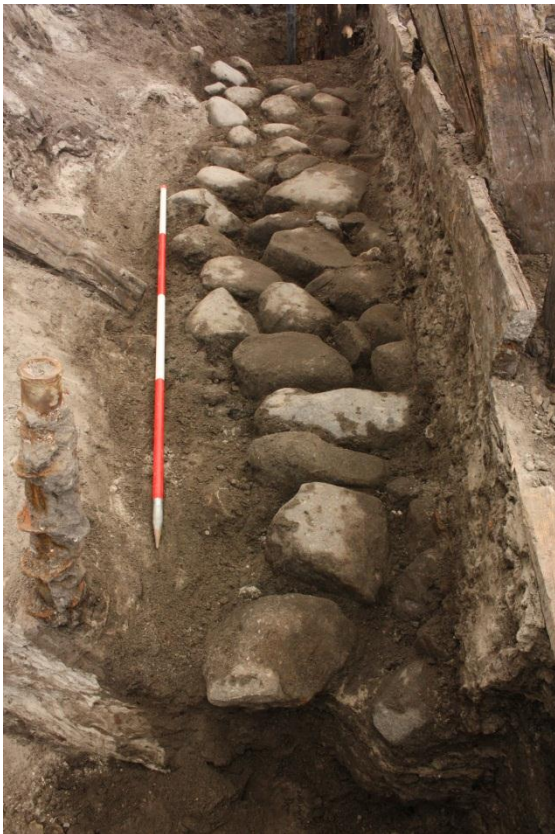
**Fig. 226** Stone surface, SS38692 on the north side of the bulwark. Looking ENE. C03\_20140526\_10451

This deposit covered the base of the cut, and overlying it was stone structure, SS38692, interpreted as a work surface for the construction or repair of the bulwark. A trample layer, SD39071, was recorded between and on top of the stones. This consisted of dark, organic material mixed with grey sand and contained only few finds of animal bones and ceramics (not prioritized for registration).

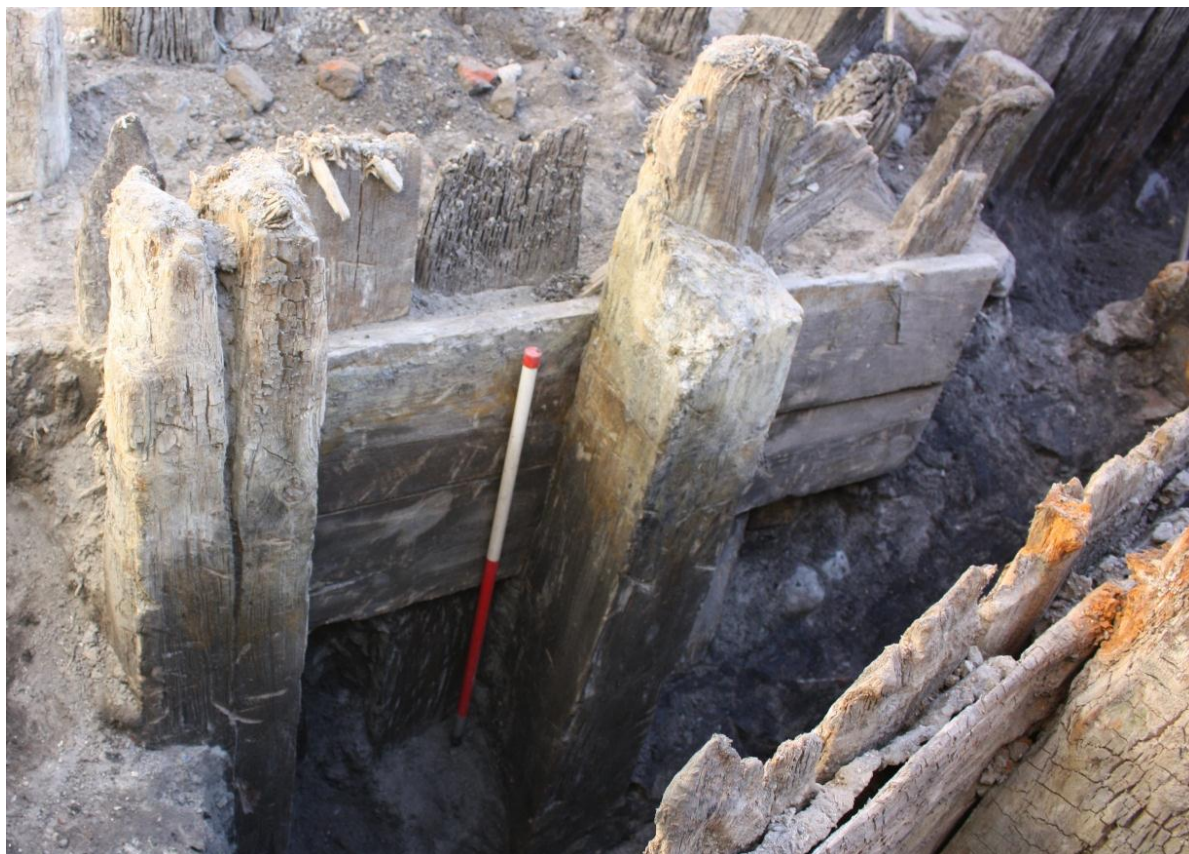
**Fig. 228** The easternmost section of bulwark SG713, excavated in the Stairway trench/ZT22798. Looking NNE. C03\_20140723\_11702 (cropped)

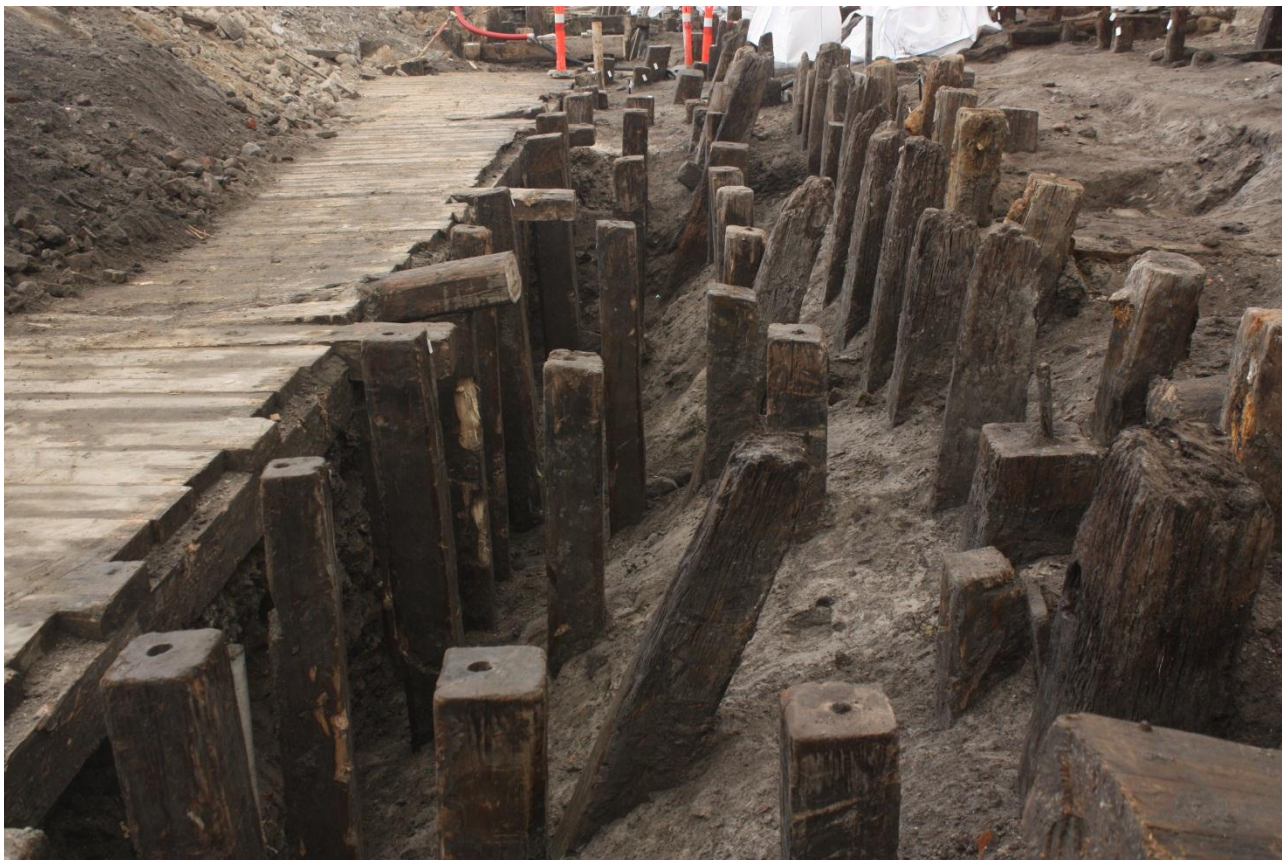
Fig. 232 Parts of Phase 4 bulwark G626, partly exposed. Storm posts (G595) are seen as slanting towards the bulwark posts. Later structures related to G583 (Phase 5) with peg holes on top. Looking WSW. C03\_20140425\_9863

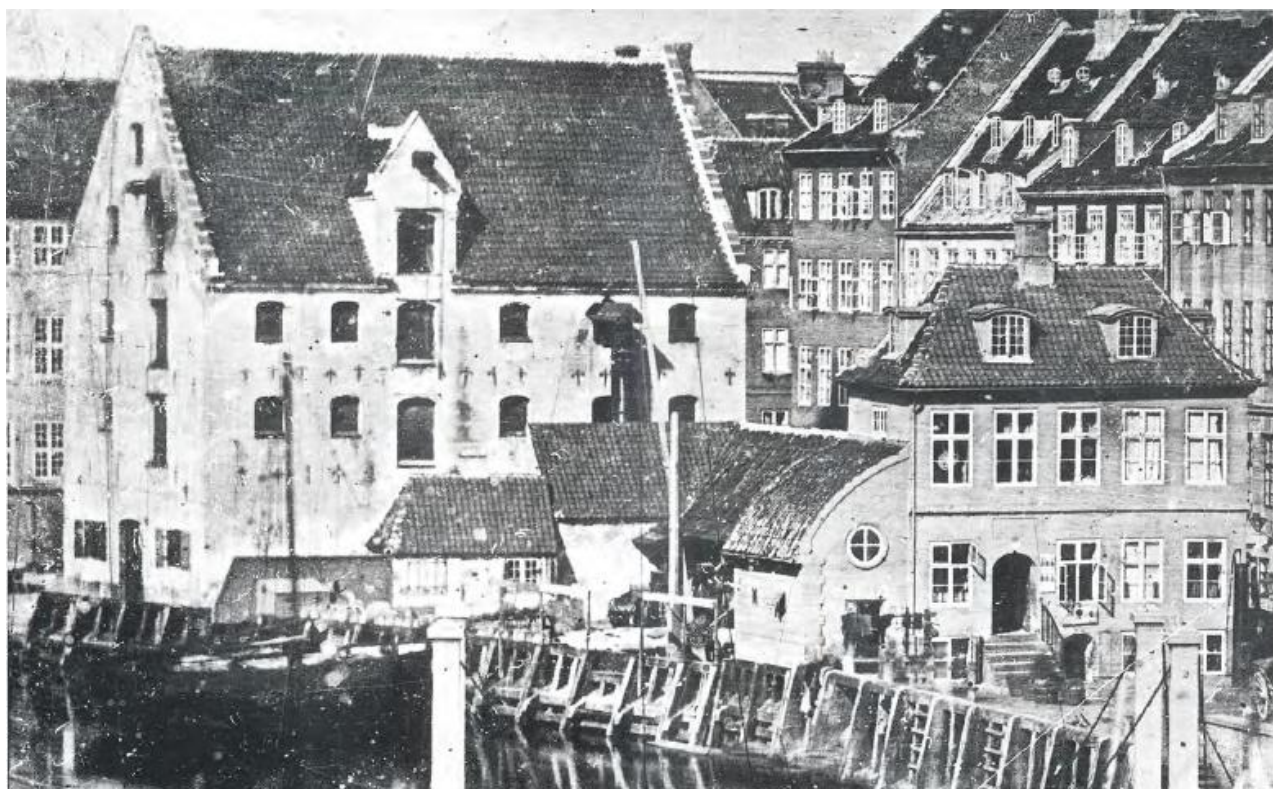
Fig. 246 Detail of a 1840 daguerrotype of Gammel Strand by T. Neubourg showing building G707, identified as the probable Bargemen's Guild House, viewed from the southeast. Another structure partially seen to the rear of the Guild house could be identified as G537, the probable *Vragerbro*.

The building G707 can probably be identified as the Bargemen's Guild House (*'Pramlaugets hus'*) which was known to have been built in the area. The 1840 daguerreotype of Gammel Strand shows a building in this location with the entrance in the eastern wall and a central chimney towards the rear (west) of the building

(see Fig.246). The buildings along Gammel Strand were known to have been demolished in 1857, which securely dates the robbing group G697 (Phase 5, see Chapter 7.5).

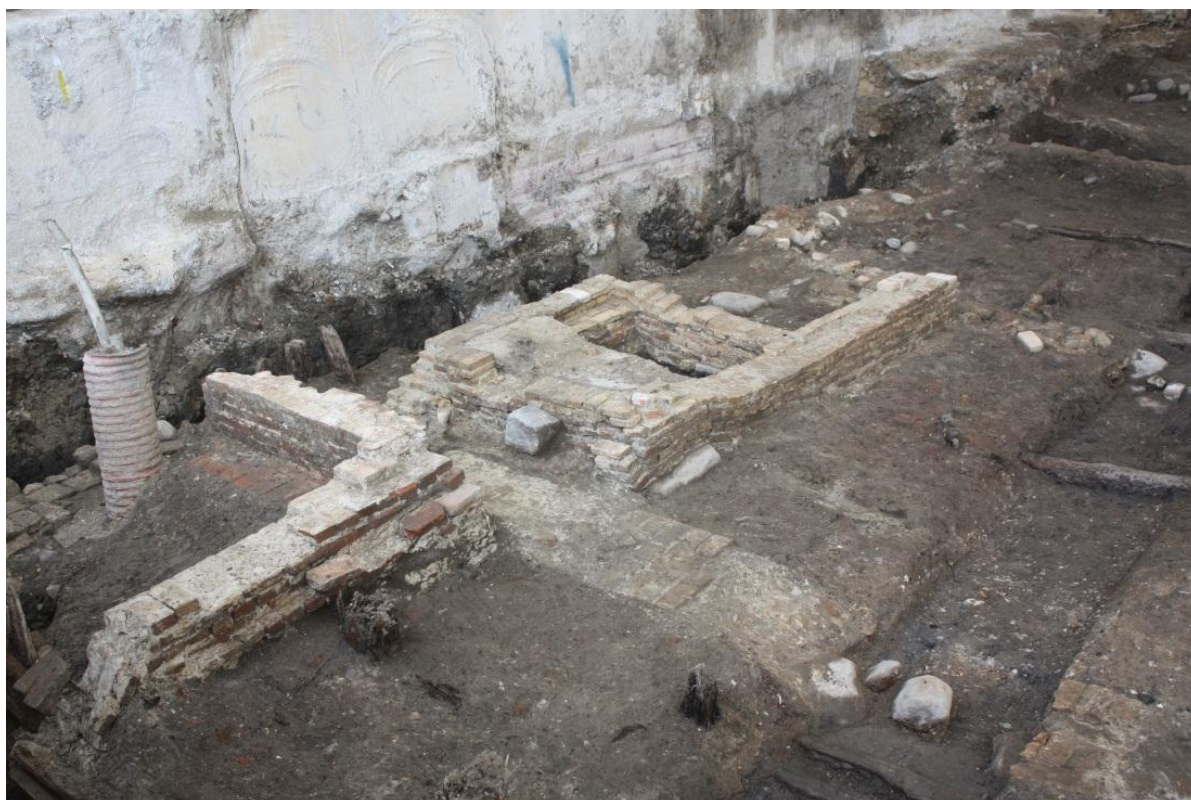
**Fig. 248** The robbed out remains of building G707, with the remains of the chimney base SG688 to the centre of the picture, and the remains of wall SG409 belonging to the probable Vragbro building G537 to the left. Looking NE.  
C03\_20140226\_8277

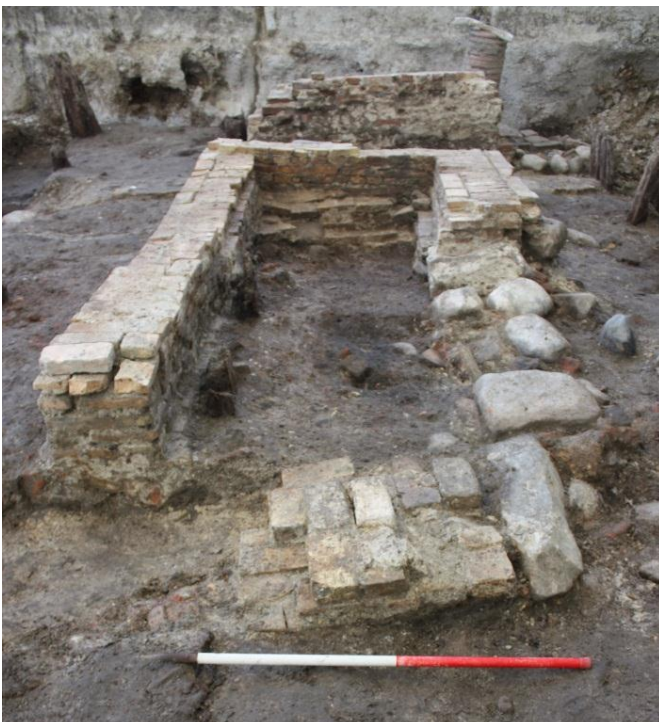
**Fig. 249** The initial construction phase SG685 of the chimney feature SG688. Wall SG675 can be seen in the foreground, and buttress SG690 to the right. Looking WSW. C02\_20140311\_8486 (cropped)

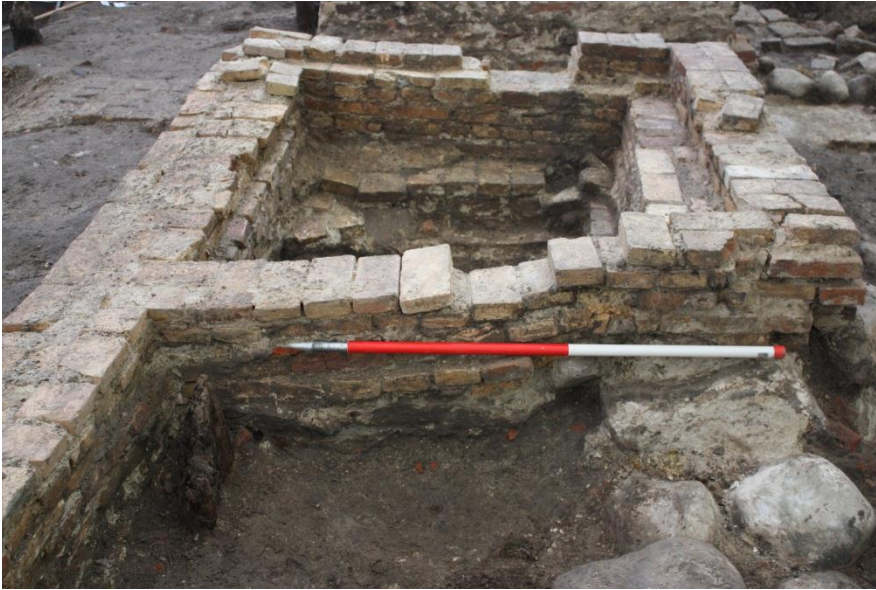
Fig. 251 The 'stub' wall SG686. The upper course can clearly be seen to be bonded into SS21939 to the left of the picture. Looking WSW. C02\_20140303\_8355

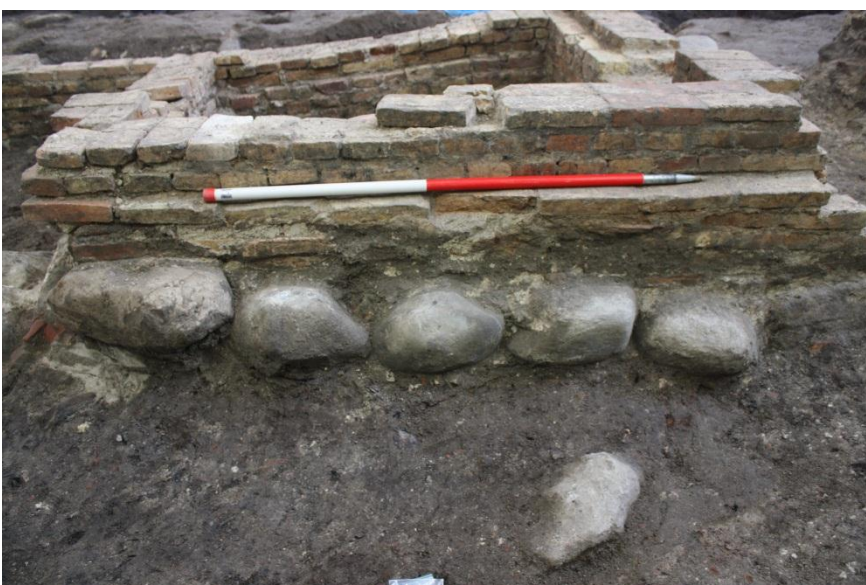
Fig. 250 The buttress SG690 to the chimney SG688. Looking SSE. C02\_20140303\_8352

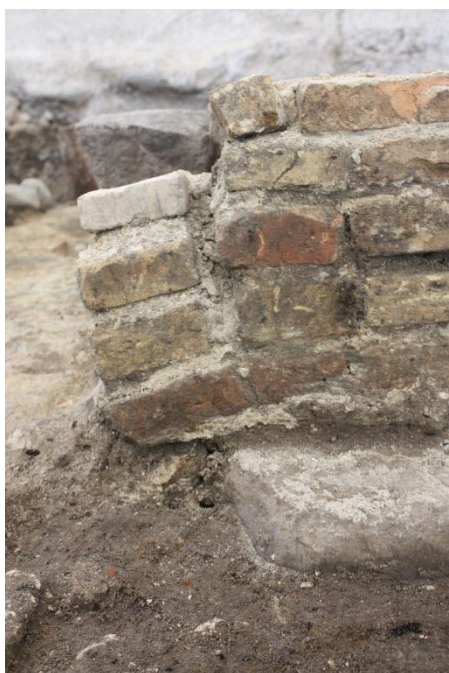
Fig. 252 The short 'stud' wall, SG696, seen here abutting the chimney base SG685 to the right and the robbed out remains of the exterior wall SG693 to the left. Looking NNW. C03\_20140311\_8681

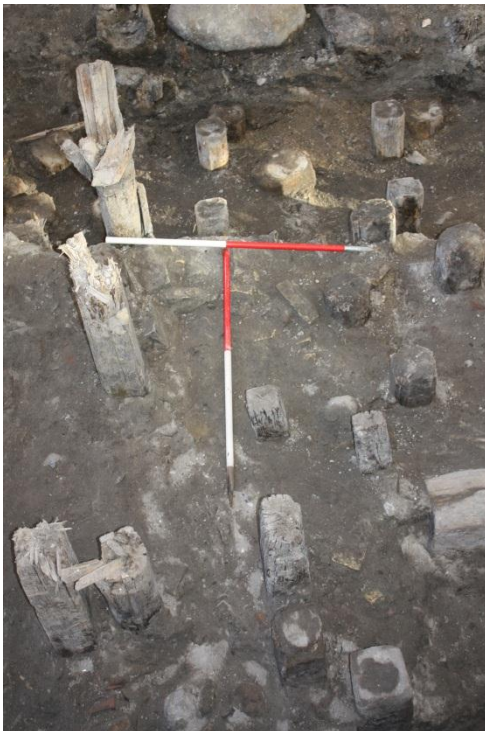
**Fig. 253 Part of the post foundation SG680. The posts do not form a coherent structure, but were thought to relate to an ancillary structure on the southern side of building G707. Looking N. C03\_20140415\_9601**

These fourteen posts do not form a coherent arrangement, and none of them returned dendrochronology dates for comparison. Due to excavation conditions (the area was machined out) no stratigraphy was recorded for the posts, making sequencing or dating practically impossible. These posts tentatively have been identified as being the foundation for an extension from the southern wall of building group G707 out into the harbour which was identified in the daguerreotype from 1840. They could otherwise belong to various unidentified harbourside structures or features in the area such as mooring posts.

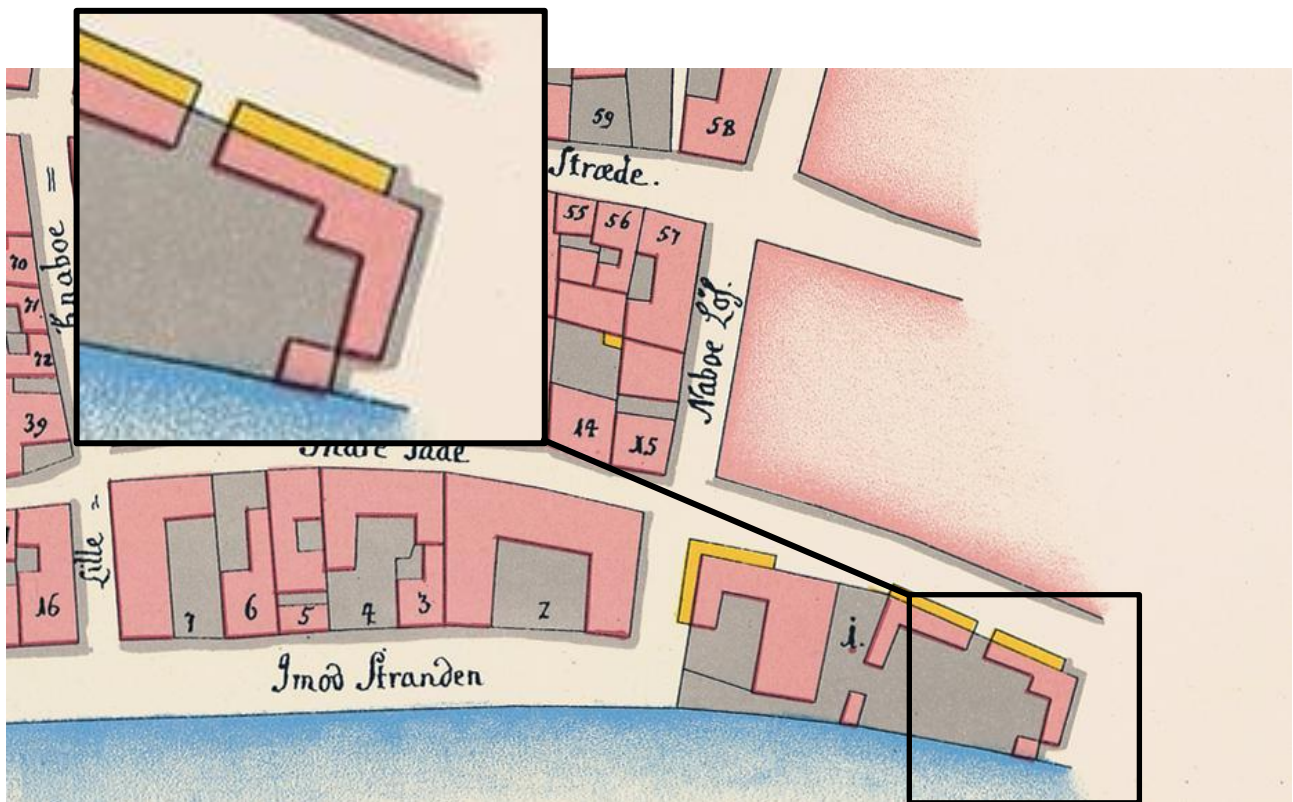
Fig. 256 detail from Gedde's 1757 'Snarens kvarter' map showing the layout of the buildings in the area. The structure in the corner between the north-south and east-west buildings can easily be seen.

It would appear from Gedde's 1757 'Snarens kvarter' map that a structure existed at that time in the northeast corner created by the north-south and east-west buildings in the area. However, there was no mention of the *Vragerbro* on this map, just the *Vejerhus* and *Pramlaugets hus*. In the *Københavnske Jævnførelsesregistre* (Copenhagen plot correspondence registers), the *Vragerbro* is not mentioned in 1756, but seems to be present in both 1689 (in Snarens Kvarter, plot nr. 1) and 1806 (in Strand Kvarter, plot nr. 57). The dendrochronology dates retrieved from the foundation timbers (see below) post date the map thereby indicating that this structure was re-built.

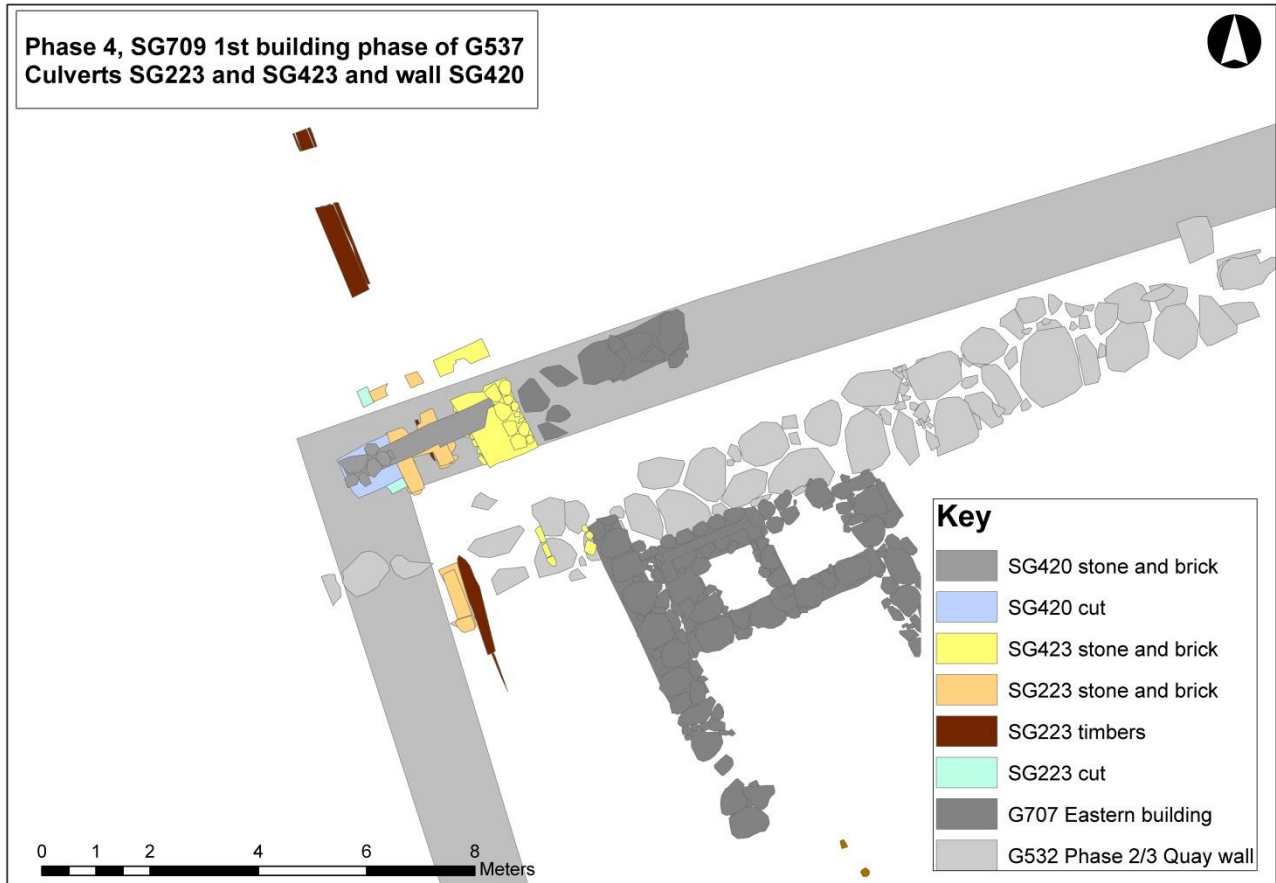
**Fig. 257 Plan of the two brick arched culverts SG223 and SG423 with wall SG420 overlying**

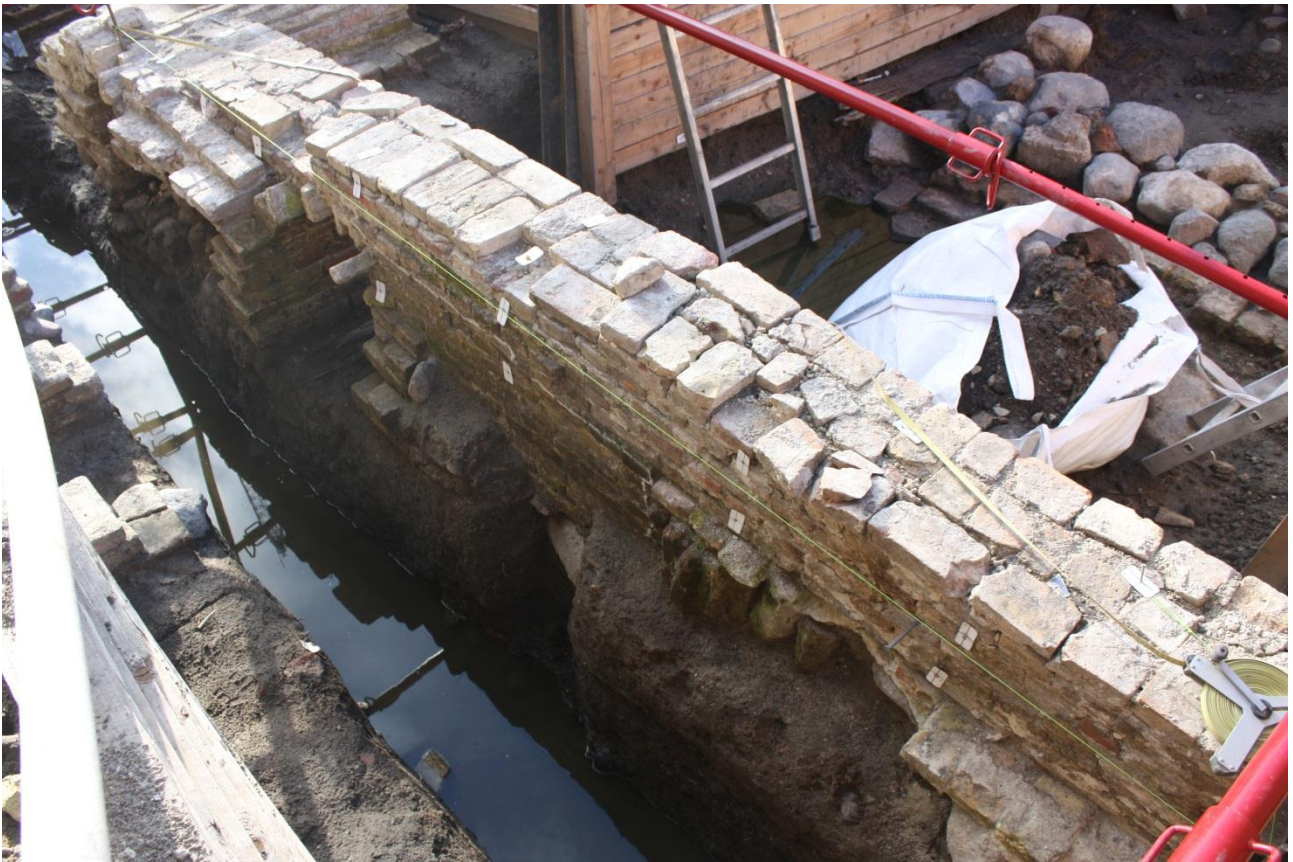
**Fig. 258** A working photo showing the recording of wall SG420 with overlying rebuild SG418, viewed from the northwest. The two culverts SG223 and SG423 can be seen in the top left of the photograph. Looking SE. C03\_\_20120718\_4967

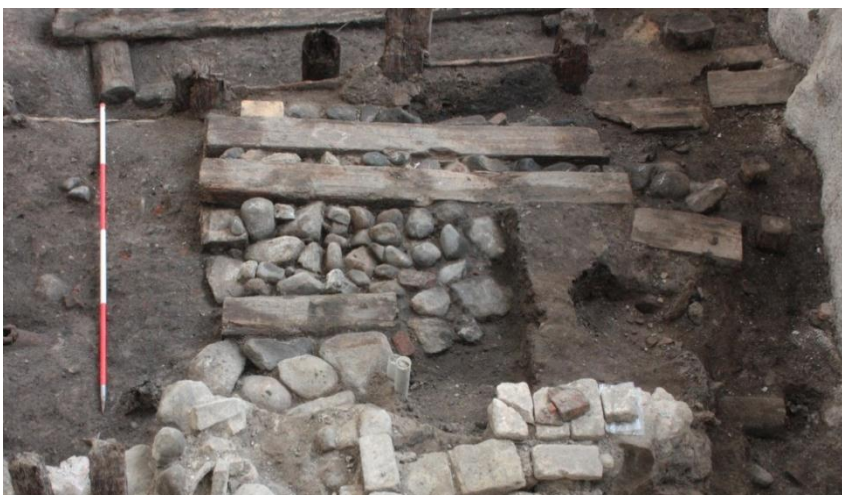
Fig. 261 Timber foundations SG410 in the Main Excavation. Looking south. C02\_20140507\_9194 (cropped)

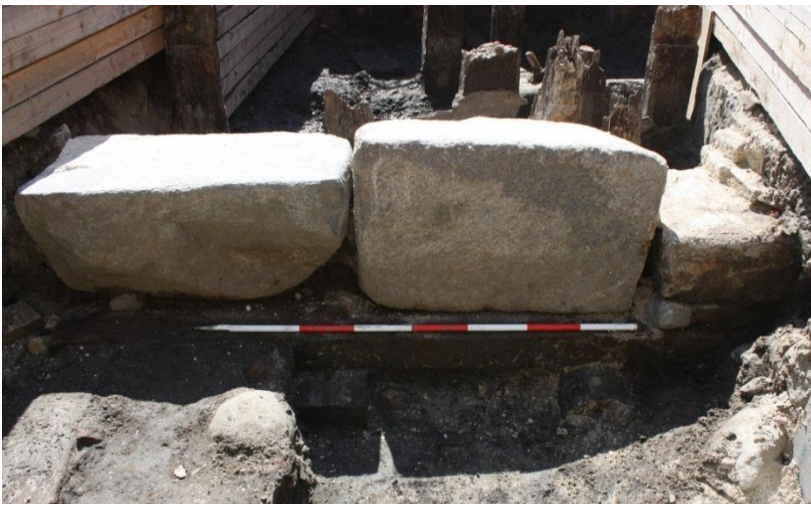
Fig. 262 Foundations SG410 in the Guide Wall trench, Looking south. C03\_20120723\_5067 (cropped)

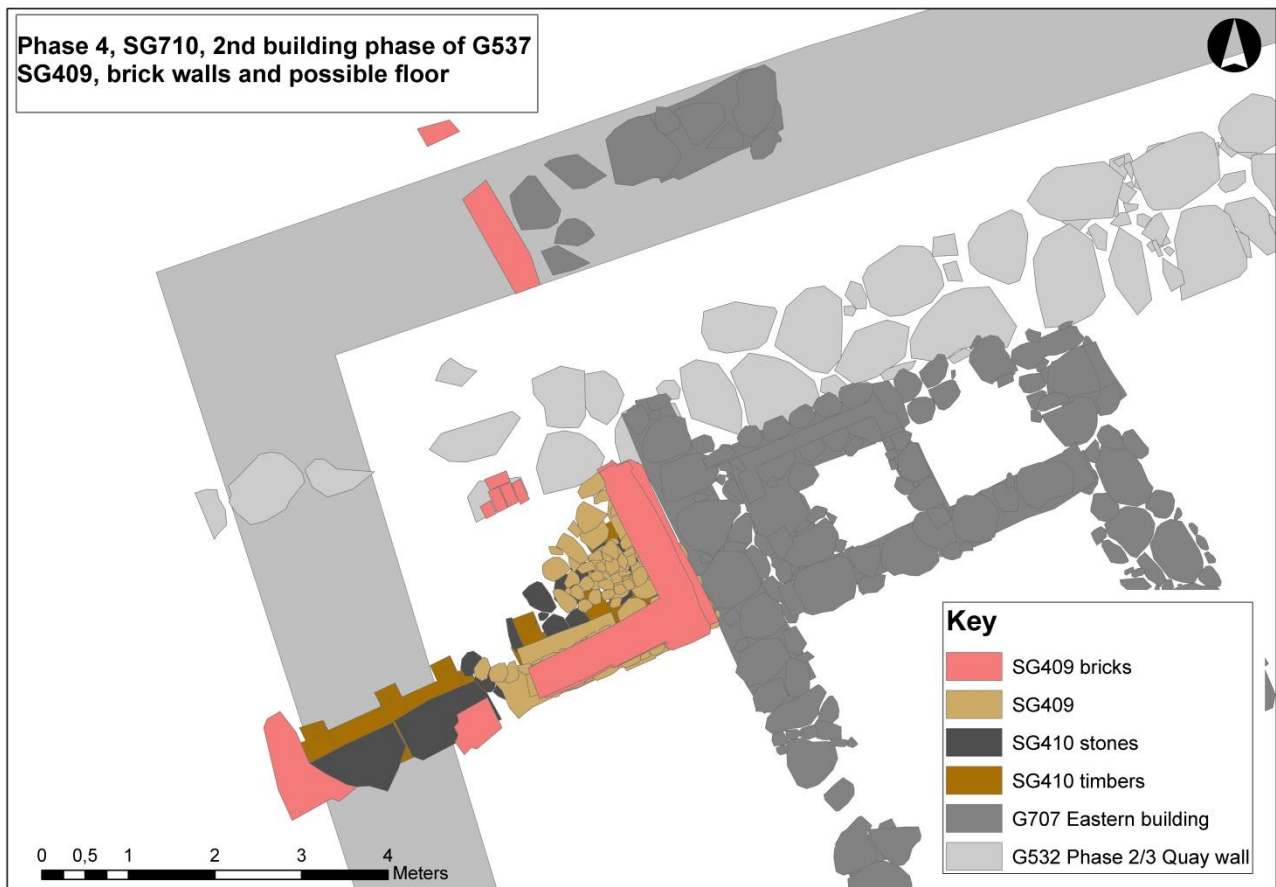
Fig. 263 Plan showing the extent of the brick walls and possible area of brick flooring in SG409

The upper structure of wall SG409 was constructed of stones and bricks SS35002 set between beams ST34967 in SG410 in the southeast corner of the wall to provide stability. Above these timbers were large, rectangular boulders, SS33632 and SS33651, along the western and northern foundations respectively. The corner of the structure between the two was then filled with rounded stones SS33678 as a drystone structure and a primary wall footing. SS50560, of red brick was built over the foundation stones. This in turn carried six courses of red Danish Modern brick wall, SS24616, laid in a stretcher bond, measuring 2.35 m by 2.15 m and 0.6 m high from a height OD of 0.81 m, and which would have been mortared to the wall SG693, before the latter was robbed out.

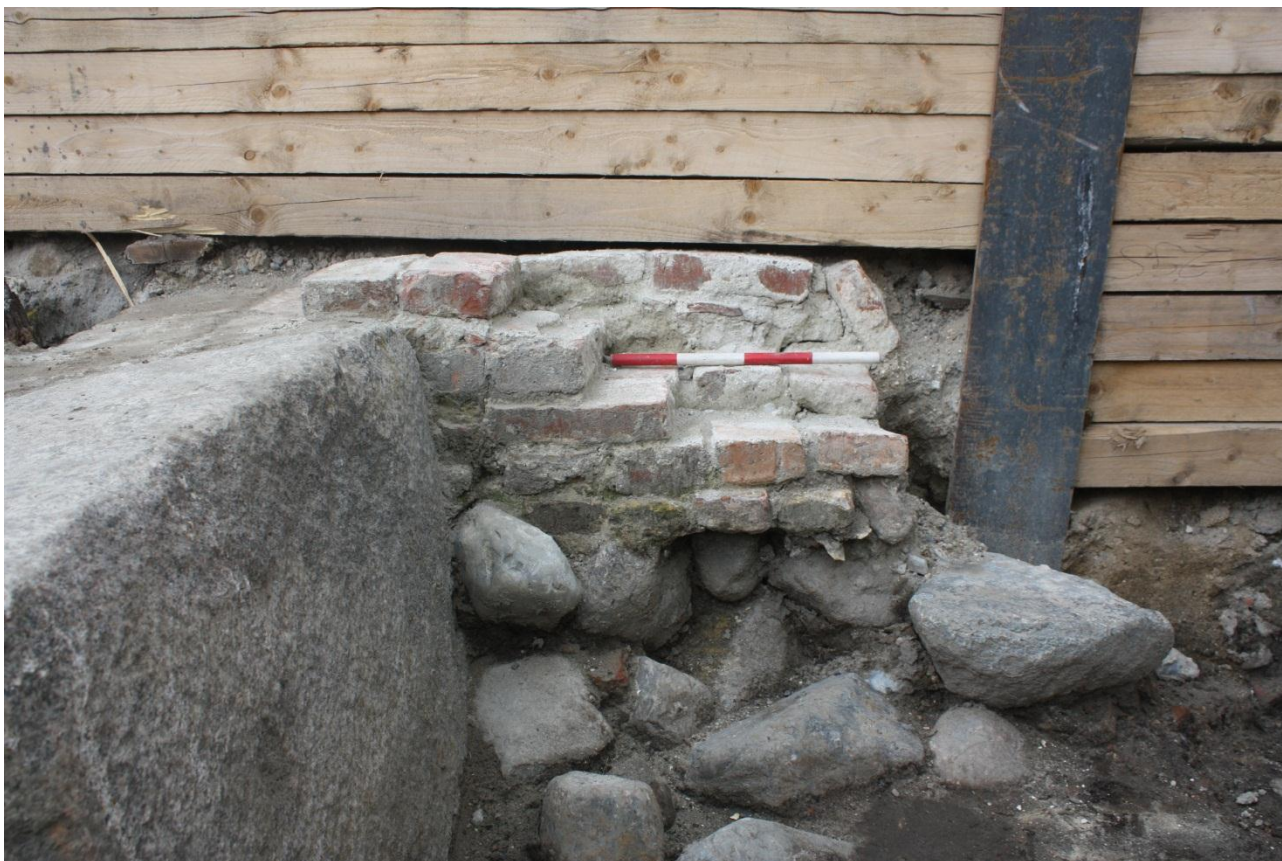
Fig. 264 the remains of wall SS9386 in SG409 over foundations SG410 in the Guide Wall trench. Looking west.  
C03\_\_20120718\_4994

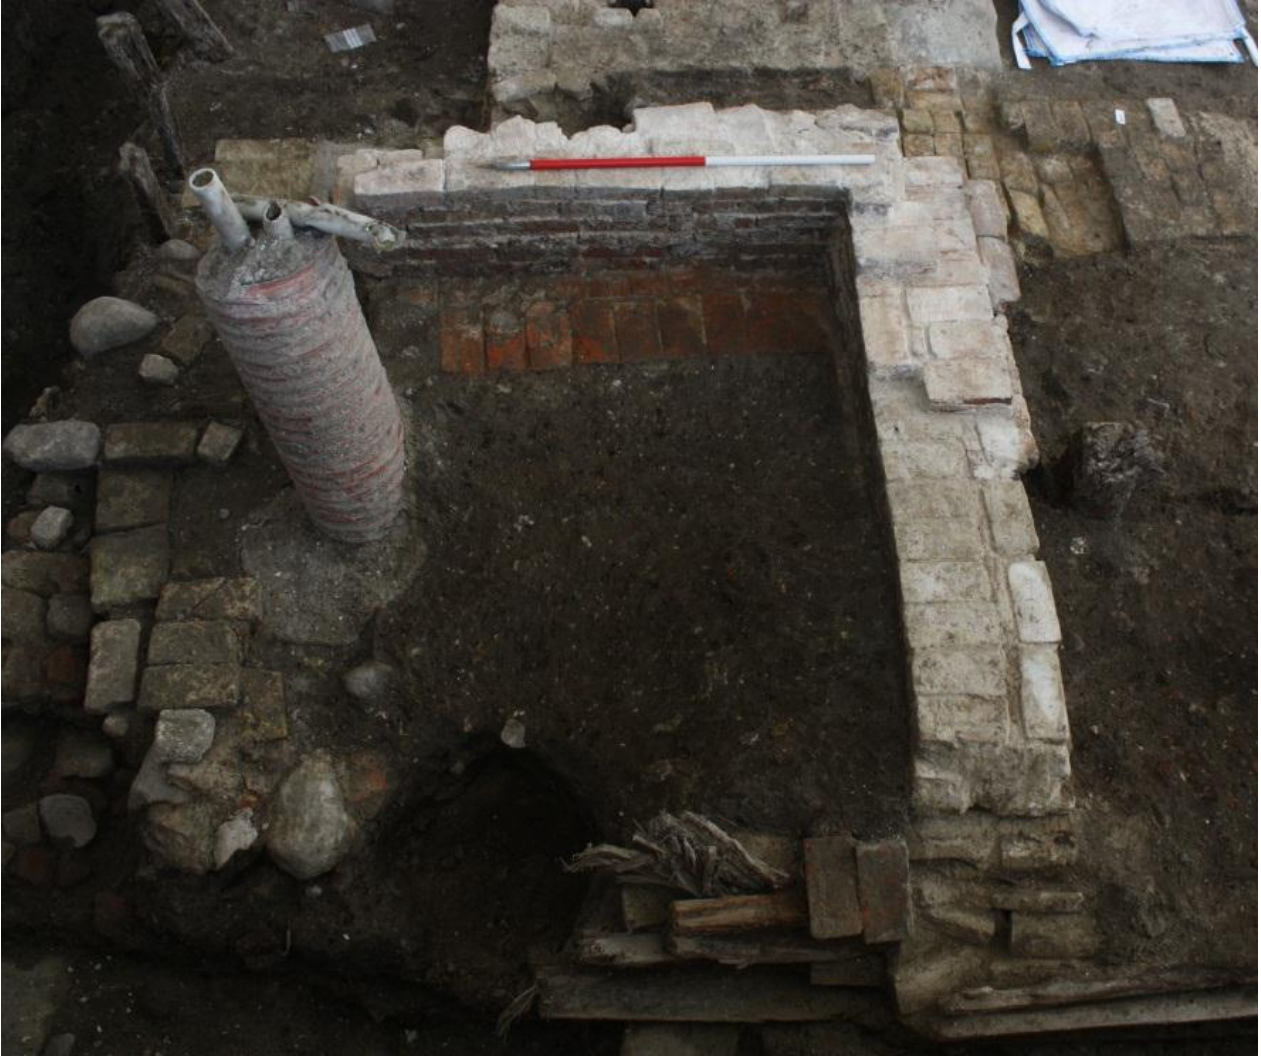
Fig. 265 The upper courses of SG409 viewed from the west. The top of drain SG689 can be seen to the top of the photograph, and drain SG708 to the bottom. The remains of the possible brick floor can be seen to the left. C03\_20140317\_8825 (cropped)

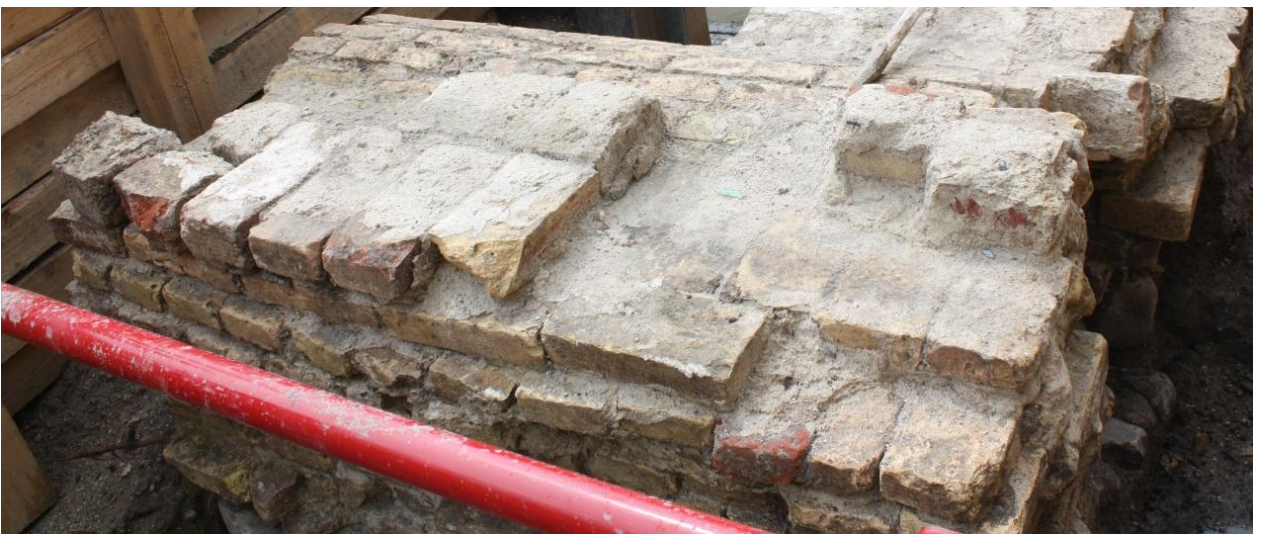
Fig. 266 SS12104 of SG409 along the east side of culvert SG423. Looking SW. The red bricks in the upper courses of the wall are clearly seen. C03\_280612\_4658 (cropped)
