### 7.4.3.3. Bulwarks

#### 7.4.3.3.1 Introduction

Table 43 Groups and sub-groups related to Phase 4 bulwarks

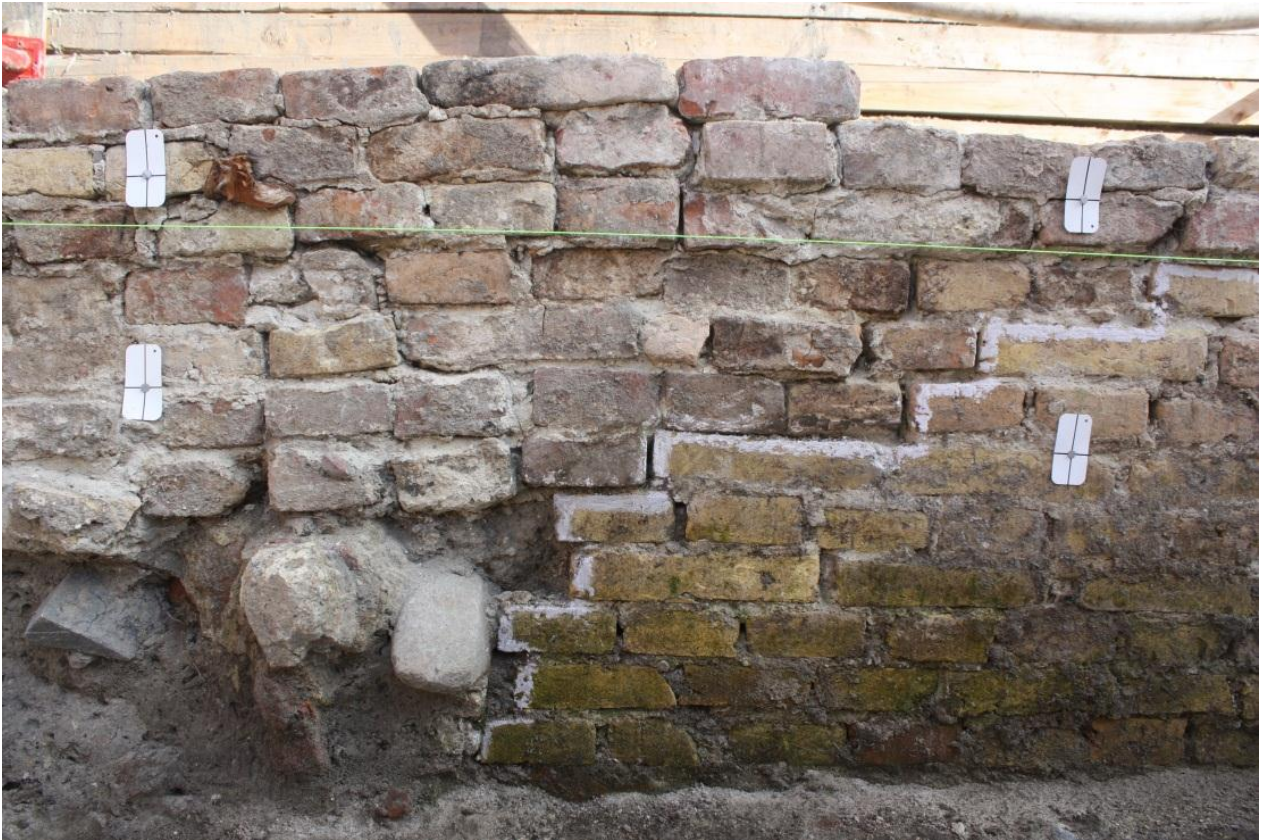
Fig. 268 The rebuild SG418 over wall SG420: the deconstruction of SG420 on the diagonal can clearly be seen, viewed from the south. The poorer quality of the overlying brickwork is evident when contrasted against the earlier wall. C03\_20120717\_4941

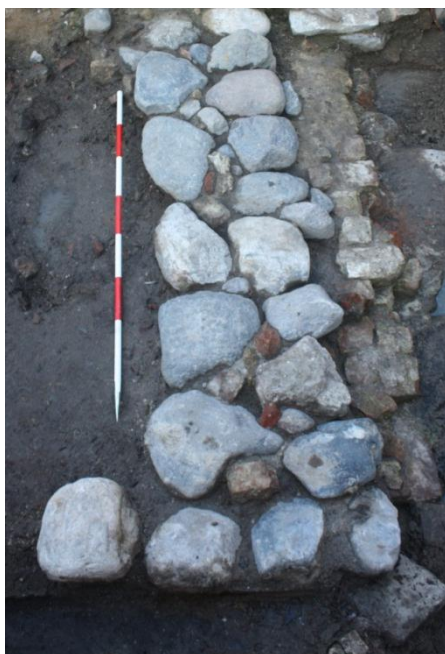
Fig. 271 Wall G424. Looking WSW. C03\_20120718\_4972 (cropped)

Wall G424 consisted of a short section of stone wall foundation which measured 2.5 m by 0.7 m and 0.2 m high. The top of the structure was at 0.44 m OD. It was built above the remains of the old harbour wall G532, and ran perpendicular to the building group G707, on the same alignment with SG420 to the north. It was constructed of natural sub-angular stones, SS11242, c. 0.3 m in diameter, laid in two parallel rows and in-filled with fragments of broken brick. The relationship to the culvert SG223 was unclear, and it could be that the wall was truncated by the culvert. This section of wall did not directly relate to any of the other structures in the area, and while the construction method was similar to SG420 to the north the larger size of materials used is indicative of a different phase of construction. This wall could have been the first instance of the creation of an enclosed ‘booth’ in the area, with wall SG420 having formed its northern boundary, or it could have formed an internal wall between walls SG420 and SG410/409.

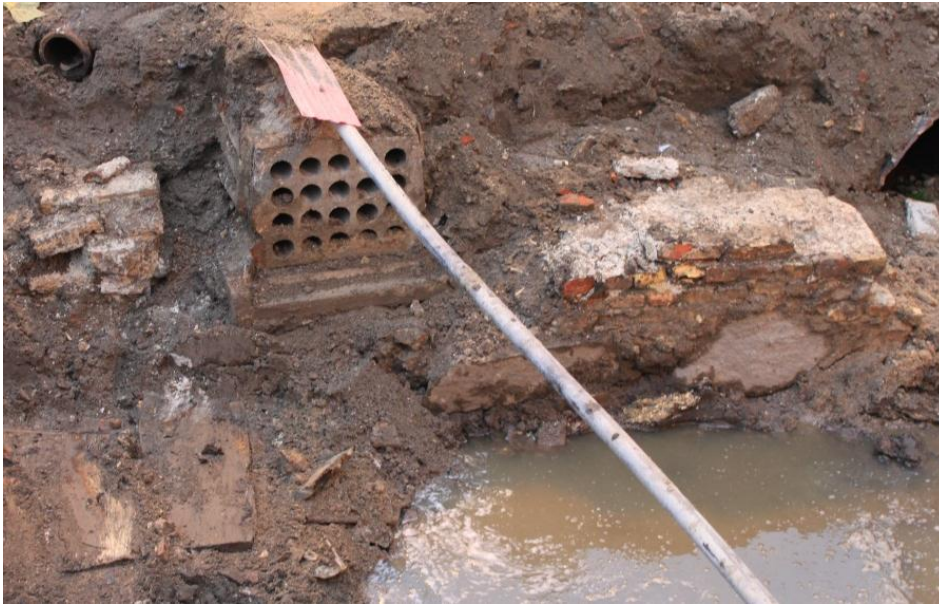
Fig. 274 The separate elements of SG501 and the modern disturbance. Working shot, looking west. C19\_IMG\_4334 (cropped)

differed, however, between SG500 and SG501, which could indicate a different phase of construction between the two walls. SG501 had large stones, SS19500 and SS19541, c. 0.35 m high, faced to their eastern sides, over the longitudinal beams, ST19485 and ST19554, to support the brickwork, SS19348 and SS19546, above, but SG500 had a single layer of smaller, natural stones, SS19509, c. 0.2 m thick, covered with a thick layer of mortar to provide a level surface on which to construct the brickwork, SS19504. SG500

Fig. 273 Wall SG500. Looking east. Despite the different preservation levels between this and SG501 (see Fig. 274 above), the contrasting use of stone in the foundation is evident. C19\_IMG\_4350 (cropped)
