# Beginning of the Metropolitan harbour (Phase 2) 1570s-1620s

# The Mid to Late Renaissance harbour; Phase 3, 1620s-1680s

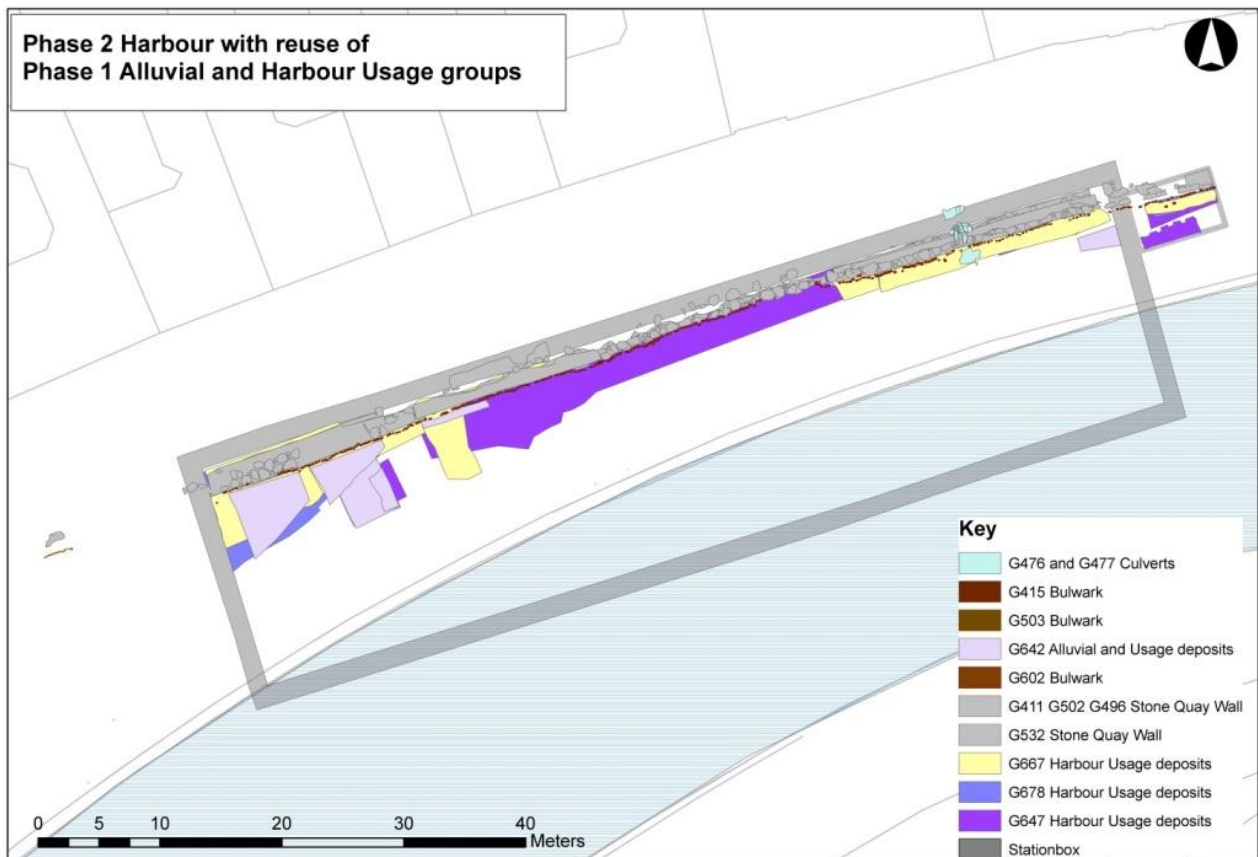
Fig. 43 Plan of harbour wall G532, Bulwarks G602, G503 and G415 and the harbour deposits, featuring the re-use of Phase 1 groups G647, G678 and Phase 2 alluvial group G642.

Associated with the harbour wall were various wooden bulwarks, set either in-front or south of the wall G532. The post line was found to continue outside of the Main Excavation trench and the stairway trench, and was represented by G415 in the Guide Wall excavation and G503 in the Oil Container trench.

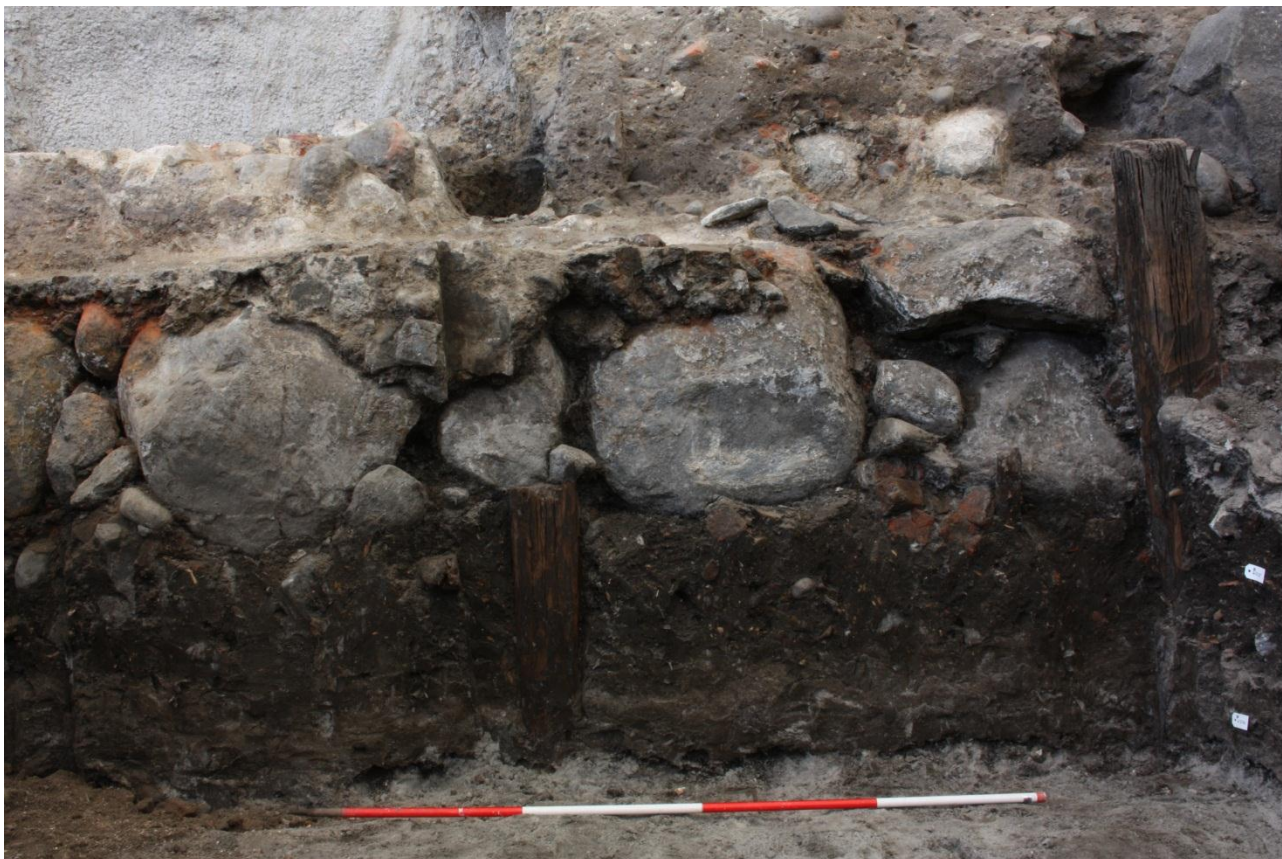
Fig. 44 profile containing sand G101 (at bottom of photo), overlain by SD55781 of Group G678, below SD55780 and SD55779 of sub group 667 levels at western area of Main Excavation. Note that construction cut SC57441 of Phase 2 Group wall G532 truncated the upper part of bulwark G656. A single post from bulwark G602 is at the right of the photo. Photo C03\_20140624\_11176 by Museum of Copenhagen.

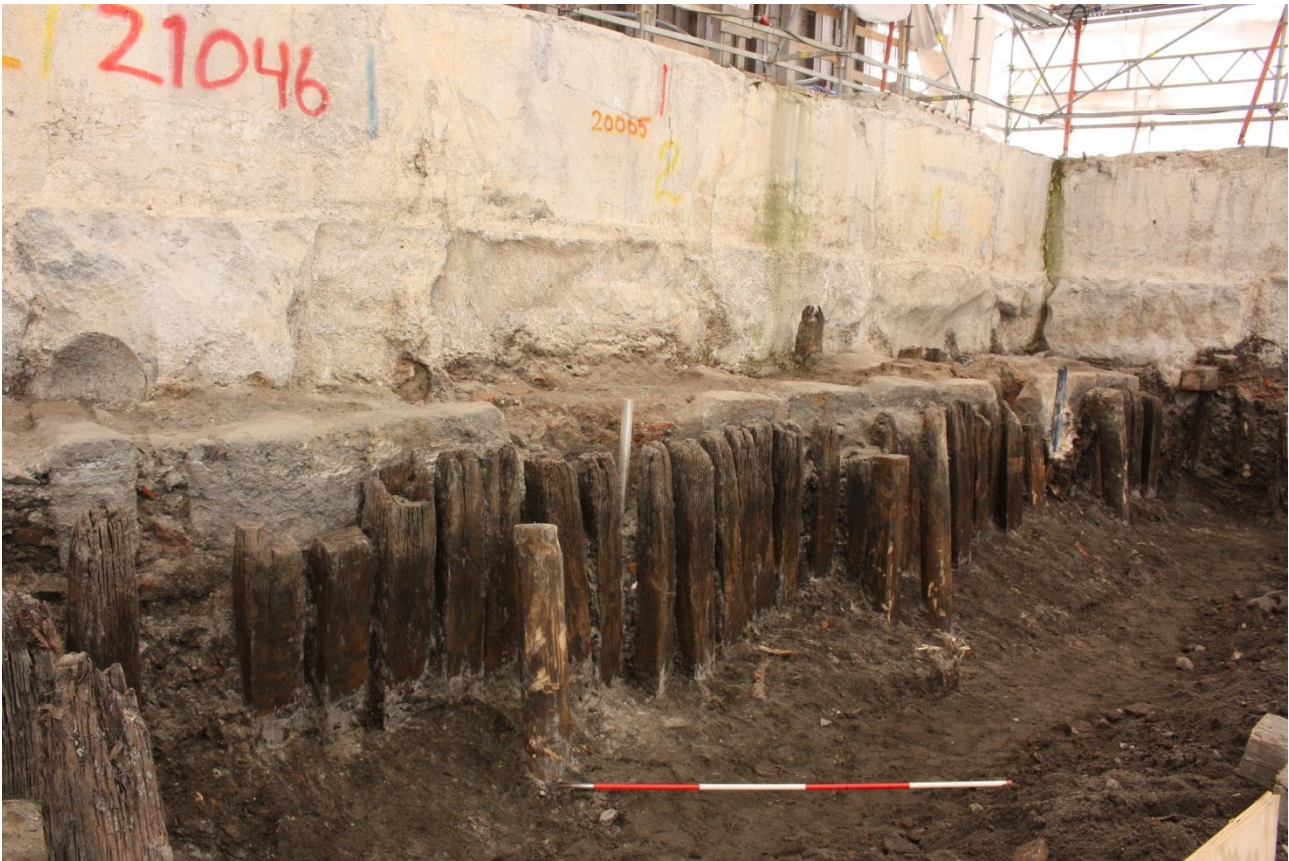
Fig. 45 Photo of Harbour wall group G532 and bulwarks group 602. Located at the eastern end of the Main Excavation looking NE. C03\_20140602\_10517

The stone harbour wall, G532, stretched for 88 m through out the Guide Wall trench and Main Excavations. Historical records state that it was constructed by 1583 and it was in use until the 1690s when the new wooden harbour was constructed. In the western area the stone harbour was in use until the 1630s when a new wooden reclamation box and then wooden harbourfront was constructed. Here, at the western end of the Main Excavation trench, the upper reaches of the wall are demolished and a new harbour is constructed southwards.

The wall was uncovered approximately 1.5 m below the present ground surface in the Guide Wall excavation and between 1.5 m and 2 m below the modern surface in the Main Excavation at an average height OD: -0.24 m at the top of the wall. It survived at a width of 2 m to 2.6 m wide and from 1.5 m to 2.5 m in height. The destruction of the upper wall part leads to an estimation of the original height. It was built within a linear construction cut with steep sides and flat base truncating the remains of the Late Medieval harbour, structures and deposits.

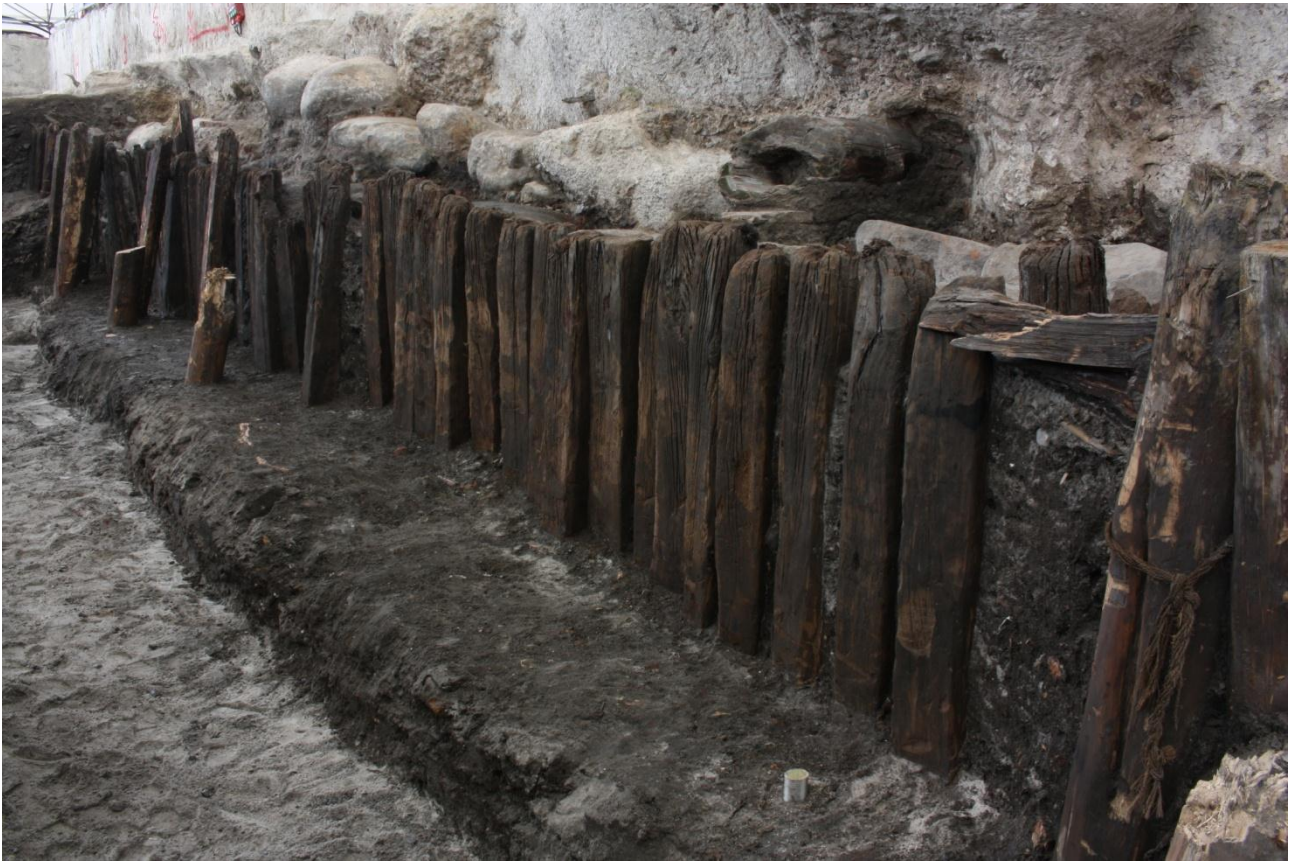
Fig. 46 Photo of central section of harbour wall G532 with bulwark G602 in front. Looking NW.C03\_20140611\_10788

The wall was first seen in the Guide Wall excavation in 2012 and in the Main Excavation and the Stairway trenches in 2014. It was built on a NE-SW orientation, although it curves slightly in the centre of the Main Excavation, which may reflect the former fluvial channel of the canal in the Renaissance period. The wall group was built directly on top of the Phase 1 Late Medieval bulwark group G616, and directly south of the Phase 1 bulwarks G467, G478 and G485. It was also built into the Phase 1 groups G647, G678, SG667 and the Phase 2 group G642 in the west.

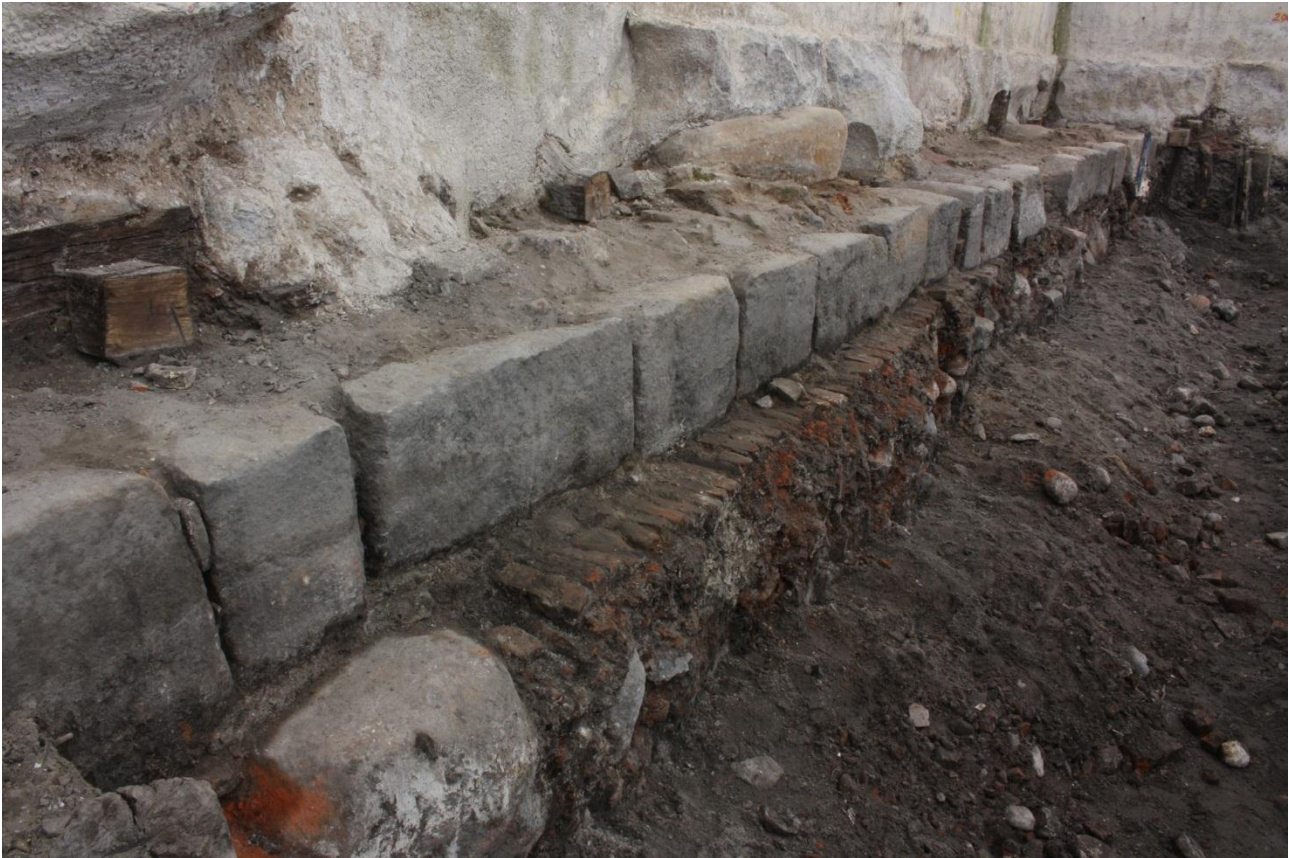
Fig. 47 Photo of eastern end of wall G532 after bulwark G602 was removed. Photo shows the different construction methodology to areas in the centre and west. C03\_20140613\_10888

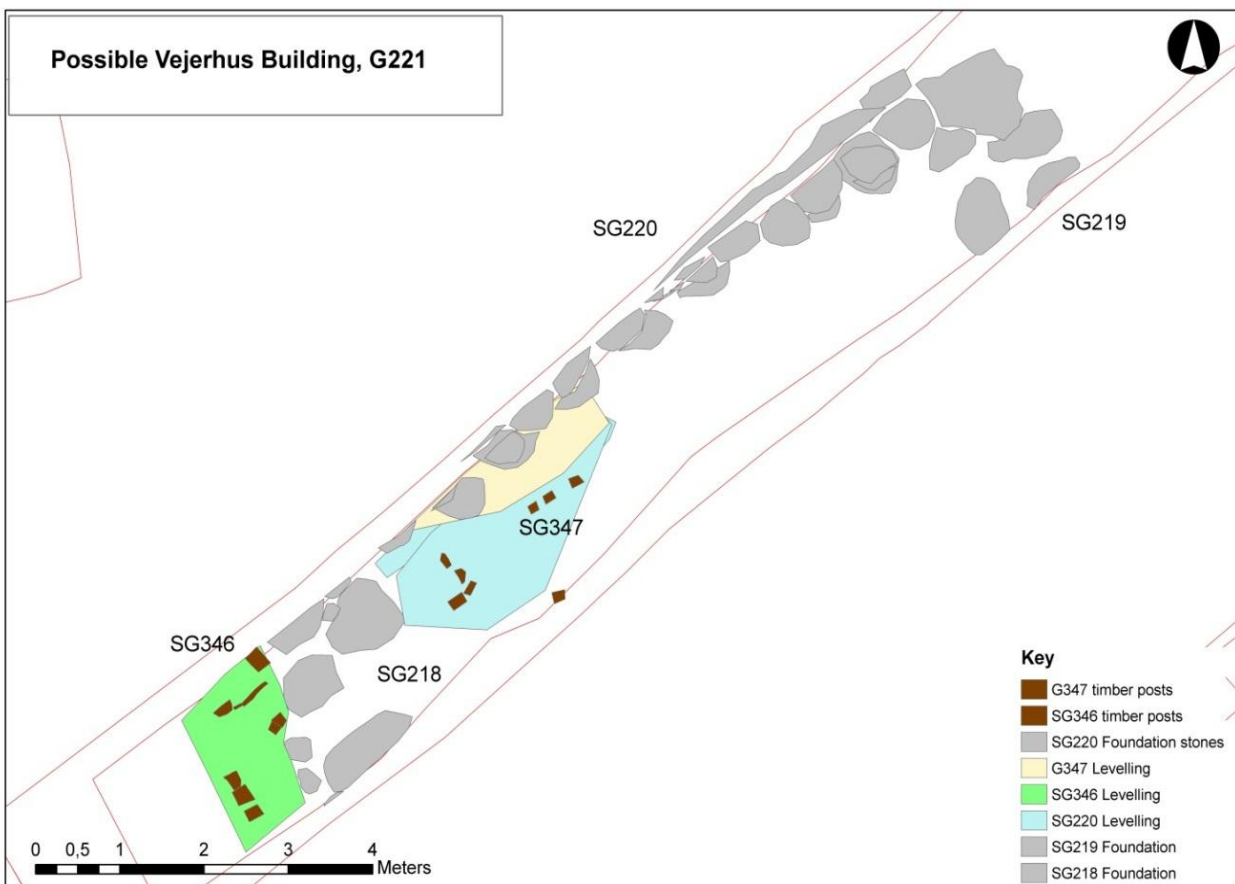
Fig. 48 Plan of possible Vejerhus building, G221. Watching brief phase, 2010

The 2010 watching brief revealed that the brick walls of the G221 structure was built on stone foundations with munkesten red brick the main form used for the brick walls. The building group consisted of 7 subgroups SG218 (western foundation wall), SG219 (eastern foundation wall), SG220 (northern foundation wall), SG289 (demolition sequences of the *Vejerhus*), SG346 (outhouse), SG347 (structural elements) and 28 contexts representing the remains of the large brick and stone built structure. These quite well preserved structural remains which were found in the western half of Gammel Strand but close to its centre, represent the northern foundation in its full length of 9.5 m, but not full width (only 1.1 m), the 2.15 m of the c. 2.2 m wide western foundation and 1.76 m of the also c.2.2 m wide eastern foundation. The whole building was approximately 13 metres wide by possibly 18 m long (using measurements linked to the believed former harbour location in the Vejerhus area and archaeological remains).

The remains of a suggested lean-to/outhouse, SG346, located on the western side of the building and the possible remains of structural elements, which potentially could be room divisions, are supposedly related to the building.

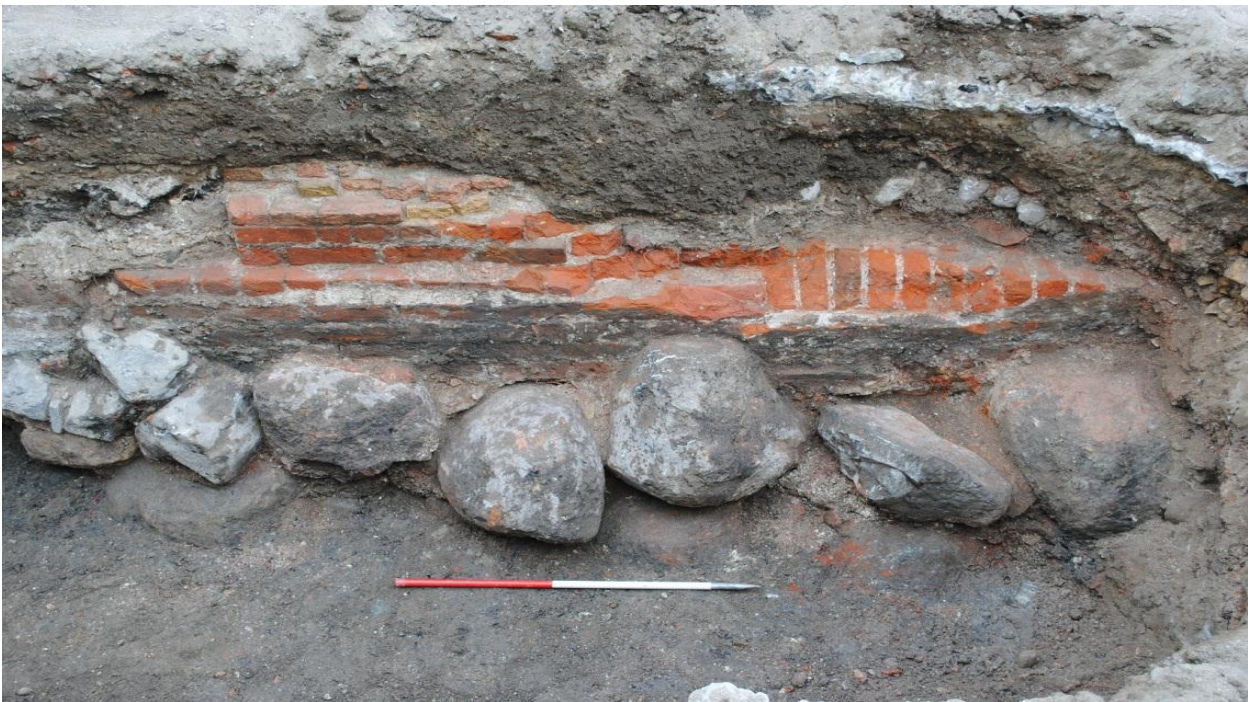
Fig. 49 Northern foundation wall SG220. Comprises Lower course (SS4298), upper course (SS4350) and overlying brick structure (SS4453) C07\_20100729\_0318

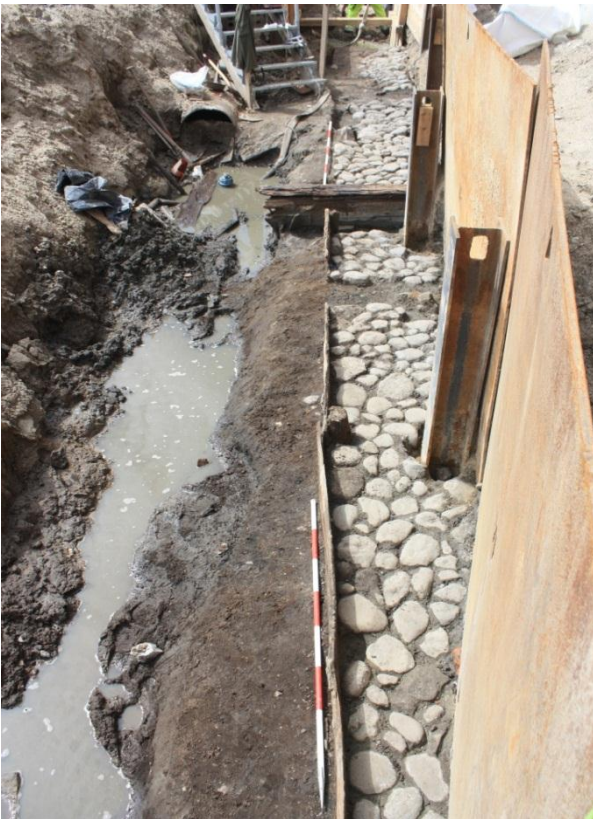
**Fig. 54 Working photo of Road Group 430 looking SW in Trench 1 of the Guide Wall trench. The photo comprises road deposit 11789 at rear and road deposit 10493 in foreground. C03\_20120723\_5083**

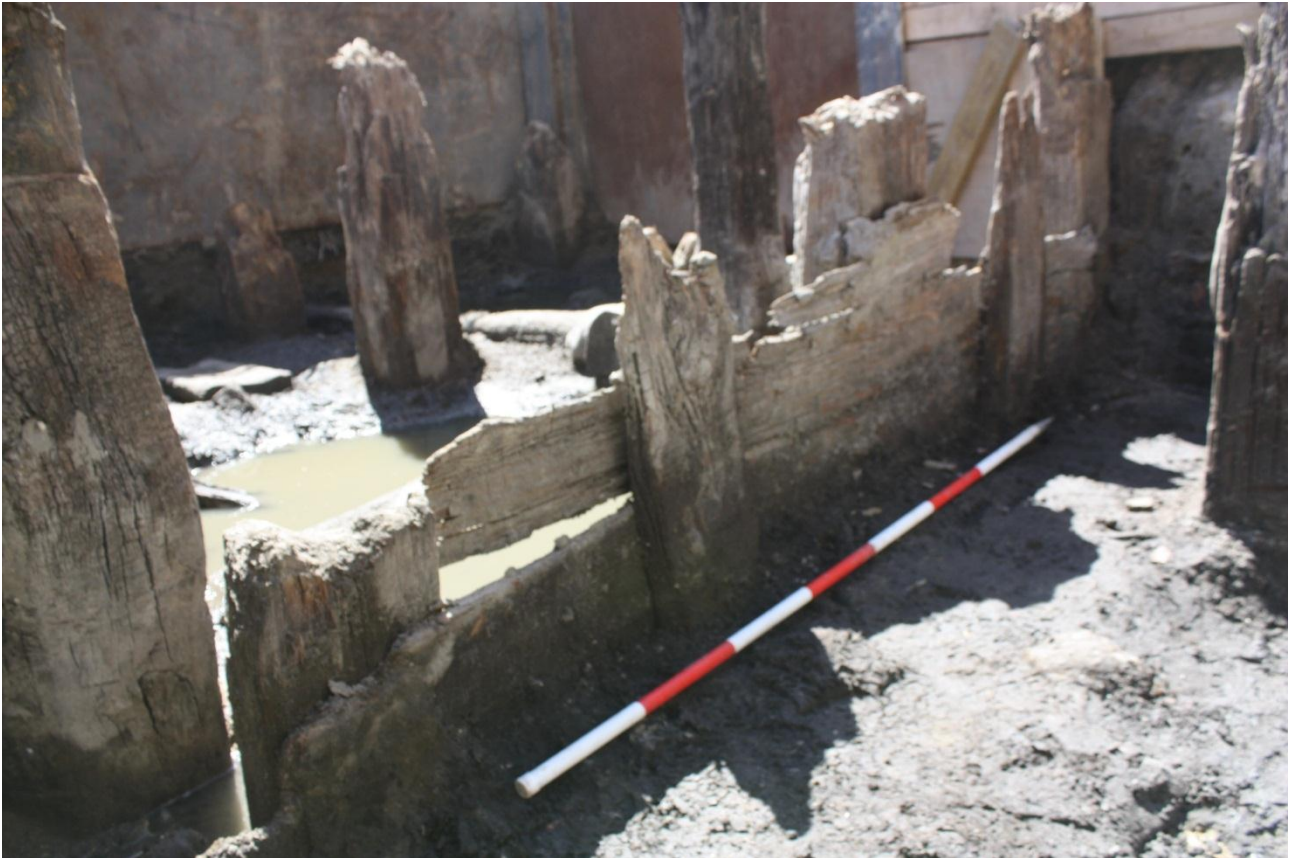
Fig. 59 Photo of reclamation fence G406, looking SW. Guide Wall excavation 2012. C03\_20120725\_5207

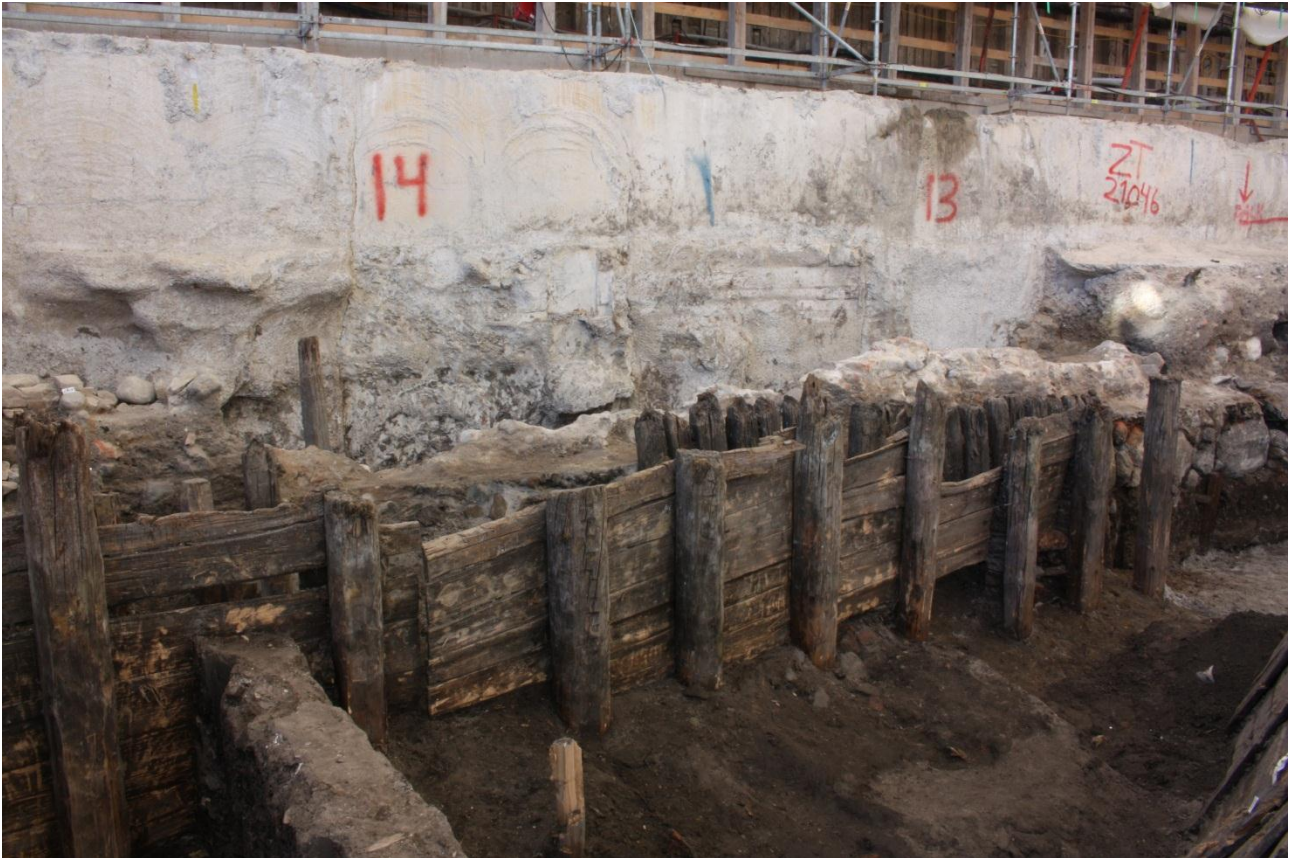
**Fig. 60 Reclamation Fence G674, Looking N-W. Note, the bulwark was constructed in two different parts, and that bulwark G602 may have been removed to build this structure. C03\_20140624\_11187**

The top of the reclamation fence in the Main Excavation trench was located between 0.02m and 0.72 m OD, and measured 9.65 m long by 0.35 m wide. It comprised of posts up to 3 m long and 0.2 m wide. The structure in this area comprised ten vertical rectangular shaped posts, three horizontal planking systems belonging to ST55660 and eight support posts driven into deposit below. The support posts were tangentially shaped and very thin at 0.04 m thick. They were attached to the posts and the support posts by nails. The fence line was orientated NE-SW, nearly reaching wall G532 at the NE end.

All sections had been nailed through the rear support planks into the front support beams. This indicated that the back, the NW facing side of the bulwark, was exposed completely prior to backfilling. The top level of planking was thought to have been truncated during demolition phase of G674 bulwark, presumably at the end of Phase 3. Surrounding these posts to its southern side was sub group SG682 from the bulwark group. The alluvial type deposit was formed by usage around the structure. The timber has since found to have been fashioned from spruce and imported from an unknown source

Dendrochronological analysis was undertaken on 18 posts and planks from G674. Of the samples, only the spruce (used for planks and some posts) was able to be dated. None of the oak posts were successful. The oak timber probably came from southern Scandinavia, perhaps from Skåne, Hålland or Sjælland. The spruce was found to have been felled in the winter of 1625/6.

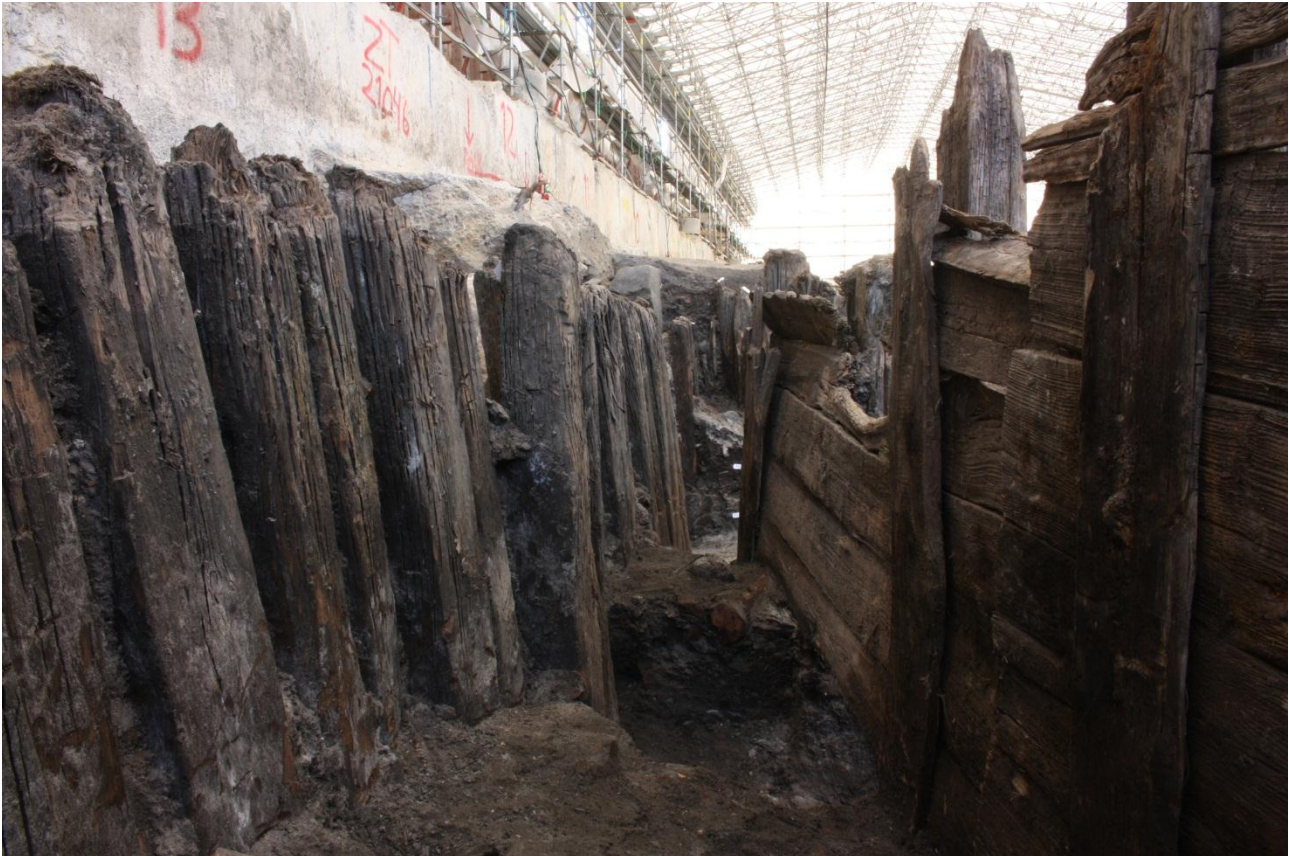
Fig. 61 Working photo of the excavation between G602 and G674 looking NE. Note the majority of the backfill has been removed. C03\_20140624\_11196.

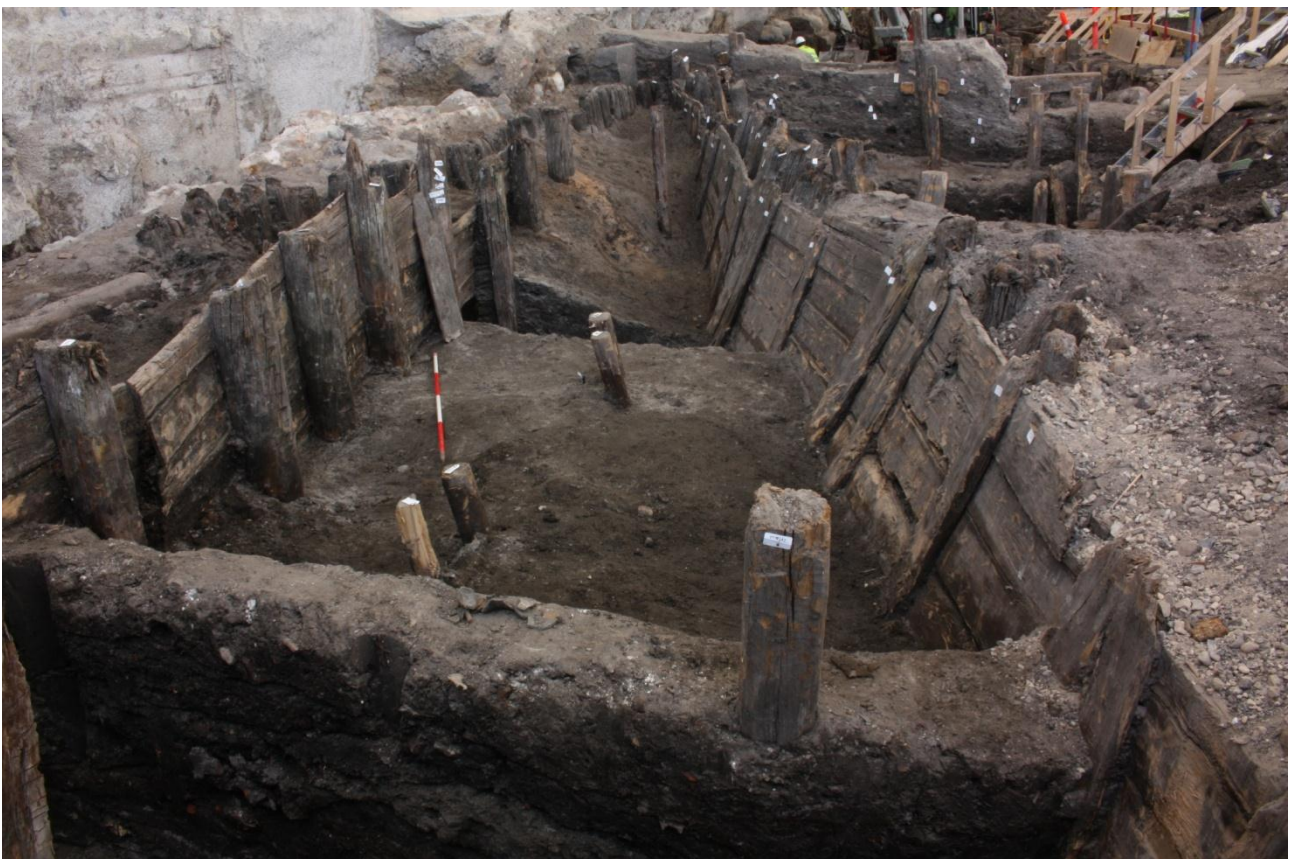
Fig. 63 Harbour wall G532 to the far left of photo, Bulwarks G674 near left, backfill group G640 centre and bulwark G648 right of photo. Looking NW. C03\_20140616\_10952

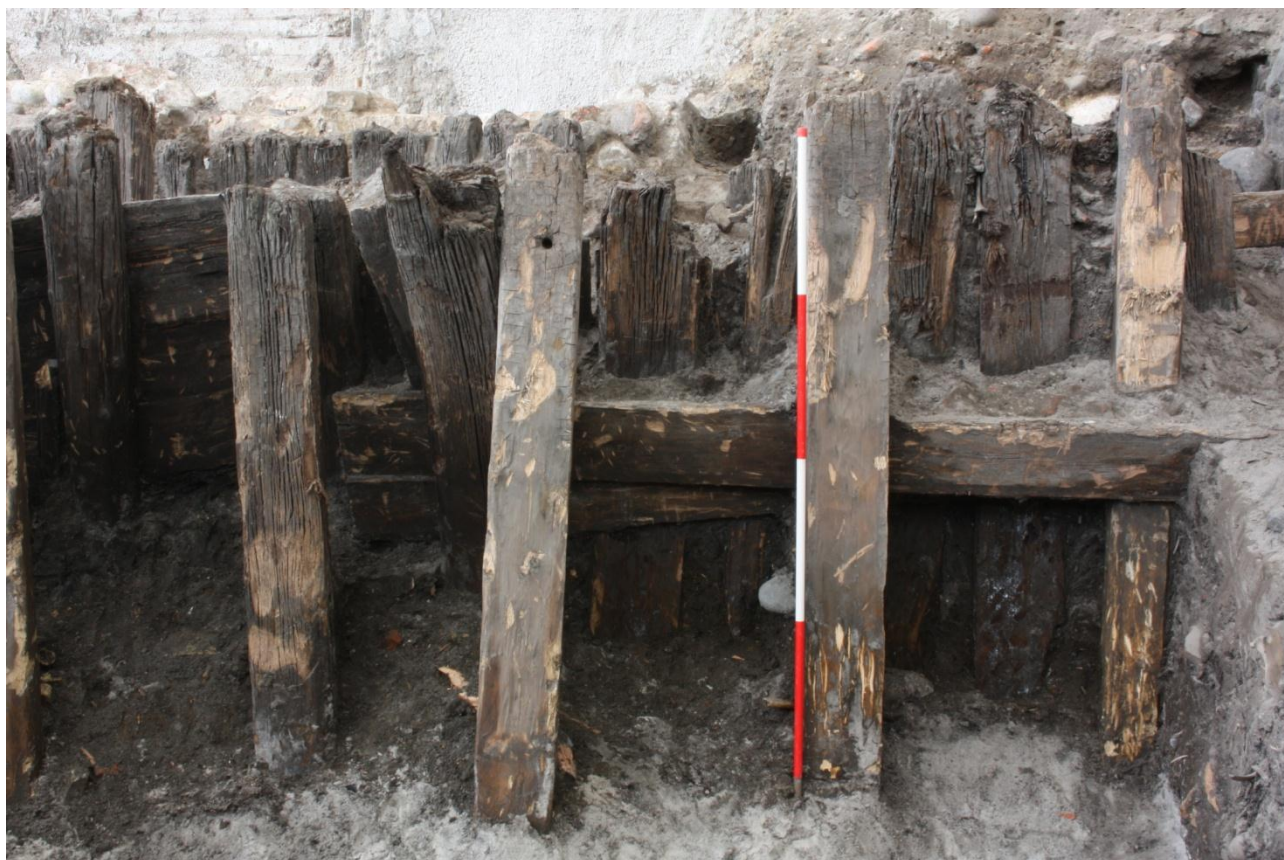
**Fig. 64** Close up of harbour bulwark G648 next to the baulk. The photo is centered on an area of repair shown by horizontal plank ST41884 and three vertically set planks (ST39435, ST39413, ST55582) used as the plank's support. The photo is looking N. C03\_20140613\_10920

layers. Leaning into these planks were support posts, positioned at an angle. The support posts were fashioned from oak and spruce, with oak being the dominant type. The bulwark was in use from the late 1620s to the late 1680s when it was finally replaced by the new Phase 4 harbourside

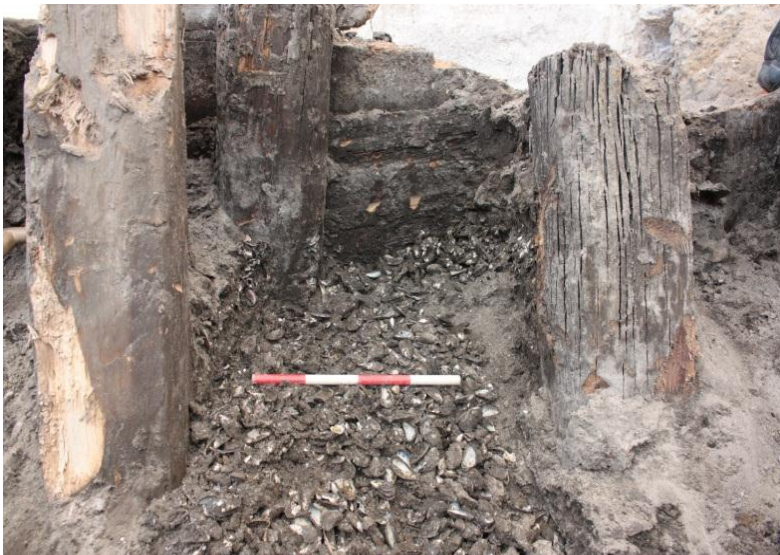
Fig. 69 Deposit SD38150, from G664. Note the large quantity of shellfish from the usage deposit. Looking N. C02\_20140526\_9538

of almost pure sand, excavated immediately to the seaward side of the southernmost timber bulwark. Where SD38150 met the timbers of the wooden bulwark, clusters of mussel shells were found immediately around the posts. This strongly suggests the area was open to the sea and that this deposit was washed in. The small patches of mid brown silt revealed evidence of many cultivated plants from the city.

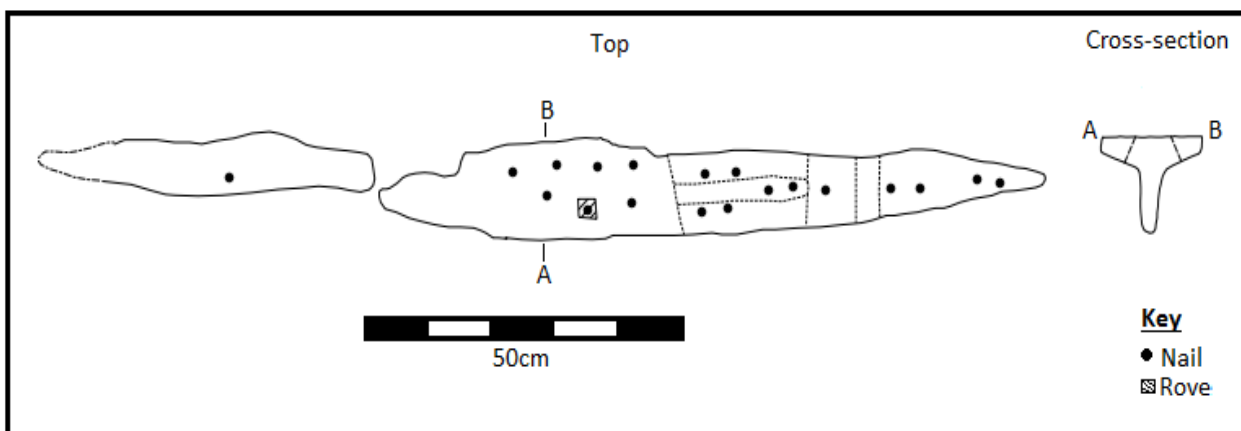
**Fig. 76** FO218893 Reconstructed keel. Dashes on cross-section show angle of nails. SD37640, G663. Drawing by G. Dickinson.

The deposit also contained remains of a ship with an oak timber beam Keel FO218893. The keel was in two fragments measuring 1.6 m long with 18 square iron nails still present. The keel was believed to be from either a small rowing boat or clinker built sailing vessel. 5-10 m in length.
