7.7. Re-infiltration trenches

7.7.1 Introduction

Chapter 8: Assessment of results and future research potential

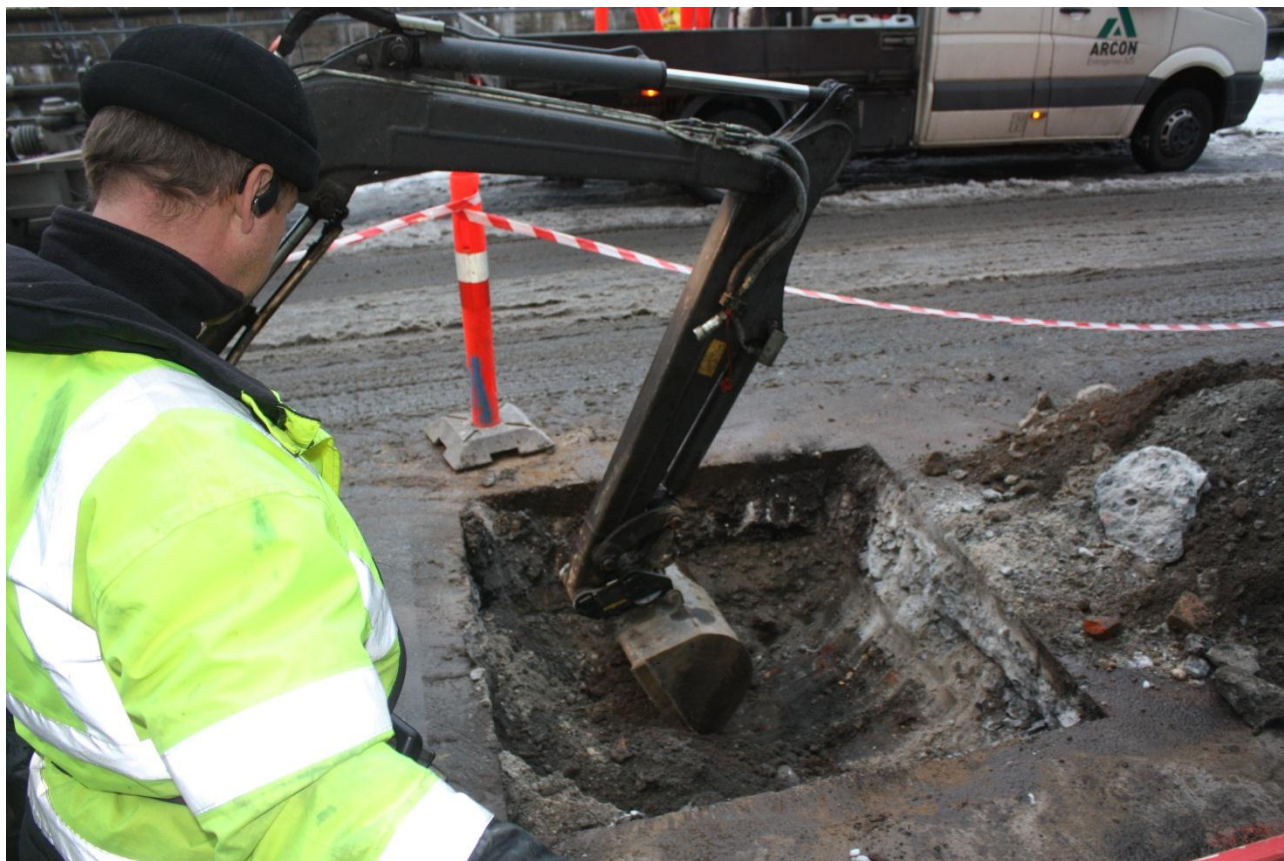
Fig. 372 Working photo of the excavation of Trench ZT19695 Re-infiltration well. C03_20121220_5516.

The trench contained one archaeological layer and two archaeological groups. The lowest layer was SD17906, a dark grey brown sand rich deposit containing a flint flake and a clay pipe stem. It was suggested by the excavator that this layer may represent the burnt layers from the fire in 1795. The layer was exposed to 0.6 m. The remaining 0.9 m was a mixture of a modern dump from the 20th Century, G103, and modern paving from 0.3 m below the surface (G100).

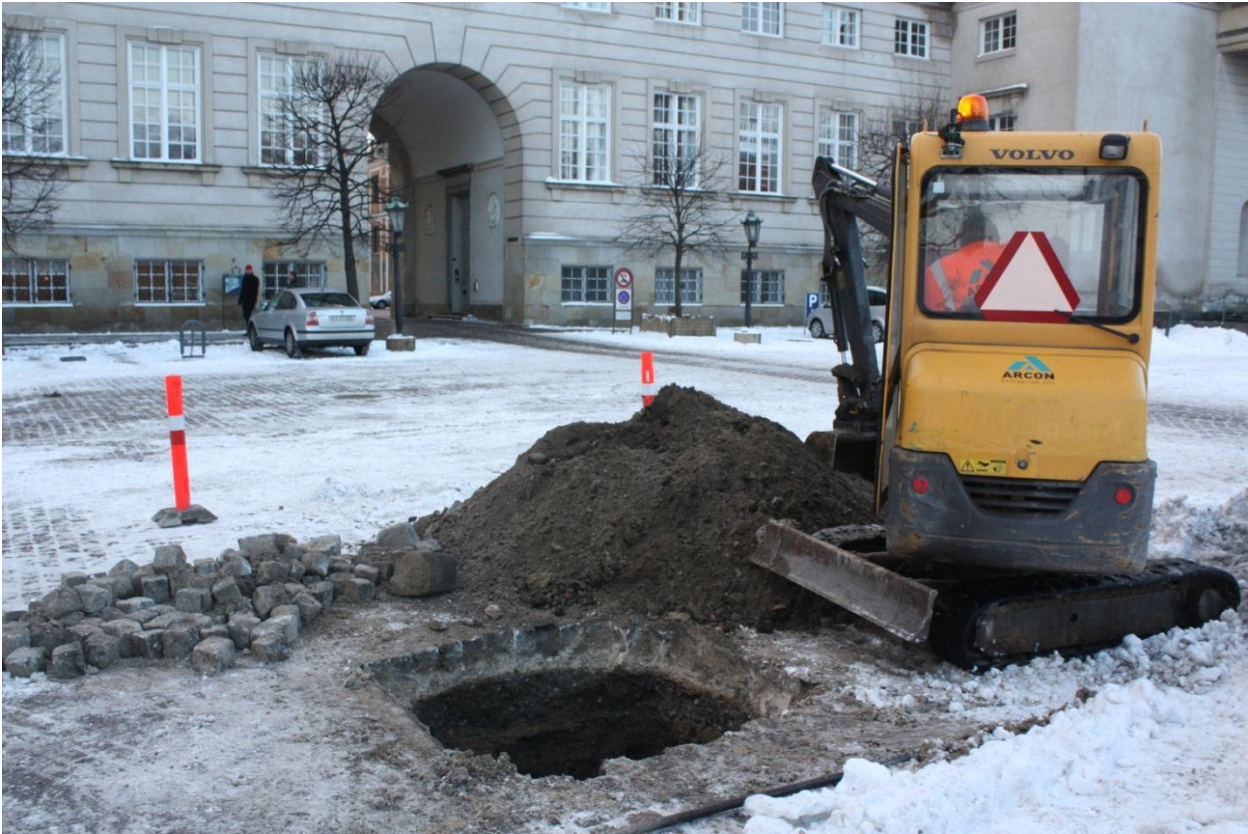
Fig. 373 Working photo of Trench ZT19718 Re-infiltration well. C03_20121220_5535

Beneath modern surface G100 was approximately 1.3 m of mixed modern deposits, presumably deposited to increase the ground level. The excavation ceased at 1.5 m below the ground level. No archaeology was uncovered at this depth.

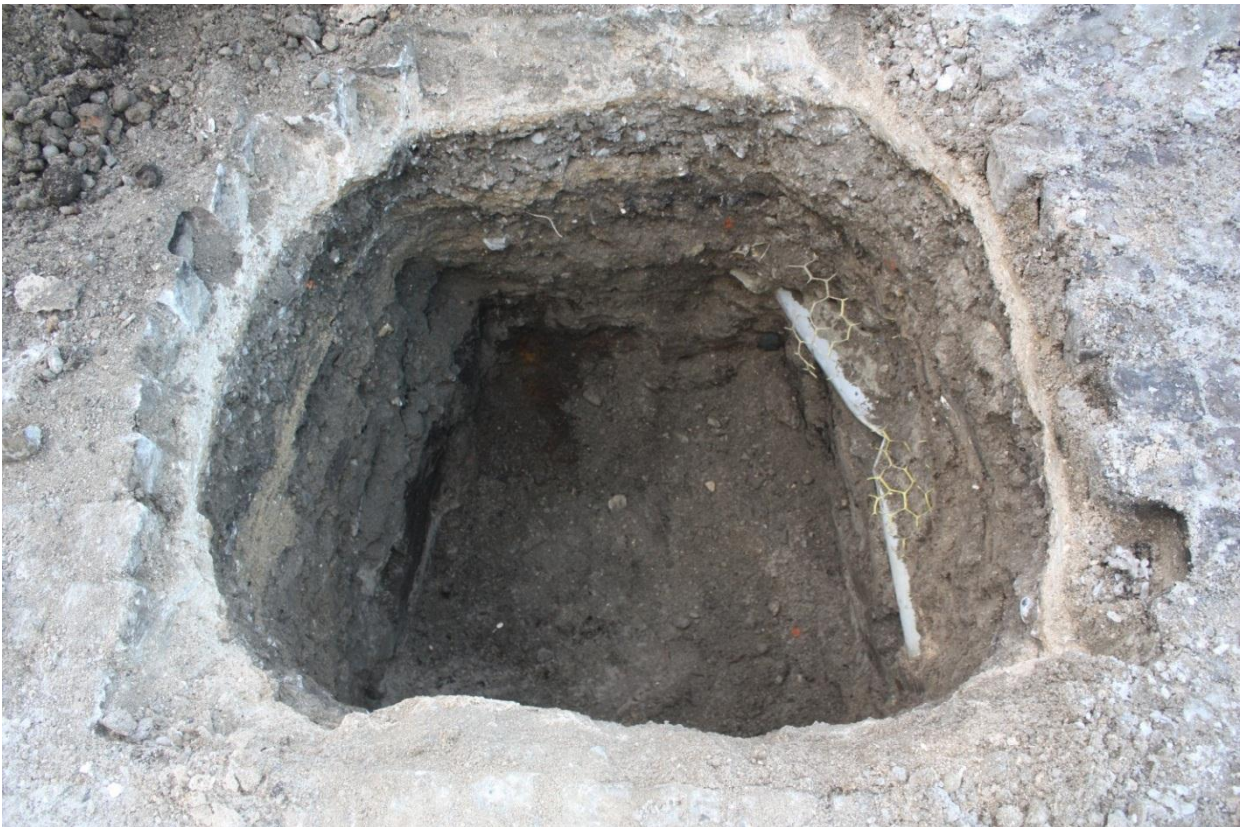
Fig. 374 Working photo of Trench ZT19718 Re-infiltration well. C03_20121220_5536

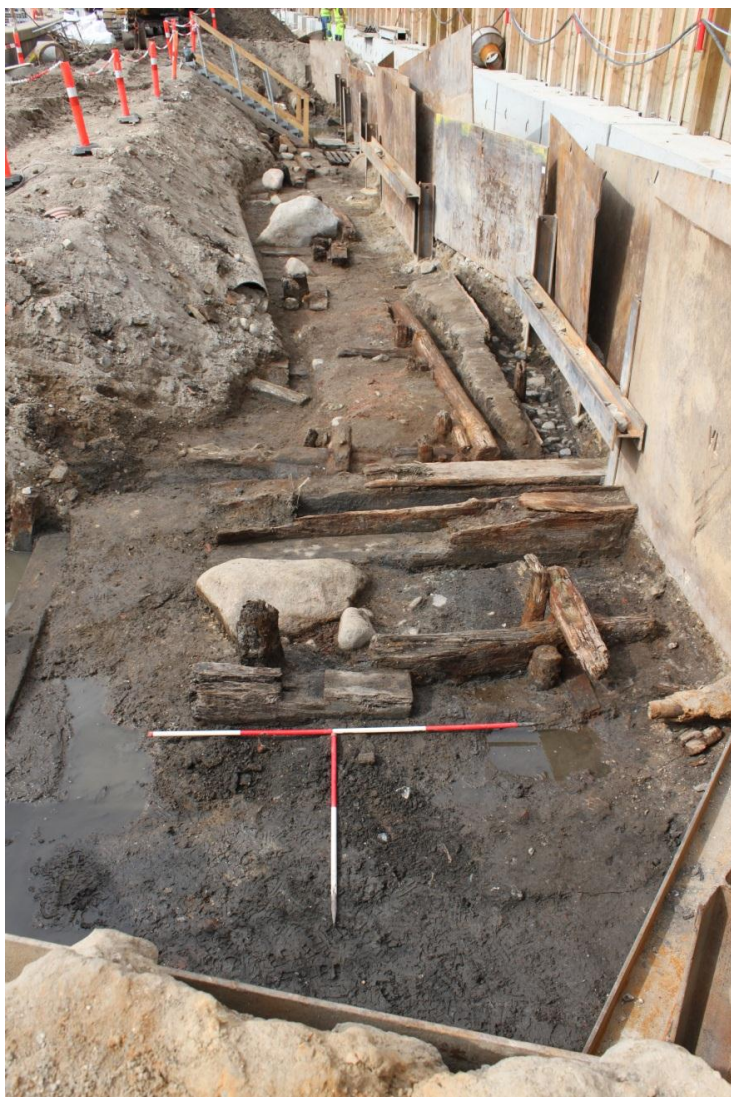
Fig. 375 Excavation of the Guide Wall trench, September 2012. Trenches 2B and 3. Looking SW. C19_20120824_3707
