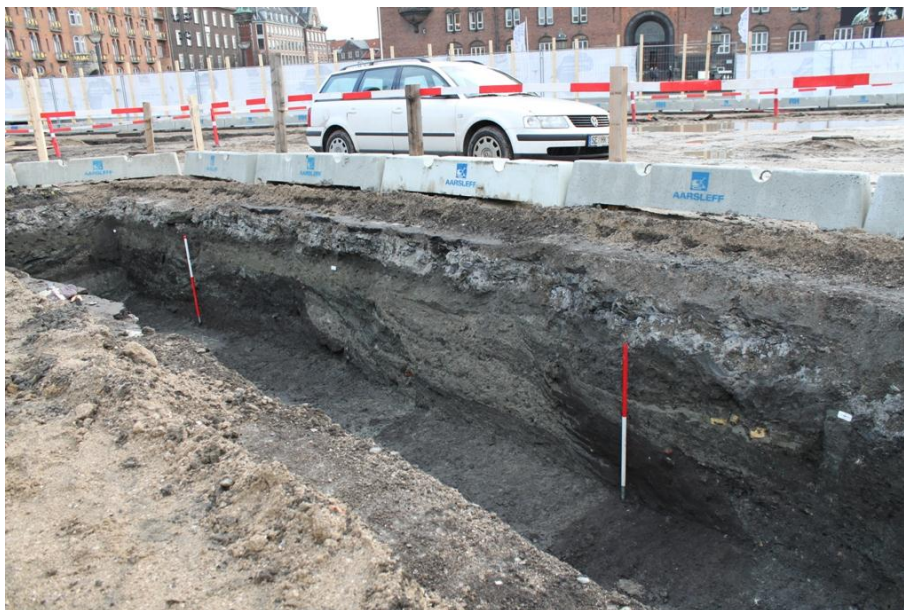
Figure 135 Possible rampart and moat deposits (Group 25) seen from west

The layers in question can be seen in the photo above, and here it can be seen that there are some very organic layers sitting over a very sterile sandy clay layer, with some repeated washes of material coming off of the sterile clay onto the organic material. It is possible that what we see here is part of the rampart (the sterile clay) and some of the natural build-up of humic material on the base of the ramparts and in the moat (the dark material). The repeated lenses of grey washing over the dark material appear to be evidence for the grey material being washed over time by rain, out over the dark material, suggesting that it was the exposed surface of the rampart for some time. Overall it seems most likely that this rampart dates to about the Christian IV era (c. AD 1600) , when the moat was altered somewhat in this area, with part of it being filled in to alter the shape of the moat in the environs of the outer gate, as was also seen in Trenches 2A and 2B. Hence it was likely filled in finally in the 1660s.

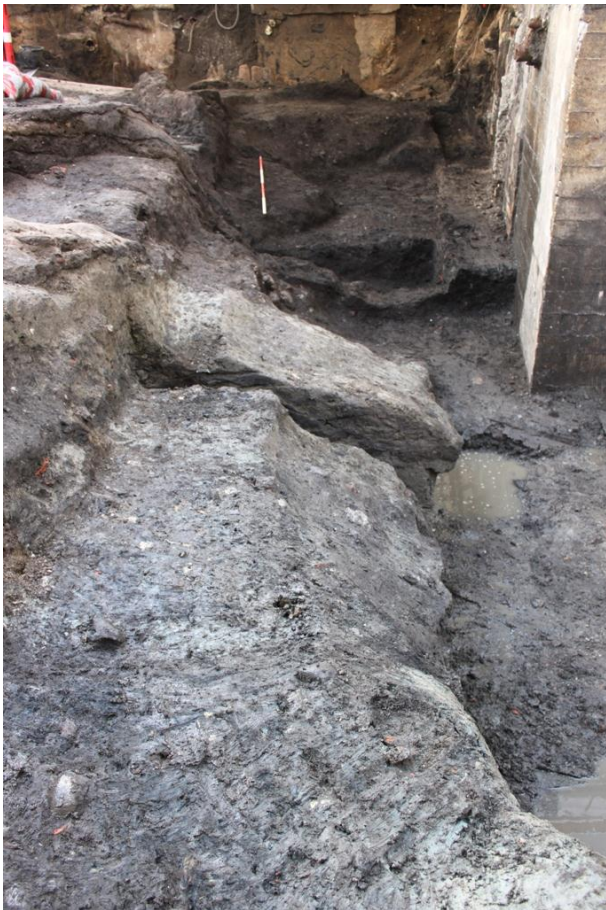
Figure 137 The linear cut Group 250 as seen at the upper levels, from northeast

A linear cut, which appeared to have been made through the moat backfills, was located along the southern edge of the toilet building in Area 3. This cut (Group 250) was filled by a series of dumps of mainly organic waste, with occasional patches of clay and mortar. It was quite deep (c. 2 m), but an accurate depth was hard to establish as it was excavated in stages over a period of time. It was truncated by the toilet building construction cut, so its true dimensions are unknown, but as it survived it measured 13 m in length, and 4 m in width.

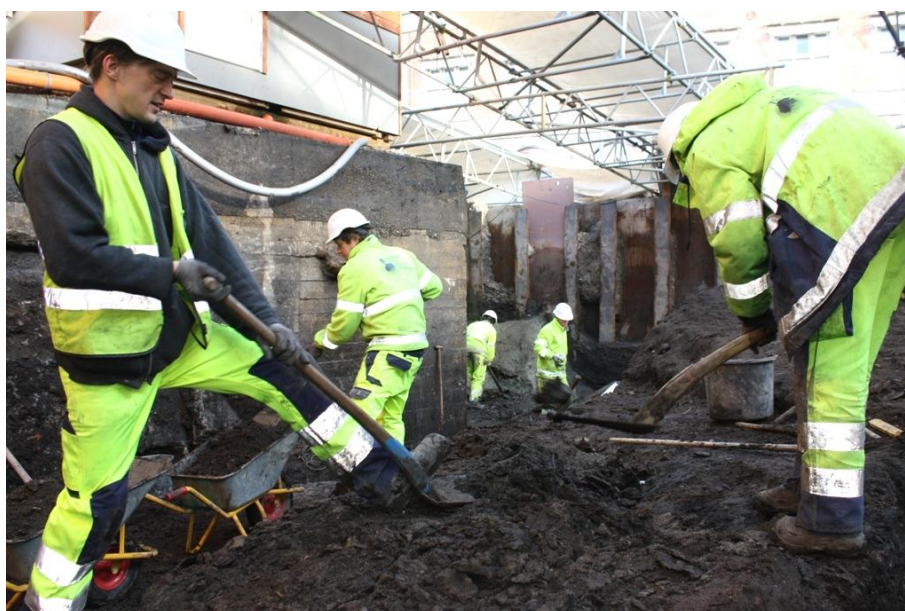
Figure 138 Moat backfills Group 200 during excavation, February 2012

All deposits seemed to be quite randomly placed, and consequently it seems likely that these layers were dumped, probably tipped from carts or barrows from the edge of the former moat/mill/mill race during a fairly rapid deliberate process of in-filling. Their often loose compaction is further evidence for the

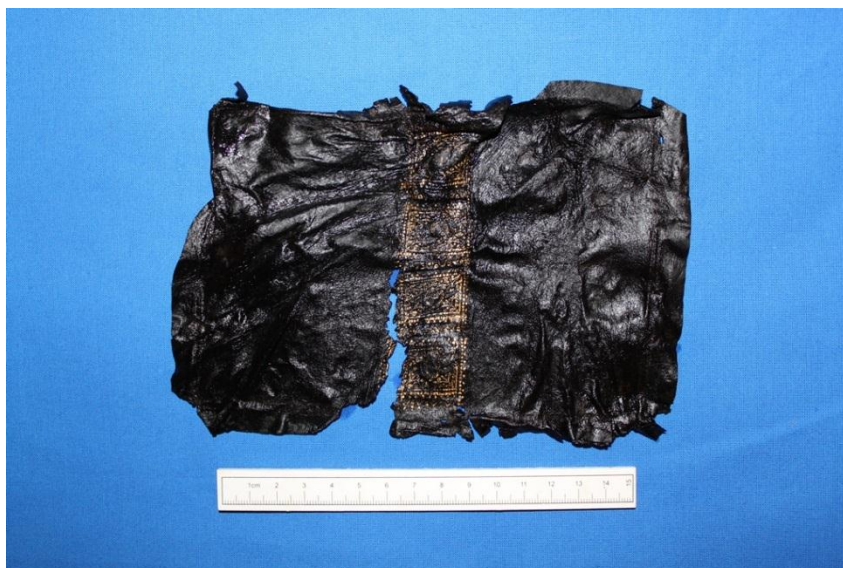
Figure 139 Leather book cover (FO 205017) from backfill Group 200

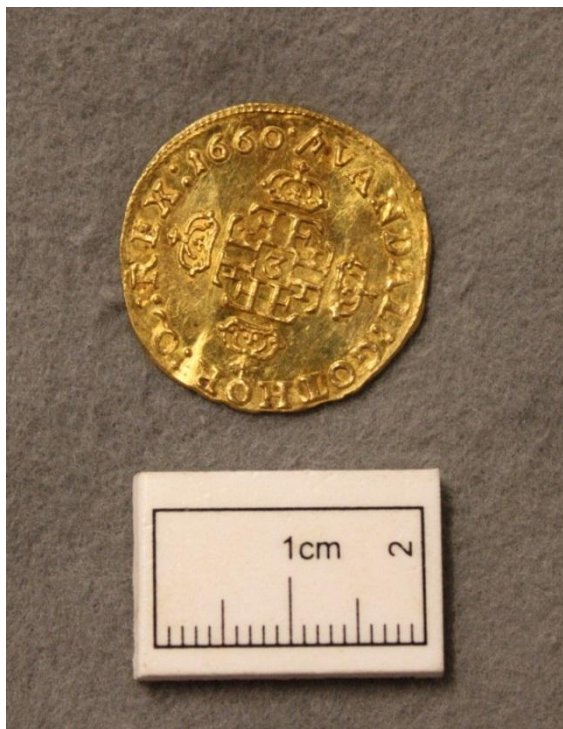
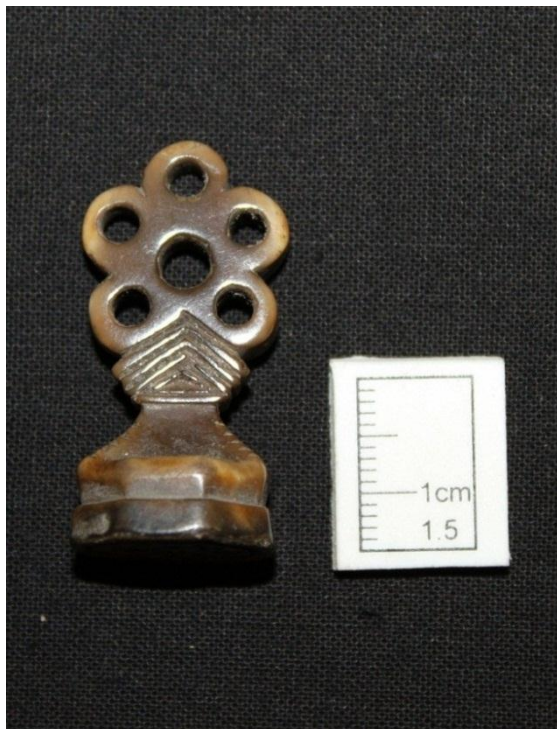
Figures 140 and 141 Gold ducat (FO 207833) and doctor's stamp (FO 207740) from Group 200

The range and quantity of finds recovered from Group 200 was very great (see below for a range of the main kinds). As well as ceramics, glass and metal artefacts, large amounts of organic and composite artefacts were recovered, many of which were quite high status, and very well preserved. One find worth particular mention was a Frederik III gold ducat (FO 207833) from AD 1660, though this item was surely a casual loss rather than deliberately dumped.

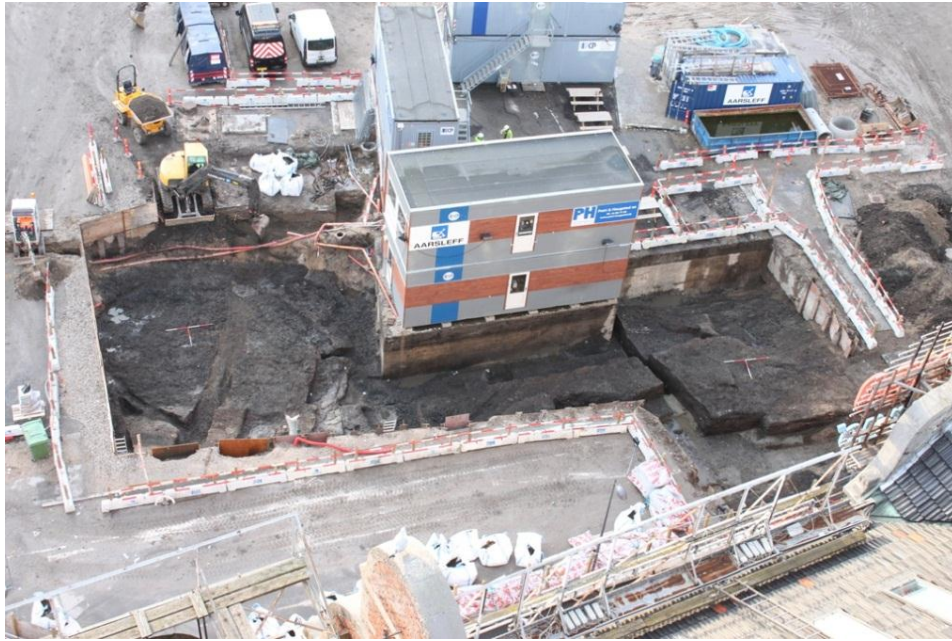
Figure 142 Moat backfills Group 200 exposed in Area 3, from northeast

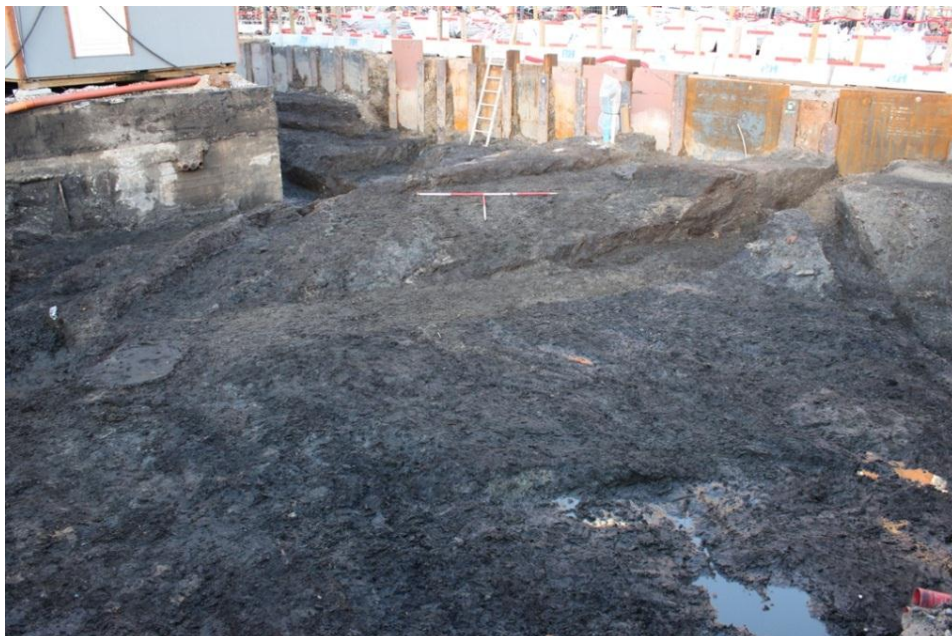
Figure 143 Moat backfills Group 200, seen from south

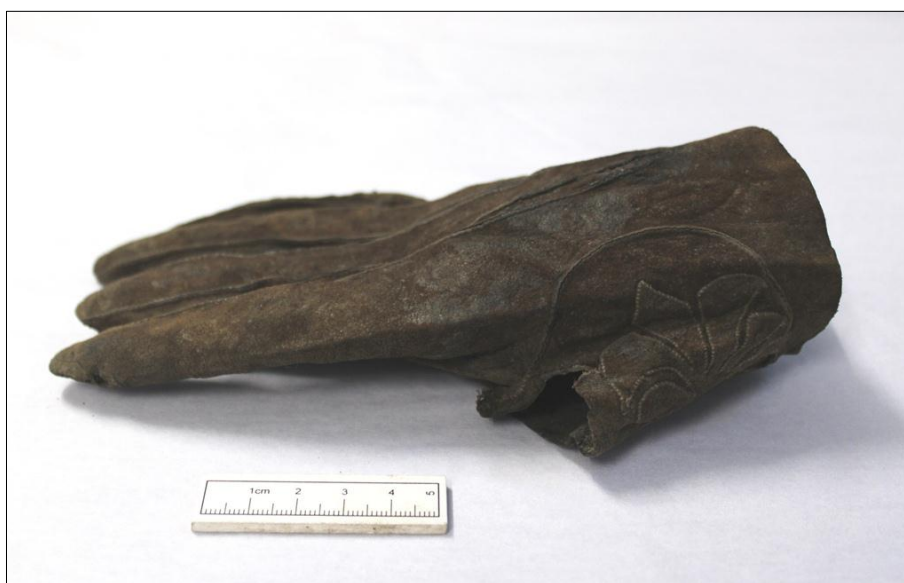
Figure 144 Leather glove (FO 210083) from backfills Group 200

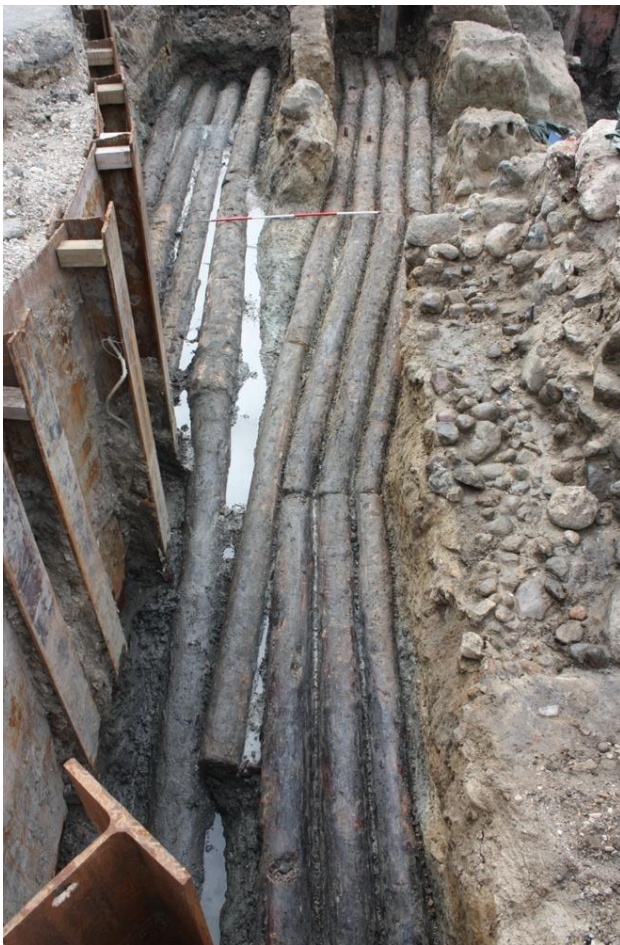
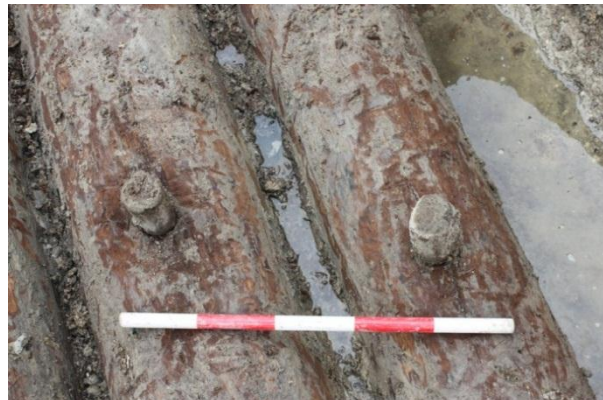
Figure 145 and 146 Evidence for cleaning of pipes in Group 306

Located in Area 4 and Area 3, a series of four waterpipes (Group 306) were documented running in a NW-SE direction, parallel to the former city moat. These were found in a vertical-sided trench cut, and were covered in a mixed backfill. The cut was made through the foundations of the former medieval gateway (Group 111), which shows that this was surely demolished by this time, as the level of truncation caused by the waterpipe trench was quite severe. There was a height change, dropping 0,2m from the north-west to the south-east indicating that the water flowed in this direction. As with the later Group 307 pipes, these had an internal bore diameter of c. 11 cm, which suggests as we might expect, that these pipes were part of the main water network, rather than being part of the system that lead from the pump to the main water network (these pipes would have a narrower bore diameter of c. 8-9 cm (Topcagic, 2014). Group 306 can be interpreted as a major water pipe construction pre-dating nearby waterpipe Group 307 to the north. The location of this group suggests the waterpipes would have run inside the city defences, probably following a route corresponding to modern day Vestervoldgade.

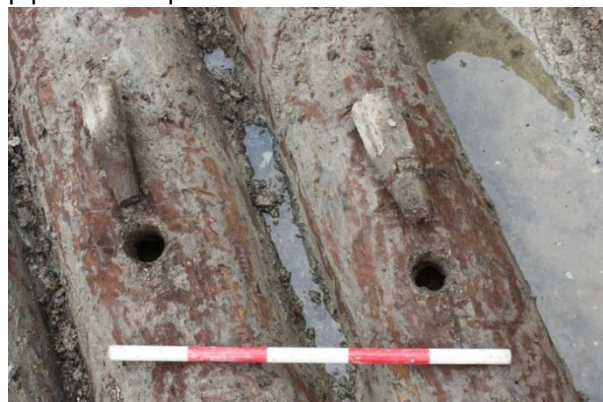
Figure 147 Left: Waterpipe Group 306 (to the right), cutting through gate foundation Group 111, seen from NW

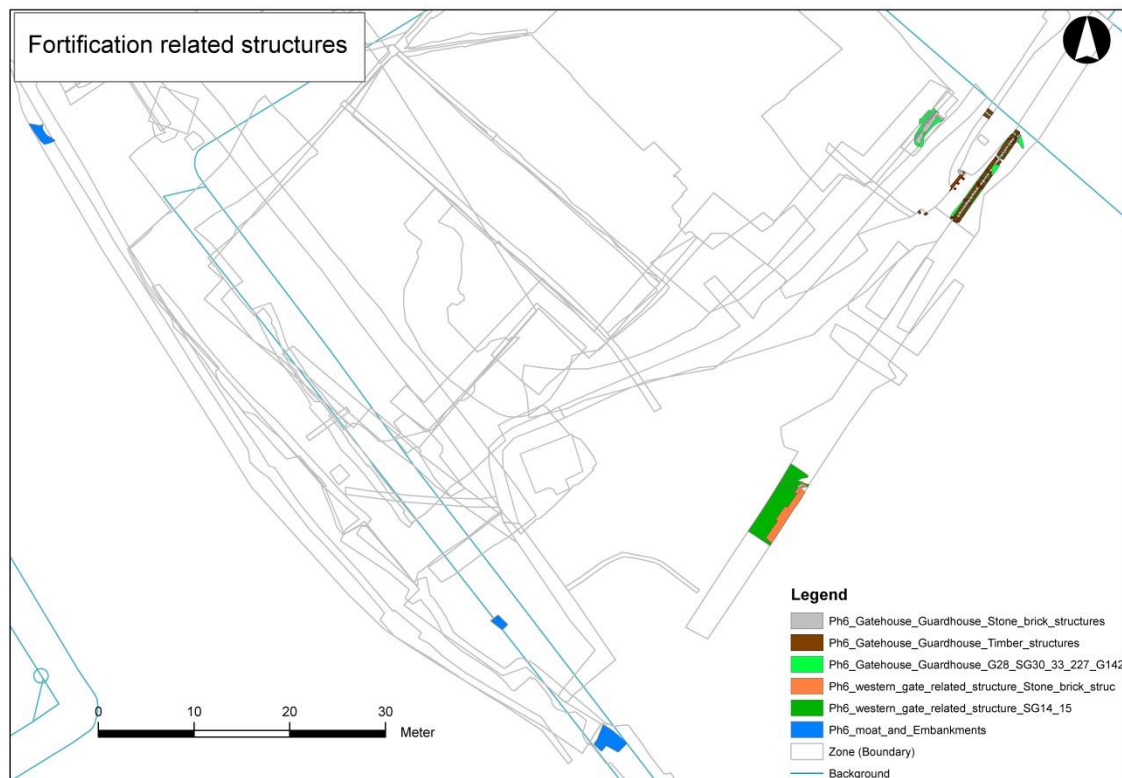
Figure 149 Phase 6 fortification related features

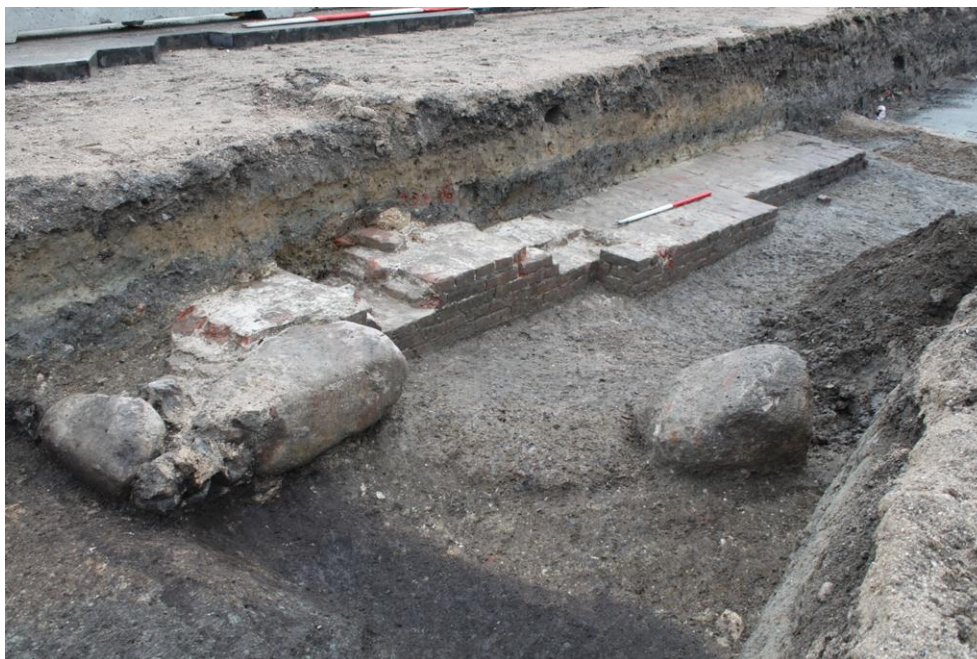
Figure 151 The wall seen from what would have been the outside (from north).

The wall survived up to five courses in height, and in some areas foundation stones were observed. Two deposits were also recorded, which are likely to have been foundation layers for the wall. These were not fully excavated.

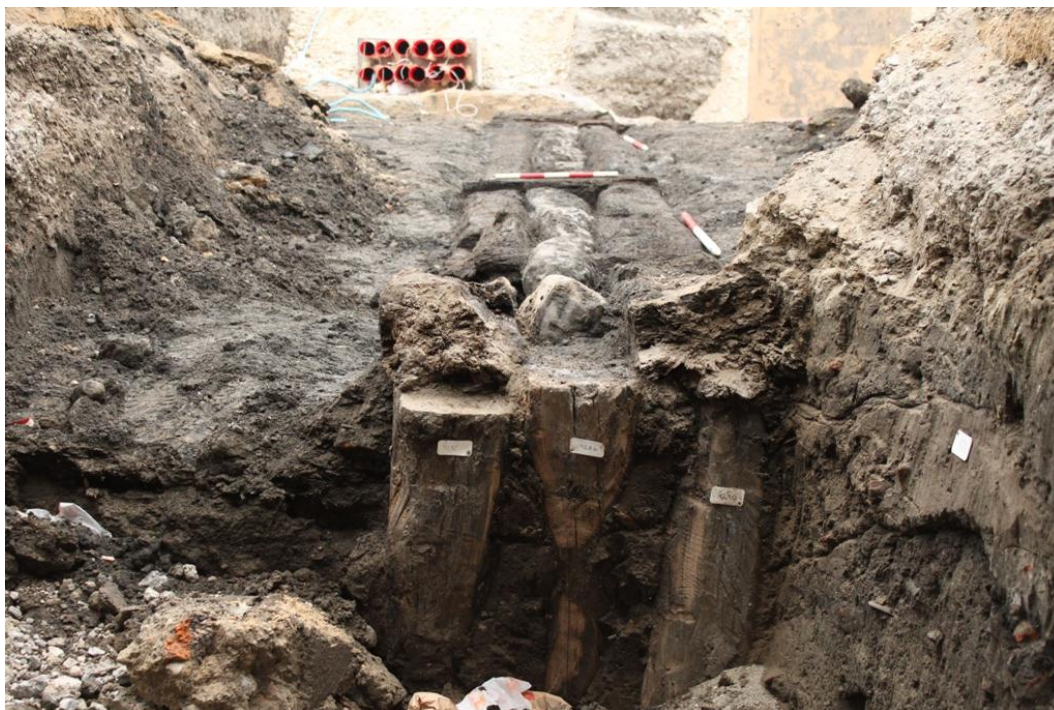
Figure 152 Foundation Subgroup 33 seen in section, from northeast

The sets of piles (all of oak) were each 1,25 m long, placed between 2 m and 3 m apart along the base of the foundation cut. On top the outer piles and supported by them, linear beams were placed horizontally within the foundation cut, running parallel along its edges with a row of sizeable stones placed in the gap in between. Finally some clay was packed into the foundation cut around all the elements, to hold them together. The top of the foundation was at a height of 5,05 m above sea level.

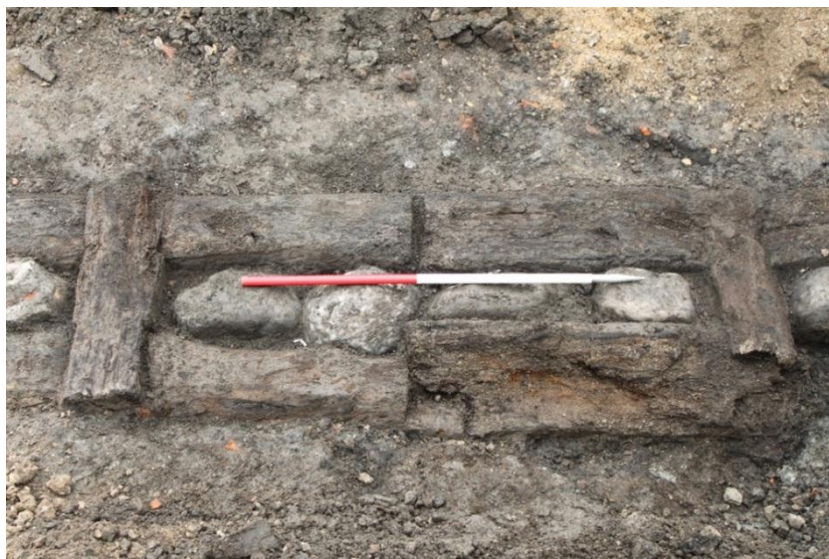
Figure 153 A section of the timber and stone foundation (Subgroup 33)

Some cross-pieces were also seen; these were shorter wooden pieces that linked the two sides of the timber linear foundations, and it may be that it was on top of these cross-pieces that the timber frames of the walls above would have rested. As these did not survive however, we cannot be certain. Overall the main building was quite substantial, measuring almost 13 m in length, and almost 5 m in width. Four dendrochronology samples were taken, and returned dates of as early as AD 1651, and as late as AD 1692 +/- 15 (Appendix 4). However, taken as a group, they appear to suggest a construction date for the building of somewhere between AD 1677 and 1685. Furthermore the timbers used appear to have all originated in Halland in Sweden.

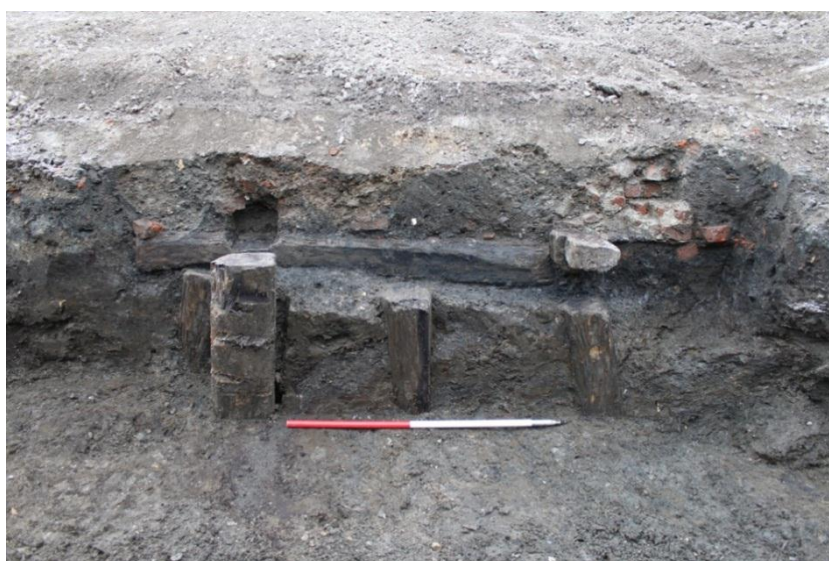
Figure 154 The foundation of the possible fireplace (Subgroup 30). Seen from southeast.

A further smaller section of foundation (Subgroup 30) found within the building may have related to an internal wall, or perhaps to the placement of a fireplace and chimney at the centre of the building. It was built in the same basic style as the main structure, with wooden piles and horizontal wooden beams.

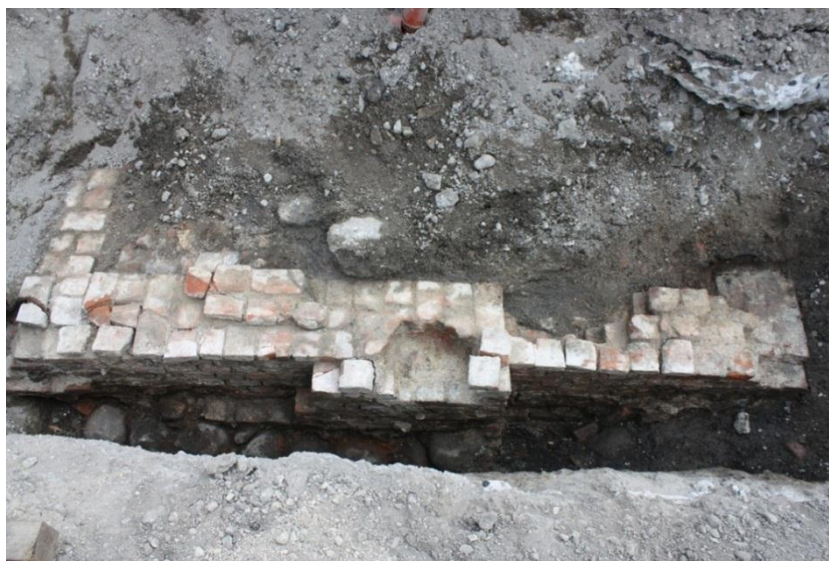
Figure 155 Annexe structure (Group 142) seen from northwest

An element of a probable rear-annexe (Group 142) to the gatehouse/guardhouse was seen in the south-eastern edge of Area 3. This comprised of a foundation cut into moat/millrace backfills, and a combination of stones and broken bricks laid in random fashion within to form a foundation, upon which was placed a brick and mortar laid foundation.

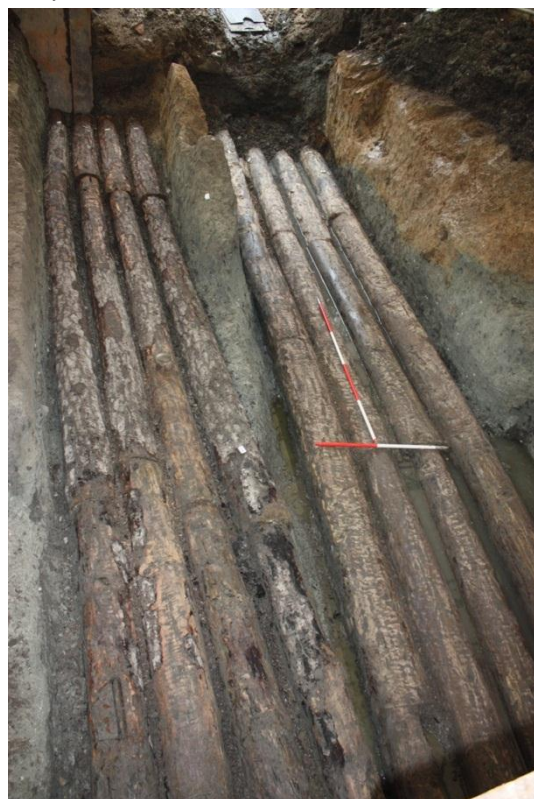
Figure 156 Water pipe Group 307 (on the right) seen from southeast

Group 306 pipes. It was clear however, that this must have been deliberately placed under the older pipe, as stratigraphically it was very clear that the Group 307 pipes were later. This was because the Group 306 pipes were clearly sealed by the backfilling of the mill/moat, with the cut for the pipe-trench only appearing when these dumps were removed. The cut for Group 307 on the other hand, was apparent much earlier in the excavation, and was clearly cut through the moat backfills.

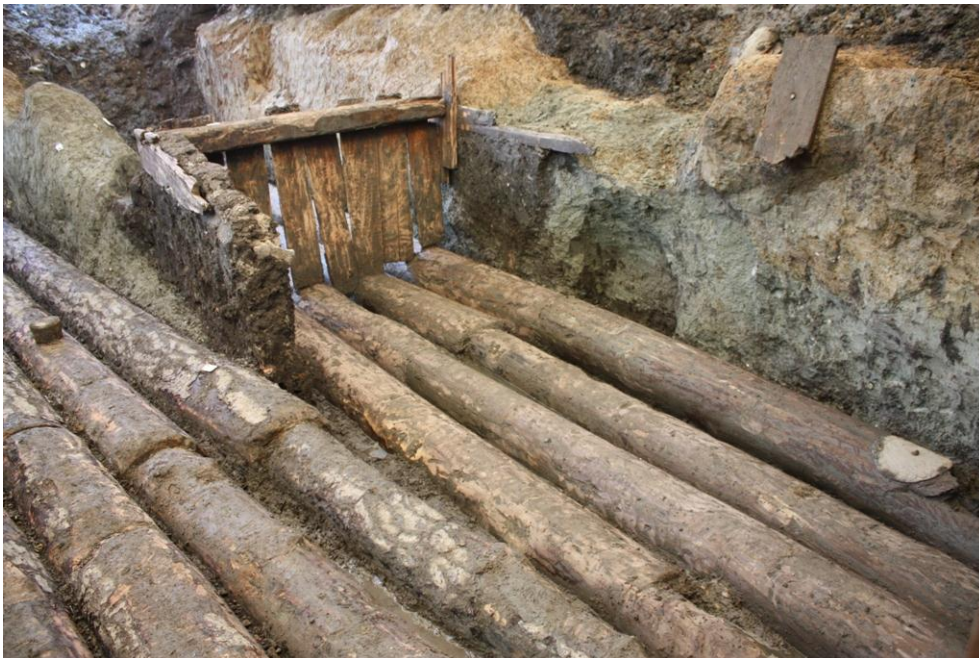
Figure 157 Timber shoring (part of Group 307) in situ, possibly for accessing the pipes to carry out repairs. Seen from south

Timbers were recorded in Area 3, which appear to have been laid as a sort of foundation or levelling aid for the pipes to be placed on. A re-cut of the trench was also recorded in Area 3. This re-cut was 'shored' with timber which had been left in situ, and appears to point to some sort of repair work carried out in this area. The Group 307 pipes were notably bigger, with broader diameters (0,35 m – 0,4 m) than those in Group 306. Another notable difference was that these pipes had had their bark removed, whereas those in Group 306 still had much of their bark attached. As with Group 306 however, the pipes had an internal bore diameter of c. 11 cm, which suggests as we might expect, that these pipes are part of the main water network, rather than being part of the system that lead from the pump to the main water network (these pipes would have a narrower bore diameter of c. 8-9 cm (Topcagic, 2014).

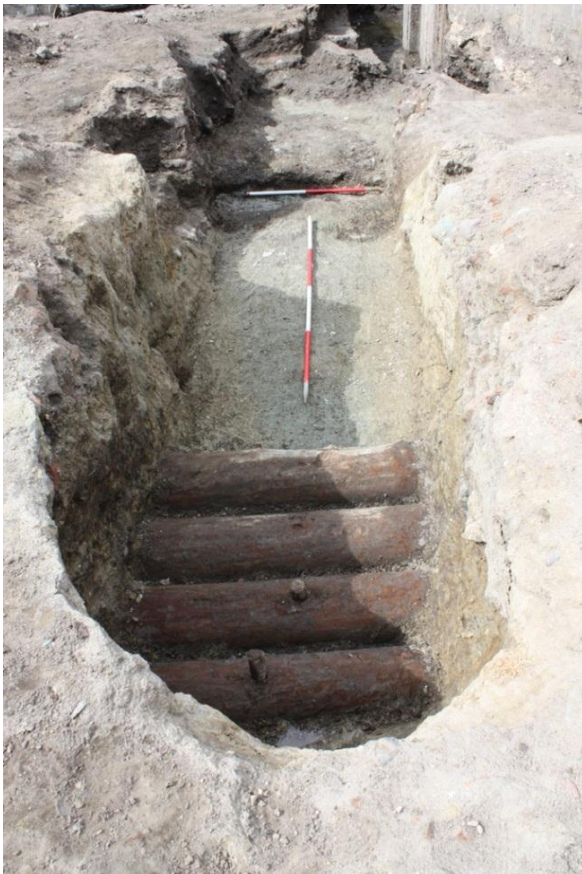
Figure 158 Water pipe access-trench Group 328 seen from northeast

One possibility is that there was uncertainty as to exactly where to find the pipes, another possibility is that the trench was dug to access the pipes, which were then tapped, and that the purpose was in fact to use water from the pipes. The trench appears to lead toward the water canal, and though the mill must have been out of use by this time, the millrace might have been kept open somewhat longer. The cut was filled with similar material to the backfills of the mill and moat, and probably was simply the material that was dug through while making the trench.

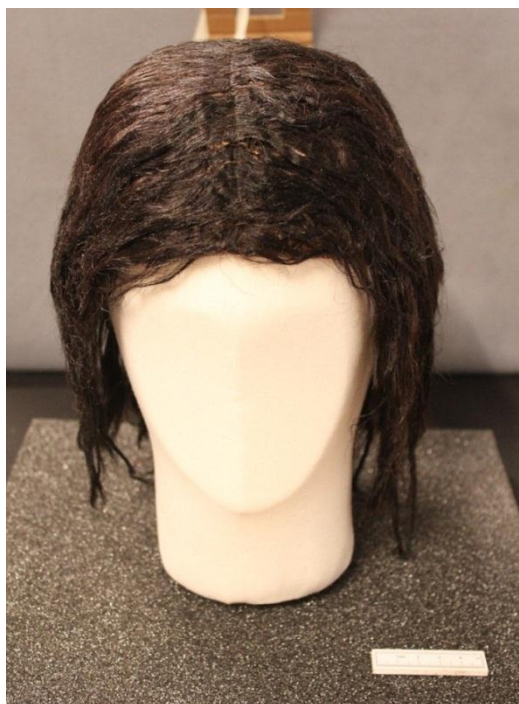
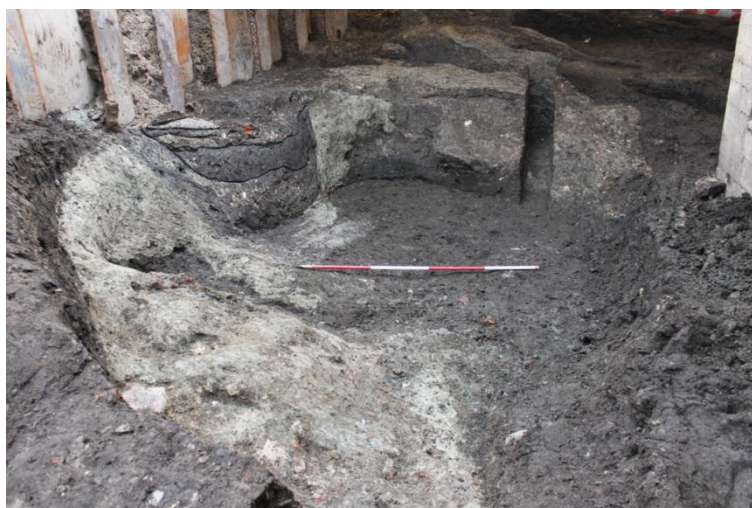
Figure 159 Pit Group 222 post-excitation. Seen from northwest.

One quite large and extremely significant pit (Group 222) consisted of a large circular cut, located within the eastern edge of the former moat/mill, in Area 3. Group 222 has been interpreted as a pit, which was cut into the already back-filled moat/mill. It was subsequently filled up with a large amount of waste material, mainly organic waste, but with a large amount of cultural material. This cultural material was in many cases very rich in nature, more so than the moat back-fills, and may suggest that this pit was filled with the household waste from a nearby wealthy household. The largest deposit by volume was also the most find-rich, and was very organic in nature. It is probable that it had a high concentration of either (or both) latrine waste or animal manure. The remaining fills mostly comprised of localised patches of heterogeneous material, some clayey in nature, possibly suggesting periods of flooding or slumping occurring while the pit was in use.

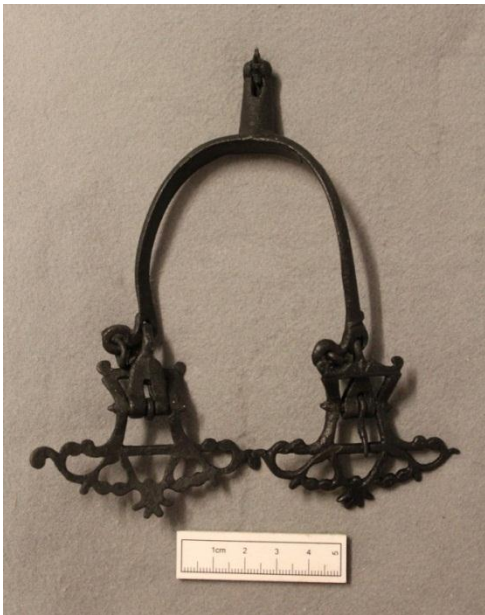
Figure 161 Spur FO 206642 from pit Group 222, post-conservation

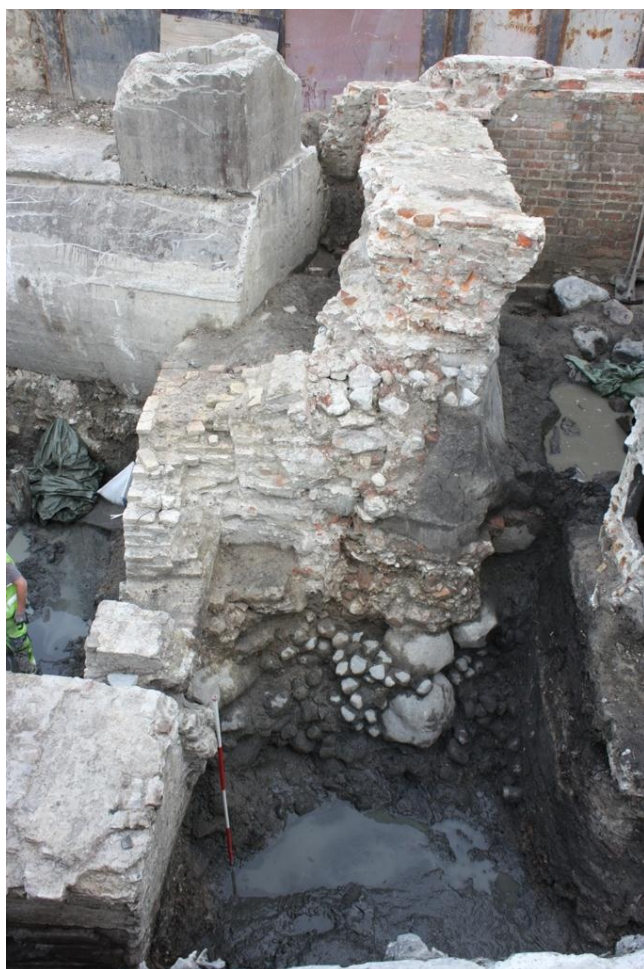
Figure 162 Robber trench Group 418 post-excavation. Note the missing corner of the bridge. Seen from southeast.

A large pit or cut feature (Group 418) was documented in Area 4, between the medieval gate and the mill race. This cut was made through some of the backfills deposited to fill up the former mill and moat, but it was also cut through a significant amount of the north-eastern side of the bridge that was built in 1500. This structure was extremely well built and solid where seen elsewhere, so it would not have been easy to cut through it in this way, and it is therefore unlikely one would do so unless that was the primary objective. Hence it has been assumed that this feature (Group 418) was in fact a robber trench, the purpose of which was to retrieve reusable material from the bridge, in particular stone and brick. This cut and its backfills are likely to belong in Phase 6, based on stratigraphy.

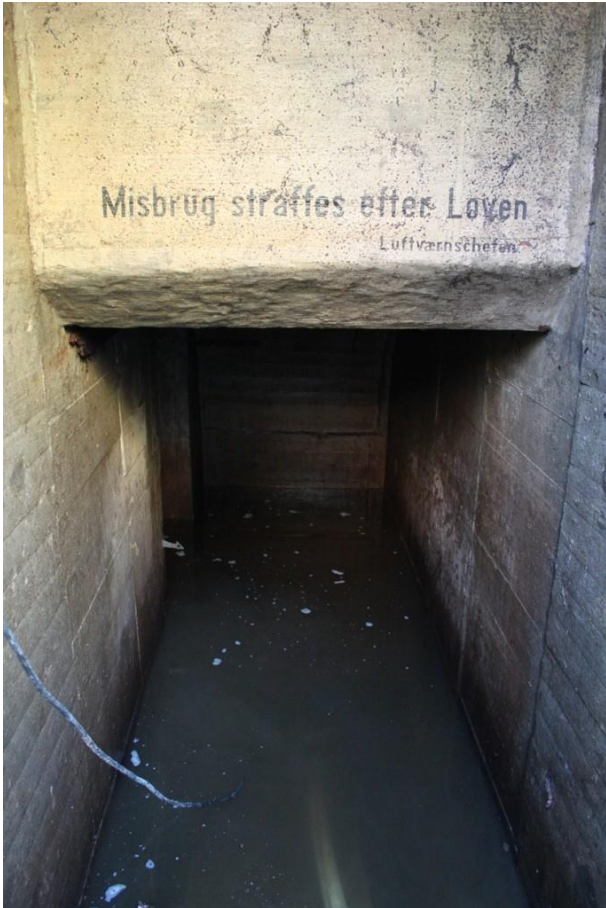
This shelter consisted of a linear reinforced concrete structure. It was set within a large and quite deep construction cut, and it is clear that the entire structure would have been below ground level, apart from the top of a centrally placed small square turret, which presumably was both a lookout and potential escape route should the main entrance become blocked.

The structure was surveyed in two parts. The first was the stairway and entrance area, measuring 1,1m wide by 2,05m high (at the bottom of the stairs). Above the entrance 'Misbrug straffes efter Løven. Luftværnchefen' (misuse punishable by law. Air Force commander) was painted in black lettering. Fragments of a wooden inner door survived, though lying broken in the doorway. The door measured 1,69m high and 0,925m wide, with 'C.L' painted in red letters. This is probably an abbreviation of Statens Civile Luftværn (The State Civil Air Defence). The stairway joined to the main tunnel section seen in Area 4 at a right angle.

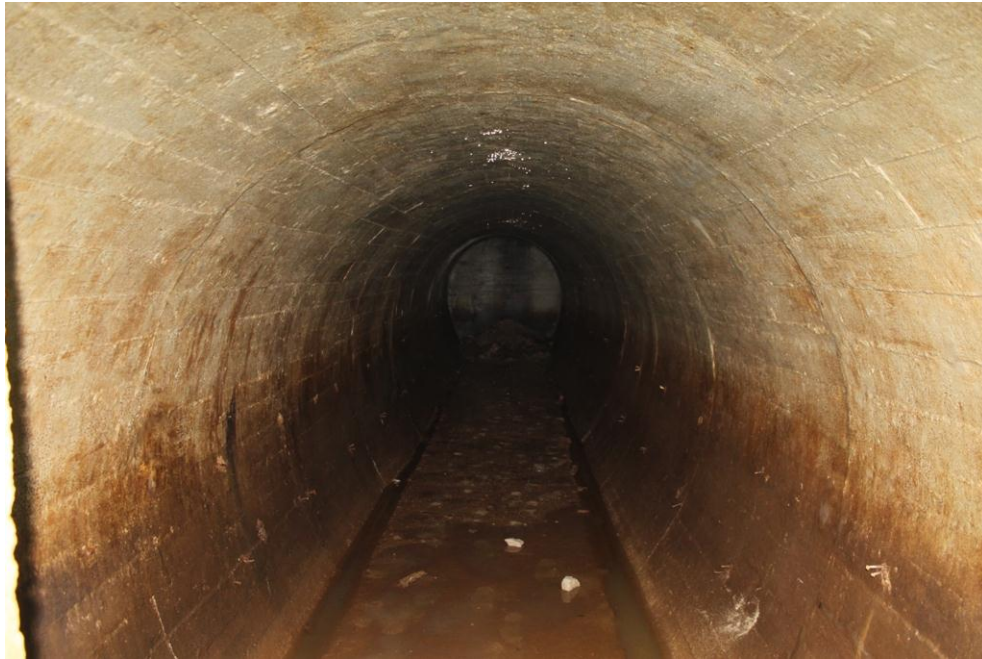
Figure 165 The interior of shelter Group 93

A deeper groove ran along both sides of the flat floor, presumably for any water that might get in to the shelter to flow along. Its likely that there would have been a drain for excess water to flow out somewhere, but this was not seen. This type of shelter would have had benches running along its length on both sides, but either they had been removed or they had rotted away. Rusted iron attachments could still be seen along the walls.

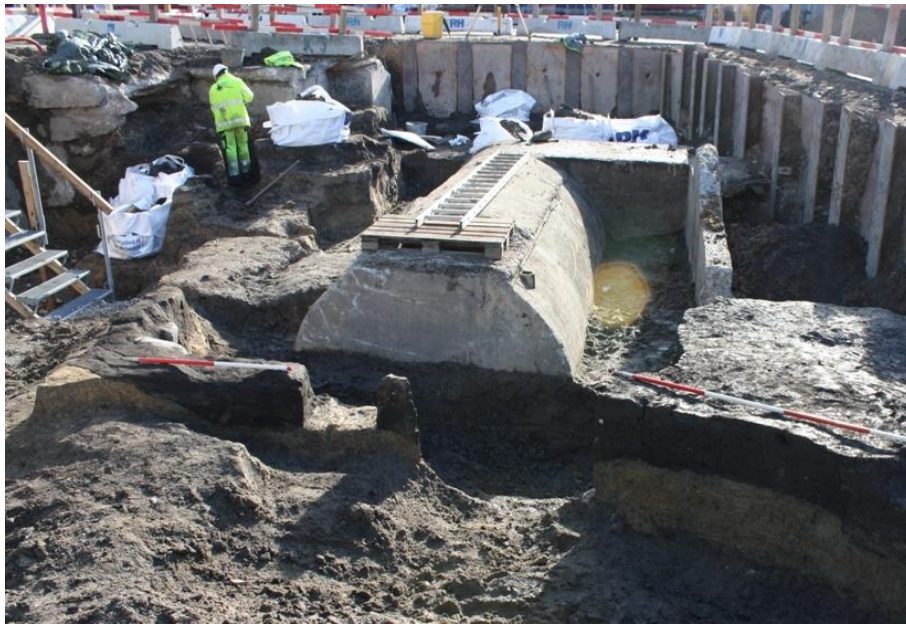
Figure 166 The eastern part of shelter Group 43, within Area 2A. Seen from north.

It was similar in form to the other shelter (Group 93), but two unusual features are worth mentioning. Along the north-eastern wall, a timber plank was attached to the wall, and at regular intervals along it, grey electrical wires were attached, which had been cut off at the ends in the past. Their purpose is uncertain, but it is possible that this end of the bunker was set up to be an emergency communication point, with phones or telegraph installed.

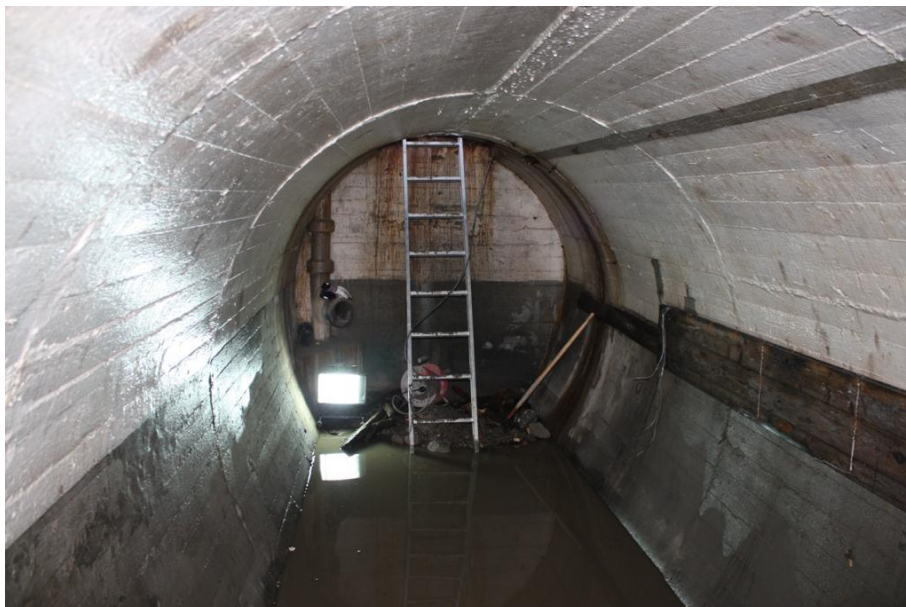
Figure 167 The northern end of shelter Group 43. Note the wooden panel and wires to the right, and the ceramic pipe in the corner.

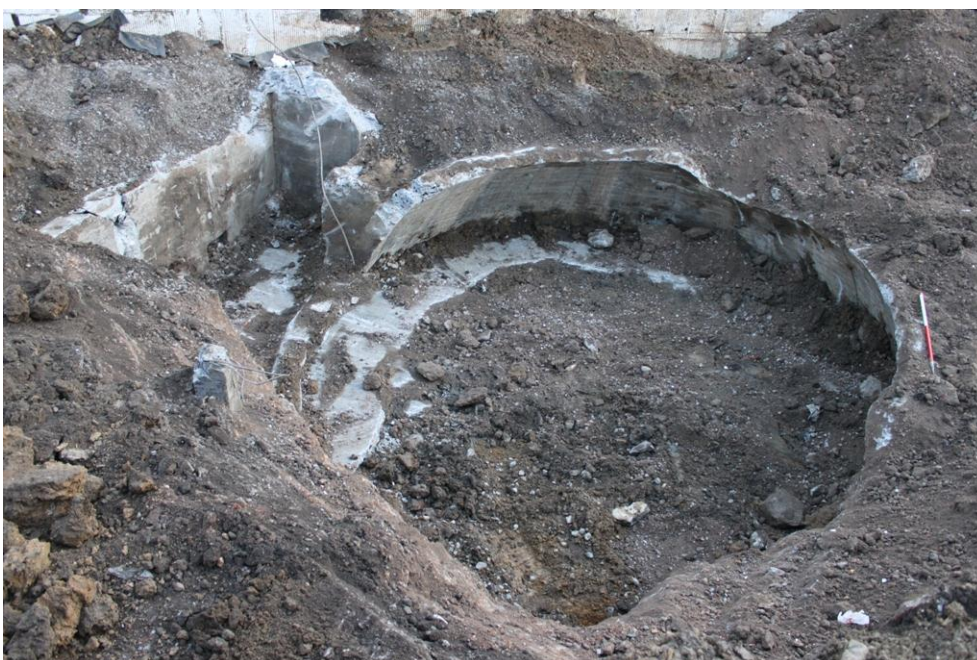
Figure 168 Air raid shelter Group 182 as it survived. Seen from southwest

The diameter of the shelter was documented (at the base where it was widest) at c. 7 m, while the staircase measured c. 1,6 m. The thickness of the concrete dome was app. 25 cms, and marks left on the concrete showed that it had been shuttered and poured in situ. It appears that the shelters would have had an internal height at the centre of c. 3,5 m. The staircase and entrance was in the north. This bomb-shelter was not physically connected to any of the others. It was largely destroyed, probably in 1947 when other bombshelters on Rådhuspladsen were destroyed (Selskabet for Københavns Historie <http://www.kobenhavnhistorie.dk/kbhkronik/ejlensen.html>). It was apparent from close inspection that the staircase to the bunker was constructed after the dome. Benches would have been fitted around the edge of the shelter, but no trace of these survived.

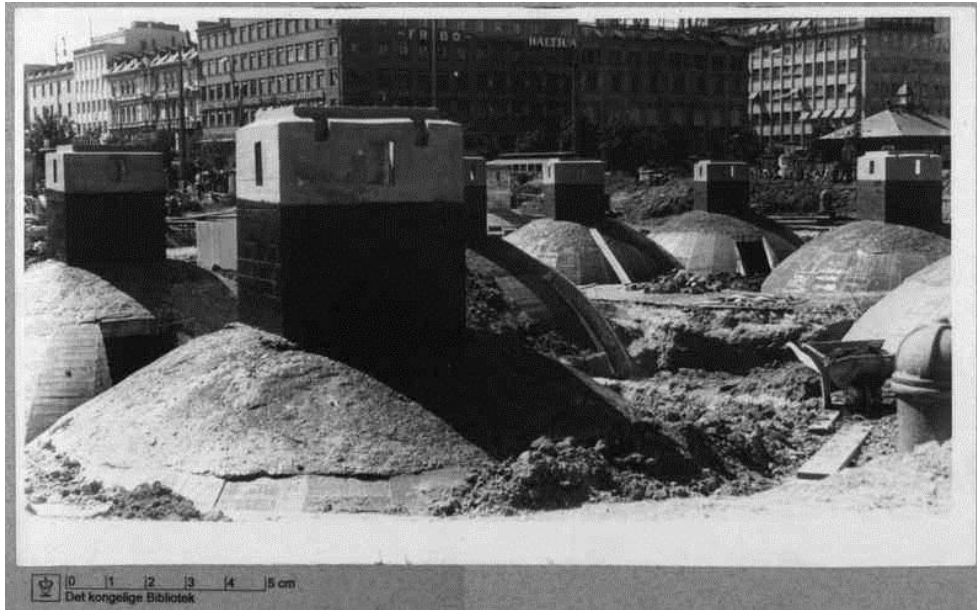
Figure 169 Some of the circular bunkers at Rådhuspladsen during construction in 1944

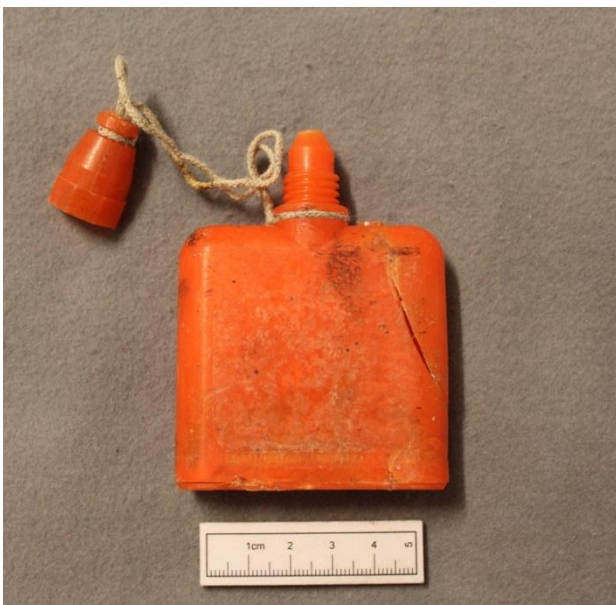
Figure 170 'Hautentgiftungssalbe' from shelter Group 182

In the base of the stairwell a drain was located in the floor. From inside the bombshelter there was also a drain, connected to a sandtrap in the entrance. In or around the drain/entrance a small orange bakelite or plastic flask was found. On the bottom of this container was written "Hautentgiftungssalbe" "eje" "115" "1943" and "44". This was part of the military equipment given to German soldiers during World War II (e.g. http://www.mp44.nl/equipment/skin_decontamination.htm). It contained skin decontamination cream for any toxic "war substance" one might come in contact with during combat, f.x. blister gas. The "eje" probably refers to the factory where the bottle was produced. 1943 is the year the bottle was produced. The 44 is melted into the plastic and this refers to the date where the ointment was filled in the bottle. The lid was (still) attached to the bottle with a nylon string, and based on photos of other bottles, it would originally have been stored in a small container of plastic coated cardboard, along with some cotton swabs. This was the only clearly military artefact relating to World War II recovered on site.
