Kongens Nytorv

Metro Cityring Project

KBM 3829, Øster Kvarter, Københavns Sogn

Kulturstyrelsen j.nr.: 2010-7.24.02/KBM-0017

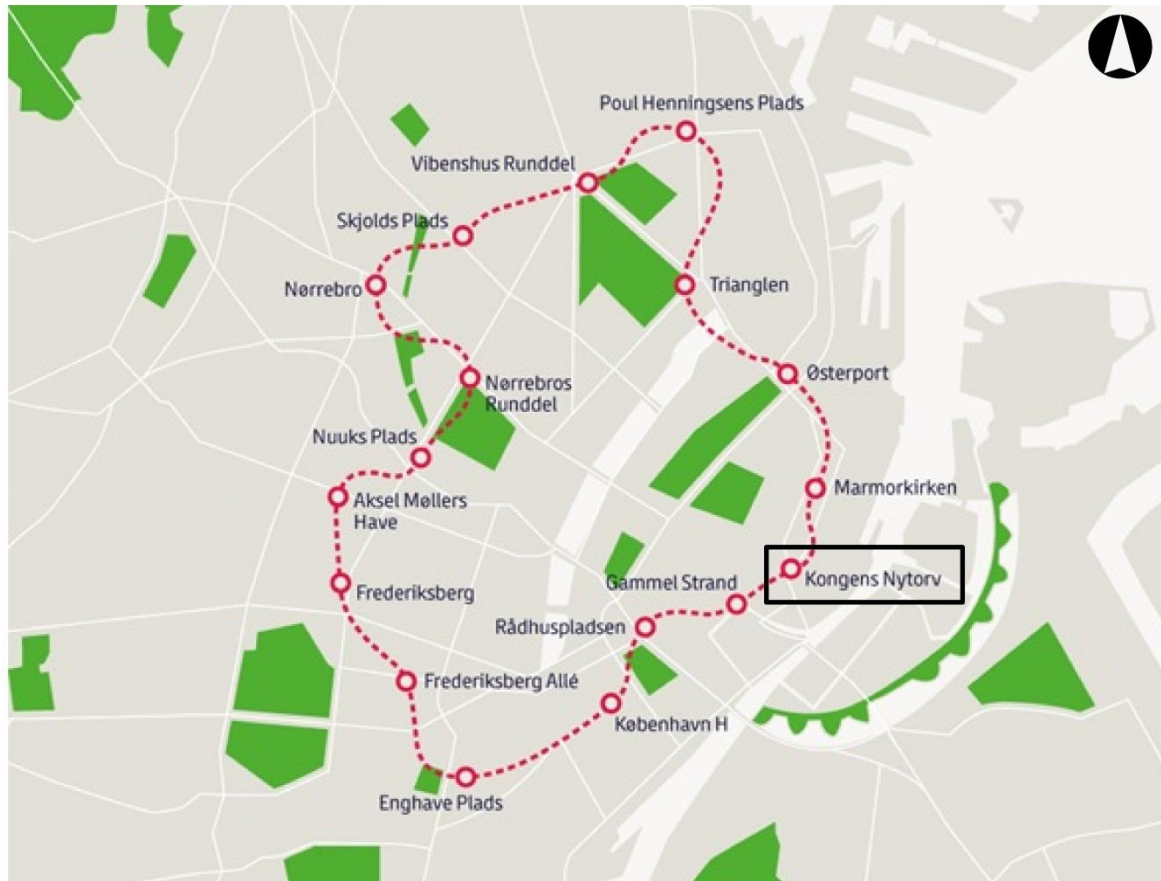
Fig. 1. Plan of the Metro Cityring with location of Kongens Nytorv marked.

The excavation at Kongens Nytorv took place in advance of the establishing of a new Metro station. This is a part of the new Metro Cityring system that will provide a new transportation system to the areas of the city surrounding the city core (Fig. 1). The Cityring is eventually going to be connected to the existing Metro system. Kongens Nytorv will be one of two already existing stations where the new metro line will meet the old one.

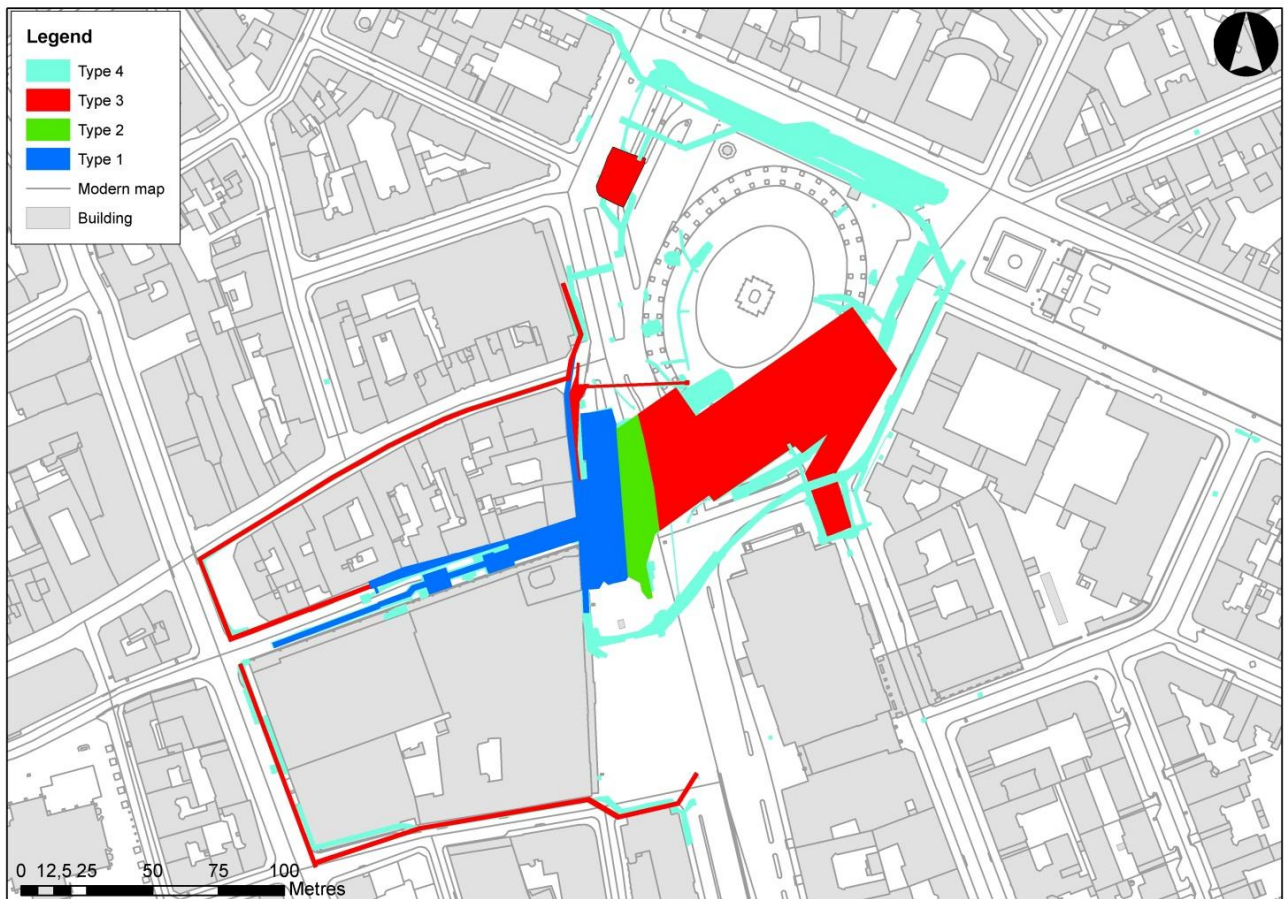
Fig. 3. Map of Kongens Nytorv with the type 1-4 areas.

Type 4 Areas with moderate potential and limited documentation possibilities

Watching brief areas where mostly less complex and larger features like levelling layers were expected. Most of the type 4 area was on the outskirts of the Kongens Nytorv area and expected to be of a relatively young age. When archaeological remains were detected the archaeologists registered the remains at a fairly high speed and in less detail.

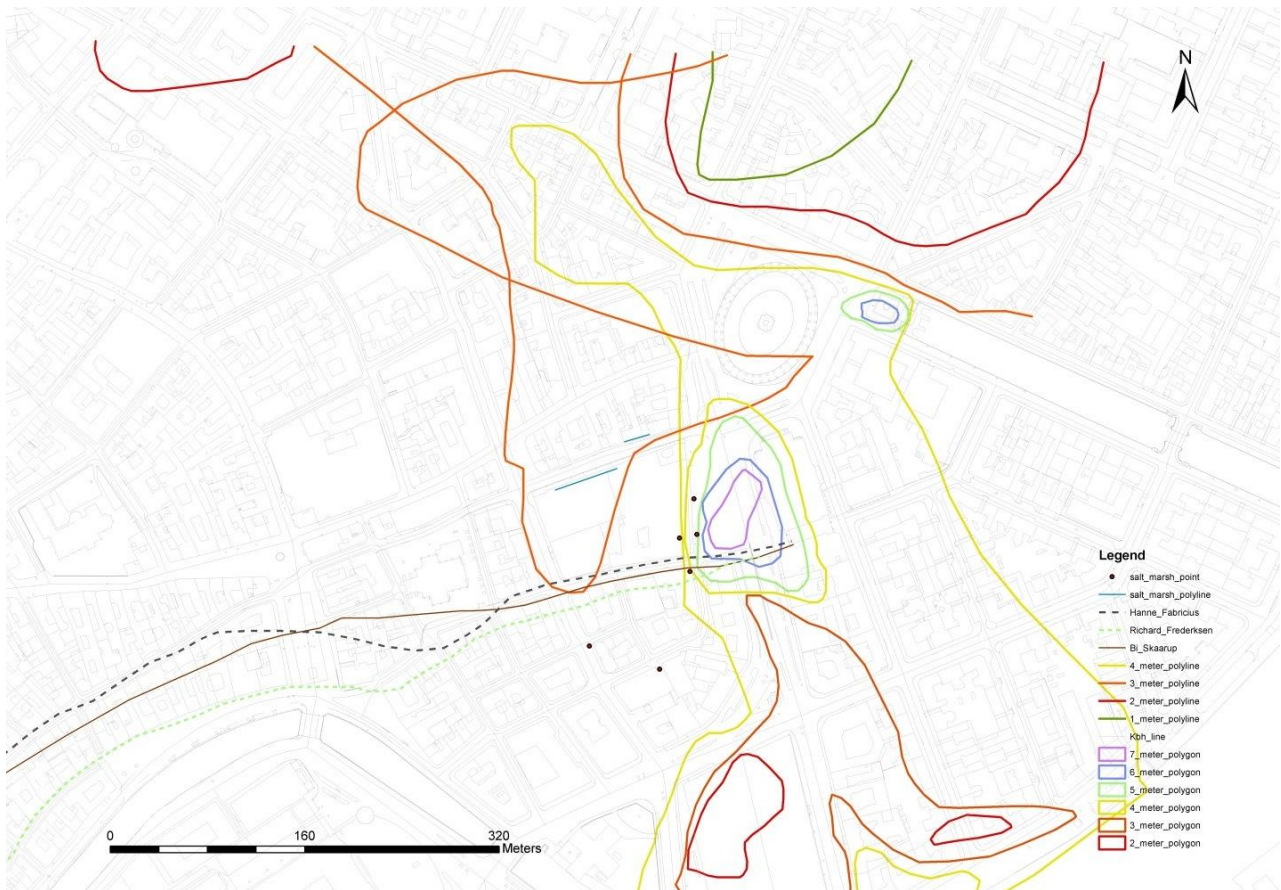
Fig. 8. The thicknesses of cultural layers around Kongens Nytorv based on drilling results at the establishment of the Metro in the beginning of the 1990s and for the Metro Cityringen (cf. Rambøll. Unknown year; GEUS database). Note the high values in the area of the estimated 17th century moat and Nyhavn's previous coverage.

The present-day area of Kongens Nytorv is situated about 4.0 m above sea level and the original topography of the area in the Middle Ages and following centuries is not known for certain, though it seems likely that sea level would not have changed very much in that time. Recent investigations have indicated that the thickness of the paving and cultural layers is between 3-4 m, at the most recent 17th century moat the layers are between 5 to 6 m thick (Kongens Nytorv borings 2012; De Nationale Geologiske Undersøgelser for Danmark og Grønland 2012). Some information has been revealed during the excavation that suggests that the ground level at Kongens Nytorv was only a little lower in the Middle Ages than today, being c. 2.0-2.5 m lower than present day street-level depending on type of feature, etc. It would also appear, based on the original topsoil seen in some areas, that this, contrary to earlier accounts (cf. El-Sharnouby & Høst Madsen 2008), was not a particularly wet or marshy area, but instead consisted of areas of grassland over a thin layer of topsoil, which in turn rested on post-glacial sediments (see further discussion Chapter 10; Phase 1 Moraine, salt marshes and other Quaternary observations).

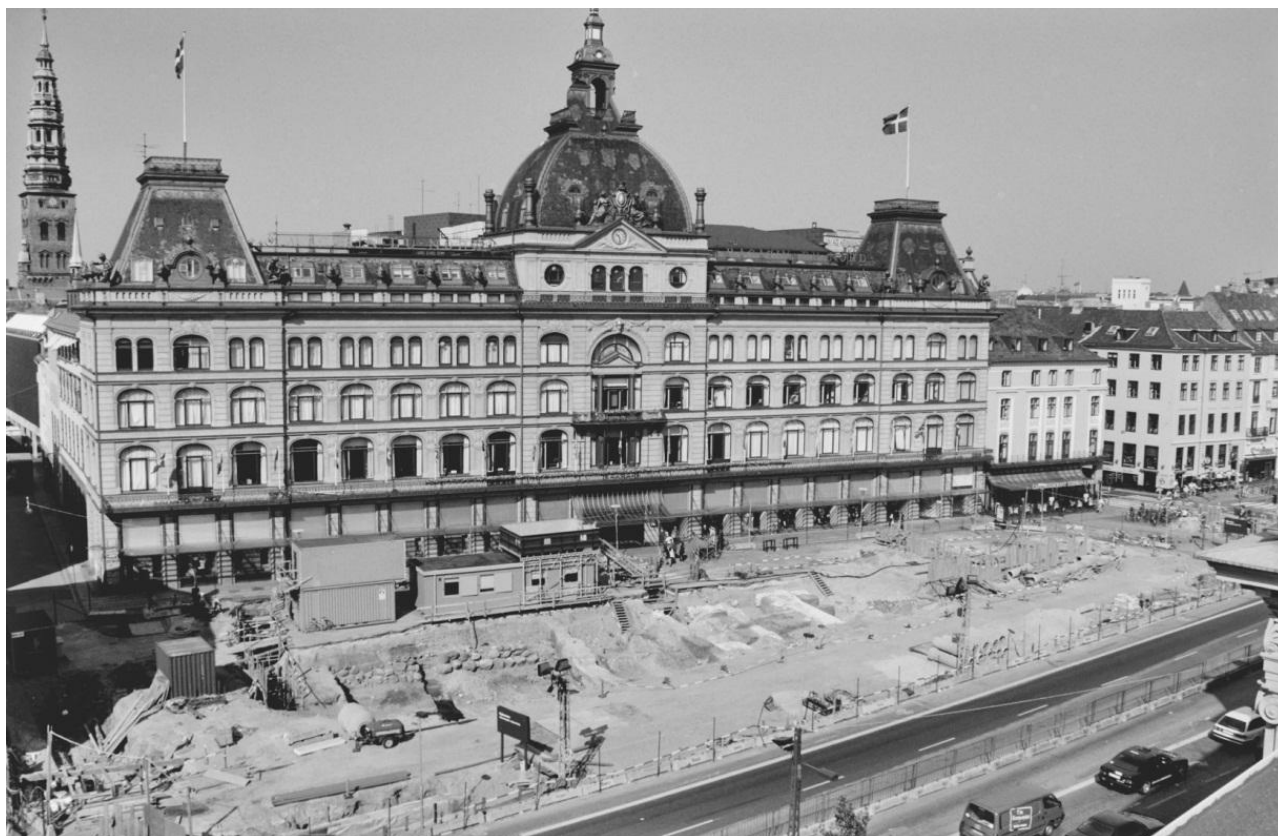
Fig. 9. Overview of Metro excavation in 1996–1998, facing west. Photo: Museum of Copenhagen.

During the first phase of the Metro development in 1996–1998 the parking east of Magasin towards Holmens Kanal (c. 1500 m²) was excavated including large parts of the fortifications and early settlement (Kristiansen 1998; 1999a-c). The dominant feature was the city's fortification, but it also uncovered a number of different features that can be linked to the settlement in the area before and after the fortification (Fig. 9). It was possible to divide the constructions and structures into five main phases.

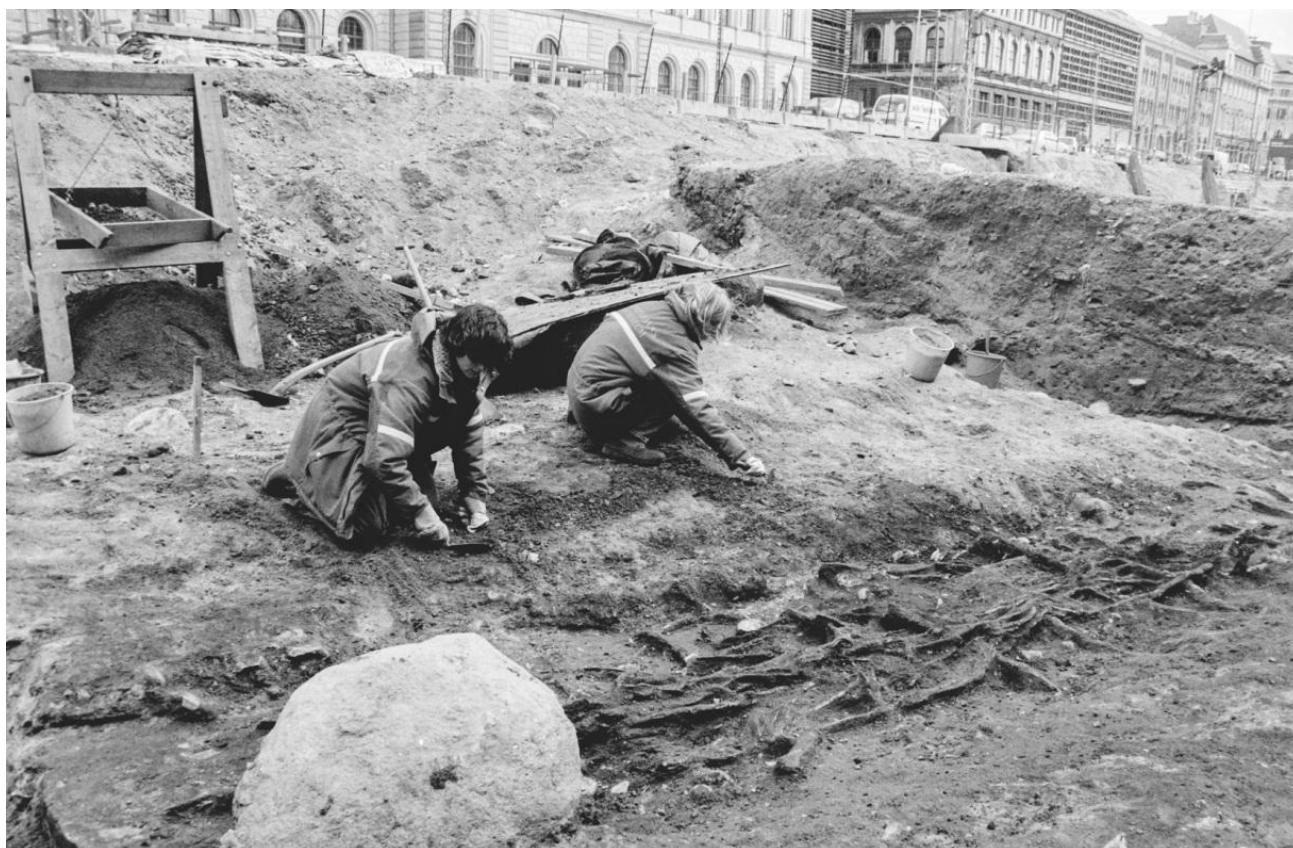
Fig. 10. Excavating north-south running wicker fence. Photo: Museum of Copenhagen.

The fence consisted of horizontal wicker. Some of the vertical poles were still in place, but the majority had been drawn up and the fence tipped over to the east (Fig. 10).

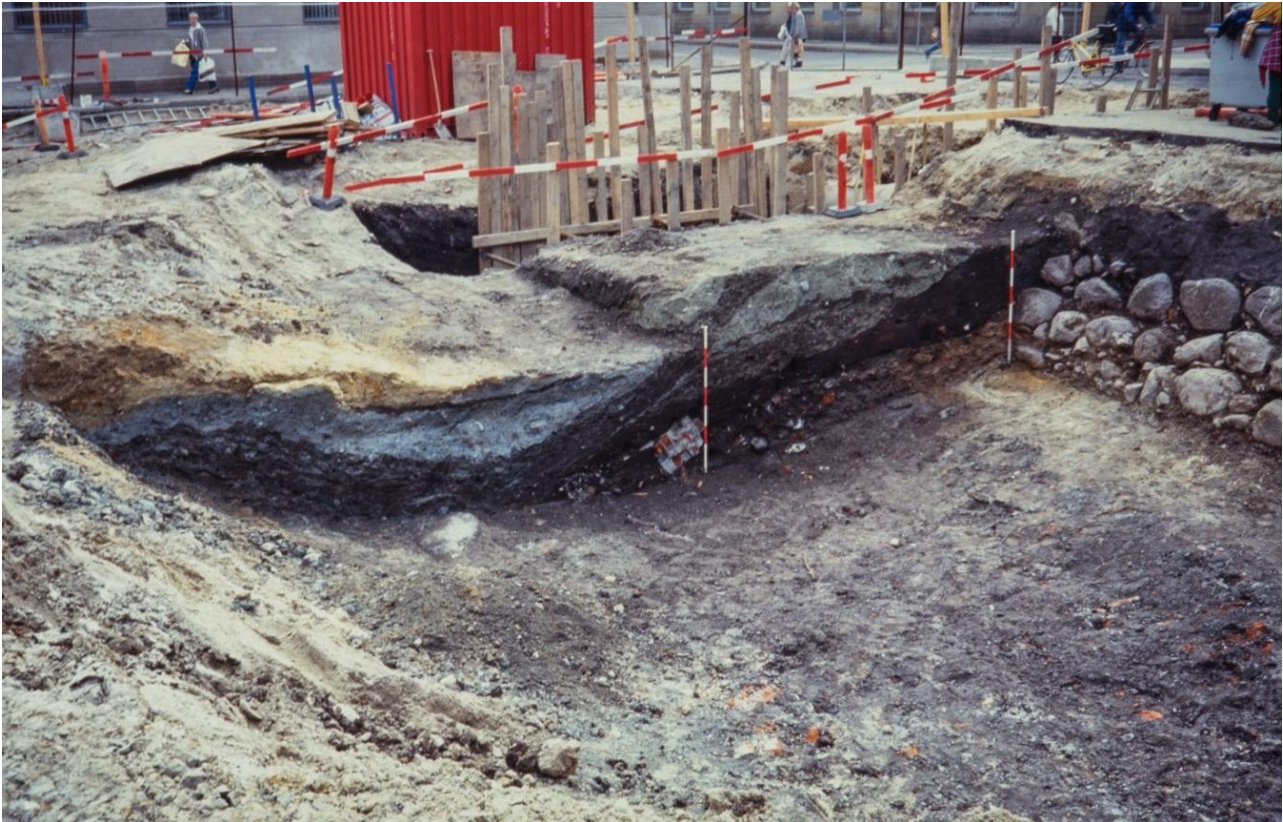
Fig. 11. Profile through Late medieval moat, facing SW. Photo: Museum of Copenhagen.

The High and Late medieval moat (CSR) could be followed the entire length of the excavation immediately east of the city wall foundation (Fig. 11) (Kristiansen 1998:82 et seq.; 1999b:156, 168 and 169). This could, however only with certainty be separated from a later post medieval moat phase (FAM) in the moat’s westerly part located under the so-called BOB-rampart (see above). The moat had been cleaned up through the Middle Ages and the edge could from the south to the north be recorded from kote c. +2.6 m – +3.6 m – +3.0 m – +2.6 m from the western extent of the city wall foundation. Based on the height of the /BRE-sequence, the moat had been at least 1.4 m deep (Kristiansen 1998:82 and 83).

At the base and the western edge of the moat, a layer (/O) consisting of sandy and sterile fill was documented. East of this the sedimentation consisted of different mud layers (“gyttje”) of varying thickness (0.2-0.6 m). It could not be clarified if the erosion and the mud layers were the result of long-term sedimentation or a late stage in the moat’s life. No datable finds were collected. Layer (IK) consisted of clean mud (“gyttje”) without inclusions of peat, which suggests that there had been at least 0.5 m of water in the moat providing a water level at kote 0 or upwards (Kristiansen 1998:83 and 84; 1999b:168 and 169). Archaeobotanical analysis showed that the environment had consisted of brackish, stagnant water. A weak salt effect showed that the mud had been formed before the filling up of Dybet between the coast and Bremerholm in the 1530–1540s (Kristiansen 1998:83 et seq.; 1999b:169).

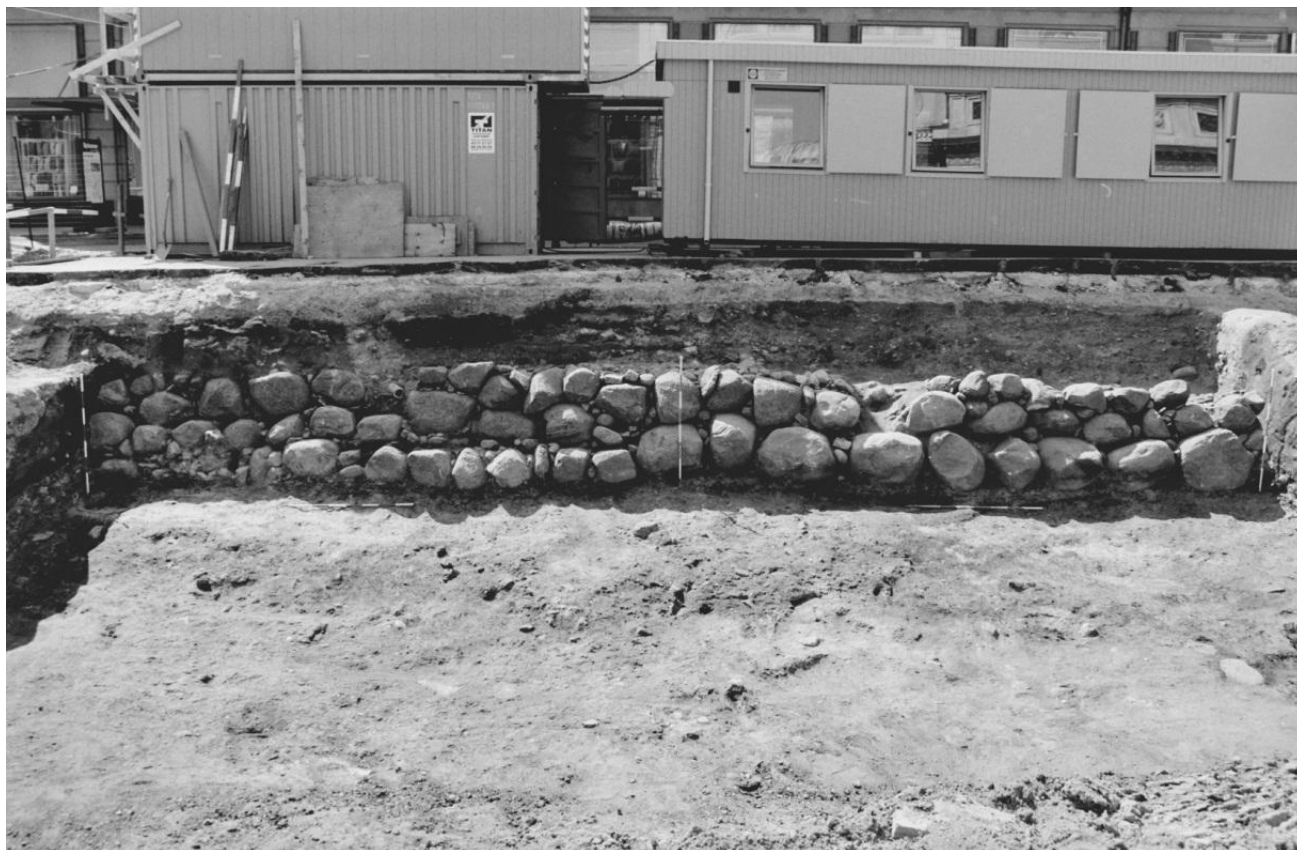
Fig. 12. Interpreted addition to the fortification in the 1580s conducted under Valkendorf's management consisting of a large foundation of boulders, facing west. Photo: Museum of Copenhagen.

Under the rule of Frederik the 2nd, the fortification underwent a major modernization along its length headed by Christoffer Valkendorf in 1581 (Kristiansen 1998:13, 98 et seq.; 1999c:185 et seq.). The rebuilding of the fortification could be seen as a substantial stone structure consisting of two to three courses immediately east of the foundation of the city wall, although the relationship between this development phase and older features was unclear at several places within the excavation area (Fig. 12).

The suggestion of a new city wall was based on the orientation and traces of mortar fringe after a masonry with 0.42 m thickness on the foundation stones (/ACP, CAH, CAL, CAS, CZS, CU, DCI, FBA, /FBB, FBC, FBD and FBE), demolition material and looting ditches, but it is worth mentioning that this interpretation is rather uncertain (cf. Kristiansen 1998:110).

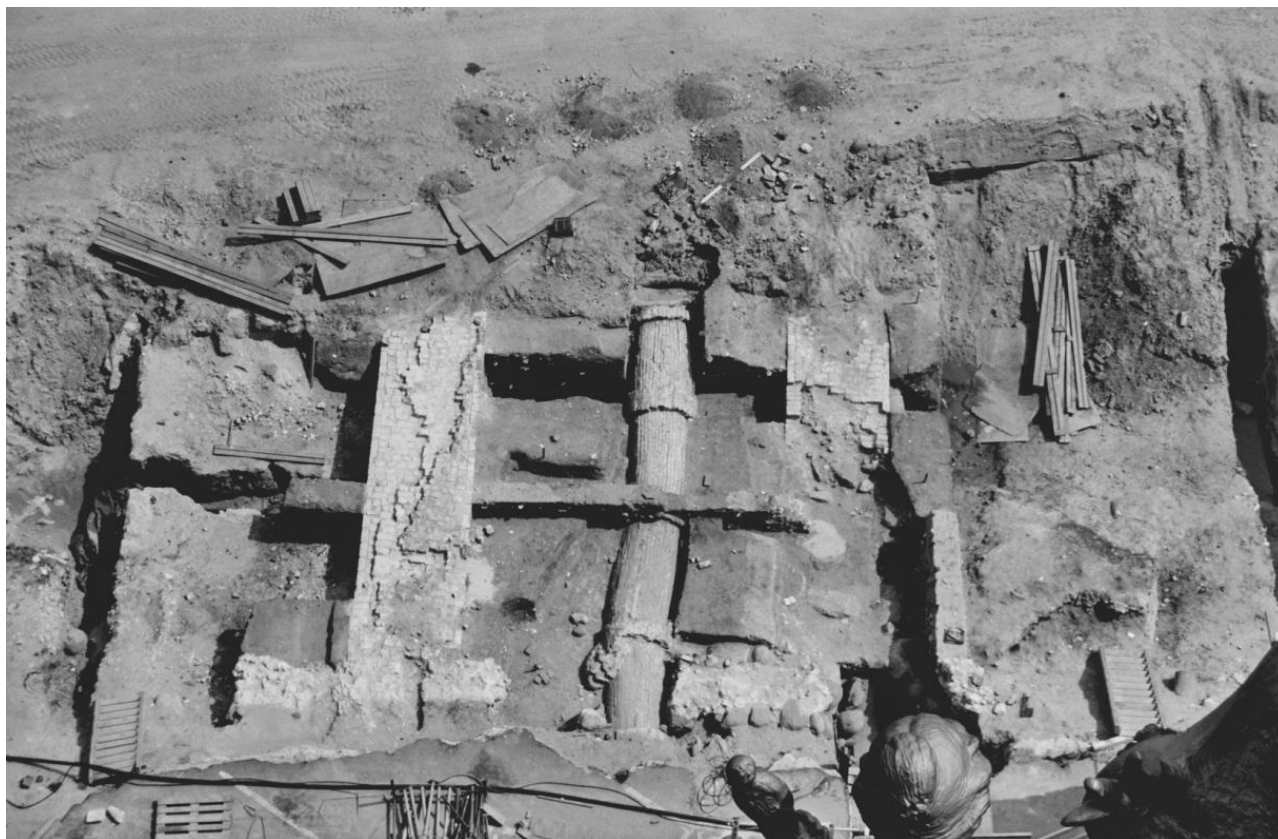
Fig. 13. Vandporten and later sewer pipe from above. Photo: Museum of Copenhagen.

Through the curtain there was a gate, the so-called Vandporten (Fig. 13), which served as a transportation route into the city for the goods that were unloaded from the ships in Holmens Kanal (AAP, /DDO, /DDP, EB, EI, LE and YG).

The gate had been 11.6 m long with a west facade 0.8 m thick. The gate room was 5.8 m wide, the sidewalls 1.9 m wide with the foundations slightly wider. The preserved height varied from 1.78 m to 2.75 m of an estimated total height of 6.0 m. The foundation of the facade was 13.0 m long and stretched respectively 1.8 m and 1.5 m outside the rest of the structure's dimensions. In relation to the gate room's width the facade was twice as wide based on the total length of the structure. The foundation was partially made of reused medieval bricks and this had survived up to street level. TL-dating of reused bricks from the gate's facade gave the dates 1200±60 AD, 1170±60 AD and 1270±60 AD (R-960501, R-960502 and R-960503). Placed between the sidewalls there was a 14.8 m long brick sewer with walled barrel vault built with small yellow bricks (LI) and an associated wooden water pipe (ASB). This sewer was somewhat misleading, TL-dated to 1400±60 AD (R-960508). In the gate room's north-eastern part traces of the paving was recorded (ED) placed c. 0.70 m under the current street level (Kristiansen 1998:124, 130, 131 and 136; 1999c:176, 194 and 195).

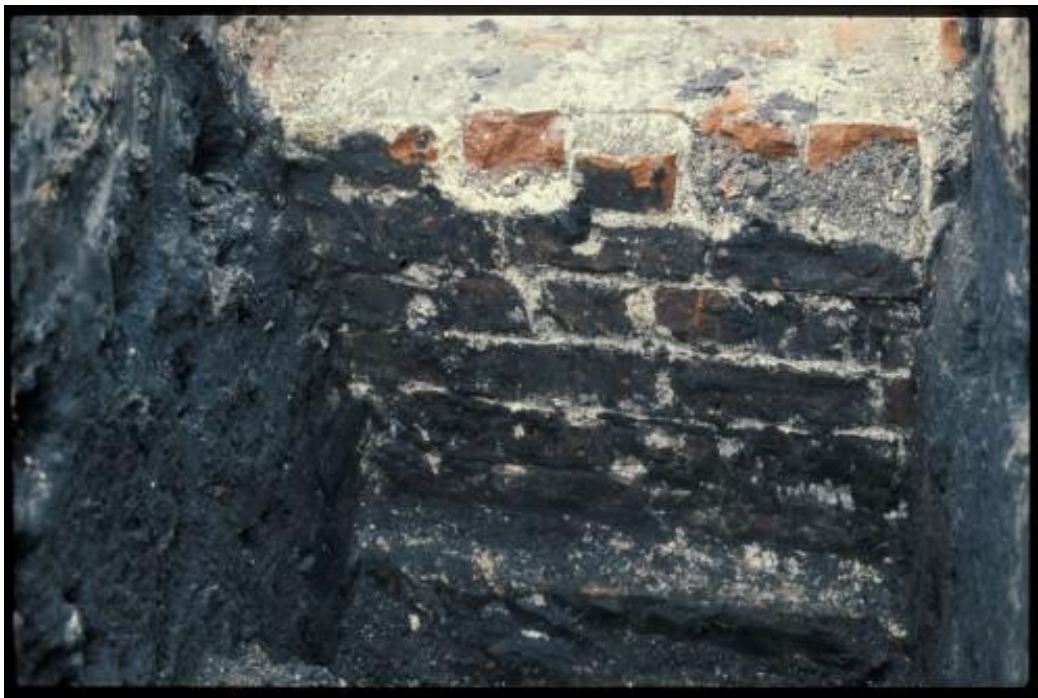
Fig. 15. Part of the brick wall in Vandporten investigated by Bi Skaarup in 1988. Photo: Museum of Copenhagen.

Kongens Nytorv No. 13: Cultural layers and a 2.1 m wide brick wall ("munkesten") perpendicular to No. 13 facade approximately 30 m from Magasin (Fig. 15) interpreted as belonging to the Late medieval tower Smørhætten (Skaarup 1988), but later interpreted as part of Vandporten (cf. Kristiansen 1999c:200).

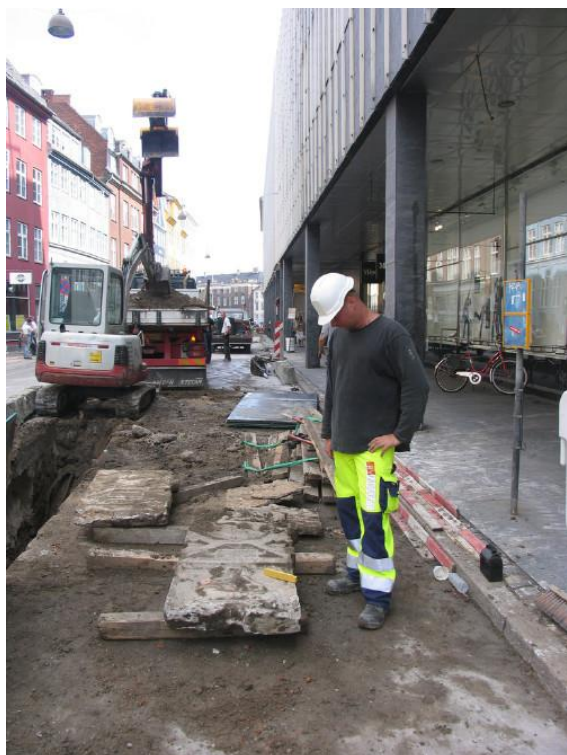
Fig. 16. The two porch stones found in Lille Kongensgade 2007. Photo: Museum of Copenhagen.

Lille Kongensgade Nos. 2-22: Smaller excavation from Bremerholm to Kongens Nytorv. In situ foundation stones and layers belonging to previous facade south of Lille Kongensgade No. 20 which may have medieval origin. In the western part remnants of a cellar foundation and walls were recorded, which in its oldest part may date to the Middle Ages. Paving and a clay layer were documented outside No. 16. Worth mentioning are two sandstones with carved human figures and Latin text, which were parts of porches built in front of entrances on timber framed houses during the 16th and 17th centuries, found between No. 16 and No. 18 (Jark Jensen 2007; Fig. 16).
