21 Phase 8 Kongens Nytorv 1650–1950 AD

21.1 Results

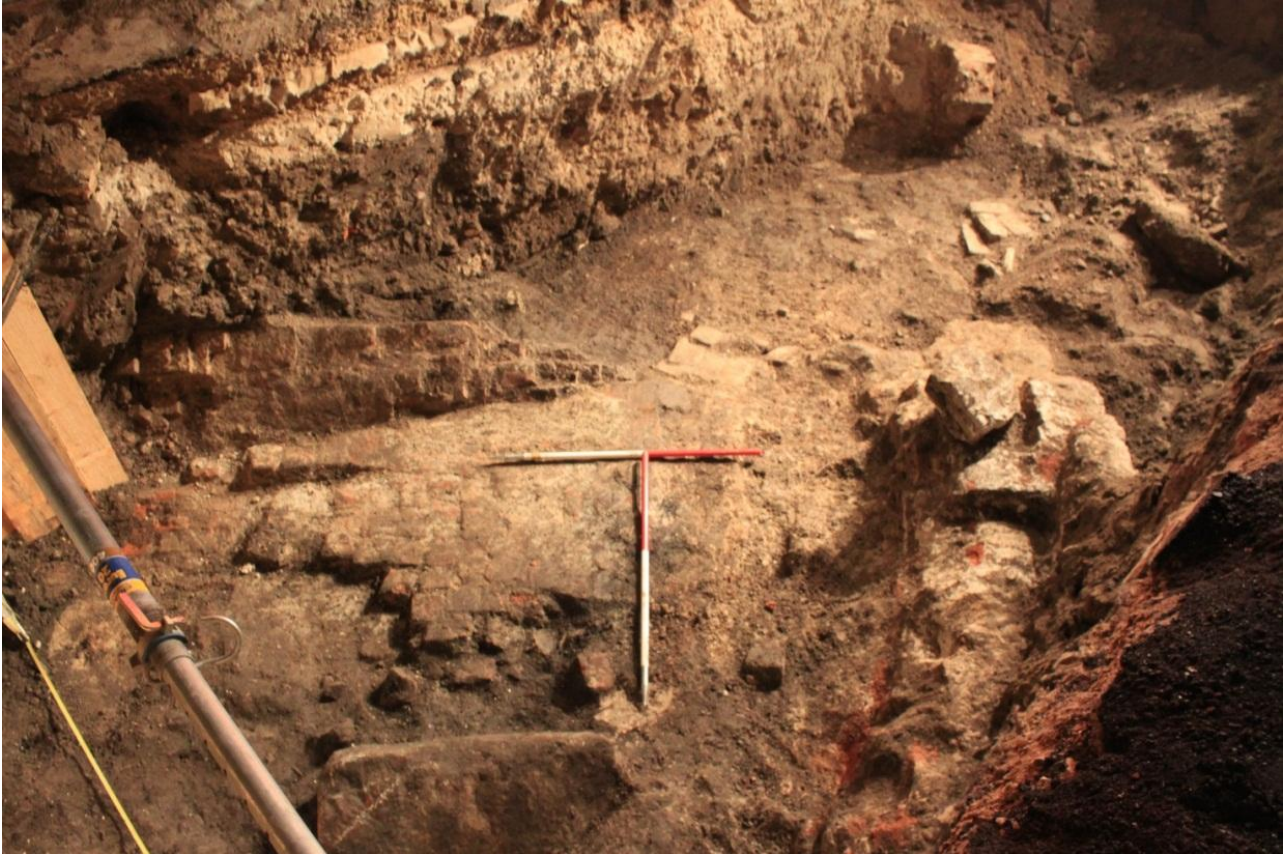
Fig. 326. Night work. Floor of square bricks (SS201489) and brick walls (SS53028 and SS201480) investigated in current Holmens Kanal, facing south. Photo: Museum of Copenhagen.

Part of a building was recorded in a watching brief trench during night work in current Holmens Kanal (ZT7627) (Fig. 326).

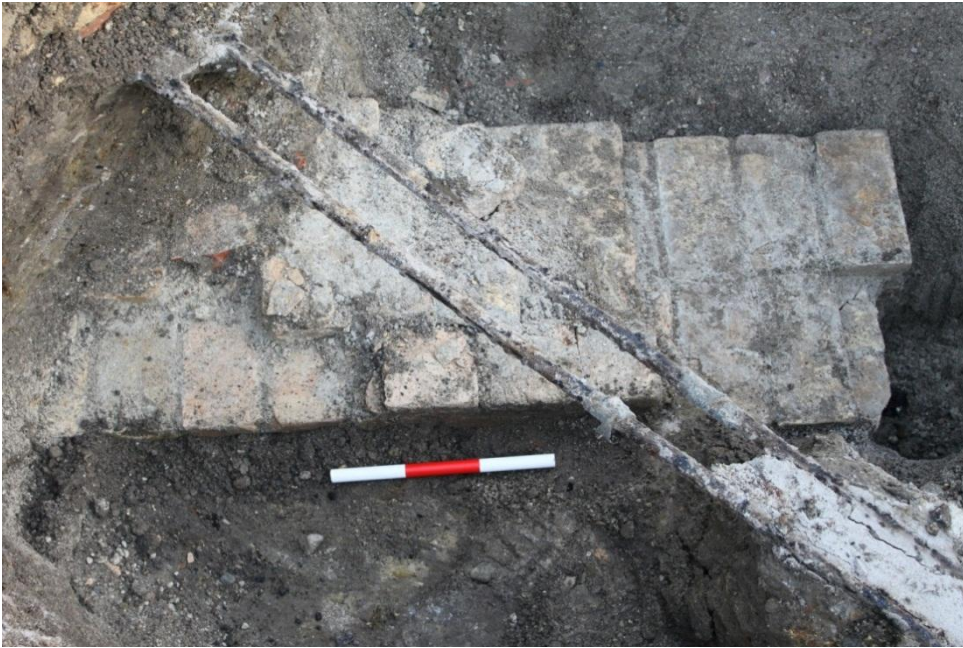
Fig. 328. Part of brick wall (SS1211) made of yellow Flensborg bricks running NW-SE, facing NE. Photo: Museum of Copenhagen.

A continuation of the building was investigated in 2013 (ZT1224). Traces of two brick walls were recorded in the southern part of a trench approximately 20 m from the NW corner of the Royal Theatre (Fig. 328). The southern wall consisted of masonry of so-called Flensborg bricks truncated by modern disturbance to the south. The number of courses was at least three rows. First sign of the bricks was seen at a depth of 0.7 metres. There were two bricks as stretcher (W-E) and four bricks as header (S-N) seen, facing north. The feature continued below the excavation limit. The northern wall consisted of four rows and was the same as southern wall, placed a couple of metres from the former structure. It was harder to see the shape since less was exposed than of the southern wall, but the same form, mortar and yellow bricks had been used. First seen at 0.78 m below the present surface, this wall also continued below the excavation limit.

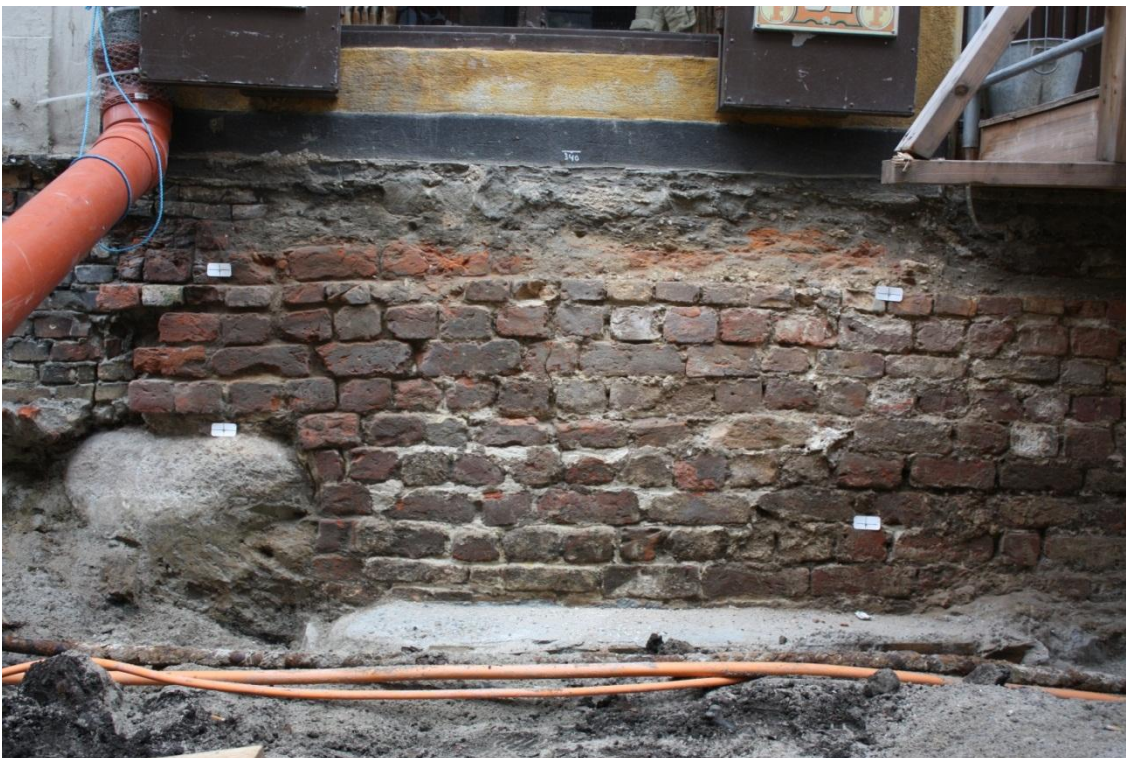
Fig. 329. Exposed brick wall and foundation stone at Hviids Vinstue, facing north. Photo: Museum of Copenhagen.

With the establishment of the new Metro Cityring it was necessary to underpin the foundations of Hviids Vinstue and other nearby buildings in order to provide additional support. Larger parts of the facade were therefore exposed and excavated, which enabled archaeological documentation of the brickwork together with foundation stones (Fig. 329).

The recording showed the different phases of maintenance work and interventions in the brick wall foundations that have happened during the years after the building was constructed in the early 1700s.

The exposed brick wall outside Hviids Vinstue confirms earlier investigations in the area containing brickwall foundations and irregular shaped granite boulders, but the wall (based on maintenance work and coursing) is later than the suggested date of the early 1500s (cf. Summerfield 2009).

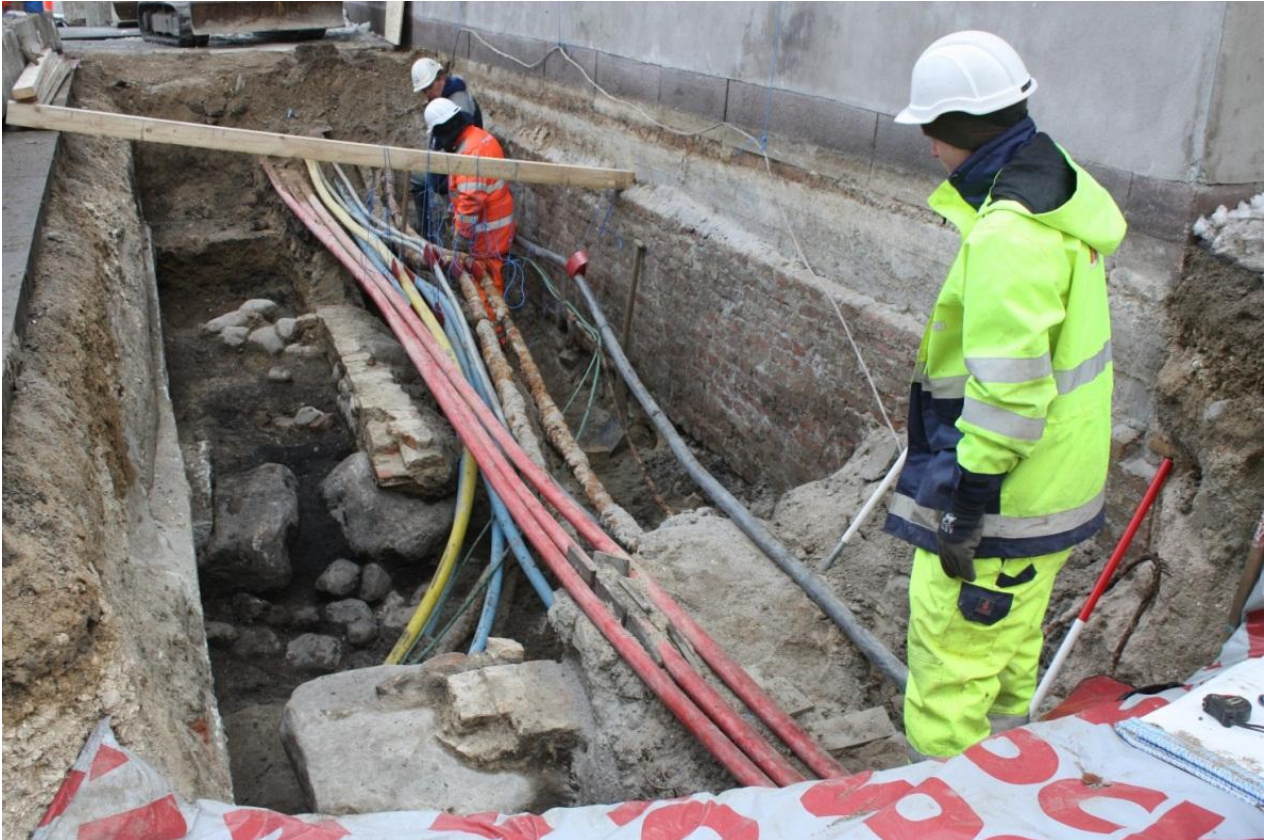
Fig. 330. Overview trench (ZT1071) outside Danske Bank with exposed boulders, stones and brick wall, facing east. Photo: Museum of Copenhagen.

Part of a building was investigated north of Danske Bank's facade in trench ZT1071 (G-201) (Fig. 330).

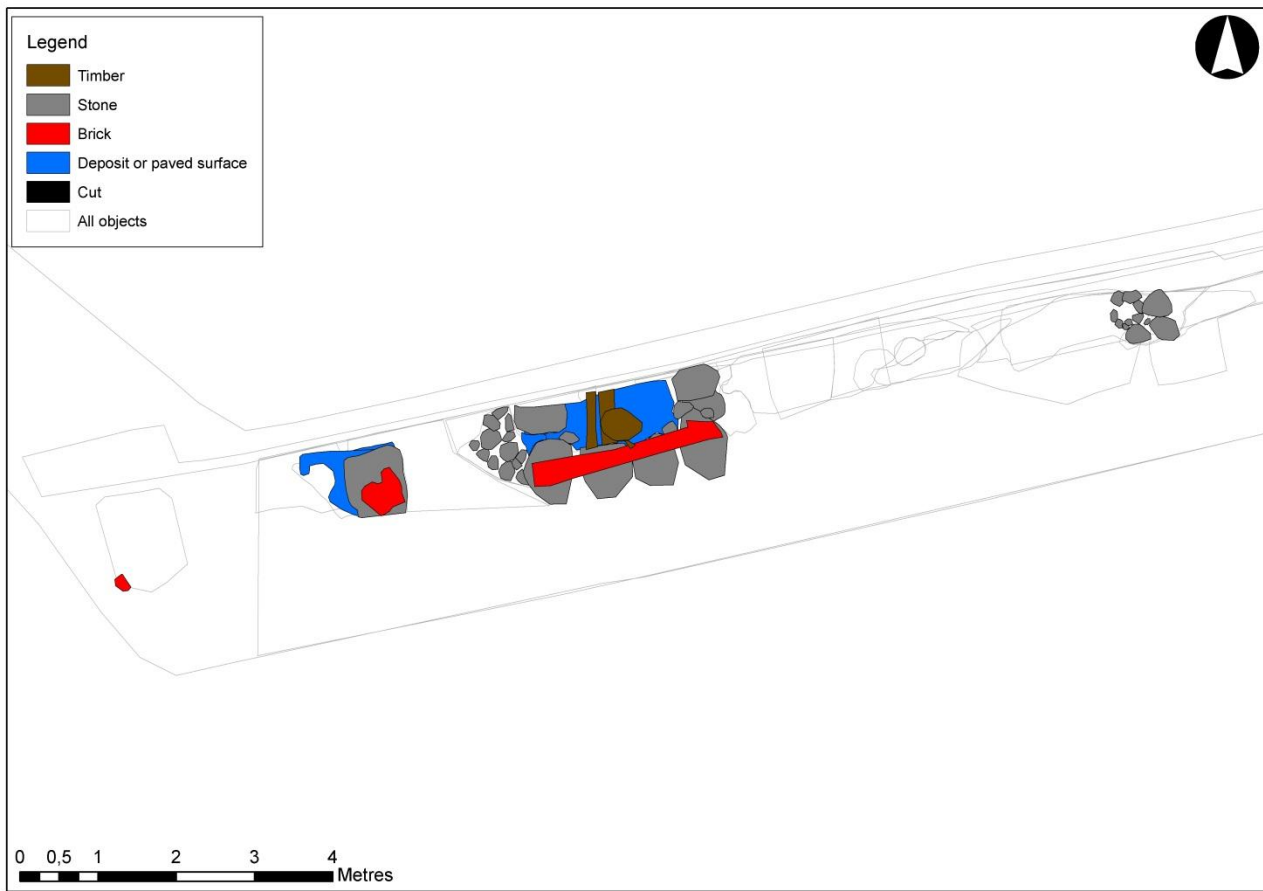
Fig. 331. Part of brick wall SS1575 belonging to a former building outside the northern facade of the present Danske Bank. In the middle – part of a bucket with unknown purpose.

Besides the remains of a floor (?) in the western part of the trench, seven large boulders (SS205148) arranged in at least two courses forming a U-shape were documented in an area of approximately 2.7 x 1.4 m surrounding an open area with a buried bucket (Fig. 331).

The bucket contained different types of waste, such as brick fragments, tiles, glass and ceramics. Below the bucket two wooden 0.7 m log logs of uncertain function was recorded. Up against the boulders an accumulation of 20 smaller stones were recorded (G-202). The southern row of boulders and a large stone to the west had served as the foundation for a later NE-SW running wall of red and yellow bricks in three courses (SS1575; SG-239902) (Fig. 332).

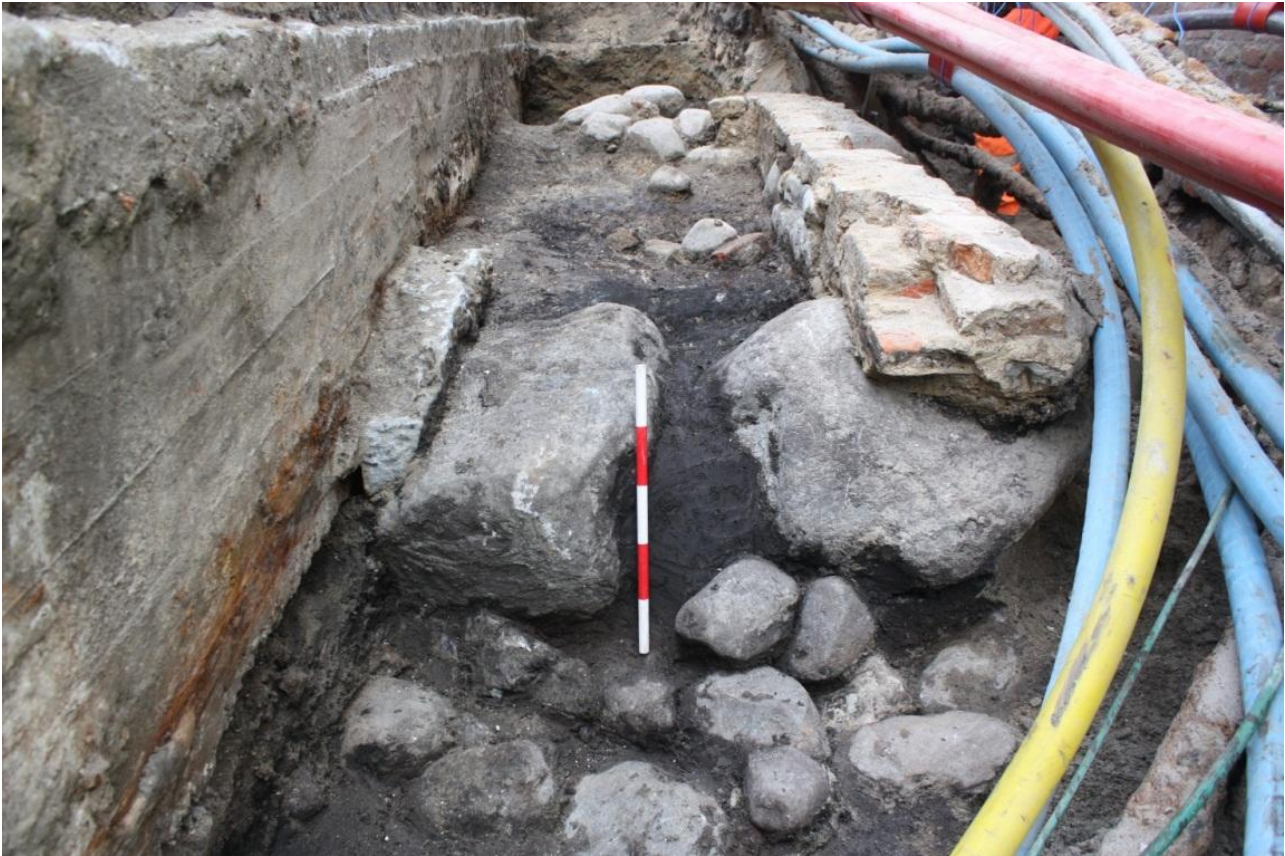
Fig. 332. Foundation (SS205148), facing NE. Above – brick wall (SS1575) belonging to a later building. Photo: Museum of Copenhagen.

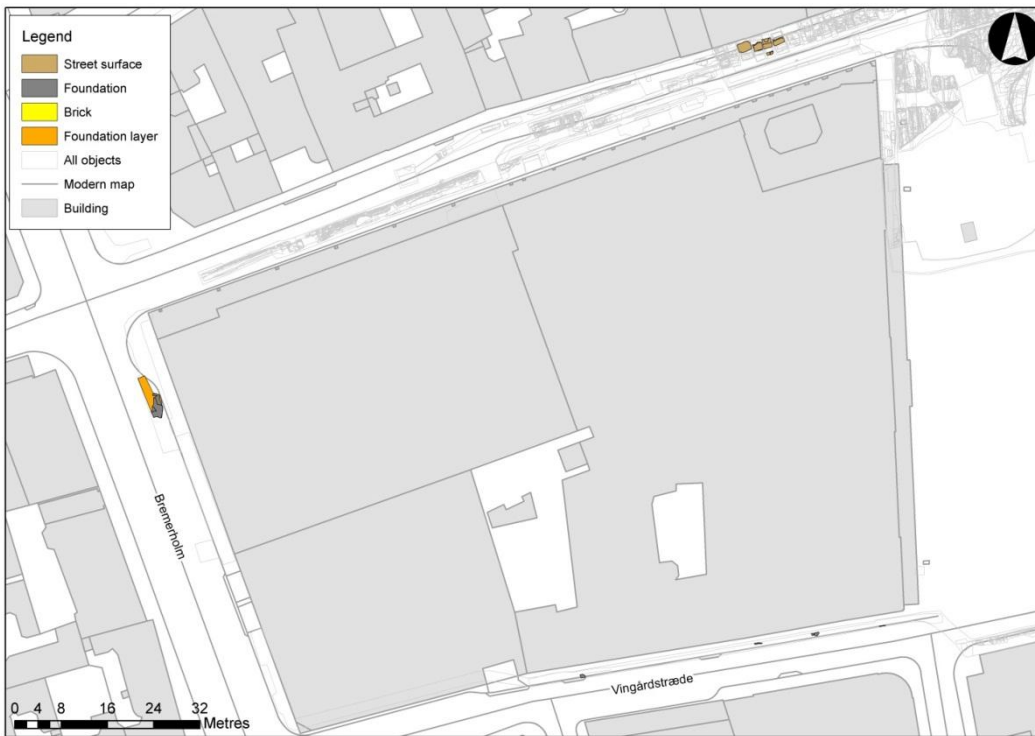
Fig. 333. Identified street surfaces in Bremerholm and Lille Kongensgade together with boulders recorded in Vingårdstræde.

A stone floor in Bremerholm outside Magasin (ZT1071) probably represents a remnant of an older building demolished in connection with the widening of Ulkegade, re-named Bremerholm, in 1932 (Fig. 333). A foundation layer of sand and a cobbled surface with stones of different sizes (0.1-0.3 m) in the same trench could be traces of a floor of a simple building – or it could represent an external surface such as a yard surface.

The foundation stones exposed in Vingårdsstræde in trench (ZT1071) probably belonged to an older building – perhaps the remnants of one of the side buildings of the Holstein-Holsteinborgske Palace from the mid 1700s. The wall may also have been part of the Hotel du Nord, which was demolished in 1893–1894.

Five different road and street surfaces dated to Phase 8 were recorded at Kongens Nytorv and adjacent streets (Fig. 333, 337 and 338). The surfaces did not differ remarkably from the already reported medieval and Post medieval road and street surfaces and consisted of brown-grey silty sand and clay with inclusions of soot, charcoal, red brick fragments, pebbles and stones. The average stone fragment size was 2.0-3.0 cm in diameter where in some places the surface had sunk into (or filled) the wheel ruts. The street surfaces recorded in Lille Kongensgade consisted of pebbles, flint and brick fragments and were in many ways similar to the road surfaces documented outside Østerport dated to the 16th and 17th centuries (see Chapter 18.1.3).

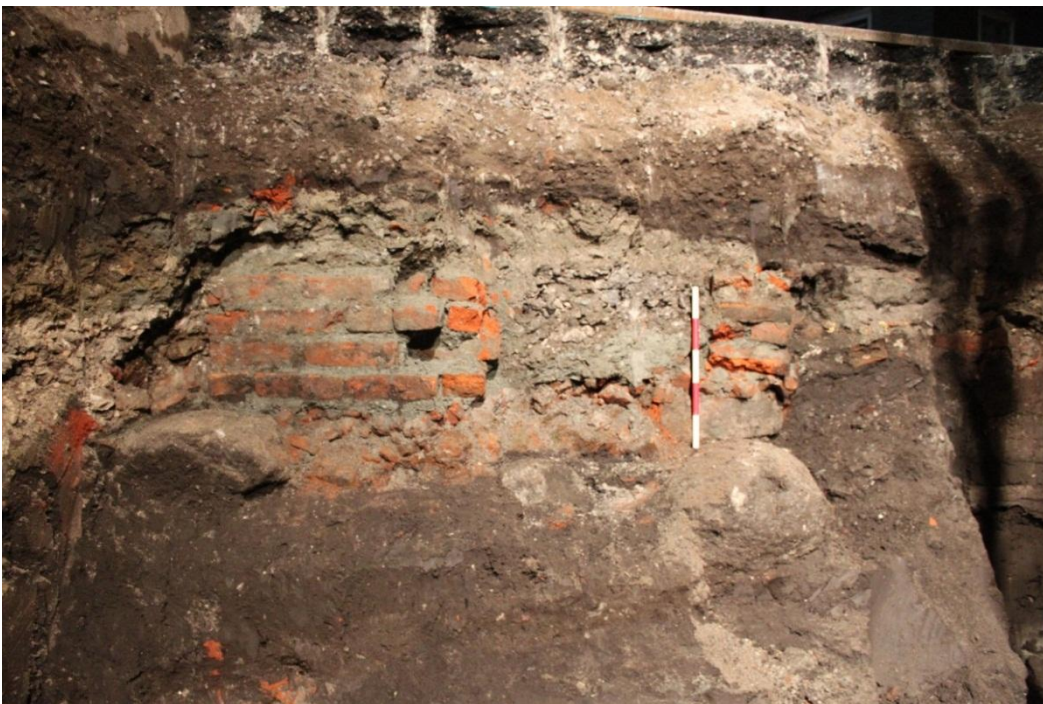
Fig. 334. Foundation stones and brick wall exposed during night work in trench ZT52627, facing SE. Photo: Museum of Copenhagen.

In a watching brief trench across Bredgade from Krinsen to Nyhavn (ZT52627) parts of a building were investigated (Fig. 334 and Fig. 345 below).

The brickwork and foundation stones belong to an earlier building with a Post medieval date. An accumulation of bricks recorded in the north could have a similar origin. Beams were revealed in the northern part of the trench and this construction may be the remnants of a bulwark and parts of a ground anchor. Similar structures have been encountered in previous surveys in the area. The structure could represent part of the guard building seen on Marcellius prospect from c. 1720 AD (see Fig. 348 below).

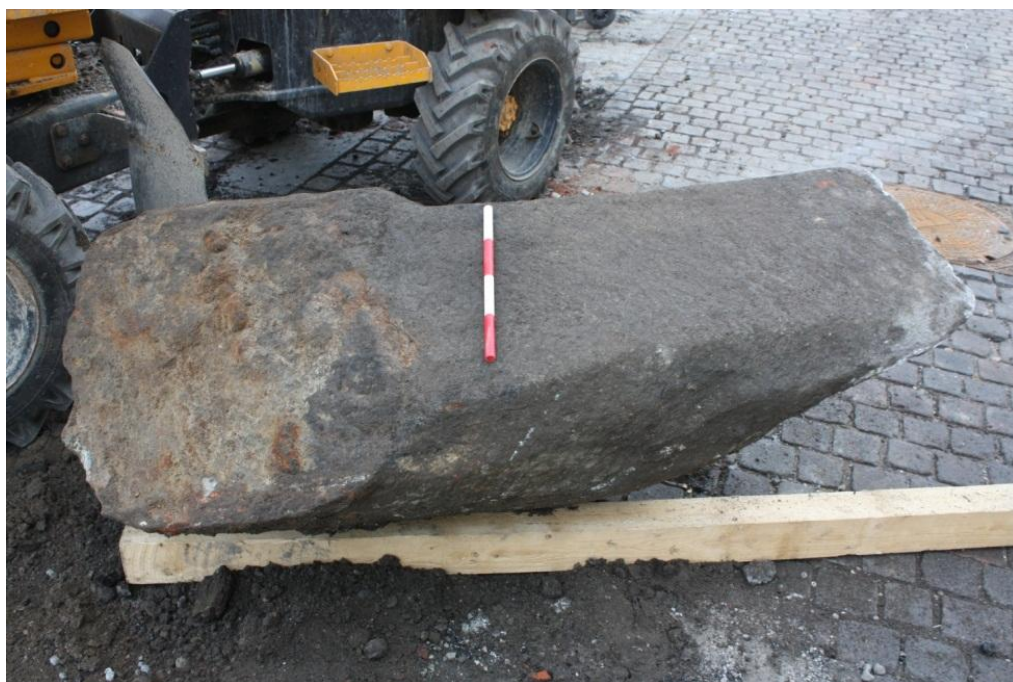
Fig. 335. Boulder interpreted as an “entrance stone” (Danish: afviser) from dump and levelling layers outside the Royal Theatre. Photo: Museum of Copenhagen.

In trench (ZT52026) extending from August Bournonvilles Passage to the SW corner of the Royal Theatre some stones were recorded and interpreted as remnants of an older building, but probably represent destruction material. Part of a wattle and daub wall (?) could be remains of a timber building seen between Store Gjethus and Lille Gjethus on a drawing from 1698 (cf. Elling 1940; Fleischer 1985). A large boulder exposed and removed from a watching brief trench outside the theatre represented an “entrance stone”, perhaps from the former Harsdorff’s Theatre (1774) west of the current theatre (Fig. 335).

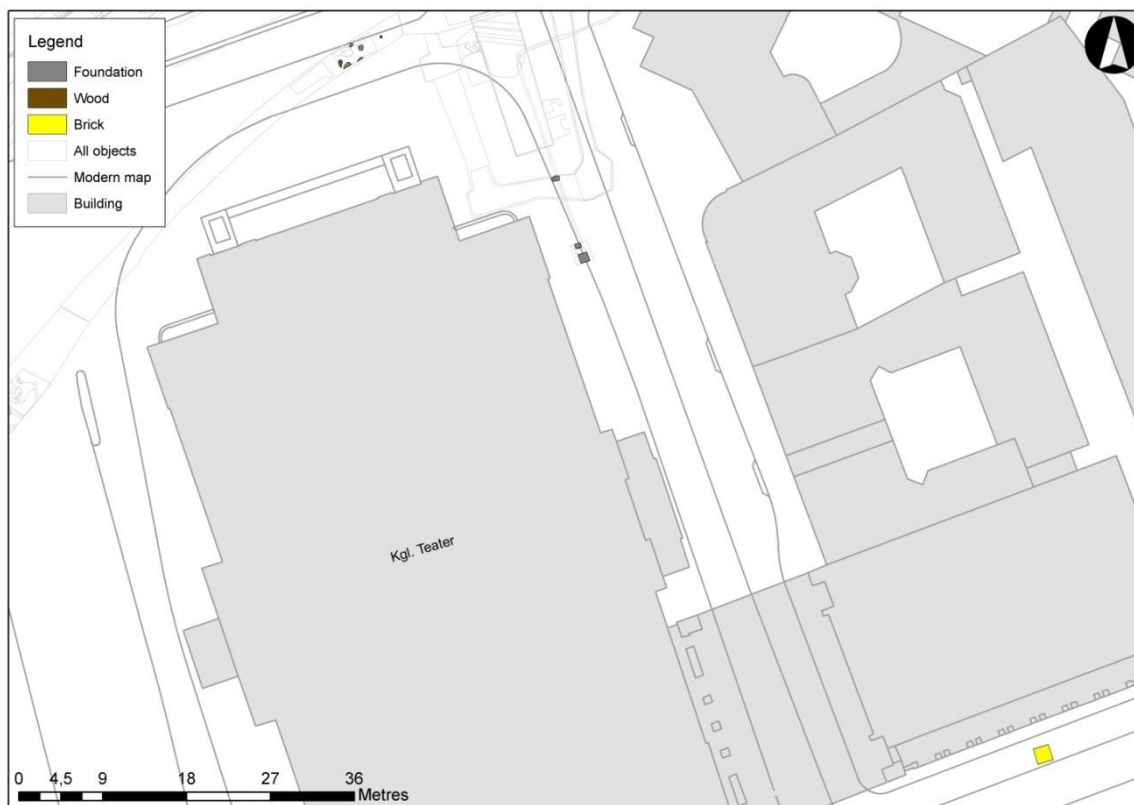
Fig. 336. Four foundation stones and lower parts of a brick wall (2.5 x 1.0 x 0.5 m) running in NE-SW direction together with brickwork and foundation layers in Heibergsgade and August Bournonvilles Passage.

In the northern part of trench ZT52963 between the Royal Theatre and August Bournonvilles Passage No. 1 a brick foundation of so-called Flensborg bricks was documented (SS53464) (Fig. 336). The width was estimated to be about 1.0 m, with the foundation continuing beyond the edge based on the location of the trench to the north. The brickwork may have belonged to Store Gjethuset built on the site in 1672 AD.

Part of a stone pavement was investigated in August Bournonvilles Passage. In a monitoring trench in Heibergsgade outside No. 7 an uncertain Late post medieval brick wall in the SW corner was recorded (1.2 m down), although without further interpretation.

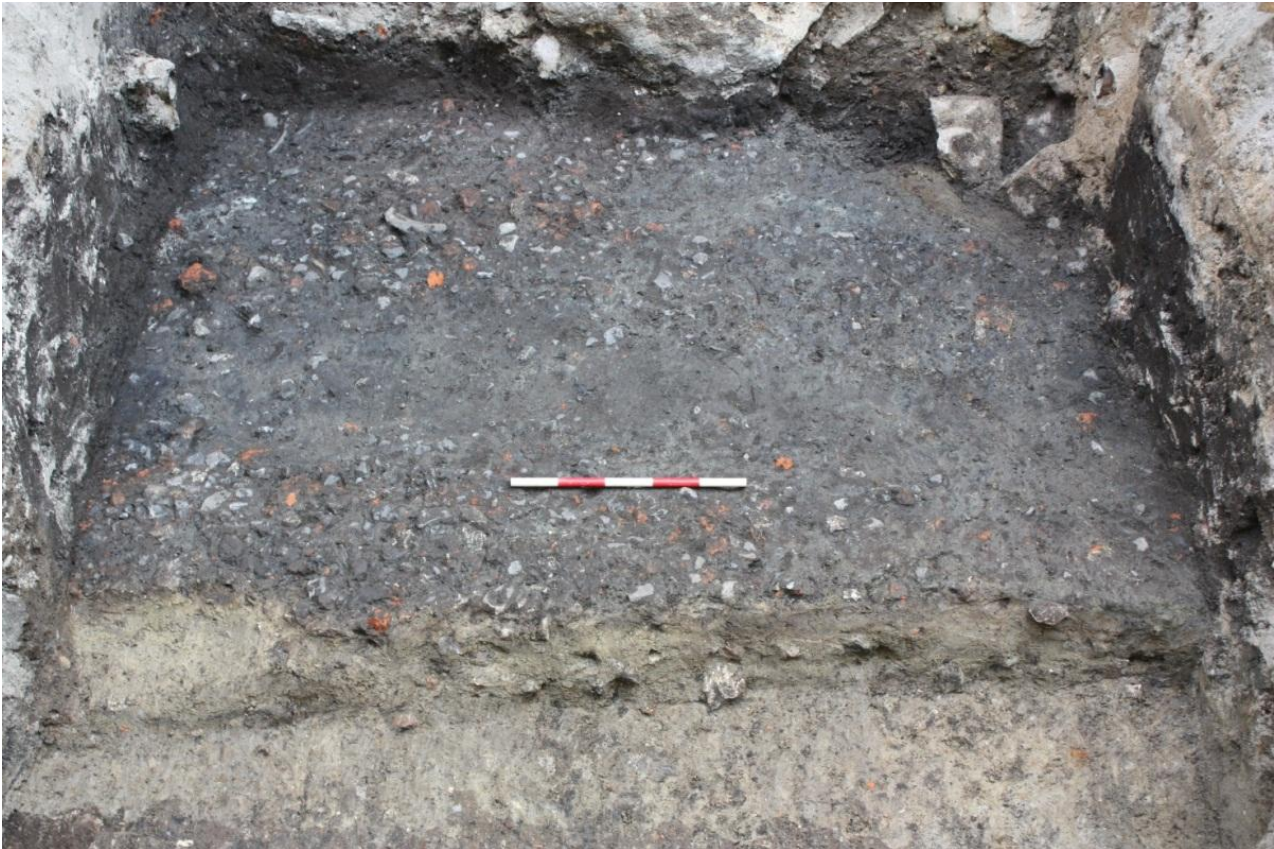
Fig. 337. Street surface (SD3376; G-228) in Lille Kongensgade, facing north. Photo: Museum of Copenhagen.

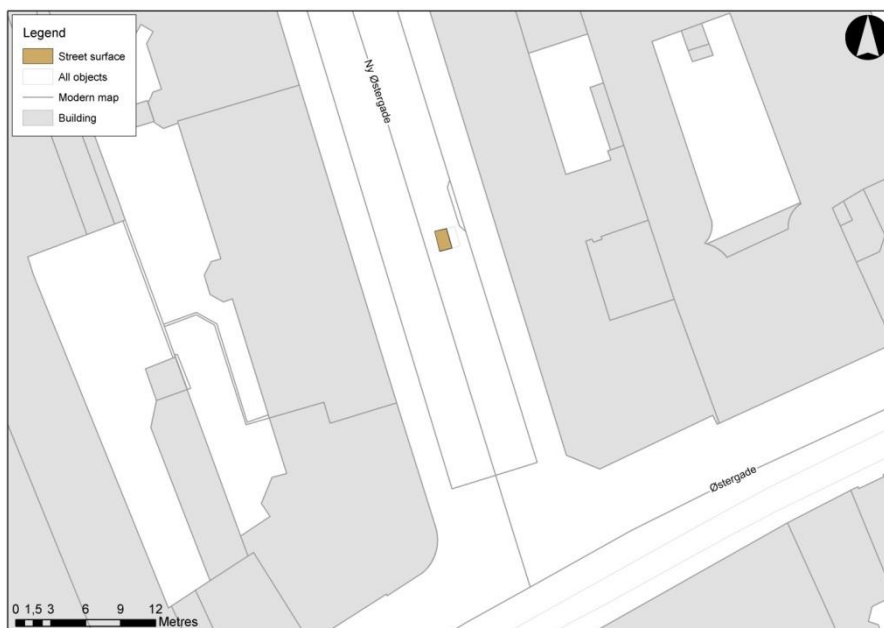
Fig. 338. Interpreted street surface and levelling layers documented in trench (ZT1007) in Ny Østergade.

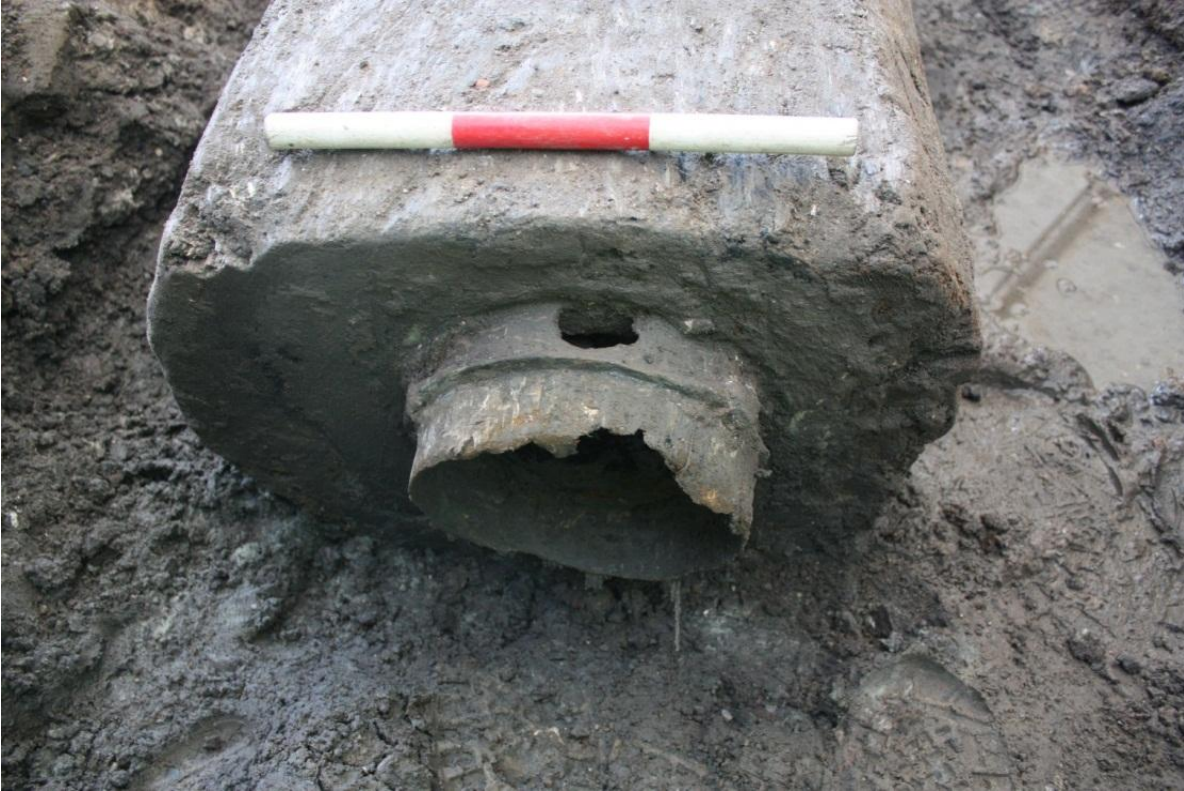
Fig. 340. Iron bolt in wooden water pipe (ST30444). Photo: Museum of Copenhagen.

Several wooden water pipes were documented both in Lille Kongensgade and at Kongens Nytorv (Fig. 339). The pipes were made of pine, had a diameter of between 0.20 m and 0.50 m, where the drilled core was from 0.10-0.20 m in diameter. Some of the pipes had joints made of metal and a covering of lead plate. In some cases the pipes had been stabilized with wood blocks or bricks (Fig. 340 and 341).

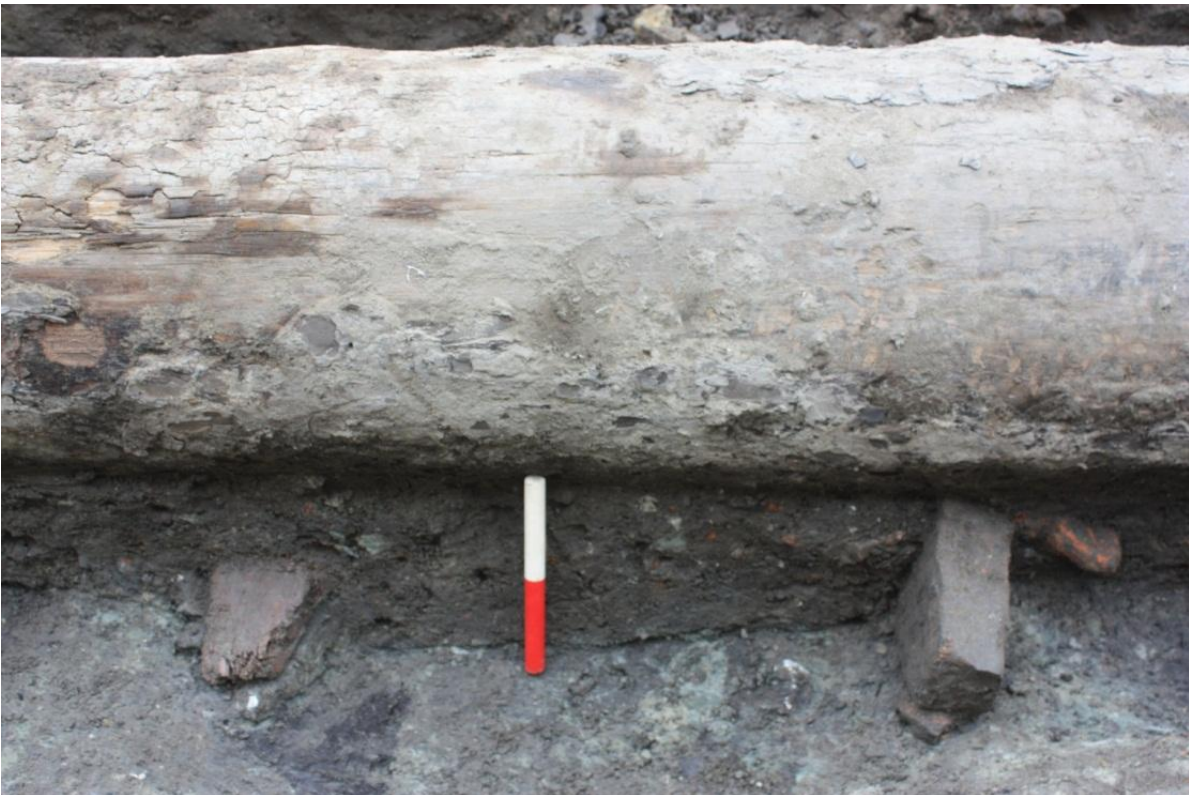
Fig. 341. Supporting wood blocks under water pipe, facing NE. Photo: Museum of Copenhagen.

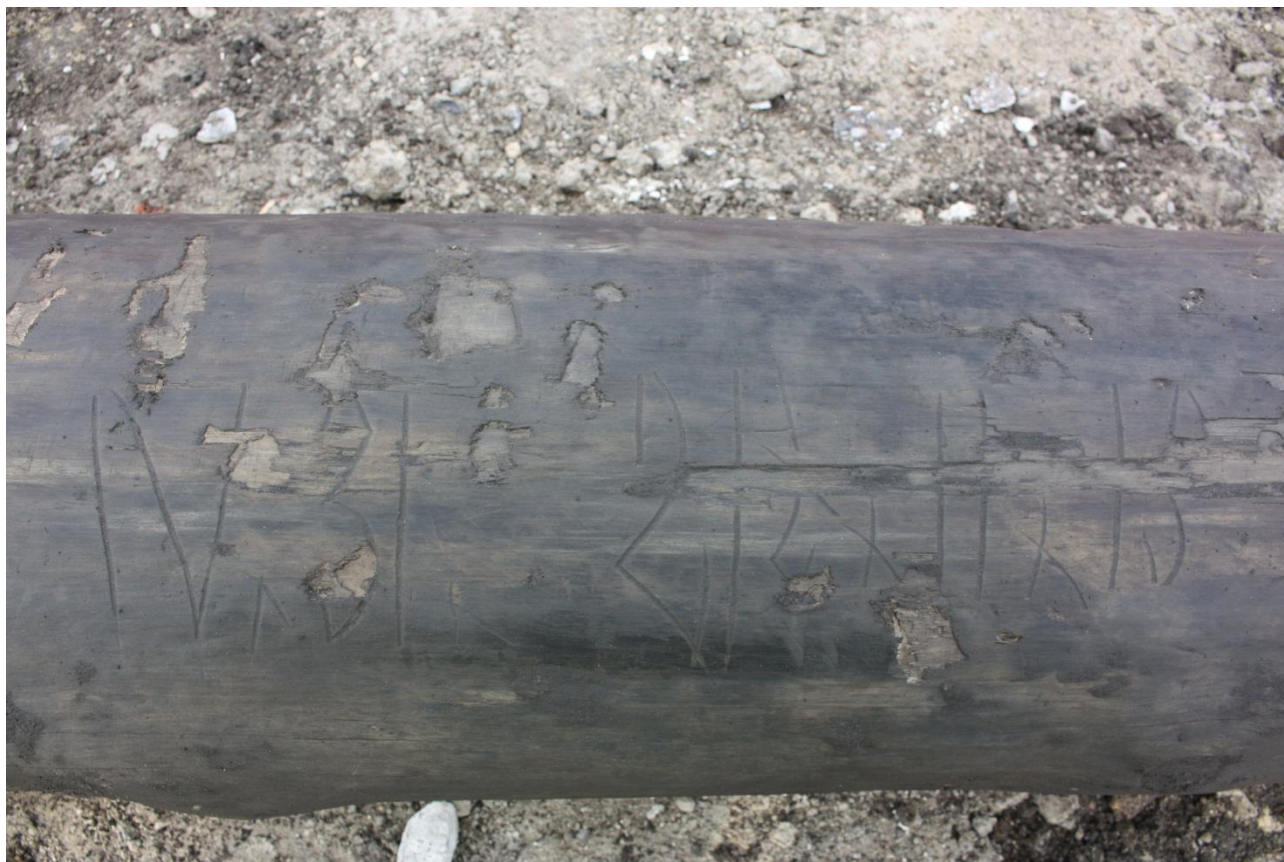
Fig. 342. Wooden water pipe showing the price of being connected to Copenhagen's pumped water system in the 1830s. Photo: Museum of Copenhagen.

One of the largest pipes exposed in the Station Box had writing on it: N x 31 x 21½ x 11 x 13 (or 15) (Fig. 342).

Number 31 fits well with price for connecting a water pipe to the common pumped water system (Topcagic 2014b). The cost according to the written sources (e.g. Hans Peder Resen's book about water in the late 1600s) was 30 rdlr. To this amount came a yearly fee of 1 riksdaler (30 + 1 = 31 riksdaler). According to the Chancellery Letter Books, Queen Dorothea ordered pine trunks for the water pipes that were 7-8 cubits long and 11-13 palm wide (c. 3 inches) in circumference from Koldinghus in 1561. Number 11 figures on the pipe and perhaps this represents the palm circumference? However, there is no 7-8 quantity, but according to a German historian, Florini (1702), the wooden pipes could be 8-12 feet long. In the cases where long pipe lines were assembled these could be 18-24 feet long. The information may have been written for the water master and his apprentice, who were responsible for the practical work needed to lay down the pipes to customers in the mid 1830s. So the text on the pipe probably represents the price for the connection to the pumped water, the lengths of the pipes in feet, and perhaps their palm in circumference.

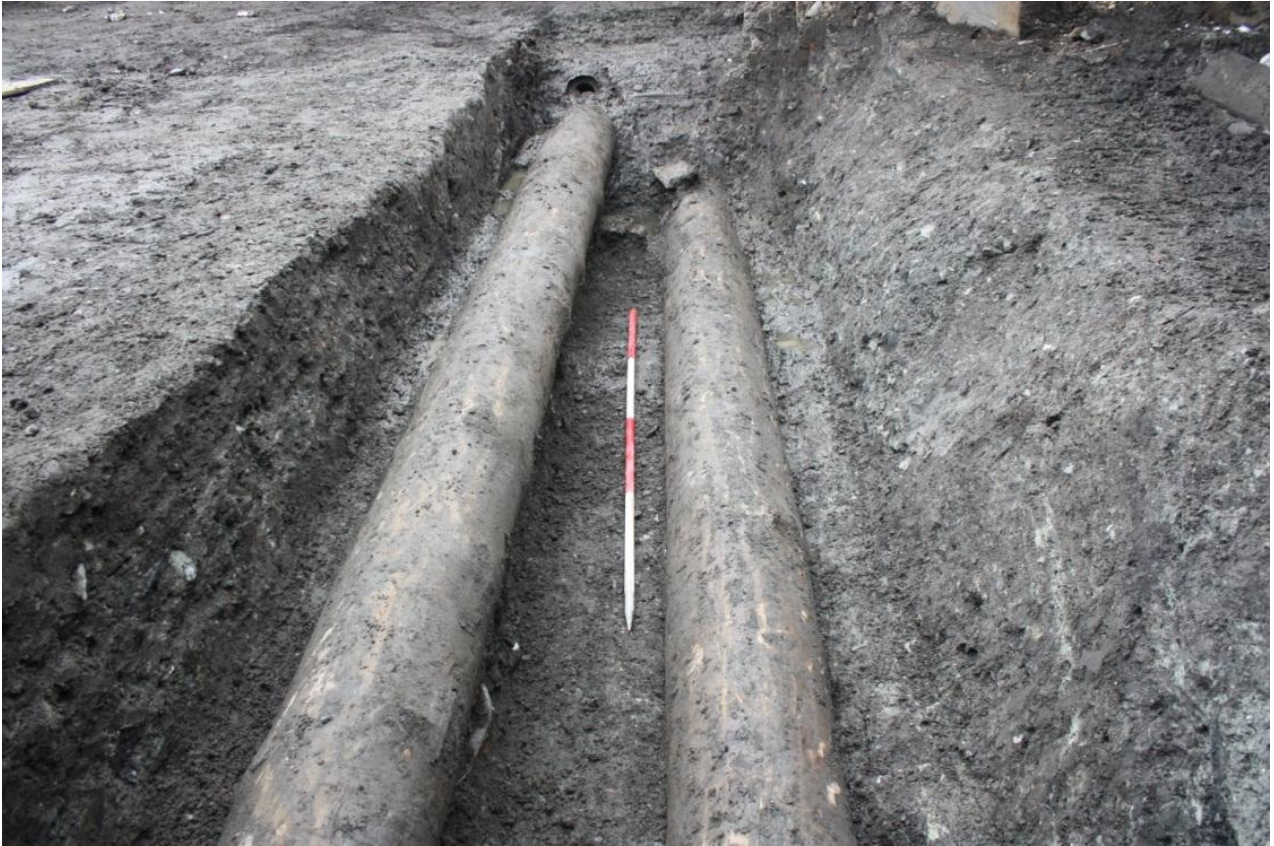
Fig. 343. Wooden water pipes (ST50924 and ST50940) in the 17th century moat, facing south. Photo: Museum of Copenhagen.

Four parallel water pipes were recorded at different depths in the 17th century moat running in a N-S direction together with a wooden dressed ditch (SC50857) (Fig. 343).

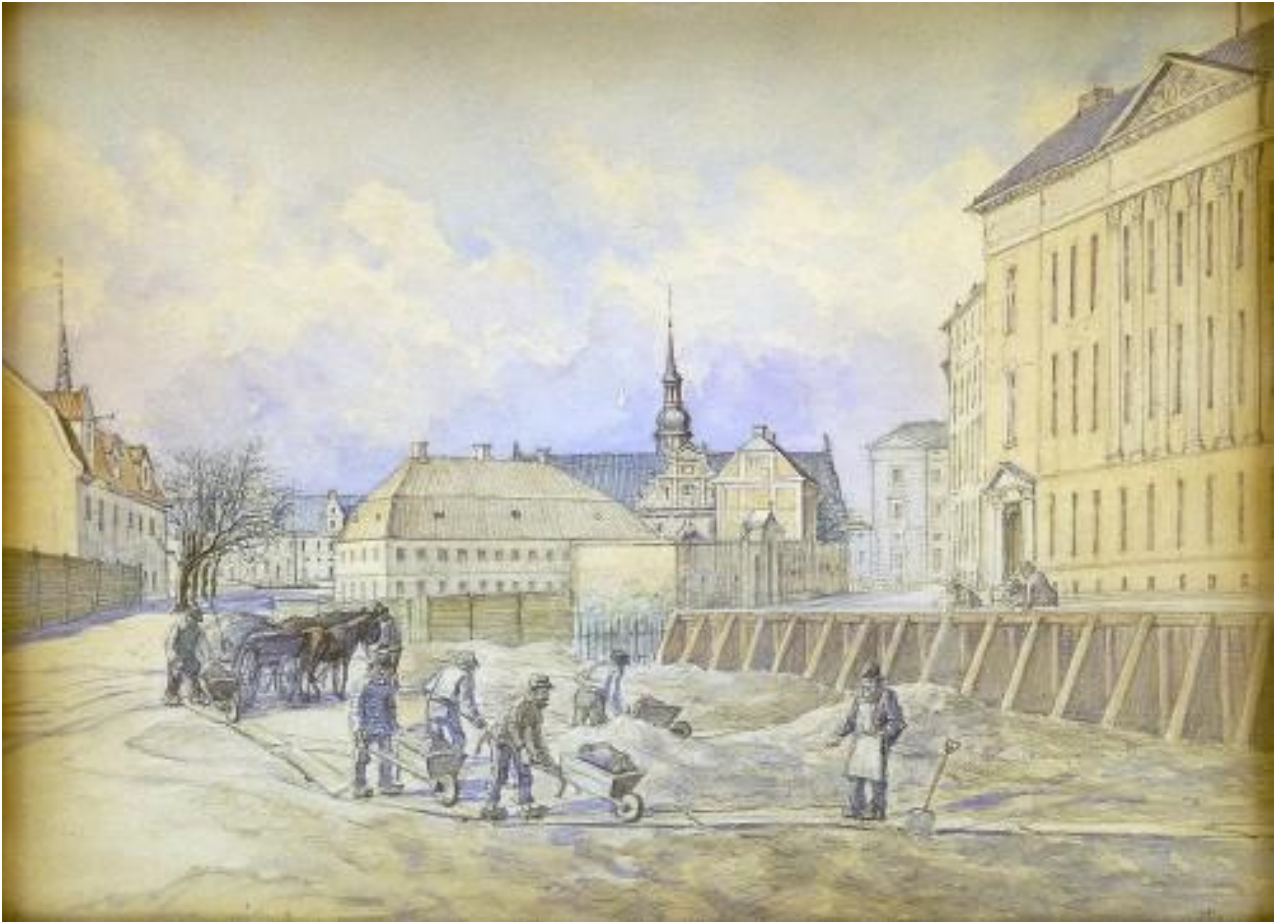
Fig. 344. Removing the last traces of Østervold. Backfilling of Holmens Kanal outside current Danske Bank in 1864 facing Holmens Kirke to the west. Photo: Museum of Copenhagen.

An interpreted well and several pits, posts, postholes and stakes were also recorded belonging to this time phase, where function and interpretation is unknown since none of these can be connected to larger structures. The levelling layers behind the former embankment and fortification consisted of mixed deposits of different colour, composition, homogeneity and finds, placed in connection with building activities, etc. The deposits recorded at Kongens Nytorv were mainly dumped here to level the area before the establishment of the square in the late 17th century. The material was also used to backfill Holmens Kanal in 1864 (Fig. 344) and to create Nyhavn's Kanal in the 1670s.

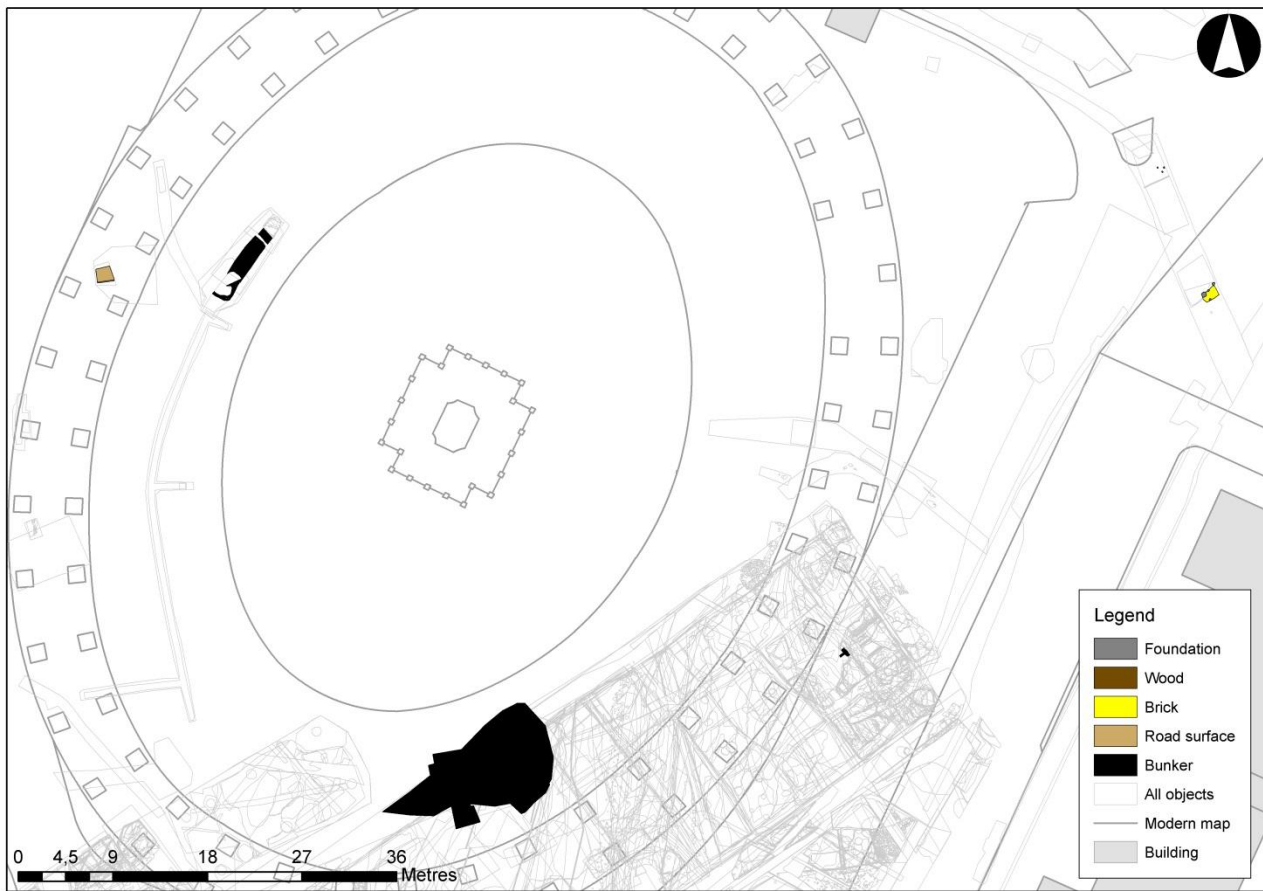
Fig. 345. World War II shelters exposed in Krinsen at Kongens Nytorv and part of a building west of current Nyhavn.

Group (G-964) in trench ZT189141 in Krinsen represents the sand bedding and cobbling of a road or external surface (Fig. 345). This surface was seen in a small watching brief trench and was isolated from other paved surfaces. Its full extent and interpretation is uncertain.

Two modern features at Kongens Nytorv should though be mentioned more closely; G-778 and G-837, consisting of refuge rooms or shelters from World War II, in trench ZT169731 and within the Station Box area (Fig. 345).

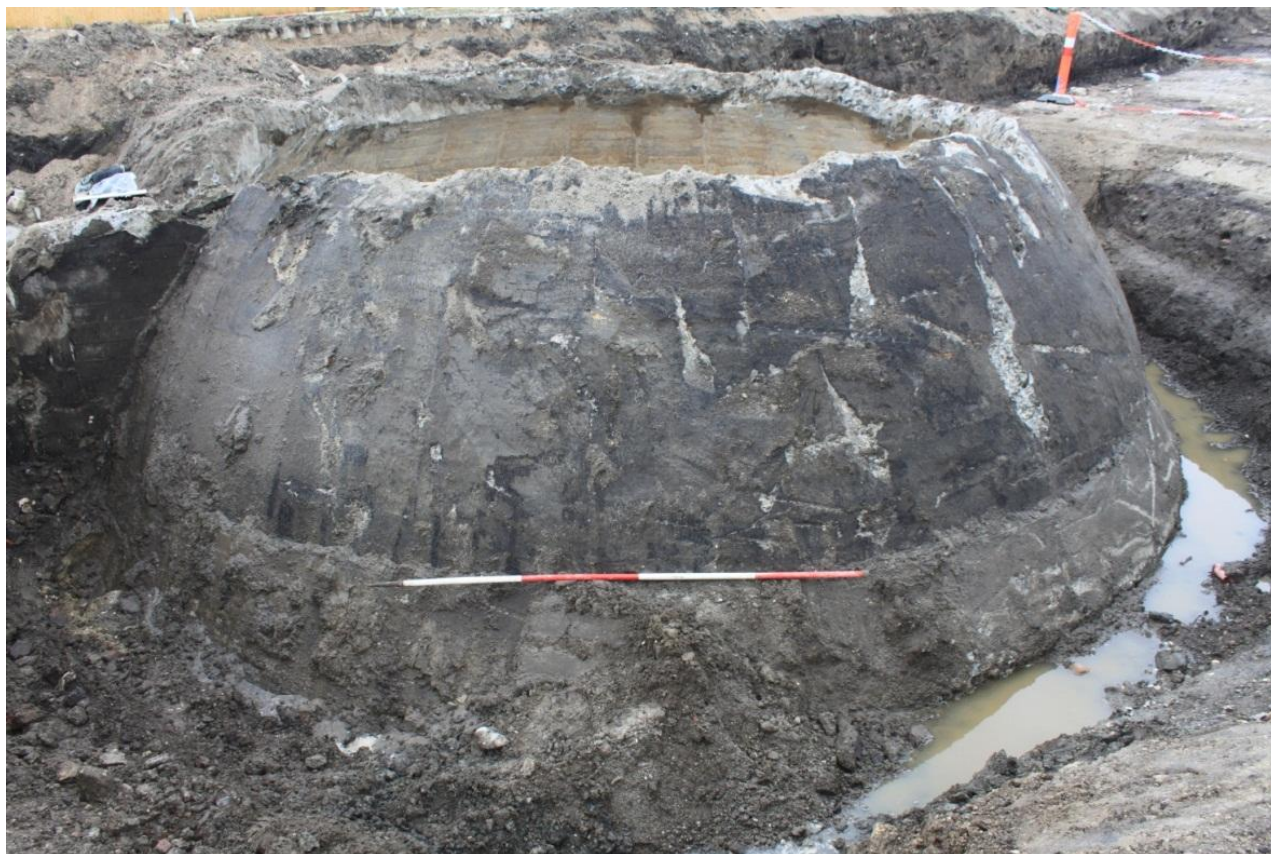
Fig. 346. Dome shaped shelter (SS168390), facing NW. Photo: Museum of Copenhagen.

The two domes were linked by a narrow corridor (1.2 m wide) with an entrance of a narrow (L-shaped) corridor. The top of the concrete domes were cut off to 2/3 rds of the original height being approximately 1.7 m high. The walls were approximately 22 cm thick. At the base the diameter of the domes was c. 6.5 m (Fig. 346).

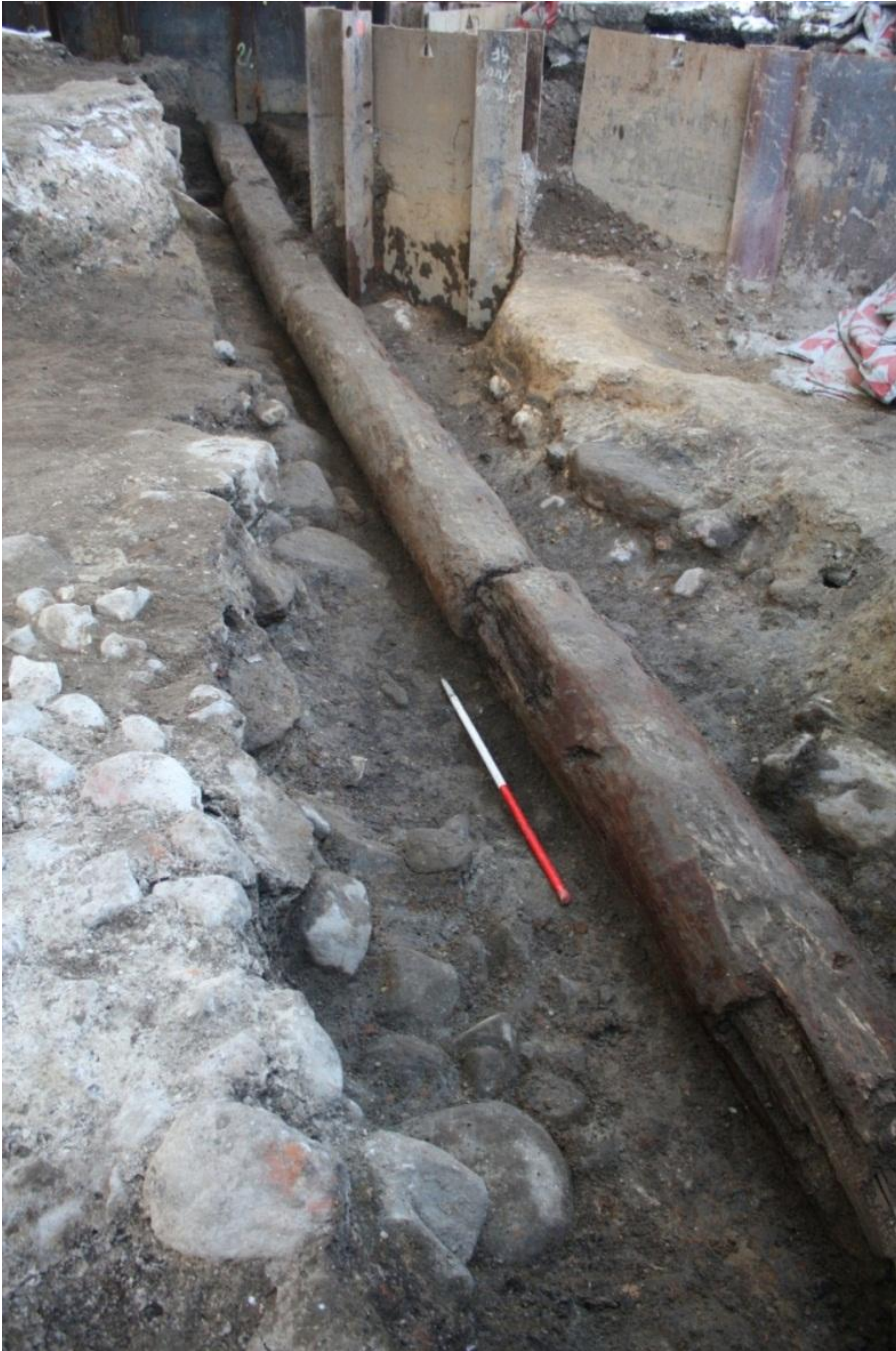
Fig. 349. One of the main pipelines at Kongens Nytorv. Wooden water pipe (ST30444; SG-336) with construction cut through the foundations of 17th century Østerport, facing SW. Photo: Museum of Copenhagen.

(customers who had paid for a water supply). The timber species used for the water pipes was pine and the wooden trunks were connected by lead and by iron bolts (Fig. 349).
