21 Phase 8 Kongens Nytorv 1650–1950 AD

21.1 Results

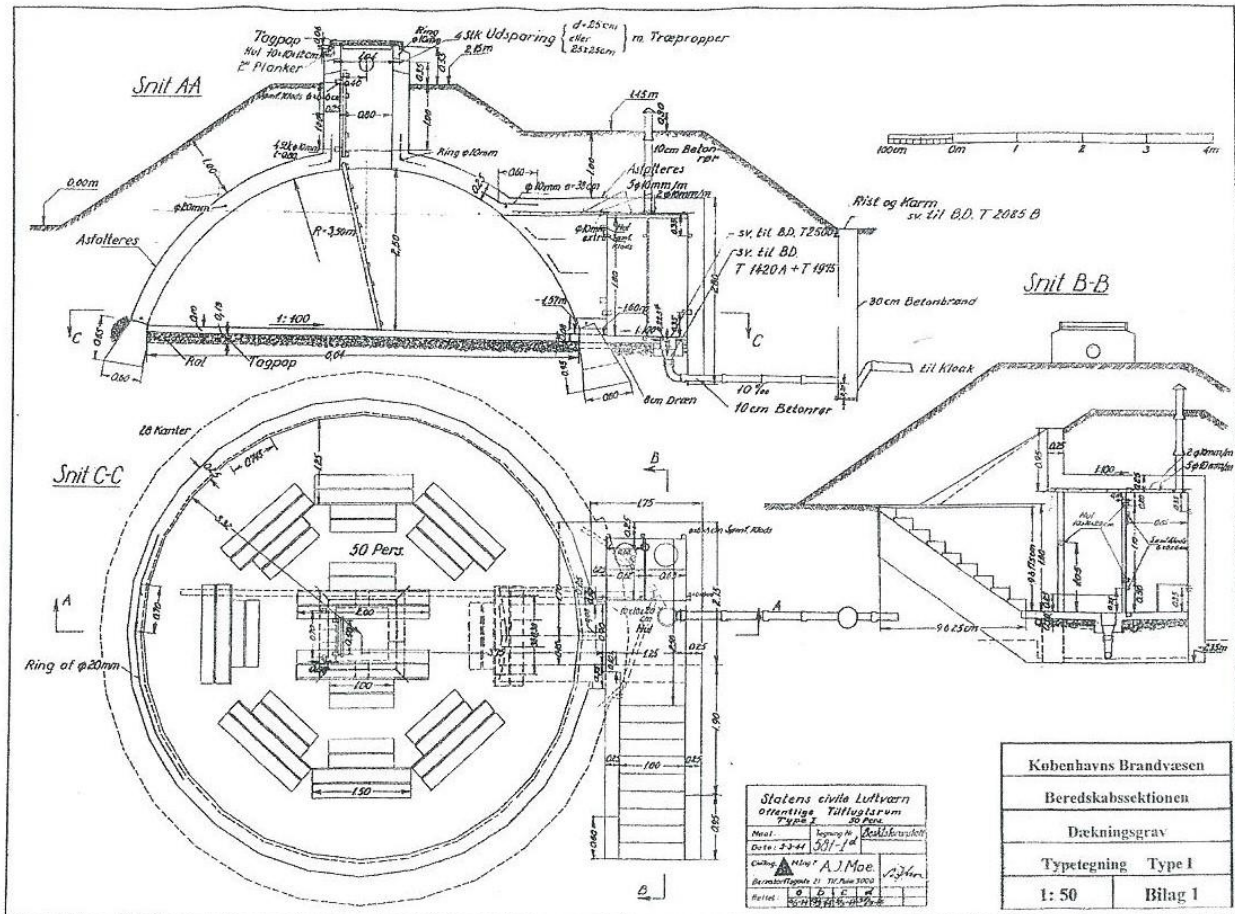
Fig. 350. Construction drawing of concrete shelter, type I. From Museum of Copenhagen.

The public shelters in concrete were built by Statens Civile Luftværn around Copenhagen during the 2nd World War (Fig. 350).

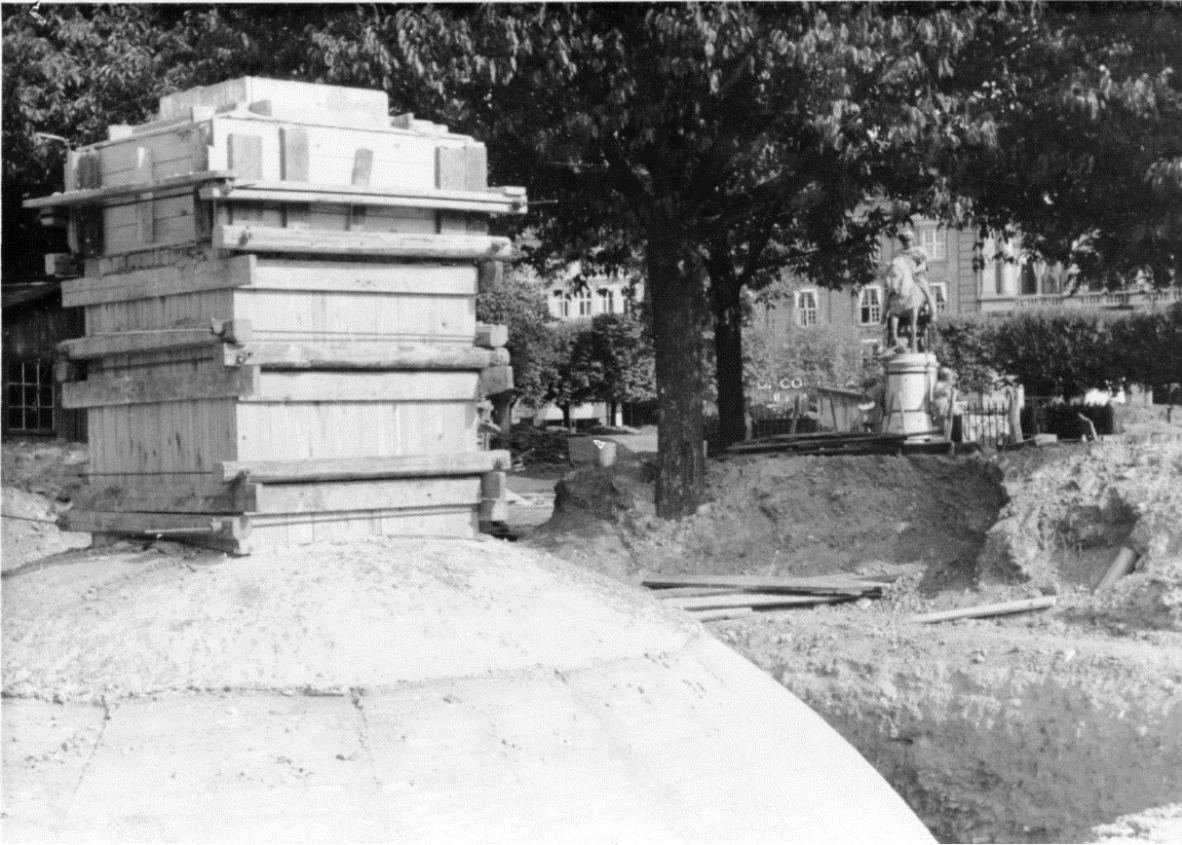
Fig. 351. Dome shelters under construction at Kongens Nytorv in 1944. From Museum of Copenhagen.
