## 12 Phase 3 Early medieval activities 1050–1200 AD

### 12.1 Results

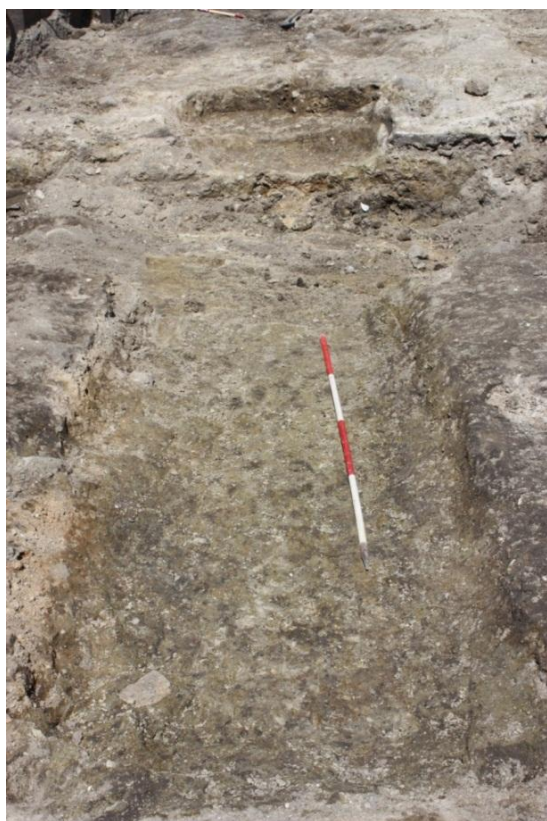
Fig. 39. Clay lined pit (SC157563) with modern truncation (removed concrete box) in the middle, facing NW. Photo: Museum of Copenhagen.

SG-332 represents a rectangular NW-SE orientated clay lined pit (c. 7.0 x 1.6 x 0.4 m) with straight, steep sides and a flat base (Fig. 39).

Lundström 2008a:13 and 15), though traces of repair and reuse in pit (SG-332) were seen in section C150834/section drawing 211598 (Fig. 39).

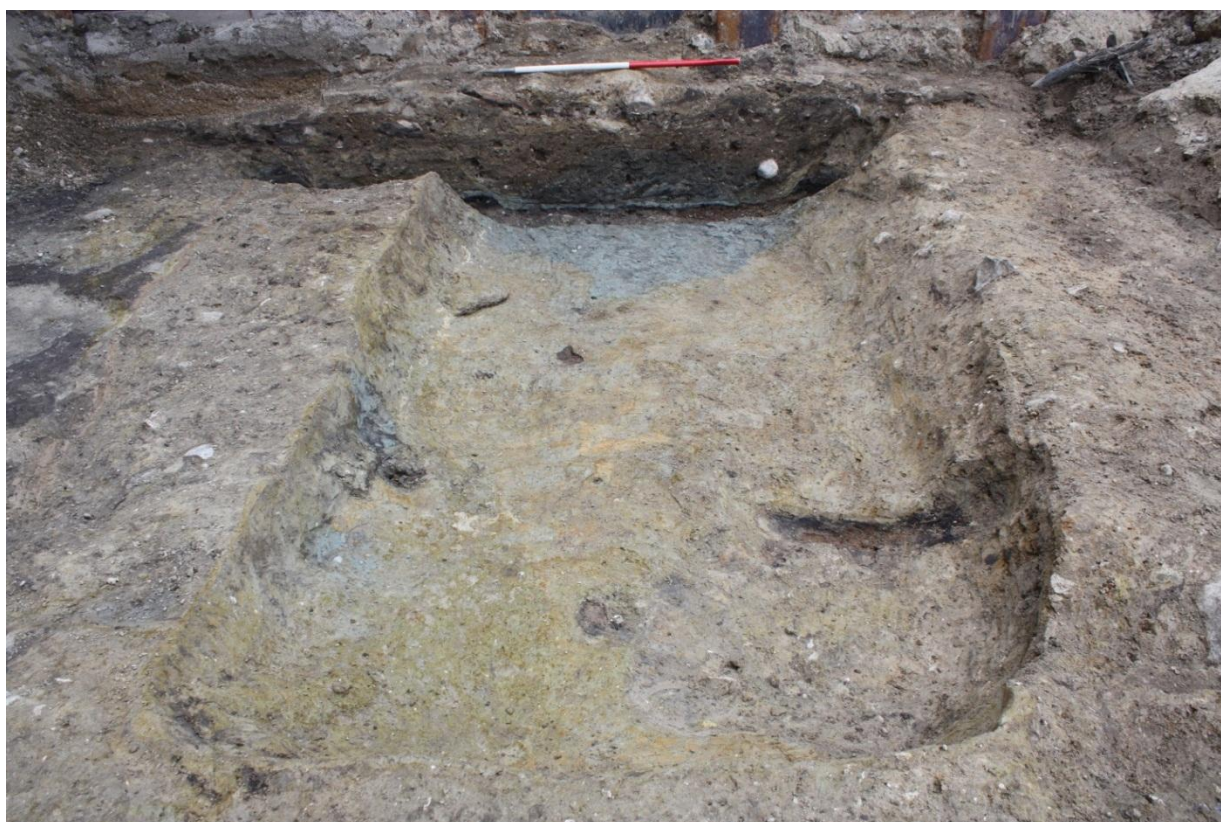
Fig. 40. Clay lined pit (SG-366), facing north. Photo: Museum of Copenhagen.

SG-366 was a north-south orientated and rectangular clay lined pit (c. 3.4 x 2.0 m), 0.3 m deep with straight, steep sides and a flat base (Fig. 40). The southern and western parts were not as deep as the northern and eastern parts. The western part of the cut and particularly the northern part were a bit diffuse, where the feature was truncated by the modern shoring. The cut was dug through a second clay lined pit and it cut one of the rampart phases, but this latter interpretation has later been re-evaluated based on AMS-datings and other stratigraphical observations (see SG-370 below). In the middle and to the north the cut truncated salt marsh layer (SD210931).

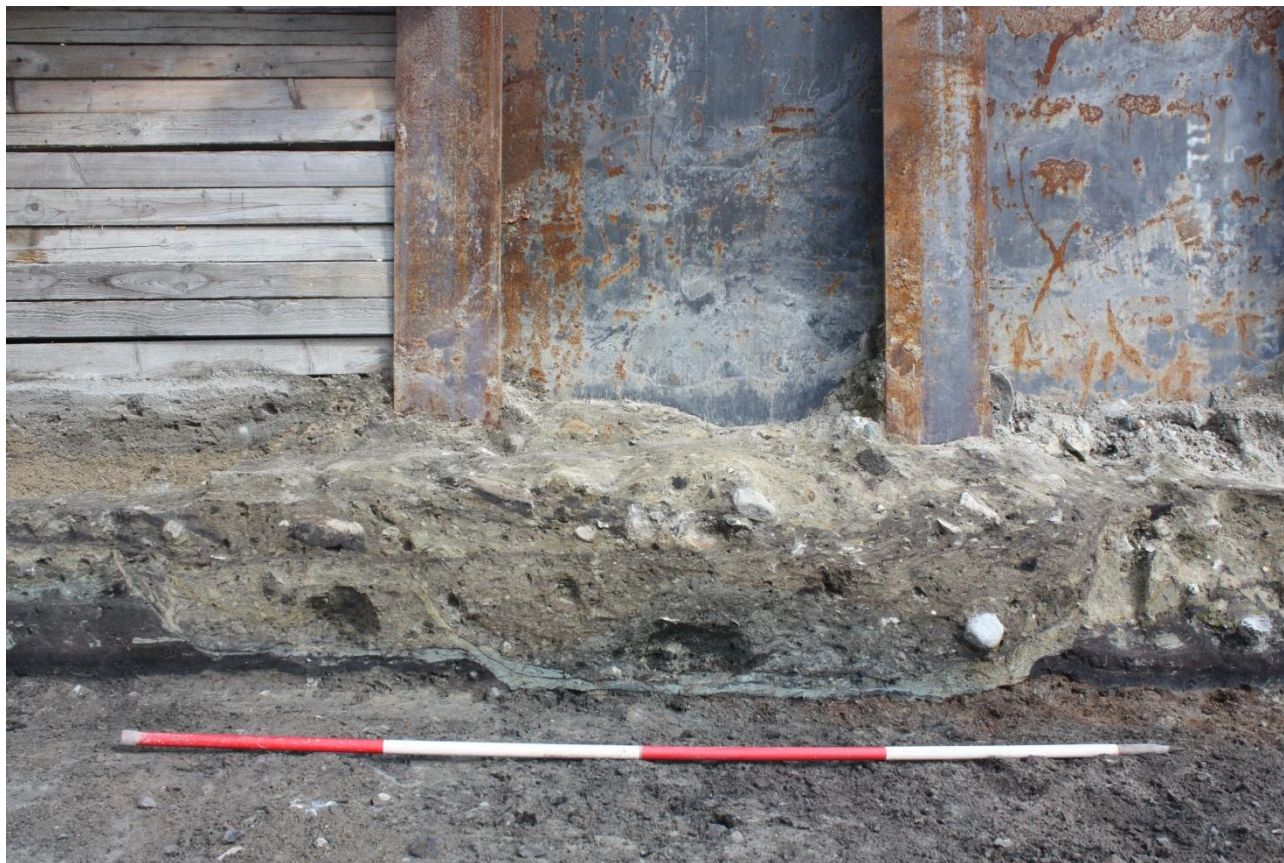
Fig. 41. Clay lining seen in section, facing south. Observe how the pit has cut through an older clay lined pit (SC92644, SG-370) to the west. Photo: Museum of Copenhagen.

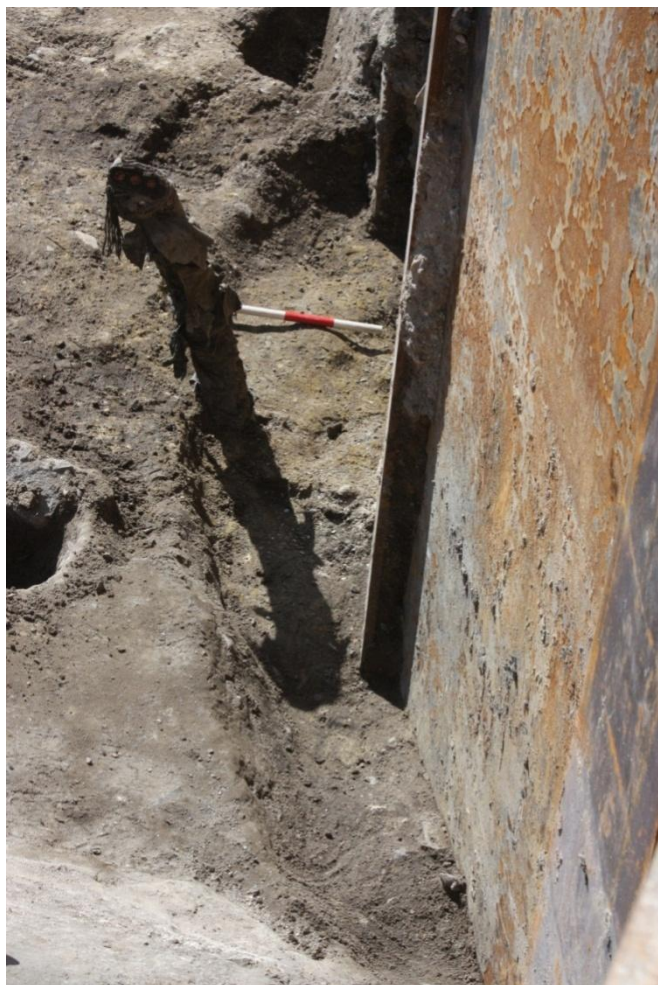
Fig. 42. Clay lined pit (SG-657), facing south. Photo: Museum of Copenhagen.

Group (SG-657) represents a clay lined pit backfilled with dumped material. There seemed to be no usage deposition within the pit. Most of the north-south orientated pit had been heavily truncated by the modern piling, but the original shape was rectangular; c. 2.3 m long, 0.3 m deep with moderate, concave sides and an irregular base (Fig. 42).

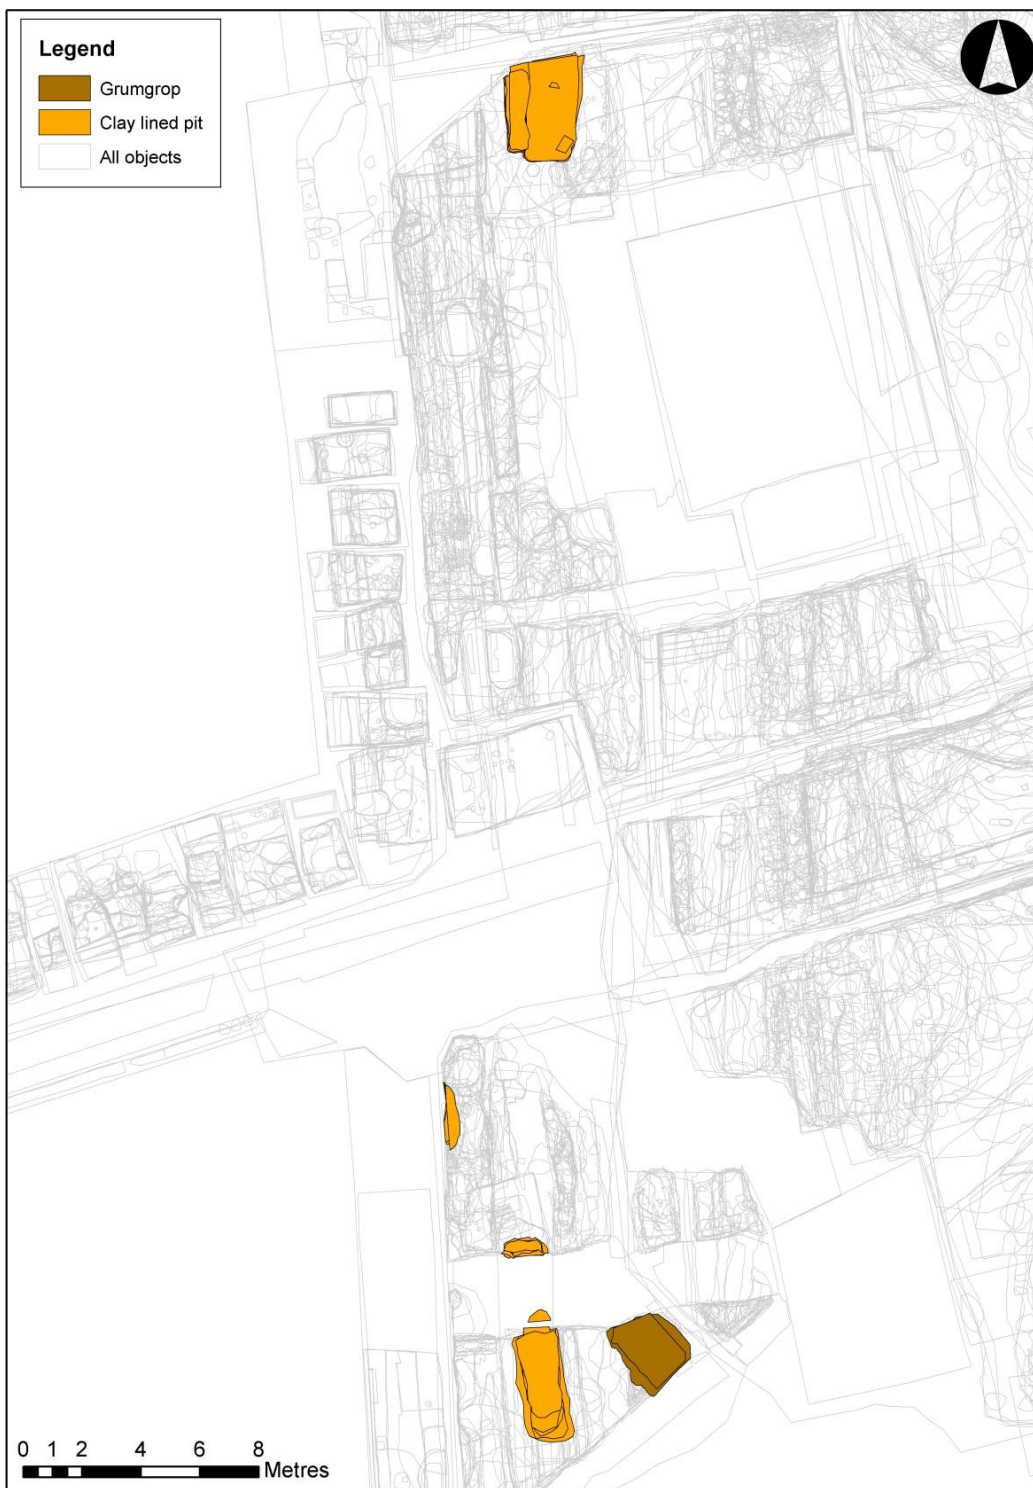
Fig. 43. Clay lined pits and interpreted so-called “Grumbod”.

None of the clay lined pits were complete due to later truncations or limits of the excavation, though recorded length vary from 2.3-7.0 m and width from 1.6-2.7 m (Fig. 43).

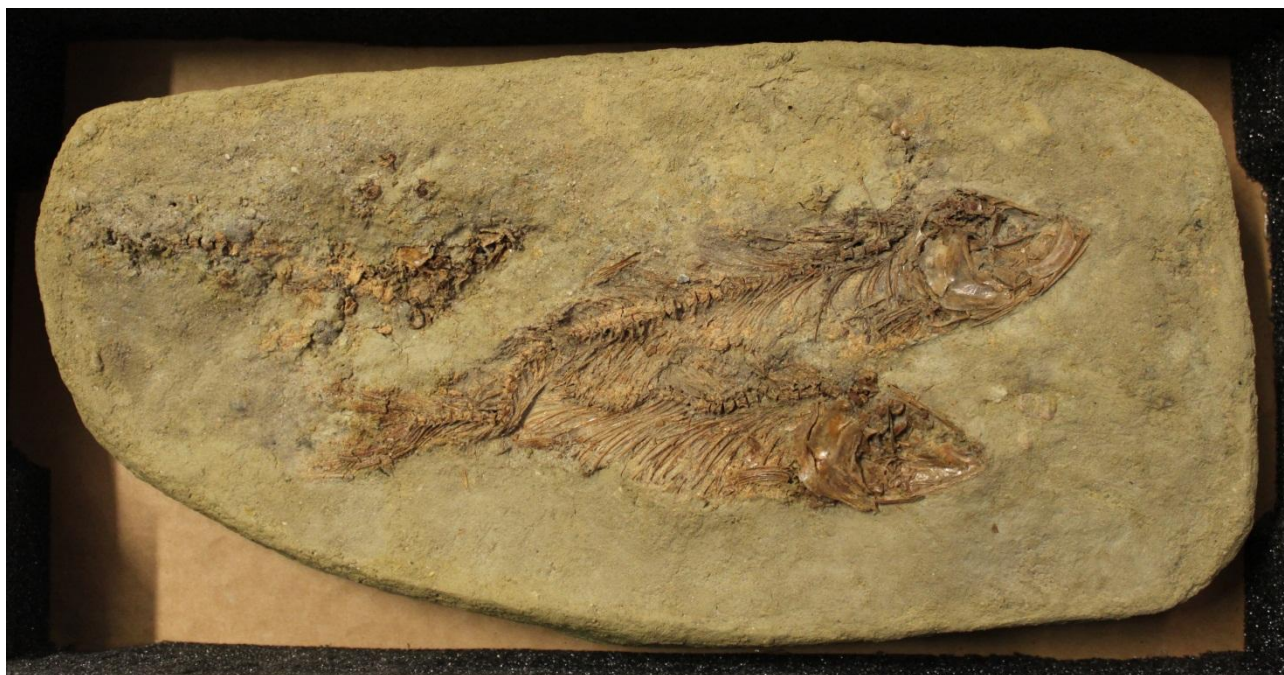
Fig. 44. Preserved herrings from clay lined pit, SG-366. Photo: Museum of Copenhagen.

In clay lined pit SG-366 in general all parts of the herring skeleton seem to be represented (Bødker Enghoff and Magnussen 2015) (Fig. 44). Since there are elements from the *hyoid arch* and *pectoral girdle*, it is possible to conclude that the herrings had not been gilled (cf. Bødker Enghoff 1996; 1999). However, some of the nine accumulations of fish bones studied separately include no *vertebrae*, and it cannot be excluded that some of the herring accumulations represent only heads of herrings. This interpretation is supported by the finds of two *præoperculae* showing cutmarks which might indicate cutting off the heads. Another explanation of the missing *vertebrae* might be that the small *vertebrae* lying behind the head bones were overlooked during the excavation and only parts of the accumulations were sampled. Many scales have also been found pressed firmly together in cakelike aggregations. Herring scales very easily detach, and the many scales might just indicate that herrings have been lying in the pit.

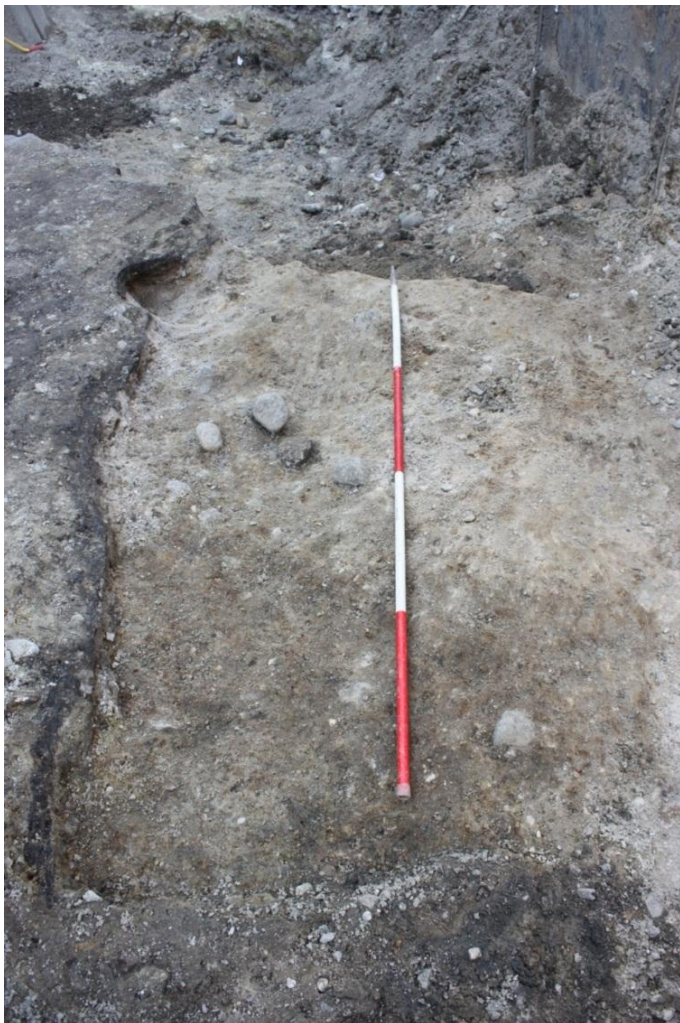
Fig. 45. Construction cut (SC157249) of the “*Grumbod*”, facing north. Photo: Museum of Copenhagen.

The irregular shallow pit (G-656; approximately 4.0 m<sup>2</sup> and 0.26 m deep) was recorded below the High medieval rampart and had been truncated on three sides by the modern piling. The sides were sharp/steep with an almost 90 degree angle between side and base. The base was flat (Fig. 36 and 45).

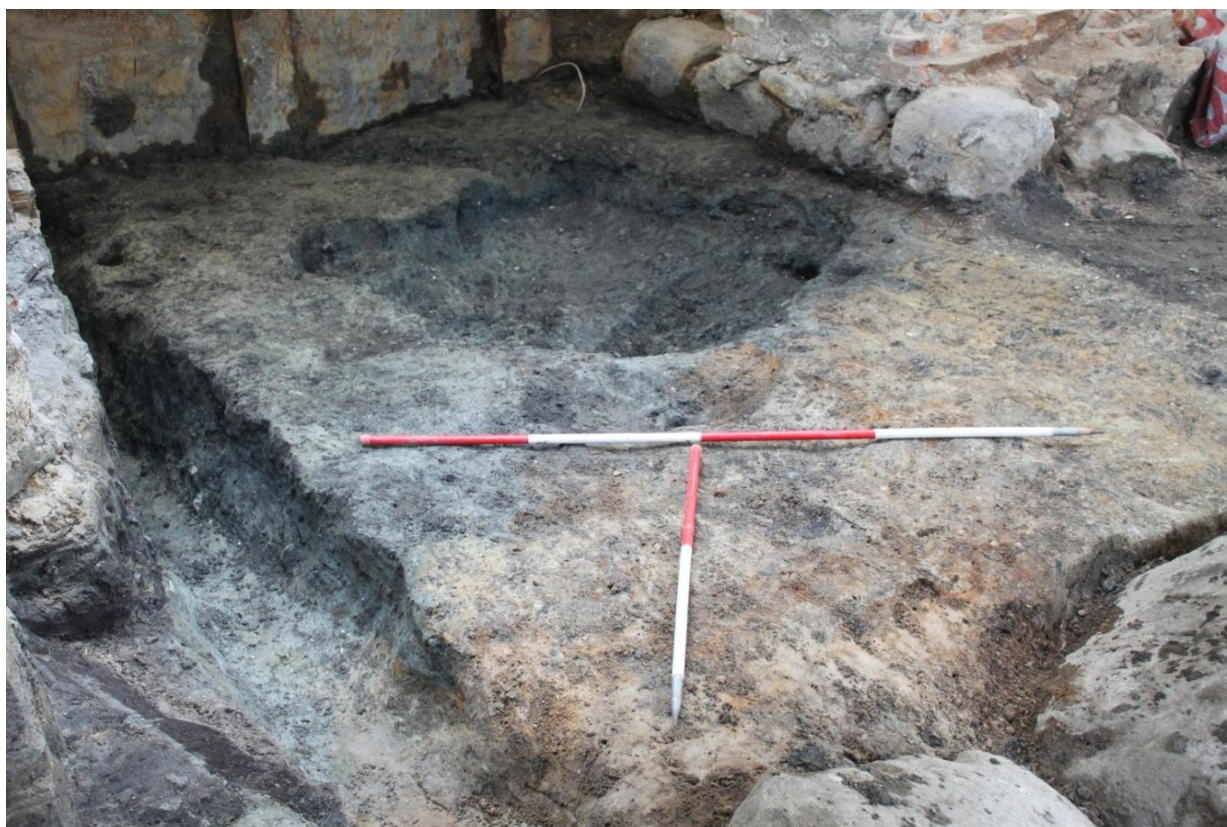
Fig. 46. Post-excitation of pit (SC131365) south of High medieval annex (SG-248), facing NW. Photo: Museum of Copenhagen.

Among the larger pits G-451 should be mentioned. The feature consisted of a cesspit and an SW-NE running ditch (Fig. 36 and 46). The two parts (ditch and pit) were interpreted as being part of the same feature.

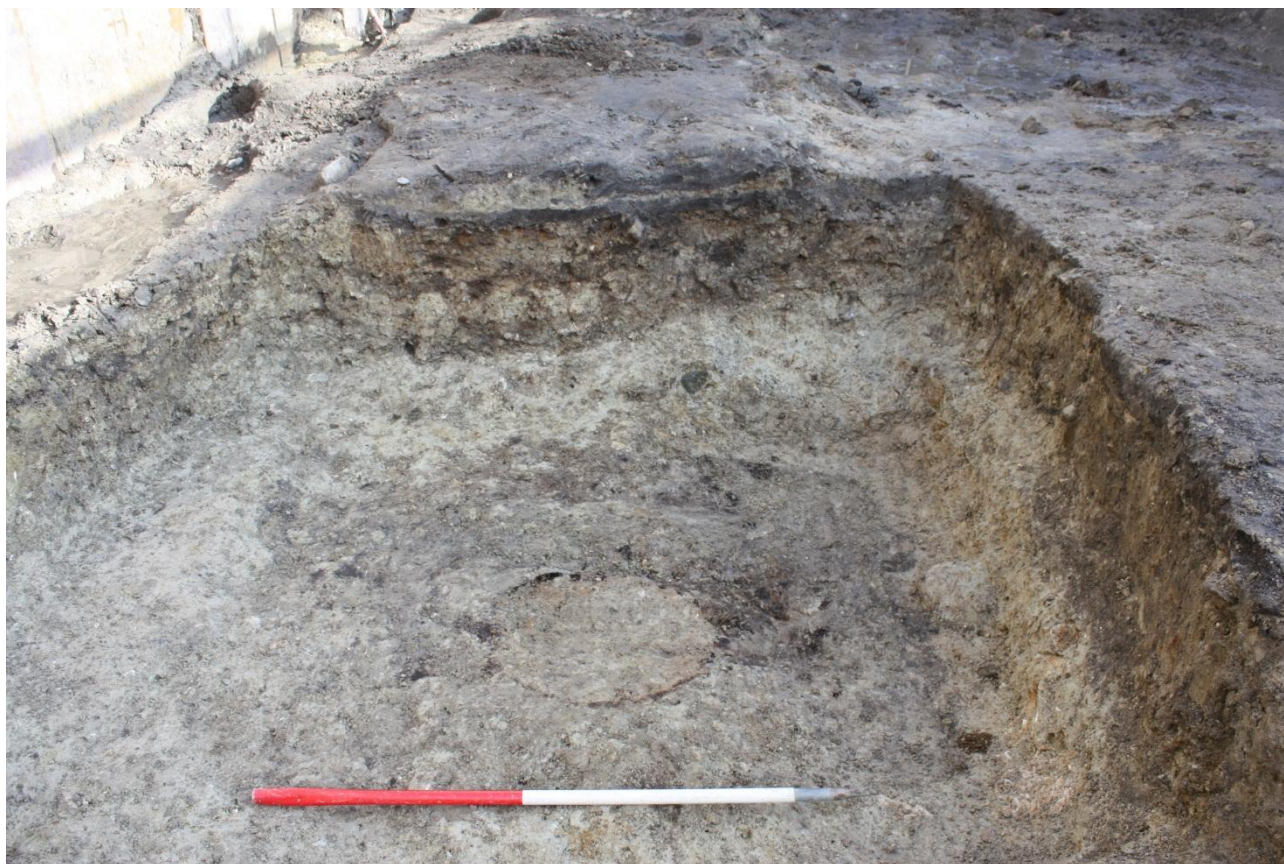
Fig. 47. Pit house. Upper and base of construction cut with top of barrel, facing north. Photo: Museum of Copenhagen.

Group G-330 represents a square pit with a stepped cut, vertical sides and flat base together with a barrel casing in the bottom of the cut (Fig. 47). The barrel (ST158499) was resting on horizontal planks (ST159464), which in turn were resting on the basal deposit of the well cut.

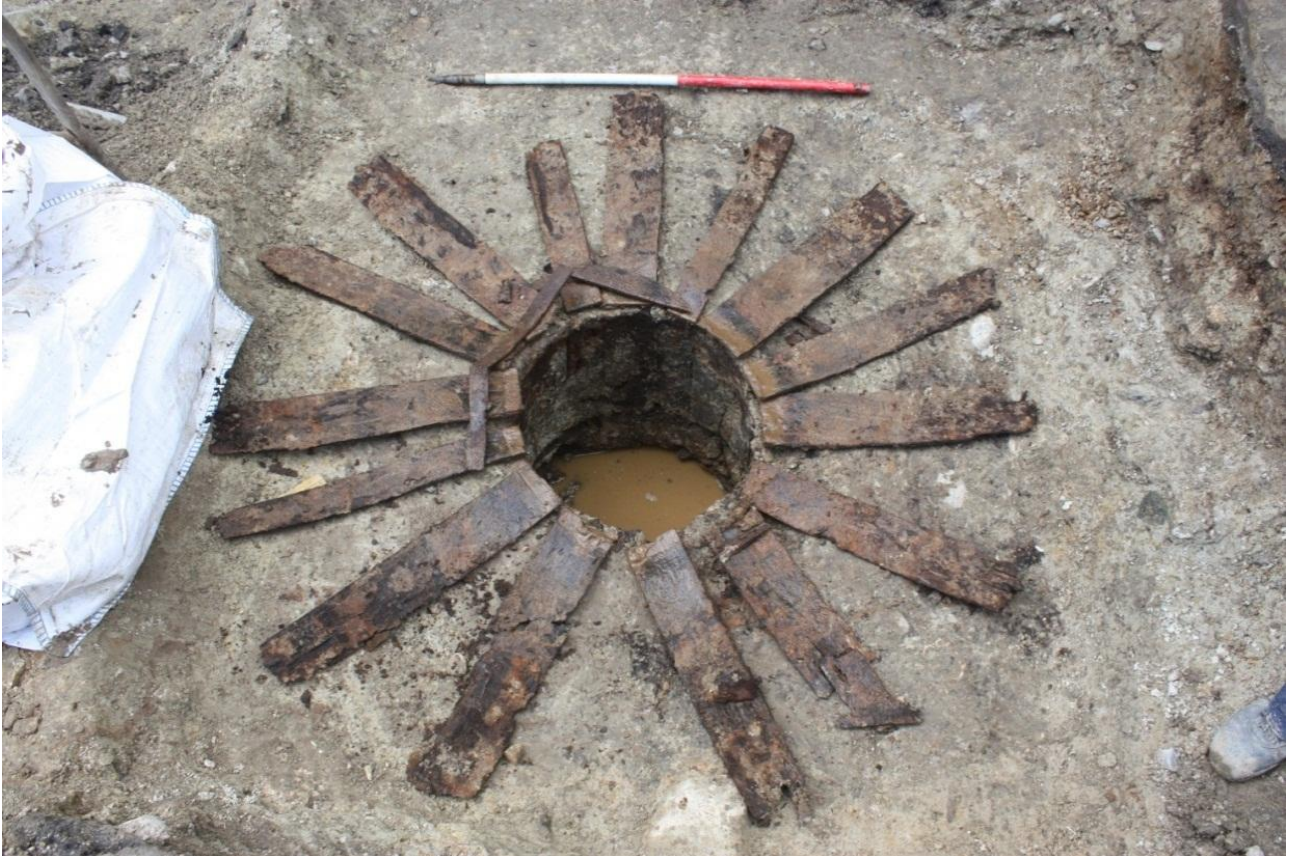
Fig. 48. Recording and removing barrel (ST158499), facing west. And of course – always avoid disturbing things such as white big bags and colleague's feet in the picture! Photo: Museum of Copenhagen.

The barrel consisted of 15 staves with the remains of wooden hoops. The planks were from 0.08-0.13 m wide and 0.60-0.70 m long. All the staves in the barrel had survived, but the bottom was missing (Fig. 48).

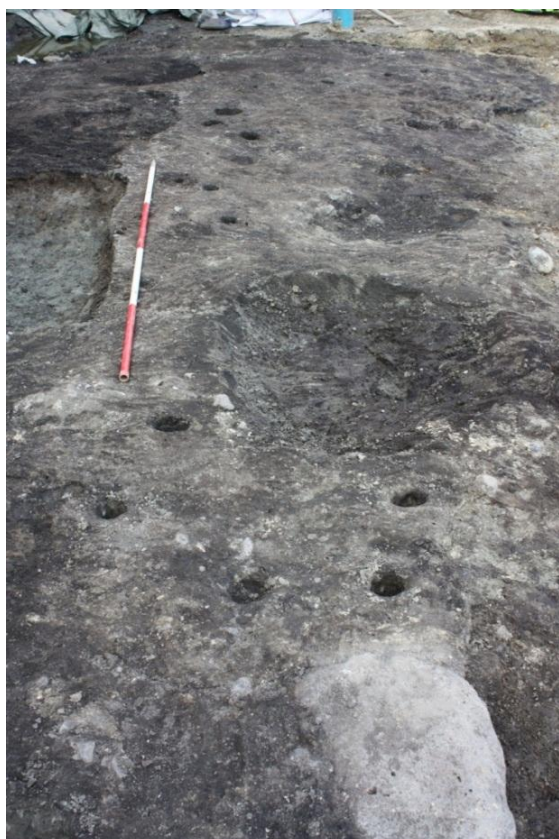
Fig. 50. Post-excavation. Concentration of stakeholes (SG-508), facing north. Photo: Museum of Copenhagen.

The postholes did not form any clear structure and further interpretations are difficult, but these probably represent part of a roof bearing construction of temporary character in connection to N-S running fence line(s) SG-508 (Fig. 36, 37 and 50).

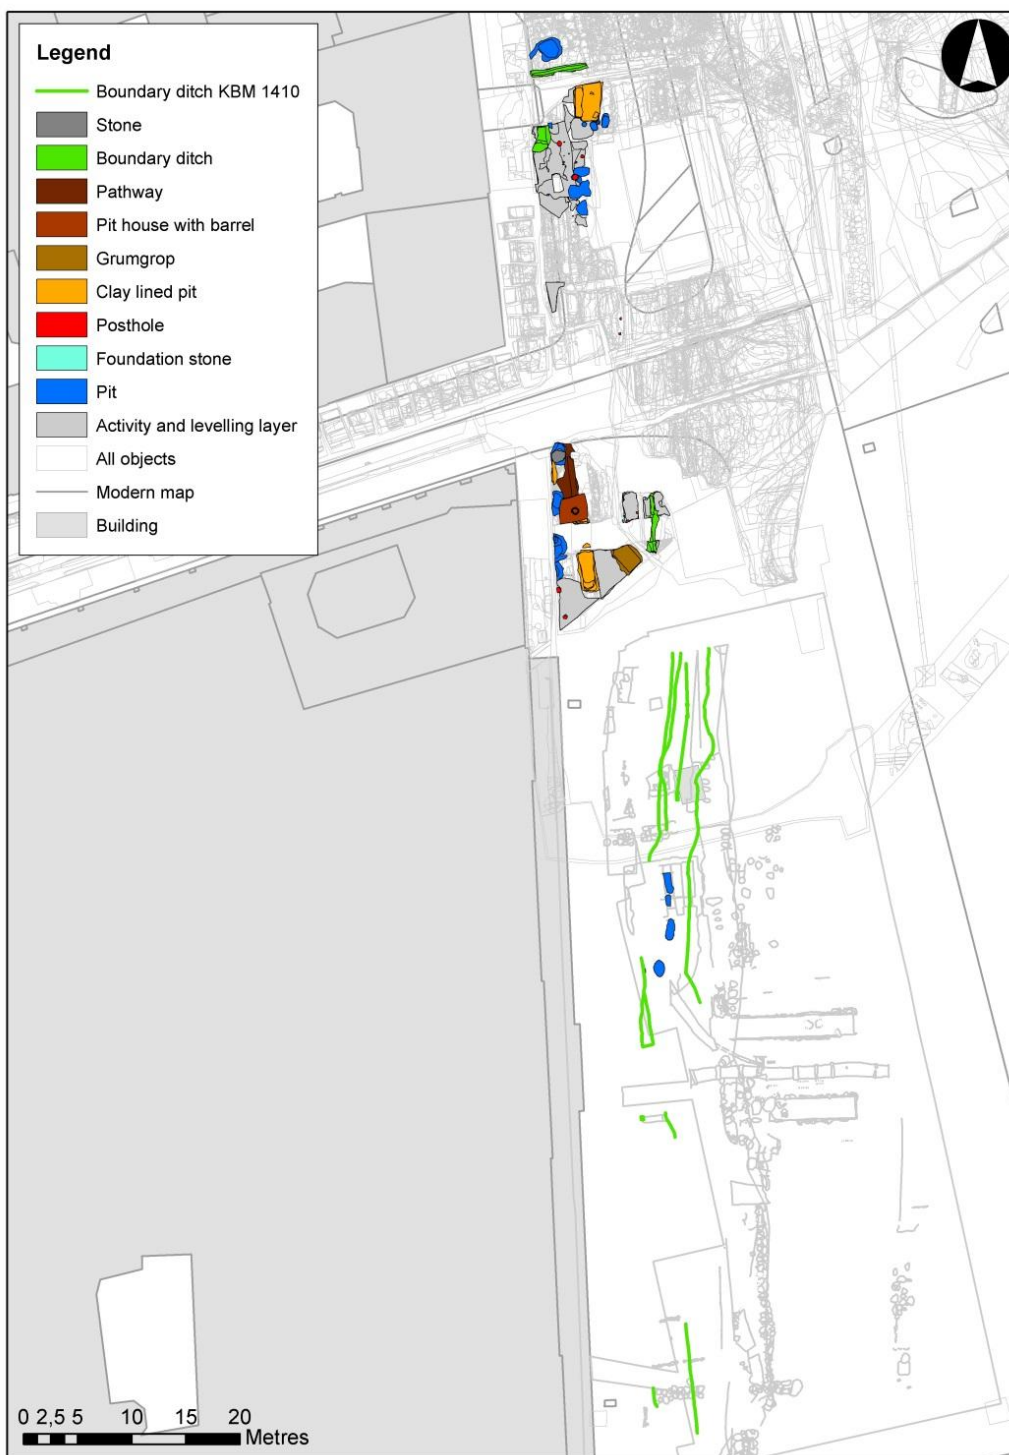
Fig. 51. Boundary ditches and pits at Kongens Nytorv; Metro excavations 1996–1998 and Metro Cityring 2010–2015.

The ditches and fence line can be interpreted as allotment fences for dividing the land behind the former rampart and a spatial continuation of the Metro investigations in 1996–1998 which revealed several north-south orientated boundary ditches in the northern and western parts of the excavation area and about 10 m east of Magasin's department store facade (see Fig. 51 and Kristiansen 1998:41 et seq.; 1999a). The oldest activities were three ditches that replaced each other and after disuse the latest ditch was followed by a wicker fence and a feature interpreted as some form of boundary bank. In the middle and southern part of the excavation area only one single ditch was documented (Kristiansen 1998:41-62; 1999a:101-108). The investigation at Kongens Nytorv shows that at least one of the boundary ditches recorded at the Metro investigations in 1996–1998 continues to the north. No evidence, due to modern truncations, could be put forward to determine if this consisted of several phases or was a single, broad boundary ditch (Fig. 51).

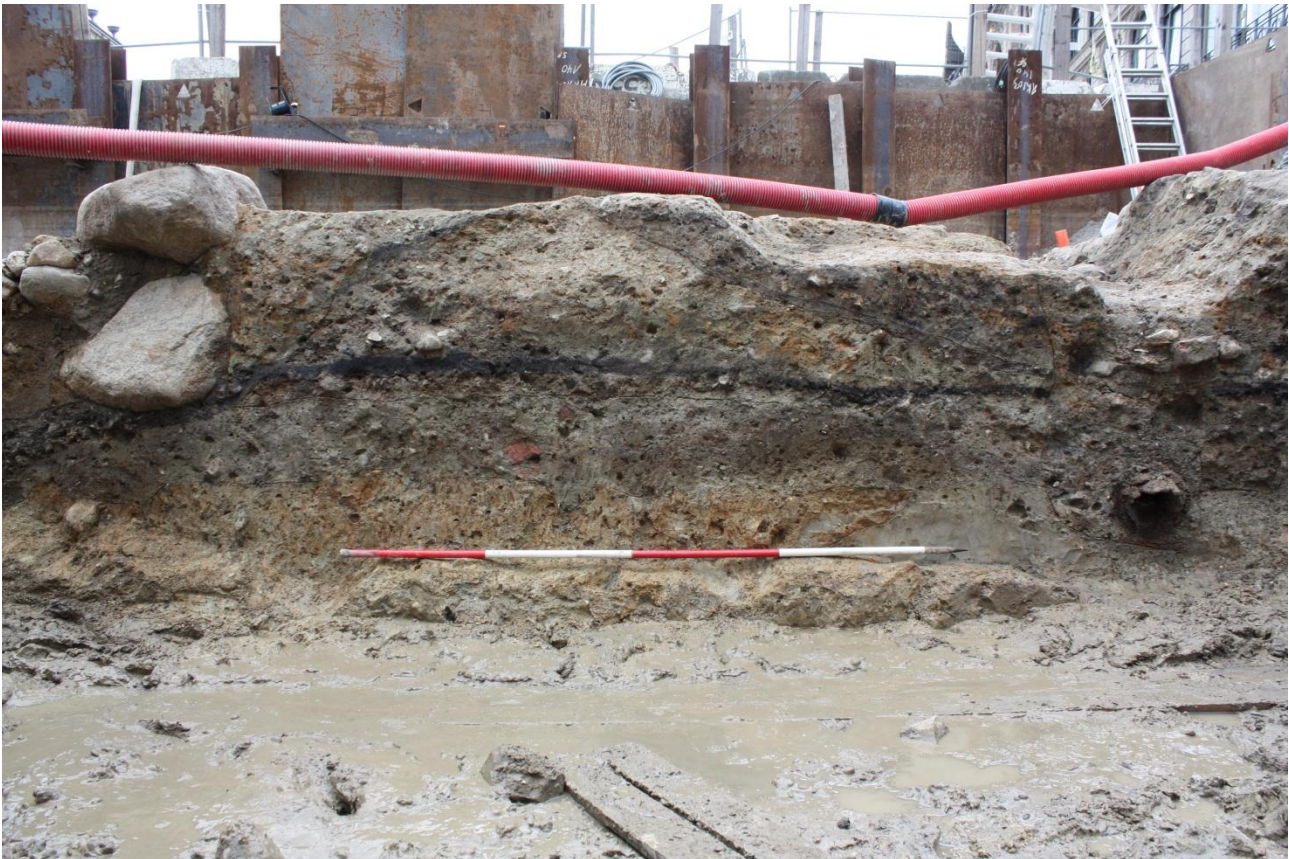
Fig. 55. Section through the High medieval rampart showing a possible core rampart (SD210411) as a lighter deposit above the dark salt marsh layer, facing south. To the left is construction cut for the city wall with boulders and to the right the possible Late medieval additions to the existing rampart appears as several dark grey-brown deposits separated by a thin and darker layer (SD210410). Photo: Museum of Copenhagen.

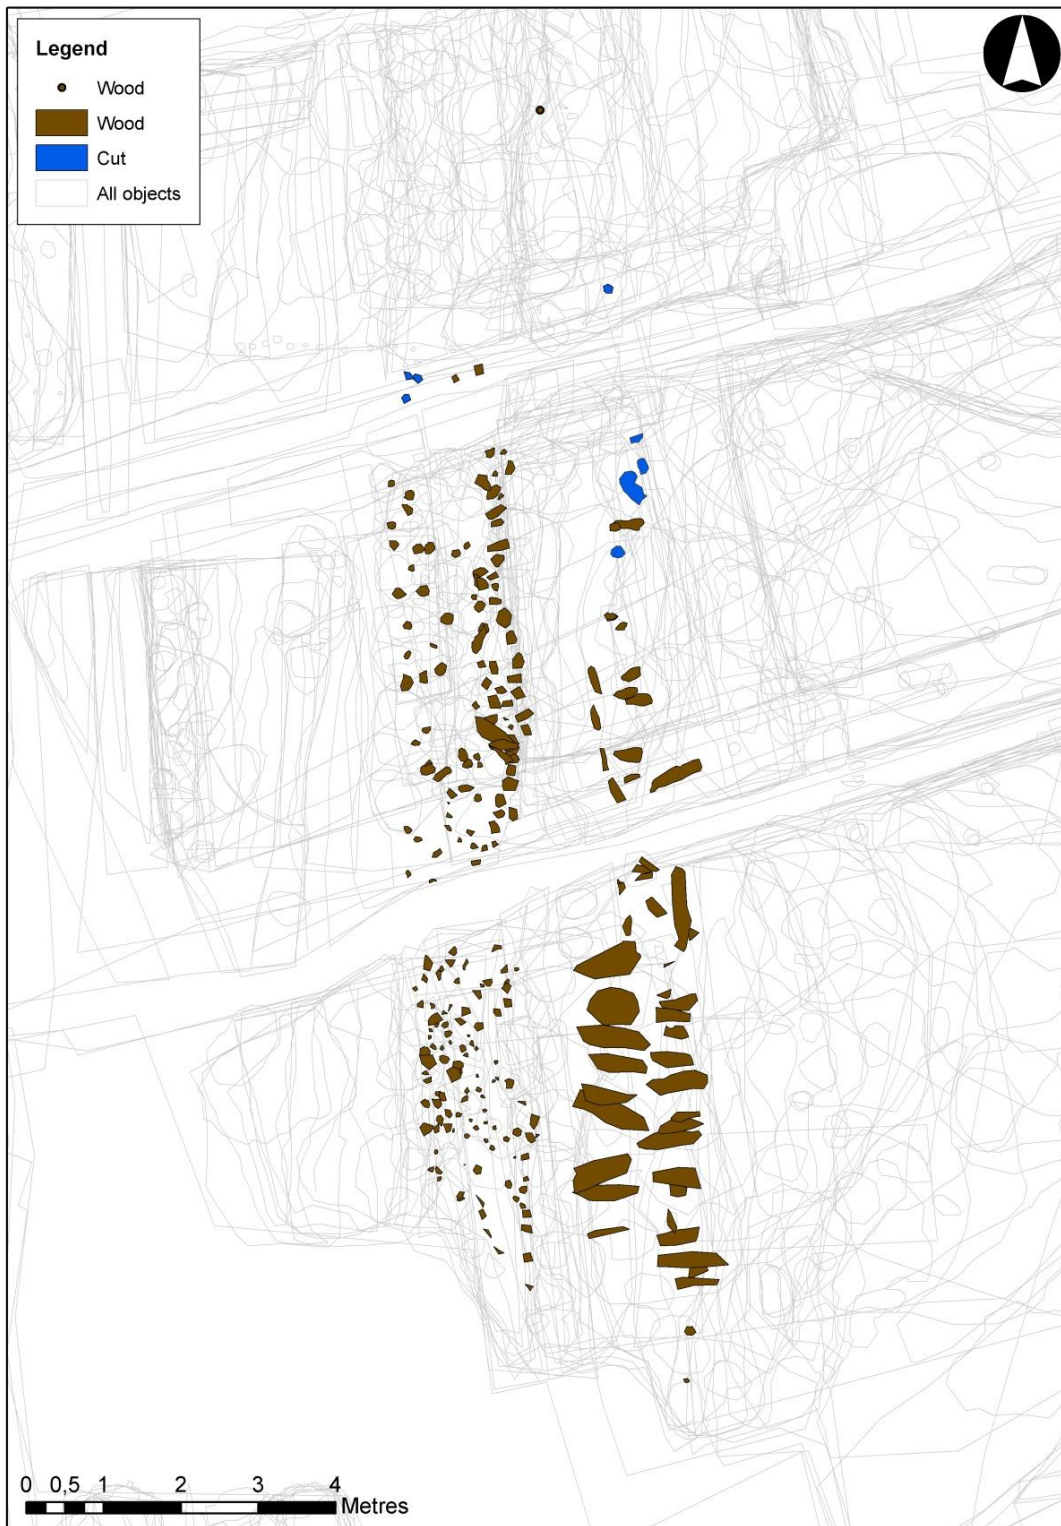
Fig. 56. Bulwark recorded in connection with the 13<sup>th</sup> century rampart.

The bulwark was documented in connection with the rampart and former moat and consisted of the remains of about 200 pieces of planks/wood were about half of them where preserved well enough to be collected. A total of 50-60 pieces have been kept to complete analysis before discarding. In addition, the National Museum has fully conserved about 60 pieces of the structure.

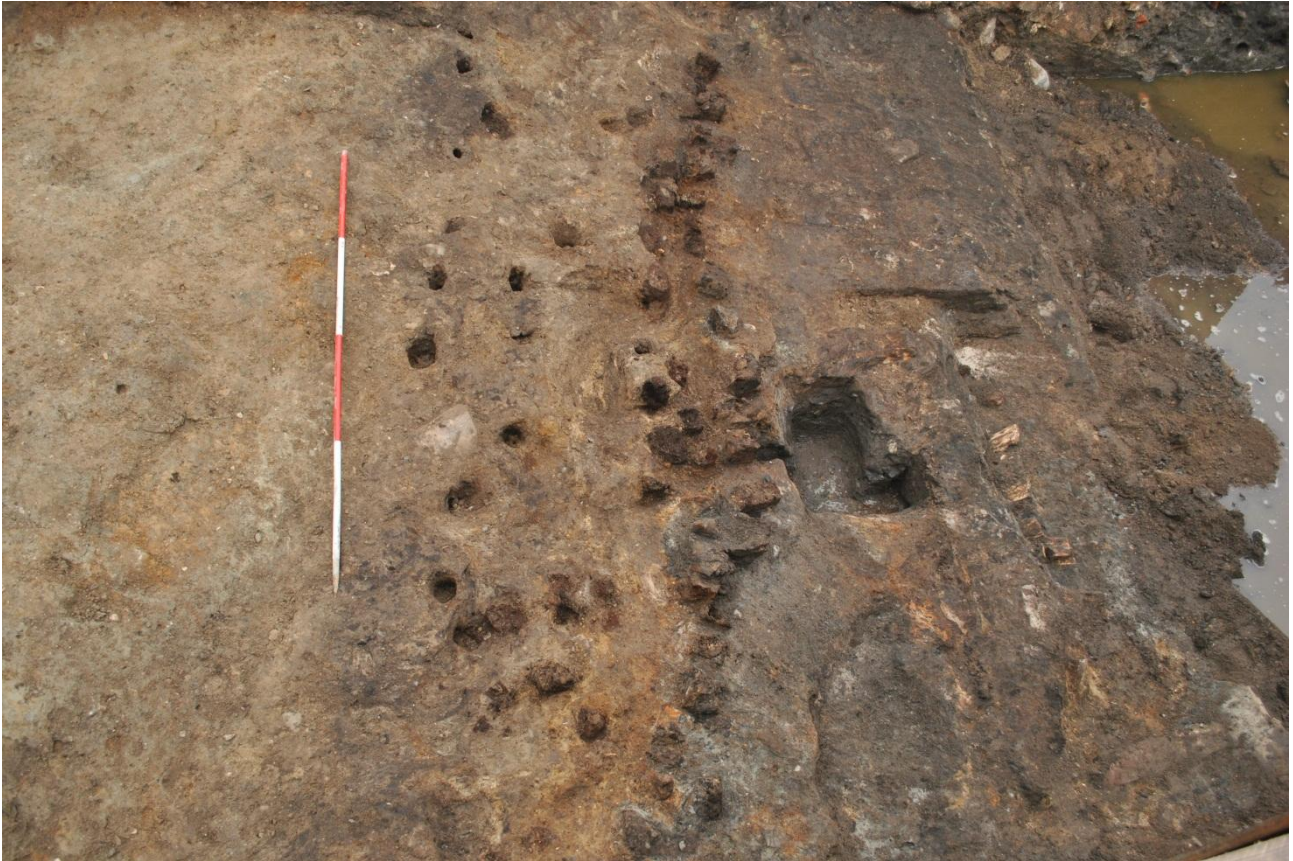
Fig. 57. Part of timber structure exposed after removing rampart layer (SD70838), facing north. Photo: Museum of Copenhagen.

Most of the posts had been sharpened to a point with an axe and driven into the ground where the tip length varied from 0.06 to 0.43 m. Some of the timbers were decayed and heavily decomposed; others pushed and bent by the pressure from the backfills of the concurrent or later rampart.

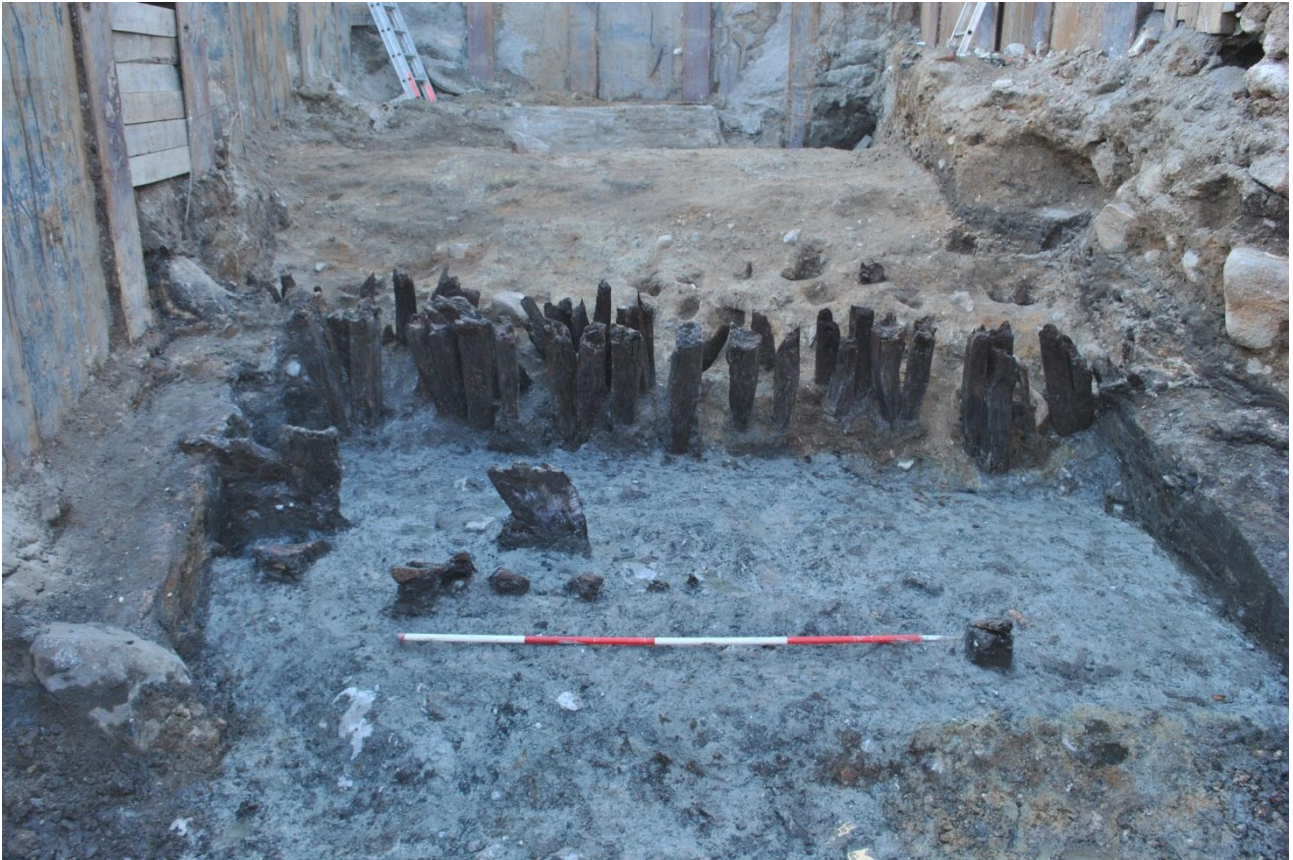
Fig. 58. Exposed bulwark with vertical and tilting timbers, rampart layer (SD70838) and moat cut (SC71871), facing west. Photo: Museum of Copenhagen.

As the timbers stretched along the construction cut to the west their condition deteriorated and the westernmost posts had become soft brown stains on the sloping moat cut. In subarea phase 5B-2 the posts were located more into the base of the moat cut and nearly all timbers survived as solid pieces, although preservation was still best on the eastern edge of the structure (Fig. 58).

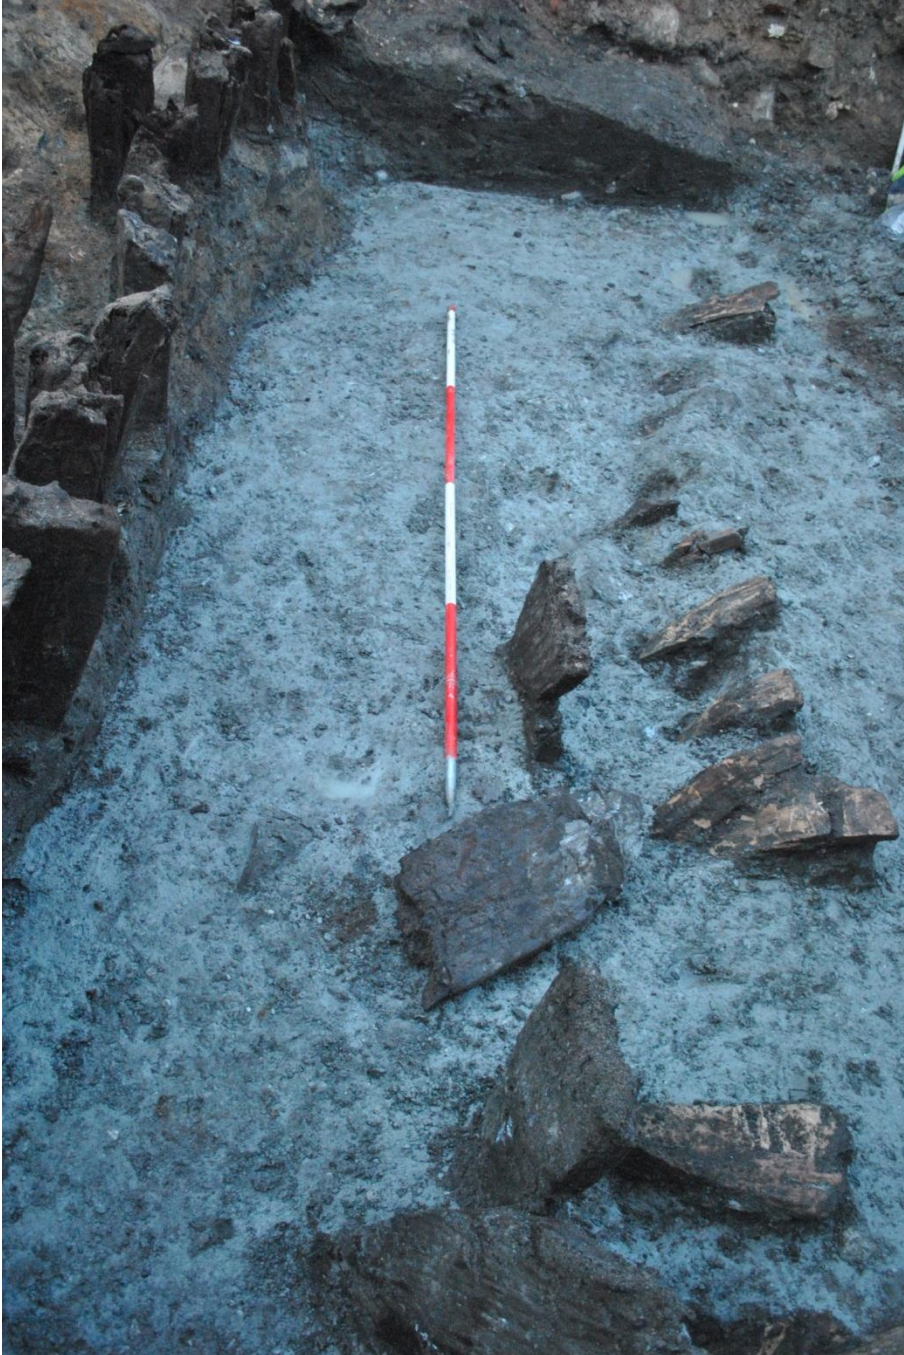
Fig. 59. Bulwark with tilting planks, facing north with section C71275 in the background. Photo: Museum of Copenhagen.

The timbers were tilting in different directions due to pressure from the backfills of the rampart from above (Fig. 59). Since the outermost posts were tilting to the east it was suggested that the planks could represent some kind of storm piles, however, this interpretation must be reconsidered since the wood mainly consisted of wider planks, probably pushed down either by subsequent maintenance work or by the pressure of the rampart lying behind the structure.

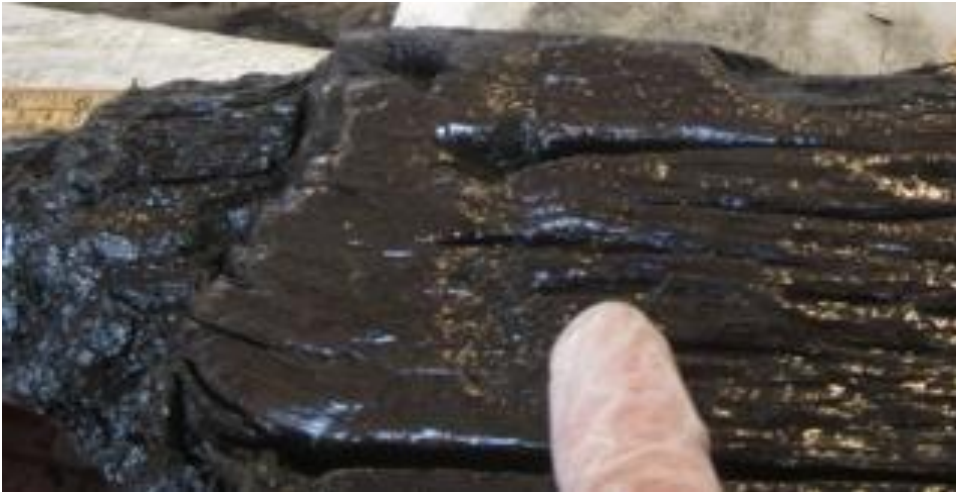
Fig. 63. The finger points at a tool mark on timber (ST70676) that might have been done with an iron dog. From Melin 2013:11.

It was observed that several of the posts were reused from an older structure and the investigated timbers had different types of auger, axe, chisel, compass, knife, positioning, saw, square and wedge marks made from symmetrical broad- and felling axes, conical and spoon chisels, an awl, a grooving iron, a chalk line and iron dogs (Fig. 63-65). If the tool marks on the timber actually are left by the latter this might be the oldest documented evidence of iron dogs so far in Scandinavia (cf. Melin 2013:11).

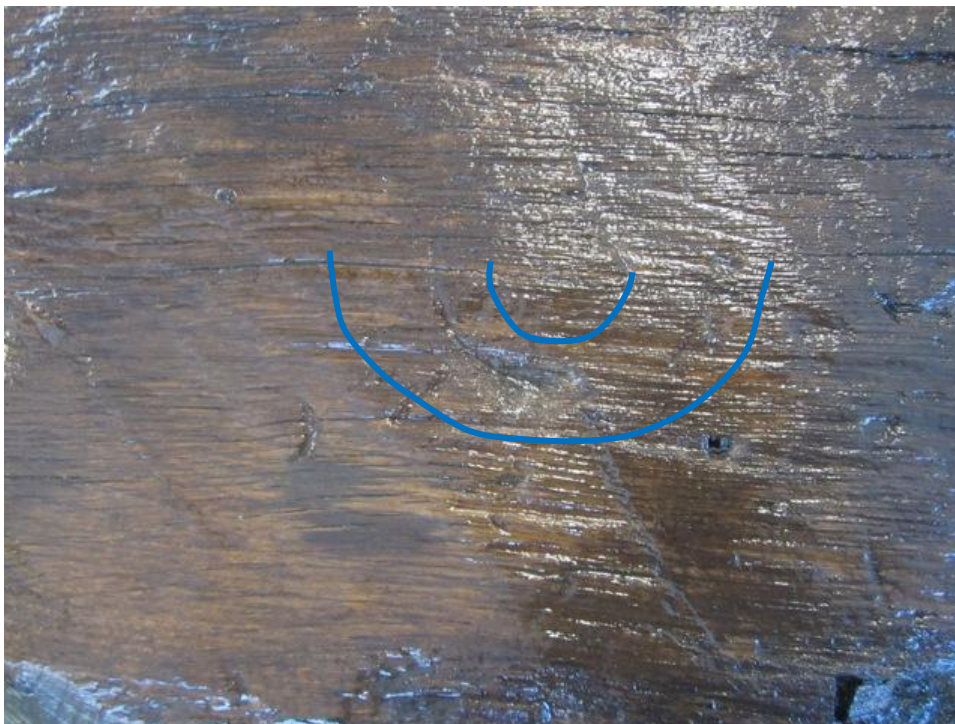
Fig. 65. Plank (ST70434) from SG-714 belonging to group B. The compass mark is visible in the middle of the blue lines. From Melin 2013:20.

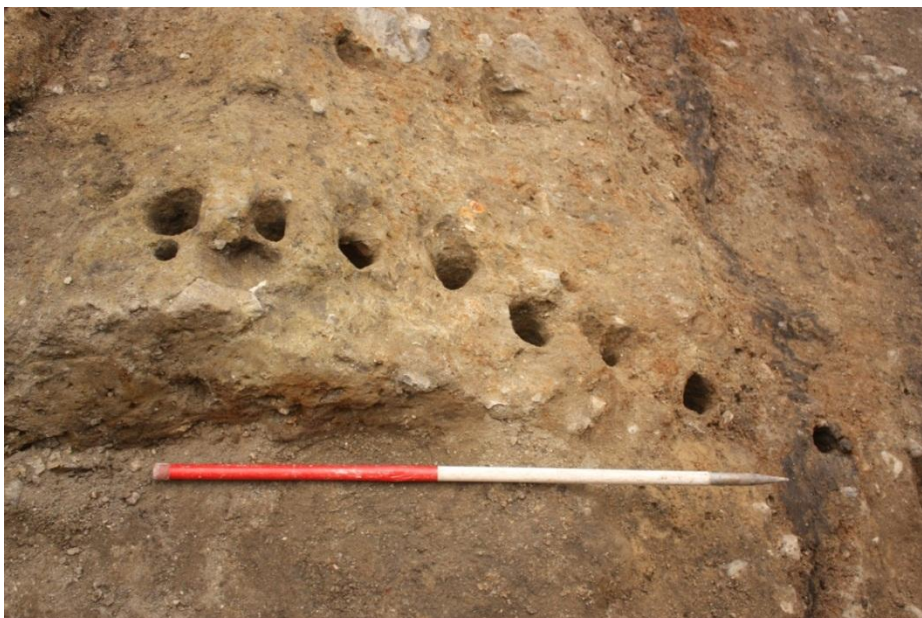
Fig. 67. Row of 9 stakeholes (SC84042-SC84100) belonging to SG-317 aligned up the slope of the rampart, facing north. The easternmost stakehole (SC84092) had truncated the underlying natural salt marshes seen as a darker stripe to the right in the picture. Photo: Museum of Copenhagen.

It seemed that the stakes were driven in given the shape of the base and sides, and that no packing was present. The stakeholes consisted of circular and rectangular cuts with a diameter of between 0.05 m and 0.10 m (Fig. 67). The depth varied from 0.06-0.32 m, and there was no distinct difference between the eastern and western parts. The stakeholes had tapered points with a sloping base. There could have been branches between the stakes, although no traces of such wattle was documented on site.

The feature is interpreted to represent some sort of fence on top of the rampart and in connection with the rampart street to the west.
