## 12 Phase 3 Early medieval activities 1050–1200 AD

### 12.1 Results

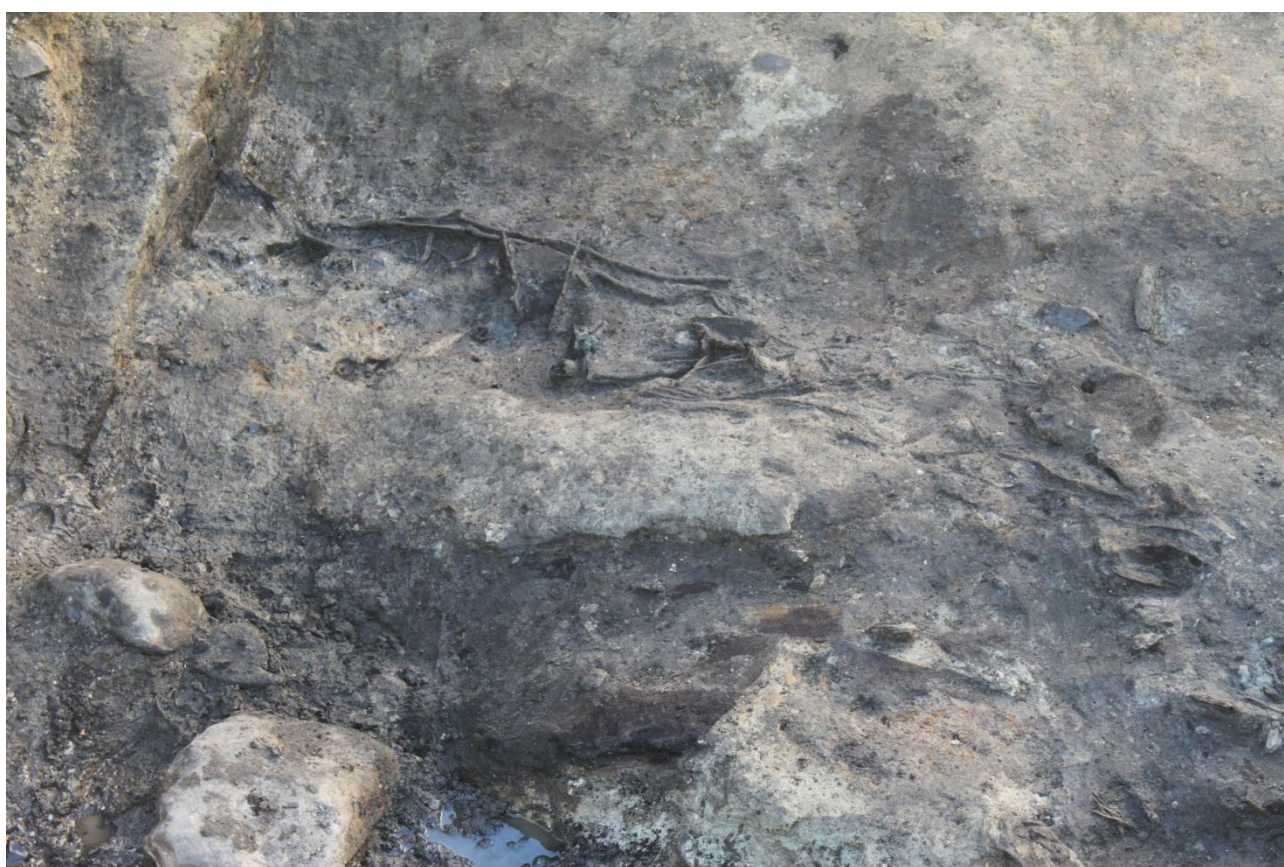
Fig. 68. Remains of wattle fence, facing west. Photo: Museum of Copenhagen.

Remains of an upright wattle fence consisting of a line of stakes and a wooden structure composed of intertwining twigs and small branches was recorded in the transition between the rampart and the moat (Fig. 68). The stakes had a length at maximum of 0.5 m. Some points were broken off, but there was still evidence of tapering – probably made with an axe. The small branches still had bark and some of the smaller twigs had thorns. The fence had probably been pushed flat from west to east when it went out of use (Fig. 68).

The structure is interpreted as a defensive feature next to the moat designed to reinforce the High medieval rampart as a continuation of the bulwark to the south. With one exception (oak) – all stakes comprised alder (*Alnus sp.*), a species often used as building material in wet environments.

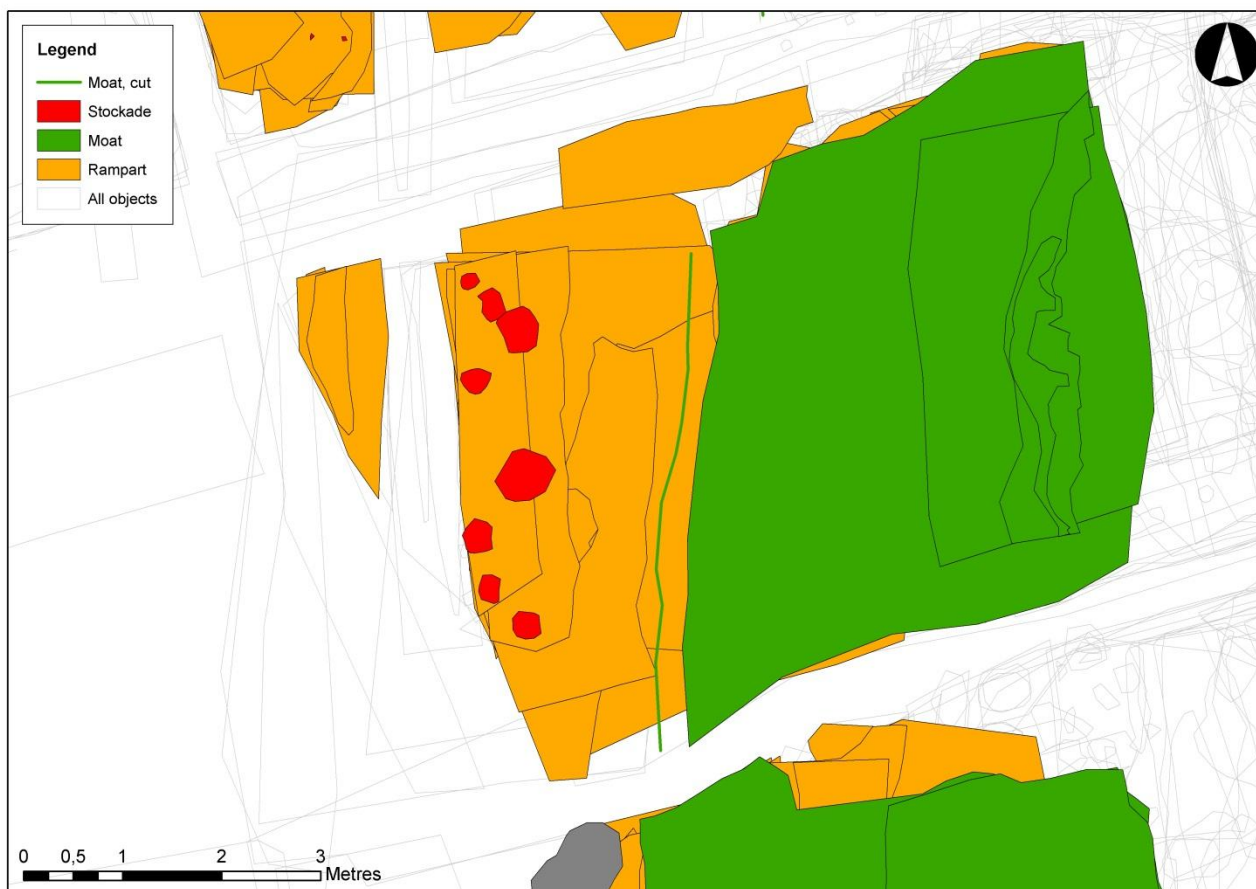
Fig. 69. Feature on top of the rampart consisting of two rows of postholes either representing a stockade or a palisade.

The structure consisted of five small and two large postholes running in a north-south direction at a distance of 3.2 m west of the city wall (G-750) (Fig. 69). The size of the postholes (d = 0.2-0.6 m and depth 0.05-0.50 m) together with the straight/vertical sides suggest that these truncations represent a larger and more complex structure. The feature was recorded between two rampart phases (SG-716) and (SG-838), where the latter could represent a Late medieval addition to the rampart.

There are two possible interpretations: either the stockade represented two separate phases of a palisade on top of the rampart crown, possibly representing part of the so-called “*Byens Planker*” mentioned several times in the written

sources in connection with the medieval fortification (see Fig. 78 and Chapter 13.2.3 for further discussion), or the concentration of postholes represented part of scaffolding (in connection with the city wall?).

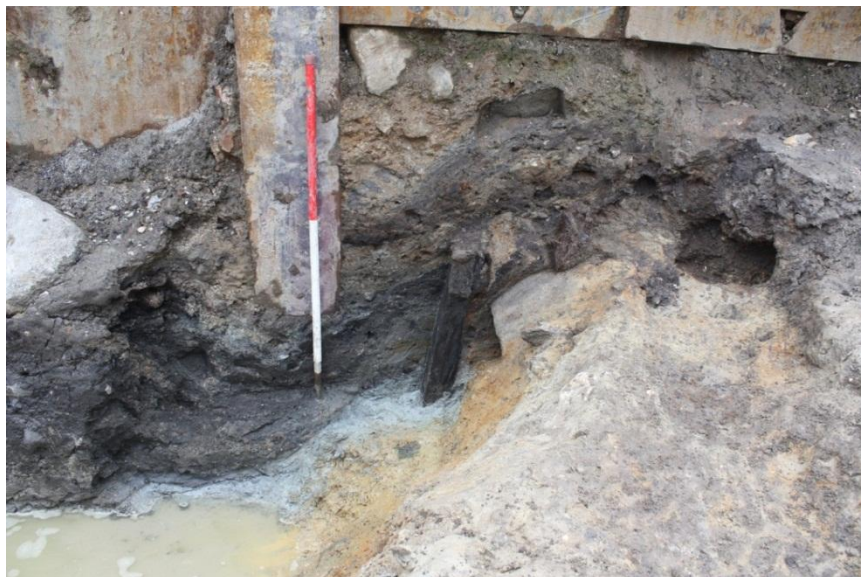
Fig. 70. Interpreted construction cut (SC93401) of the oldest 13<sup>th</sup> century moat seen in section, facing south. The bulwark (SG-540) was probably rammed into the base of the cut after the moat was dug, whereupon moat deposits silted up around the timbers as indicated in the section. Photo: Museum of Copenhagen.

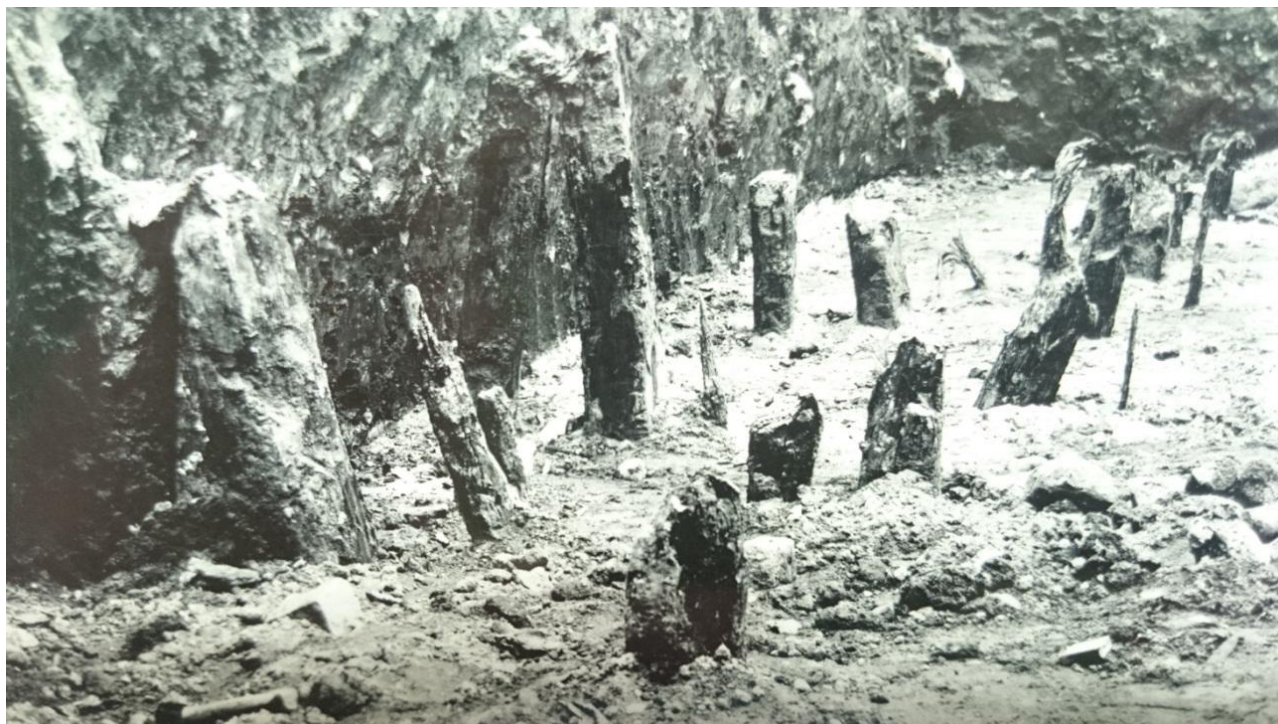
Fig. 76. Reinforcement of the embankment in the form of pile work in natural substrate along Norra Vallgatan in Malmö (Kv Skepparen). In the background – presumably remains of the rebuilt rampart alternatively former salt marshes (darker layers in the section; cf. Kling och Lindgren Hertz 1990: Fig. 10). From Malmö Museum, Rapport 33:03.

Similar bulwark reinforcement has also been documented in Malmö. Piles in Norra Vallgatan No. 90 (Kv Skepparen) consisted of four-sided and round oak posts including one outer row of oblique piles (cf. Kalling 1954a; 1954b:103-104 and Fig. 76).

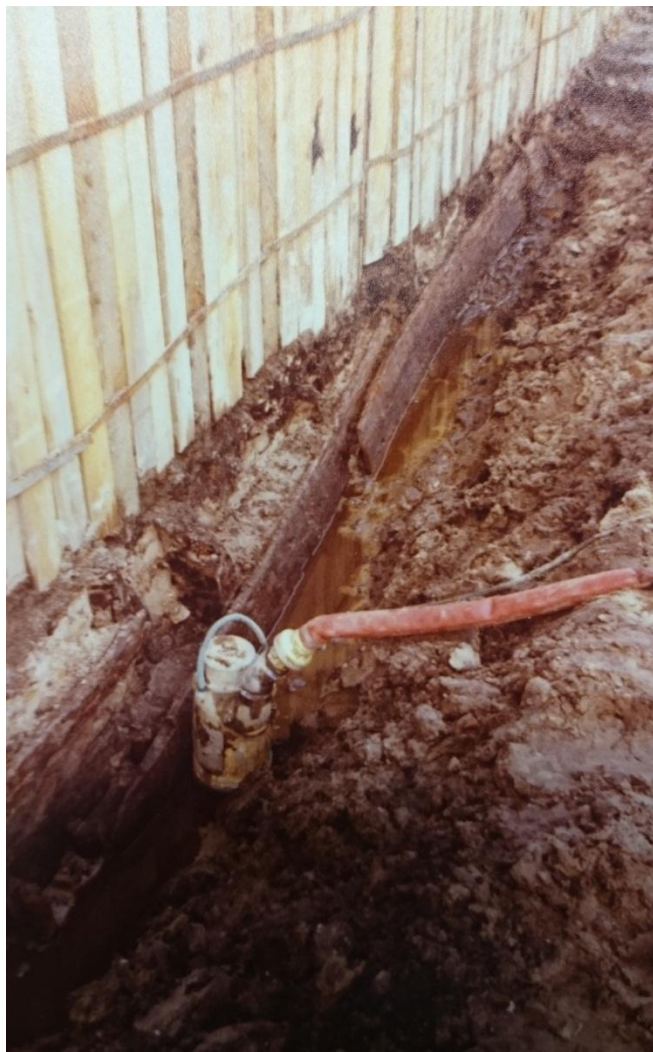
Fig. 77. Byens Planker investigated in Kv Neptun, Malmö. From Malmö Museum, Rapport 35:02.

The city planks in Malmö are dated to the early 14<sup>th</sup> century stretching along Norra Vallgatan from Malmöhus to current Drottningatorget (Reisnert 1998:27 et seq.). Part of the feature has been documented in Kv Neptun consisting of a long row of piles in natural sand (Johansson 1976). Up against the posts' southern side there were three horizontal planks (about 4 m long and 0.25 m wide) in a row, partly overlapping and constructed of used boat parts (Fig. 77). On the northern side of the boards there was coarse sand and between the posts and south of these remains of a wattle fence were recorded (cf. wattle fence Kongens Nytorv below). On the southern side of the planks and along with these there was a compact layer of turf.
