## 14 Phase 4b Late medieval city wall 1350–1550 AD

#### 14.1.1 City wall – building material and construction details

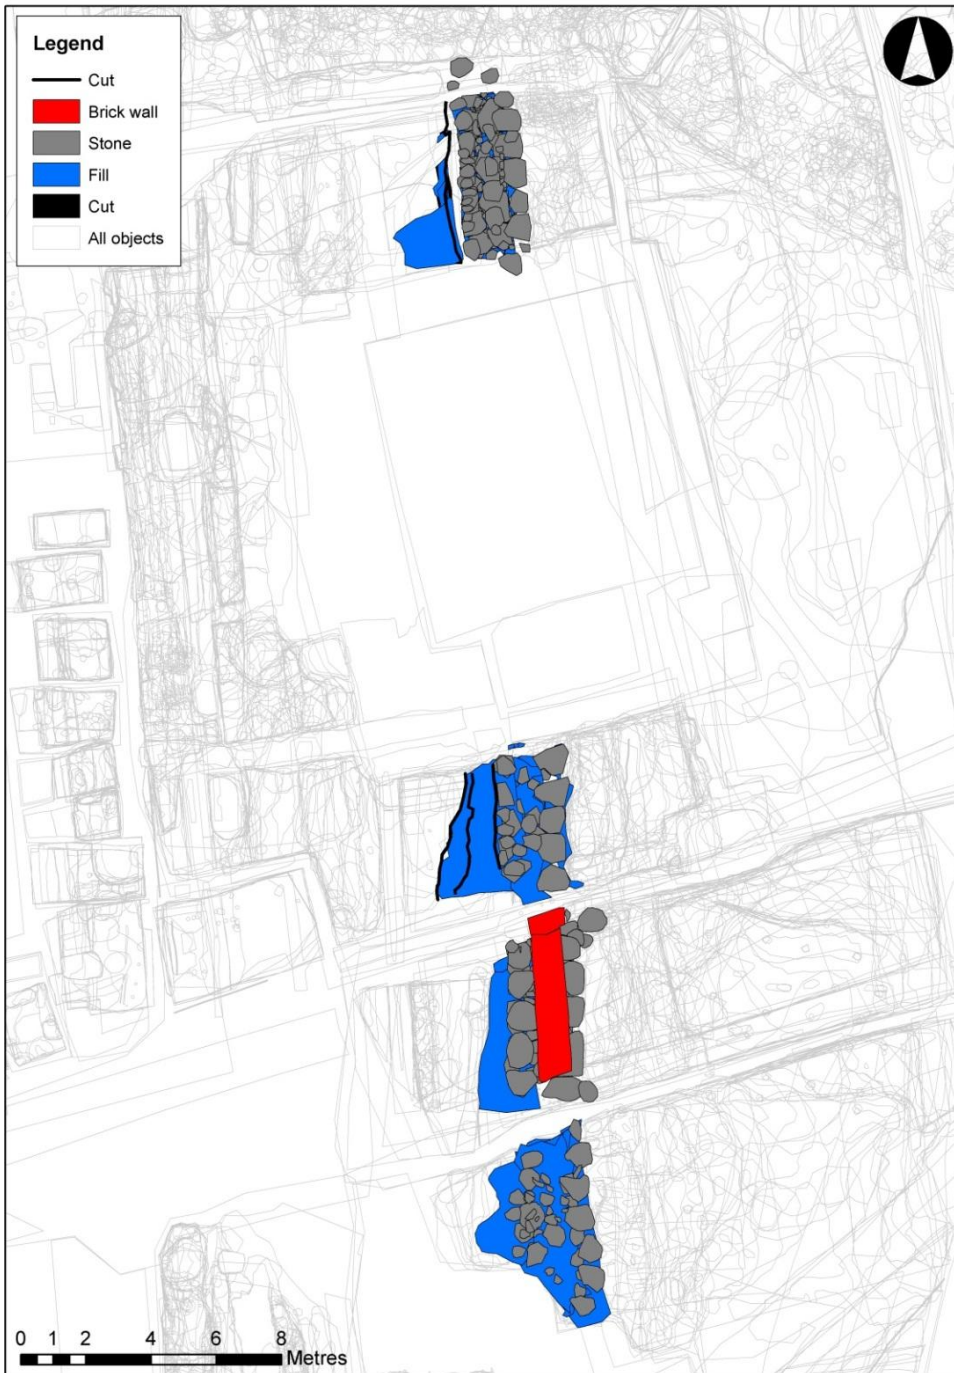
Fig. 80. Details of medieval city wall with construction cuts, foundation stones, limestone ashlar and brick walls investigated outside Hotel D'Angleterre and between Lille Kongensgade and Østergade.

The construction cuts for the city wall had vertical, straight sides to the east and irregular sides to the west (Fig. 79 and 80). Depth varied, but recorded in section this was between 0.5-2.0 m, and deepest in the area where the wall was best preserved outside Lille Kongensgade. Measured width was at the most c. 4.0 m and much wider than the wall itself (see below). The maximum length was 19.7 m (5.3 + 4.0 + 4.3 + 6.1 m) – a length that must be seen together with later disturbances and larger truncations within the excavation area. The base was variously concave, flat or irregular, dependent on the imprints from the overlying foundation stones.

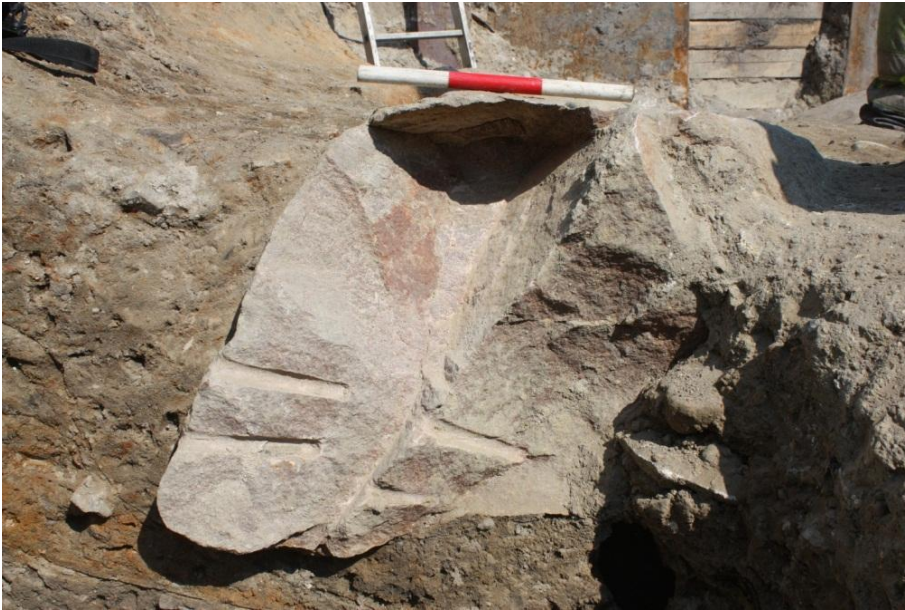
Fig. 82. Foundation stone (SS146448) with chisel marks, facing north. Photo: Museum of Copenhagen.

The foundation consisted of three layers of unfinished granite boulders (Fig. 81). The foundation had a length of 39 m from north to south, a width of 2.3 m and a height of at least 2.0 m (based on the difference between the top of the stones and the base of the construction cut). The courses and the rampart layers had been built “step by step”, where the purpose of the rampart primarily had been to stabilize the foundation and brick wall, where the upper coursing was placed 0.6 m west of the underlying foundation stones. The tops of all the boulders were almost level which suggests that great care was taken to ensure their stability. At least two of the boulders exhibited tool marks in terms of chisel marks and wedge holes (Fig. 82).

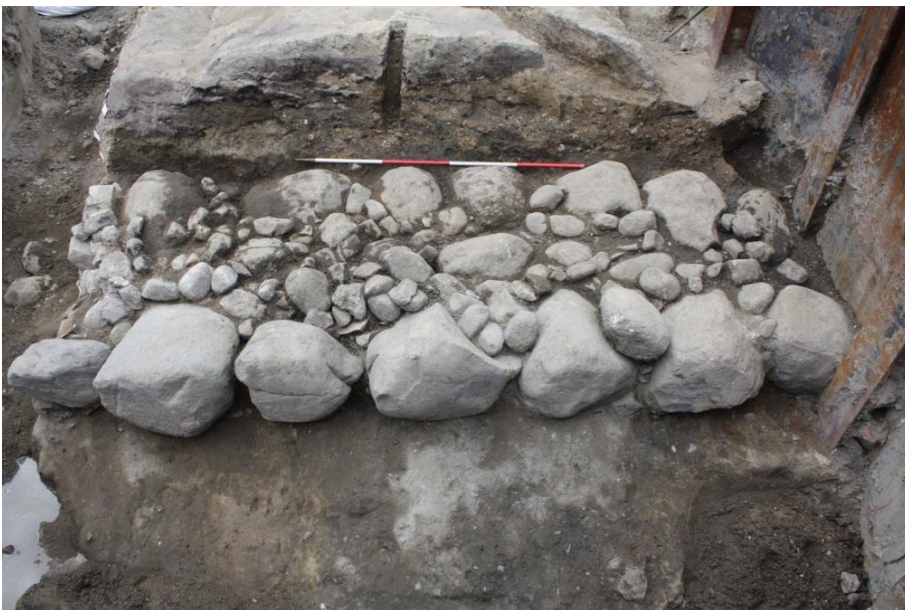
The infill in the gap between the east and west facing courses consisted of sand, pebbles and flint together with bigger and smaller stones. Some of the stones seemed to have been arranged intentionally in a line behind the face of the wall to the east, whilst others were placed in randomly in the core of the foundation (Fig. 83). The purpose was to strengthen the structure and inhibit later movement or slippage.

Fig. 83. The lower part of the foundation together with (SS90812) filling the core between the lower east and west facing courses, facing west. In front – part of the moat, behind the built rampart. Photo: Museum of Copenhagen.

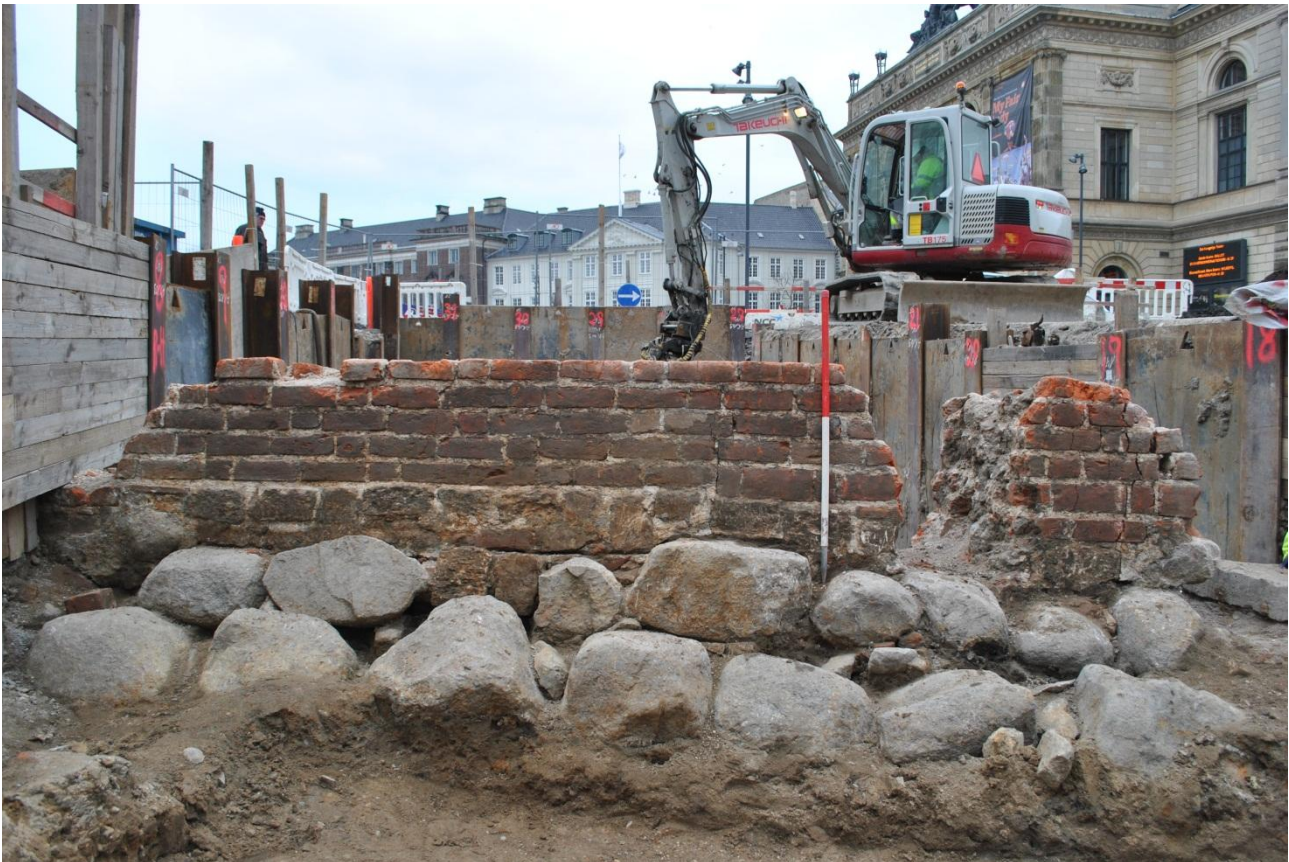
Fig. 84. General view of brick wall and foundation, facing east. Photo: Museum of Copenhagen.

The brick wall had originally been c. 0.9 m wide (1.5 cubit or three tiles thick, where one Zealand cubit = 0.6326 m). The brick wall was built in monk bond, i.e. two stretchers between every header with the headers centered over the perpendicular joint between the two stretchers in the course below, in the bond's most symmetric form (Fig. 84).

The lowest course of limestones on the west side had been laid with limestones (Fig. 84) whose length was up to 0.28 m with a thickness between 0.09 and 0.16 m. The limestones were mainly rectangular, but a few of the stones were also quadratic. Most of the limestones were coursed in the medieval manner, but there were some irregularities occurring where there was a need to adjust the overlying, mostly linear courses on the underlying very irregular granite boulder base. Therefore it had been necessary in several places to vary the width of the limestones as well as place them on edge. The limestone course acted as a transition zone, between base and wall, where it passed on regularity to the overlying brick courses.

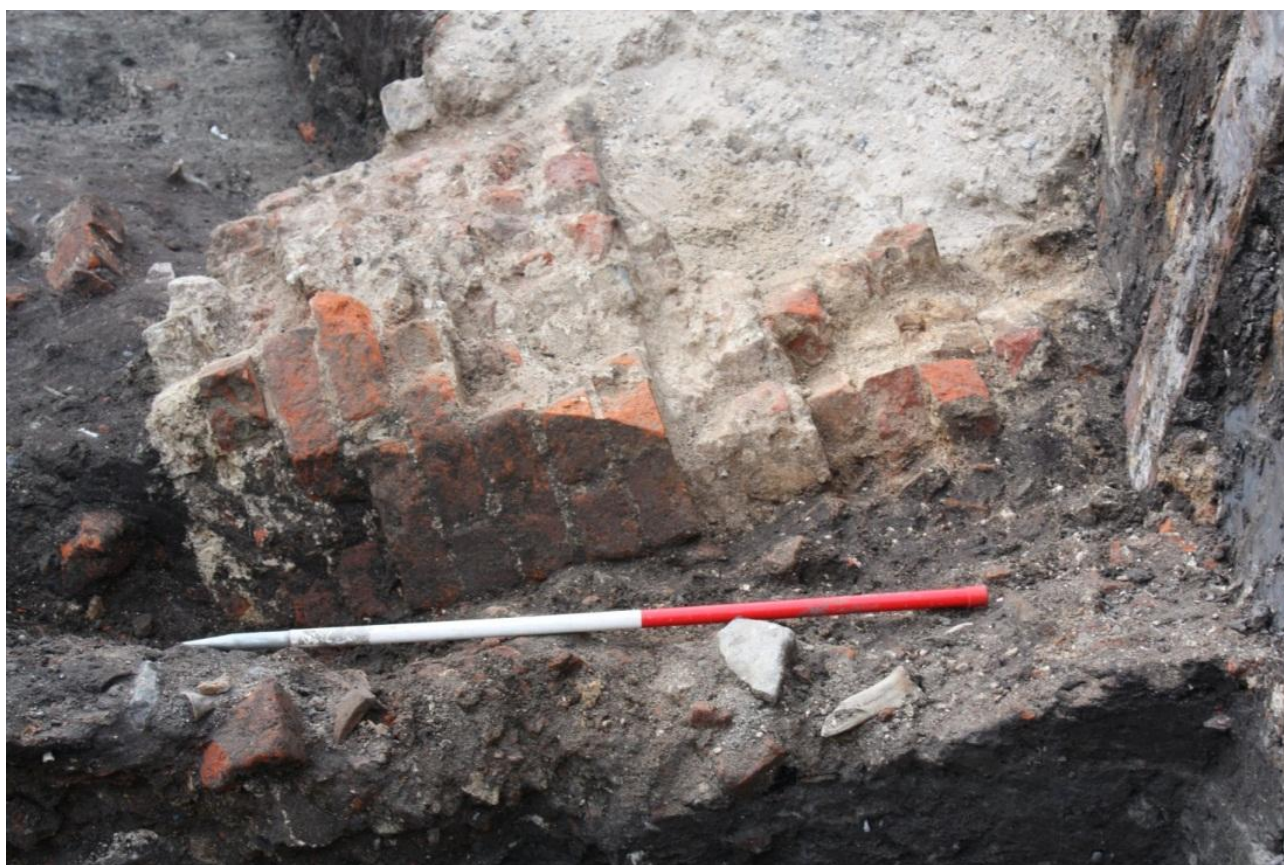
Fig. 85. Collapsed and partially truncated brick wall (SS21934) in the Late medieval moat. Photo: Museum of Copenhagen.

Context (SS21934) consisted of a monk bonded double faced brick wall of mid red bricks (“munkesten”) and rubble fill (Fig. 85). It seemed to be lying on its face, but to the north there was also a brick face, indicating that this was the corner of a wall. It also looked as if there had been an angle 45 degree here – perhaps a cut corner. Some of the bricks, mainly in the fill, were badly fired. The finish of the mortar was smooth. The wall was 1.60 m long, 1.65 m wide and with a depth of 0.50 m.

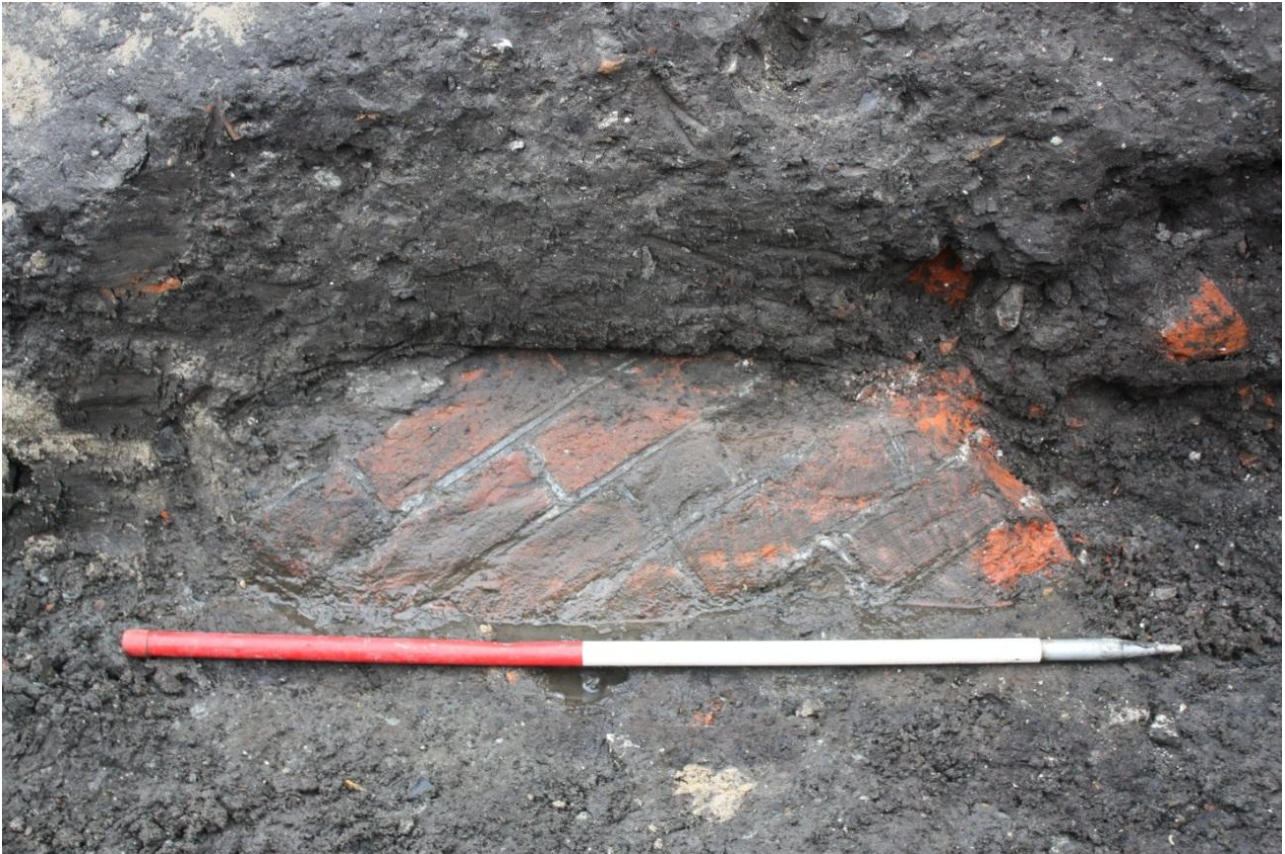
Fig. 86. Monk bond. Part of brick wall (SS24827), facing west. Photo: Museum of Copenhagen.

Due to the Transformer Station only part of the face of SS24827 was seen and the feature remained unexcavated. It consisted of five courses of mid orange medieval bricks, fully laid with an uneven finish of mortar. Distinct from the other two brick walls (SS21934) and (SS22335), this structure consisted of monk bonded bricks with two stretchers for every header (Fig. 86).

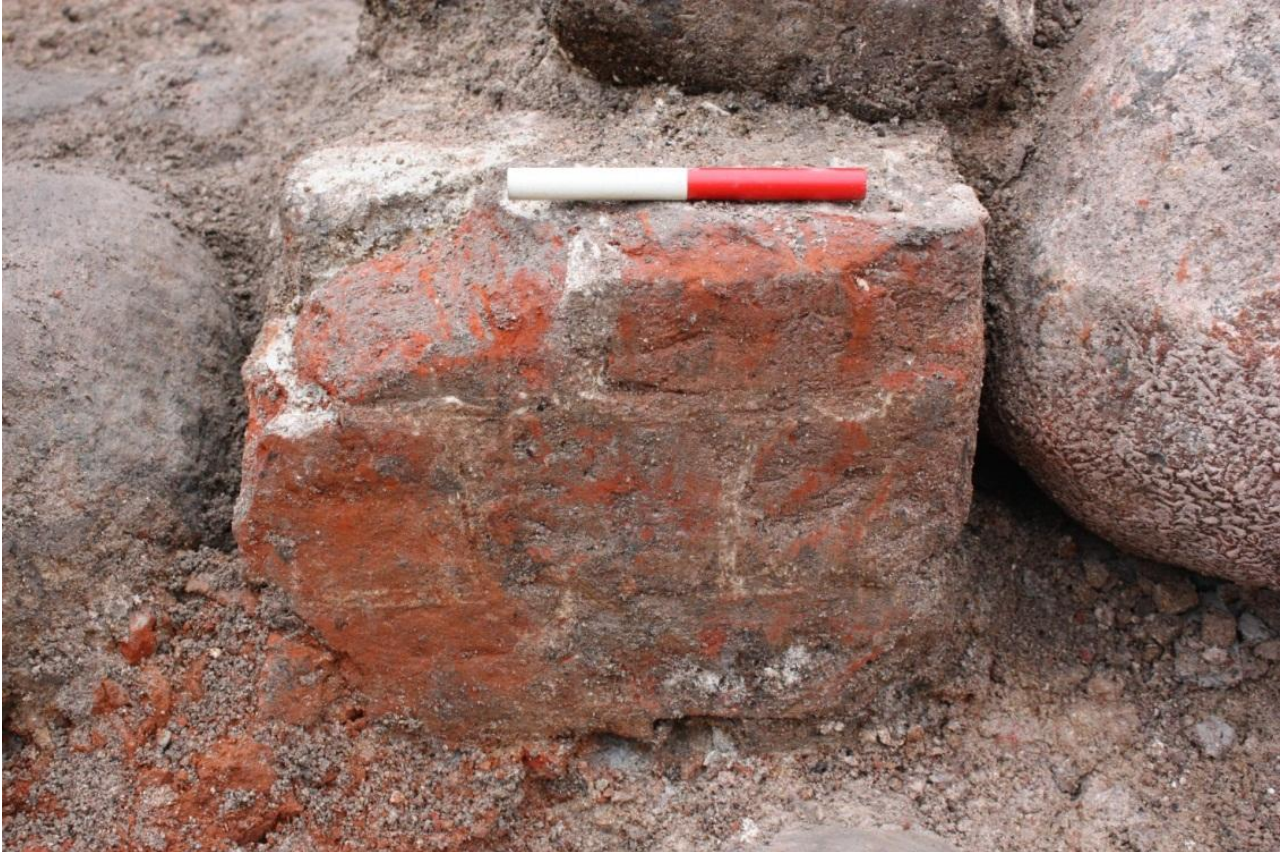
Fig. 87. Close-up photo. Part of an interpreted merlon (SS311725) probably from the former city wall between two of the stones in foundation (SS503426), facing north. Photo: Museum of Copenhagen.

Masonry reused and documented in the 17<sup>th</sup> century dam can perhaps tell something about the city wall's upper parts. Square blocks (SS311725) and (SS311734) consisted of 3 courses of red bricks ("munkesten") with white tuck mortar within foundation (SS503426). The features are interesting – the shape and the finished edges suggest that these represent the lower part of merlons, reused as building material when the city wall was demolished in the early 17<sup>th</sup> century, the latter dated by building material in the Late medieval moat (cf. Kristiansen 1998:65, 77 and 78; 1999b:165 and 176).

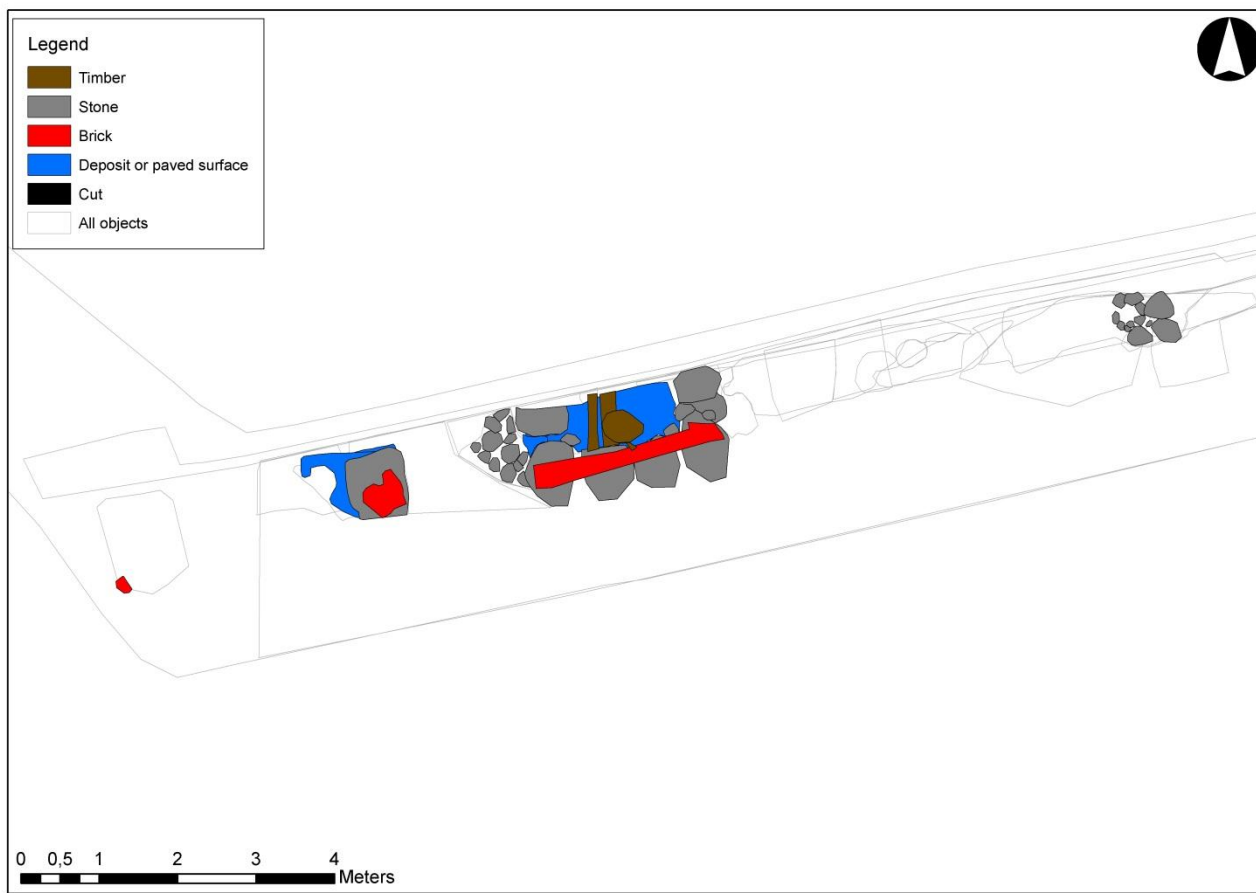
Fig. 88. Part of the former city wall incorporated in a later building outside Danske Bank’s facade.

Outside Danske Bank's facade foundation stones from the former city wall had been reused as foundations for a later brick wall, probably part of the building seen on Geddes elevated map from 1760 replaced by Peschiers Gård (Danske Bank) in 1796. Seven large boulders of at least 2 courses forming a U-shape were documented in an area of approximately 2.7 x 1.4 m surrounding an open area with a buried bucket (Fig. 88). Post-excavation interpretation concludes that the boulders (SS205148), or at least some of them, were part of the city wall after comparing these with the city wall foundations investigated in 1996–1998 (Fig. 92 and cf. Kristiansen 1998:73 et seq.; 1999b:162-165). Further investigations were not done in the trench due to the excavation limit.

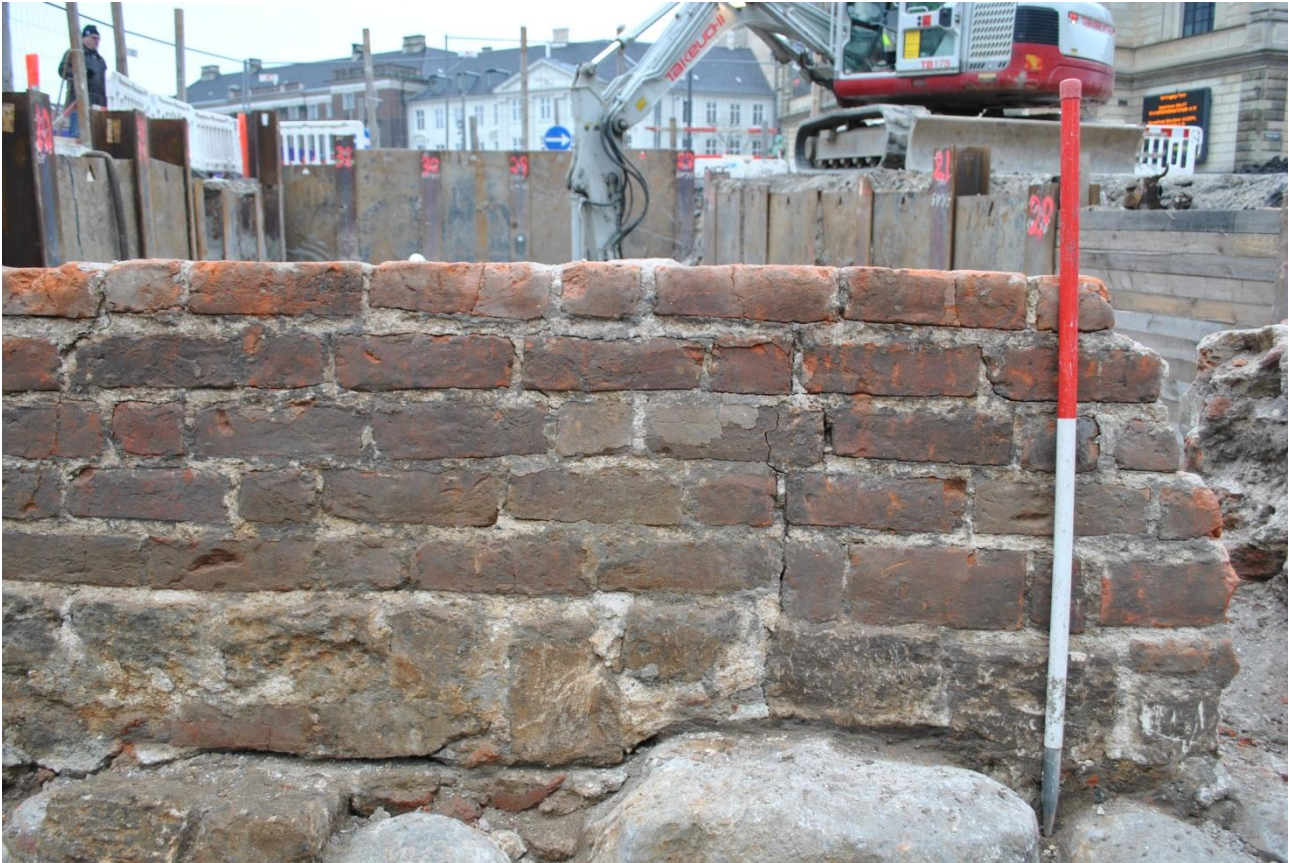
Fig. 89. Detail of brick wall and limestone coursing, facing east. Photo: Museum of Copenhagen.

No in-depth studies of the mortar joints were made on site besides certain quotations about composition. It is therefore impossible to use these observations as dating evidence and the images also provide limited illumination (cf. Fig. 89). Older brick joints are often characterized by smoothed, edge swept joints replaced by swept joints with prismatic shape and sharp middle back – one Late medieval variant has a rounded bisection. The Gothic joints are

Based on this information there are clear similarities between the city wall investigated in 2010 and earlier documentations, both in respect to building material and techniques and to stratigraphical relations to the original embankment. The width of the brick wall varied from 0.86 m to 1.20 m placed on 2-3 courses of large granite boulders where the width of the foundation was 1.1-2.2 m. The construction cut truncated the salt marshes and the foundation stones had been placed step-wise. Limestone ashlar were later placed at the base of the wall to level the masonry built using monk coursing and with brick size 27.0 x 12.5 x 9.0 cm (Fig. 89).

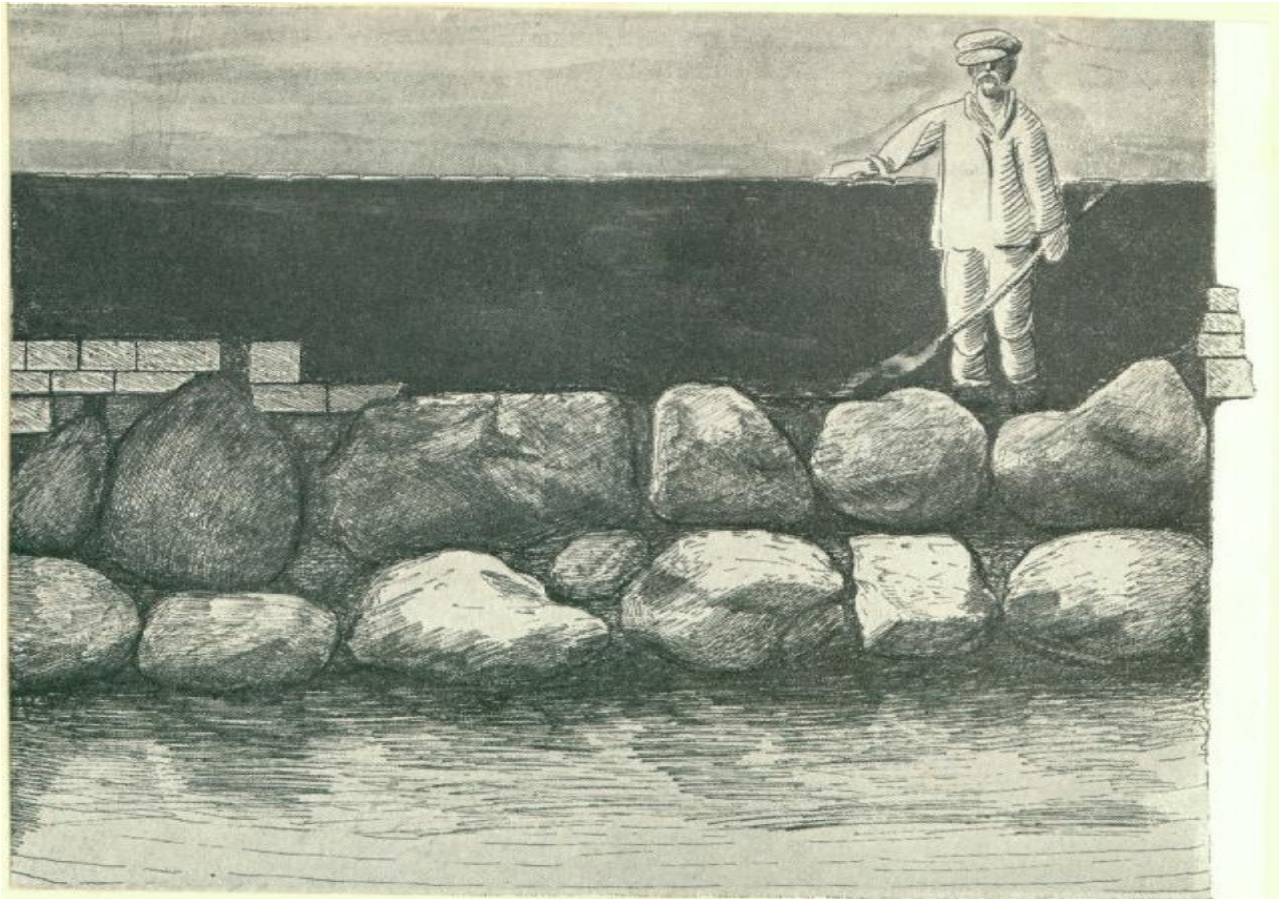
Fig. 90. Medieval city wall exposed outside Hotel D'Angleterre. From Linde 1929.

Lassen (1855:20) describes a 4-5 cubits high wall between the former Østerport and the guard house, though without mentioning the precise location. Approximately 17.3 m outside Hotel D'Angleterre part of the medieval rampart and city wall consisting of two courses of granite boulders, a 1.2 m wide brick wall with lime dressed masonry and the moat with 16<sup>th</sup> century fill have been recorded (Fig. 90). The underlying salt marsh layer was visible in the section (Linde 1929; Berlingske Tidende 1929; Ramsing year unknown).

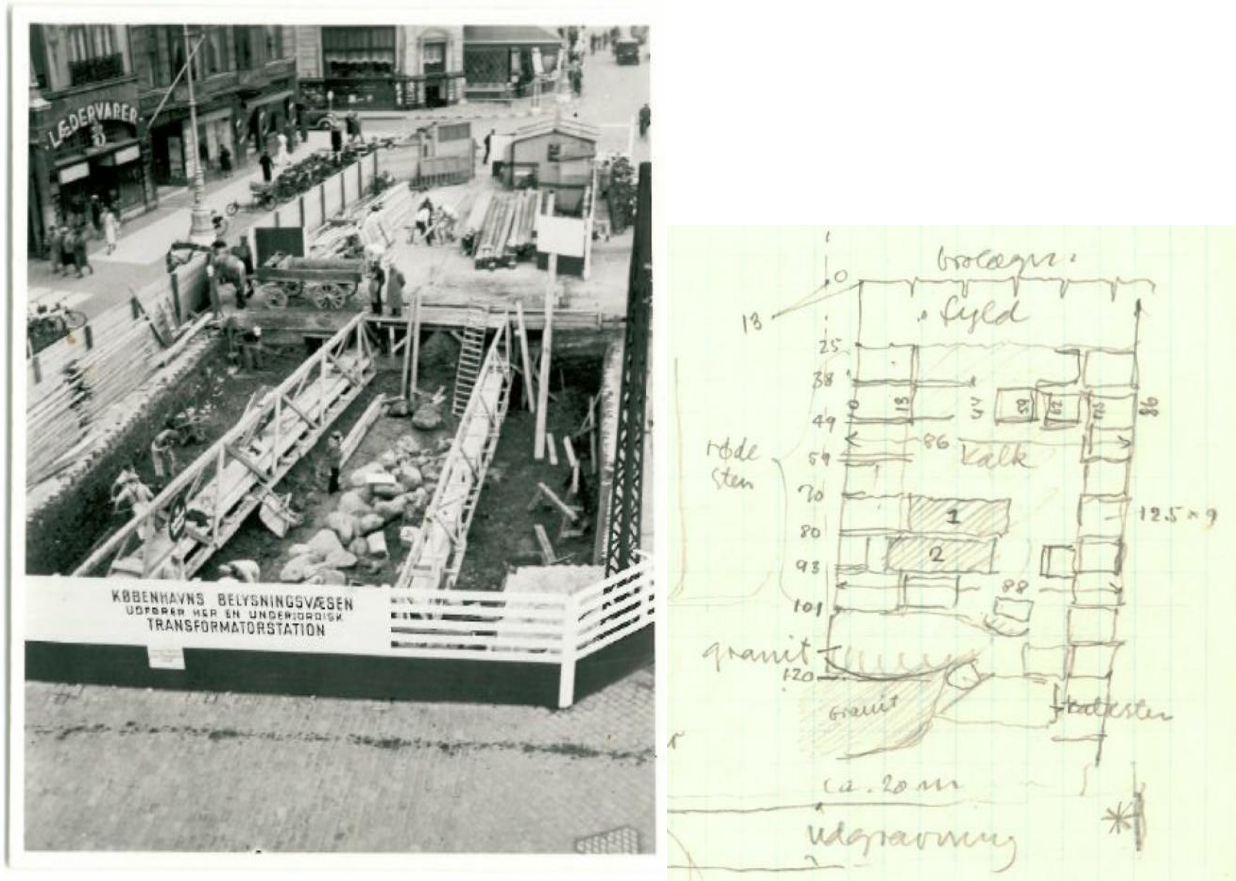
Fig. 91. Earlier investigations of the city wall at Kongens Nytorv. Section through the brick wall and foundation stones documented between Lille Kongensgade and Østergade. From Jensen 1941 and Kayser 1969.

In connection with the construction of a Transformer Station in 1941 part of the rampart and stones belonging to the city wall was documented (Fig. 91). The foundation appears on several images and drawings as a c. 11.25 m long and 2.00 m wide NW-SE orientated line of boulders consisting of at least two courses lying between kote +1.60 and +2.08 m. East of the boulders part of a collapsed brick wall and seven stones were recorded. What the proposed dating to 1490 AD is based on is unclear (Berlingske Tidende 1941; Jensen 1941).

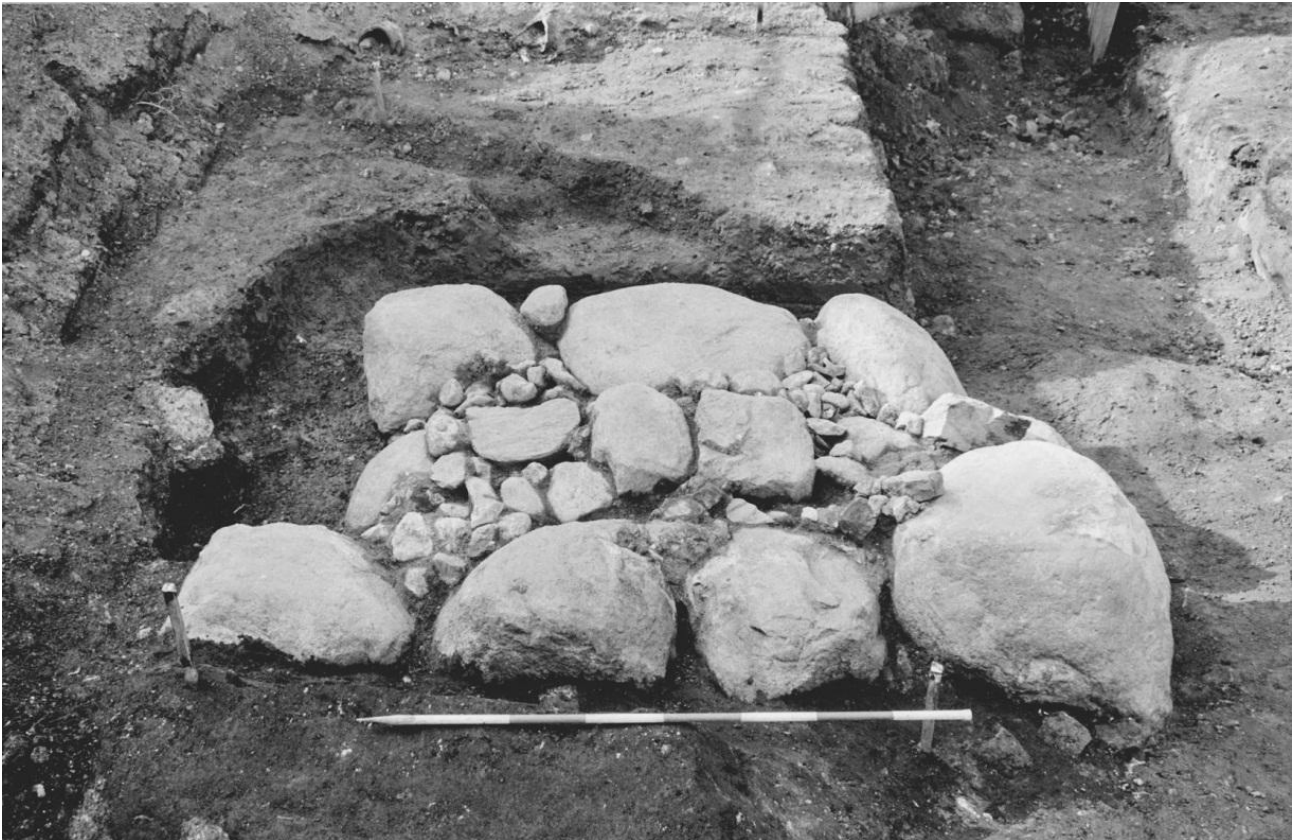
Fig. 92. Foundation for the city wall investigated in 1996, facing west. Photo: Museum of Copenhagen.

At the Metro investigations in 1996–1998 the city wall was preserved as three foundation courses consisting of two rows of stones with a width between 1.1-1.7 m and a height of at least 1.4 m (Fig. 92). The top of the foundation was not preserved and no mortar was recorded on the stones. The courses and the rampart layers had been built “step by step”, where the purpose of the rampart primarily had been to stabilize the boulders. Part of the wall was also found as decomposition layers of bricks and ashlar limestone above the mud layers in the former moat (Kristiansen 1998:73 et seq.; 1999b:156-158, 161 and 162). This destroyed part of the city wall consisted of a continuous remnant of a brick wall, at least 1.8 x 1.2 m with monk coursing together with bricks and limestone ashlars. The remnant was interpreted as part of the parapet. The wall had been 0.42 m thick with unfilled joints. No reused bricks were identified in this part of the brick wall. The suggestion of a new city wall was based on the orientation and traces of mortar scar by masonry of 0.42 m thickness on the surface of the foundation stones and demolition material and robber trenches, but it is worth mentioning that this interpretation was rather uncertain. Since there were no traces of the brick wall itself, this was explained by the fact that the wall could have been standing on higher placed sill courses. Suggestions that the city wall was restored at some time could also be explained by functional differences within the new structure (cf. Kristiansen 1998:108-110 and 115).

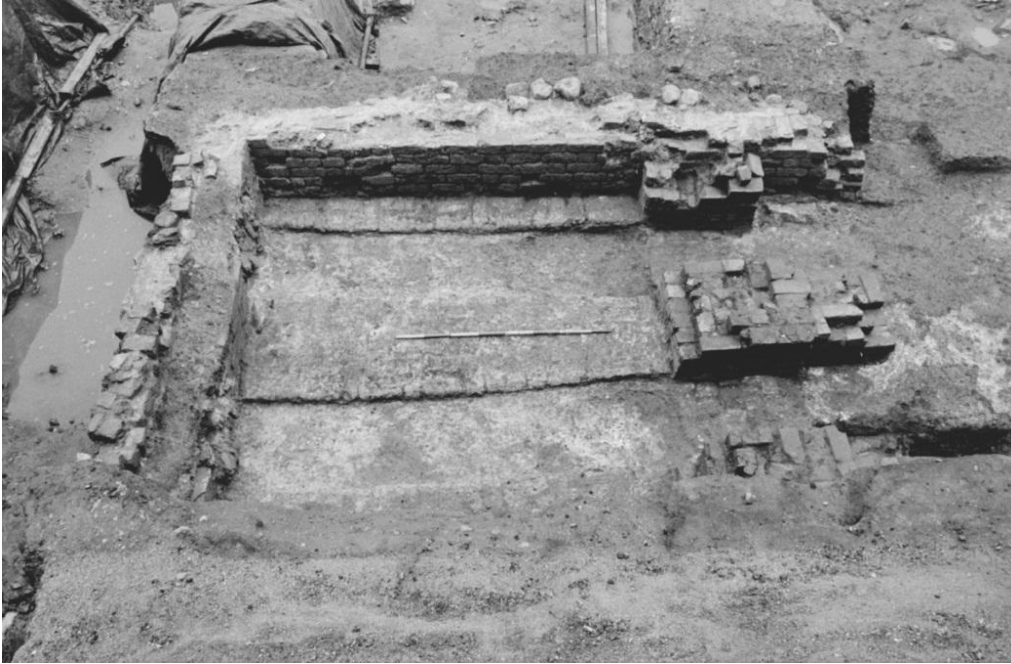
Fig. 94. Tile stove investigated at the Metro excavations 1996–1998, facing east. Photo: Museum of Copenhagen.

A brick kiln built in several phases (stove, brick floor, two brick benches, six heating channels and brickwork of “munkesten” preserved in six courses) was recorded west of the oldest rampart line (Fig. 93 and 94), interpreted as being used for brick production connected to the construction of the city wall and covered by a later phase of the rampart. TL-dates of bricks in the stove were dated to  $1210\pm 60$  AD and  $1310\pm 60$  AD. Charcoal (*Fagus silvatica* and unknown, unknown old-wood effect) from the fire pit was C14-dated to  $770\pm 50$  BP or 1161–1297 AD (cal 2  $\sigma$ ) (Kristiansen 1998:65 and 93-95; 1999b:156, 157, 159, 169 and 176 and C14-datings from KBM 1410. 2012).

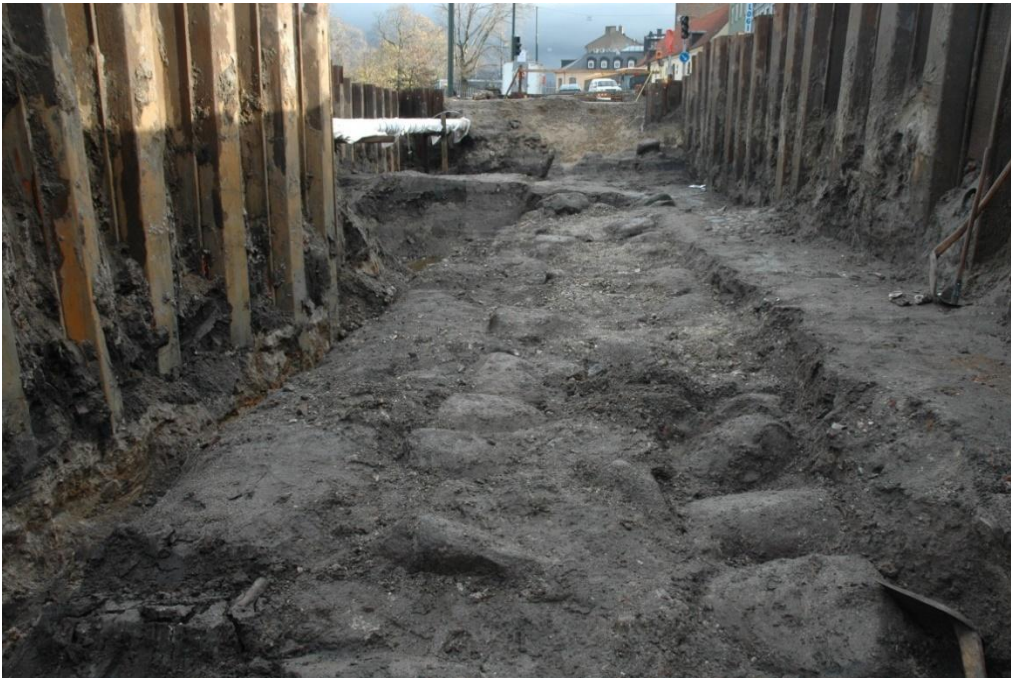
Fig. 95. Foundation of the so-called “strandmur” facing east in Norra Vollgatan in Malmö. Photo: Malmö Museer, Rapport 2009:047.

The wall had probably been 9 cubits high (5-6 m) with an earthwork lying behind. During the time of Frederik the 1<sup>st</sup> the fortification was straightened with an inner embankment as high as the city wall and with a width of 16 cubits – though it is uncertain if the latter is valid for the area around Østerport (cf. Thorsen 1926:226 and 234). In comparison the city wall in Malmö, Scania from the early 15<sup>th</sup> century would have been 9 cubits high – c. 5.5 m with a width of “three stones” (c. 0.9 m) standing on a one metre high foundation of natural boulders (Rosborn 1984:37; Reisnert 1998:32 et seq.; Olsson och Ödman 2009 and Fig. 95 and 96).

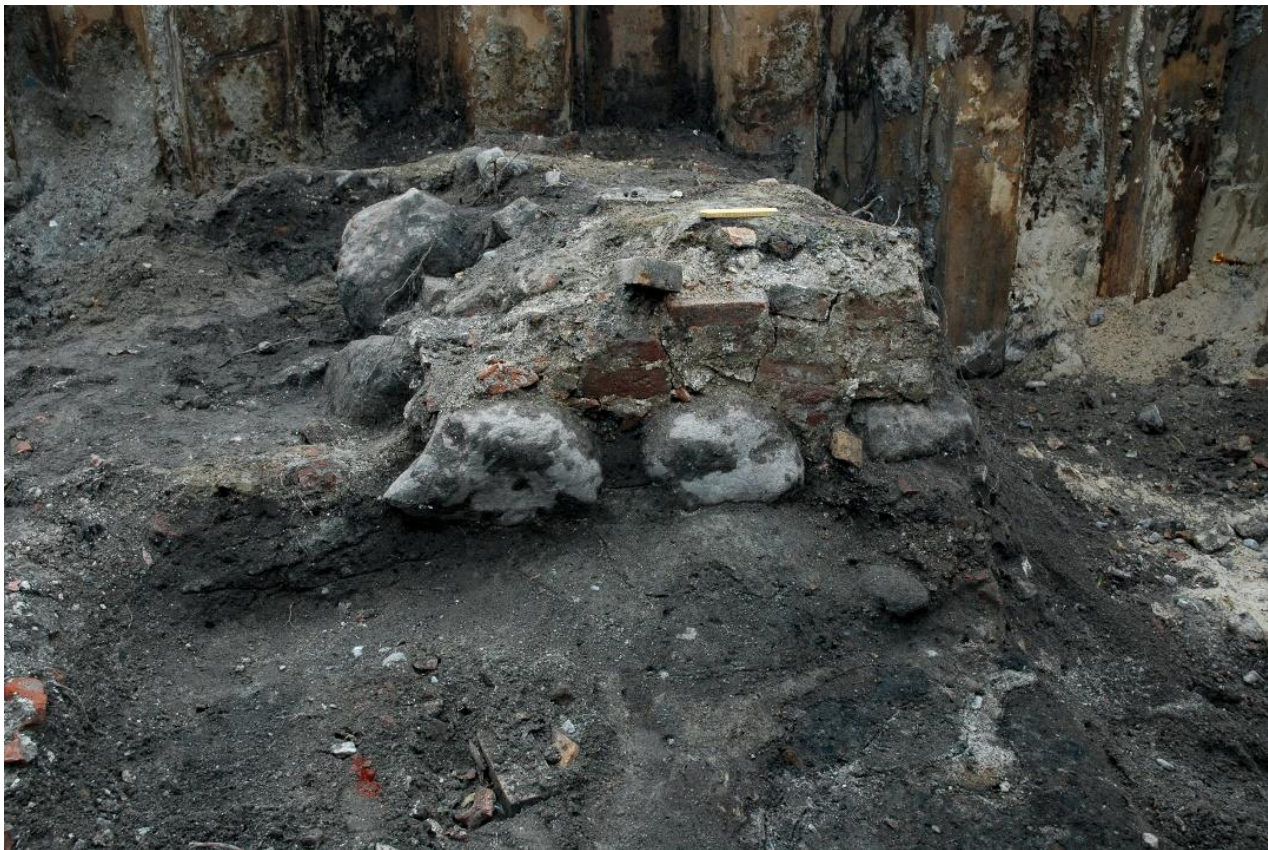
Fig. 96. Part of the medieval "strandmur" investigated in Norra Vollgatan in Malmö. Photo: Malmö Museer, Rapport 2009:047.

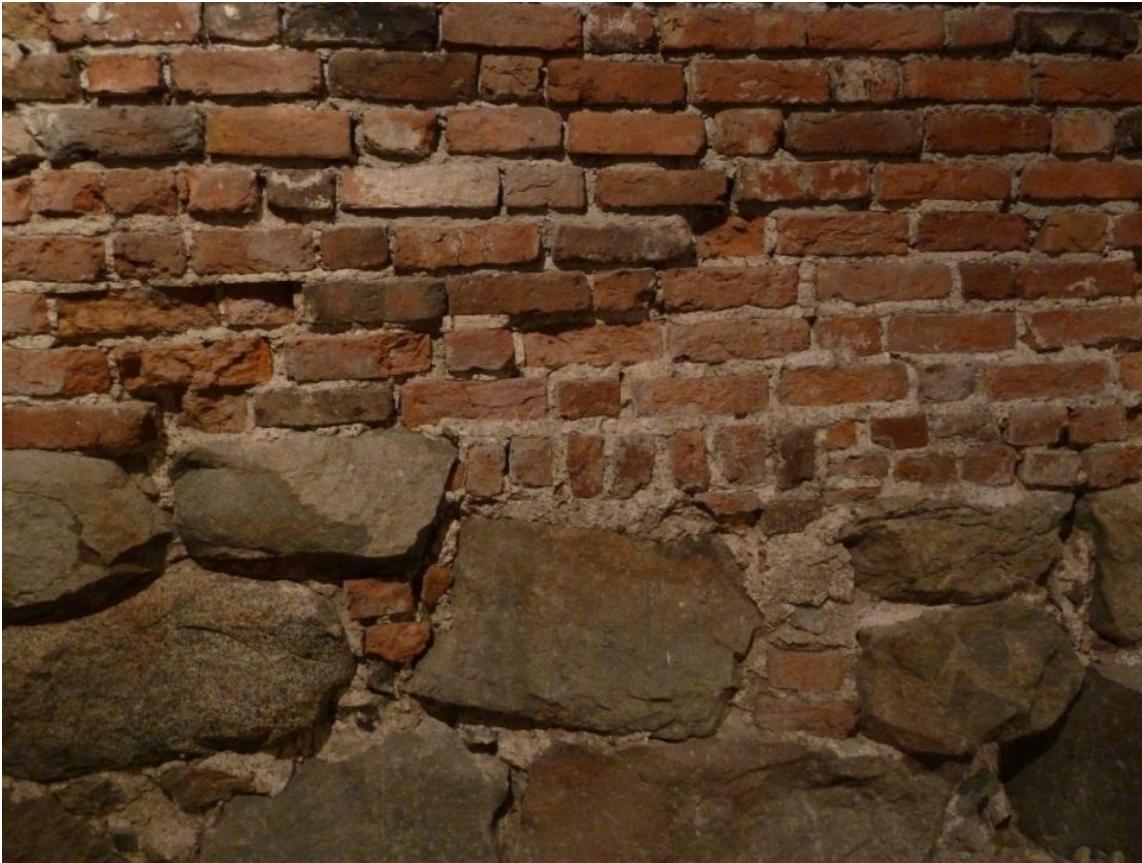
Fig. 97. Example of a Late medieval brick wall. Stockholm's city wall dating from c. 1530 AD. Photo: Morten Steineke.

As a nearby example, the medieval city of Malmö was not fortified until 1393, after the ravages of the Victual Brothers. The construction work was carried out in stages – notes are made in Registrum three times and there is a significant time difference between the two former. In 1419 the city borrowed 300 silver marks from the church for the building of a brick wall without delay by order of Eric of Pomerania, which should have been finished in three years, though the construction took a considerably longer time than that. As late as 1434 Eric of Pomerania again commanded all citizens to contribute to the city's new fortification, but not before 1517–1519 AD was the last part of the city wall completed (Reisnert 1998 and see also Fig. 97).
