16 Phase 4d Late medieval and Renaissance fortification 1350–1600 AD

16.1 Results

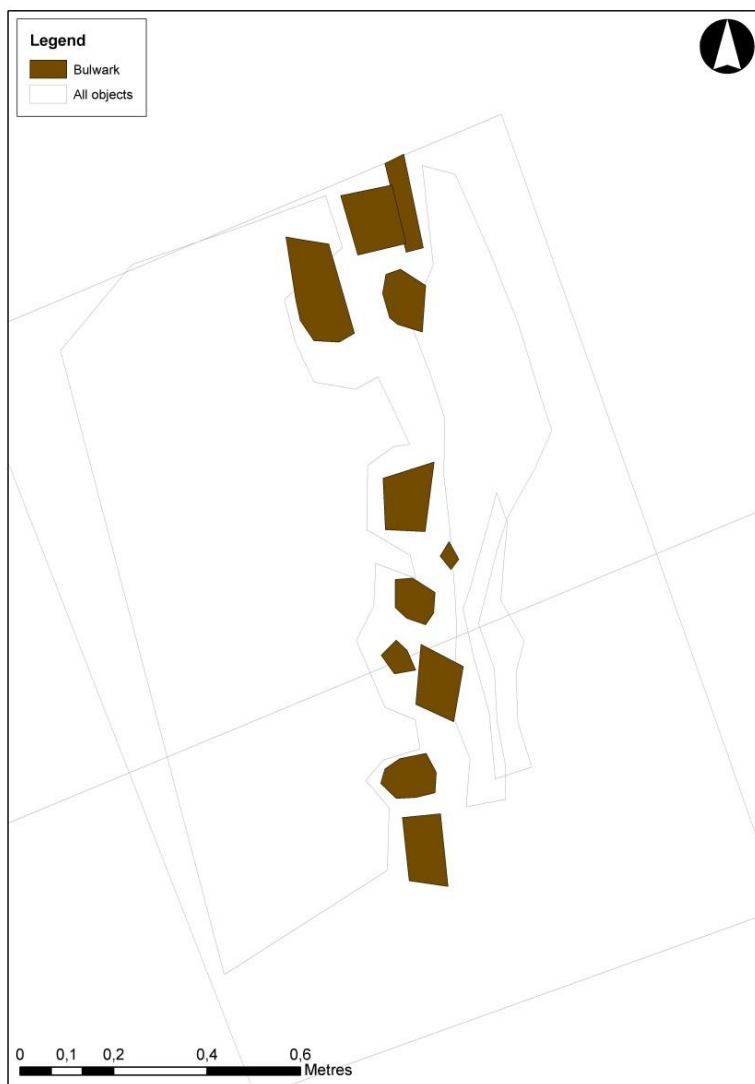
A north-south orientated timber structure was investigated at Kongens Nytorv opposite the end of Strøget 31.0 m from the SE corner of Hotel d'Angleterre, consisting of 11 wooden posts (Fig. 141). The feature consisted of five larger mostly rectangular posts with six smaller, more rounded posts in between. All posts were vertically set, except at the north end of the structure where there was a horizontal plank (ST162149) that seemed to represent some planking behind the vertical posts.

Fig. 141. Bulwark from the mid 16th century at the SE corner of Hotel d'Angleterre.

There was an impression on site that the structure was curving slightly to the west, although the trench was too small to be certain. The posts seemed very well set and it is thought that they were driven into natural at the base of the moat, and that this structure was some kind of revetment since three contexts in subgroup 457 on the east side of the posts were interpreted as purposeful backfilling behind the posts. Peg holes in one of the saved timbers shows that this timber was a reused piece from a so-called "vognkæp" (English: rong) (Fig. 142 and 143). A sawed board made of spruce or pine was also recorded (Melin 2013:27).

Dendrochronological dating of the timber structure placed this between the mid 15th century and the mid 16th century (Tab. 38). Some of the timber represented reused wood. The source of the oak wood was the Swedish west coast (Halland and Bohuslän) and for the pine this has been determined as Gotland (Linderson 2015).

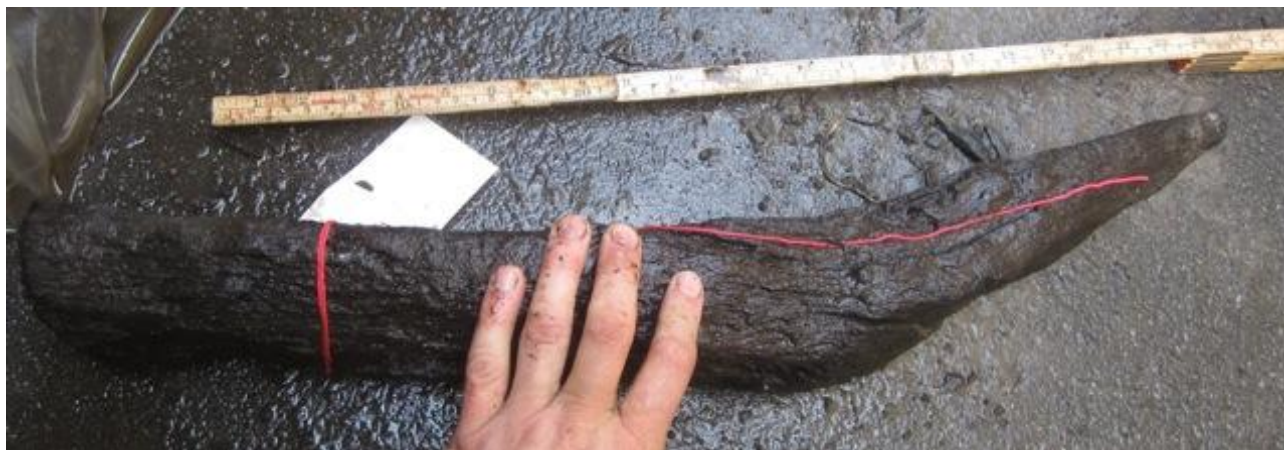
Fig. 142. Part of "vognkæp". Photo: Karl-Magnus Melin, Knadriks Kulturbygg AB.

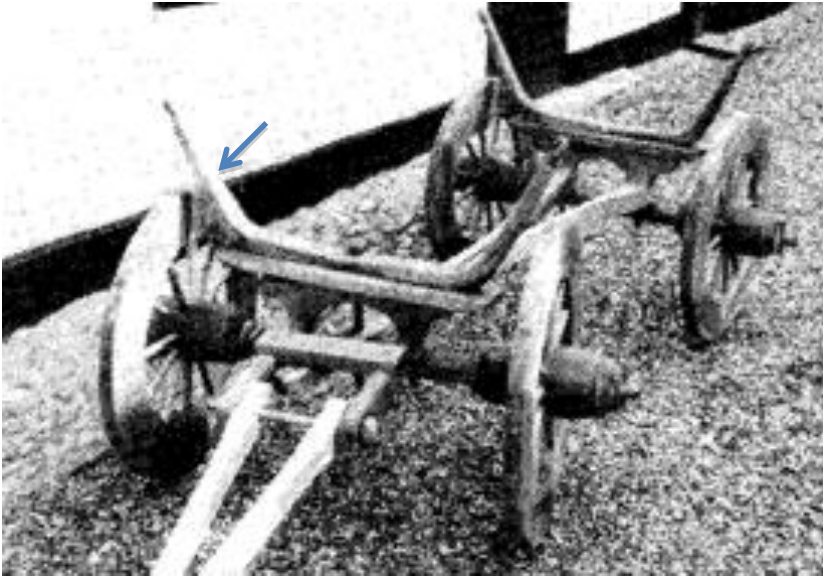
Fig. 143. The arrow points at a “vognkæp” re-used in the 16th century bulwark. Photo after Schovsbo 1987:137 and modified by Melin (2013:26).

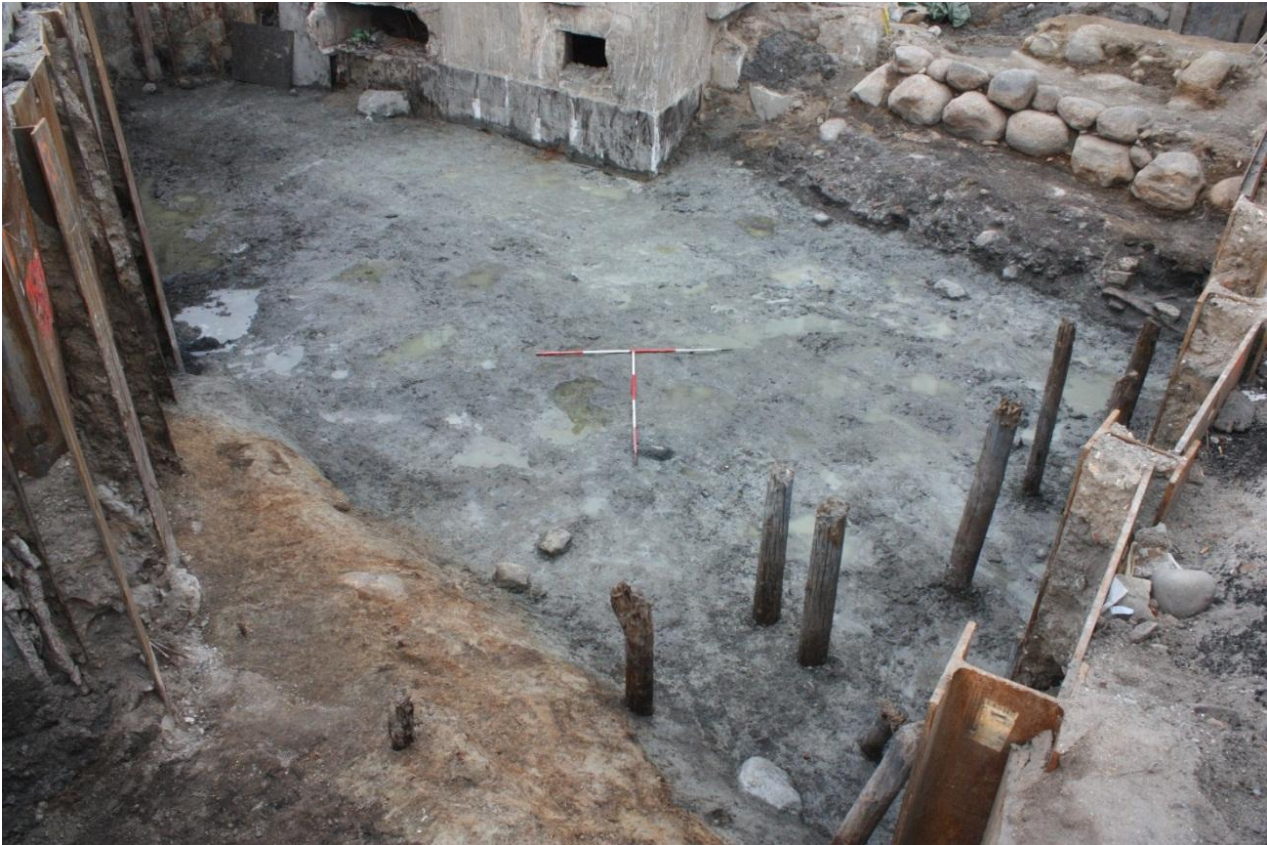
Fig. 144. Excavated 16th century moat, facing SW. The timber belongs to a later bridge structure. Photo: Museum of Copenhagen.

The Late medieval moat could not be separated from the earlier moat, but has been at least 10.5 m wide and was followed for a length of approximately 55.0 m running in a north-south direction (Fig. 144). The base was recorded between kote -1.0 and -0.5 m. The east side of the cut had a moderate slope (45 degrees) and had a moderate to gradual break of slope at the base. On the west side the edge was diffuse and was overcut during excavation and truncated by the Transformer Station and a modern concrete structure, which affected the exact shape and levels of the cut. The cut was steep (approximately 60 degrees to horizontal) and convex. The cut also flattened off towards the city wall foundation, leaving a very gently sloping “flattish” strip directly in front of the structure. The top of the construction cut varied from kote +0.65 to +0.10 m, the base between kote -0.45 to -0.70 m. These results can be compared with the medieval moat investigated in Vester Voldgade at Vartov, as a c. 15.0 m wide trench with the base at kote -2.0 (cf. Jensen 1934).

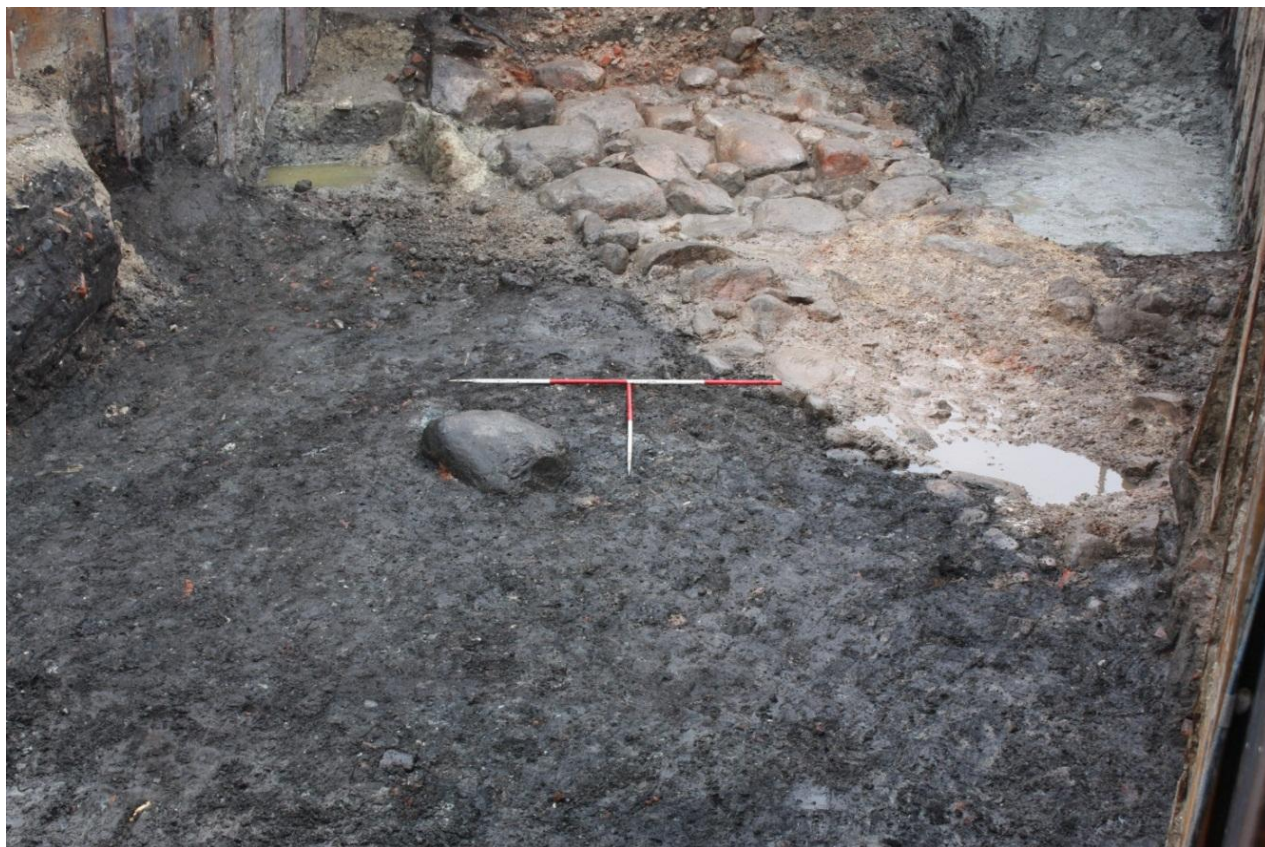
Fig. 145. Sedimentation (SD24889 and SD24916) south of the remains of the 17th century dam, facing north. Photo: Museum of Copenhagen.

The sedimentation in the moat varied from 0.1-0.5 m in thickness and consisted of lensed dark brown and black decomposed peat together with light and mid blue, grey and yellow clayish silt with different types of inclusions and a large amount of household waste and building material (Fig. 145). Lenses of silt indicate slow flowing water and no traces of peat rhizomes were registered. Of zoological remains, mussels and snails were documented. Some of the findings were probably connected to the later deconstruction phase and pressed into the underlying and soft deposits, but overall this assumption does not affect the dating and deconstruction phase of the moat.

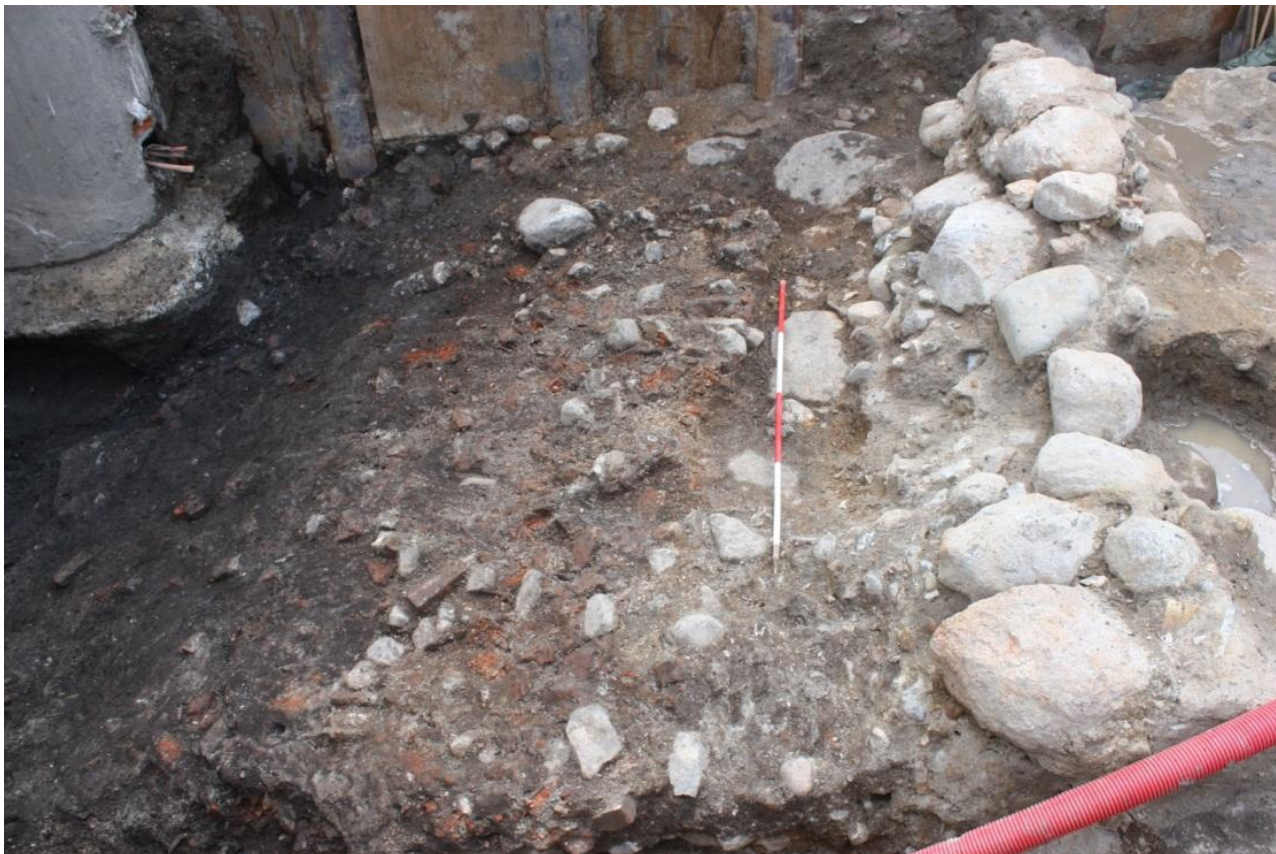
Fig. 147. Backfill in the 16th century moat consisting of different sorts of building material, facing south. To the right – part of the city wall foundation. Photo: Museum of Copenhagen.

The backfilling of the 16th century moat consisted of mixed building and demolition material and a large amount of domestic waste of different colour, composition, homogeneity and inclusions of finds. This backfilling happened mainly from the west to the east (Fig. 147) and can be dated from the late 16th century to the early 17th century, mainly based on the collected and registered pottery (1550–1650 AD).

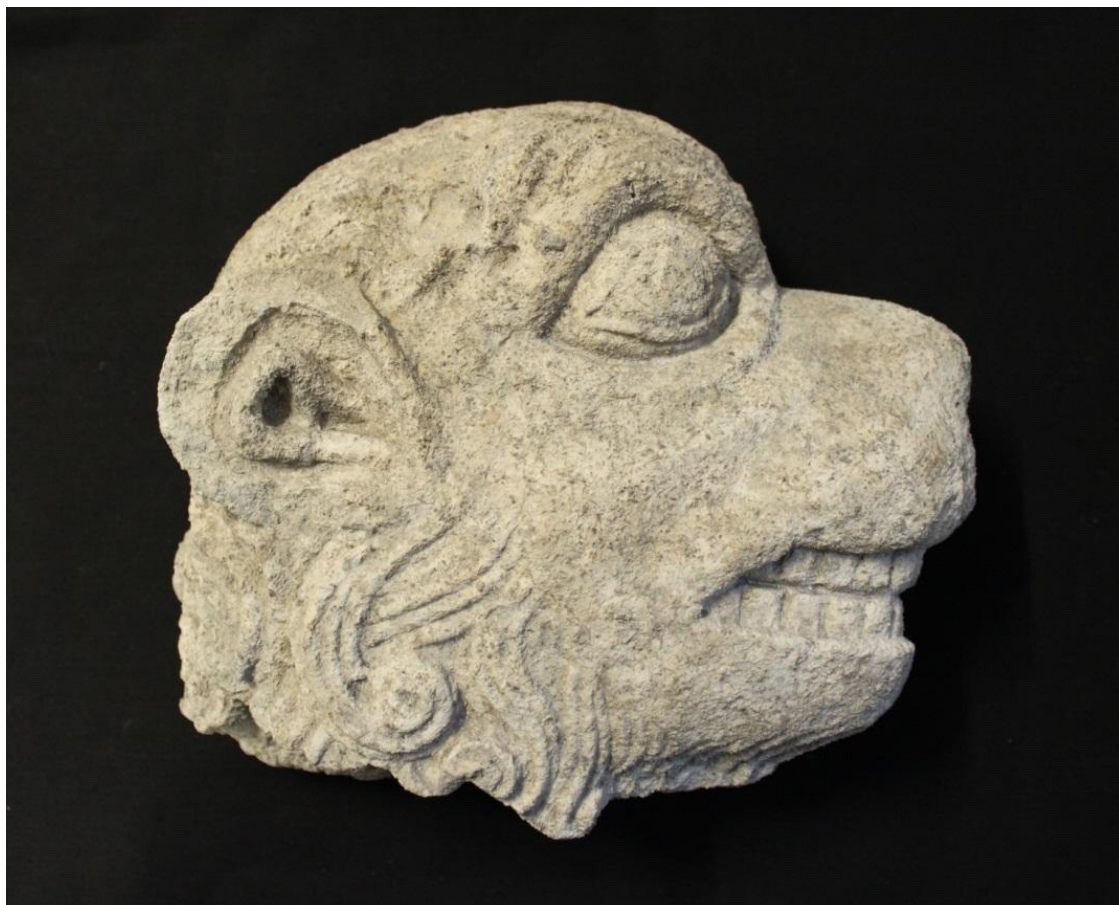
Fig. 148. Romanesque lion head of limestone from one of the basal layers in the Late medieval moat. Photo: Museum of Copenhagen.

The limestone lion head (Fig. 148 and 149) is either Romanesque or Late medieval (cf. Rejnert 2012; Vedsø 2016a) – probably representing some sort of decoration on the medieval gate building. There is also a parallel to the lion head in the form of a chalk console from c. 1250 AD in Karlstrup church between Copenhagen and Køge (Nyborg 2016).

The lion head was analysed using X-ray fluorescence and a handheld digital microscope with and without UV fluorescence lighting (Rask og Christensen 2011). The sculpture fragment is made of limestone and there are no traces of paint. Possible wear is seen for example on the edges of the detailing, as the curly mane, ear and eye are not entirely sharply delineated. Microscopy of the most protected areas, i.e. grooves in the ear, between the teeth and on the mane, show no signs of paint preservation. It seems that the limestone has been eroded by wind and weather, which also explains the many fossils exposed in the surface of the figure.

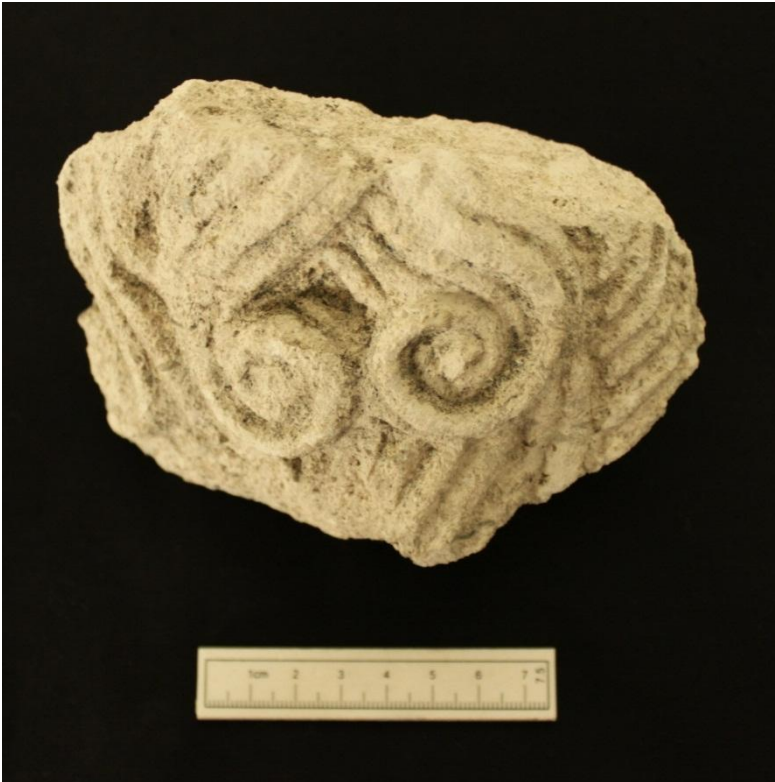
Fig. 149. Early Post medieval limestone architectural embellishment, possibly representing part of the lion's mane (FO204985). Photo: Museum of Copenhagen.

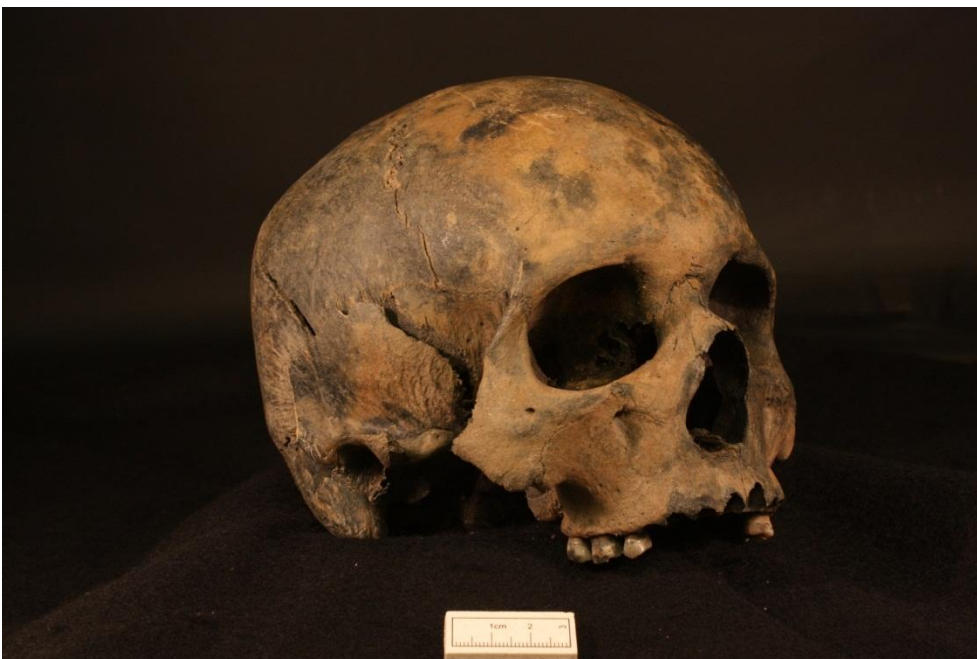
Fig. 150. Human skull (FO206688) found in alluvial deposits in the 16th century moat. Photo: Museum of Copenhagen.

The cranium found in the bottom of the moat not far away from Østerport (Fig. 150) has a clear hole in the transition between the forehead and the parietal bone (not seen on the picture) and may have belonged to a condemned person, whose skull had been placed on a pole at the gate as a warning.

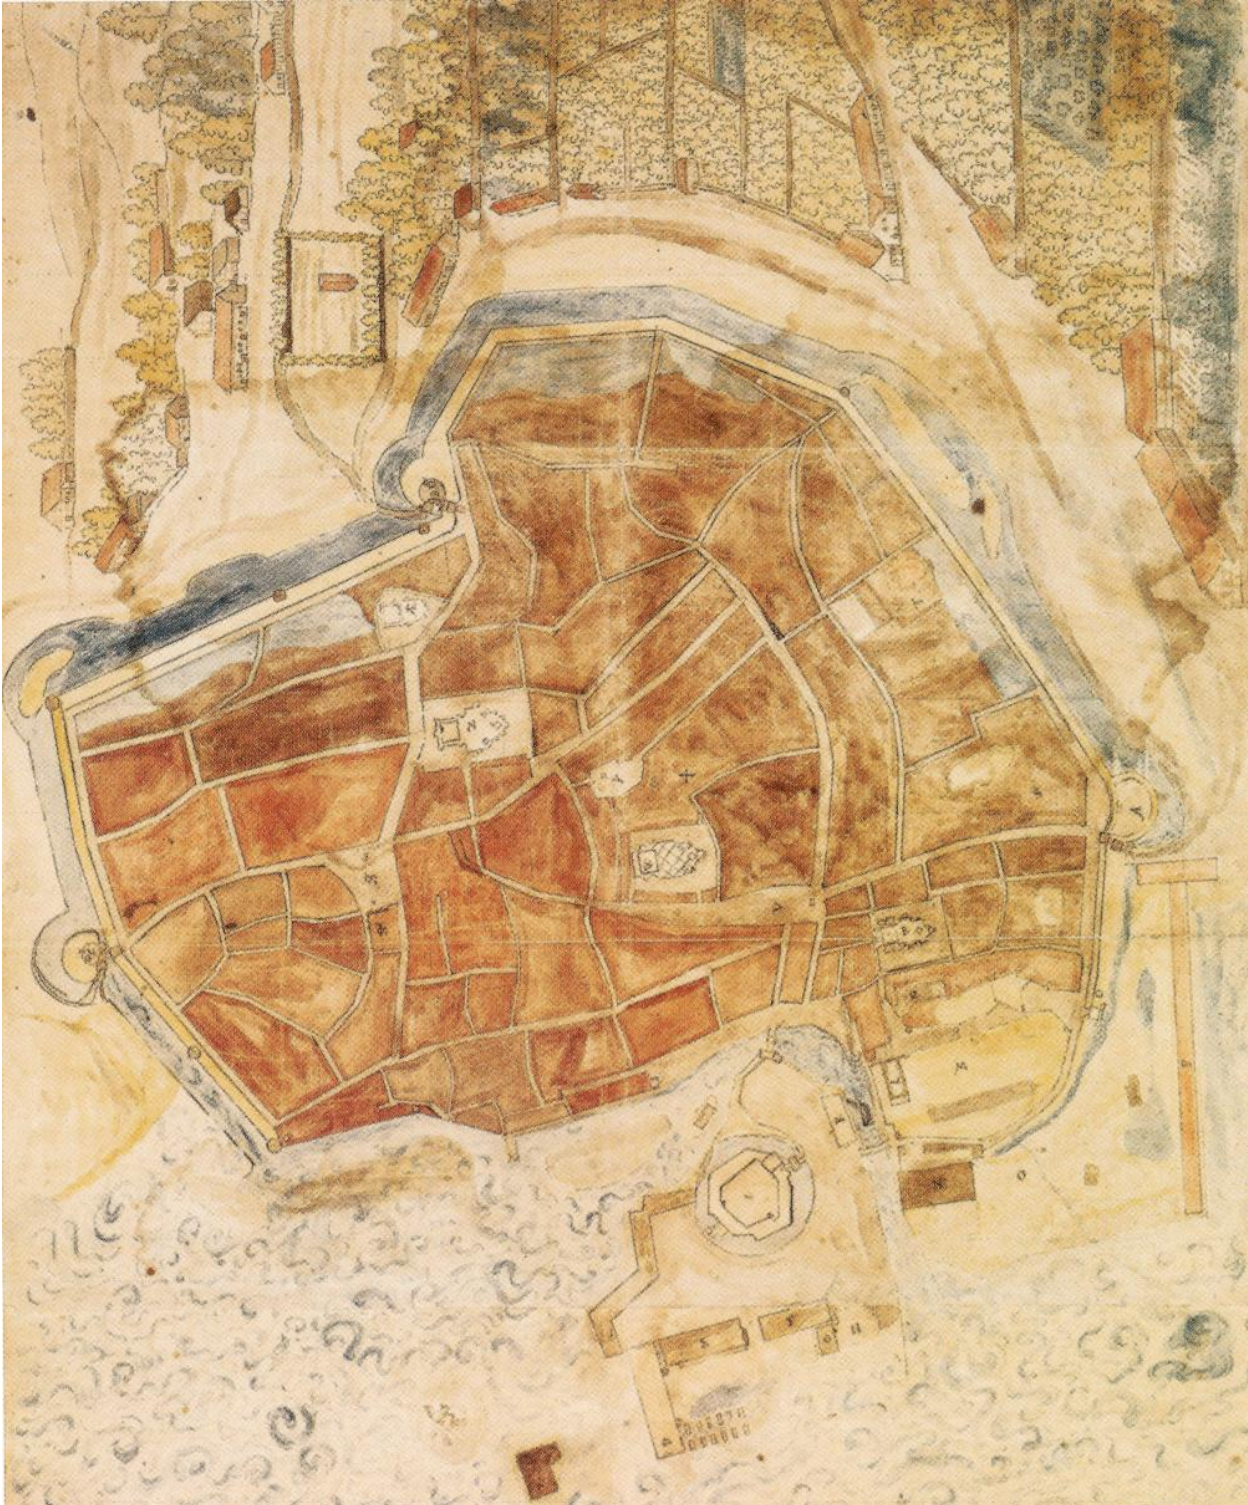
Fig. 151. The oldest map of Copenhagen from c. 1590 AD with Østervold and the eastern gate to the right. From Lorenzen 1930, kort I.

1926:235). In 1530 the rampart was made more massive on the inside by supporting the city wall with an embankment that was 16 cubits wide, but this estimated width is uncertain for the Østervold area due to the location of the nearby rampart street, buildings, etc. (cf. Lassen 1855:9; Thorsen 1926:234 and Fig. 151).

South of Østerport the Late medieval moat had contact with the sea – though in which way is still unclear. It could have been in the form of a stream as seen on the map from c. 1590 (Fig. 151), or as a small sluice as seen on the reconstruction proposal by Thorsen 1923 (Fig. 152).

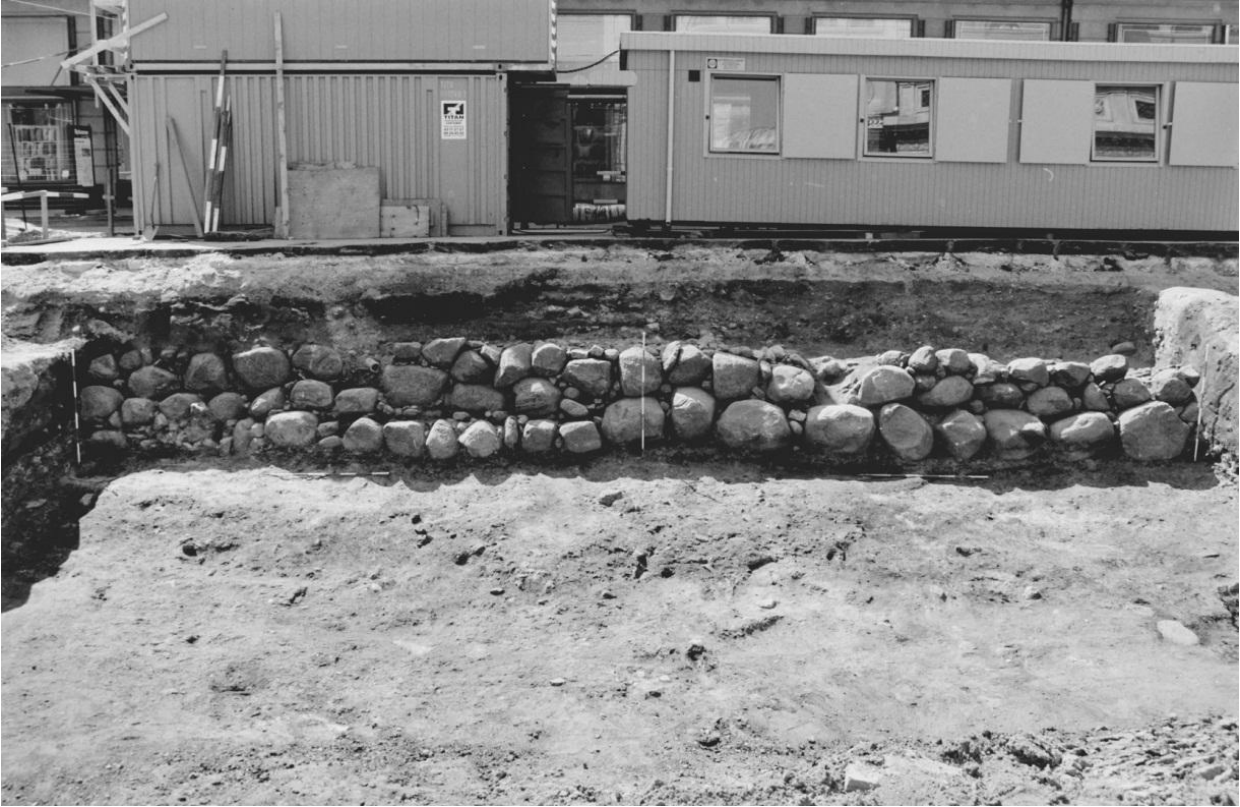
Fig. 153. Valkendorf's reinforcement of the fortification in the 1580s investigated at the Metro excavations in 1996–1998, facing west. Photo: Museum of Copenhagen.

At the Metro investigations in 1996–1998 this rebuilding of the fortification in the 1580s could be seen as a substantial stone structure consisting of two to three courses immediately east of the foundation of the medieval city wall, although the relationship between this development phase and older features was unclear at several points within the excavation area (Fig. 153). As part of the construction work the rampart partially had been made of peat (?) and made taller and wider, covering at least 1.4 m of the wall base (Kristiansen 1998:13, 98 et seq.; 1999c:185 et seq.).

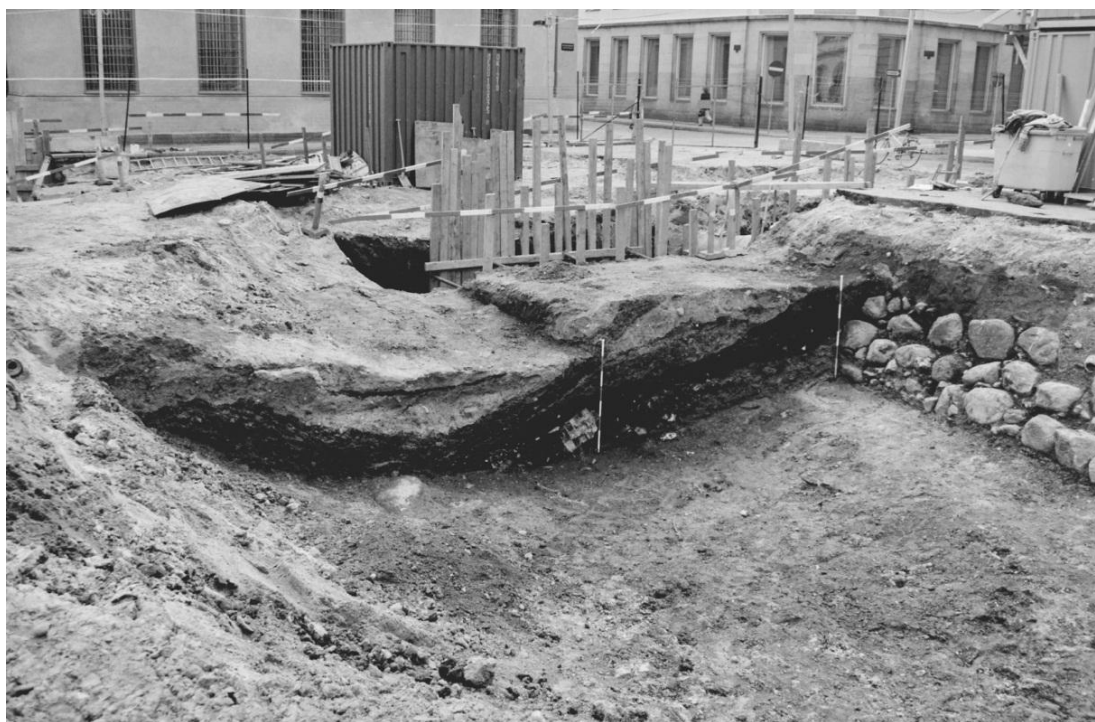
Fig. 155. Late medieval moat with sedimentation layers investigated at the Metro excavations in 1996–1998, facing SW. In the middle part of the section part of the destroyed city wall can be seen. Photo: Museum of Copenhagen.

At the former Metro investigations in 1996–1998 several samples were collected to determine the environmental conditions in the Late medieval moat. The sediments consisted of natural “gyttje” deposited in freshwater and swamp peat with vegetation that thrives on low water, the latter at kote +0.4 to +0.6 m, which proves that the connection to the sea at this moment was interrupted. Some of the layers recorded were interpreted as cleaning layers from the moat when still in use (cf. Kristiansen 1998:112 and 113; 1999c:188-190).

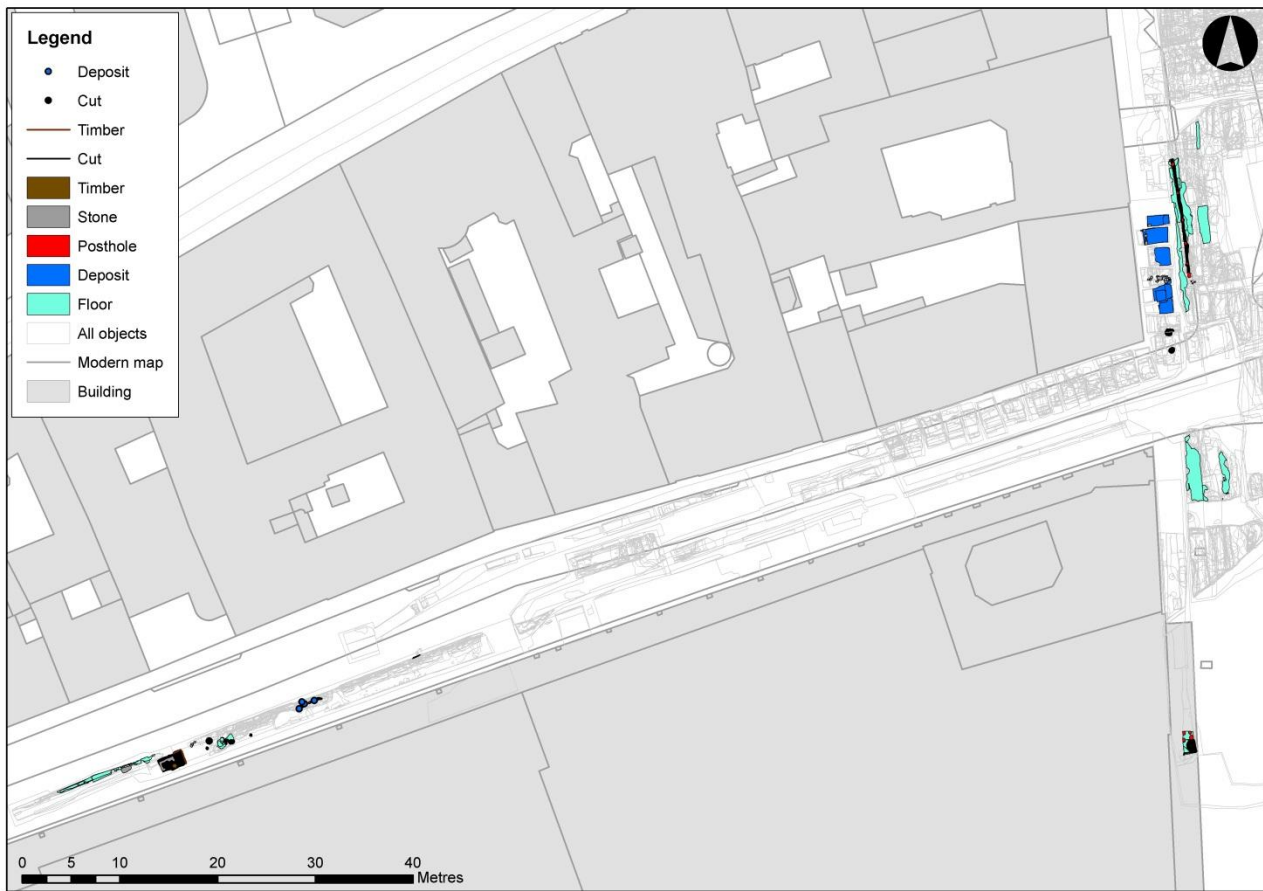
Fig. 157. All building remains from the High and Late medieval period.

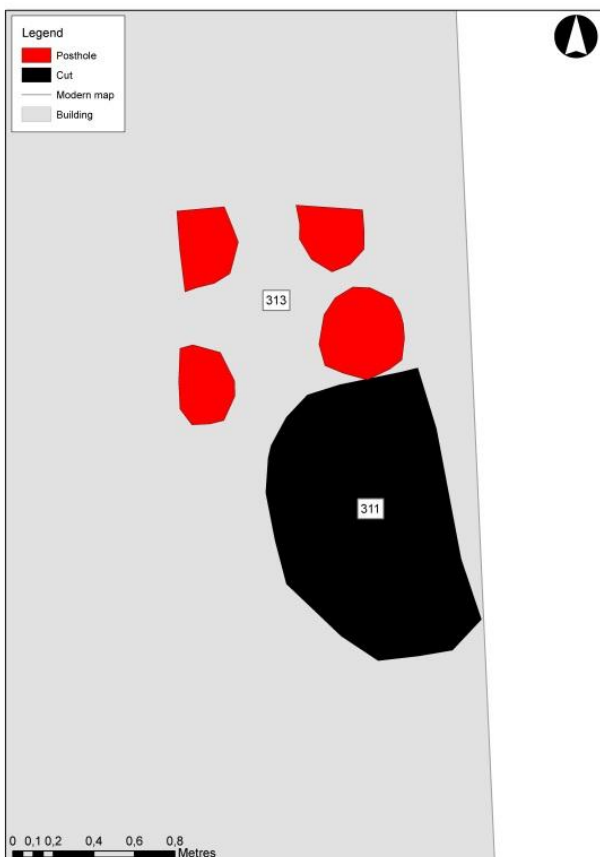
Fig. 159. The postholes and pit SG-311 representing interpreted building G-500871.

In subarea phase 1S G-500871 represents a probable building structure comprising an E-W stone wall foundation which constitutes an external southern wall, a group of four internal postholes and a barrel in a pit which could constitute a storage feature (SG-311) (Fig. 159 and 160). These features were all cut into possible floor or activity layers.

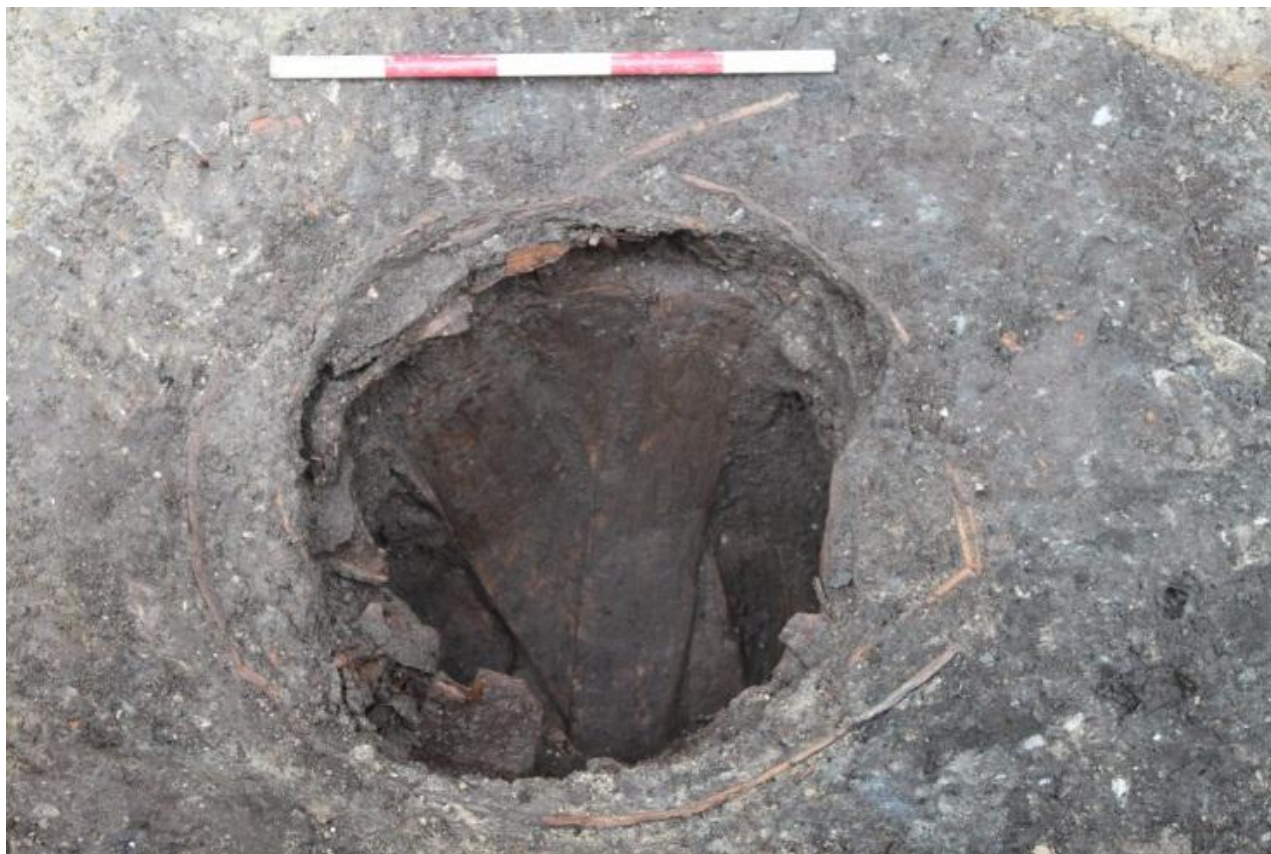
Fig. 160. Exposed upper part of wooden barrel SG-311, facing west. Photo: Museum of Copenhagen.

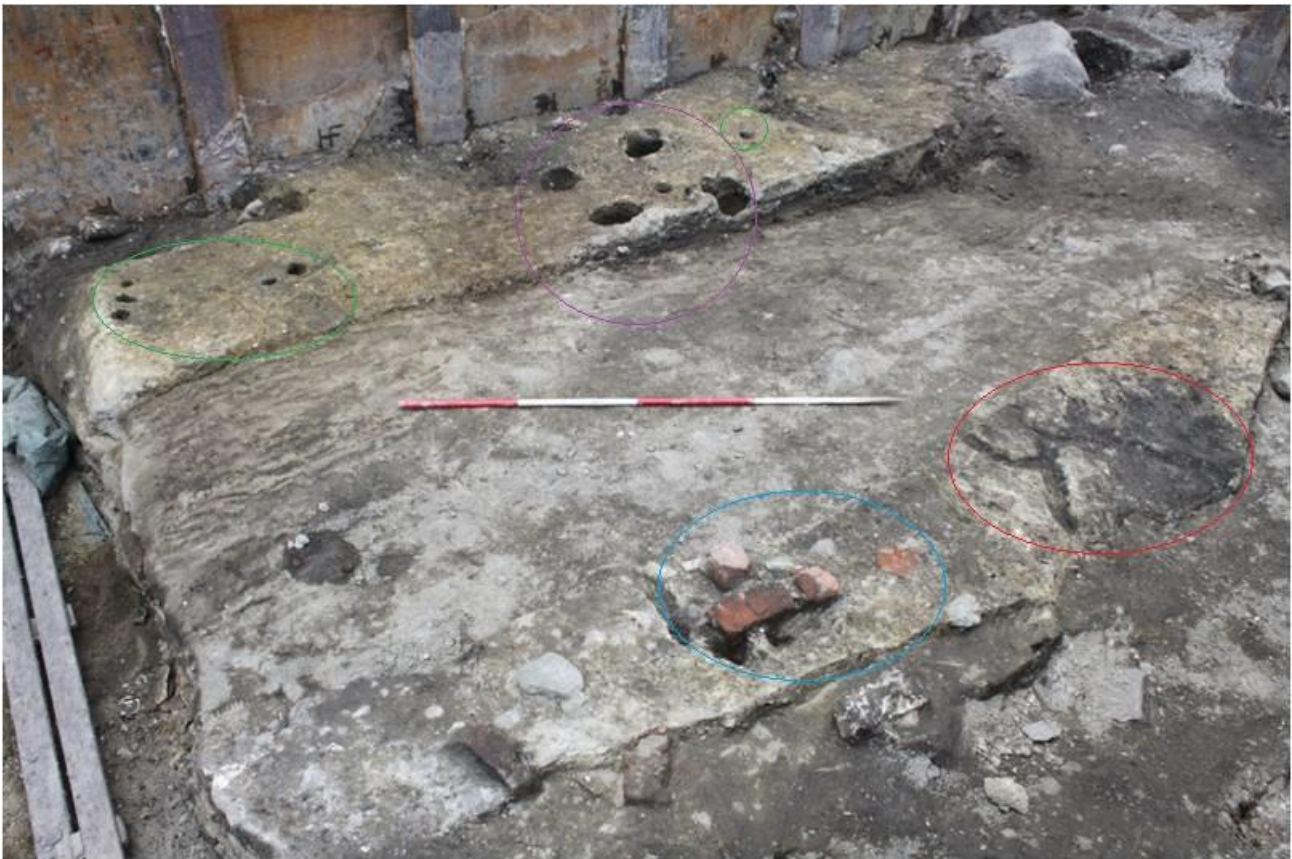
Fig. 161. Yellow-grey surface (SD155640) in phase 1 and 2 of the forge G-660. To the right are the impressions of possible equipment like bellows SG-668 marked with a red circle. Stakeholes SG-661 are marked in green circles and the northern part of SG-663 is marked with a blue circle. Cutting through (SD155640) in the upper part of the picture marked with a purple circle – four of the postholes within G-302 – see paragraph on phase 2. Photo: Museum of Copenhagen.

The surface consisted of a stony layer which was interpreted as a hard wearing floor surface upon which to construct the internal elements of the forge. It showed signs of wear from significant human activity. The surface had various elements cut into it which have been interpreted as relating to the internal structure of the forge; stakeholes (G-661) were thought to represent part of a framework for equipment, while SG-663 consisted of two brick platforms and two sets of impressions, all of which would have carried equipment within the forge. SG-668 was interpreted as the impression of bellows, with SG-669 as potentially part of the framework which supported them. The brick platforms showed signs of wear, and so could have been supports for an anvil base or for a quenching bucket, etc.

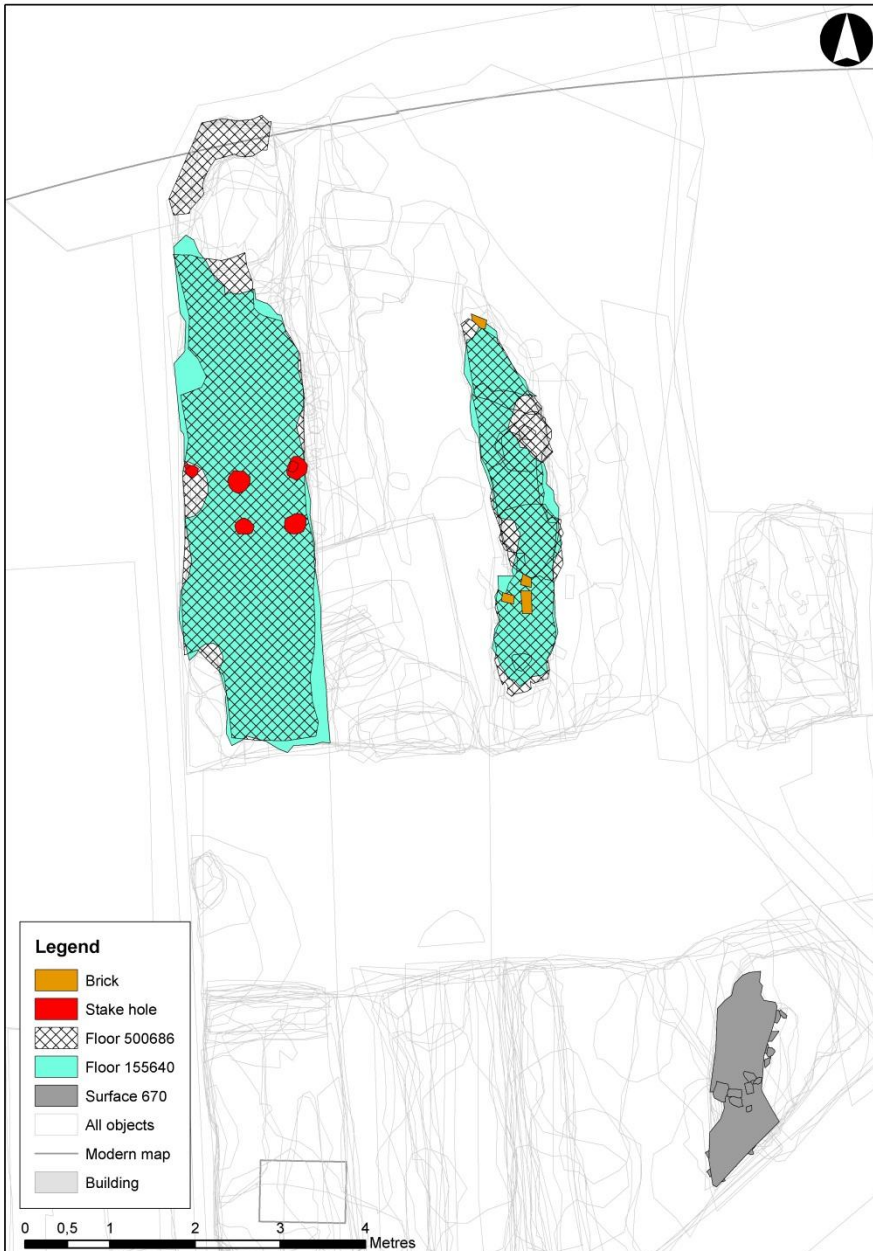
Fig. 162. Floor SD155640 and bricks SG-663 represents phase 1 of the forge. Postholes SG-302 and floor layer SD500686 represents phase 2. To the lower right is surface G-670.

Phase 1 was overlain by floor SG-500686 which represents an episode of re-flooring and running repairs, thought to be a restructuring of the building because the floor cancelled out a series of earlier postholes, and had a series of new postholes cut into it (Fig. 162). However, there also appeared to have been a continuation of activity, as this flooring was laid around the brick platforms in SG-663. It was thought on site to have been very clean and so could have been regularly swept whilst in use. It was also noted that the southern half of the western side was slightly depressed and more mixed which could indicate a trampled area. Floor repair (SD154552) within this group at the eastern side of the

forge, was thought to have been the result of some activity associated with metal production and could represent a smithing pan. Cut through this floor was posthole group (SG-302), the main four postholes of which were thought to represent a structure within the forge – possibly a working platform, as the area to the south of it was very compacted and heavily used (Fig. 162). Pit (SG-500687) was also recorded as having been cut through this floor layer, however given the amount of truncation the interpretation is difficult – it could have had a specific function within the forge, or it could represent the deconstruction of the structure.

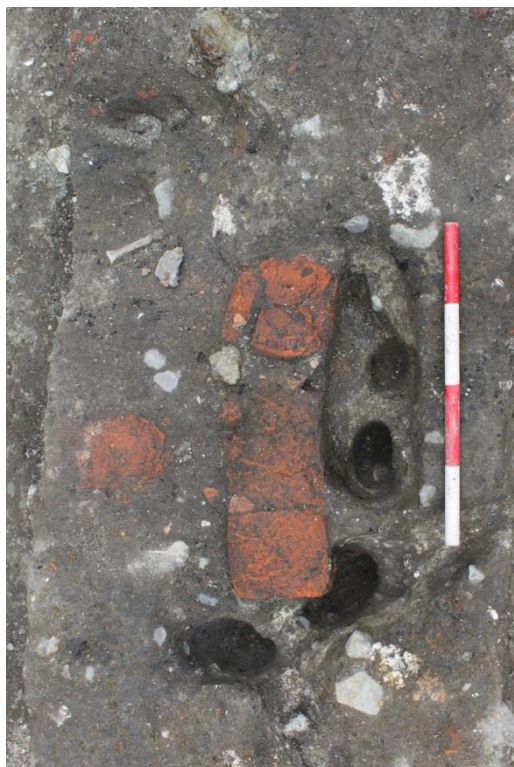
Fig. 163. Bricks (SS155322) together with stakeholes (SG-500882) facing north. Photo: Museum of Copenhagen.

Stakeholes SG-500882 represents a probable structural repair or alteration to the brick platform SG-663 (Fig. 163). It is uncertain what form these repairs may have taken – a horizontal frame is a possibility or a continuation of stakes to form a frame or fence. A curve in the southern gully (SC155031) was thought to have been caused by the placing of a

barrel or bucket which wore down a groove. These repairs were deliberately deconstructed, as shown by the elongation of the holes made when the stakes were removed, which supports other evidence that the forge was deliberately deconstructed. Over this repair was a small area of re-flooring, (SD154360), which was slightly green and contained some copper slag. If copper was being worked here as well as iron, then that may explain the green colour of the floor repair (SD154552), mentioned above.

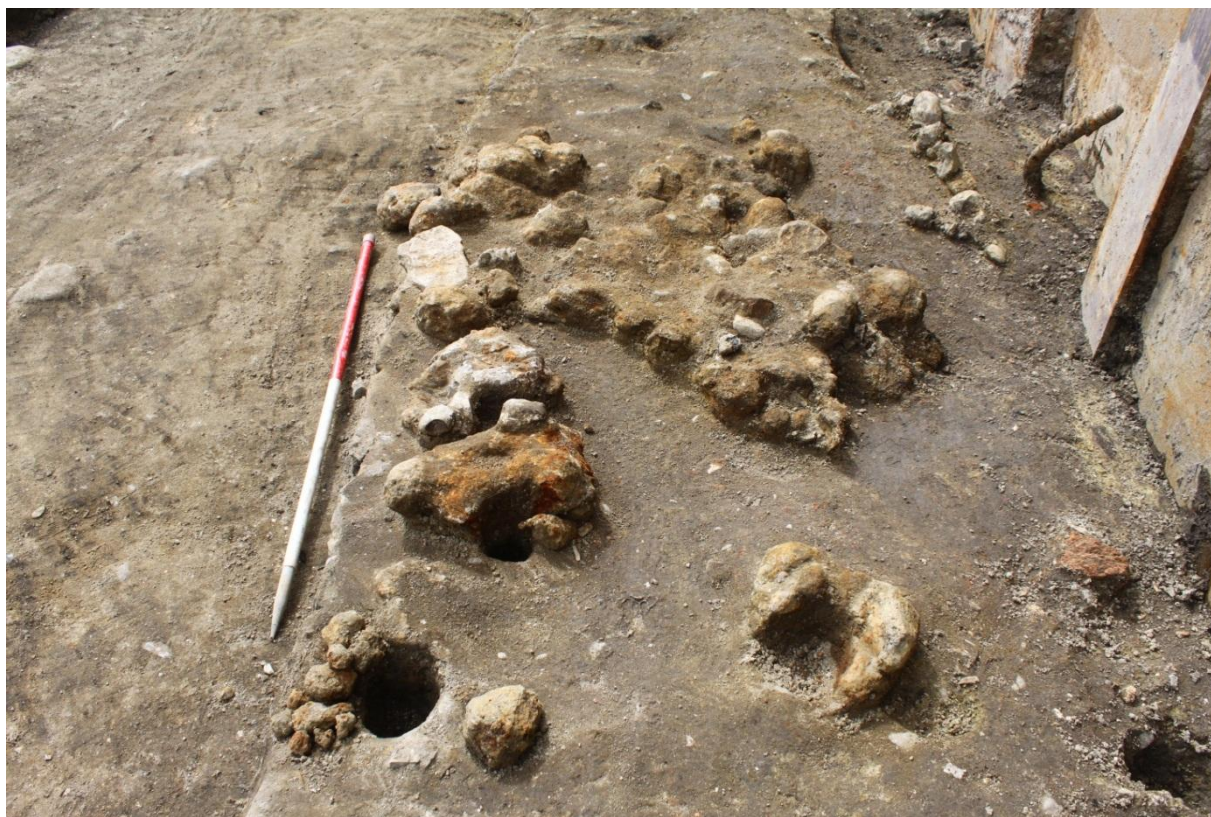
Fig. 164. Slag in context (SD154576), facing south. Photo: Museum of Copenhagen.

The analysis of slag from (SD154576 and SD154379) indicated that the activities taking place within the forge were primary smithing. Also, a hammerscale sample from (SD154279) shows that the only process performed in the workshop was primary smithing (Jouttijärvi 2013:3). The origin of the bloom iron points to Norway and Sweden, and slags found in other areas of the excavation were almost identical in composition to the slag material from forge building G-660. This either indicates that the forge deposited its waste material over a large area, or it is a sign of more than one forge in the area that worked iron blooms from the same common source (Jouttijärvi 2013:1).

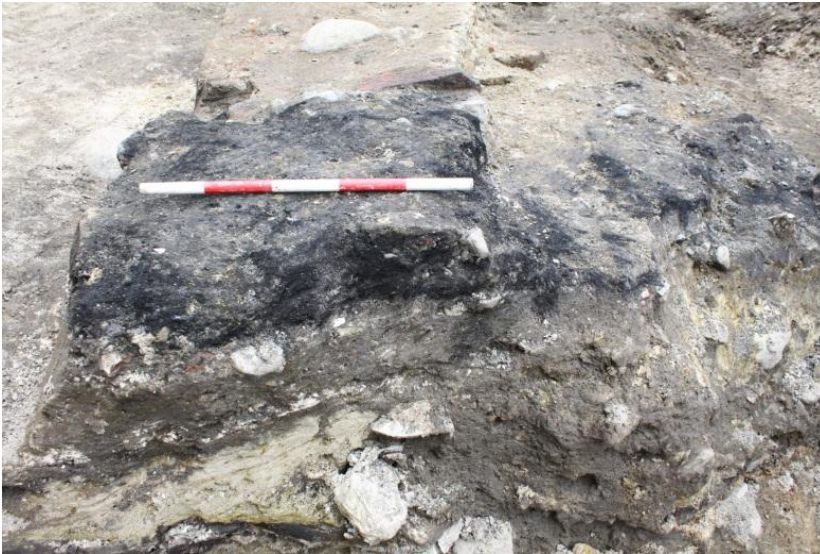
Fig. 165. Deposit (SD154859) of charcoal in G-500688 facing north. Photo: Museum of Copenhagen.

G-500688 represents some sort of burning activity (Fig. 165). It has been interpreted as a hearth, or representative of some industrial process or metalworking, as evidenced by the presence of lime in the middle deposit (SD156248). No plant material was found in the deposit, indicating that this was unlikely to have derived from domestic activity. No metal was found in the lowest deposit (SD156413), but the uppermost charcoal layer (SD156232) contained a moderate amount of hammerscale and animal bones, which could suggest a change in the type of activity taking place in the area. There were no positive structural elements associated with this group, therefore it was not possible to associate this activity with a forge building and it is stratigraphically older than G-660 and in the same location, but it could at least be a predecessor.

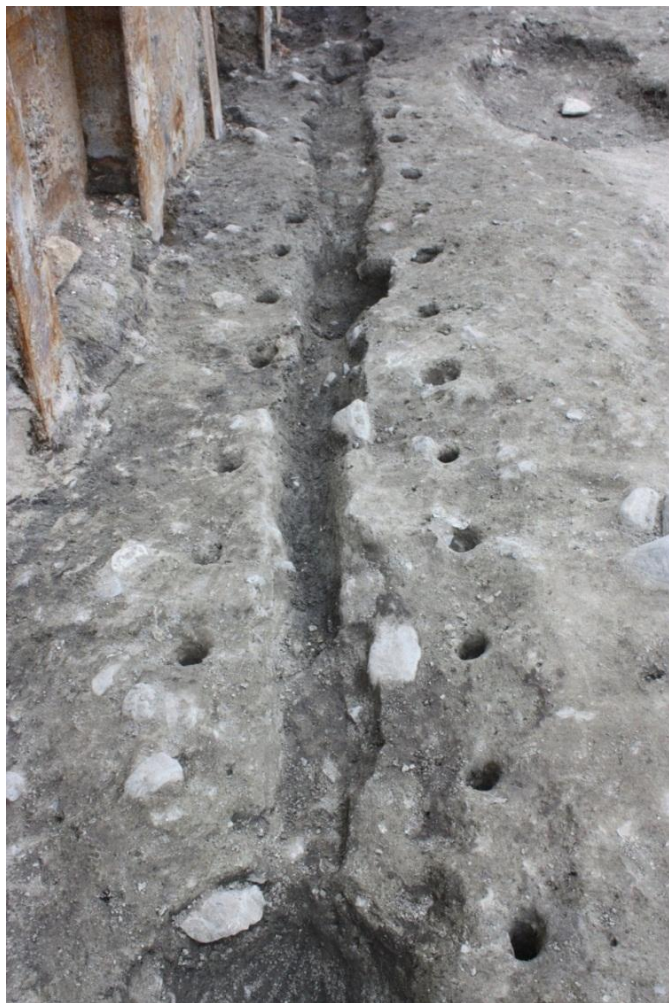
Fig. 170. Part of fence line G-310104. Between the two rows of stakeholes is the cut for the sill beam belonging to building G-580 (see above), facing north. Photo: Museum of Copenhagen.
