16 Phase 4d Late medieval and Renaissance fortification 1350–1600 AD

16.1 Results

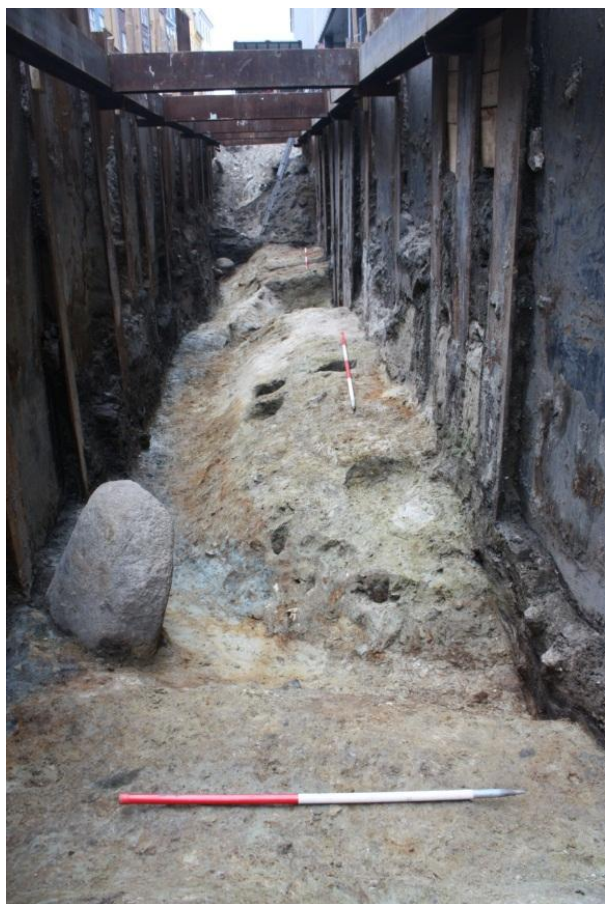
Fig. 171. Part of exposed boundary ditch (the cut) G-210, facing NE turning to the south at the west end. Photo: Museum of Copenhagen.

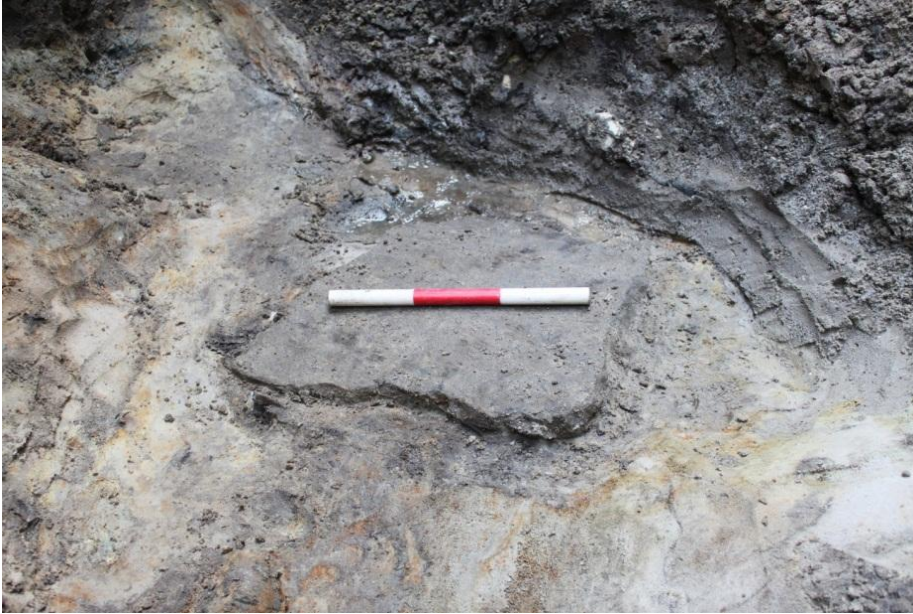
Fig. 174. Stepping stone (SS62992; G-968), facing east. Photo: Museum of Copenhagen.

The pad stone (SS62992) was pressed into natural and could represent a stepping stone (Fig. 174). It was found in the NW corner of building G-205, and so may have been a corner pad stone for the wall, but it was not registered during the excavation of the building.

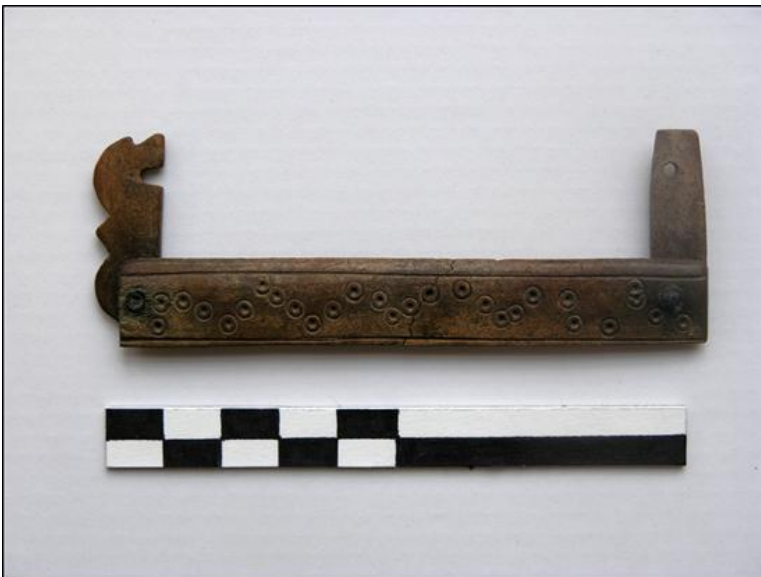
Fig. 175. Fragment of Late medieval bone comb case (FO203594) with incised ring and dot ornaments and butterfly terminal plates. Fixed with copper rivets. Find from ditch G-986 which is a later phase of ditch G-210. Photo: Museum of Copenhagen.

The ditch probably had the same function as ditch (G-210) to the NE, and there appeared to have been a gap between them where building remains (G-204) and (G-205) were located. G-968 is on the same stratigraphical level as G-252 which means it is a later phase of G-210. Finds of early redware and older type Siegburg do indicate a High medieval date for the ditch (cf. Fig. 175). G-204 is stratigraphically younger than G-210 and might represent a change of use in the area.

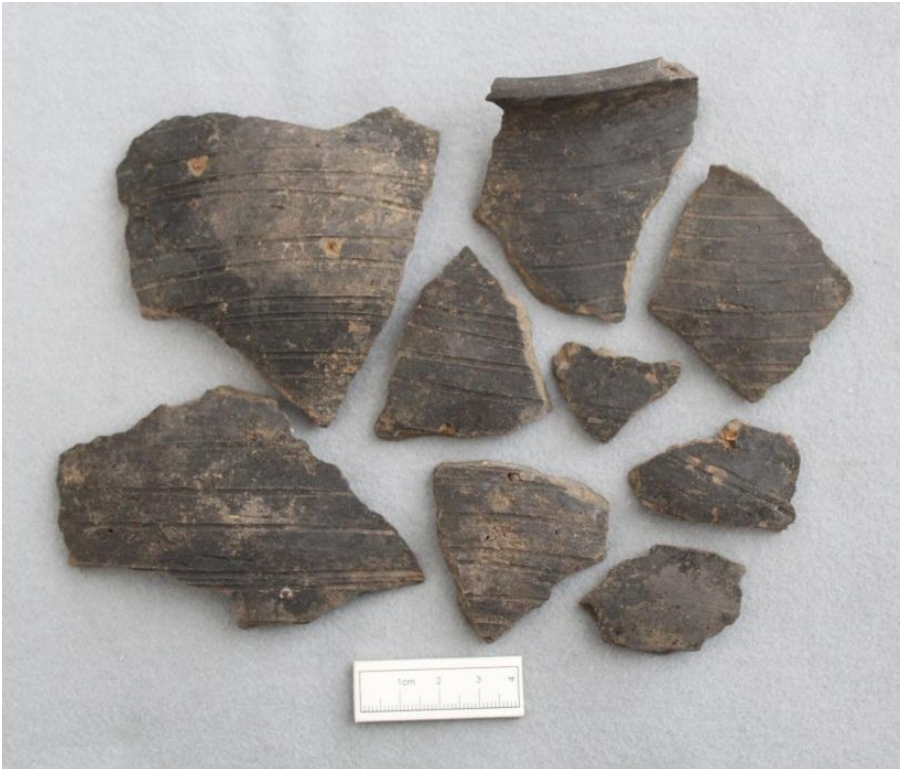
Fig. 177. Baltic ware pot (FO203807) with everted rim and incised horizontal lines from SG-439 in ditch G-210. Date: 1000–1200 AD. Photo: Museum of Copenhagen.

G-210 is cut by building G-253 which is interpreted as dating to the 14th century. Based on finds the ditch could date back to the 12th century, but definitely in the 13th century (Fig. 177 and 178).

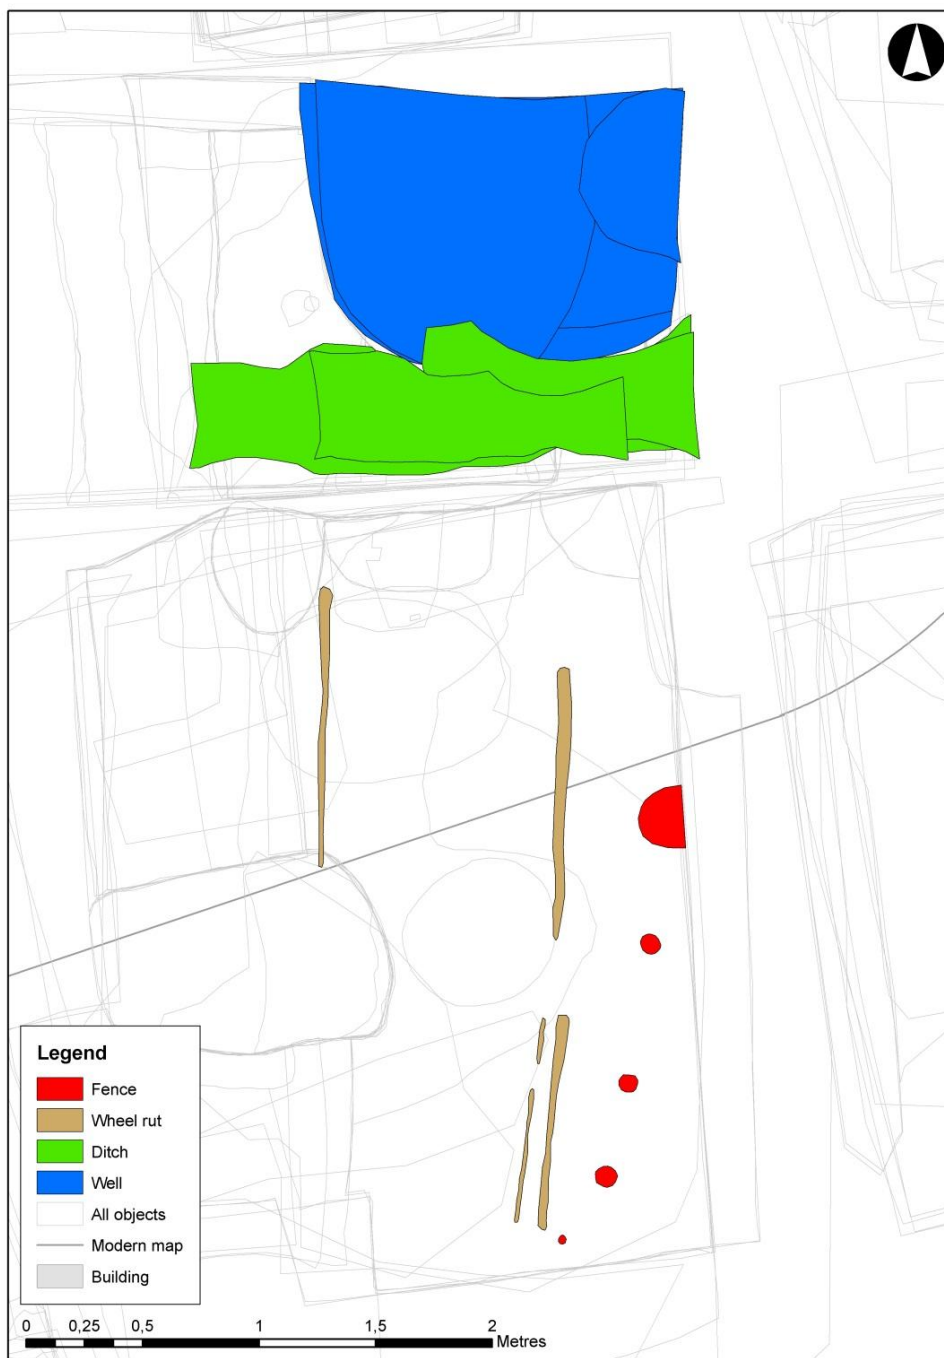
Fig. 179. Well G-250 with wheel ruts G-371, ditch G-310 and fence line G-365.

Wheel ruts G-371 represents four shallow depressions that were oriented north-south. The distance between the ruts was approximately 1.0 m. They were aligned with fence line G-365 consisting of a NNE-SSW alignment of five post- and stakeholes, where the southernmost stakehole was a bit out of alignment to the west and a little shallower. The fence line yielded no finds or suggested date, but placed just west of the wheel ruts, the fence line could be part of the same structure (Fig. 179). The wheel ruts are later than boundary ditch G-310 and must represent a new use of the area. They were leading to well G-250 which suggests that the street had been used in connection with either the construction, use or deconstruction of the barrel lined well.

The distance between the wheel ruts agrees with what has been observed in Østerport just north of phase 2+3 (see Chapter 15.1). It is more than likely that these wheel ruts represent a phase of the rampart street leading to and past the inner gate building.

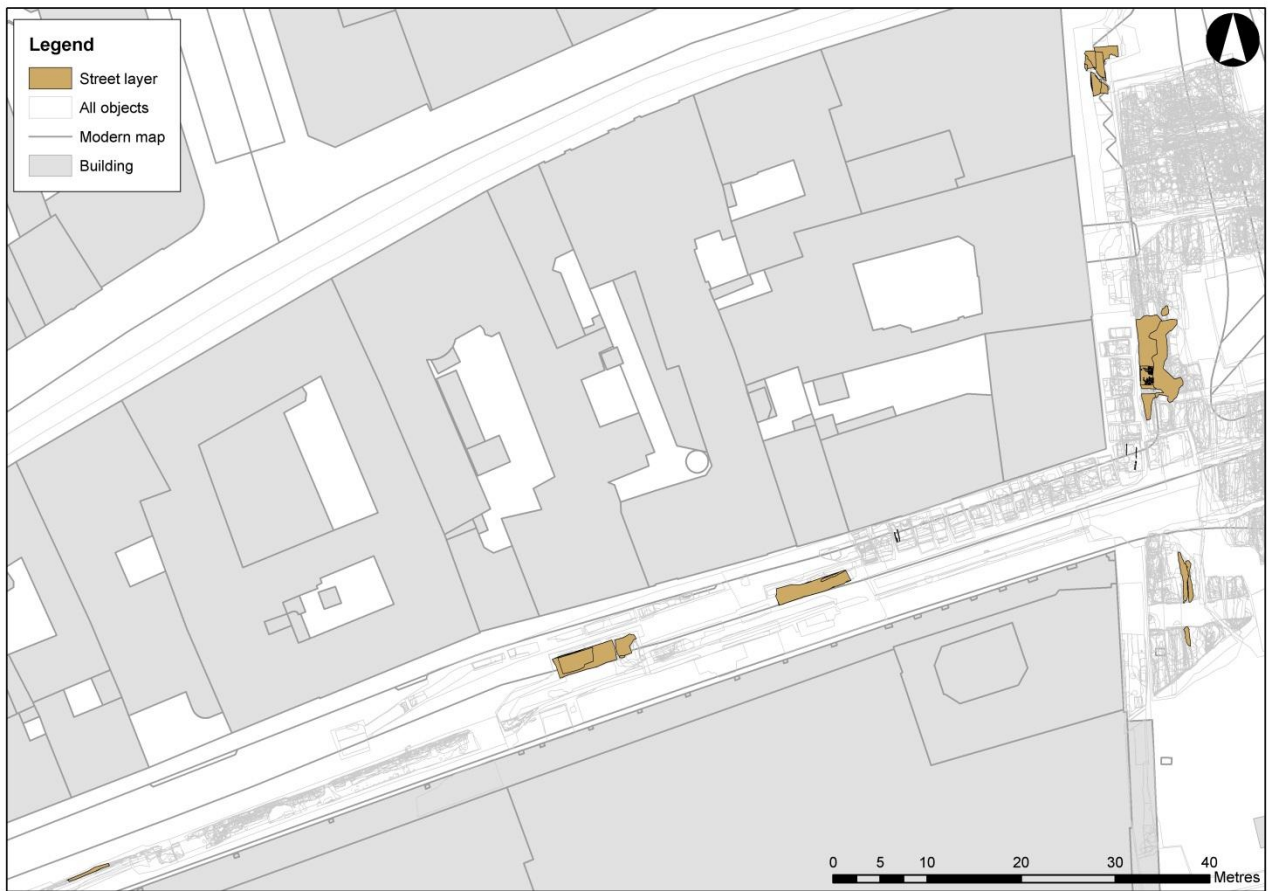
Fig. 180. All streets in the High and Late medieval period, G-500919.

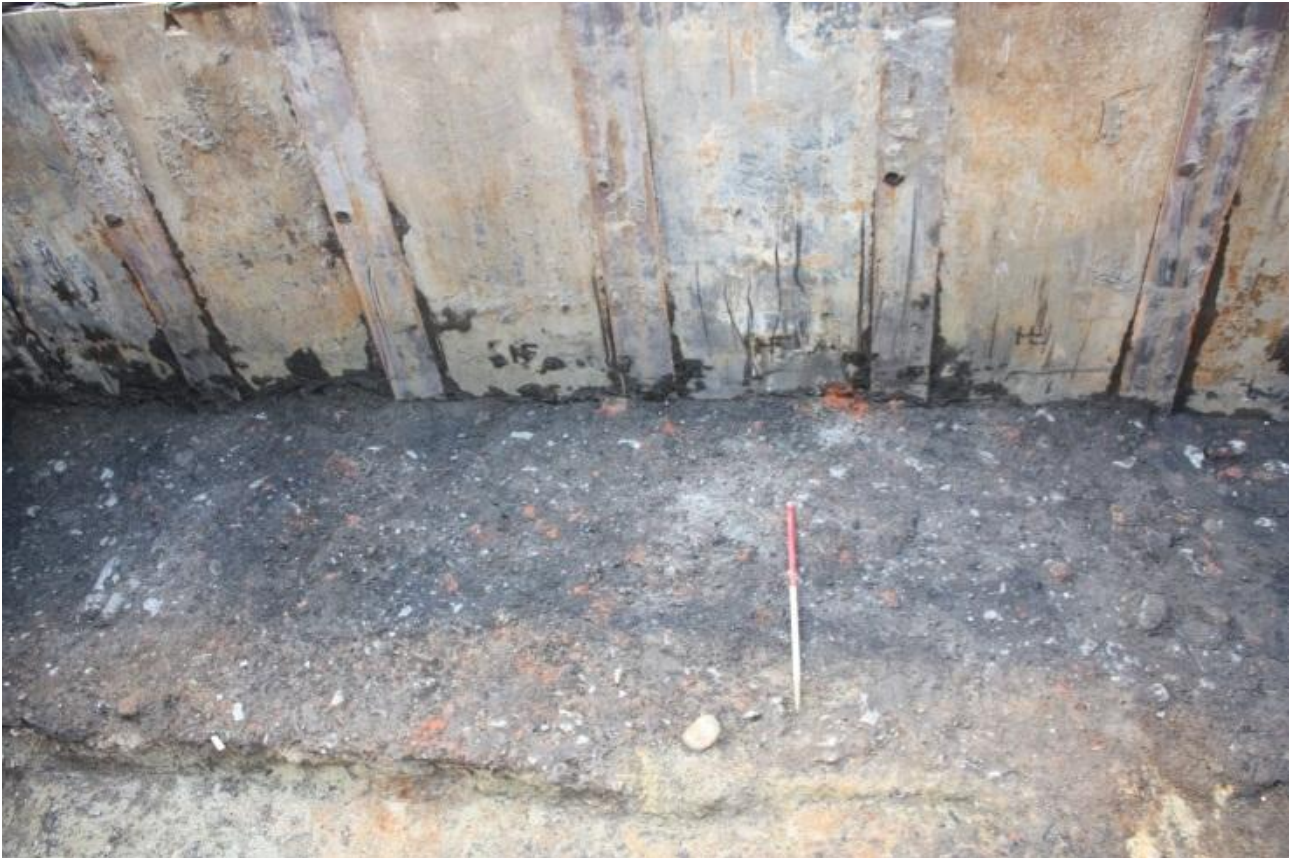
Fig. 181. Street G-744, facing south. Photo: Museum of Copenhagen.

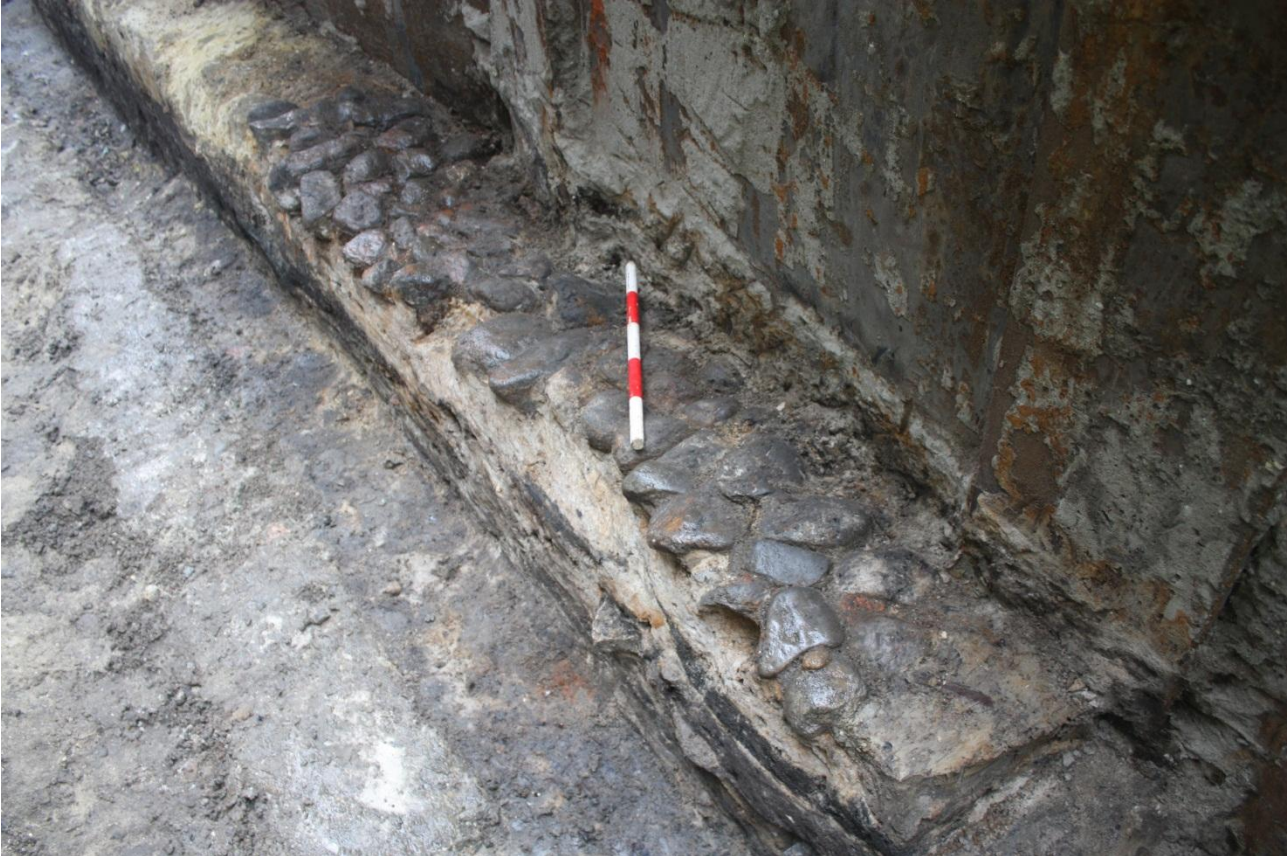
Fig. 182. G-979 with a cobbled surface of granite stones, facing NW. Photo: Museum of Copenhagen.

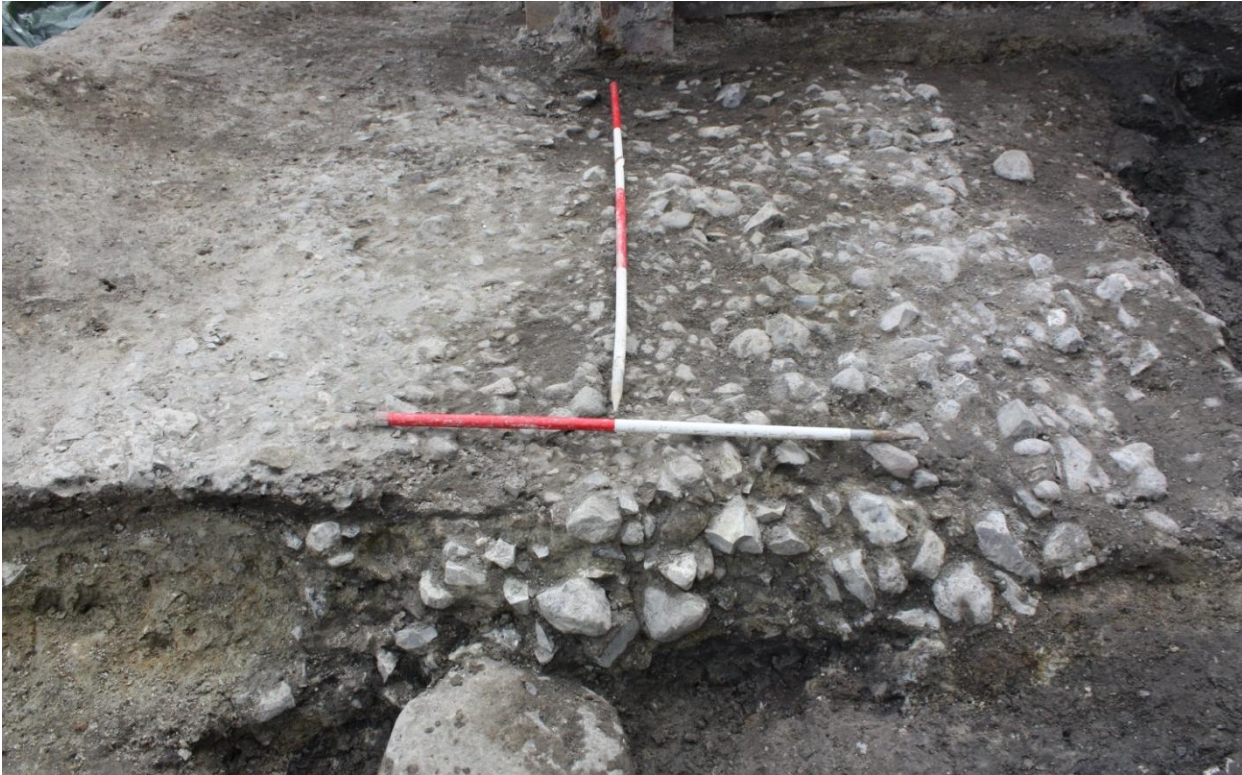
Fig. 184. Part of street surface (SD81926) in rampart street G-490, facing south. Photo: Museum of Copenhagen.

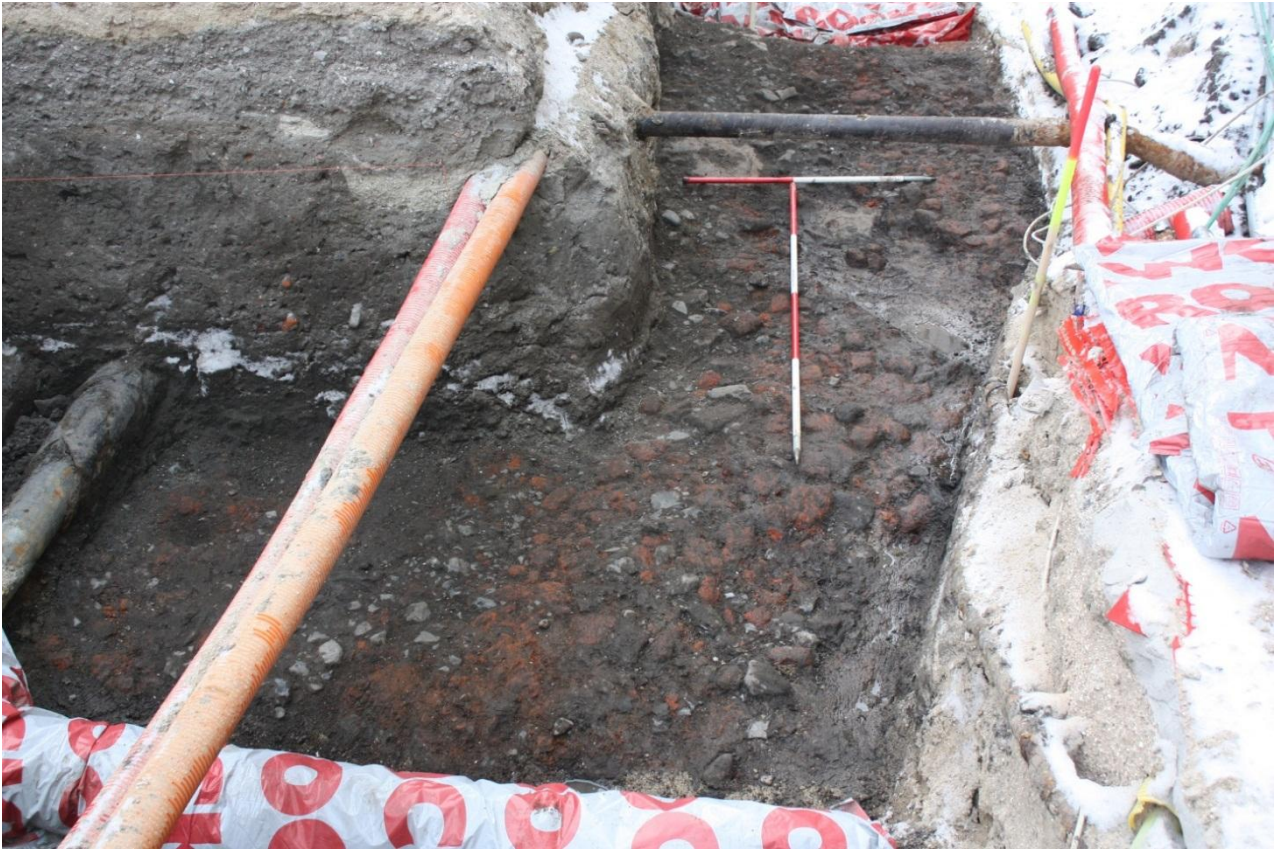
Fig. 185. Stones and brick rubble surface (SD30725) in street G-500878, facing south. Photo: Museum of Copenhagen.

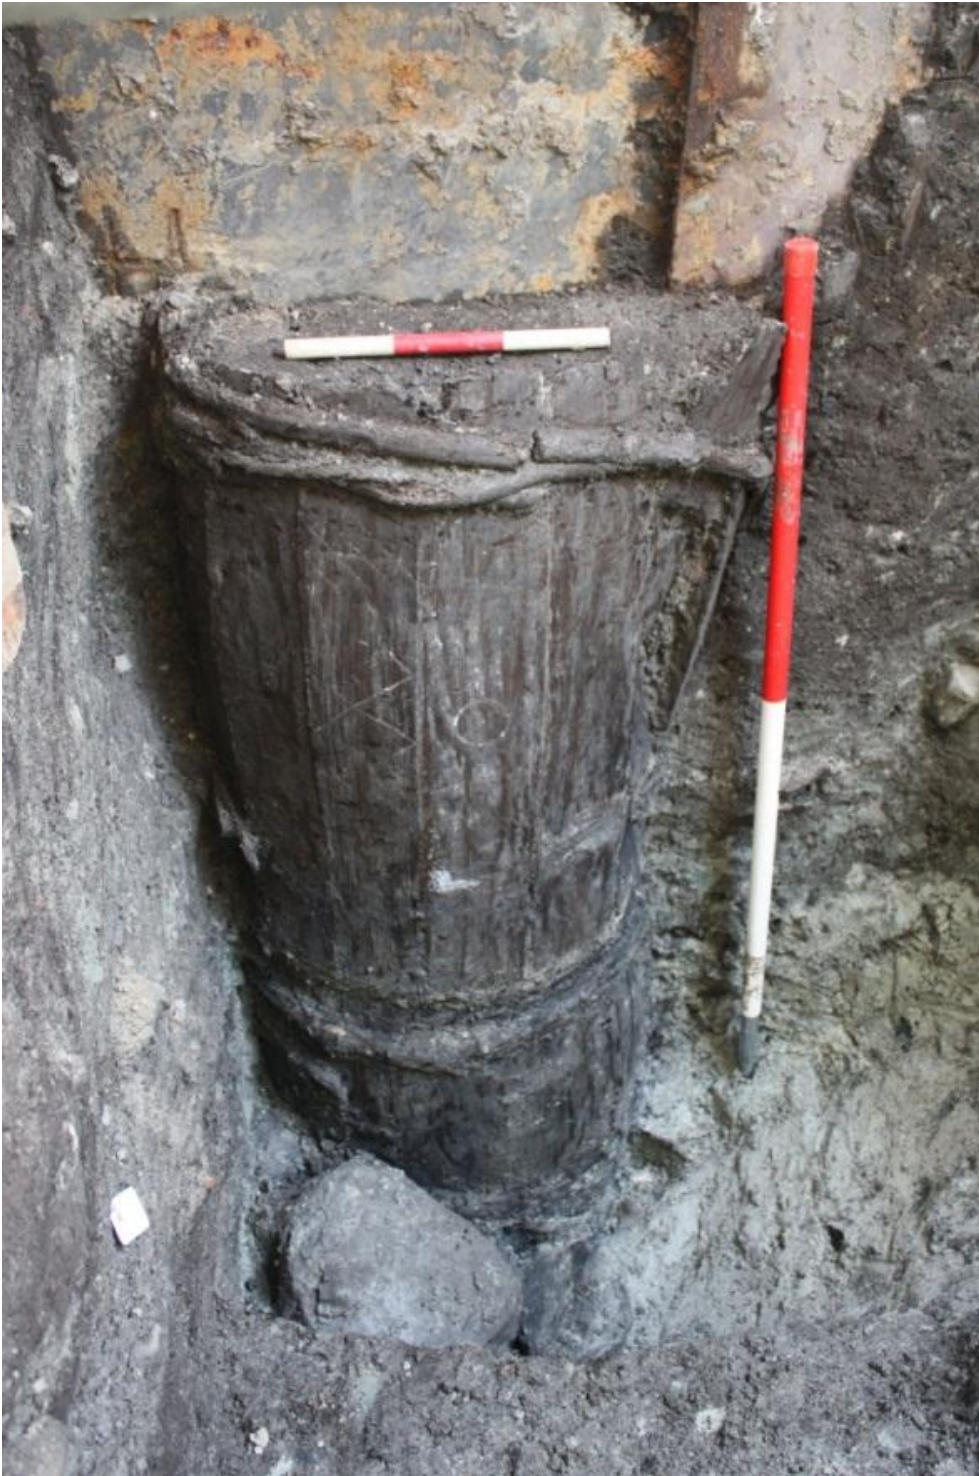
Fig. 186. G-250. Upper and lower barrels in situ, facing east. Photo: Museum of Copenhagen.

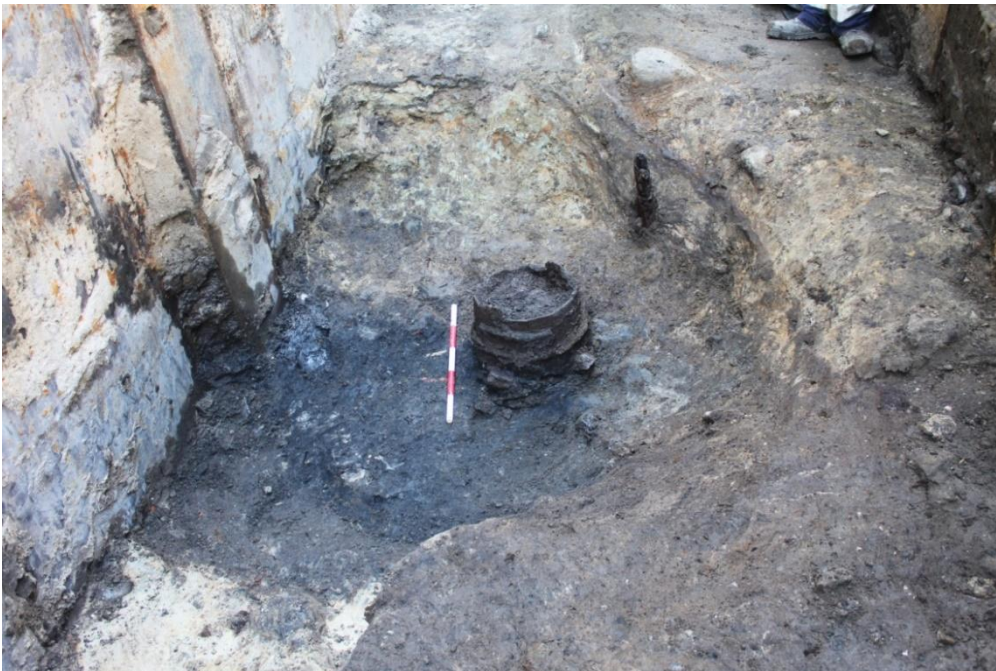
Fig. 187. Post-excavation. Exposed bucket SG-239913 and one of the vertical stakes, facing SW. Photo: Museum of Copenhagen.

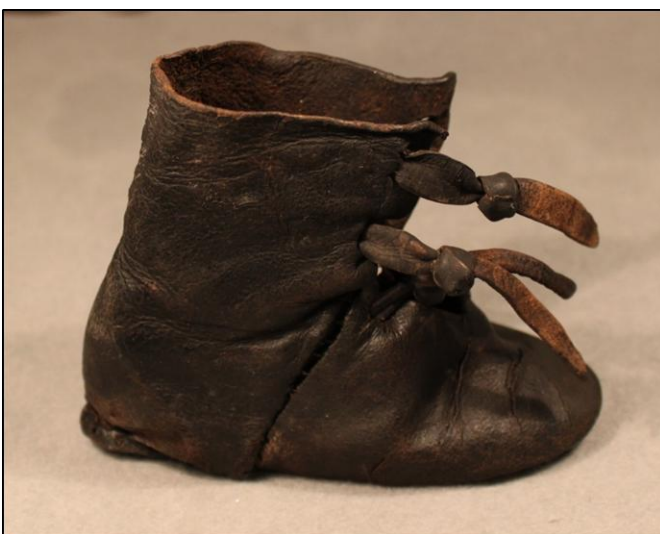
Fig. 188. Intact medieval child's ankle boot (FO202484) found in bucket SG-239913.

SG-239913 is a bucket and its fills found within pit G-209 (Fig. 187). The bucket had a diameter of 0.24 m and was 0.23 m deep. The fills were thought to be part of the disuse of the bucket and pit (household waste) (cf. Fig. 188), with the possible exception of 201876, which consisted of the degraded remains of the base and some of the underlying deposit. It may also have contained some remains associated with the final use of the bucket, so it is interpreted as part of the usage.

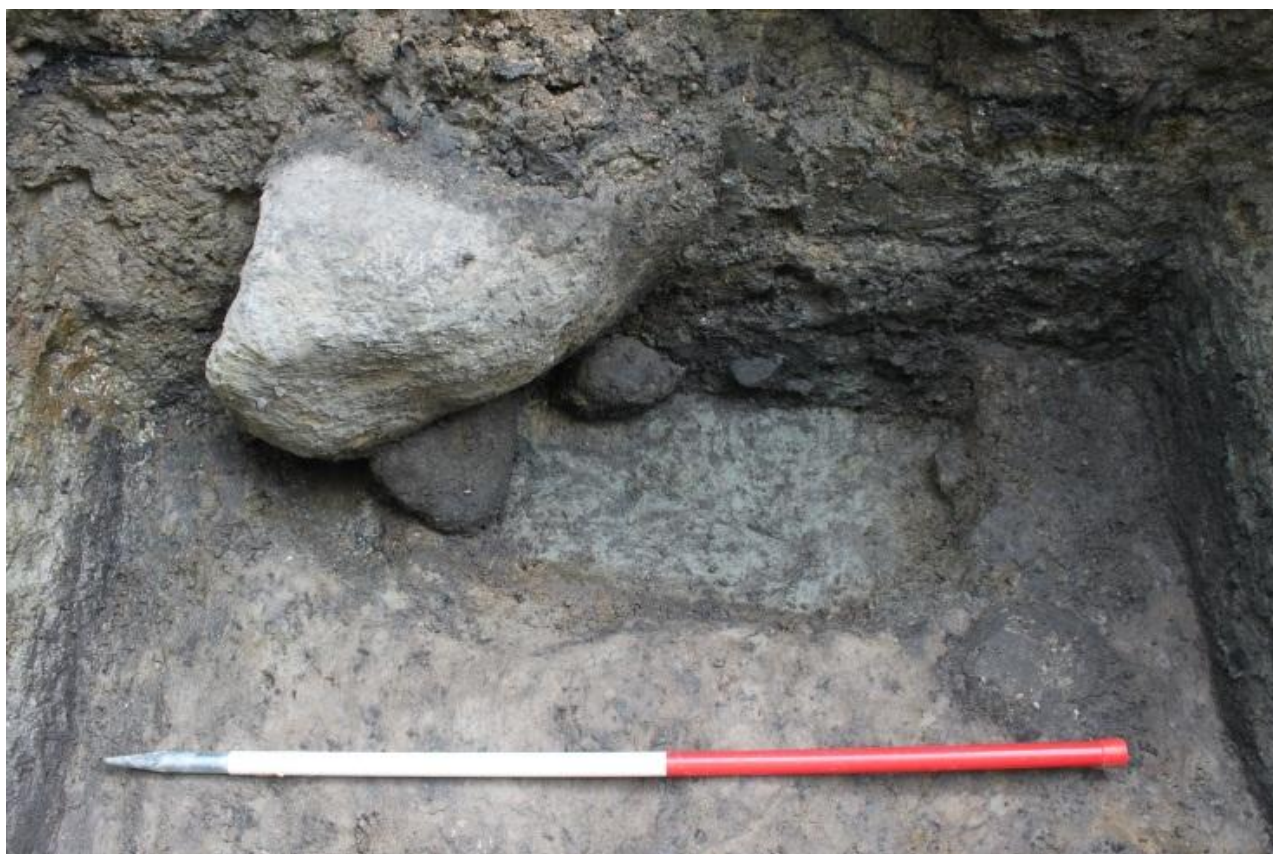
Fig. 189. Exposed pit G-298, facing east. Photo: Museum of Copenhagen.

G-298 represents a sub-circular shallow pit. It occurred at a similar stratigraphic level to boundary ditch G-297 to the north, and was aligned with the stakeholes (G-536) to the west, so this pit could relate to the estate or field boundary (Fig. 189). These activities belong to some of the stratigraphically oldest features in the area. Among the finds are ceramics (late greyware 1200–1450 AD).

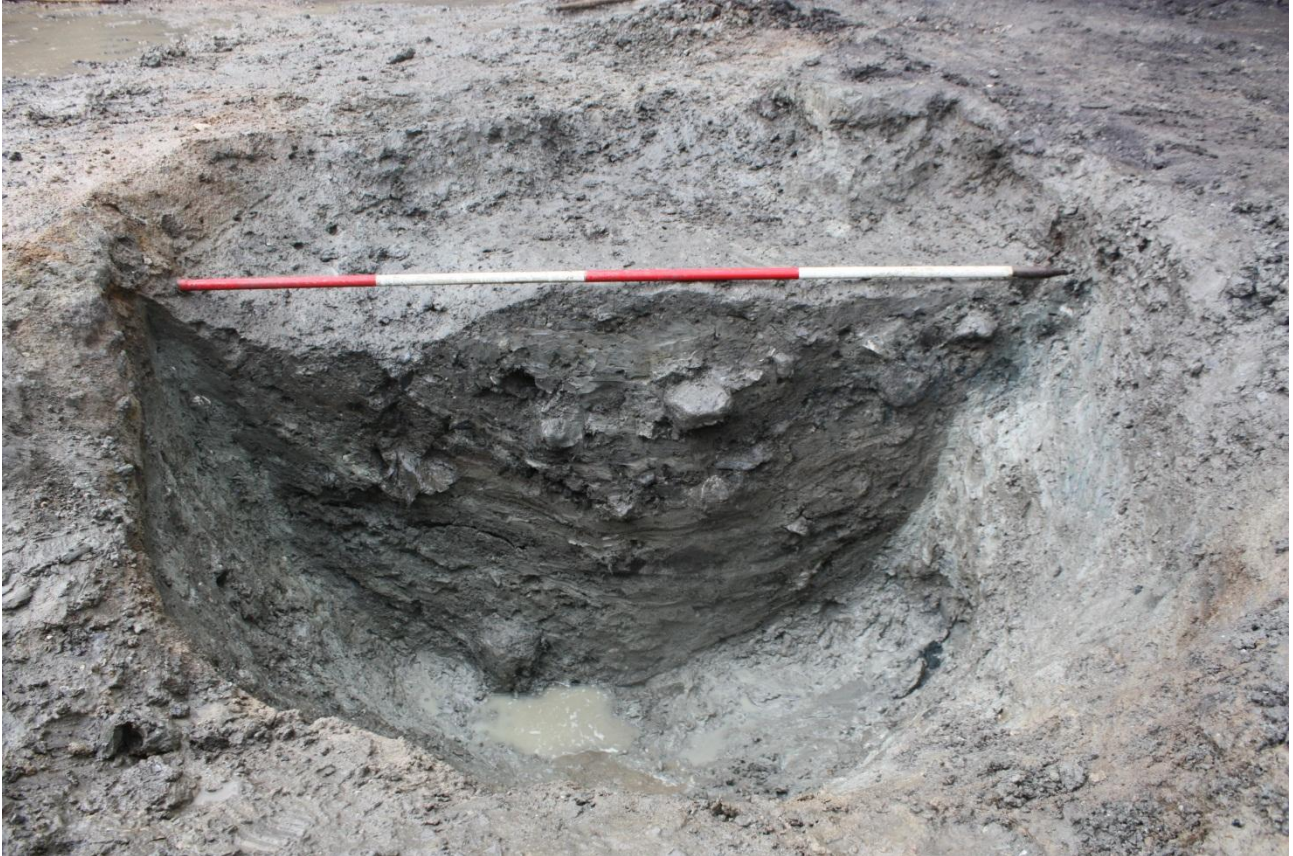
Fig. 190. Section of pit (SC89178) with different backfills, facing south. Photo: Museum of Copenhagen.

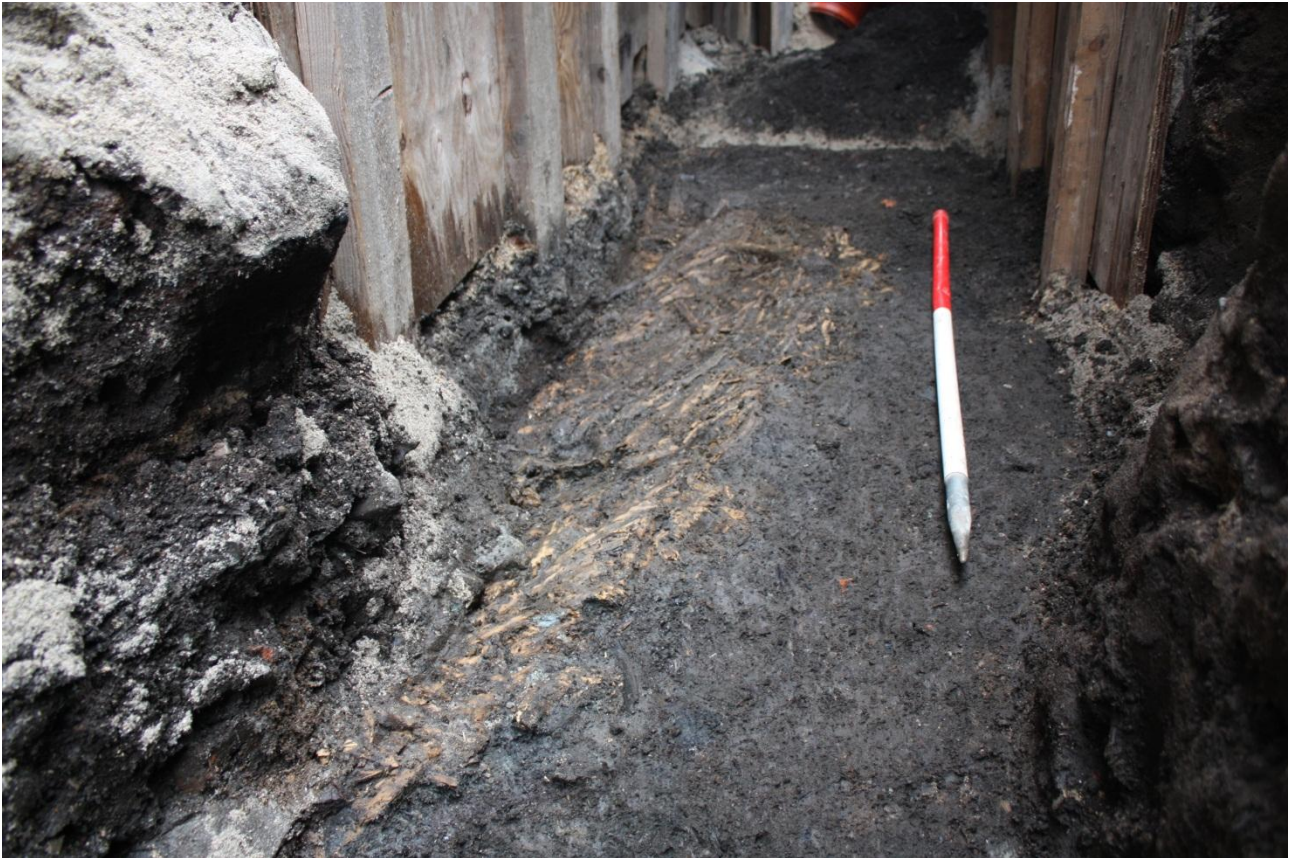
Fig. 191. Wattle (ST29125) in pit group G-500056, facing NE. Photo: Museum of Copenhagen.

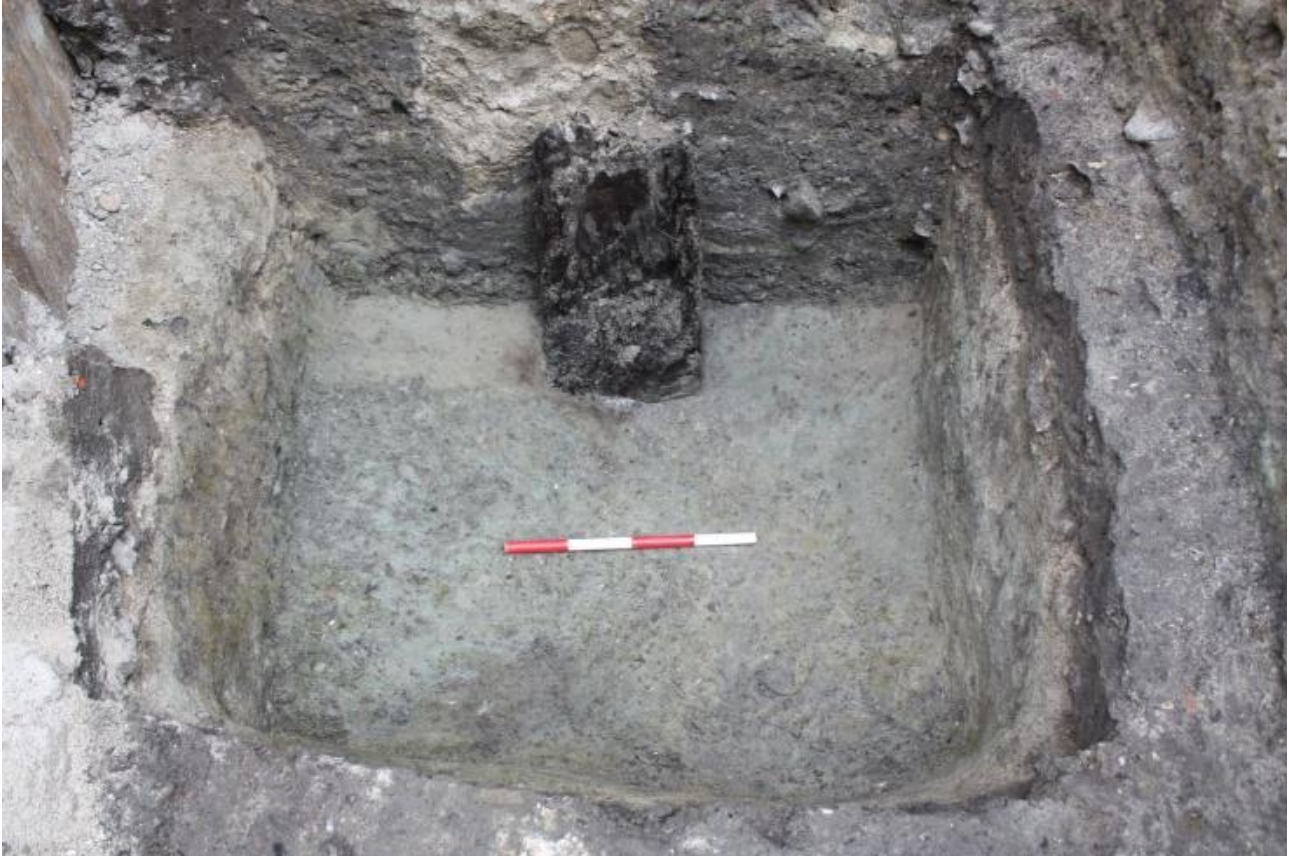
Fig. 192. The very large posthole G-362, facing north. Photo: Museum of Copenhagen.

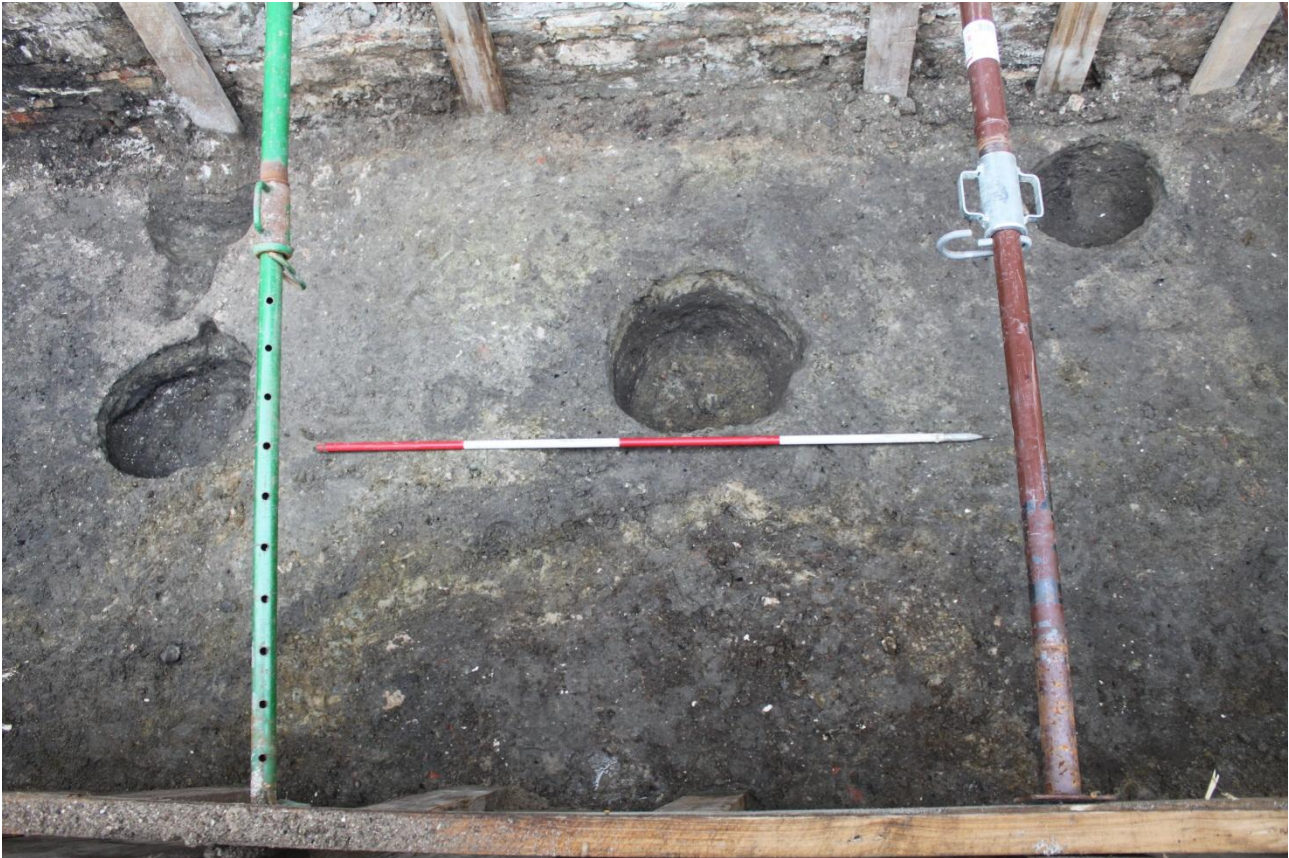
Fig. 193. G-363. Excavated postholes (SC28920, SC28977, SC29000 and SC29097), facing west. Photo: Museum of Copenhagen.

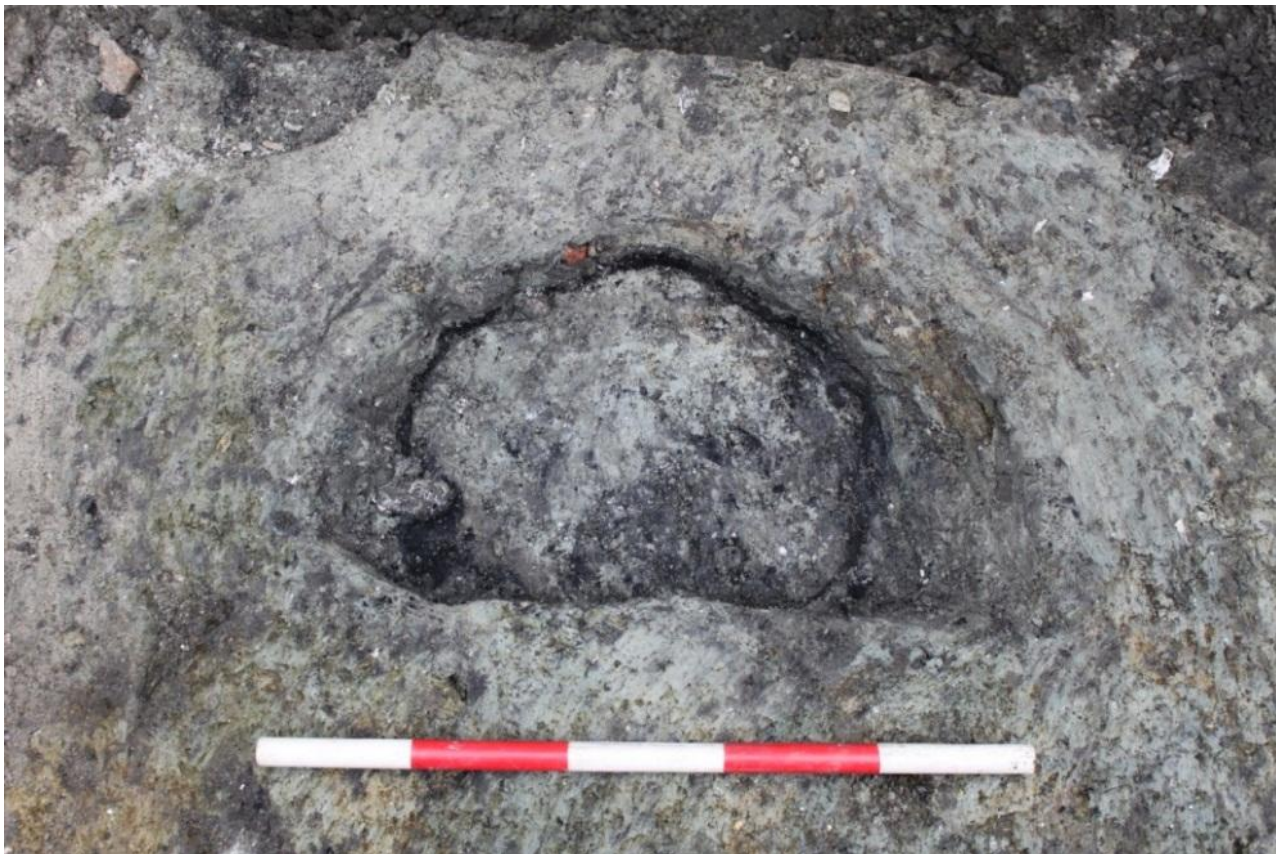
Fig. 194. Exposed posthole (SC4029; G-500923), facing west. Photo: Museum of Copenhagen.

G-500923 represents an oval posthole that might be part of a N-S structure with posthole SG-500922 to the north (Fig. 194). Possibly these two postholes are to be viewed in connection with the N-S row of stones belonging to G-222.
