KØBENHAVNS MUSEUM / MUSEUM OF COPENHAGEN

## Frederiks Kirke (Marmorkirken)

KBM 3833, Sankt Annæ Øster Kvarter, Frederiks Sogn, Sokkelund Herred, Københavns Amt

Kulturstyrelsen j.nr.: 2010-7.24.02/KBM-0015

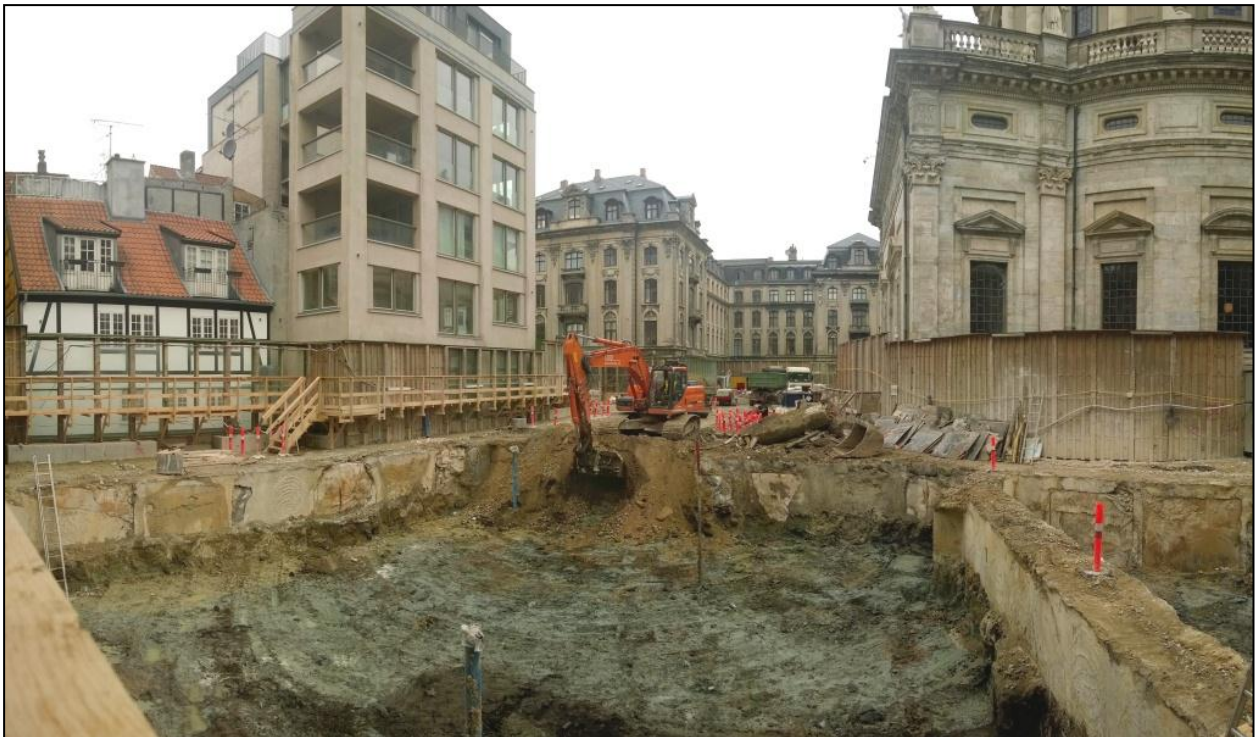
The guidewall trenches were dug under permanent supervision with a mechanical excavator on wheels with a two-meter wide toothless bucket. Guidewalls were two meters wide and 1,5 m deep. The station box was excavated with a large, mechanical excavator fitted with a trenching bucket with protruding teeth. The machine reduced the existing ground level by approximately 2.5 meter to a depth of 0.4 masl. The deposits were not excavated horizontally and it was therefore not possible to reach a thorough understanding of the stratigraphy (Fig. 12). In total, during the watching brief phase, more than 2.500 cubic meters of soil were removed.

Figure 12. Excavation of the station box southwest of the church in 2014.

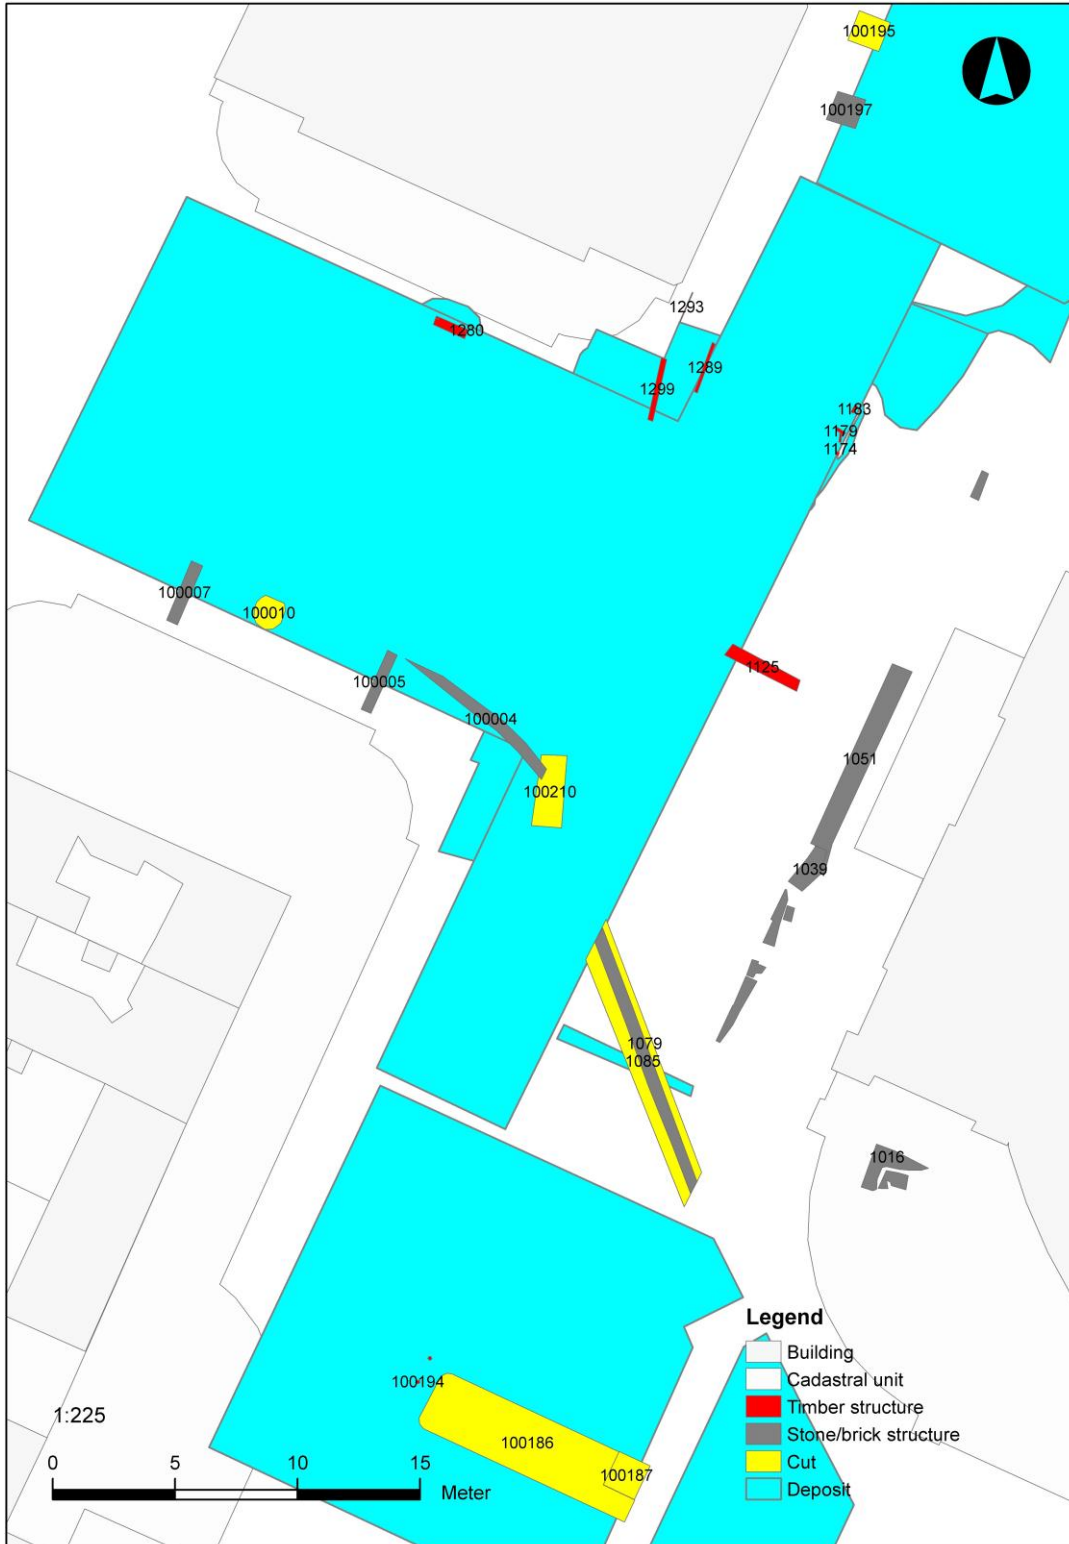
Figure 13. Archaeological contexts within the station box.

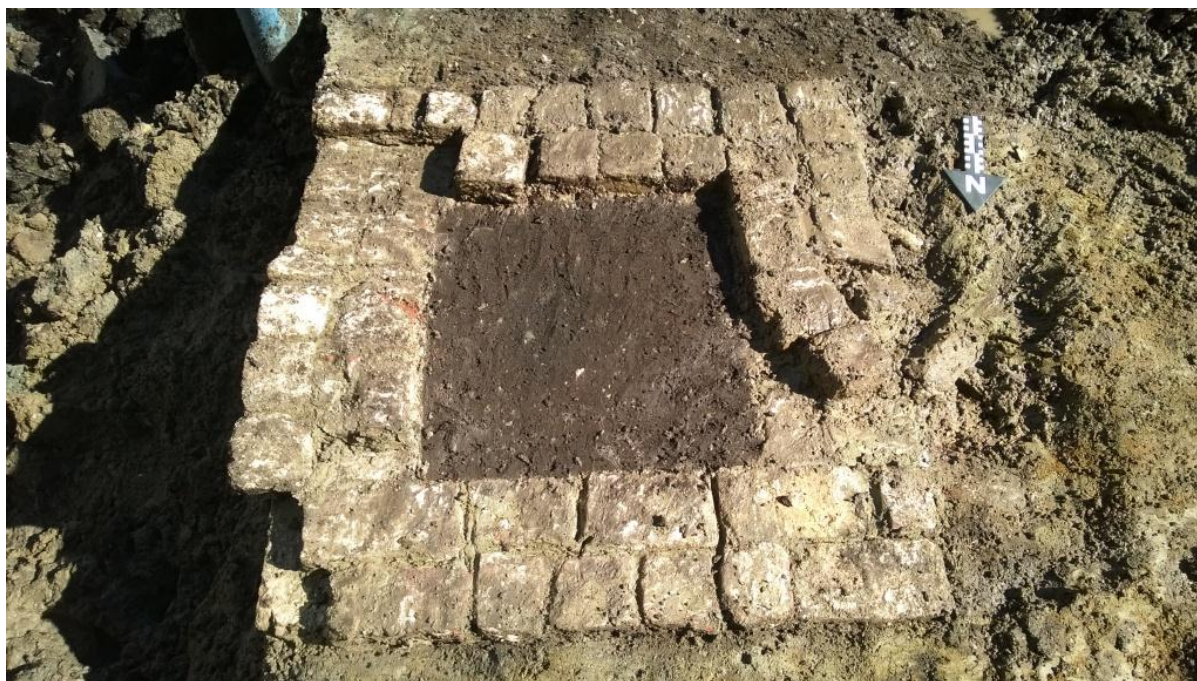
**Square brick structure (S100197).** Square, box-shaped brick structure with external dimensions 1.15 x 1.15 m and inner dimensions 0.6 x 0.6 m. The wall of the “box” is two bricks wide and is preserved in three bonds. No mortar has been used but traces of white mortar shows that they are recycled. The uppermost preserved bond consists of halved bricks, while the lower bond is mainly whole bricks. The bricks are reddish with dimensions of 26x14x6 cm. The bottom of the box feature consists of bricks laid directly on top of yellow till. The layer of bricks at the bottom of the box protrudes 2 cm higher than the lowest course of the box wall (Fig. 25). No cut for the feature was identified, perhaps because the box wall is constructed close to the edge of the cut. Inside the box, at the bottom, was a homogeneous, dark layer (SD 100198) containing an iron nail and a modern Late Redware sherd. Interpretation is uncertain but it appears to be some sort of drainage or collection well. A probable date would be in the 1800s.

Figure 14. Brick structure S100197 seen towards South.

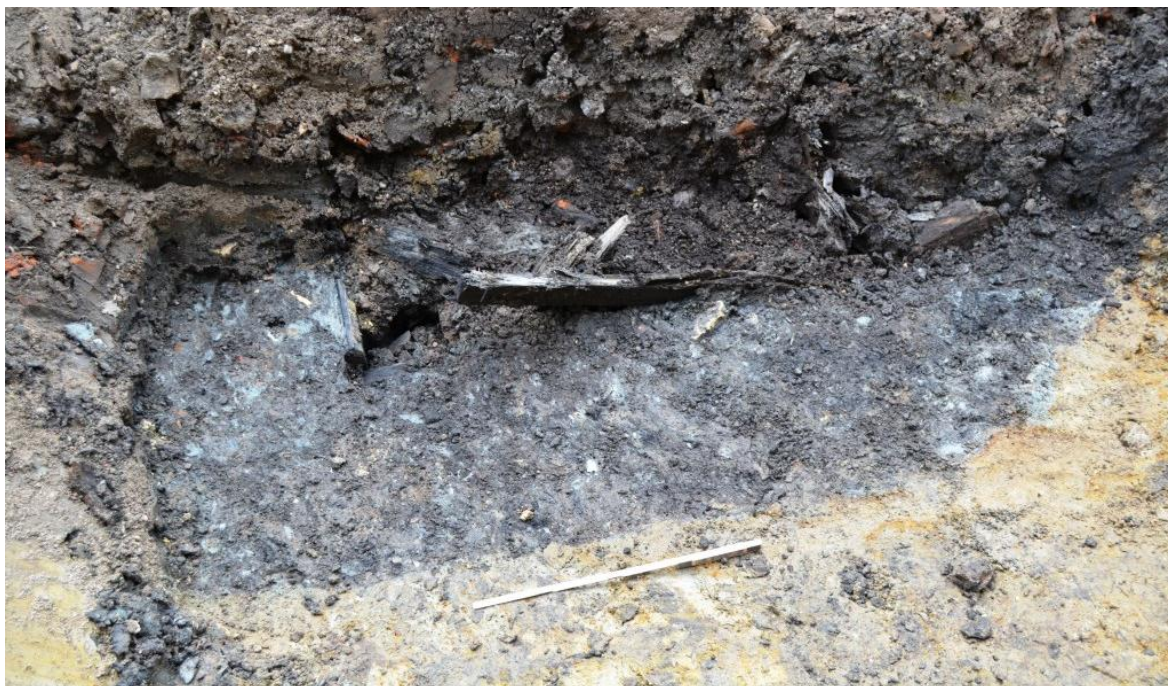
In the middle of the cut was placed a rectangular wooden well box (S1280) with corner posts. The two visible corner posts visible in the guide wall were placed 1.3 meter apart. One of the corner posts was extracted and it became clear, that it had been attached to a deeper lying timber by a mortise and tenon joint (Fig. 27). Based on the length of the corner post it could be established that this timber would be a further 1.5 m below the bottom of the guide wall or at least 3 m below current street level. The well box itself was built from boards that, without visible joints or nails, were positioned behind the corner posts.

Figure 15. Well S10 with remains of the wooden well box. The cut (1276) for the well is seen clearly against the yellowish-brown natural clay.

A fragment of a Gouda clay pipe bowl with a maker's mark (FO100226) dates the deposit inside the well (SD1284) to around the mid-1700s and provides a *terminus ante quem* for the structure. Perhaps the well was filled prior to construction work on the church. Many wells were closed as the water pipelines were established along the major thoroughfares in the district. Others were filled because they no longer had any water.

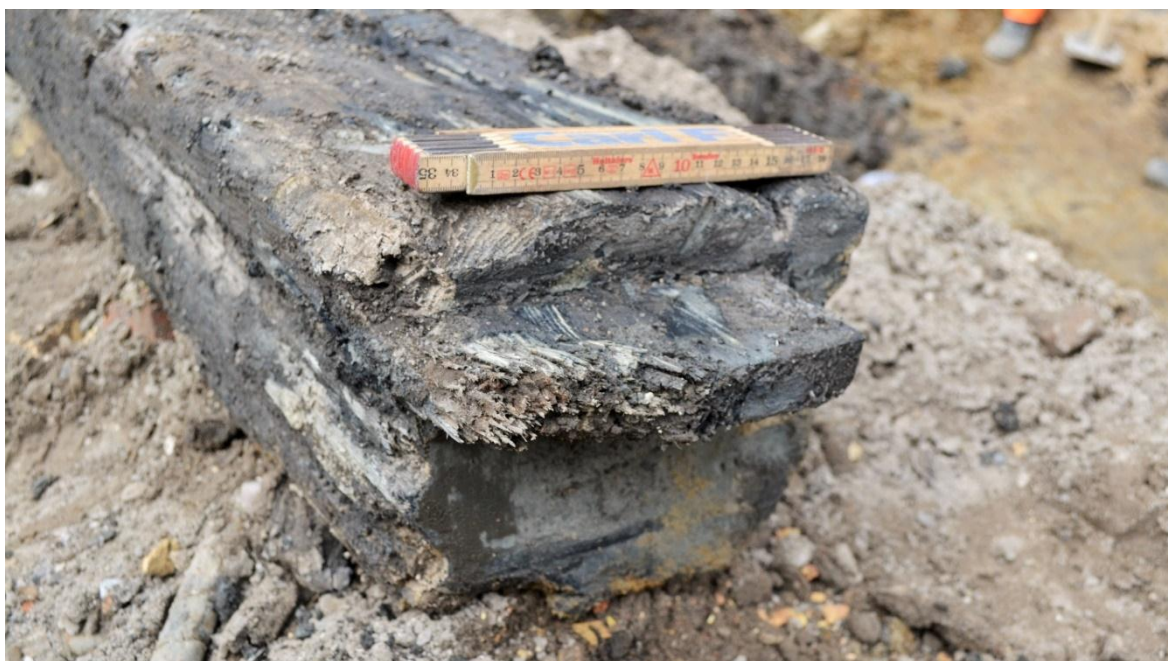
Figure 16. Extracted corner post from well S10 showing evidence of a mortise and tenon joint.

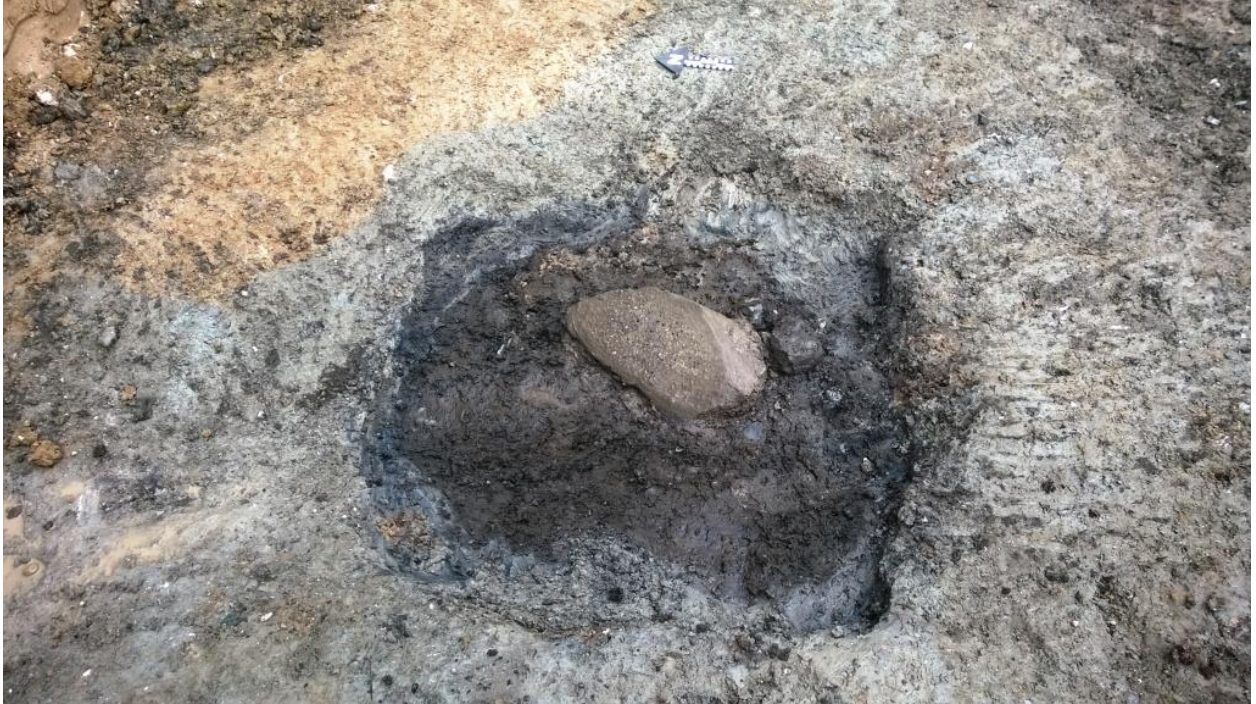
**Well (100195 and 100196).** Well fill deposit 100196 contained Late Red ware and Grey ware, clay pipe stems, a leather fragment and a carved stick. The larger stone in the middle of the well is a fragment of a mill stone (Fig. 28). The well cannot be dated more accurately than the 16-1700s.

Figure 17. Cut for well (100195) and fill in well (100196).

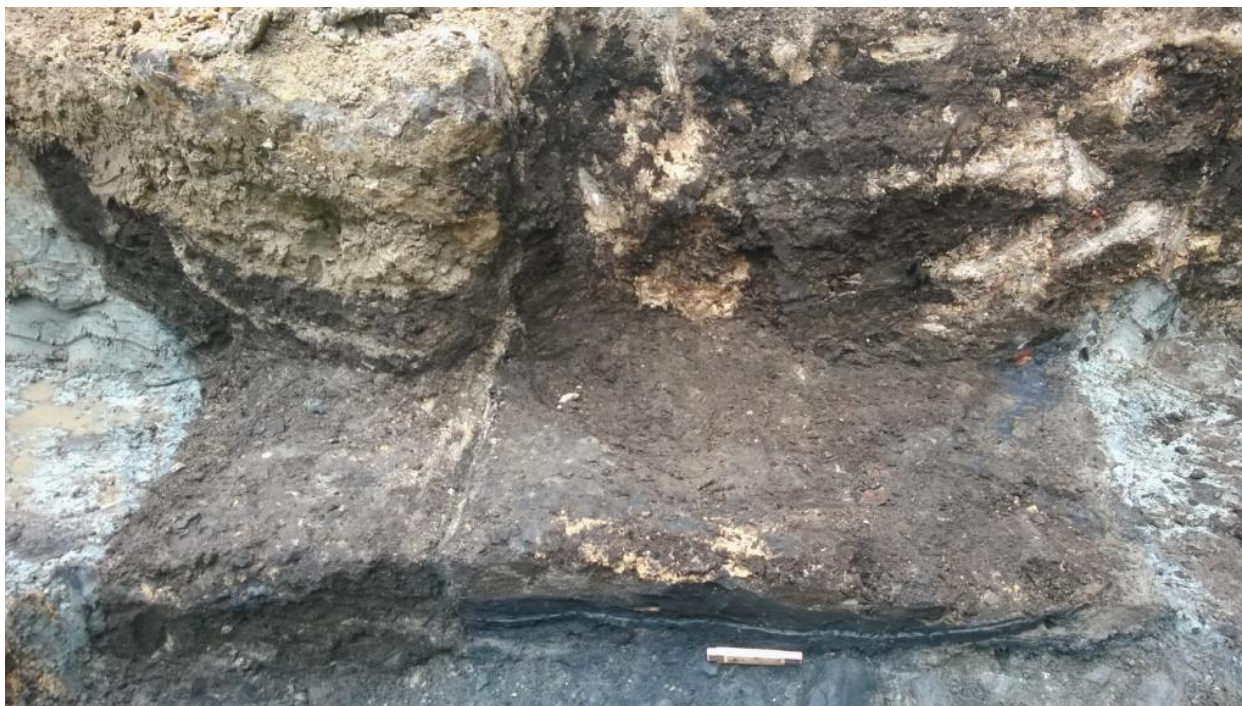
**Massive dump/levelling layers in station box (Group S12).** Within the guidewall trench and in the station box were found massive dump layers, up to 1,5 m thick (SD1216, SD100209 and SD100216). These deposits probably represent many cart loads of household waste deposited at the site over a long period. There were clearly variations between the layers that varied between obvious dung deposits, concentrations of bone and silty/mixed deposits (Fig. 29). It was not possible to investigate the layers in much detail as the character of the watching brief did not justify stopping the machine. The procedure of the machine digging vertically and hoisting up earth from the side further complicated observations. Finds collected from the dump layers date these to the 16-1700s.

Figure 18. Part of S12: SD1216 is a 10 cm thick, greasy layer of homogenous, dark brown rotted / partly rotted organic material with many wood fragments, straw and a few Late Redware sherds and porcelain. Two samples were collected. The layer is a midden layer or a wet dump layer / sludge.

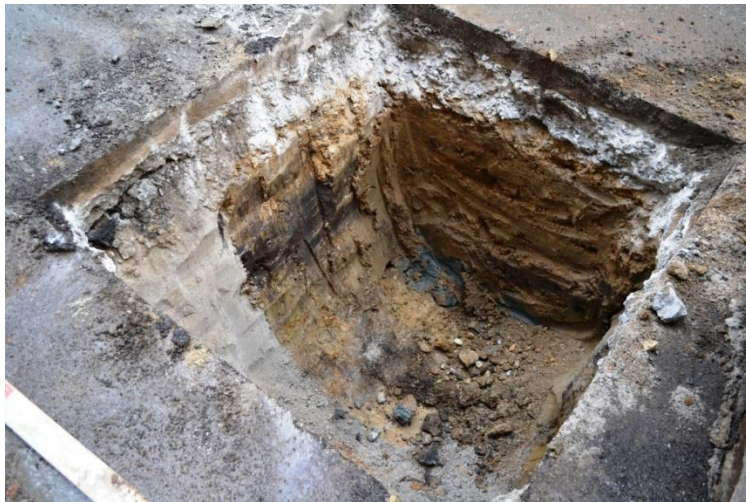
Z100106 (well P05.516). Trench contained a modern cut for pipe (100107) and a cultural layer interpreted as a dump/levelling layer (100108) (Fig. 30). The latter can be followed to a depth of 1,5 m.

Figure 19. Trench Z100106 with SD100108 visible as a dark layer in the side of the trench.

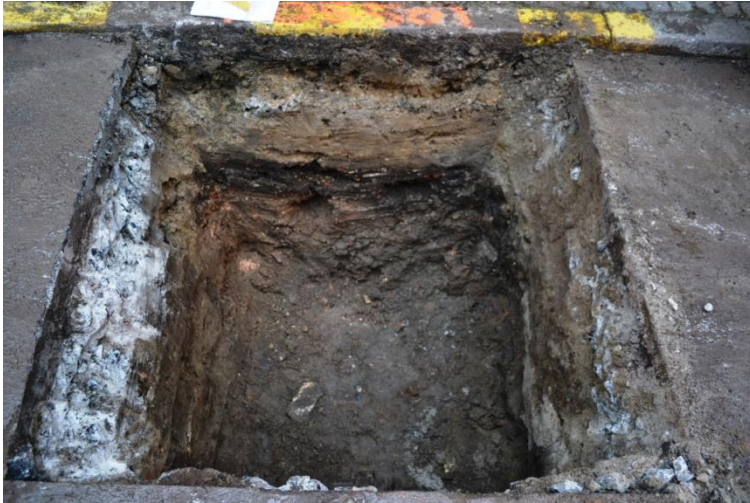
Z100085 (reinfiltration well). Approximately 0,5 m below street level was found a compact, dark brownish dump layer containing stones, CBM and animal bones (SD100086) (Fig. 31). Finds include late redware sherds and an industrial ware sherd that dates the layer from the mid-

1700s. Below this was a yellowish grey clayish sandy layer with some CBM, but little other cultural material (SD100087).

Figure 20. Trench Z100085. Dump layer SD100086 can clearly be seen as a dark horizon in the section.

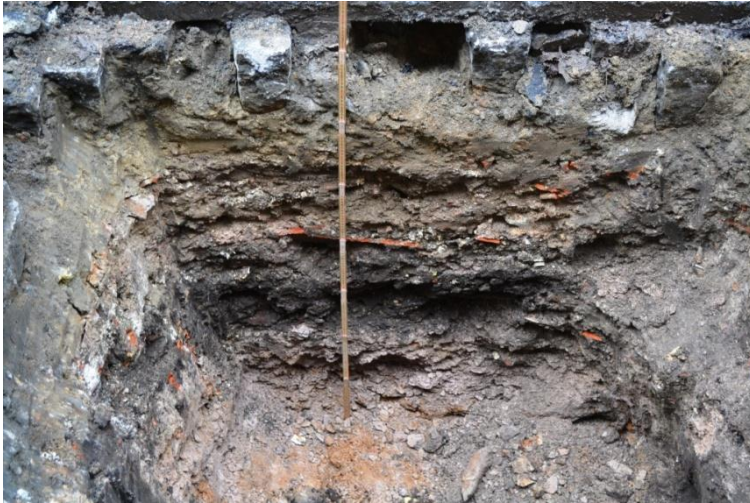
Figure 21. Trench Z100091.

Z100091 (well P05.522). In this trench was found a dump layer 0,45 m below street level (Fig. 32). The layer was light, yellowish sandy clay (SD100092) and was situated above a dark, clayish dump layer, c. 0.45 m thick (SD100093). Below the latter is seen a construction dump layer containing eroded marble, marble fragments, and a sandstone floor(?) tile, most likely

from the construction of the church (SD100094). The finds provide a likely date for the layer of 1775-1850, but it could also be later.

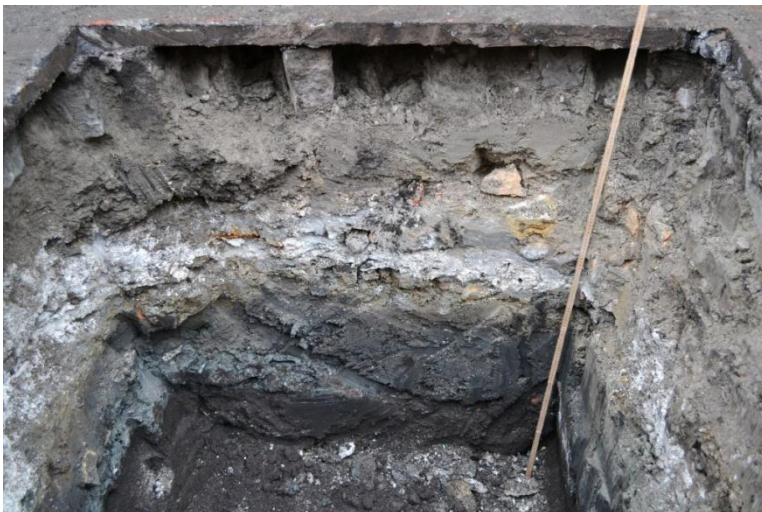
Z100096 (well P05.503). The location of a calcareous layer approximately 0,5 m below street level suggests that it is part of a foundation (SD100097) (Fig. 33). However, a cut for a foundation wall was not found. Incorporated in the layer was small-sized debris from tile bricks and smaller stones. The layer should probably be associated with activity related to the church's construction. At 1,05 m below street level could be seen a dark dump layer (SD100098). It contained a fragment of Dutch majolica, which dates the layer to around 16-1700s. A 0,2 m thick layer of compact, greyish-blue clay is probably a levelling layer (SD100099).

Figure 22. Trench Z100096 with the calcareous layer SD100097.

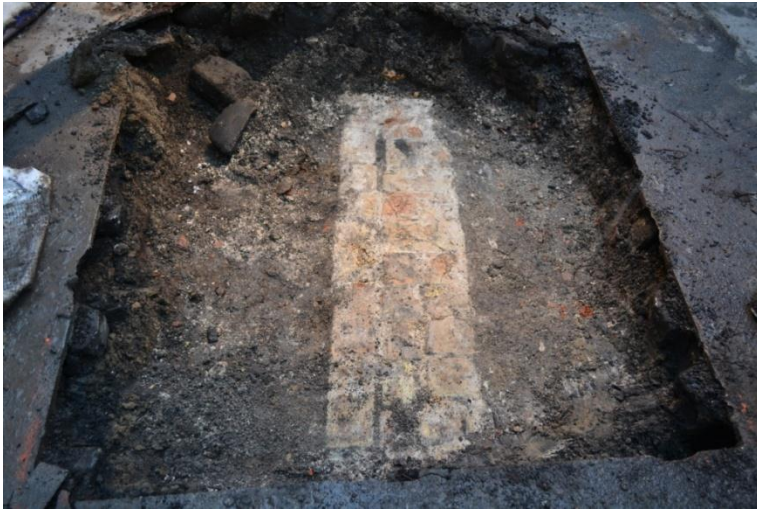
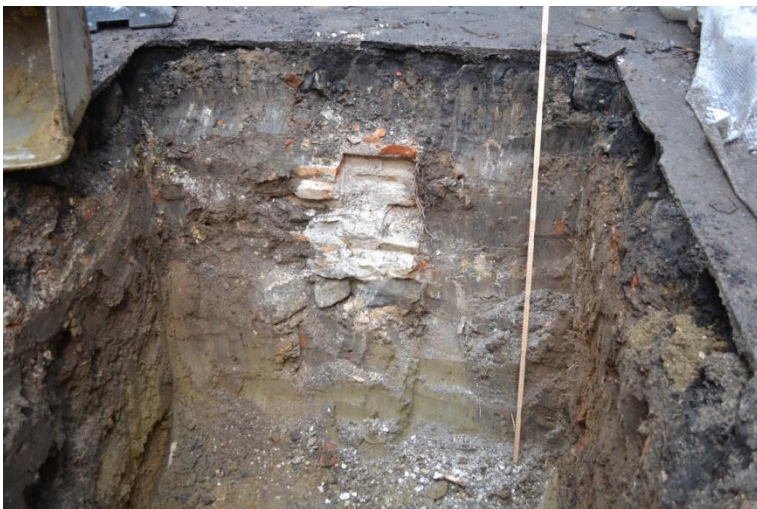
Z100112 (well P05.348). A brick wall foundation (SD100113) was found 0,2 m below the surface in the backyard to 77 St. Kongensgade (cadastral unit 64a) (Figs. 33 & 34). The yellowish-pink coloured bricks had dimensions of 23x12x4 cm. The mortar was fine, porous, sandy and light-coloured. At the upper part could be seen the remains of a 1½-stone brick wall. It could be followed to a depth of 0,5 m below the surface where a stone foundation appeared. It was two stones wide and was set in a levelling layer of mortar placed on top of large field stones (0,25-0,3 m in diameter). The stones were placed so that the largest were facing outwards. The field

stones were placed in a 0,5 m thick deposit of yellow or orange sand and clay (SD100115). The deposit surrounding the foundation consisted dominantly of CBM and secondarily of brownish-black clay (SD100114).

The foundation likely belonged to one of the rear buildings, which can be seen on Geddes elevated map from 1761.

Figures 23 and 24. Foundation S100113 seen in plan and in section.

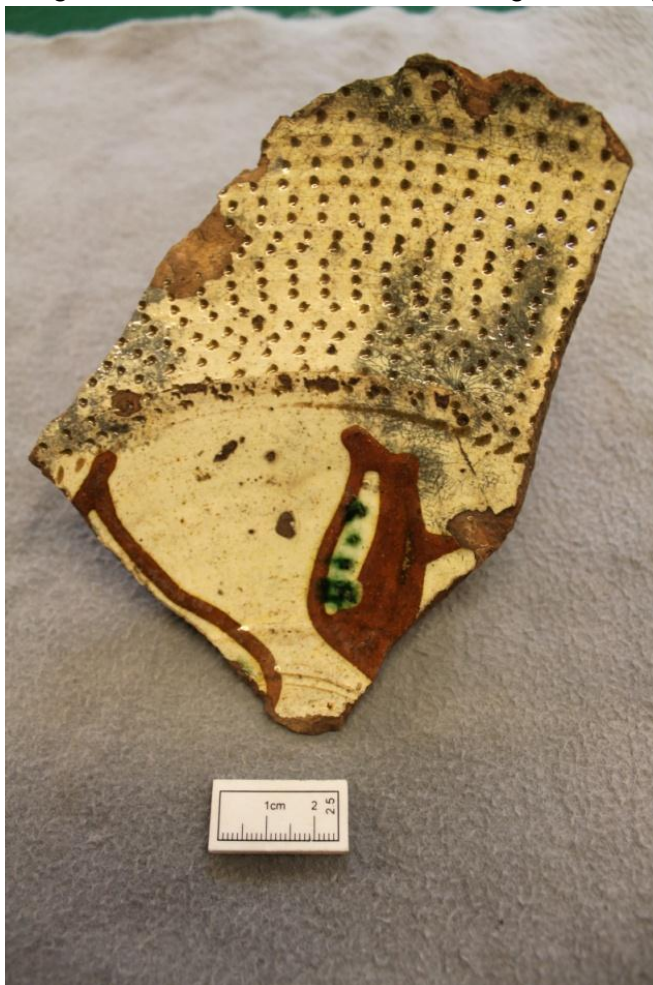
Figure 1. Frederik's Church. 17<sup>th</sup>/18<sup>th</sup> century late redware (slipware) dish with trail slip and sgraffito decorations (FO 100270).
