## 7.5. Phase 5. The Final Working Harbour, 1820s-1870s

### 7.5.1. Summary

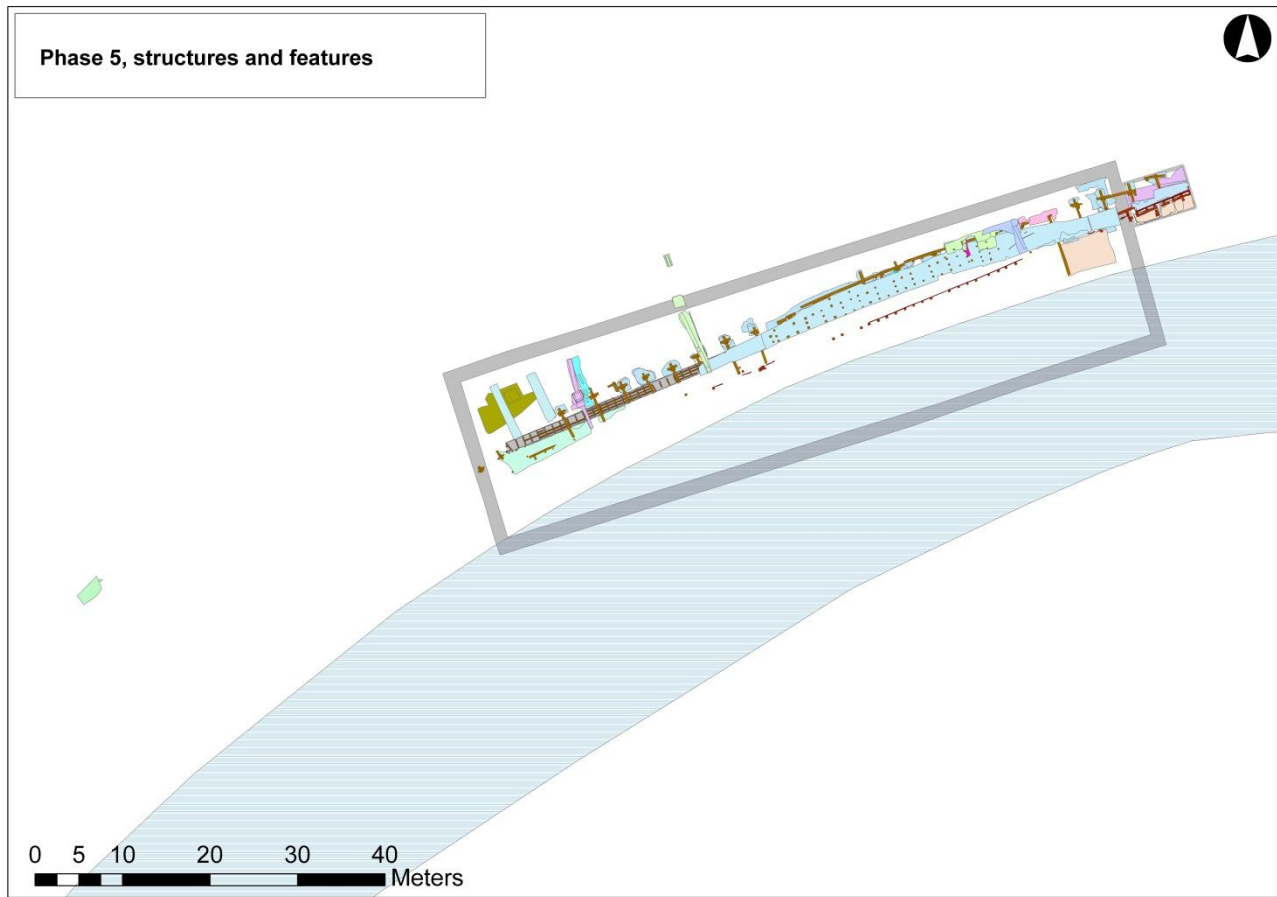
Fig. 319 Plan of all Phase 5 structures and features. See also A3 version in appendix XX

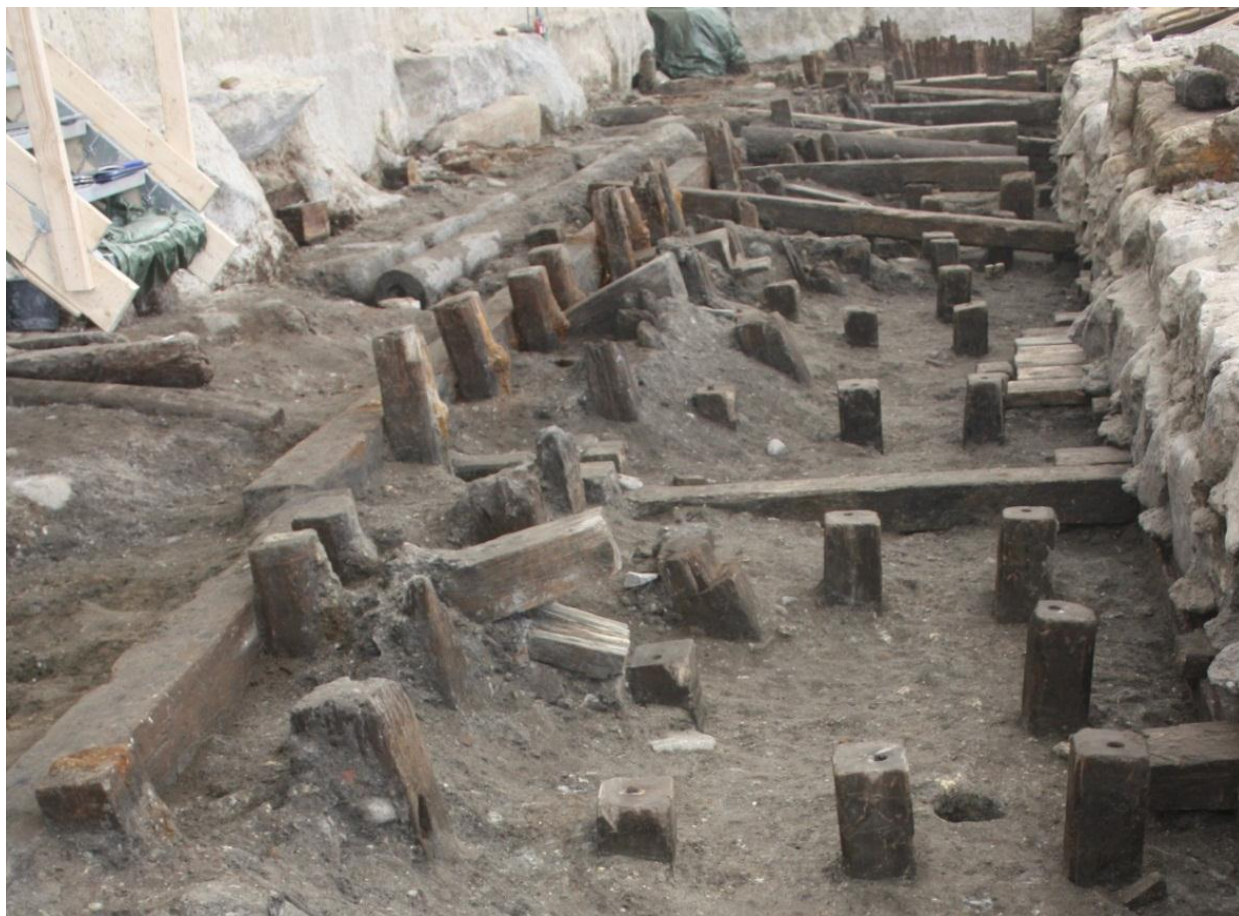
Fig. 322 Land tie group G562 to the left, with truncated and disturbed anchor beams. The upright posts with peg holes for the contemporary *Fiskegang* (G583) can be seen to the right hand side of the picture. C03\_20140331\_9244 (cropped)

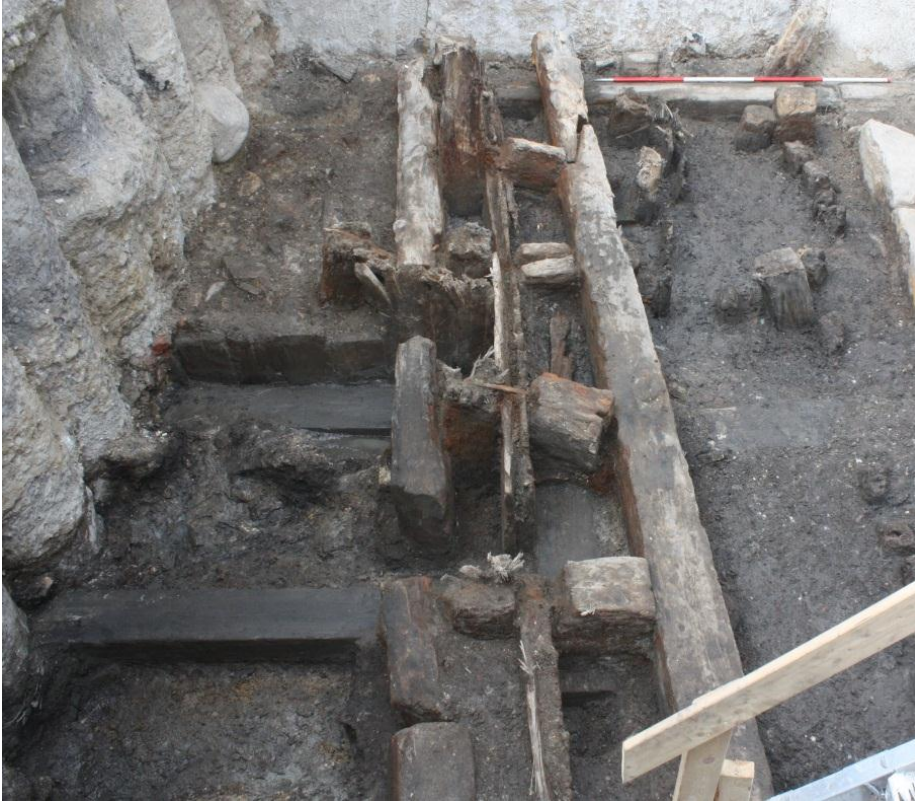
**Fig. 326** The remains of the bulwark under excavation in the Stairway trench/ZT22798. Looking west. C03\_20140403\_9295 (cropped)

The bulwark only remained complete in the Stairway trench in the eastern end of the Main Excavation trench. It was constructed from southwest-northeast aligned planks ST13627 held in place with a batten (14013) across the top to the south. This was reinforced by a row of square posts, ST13444, ST13436, ST51240, ST51244, ST51248, ST51252, ST51256, and ST51844, driven into the underlying deposits with a beam, ST13623 and ST13454, in front of them. Behind the planking, to the north, were a series of blocks ST's 13806, ST13634, ST51224, ST51228, ST51232, ST51236, ST51868, and ST53397, between the planks and a stretcher beam ST13789. All these elements were fastened together with an iron bolt. The planks formed two rows and lay horizontally to the south and vertically to the north. It was suggested that the upper edge of the planks would have corresponded with the old waterline, and the alternating of wet and dry environments would have resulted in the deterioration to the top edge of the planks seen in the excavation, and consequently the upper extent of the bulwark may have originally been higher. One storm post, ST51882, was recorded towards the easternmost end of the excavation. Behind the timberwork was a series of four mixed dump deposits which contained building rubble and very mixed finds.

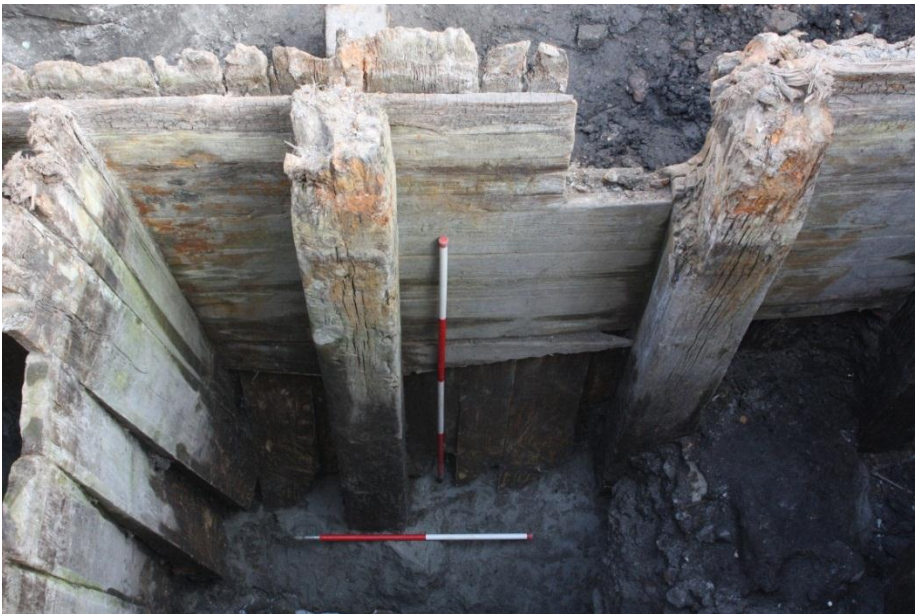
**Fig. 327** The excavated planking construction of the bulwark in the Stairway trench. Looking north. C03\_20140718\_11660

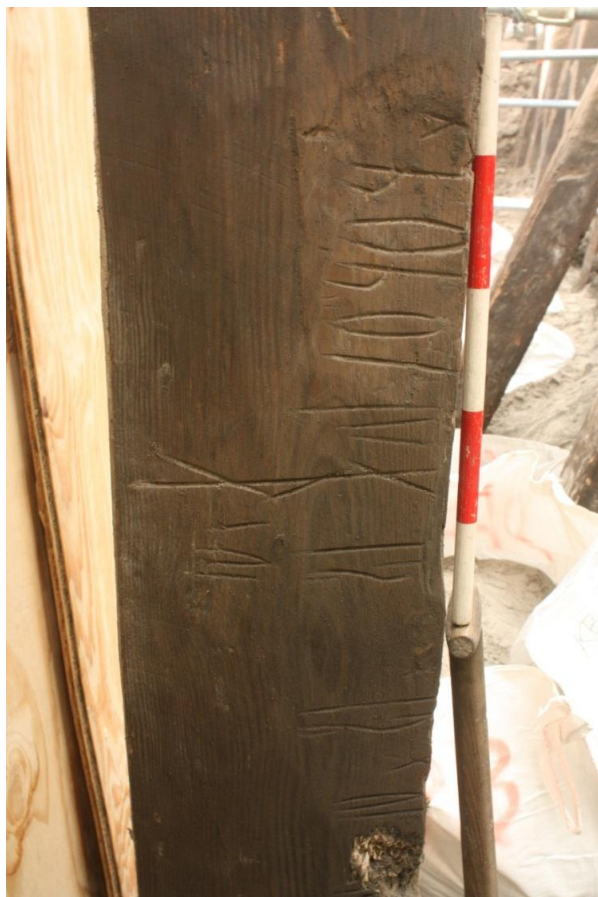
Fig. 328 The marks on timber ST28486 (G591). C03\_20140515\_10289

One of large bulwark posts, ST28486, had marks incised onto its east facing surface (see Fig. 328). They were not carpenter's marks, but presumably relate to the construction of the harbour front in the 1820's.

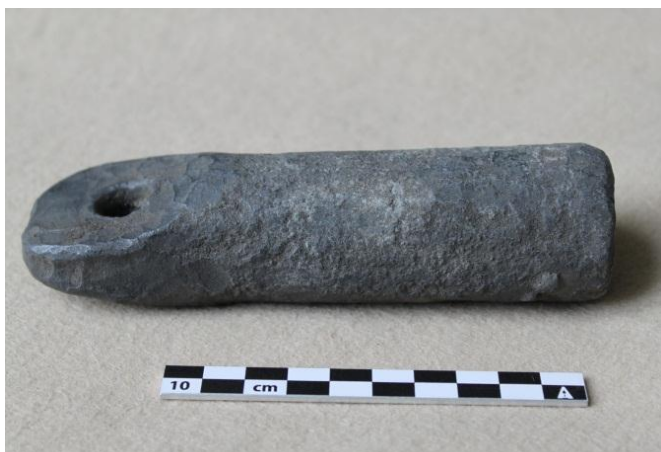
Fig. 335 FO 212461. A lead line to ascertain the depth of water. Recovered from SD53332 (G629)

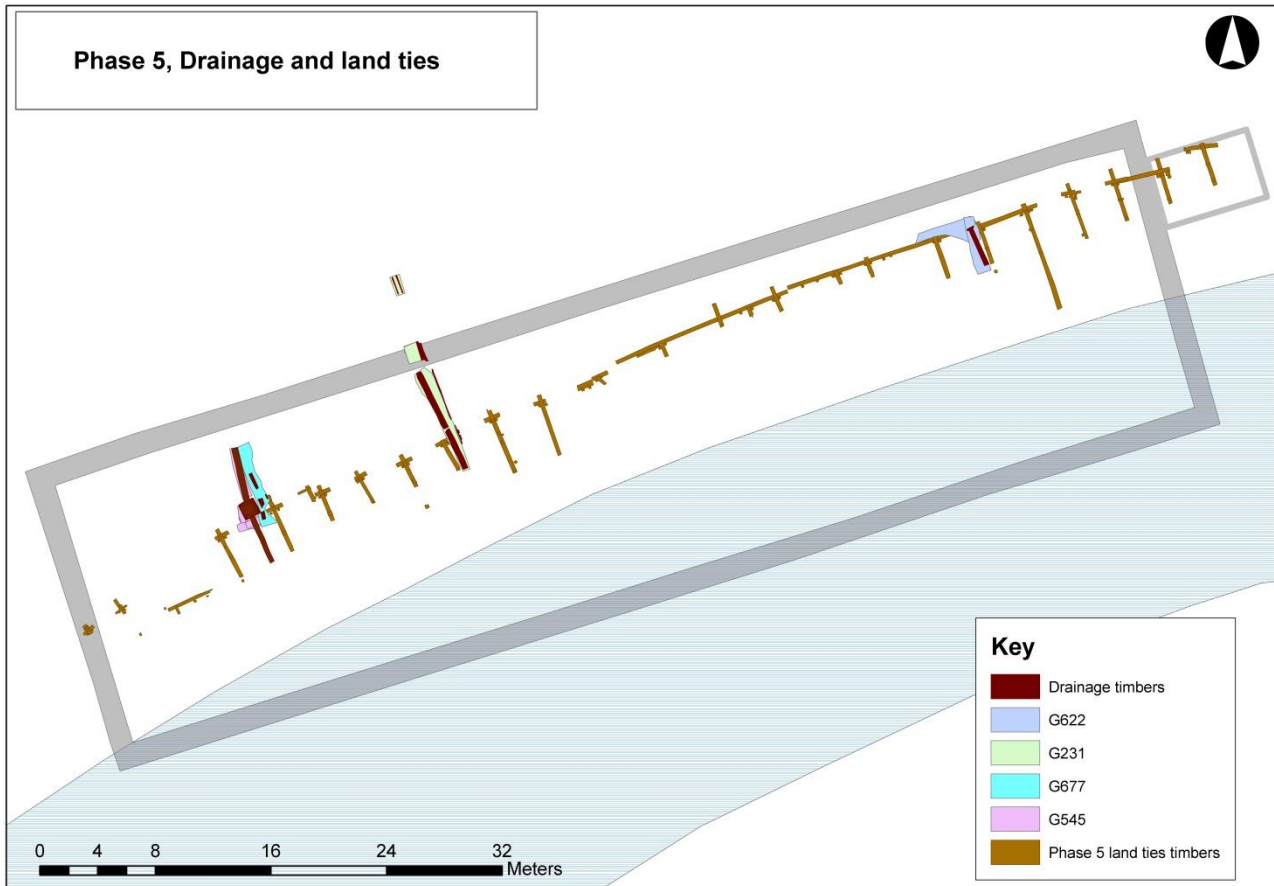
Fig. 337 Plan showing the four drainage features in relation to the Phase 5 land ties

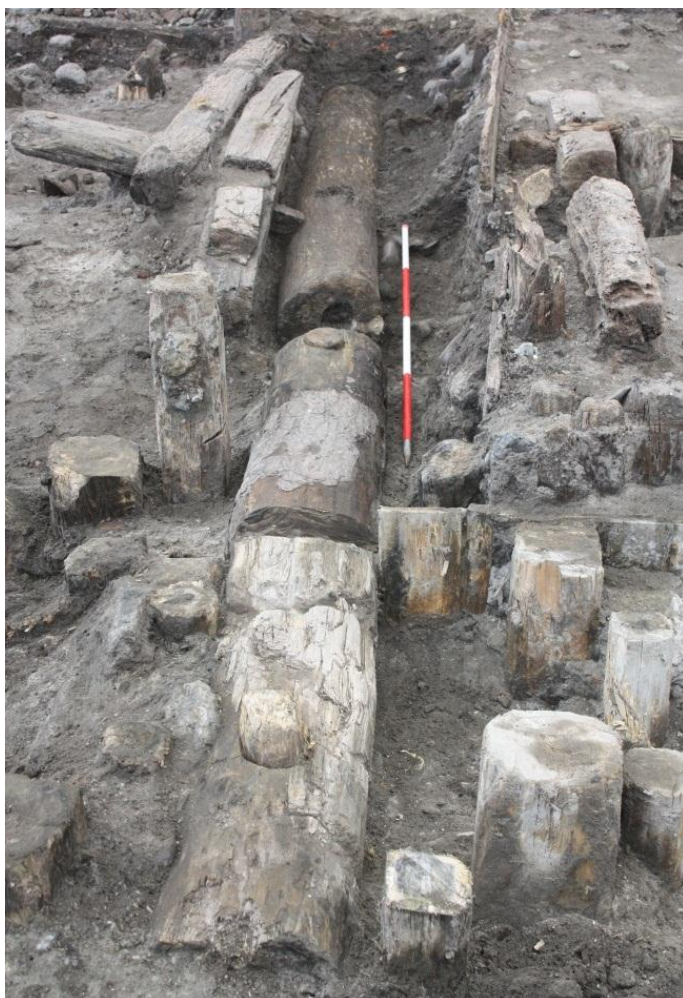
**Fig. 338 Southern extent of drain G231, viewed from the south. The gap created in the Renaissance wall can be seen to the top, and the plank shoring for the edge of the trench to the right. C03\_20140423\_9722**

Drain G231 was cut through the backfill deposits of the previous phases of harbour development, and also necessitated the removal of stones from the Renaissance harbour wall. To the north, during a watching brief, the feature consisted of two planks lining a cut, although the timber pipe itself was not seen. This could be due to the relative depth of the watching brief and Guide Wall trenches compared to the Main Excavation trench which was c. 0.4 m to 0.6 m lower. In the Main Excavation trench, wooden pipe, ST33533, was truncated through the middle by a modern gas pipe cut. The southern half, which still

of the pipe, the southern two of which contained timber plugs, were probably for maintenance. The eastern edge of the cut for the pipe, ST34160, was lined with horizontal planks, ST34603, propped up with three posts, ST35988, ST35992 and ST35996, to shore up the trench while the pipe was laid, and it may be these which were seen further north. The northern end of the timberwork was situated at 0.8 m OD, while the southern extent was at -0.4 m OD, giving a gradient of 1:12 over the 14.4 m extant length of the pipe.

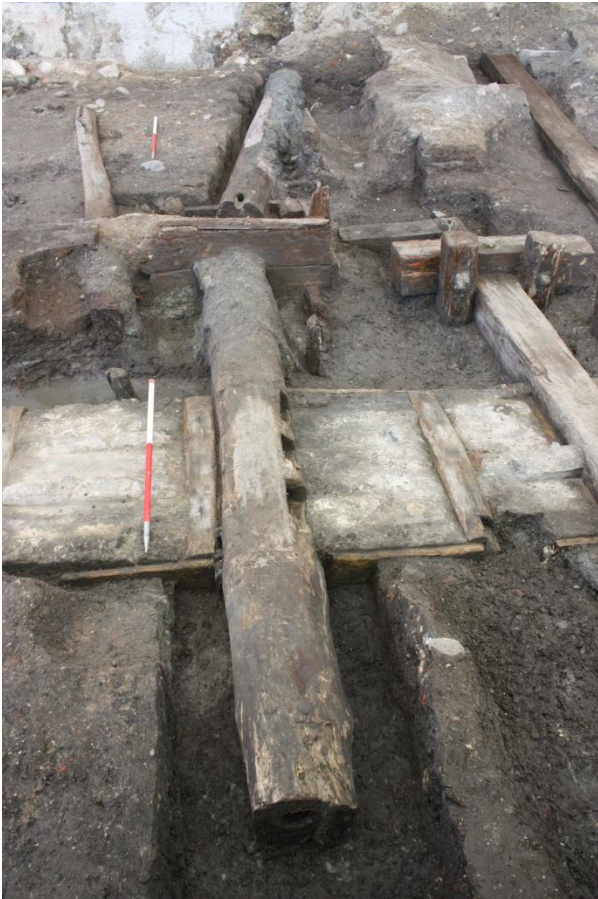
Fig. 341 Overview of the water filter pipes with the timber box between. Looking north. C02\_20140312\_8529

The feature interpreted as a waterfilter, G545, consisted of a timber box with two waterpipes extending from it; ST25600 to the north and ST25560 southeast. The box was constructed from four sill beams, ST34297, into which were jointed four timber posts, ST25931, one in each corner, with timber planks, ST25962, set horizontally between; four surviving to the south, two to the north and east, and one to the west, and a timber plank floor, ST25950, constructed of five planks. The lower three side planks on the north and south sides were shaped to fit around the two water pipes, and so the pipes and timber sides must have been constructed simultaneously. The plank floor sat inside the timber sides and was shaped to fit around the posts. The exterior of the waterpipes were packed with blue clay SD25395 to cover the joint with the timber box to make it watertight. The clay also covered most of the outside of the southern side of the timber box to fill the extent of the construction cut, but was seen nowhere else. This extended along the entire length of the northern water-pipe, but may have been truncated away from the southern pipe as there was also no bark covering it, as there was to the north. The northern water-pipe had a wooden bung in its southern end, and a 0.06 m hole bored at an angle into the top of the pipe. The inside of the box was filled with gravel SD25574, and below this over the timber floor was a layer of organic silts SD25784 which was presumed to be the filtrate, as was a thin silting episode SD34335 underneath the floor planks over the base of the cut. All the timber elements were constructed from pine, and the southern pipe may have been truncated to the south when the 1880s harbour wall was built. The structure does not exhibit much of a

gradient, with the northern end at sea level, and the entire southern pipe level at -0.05 m OD. Dendrochronology samples taken from both water pipes did not return a date.

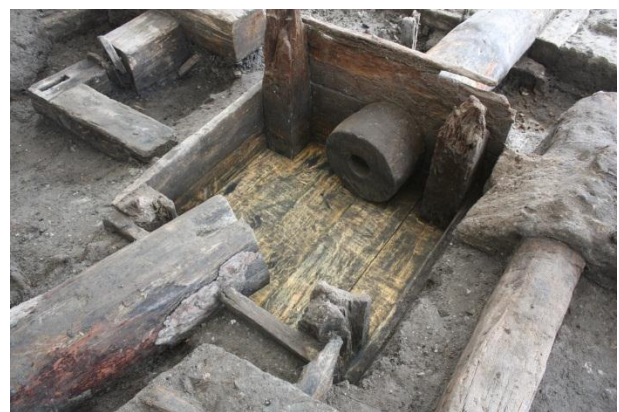
Fig. 340 Detail of the excavated central filter. Looking southeast. C03\_20140314\_8795

This feature was interpreted as a water filter used to remove waste products from foul water before it was disgorged into the canal, as it is very similar to a structure found on 19th Century plans. There were indications that the gravel infill had been cut into from the western side as the planking on that side was disturbed, and the gravel spilled slightly over on to the surrounding area. This disturbance could have been to access the filter box to bung the northern pipe and drill the hole into the top of it - perhaps in order to increase the pressure of the water flow, or to clean out the filter. This feature could also have been part of a standpipe at street level which would have been attached to the small bored hole in the top of the northern pipe. The box 'filter' would then have been used to catch the overspill water which was then channelled back into the canal via the southern waterpipe. The cut on the western side could then represent the time when the standpipe was removed.

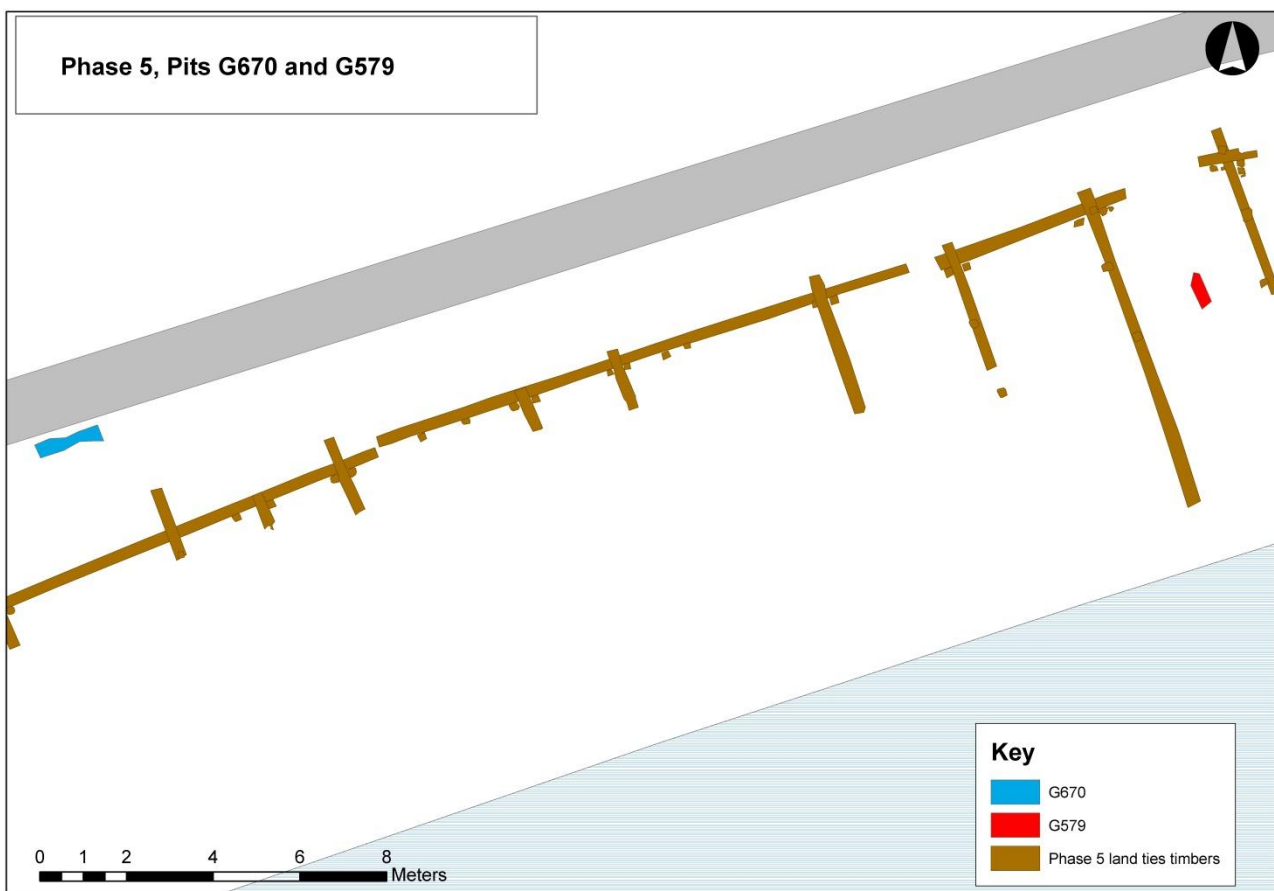
Fig. 343 Plan of the two pits in the Phase 5 of development of the harbourside

These two pits were thought to relate to the construction or deconstruction of other, unidentified features in the area. Both were truncated and so their full extents were not known. The eastern pit, G579, measured 0.82 m by 0.3 m and 0.19 m deep from a height of -0.11 m OD and was filled with sterile material, while the western pit, G670, measured 1.42 m by 0.28 m and 0.2 m deep from a height of 0.28 m and contained a mixed backfill with some domestic-type waste of ceramics and bone. Due to their locations and stratigraphic relations, they were unlikely to be associated with any land ties in the area.

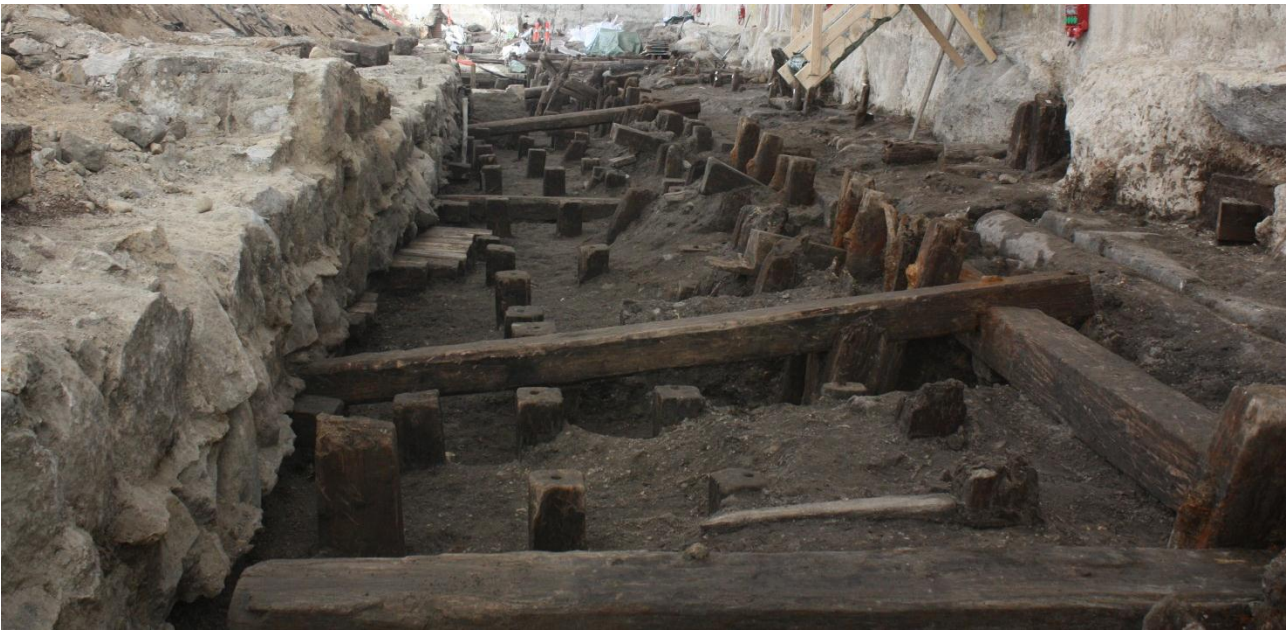
Fig. 350 View of the stone harbour wall looking west shows some of the land ties in-situ. In the middle of the picture the anchor beam from G600 can be seen overlying the stretcher beam from G562 from Phase 5, and fastened to it by means of a lap joint and an iron bolt. The square timber posts throughout are the *fiskegang* from the previous phase, and the truncated anchor beam in the foreground is also from land tie G562 in Phase 5. C03\_20140331\_9229 (cropped)

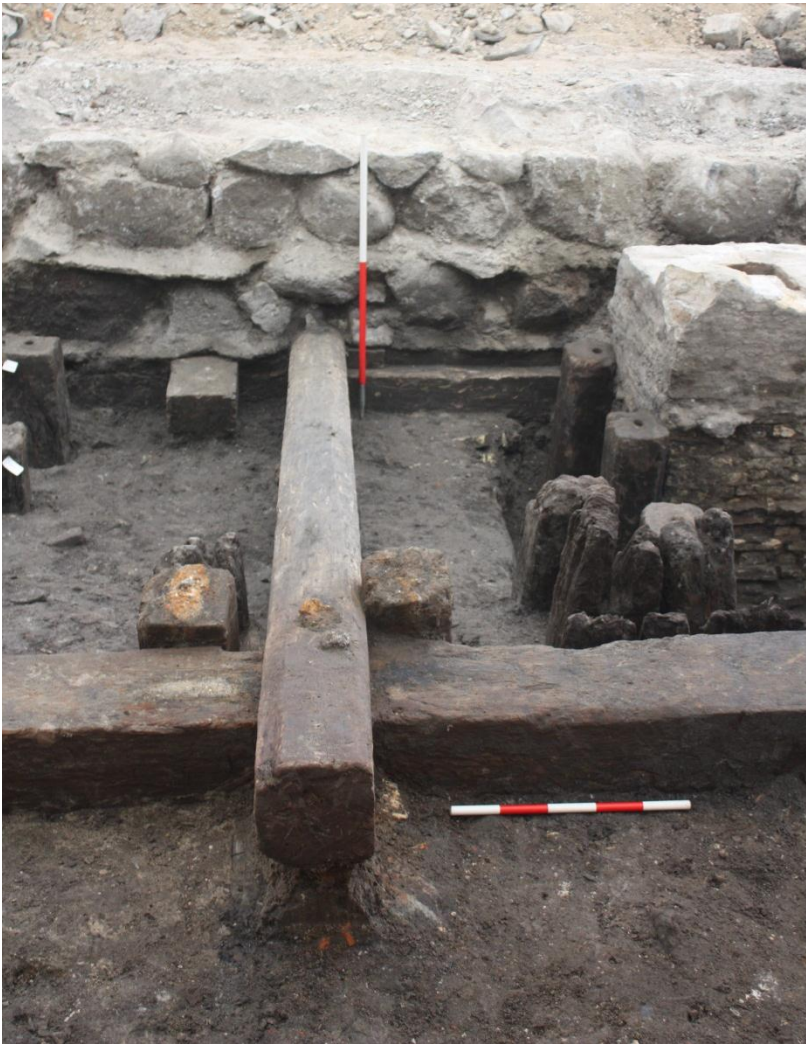
Fig. 351 The harbour wall was constructed from land ties (G567 seen in the foreground), a wooden platform, and 2-3 remaining courses of stones. The mortar lips can be seen between the stone courses and the brick foundation G621 can be seen in the right of the picture. C03\_20140327\_9162 (cropped)

The stone harbour wall was constructed on top of the timberwork foundation by bedding large stones onto a layer of mortar over the planks. Three courses of 19<sup>th</sup> Century stonework were recorded as SS19332, SS20007 and SS20055, with squared-off stones lying on their long edge to the seaward side of the wall, and more roughly shaped boulders behind. The stone sizes varied from 0.23 m by 0.13 m, up to approximately 0.8 m by 0.5 m, but were generally fairly uniform in size. The stonework was a mixture of Öland sandstone, fine grained sandstone and concrete. Each course was mortared together, with a mortar 'lip' between the first and second courses. This lip was interpreted as evidence of a construction technique, where the first course of stones was laid then material was backfilled behind the stones before the second course was laid. However, a later cut close to the wall, SG548, was observed in the middle and western half of the trench, which was interpreted as

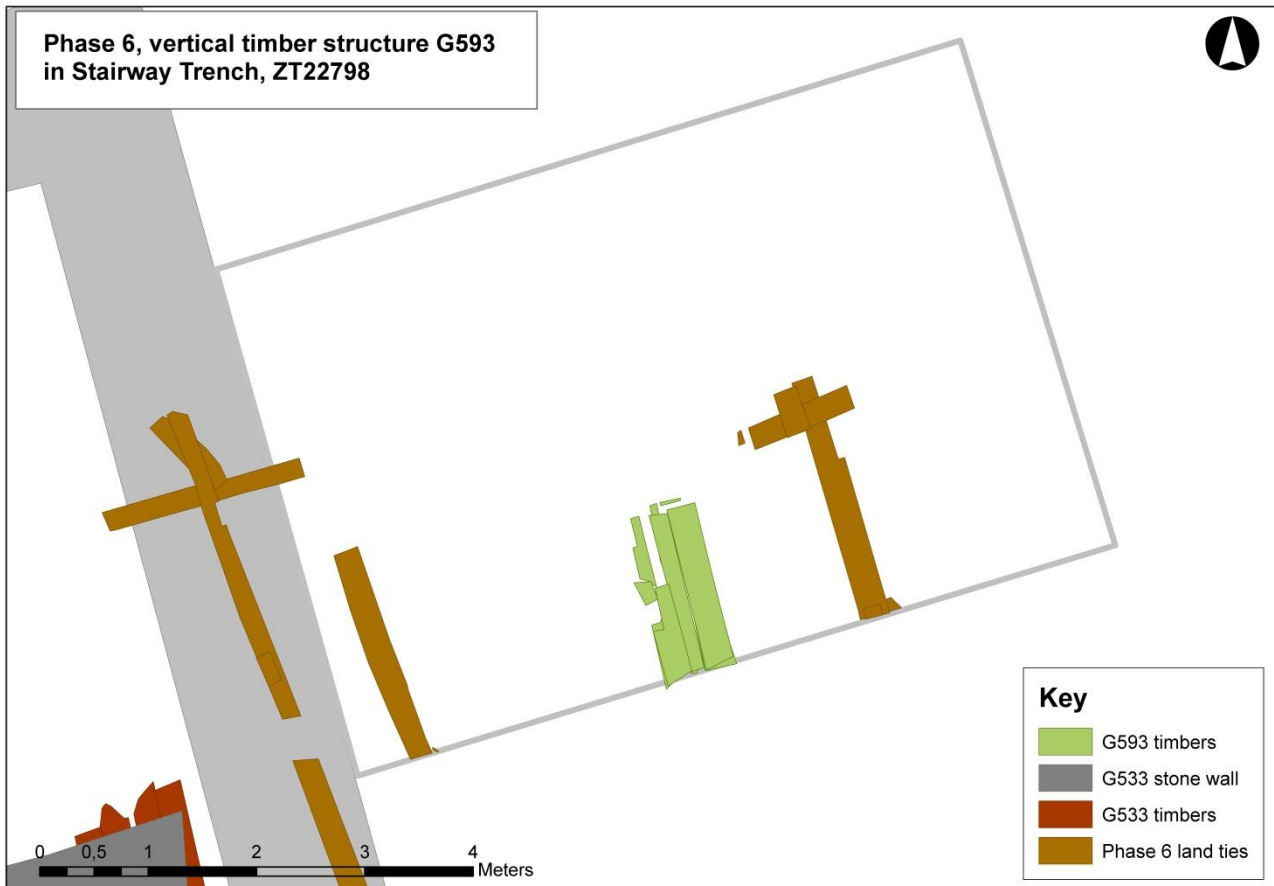
Fig. 355 Plan showing the vertical timber structure G593 in the Stairway trench/ZT22798

In the middle of the Stairway trench abutting the south side of the Phase 5 bulwark was a north-south aligned timber structure G593, which measured 1.56 m by 0.67 m and 0.85 m deep. This structure was cut through the backfills behind the 1880s harbour wall, and the northern side of the structure was bounded by the Phase 5 timber bulwark G591. It was constructed from five north-south slender beams or thick planks, and 6 vertical planks ST50883. The beams were placed in 2 parallel lines; beams ST50917 and ST51806 to the east with ST51267 acting as a wedge to the north; and ST52117, ST52087 and ST52132 to the west. These were thought to be a guide for the 6 vertical planks positioned between them. The northern most two vertical planks are about 0.45 m higher than the others which corresponded with the height of the adjacent planking and bulwark post, though they appeared broken at the top, and had been shaped along the northern side to fit against the planking of the bulwark. The whole structure was backfilled by a mixed pebbly clay dump layer SD50743 that extended westwards out of the trench. Dendrochronology samples taken from two of the vertical planks did not return a date. This structure was thought to be associated with the 1880s stone harbour wall, although the precise interpretation of the timber structure was problematic without the relation with that structure. It may have been shoring connected with an episode of repair or maintenance of the stone wall, however the stone wall was not exposed in this area to ascertain the presence of any corresponding repairs.

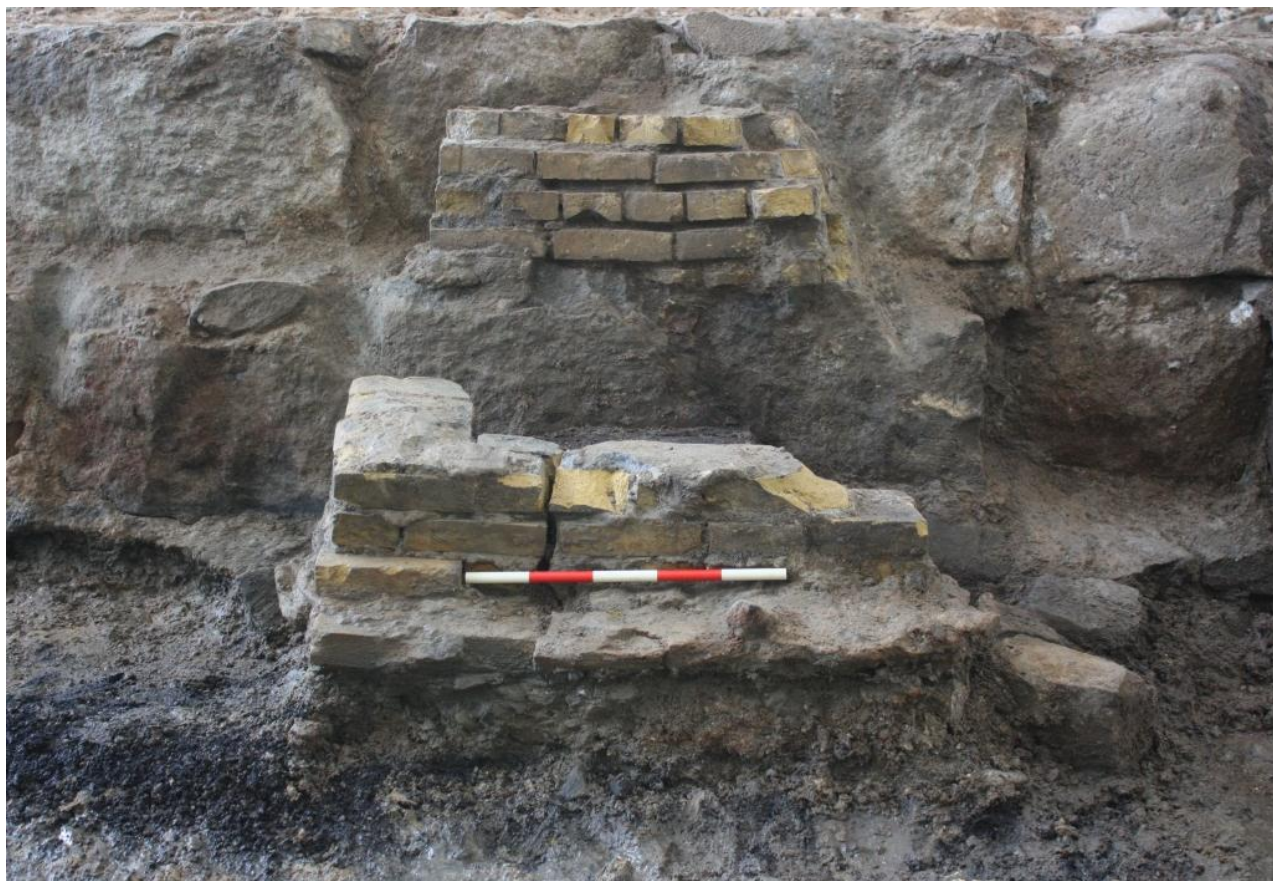
**Fig. 358** Brick street light foundation G625 abutting and built into the earlier 1880s stone harbour wall looking south. C03\_20140204\_7913 (cropped)

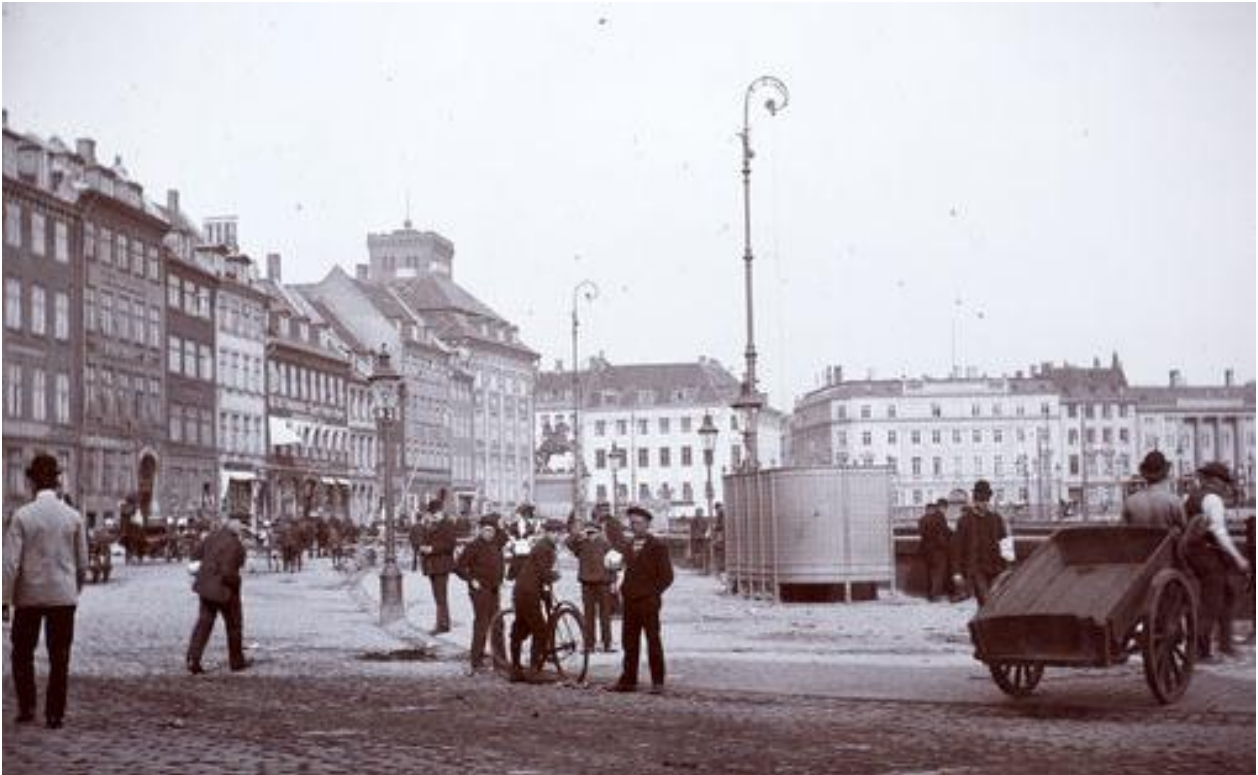
Fig. 359 Photo of Gammel Strand dated to c. 1908. The shorter, more common street lamps can be seen in the left foreground, along with the tall iron lamps along the harbour front. Museum of Copenhagen

Photographs of the harbour from the late 19<sup>th</sup> and early 20<sup>th</sup> Century show a series of street lamps throughout the area with some situated close to the harbour wall, although their precise location is difficult to determine. There are also two tall iron lamps beside the wall which would require the depth of foundation which these brick structures provide. These tall lamps can be seen in a photograph from 1908 (see below), but are not present in a photograph dated c. 1905 (Torvehandel på fisketorvet på Gammel Strand, c. 1905 on Væggen), and so date from the early 20<sup>th</sup> Century.

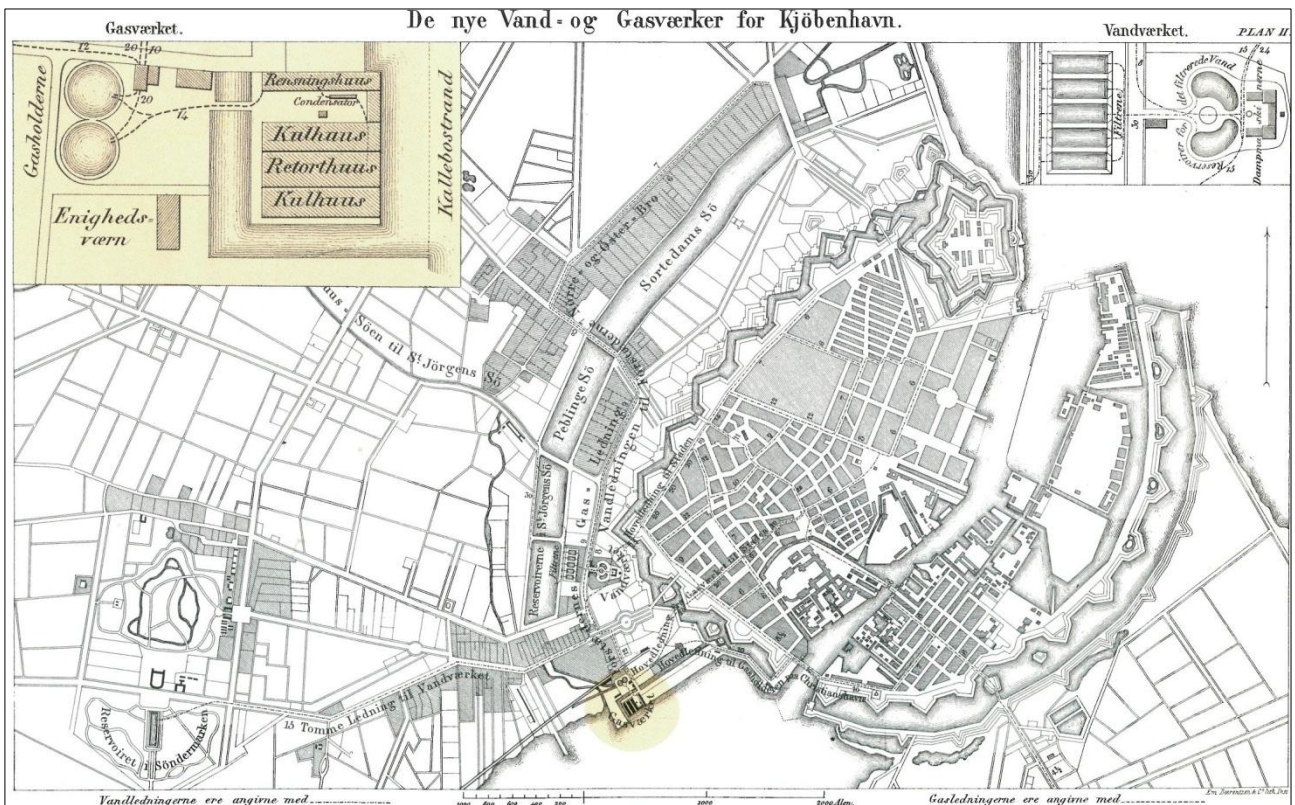
Fig. 361 Map from 1852 showing the route for the projected gas pipelines. Copenhagen City Archive

Gas street lighting was first introduced to Copenhagen in 1857 (*Anonymous* 1982: 13) but a map from 1852 showed the projected route of the proposed gas pipelines. Three gas pipes were found within the Main Excavation trench, one with a large diameter; G541, and two narrower; G542 and G574. There was also a narrow iron pipe to the south of G621 which was recorded as associated with the brick foundations for a street light (see above). A total of three gas pipes were also found in the Guide Wall trench. One of these was found to be the western part of gas pipe group G541. Located 4 m north was G720, a gas pipe with approximately the same diameter as G541. This was also recreated in the post excavation phase from many gas pipe cuts on the same orientation within Trenches 1/ZT9164, 2a/ZT12420, 2b/ZT13818 and Trench 3/ZT13569. The final gas pipe group was G721, a narrower service pipe only seen in the very NW of Guide Wall Trench 1/ZT9164.

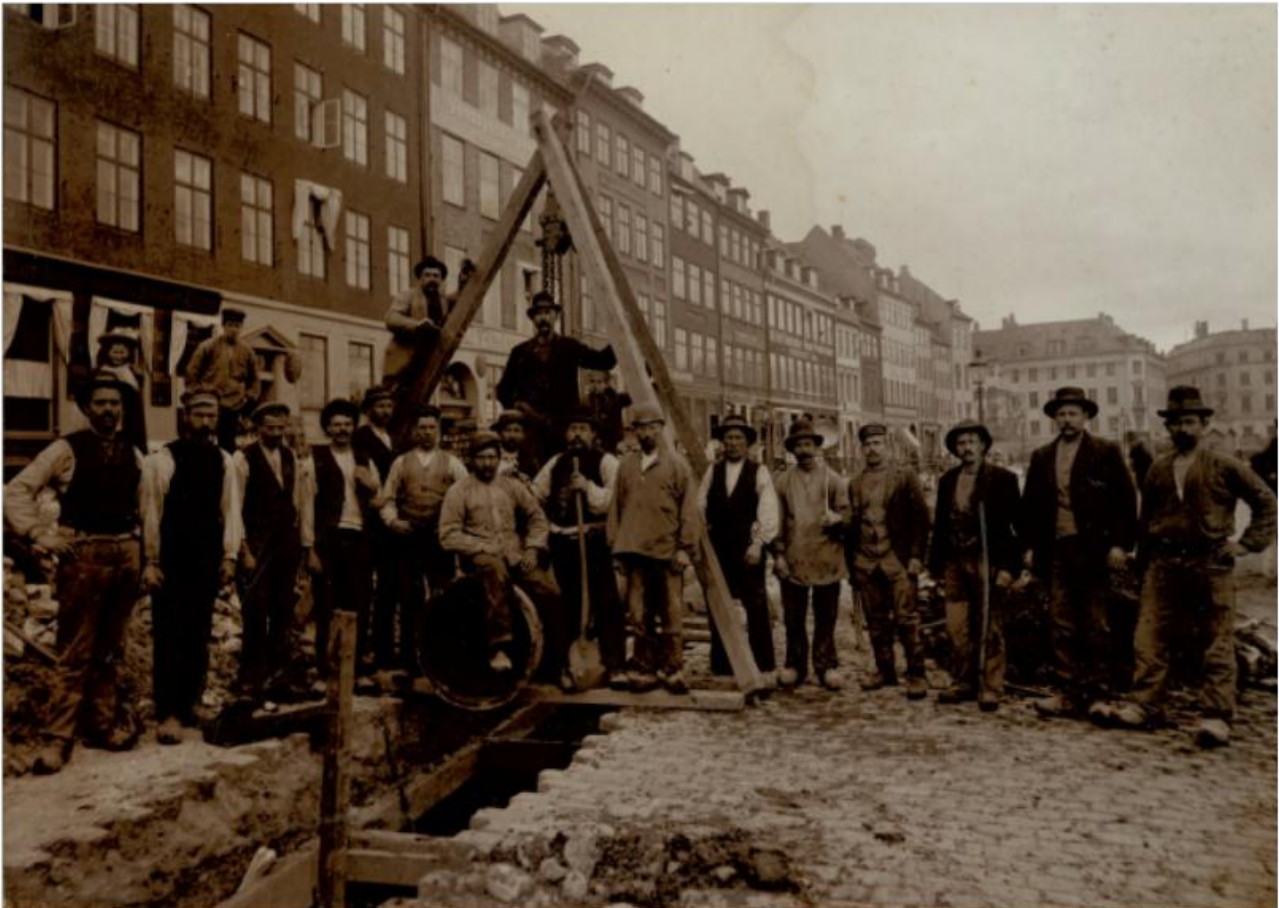
Fig. 362 The large northeast-southwest gas pipe G541 being laid at Gammel Strand during the early 20<sup>th</sup> Century. The normal, shorter street lamps can be seen in the background. Museum of Copenhagen

The large northeast-southwest oriented gas pipe, G541, which measured 84.21 m by 2.11 m and 0.5 m deep from an average height of 0.33 m OD, truncated most of the late 19<sup>th</sup> Century deposits from the southern part of Trench 1/ZT9164 of the Guide Wall trench and then continuing along the northern side of the Main Excavation and Stairway trench. There were probably two episodes of gas pipes within this cut, with the first being removed before the other was placed onto the wooden strut supports found further east. Two large vertical iron pipes, c. 1.2 m in diameter located towards the western end of the pipe, may have been connected to the pipe or may have been beneath it for support. The gas pipe itself was removed by machine and was not surveyed. Neither of the two narrower gas pipes, G542 or G574, connected with the large east-west pipe G541.

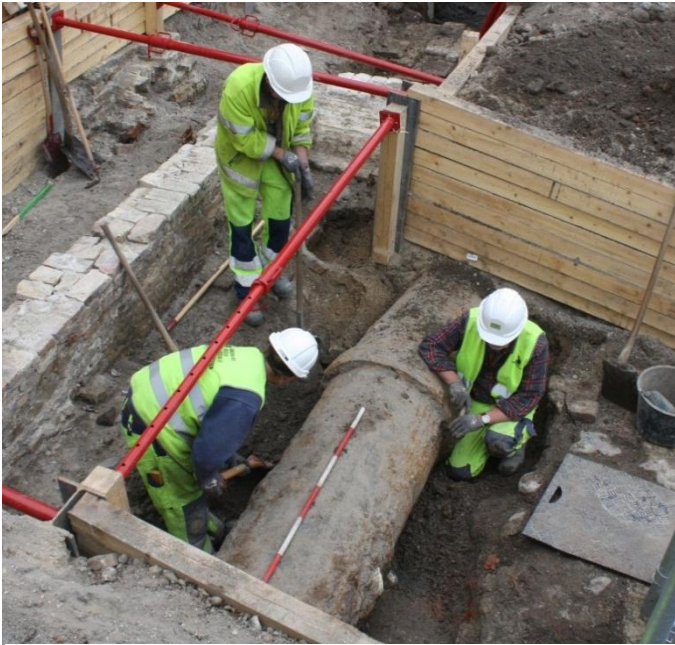
Fig. 363 Working shot showing the gas pipe cut SC9090, G720, in the Guide Wall trench as it was found during excavation, viewed from the southwest. C03\_280612\_4589 (cropped)

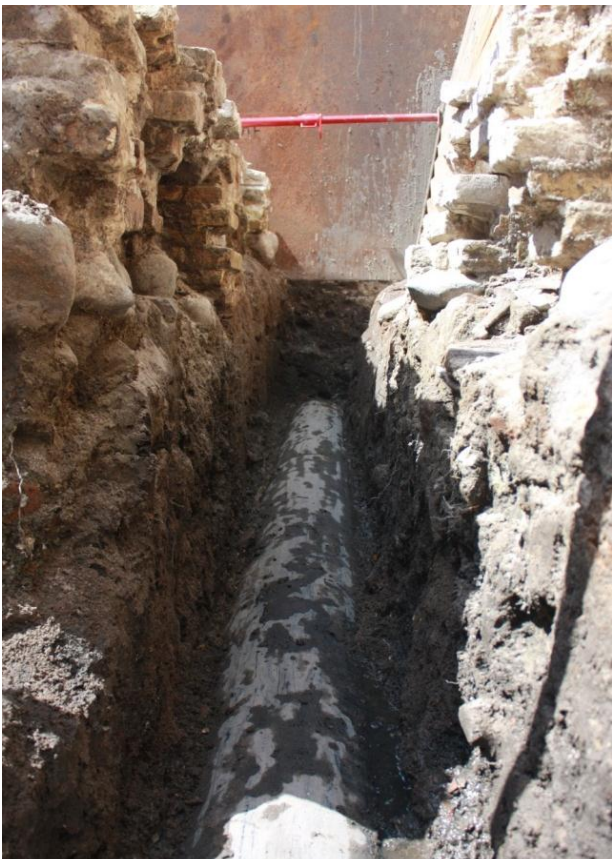
Fig. 364 The northern gas pipe cut SC9729, G721, in the Guide Wall trench looking west. C03\_20120713\_4923

Group G721 was located in the northern part of Trench 1/ZT9164, 1.5 m north of G720 and orientated on a SW-NE direction. The group measured 12.9 m long by 0.65 m wide by 2 m deep and truncated the northern section of the building G707 and some deposits beneath. The construction cut contained backfill comprising urban waste from the 17<sup>th</sup> to the early 20<sup>th</sup> centuries with finds such as glass bottles, ceramics, CBM and animal bone within the fill. The gas pipe was smaller in diameter than the pipes seen in pipes G541 and G720 and was made from rubber.

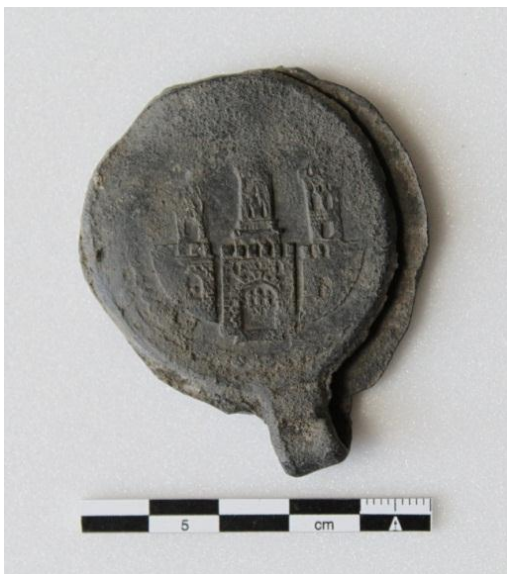
Fig. 366 FO211629. Well preserved lead cloth seal (probably from Hamburg) found in the large levelling dump SD20146 (G636) which covered the entire site. This demonstrates the very mixed nature of the material with a probable 16<sup>th</sup>-17<sup>th</sup> Century cloth seal found in a late 19<sup>th</sup> Century deposit. Museum of Copenhagen

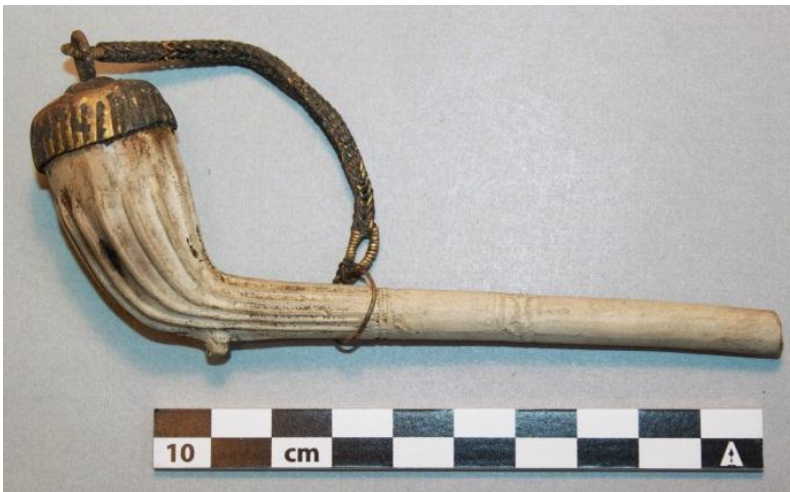
Fig. 367 FO213419. Clay pipe found in the levelling dump SD20146 (G636). Its design comes from the Schmidt family in Stubbekøbing and dates to around 1740-70. The unusual lid is probably brass which contains four holes and is attached to the body of the stem with a decorative wire. Museum of Copenhagen

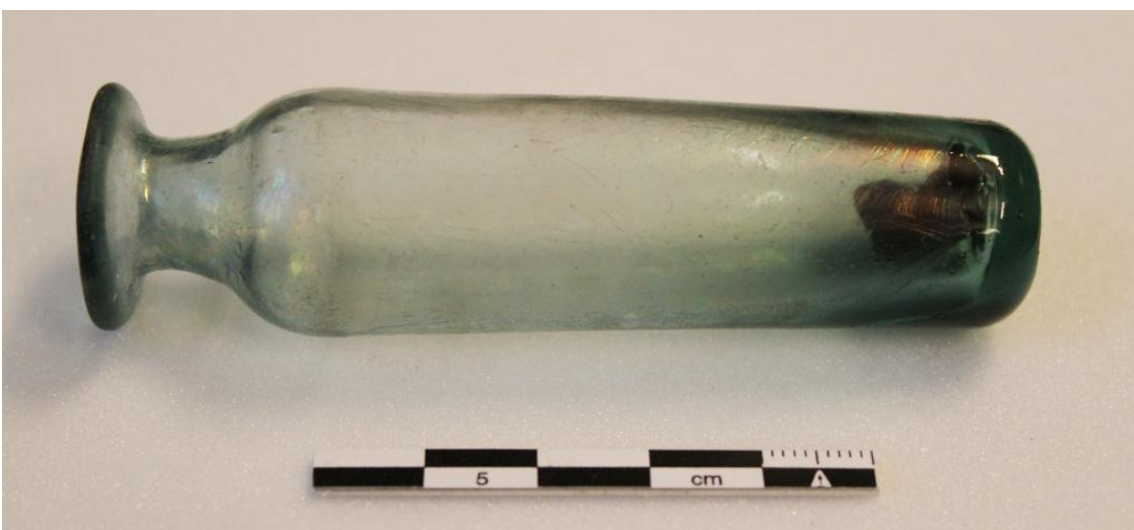
Fig. 368 FO213530. A small glass bottle found in the levelling layer SD20146 (G636). The remains within the base of the bottle could be the bottle stopper. Museum of Copenhagen

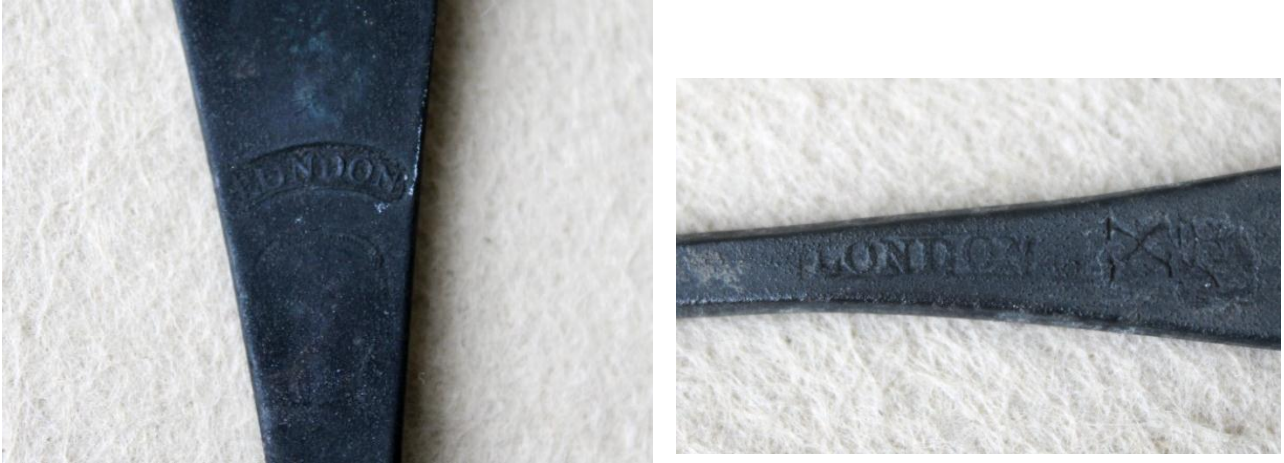
Fig. 369 FO213355 (left) and FO213357 (right). Two spoons with the stamp 'London' on the back, found in the levelling layer SD20146, G636. Museum of Copenhagen
