Late medieval city wall 1350–1550 AD

City wall – building material and construction details

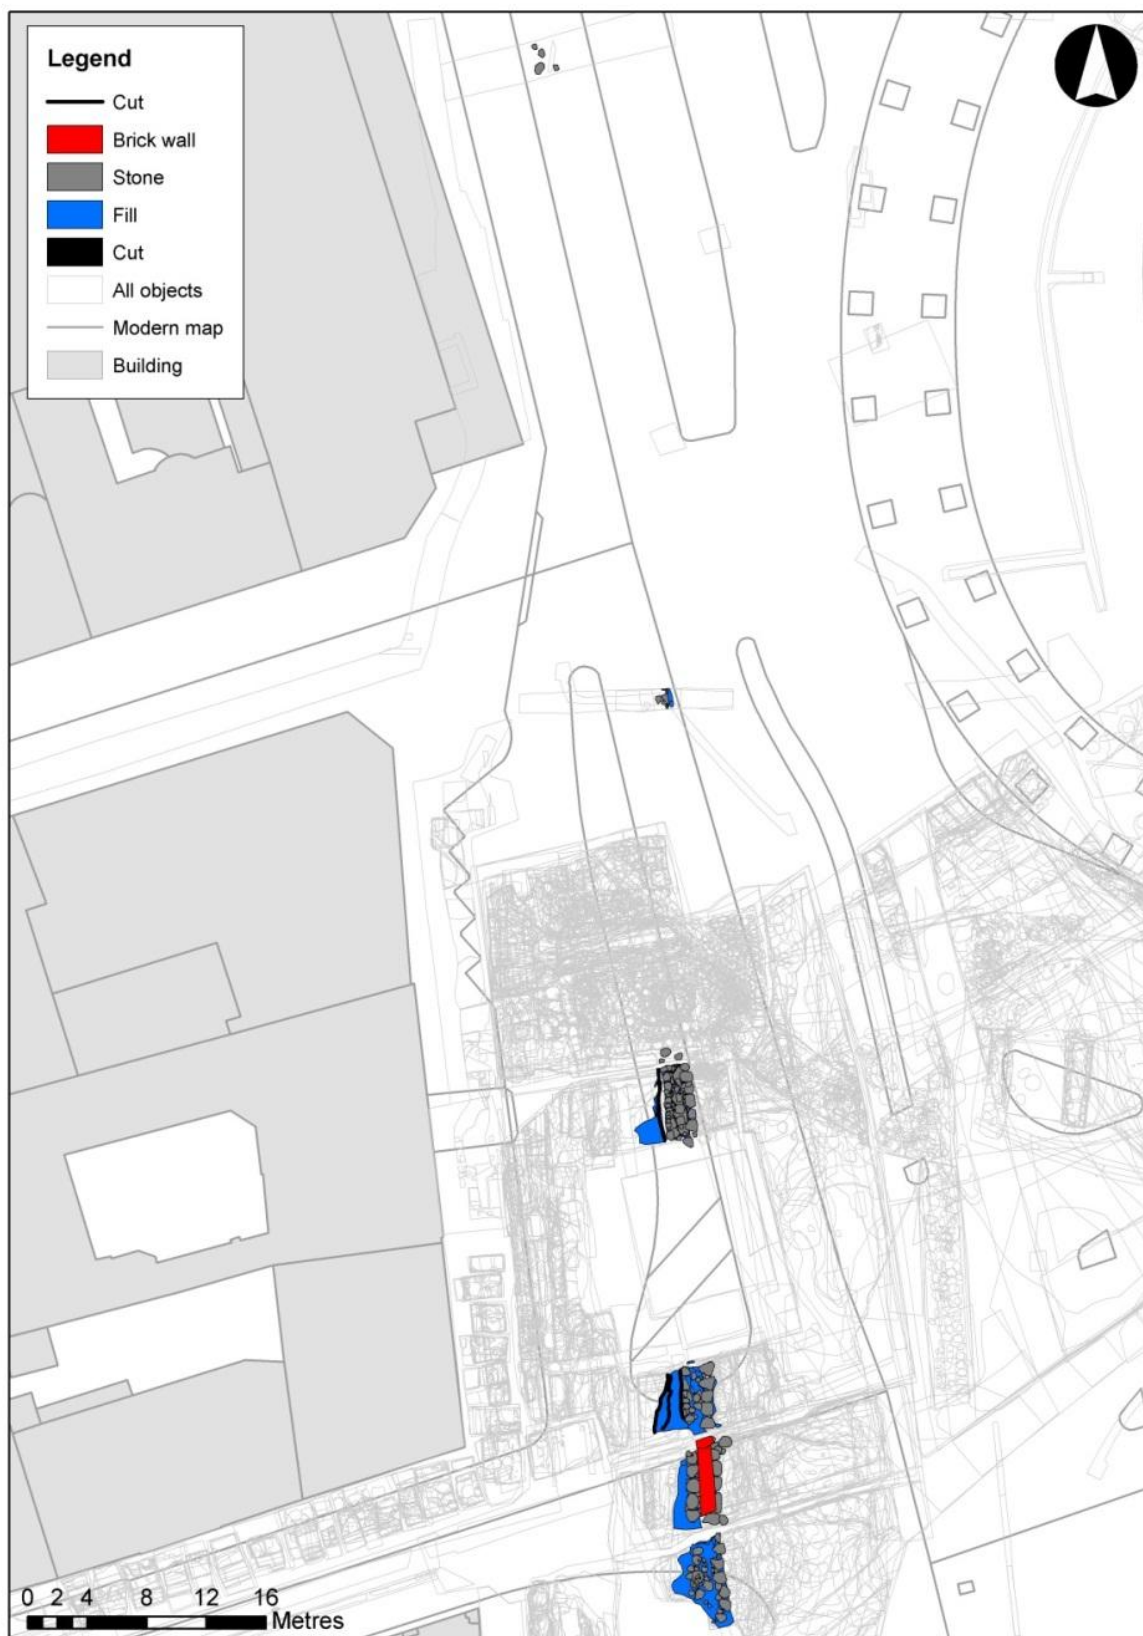
Fig. 62. Overview of investigated medieval city wall with construction cuts, foundation stones, limestone ashlar and brick walls outside Hotel D'Angleterre and between Lille Kongensgade and Østergade.

The foundation consisted of three layers of unfinished granite boulders (Fig. 62 and 63). The foundation had a length of 39 m from north to south, a width of 2.3 m and a height of at least 2.0 m (based on the difference between the top of the stones and the base of the construction cut). The courses and the rampart layers had been built “step by step”, where the purpose of the rampart primarily had been to stabilize the foundation and brick wall, where the upper coursing was placed 0.6 m west of the underlying foundation stones. The tops of all the boulders were almost level which suggests that great care was taken to ensure their stability. At least two of the boulders exhibited tool marks in terms of chisel marks and wedge holes.

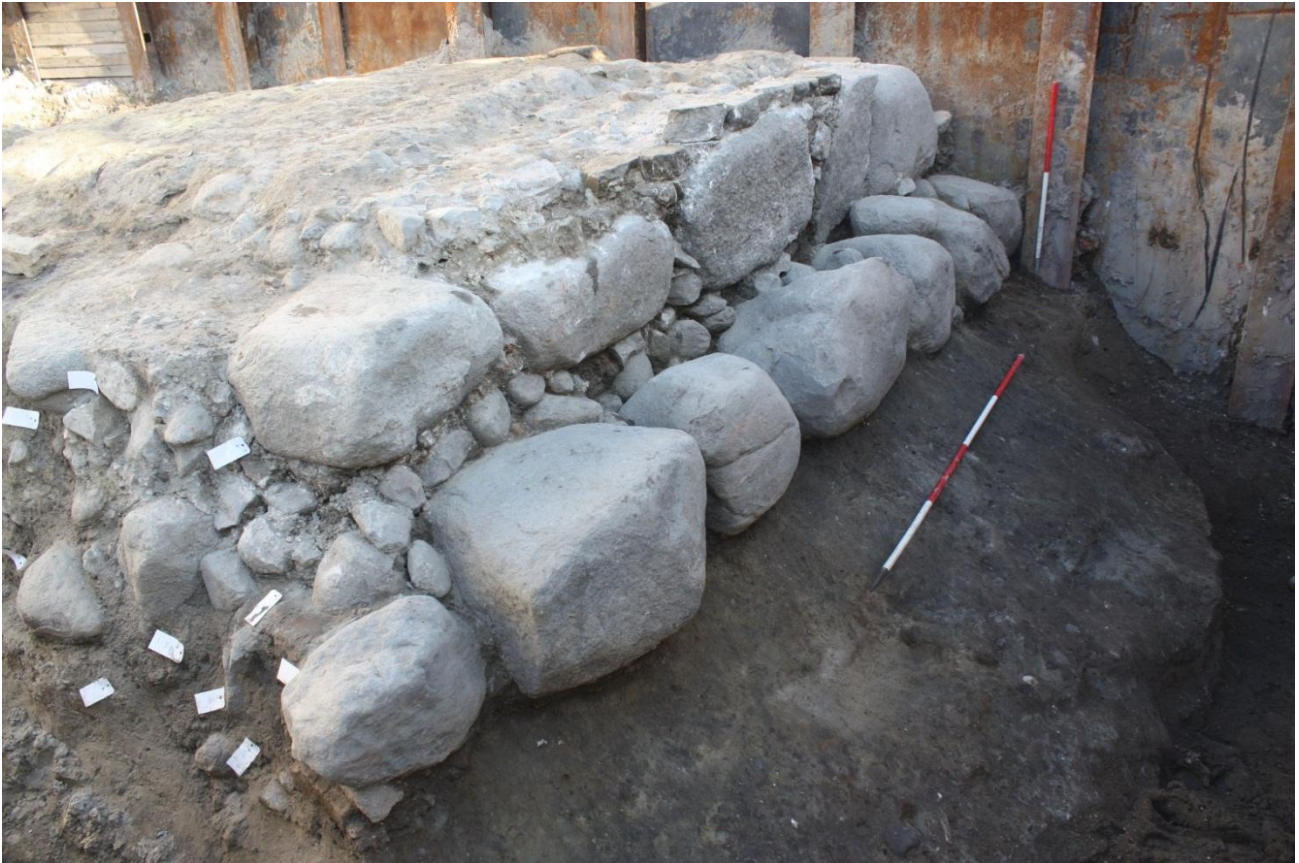
Fig. 63. The eastern face of the city wall foundation with two courses of boulders and intermediate stones and backfills, facing NW. To the right – part of the sloping moat. The structure was truncated by the shoring to the north and the Transformer Station to the south. Photo: Museum of Copenhagen.

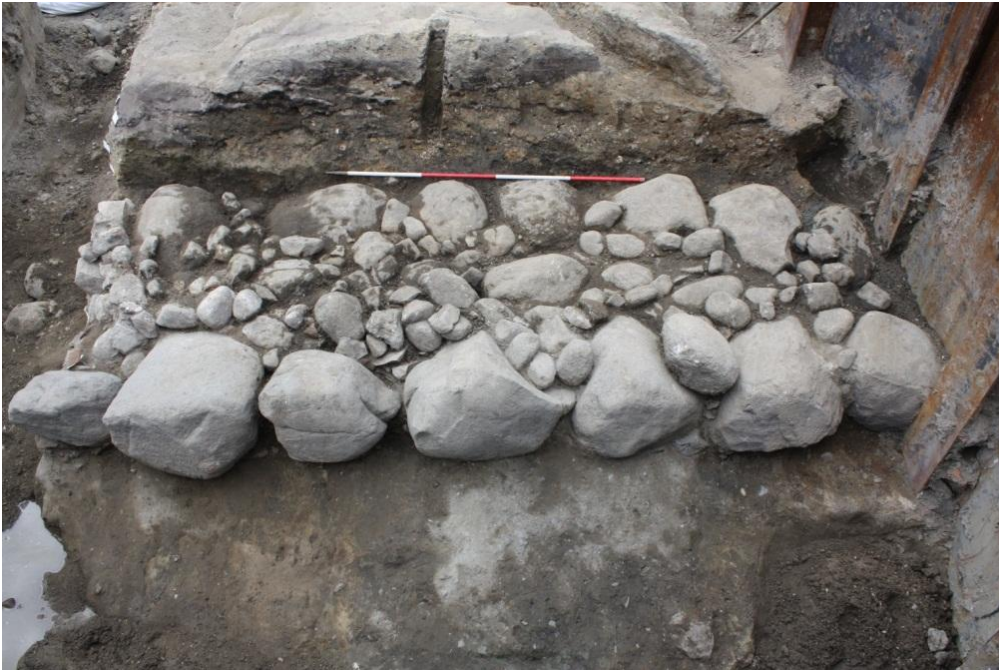
Fig. 64. The lower part of the foundation together with filling the core between the lower east and west facing courses, facing west. In front – part of the moat, behind the built rampart. Photo: Museum of Copenhagen.

The infill in the gap between the east and west facing courses consisted of sand, pebbles and flint together with bigger and smaller stones. Some of the stones seemed to have been arranged intentionally in a line behind the face of the wall to the east, whilst others were placed in randomly in the core of the foundation (Fig. 64). The purpose was to strengthen the structure and inhibit later movement or slippage.

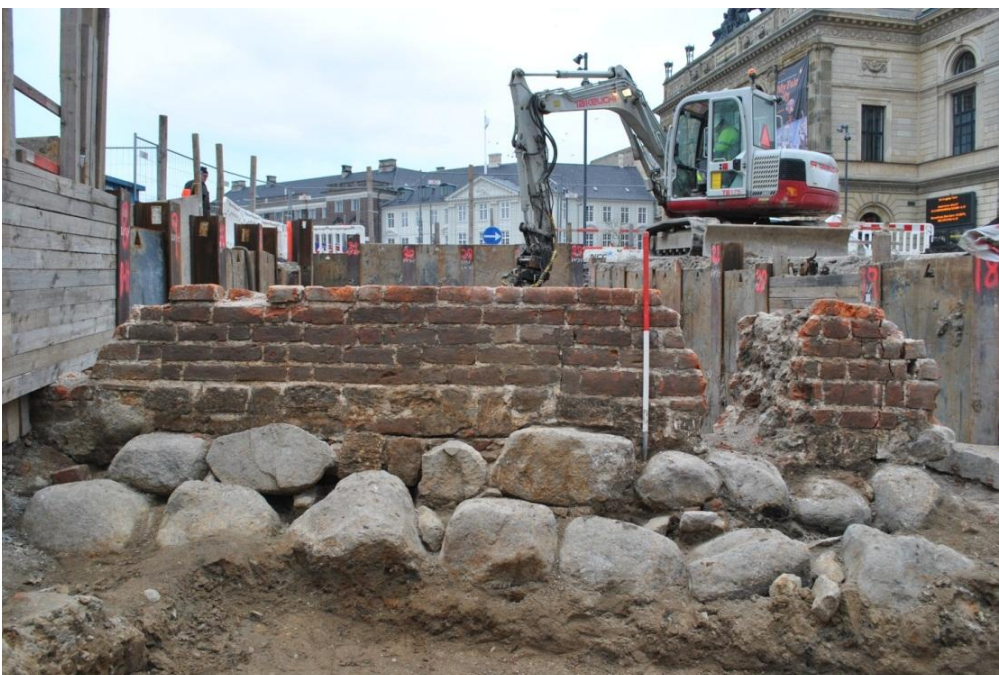
Fig. 65. General view of brick wall and foundation, facing east. Photo: Museum of Copenhagen.

The remaining part of the curtain wall consisted of five courses of medieval bricks (“munkesten”), mortared together with sandy lime and a lower course of rectangular limestone ashlar on the eastern side facing the moat (Fig. 65). The bricks general size was 0.28 x 0.12 x 0.09 m, but there were also bricks with varying sizes between 0.27-0.29 x 0.10-0.13 x 0.07-0.11 m. In the base of the wall some of the bricks were cut into size. To make the coursings fit better, some of the bricks were placed upright so the top of the bricks were facing front. One brick had also been halved lengthwise (so-called “mesterpetring”).

The brick wall had originally been c. 0.9 m wide (1.5 cubit or three tiles thick, where one Zealand cubit = 0.6326 m). The brick wall was built in monk bond, i.e. two stretchers between every header with the headers centered over the perpendicular joint between the two stretchers in the course below, in the bond's most symmetric form (Fig. 65).

The lowest course of limestones on the west side had been laid with limestones (Fig. 65) whose length was up to 0.28 m with a thickness between 0.09 and 0.16 m. The limestones were mainly rectangular, but a few of the stones were also quadratic. Most of the limestones were coursed in the medieval manner, but there were some irregularities occurring where there was a need to adjust the overlying, mostly linear courses on the underlying very irregular granite boulder base. Therefore it had been necessary in several places to vary the width of the limestones as well as place them on edge. The limestone course acted as a transition zone, between base and wall, where it passed on regularity to the overlying brick courses.

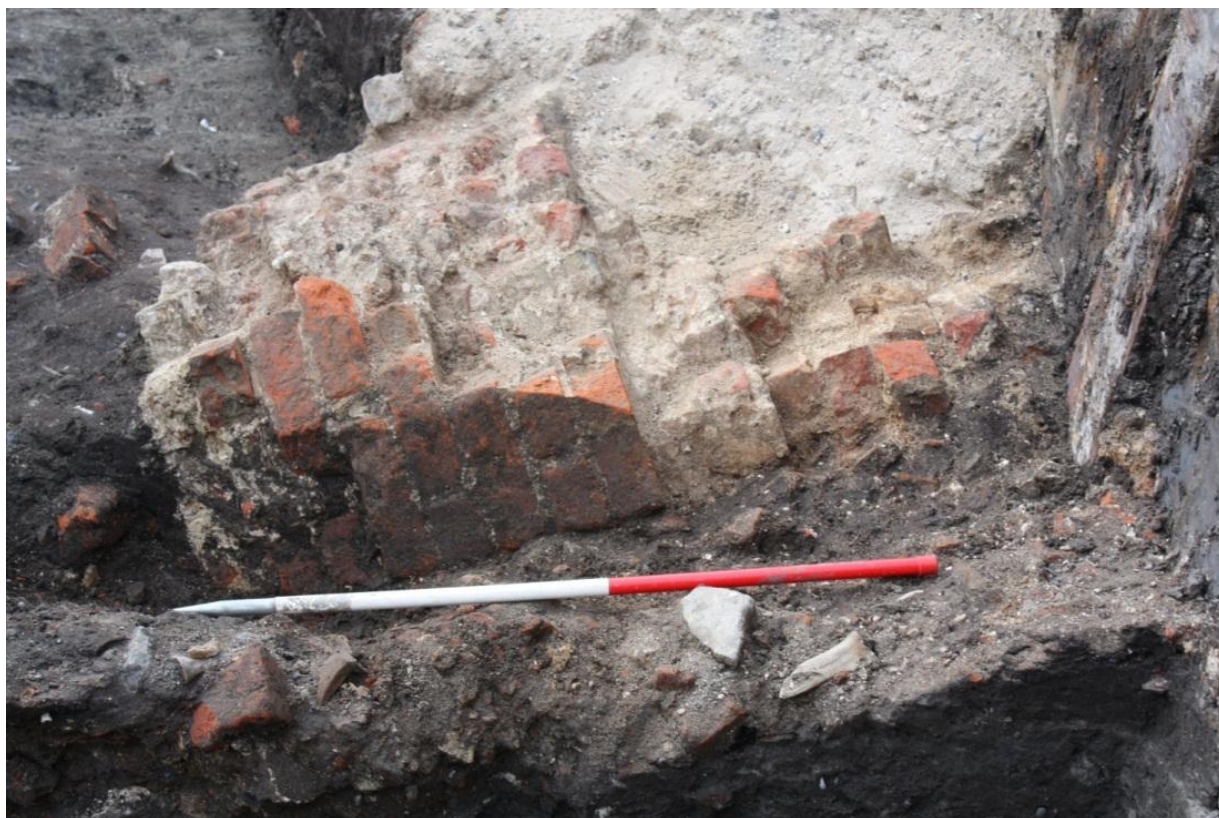
Fig. 66. Collapsed and partially truncated brick wall in the Late medieval moat. Photo: Museum of Copenhagen.

Different parts of the city wall were also recorded among the demolition material and backfills in the Late medieval moat and reused in the 17th century dam structure (Fig. 66 and 67).

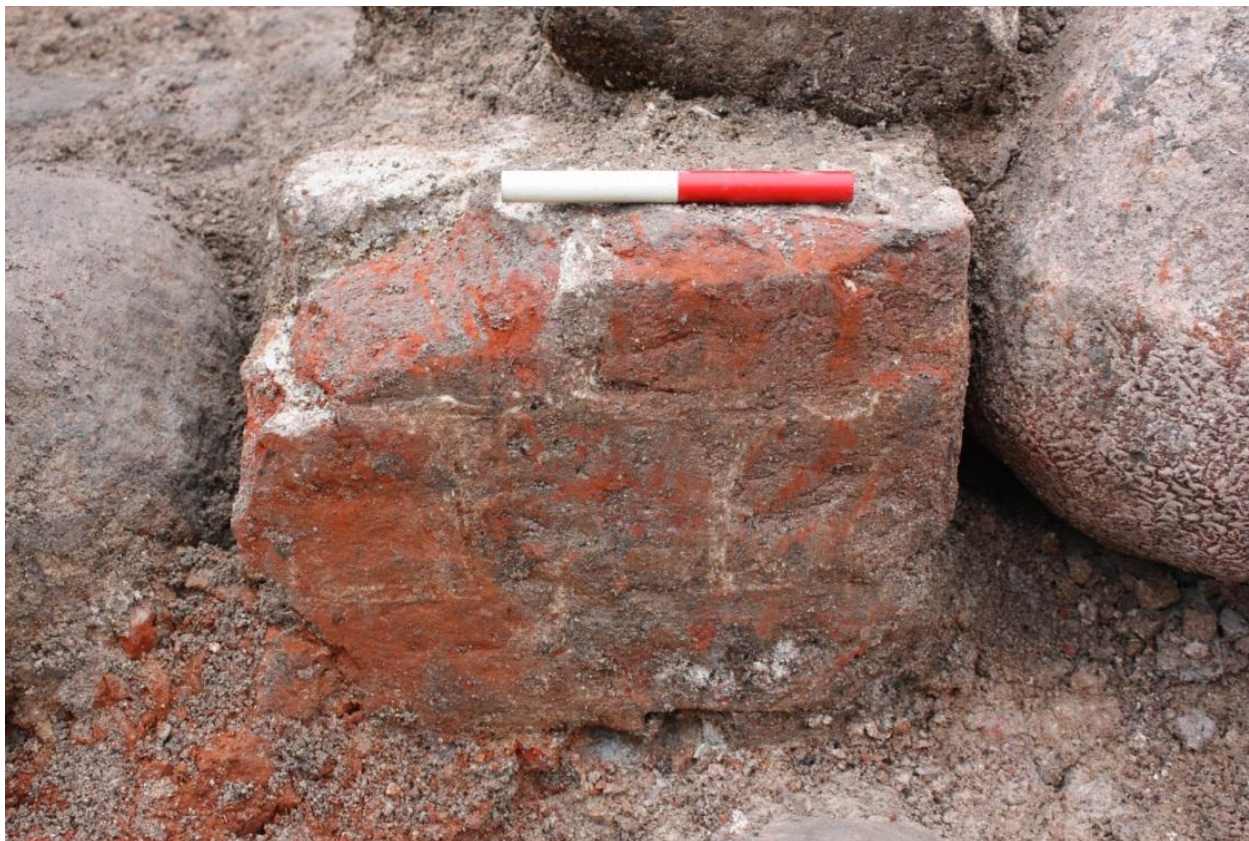
Fig. 67. Close-up photo. Part of an interpreted merlon probably from the former city wall between two of the stones in the dam structure, facing north. Photo: Museum of Copenhagen.

Masonry reused and documented in the 17th century barrier tower can perhaps tell something about the city wall's upper parts. Two square blocks consisted of 3 courses of red bricks ("munkesten") with white tuck mortar within foundation. The features are interesting – the shape and the finished edges suggest that these represent the lower part of merlons, reused as building material when the city wall was demolished, the latter dated by building material in the Late medieval moat. A crenellated parapet can also be seen on the northern part of the city wall between Vesterport and Nørreport on Braun and Hogenberg's prospect over the city from 1587 AD (Braun and Hogenberg 2008).

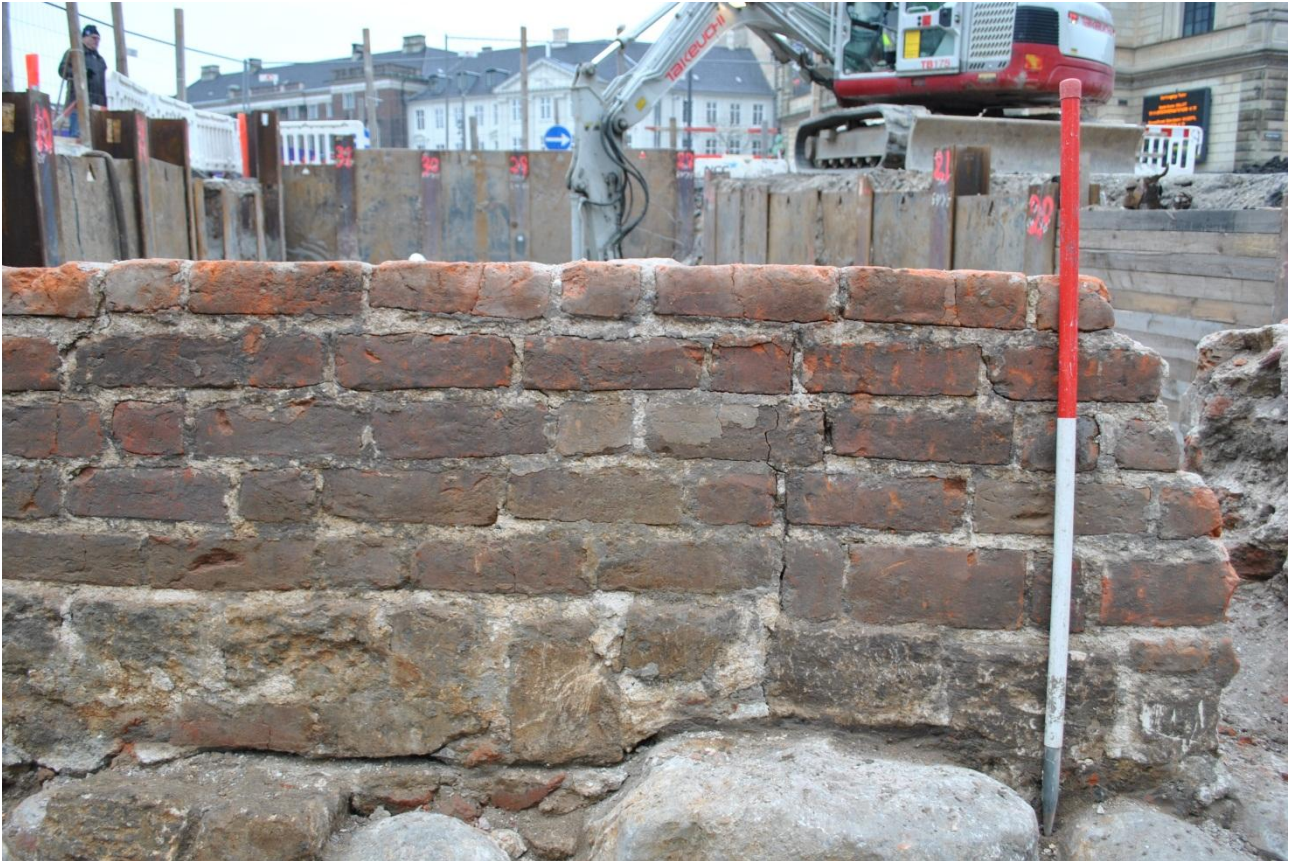
Fig. 68. Detail of brick wall and limestone coursing, facing east. Photo: Museum of Copenhagen.

embankment. The width of the brick wall varied from 0.86 m to 1.20 m placed on 2-3 courses of large granite boulders where the width of the foundation was 1.1-2.2 m. The construction cut truncated the salt marshes and the foundation stones had been placed step-wise. Limestone ashlar were later placed at the base of the wall to level the masonry built using monk coursing and with brick size 27.0 x 12.5 x 9.0 cm (Fig. 68).

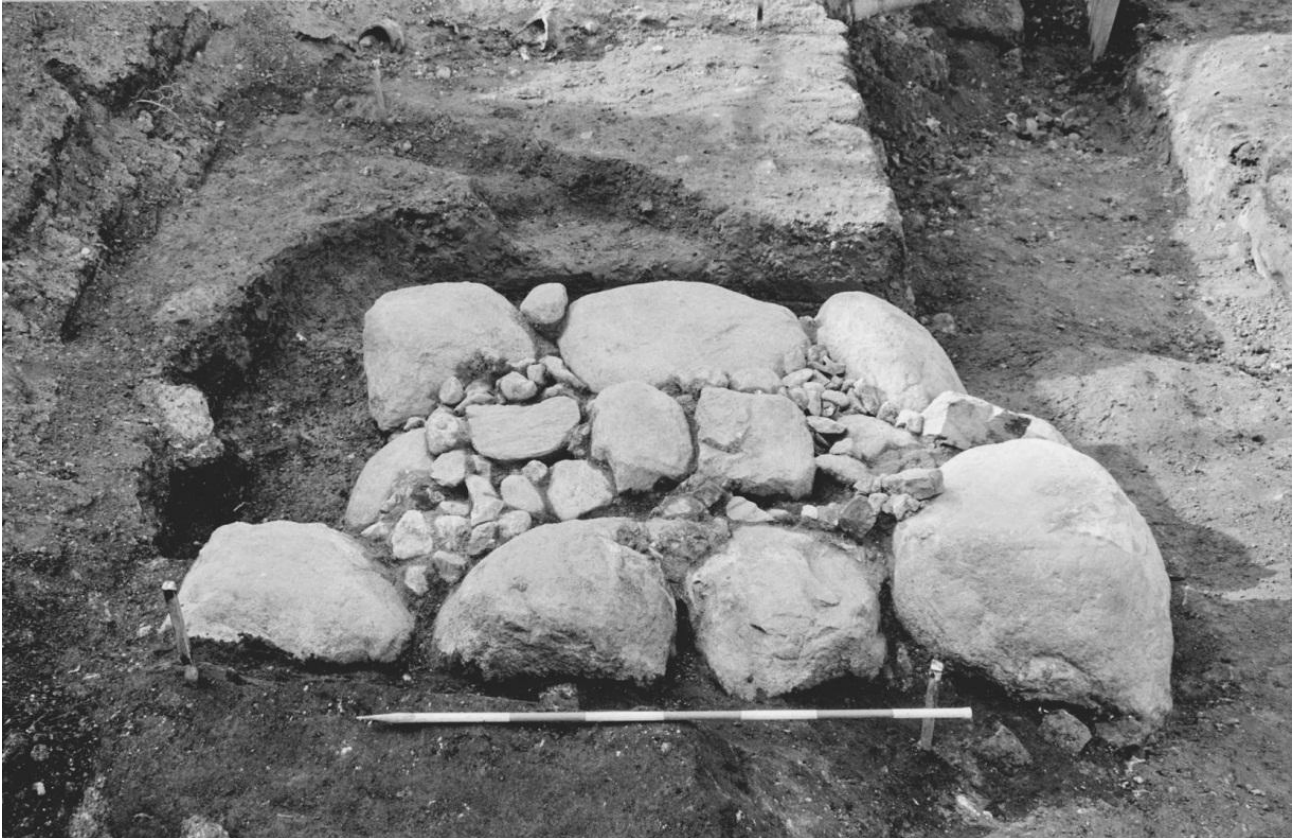
Fig. 70. Foundation for the city wall investigated in 1996, facing west. Photo: Museum of Copenhagen.

At the Metro investigations in 1996–1998 the city wall was preserved as three foundation courses consisting of two rows of stones with a width between 1.1-1.7 m and a height of at least 1.4 m (Fig. 70). The top of the foundation was not preserved and no mortar was recorded on the stones. The courses and the rampart layers had been built "step by step", where the purpose of the rampart primarily had been to stabilize the boulders. Part of the wall was also found as decomposition layers of bricks and ashlar limestone above the mud layers in the former moat (Kristiansen 1998:73 et seq.; 1999b:156-158, 161 and 162). This destroyed part of the city wall consisted of a continuous remnant of a brick wall, at least 1.8 x 1.2 m with monk coursing together with bricks and limestone ashlars. The remnant was interpreted as part of the parapet. The wall had been 0.42 m thick with unfilled joints. No reused bricks were identified in this part

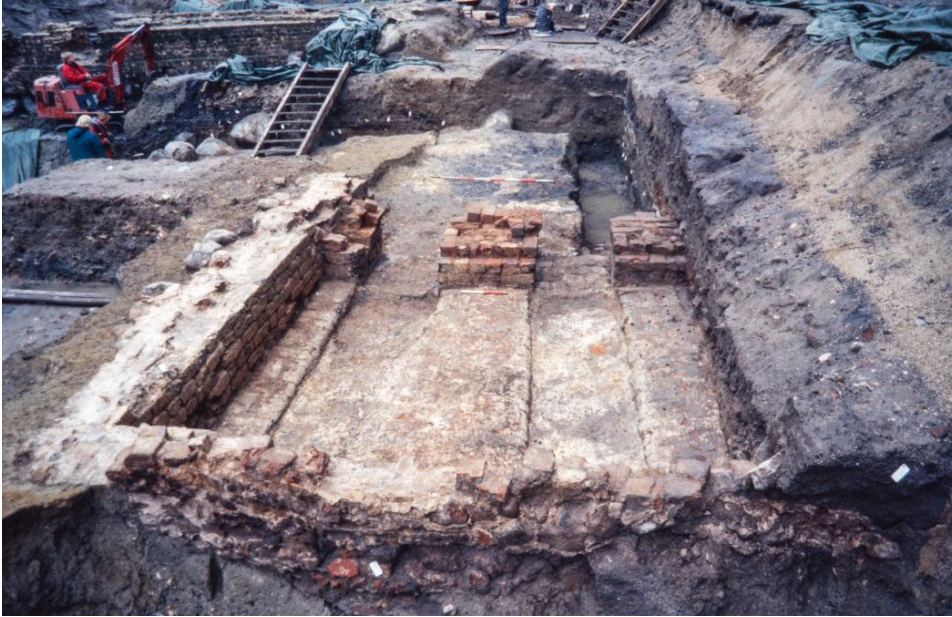
Fig. 72. Tile stove investigated at the Metro excavations 1996–1998, facing south. Photo: Museum of Copenhagen.

During this archaeological excavation three samples from mortar connected to a wall remnant were TL-dated to the 12th and 13th century. A brick kiln built in several phases (stove, brick floor, two brick benches, six heating channels and brickwork of “munkesten” preserved in six courses) was recorded west of the oldest rampart line (Fig. 71 and 72), interpreted as being used for brick production connected to the construction of the city wall and covered by a later phase of the rampart. TL-dates of bricks in the stove were dated to c. 1210 AD and 1310 AD. Charcoal from the fire pit was C14-dated to the early 1200s (Kristiansen 1998:65, 77, 78 and 93-95; 1999b).

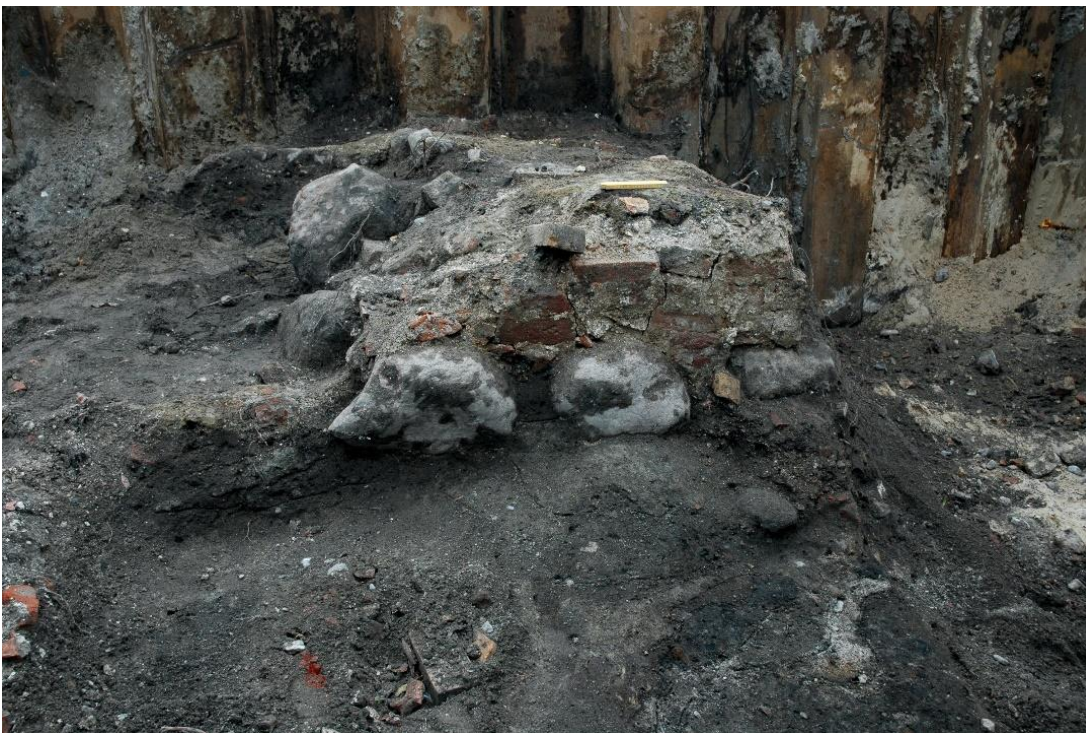
Fig. 73. Part of the medieval “strandmur” investigated in Norra Vollgatan in Malmö. Photo: Malmö Museer, Rapport 2009:047.

The wall had probably been 9 cubits high (5-6 m) with an earthwork lying behind. During the time of Fredrik the 1st the fortification was straightened with an inner embankment as high as the city wall and with a width of 16 cubits – though it is uncertain if the latter is valid for the area around Østerport (cf. Thorsen 1926:226 and 234). In comparison the city wall in Malmö, Scania from the early 15th century would have been 9 cubits high – c. 5.5 m with a width of “three stones” (c. 0.9 m) standing on a one metre high foundation of natural boulders (Rosborn 1984:37; Reisnert 1998:32 et seq.; Olsson och Ödman 2009 and Fig. 73).

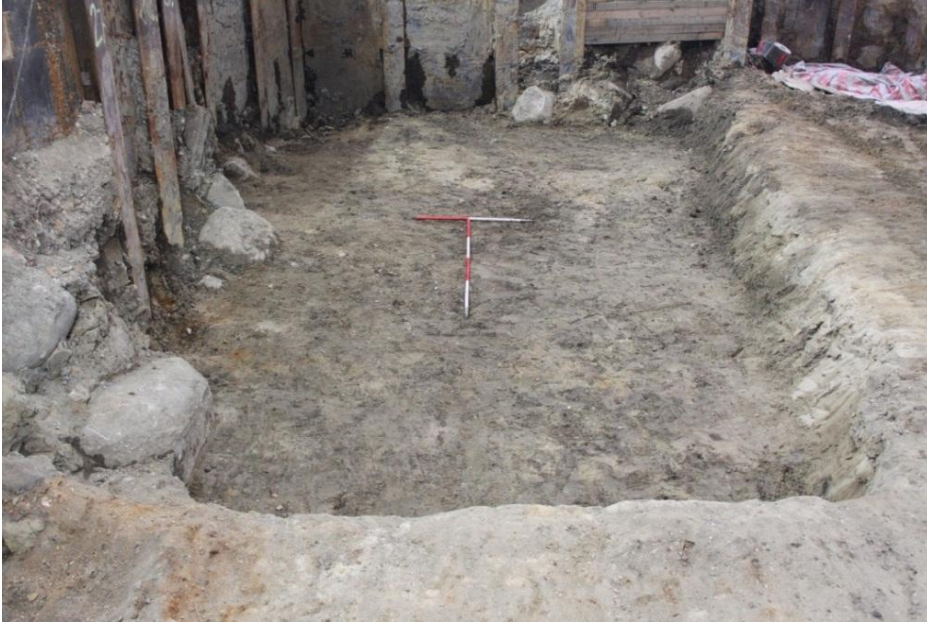
Fig. 75. Post-excitation. Northern construction cut of the gate building without foundation stones, facing east. Photo: Museum of Copenhagen.

The construction cut for the gate building could be followed both in the northern and southern parts of the structure truncating the natural clay and sand. Only half of the northern part of the gate building was investigated where the foundation cut formed four separate L-formed cuts recorded at a distance of 8.4 x 4.4 m. Four cuts surrounded the southern foundation over a total distance of 7.2 x 6.5 x 9.1 m. Both truncations were limited by the excavation area and by the Late medieval moat cut to the west (Fig. 75).

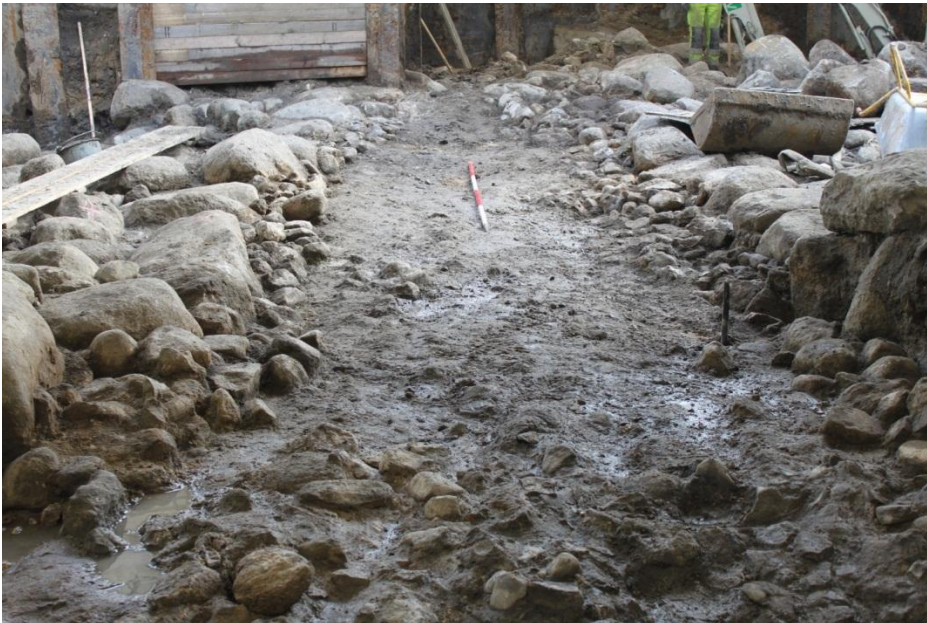
Fig. 76. Backfill and concentration of smaller stones in the construction cut on both sides of the gateway area, facing east. The extension of Østerport in the 17th century can probably be seen as a slight bend of the gateway. Photo: Museum of Copenhagen.

Smaller stones were within the gateway area extending for a distance of 10.0 m up close to the northern and southern foundation walls. These may have functioned as a stabilizer within the created construction cut and the later backfill (Fig. 76).

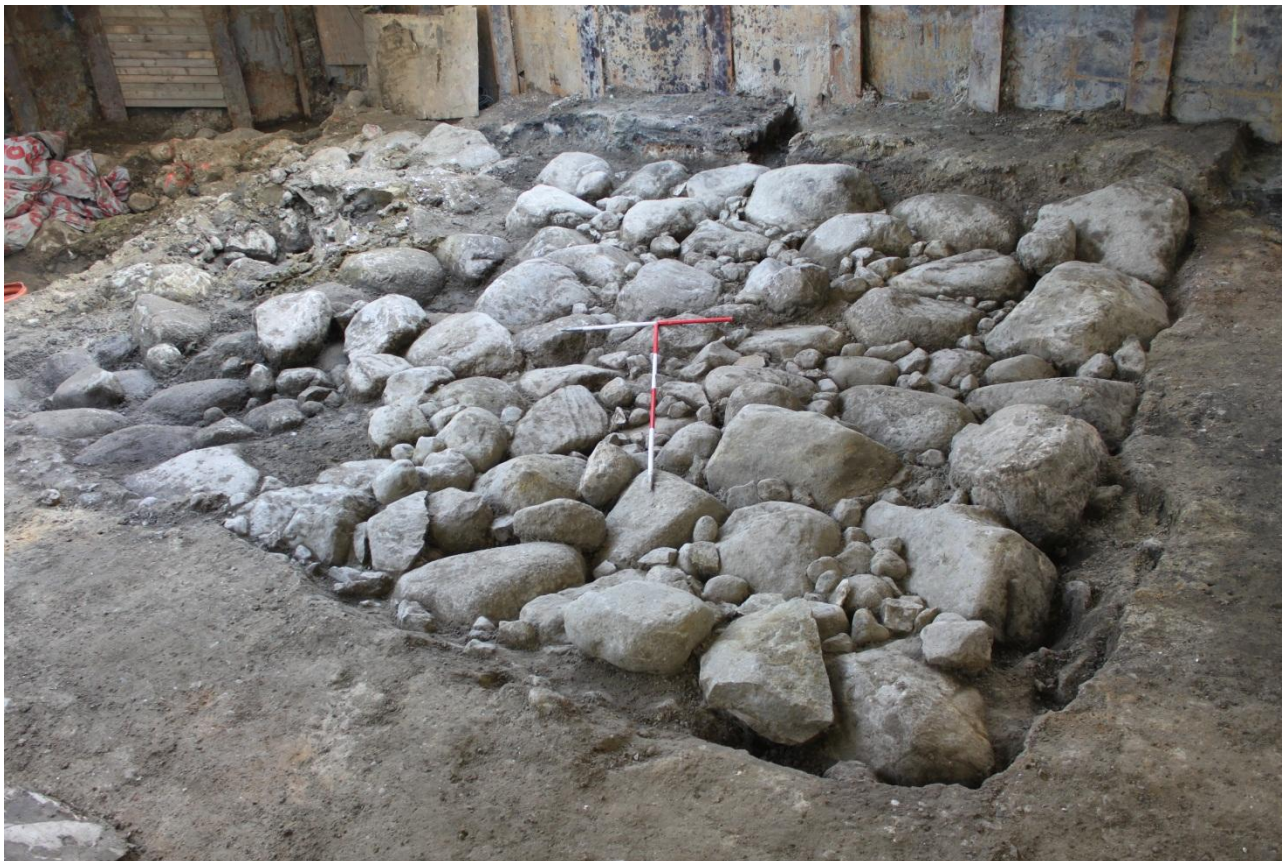
Fig. 77. Southern foundation layer of big boulders and smaller stones dug into natural, facing SE. Photo: Museum of Copenhagen.

The main foundation to the gate building consisted of a dry stone structure comprising of light and mid grey unfinished stones and boulders (Fig. 77). The dimensions varied – the main foundation stones and the outer skin of stones in the foundation had an average of 0.50-1.50 m in diameter, the packing consisted of smaller fill stones with an average of 0.05-0.40 m in diameter. In between, the fill consisted of firm, yellow-brown clay, silt and sand together with smaller stones.

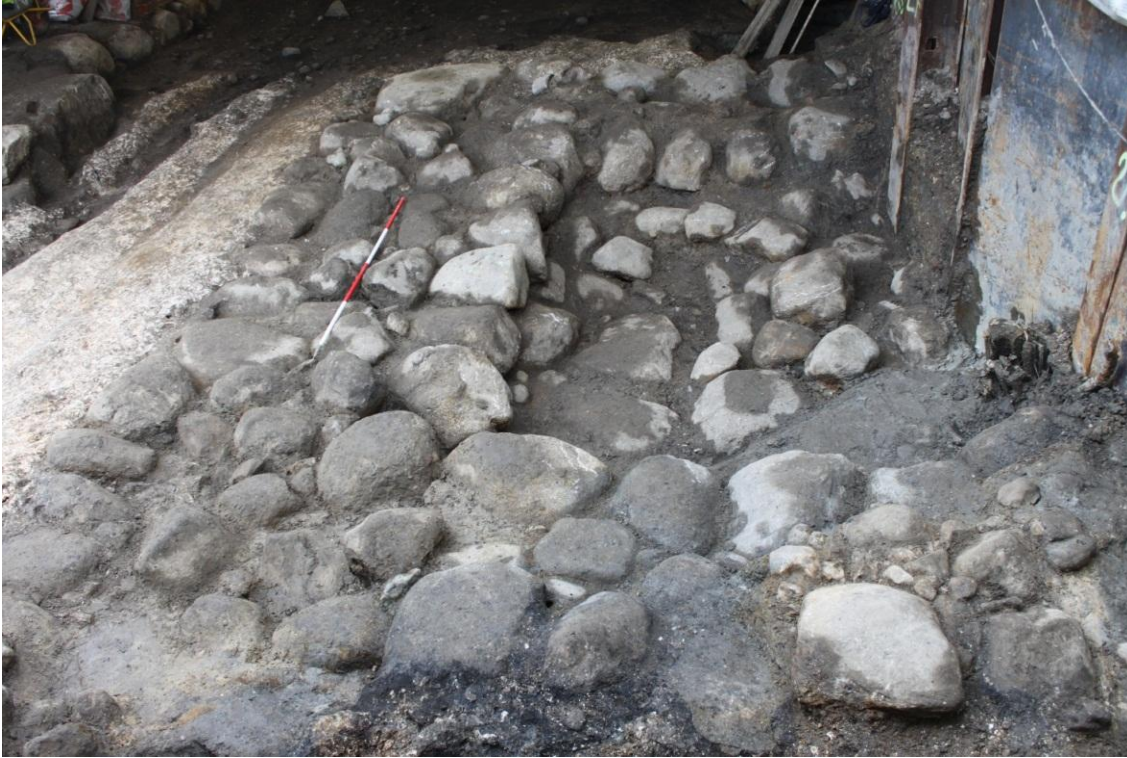
Fig. 78. The NW room in the gate building, facing west. In the foreground – part of the partition wall. Photo: Museum of Copenhagen.

The gate building had been divided into four rooms where the NW and SW rooms could be measured to 4 m² and 6 m² (Fig. 78). The building itself including the outer walls was approximately 140 m², where the gateway constituted c. 25 m², though the size is uncertain due to later additions in the 15th century. One of the structures formed an upper row of foundation stones for the northern wall of the two rooms in the northern part of the building. Like the foundations, the walls consisted of light and mid grey roughly unfinished stones and boulders; outer skin stones were an average of 0.50-1.50 m and the packing of smaller stones were between 0.05-0.40 m in diameter.

The natural boulders had been carefully placed in relation to each other where flat side(s) were placed out- or upwards, either to achieve a smooth surface or to facilitate the work with the next layer of stones. After placement, the remaining gap was filled with stones and compact light white-yellow mortar and firm brown-grey sand and clay with inclusions of charcoal, pebbles, small stones and red brick fragments. The foundation material between the stones and boulders within the separated rooms consisted of compact and hard silty clay and sand of different colours and inclusions of charcoal, CBM, pebbles and stones. Nothing implies that the upper and exposed stone walls had been plastered, etc. (Fig. 78 and 79).

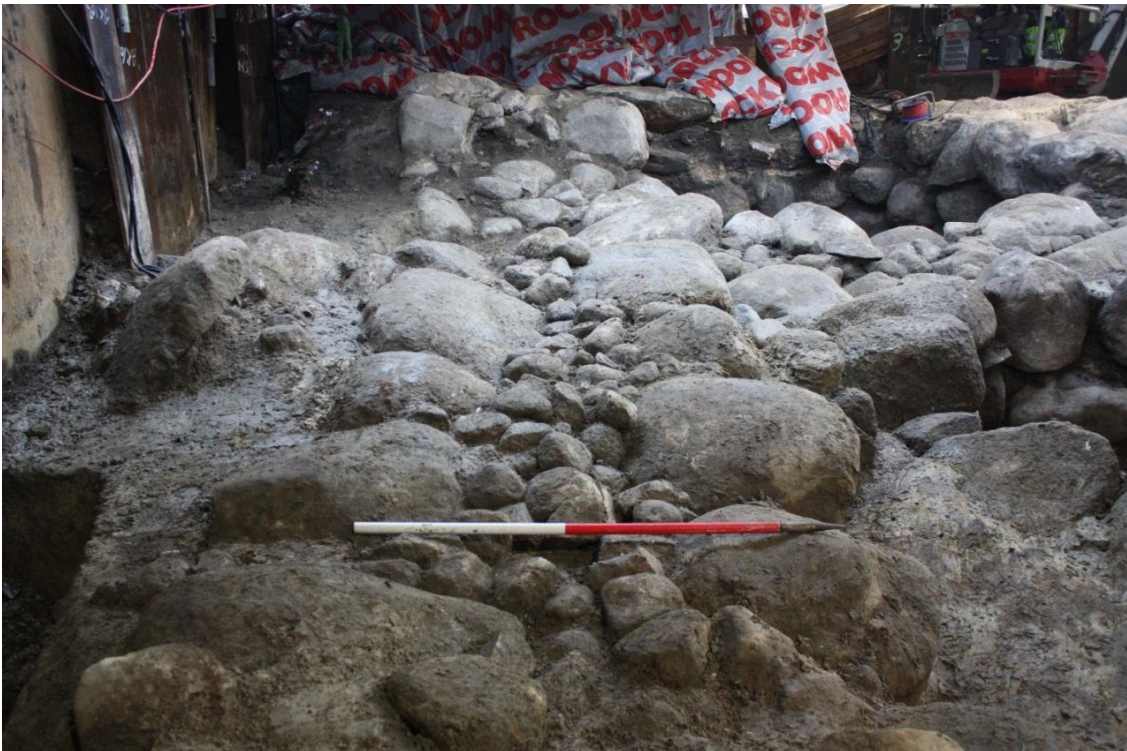
Fig. 79. Construction detail. The southernmost and double faced wall with packing material of smaller stones, facing west. Photo: Museum of Copenhagen.

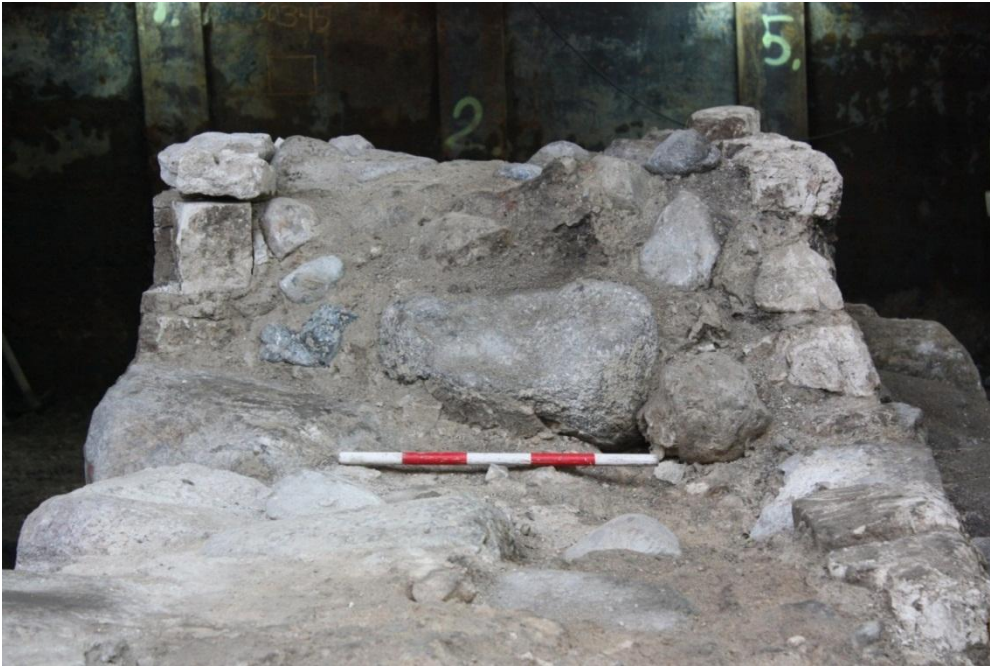
Fig. 80. Cut through the NW gateway showing the two faces of ashlar stones and core consisting of smaller and bigger stones with mortar, facing west. Photo: Museum of Copenhagen.

Two lengths of a limestone wall of blocks on top of the northern foundation wall in the gateway area had survived. The length was 0.9 m and 2.4 m respectively (Fig. 80). Despite the fact that only a minor part of the structure was recorded, this sequence of limestones had probably existed on both sides of the gateway in connection with the top section of the foundations.

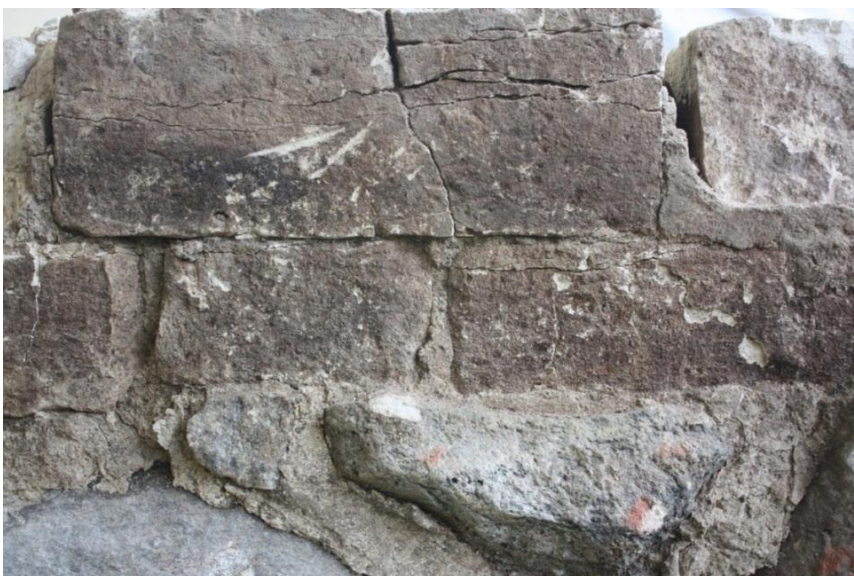
The largest limestone block was 0.45 x 0.18 x 0.21 m and the smallest 0.21 x 0.11 x 0.20 m (Fig. 81). The pointing was very varied in thickness – from approximately 0.025 m to 0.010 m. The limestones were in some cases tapered at the back. At the northwest corner of the ashlar structure there was one stone that formed a corner with a wall going in a north-south direction keyed into this part of the wall.

Fig. 81. Detail. Close-up photo of limestones, facing north. Photo: Museum of Copenhagen.

Fig. 105. Limestone ashlars in Absalon's Castle under Christiansborg. Compare with the limestone blocks in the eastern gate building; figure 81. Photo: Morten Steineke.

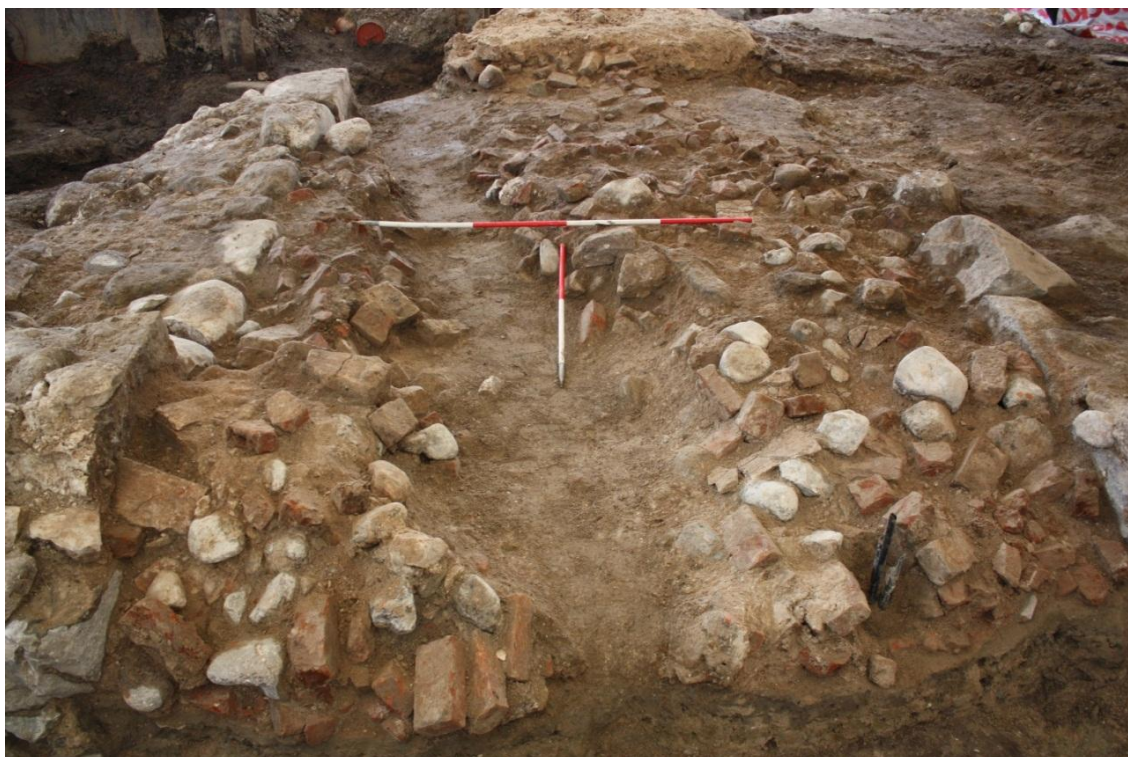
The demolition material consisted of mortar and light and mid white, brown, grey and yellow sandy silt and clay with mixed inclusions of charcoal, ash, shell, pebbles, stones and fragments of lime- and “munkesten” (Fig. 82). The cuts were remains of stone imprints and interpreted as robber cuts of different size and depth.

Fig. 82. Demolition material consisting of red bricks, stones, limestone and mortar in the gateway area, facing east. In the middle traces of a modern pipe line cut. The truncation in the middle represents a modern disturbance. Photo: Museum of Copenhagen.

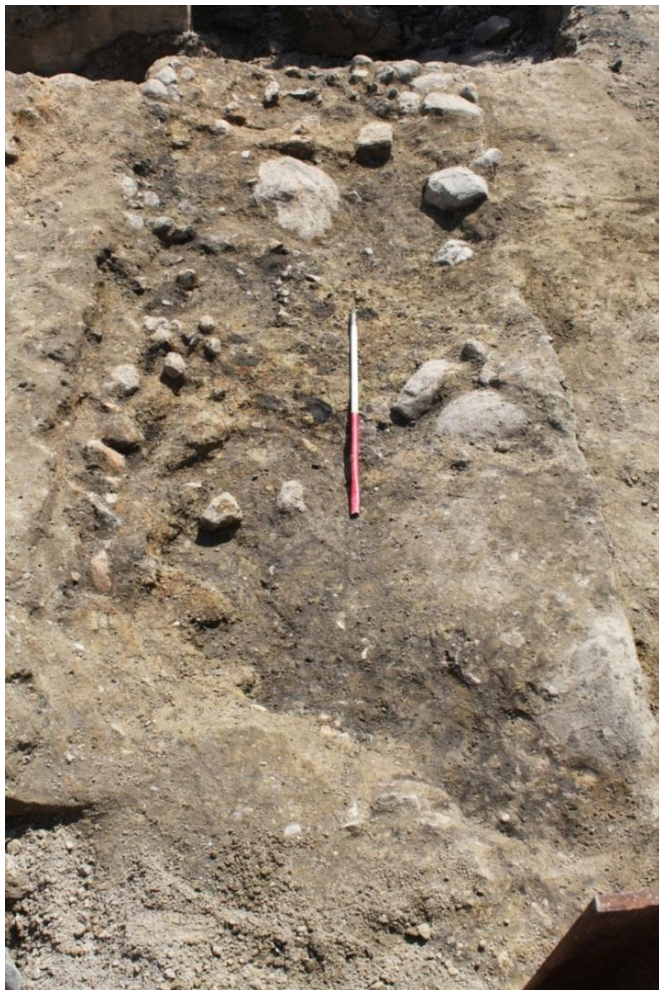
The feature consisted of a very diffuse north-south orientated layer (5.50 x 1.90 x 0.20 m) with a base of greyish sand, big chunks of yellow clay and several stones of different sizes (Fig. 83). The largest stones were 0.86 x 0.47 x 0.15 m, but there was a great variety in sizes – from larger to smaller stones and rubble. Approximately 55 stones were recorded. Yellow lumps of clay indicated traces of removed stones beside the ones surveyed. The subgroup was interpreted as traces of a retaining wall or buttress that had been robbed out and where only a few stones and the clay between them were left.

Fig. 83. Foundation layer in connection with the eastern gate building, facing south. Photo: Museum of Copenhagen.

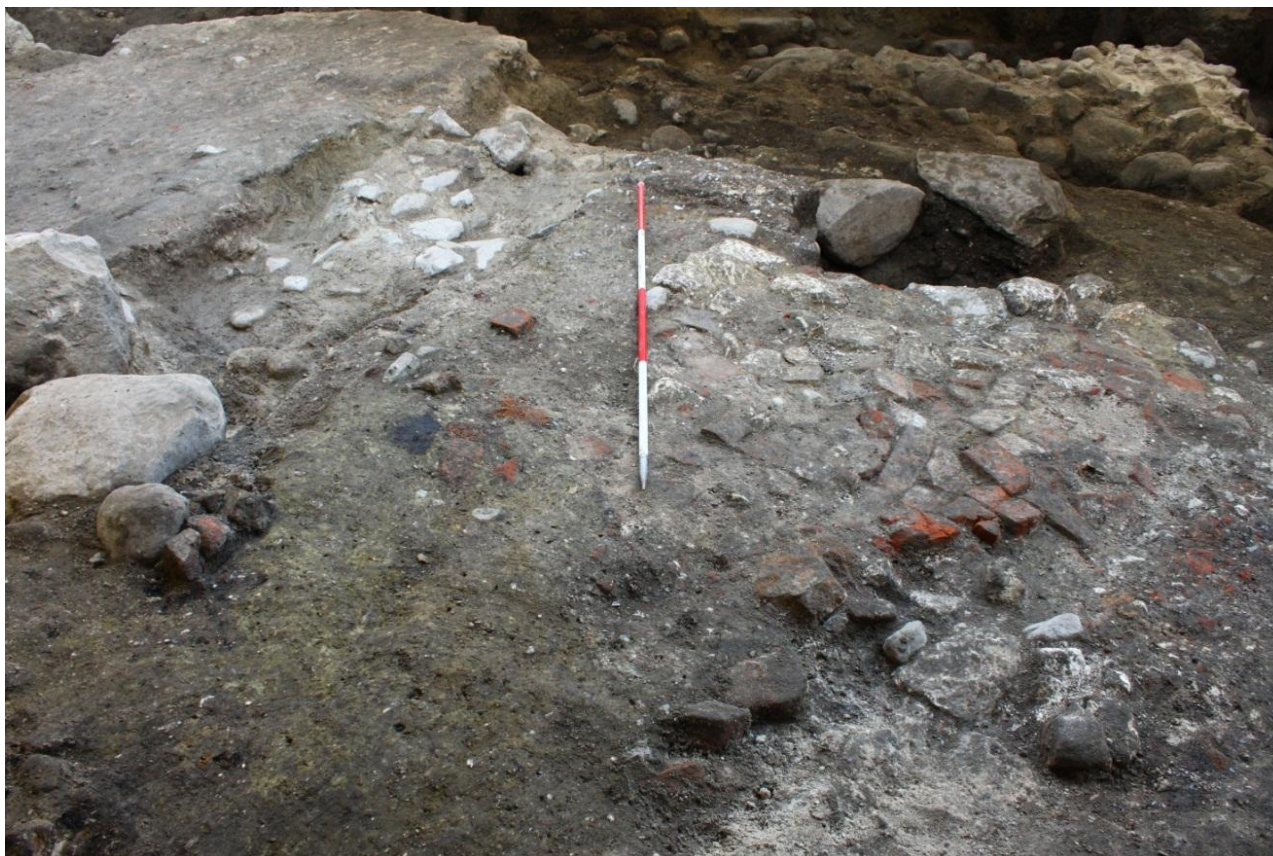
In the SE room of the building a clay floor was recorded in association with and partly overlying the well, together with foundation layers of mortar with inclusions of pebbles, charcoal and CBM underneath an irregular brick built pavement (Fig. 84). The irregular brick pavement (2.5 x 4.5 m), laid to provide a dry surface close to the well, consisted of various bricks and large brick fragments (“munkesten”) mixed with worked limestones.

Fig. 84. Part of brick and limestone floor in connection with the well, facing NE. Photo: Museum of Copenhagen.

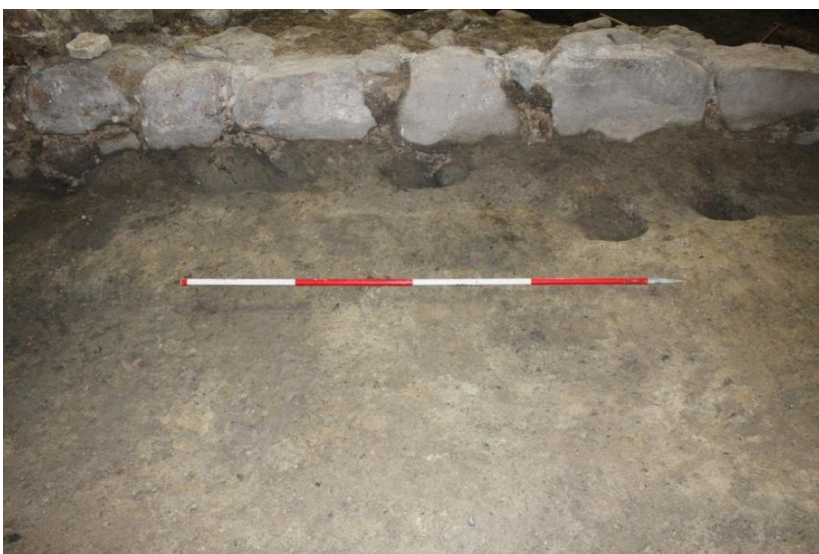
Fig. 87. Post-excavation. Row of interpreted scaffolding holes within the gateway area, facing north. Photo: Museum of Copenhagen.

In conjunction with the gate building 17 postholes were documented (Fig. 86). Six of these were located close to the northern gateway wall and must be considered as remnants of a scaffold during subsequent work on the gate as these postholes cut through older road surfaces (Fig. 87). This maintenance work cannot be more closely dated than between 1400–1550 AD. In the building's NE part there were three rows of postholes – one running N-S and two running in an EW direction.
