Late medieval city wall 1350–1550 AD

City wall – building material and construction details

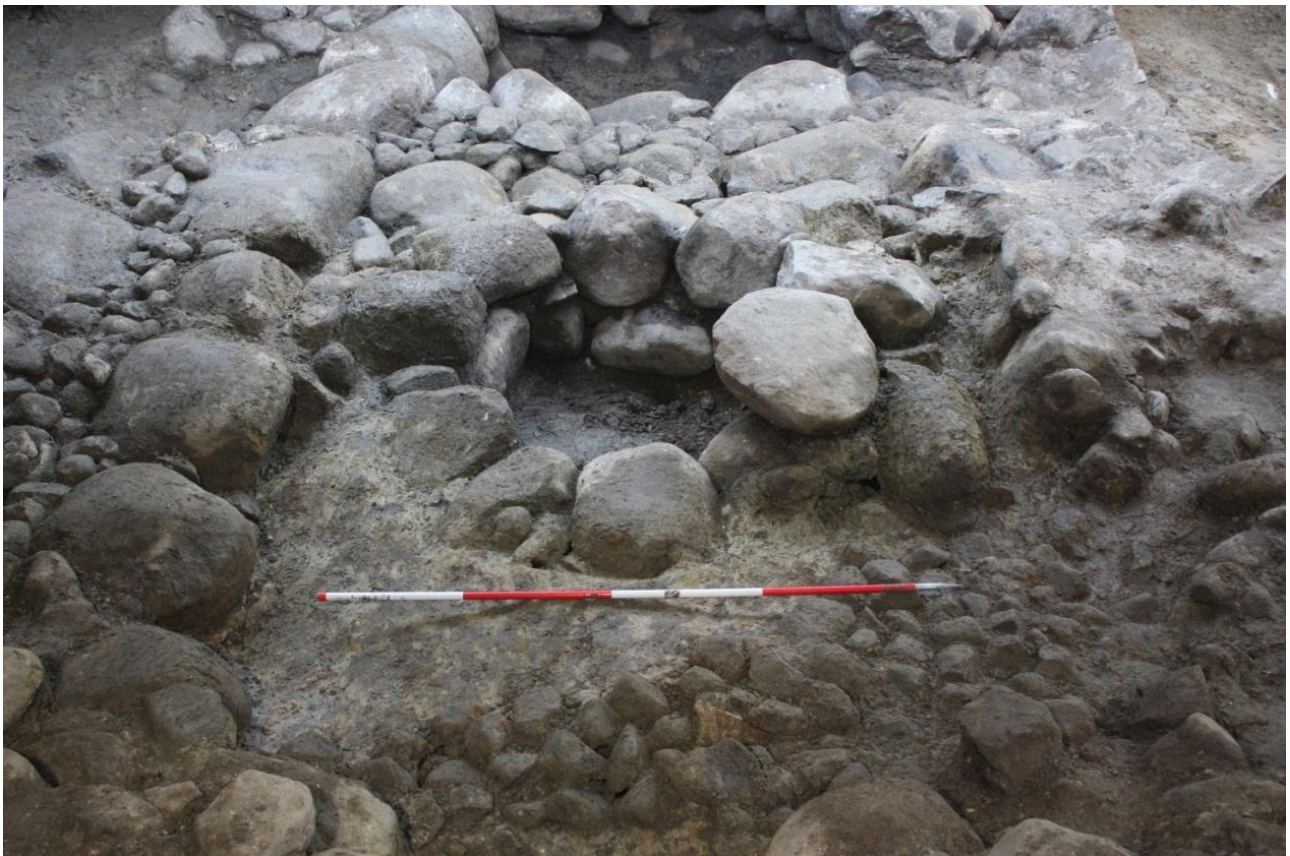
In the SE room of the building a well was recorded. This consisted of a circular dry stone structure, approximately 2.5 m in diameter (Fig. 88). Depth is unknown since the last stones were removed by machine due to time pressure and inflow of ground water, and therefore the bottom was not fully investigated. This should though have been around 4.0 m at the most.

The stones in the well case consisted of a total of seven courses of mid grey, uneven granite stones, with the exception of a line of three squared, well finished chalk blocks (Fig. 88). Construction details show that the stones had been gradually built up together with surrounding clay deposits to keep the well tightly sealed. The stones were placed with flat side inwards. Bigger stones were documented at the top, more squared, shaped stones further down in the underlying courses.

Fig. 88. Top of well case and surrounding packing material, facing west. Photo: Museum of Copenhagen.

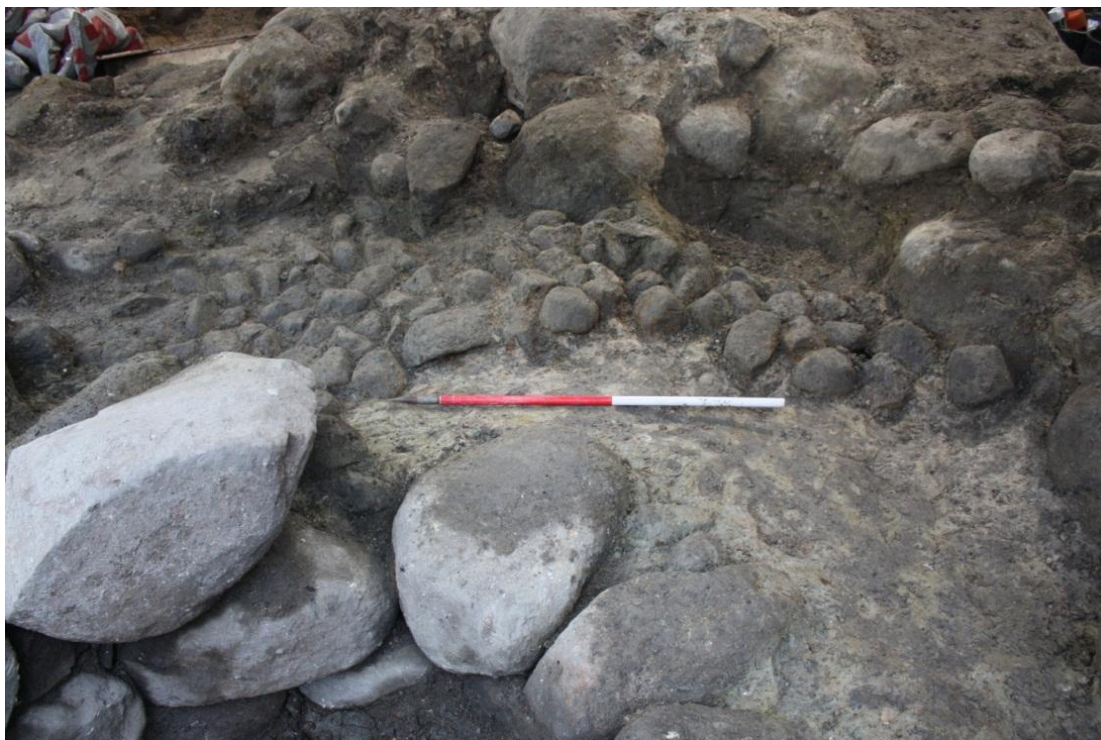
The packing material consisted of rubble and smaller stones placed around and butting the larger stones in the well case. This was then sealed with bonding material of firm, light and mid yellowish green and grey clay with inclusions of CBM, mortar and bones (Fig. 89).

Fig. 89. Packing material of clay and smaller stones, facing E-NE. Photo: Museum of Copenhagen.

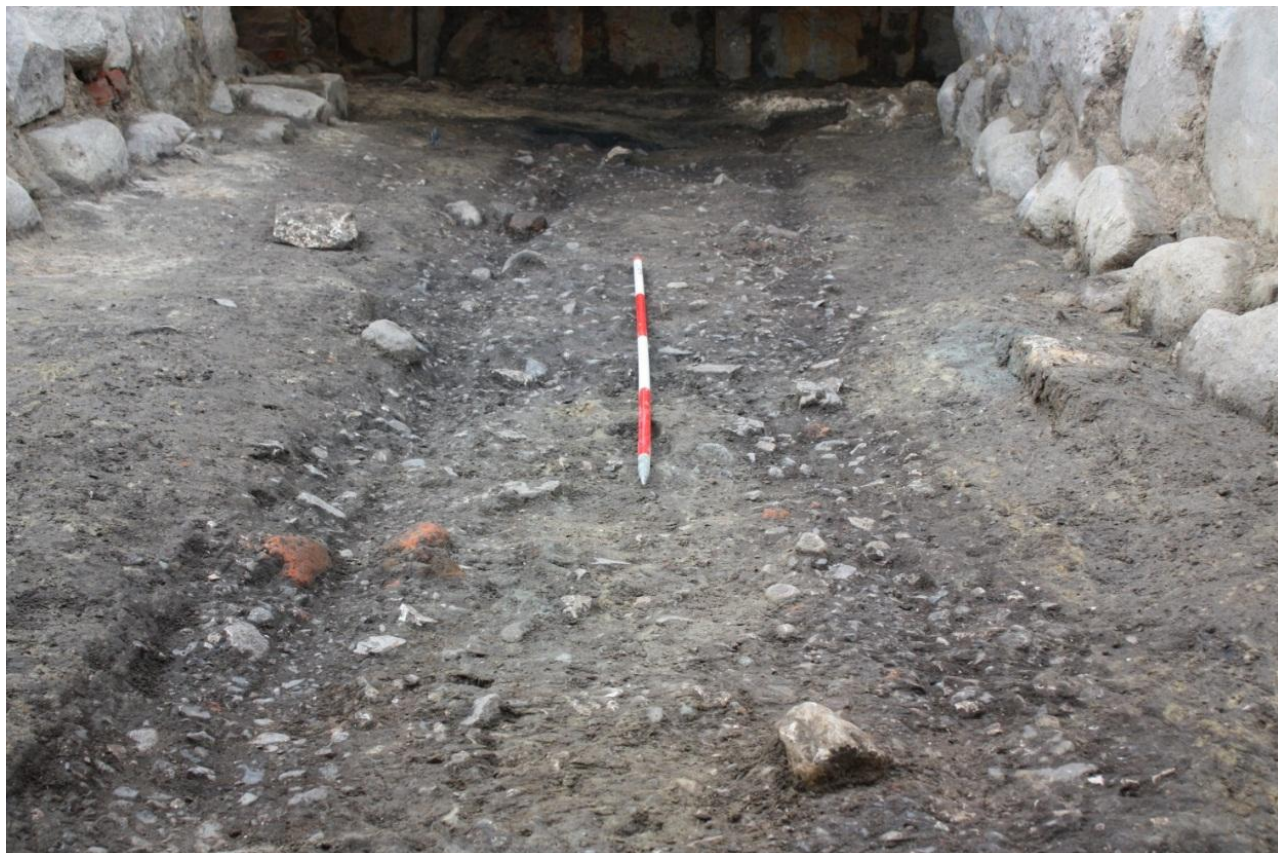
pieces of twig and straw. The average stone fragment size was 2.0-3.0 cm in diameter where in some places the surface had sunk into (or filled) the wheel ruts (Fig. 90).

Fig. 90. Road surface with wheel ruts, facing west. Photo: Museum of Copenhagen.

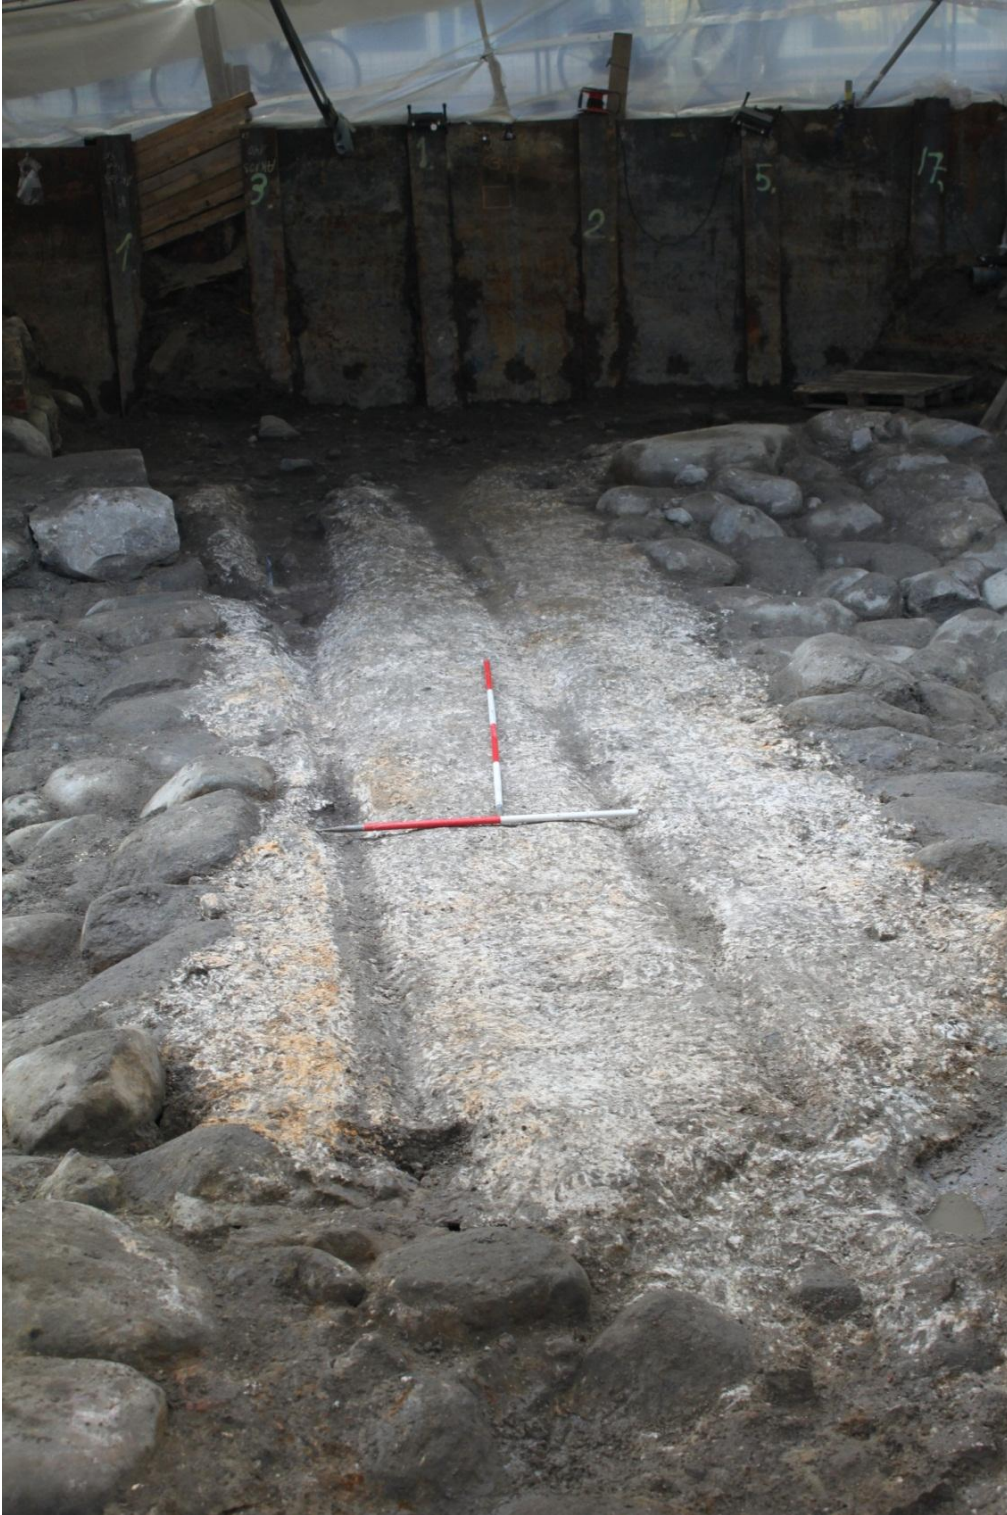
The sides of the ruts were irregular/gentle and the depressions had a concave and irregular base. The deepest parts of the ruts were 0.08-0.20 m wide and the maximum depth varied from 0.04 m to 0.18 m. The ruts became much deeper and wider just at the western end of the gate, where they were about 0.15 m deep and 0.60 m wide. The width and depth indicates heavy loads and wear which had necessitated the subsequent maintenance work filling the depressions with smaller stones and pebbles. The cart wheel spacing varied from 0.9-1.1 m and shows that the spacing had not changed during the time the gate building was in use. In places, it seemed like there were identifiable hoof marks from horses (Fig. 91).

Fig. 91. Road surface with wheel ruts, facing west. Note how the mortar layer overlaps the foundation stones in the wall. Photo: Museum of Copenhagen.

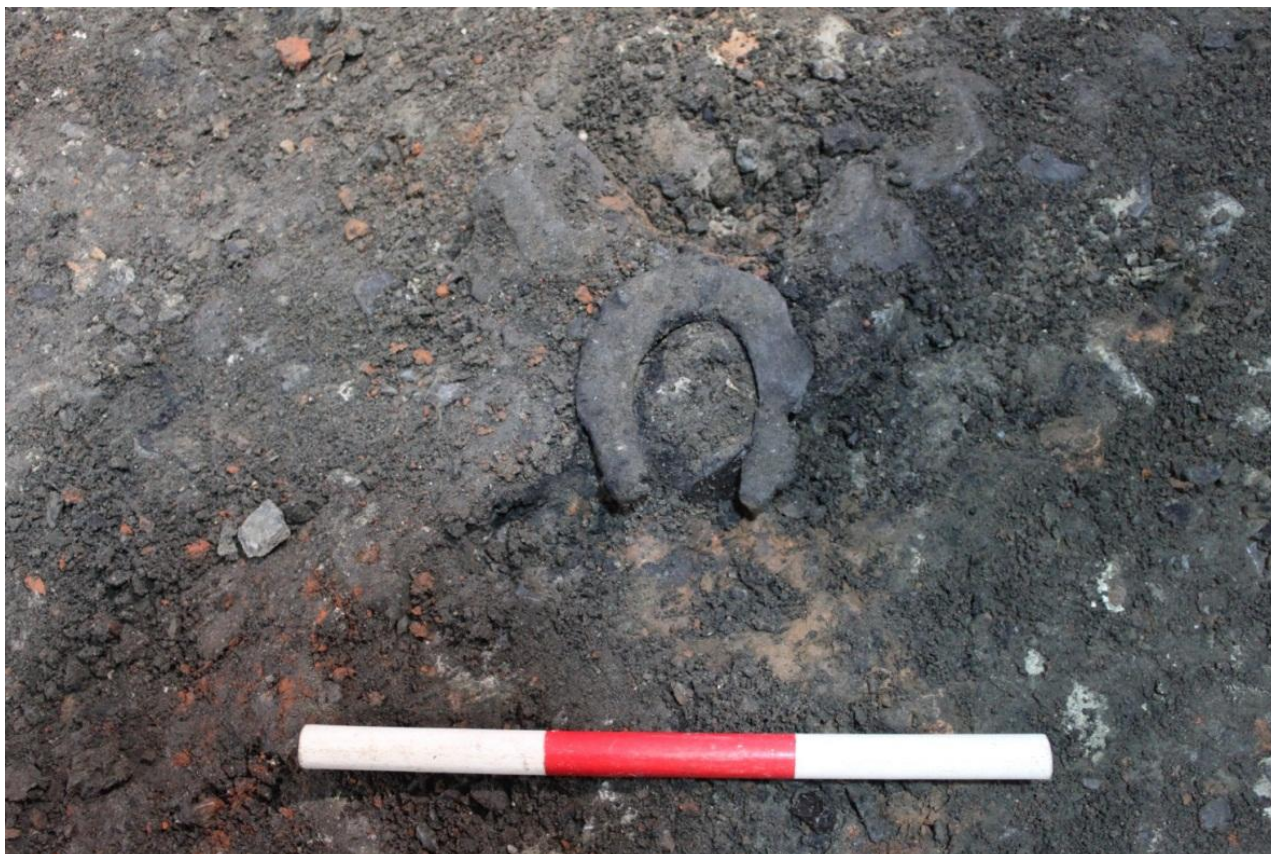
No datable material was collected from the foundation layers (roof tiles, part of a button, an iron nail, a flint blade and bones), but finds from the different road surfaces consisted of ceramics (Early redware; 1200–1400 AD and Late greyware: 1200–1400 AD) and an iron horseshoe (Fig. 92) from one of the oldest road surfaces was dated to between 1150–1350 AD and most likely between 1200 and 1270 AD (cf. Clark 1995:95-96).

Fig. 92. Horseshoe in situ from above. Photo: Museum of Copenhagen.

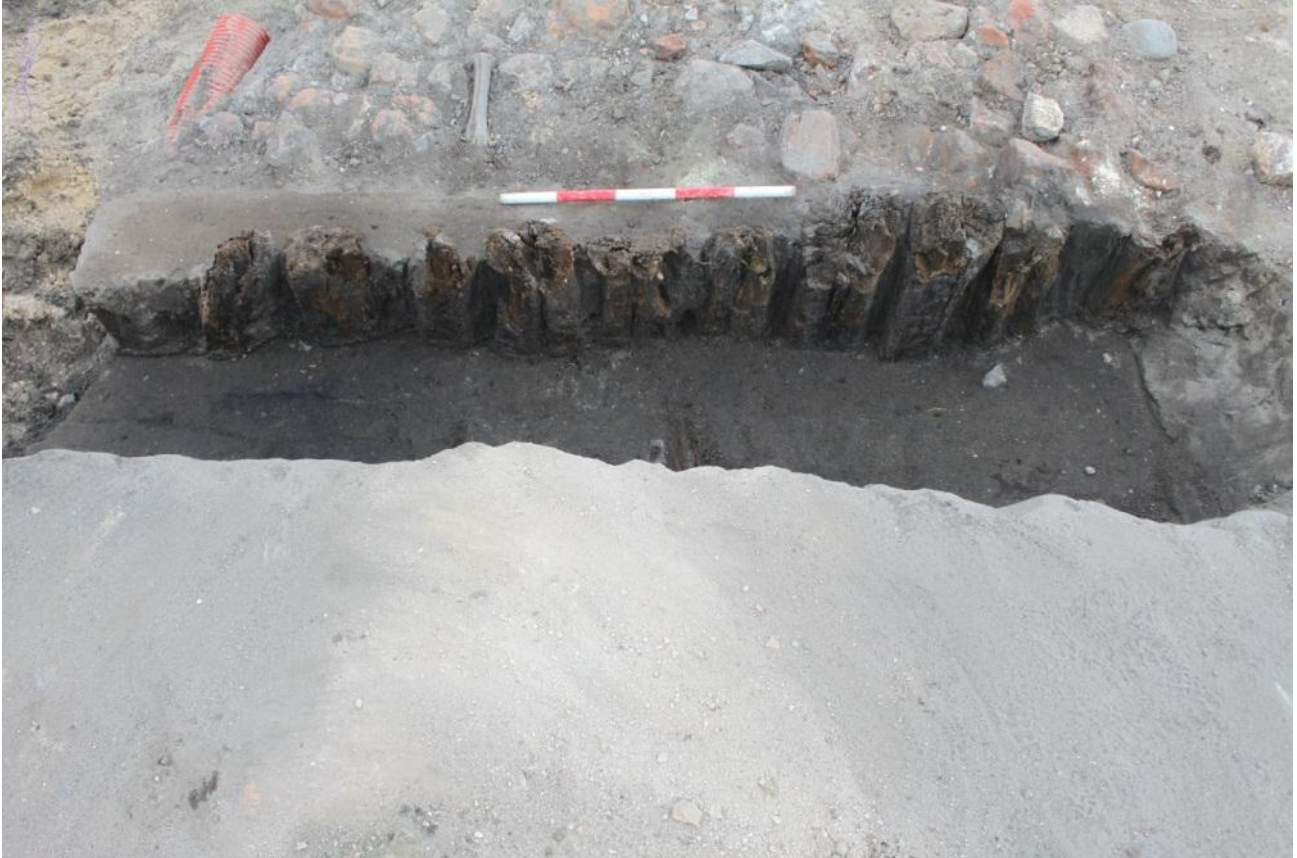
Two rows of standing timber and postholes were documented east of the gate building (Fig. 94). Structure (G-815) consisted of a row of vertically set timber posts running in a NE-SW direction, partly truncated by the central heating trench and not fully exposed due to the excavation limit in 2012. The other row of posts (G-829) was recorded 6.0 m to the north and represented a NE-SW post line consisting of 20 postholes (Fig. 93). Despite the stratigraphical relation being unclear, and the height difference is as much as 0.9 m (kote = +1.8 m and +2.7 m), the spatial location and direction argue respectively that the structure is connected in some way to the road surfaces.

Fig. 94. Partly exposed row of timber posts in a created test trench, facing NW. Photo: Museum of Copenhagen.

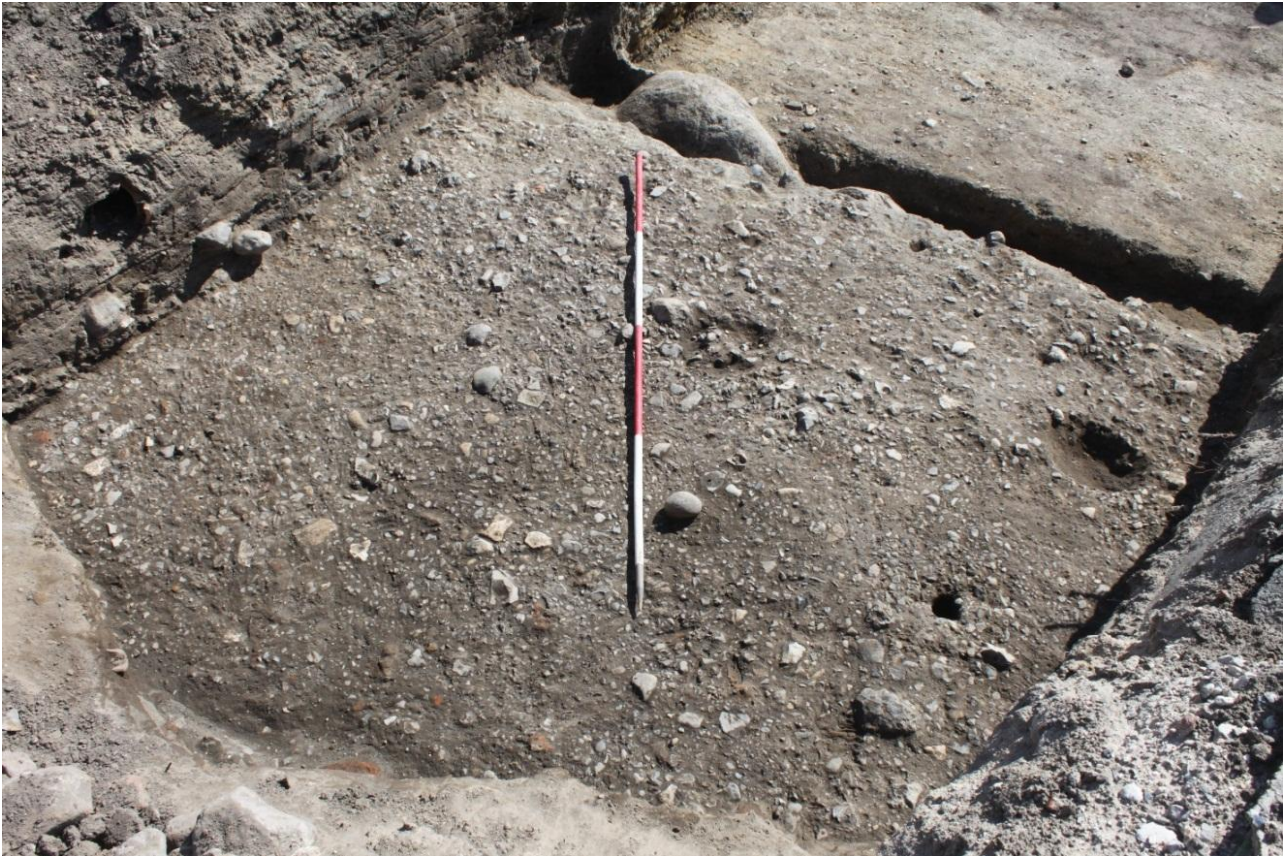
The road surfaces were heavily truncated by a modern central heating pipe trench running in a NW-SE direction. The surfaces consisted of a mixture of dense gravel, rounded pebbles, broken flints and brick fragments (Fig. 96 and 97). The crushed flints were approximately 1-5 cm in diameter. Some fragments of medieval bricks and bones had been incorporated, but these were not common and constituted less than 5%. The material between the stones consisted of silty brown and grey sand with decomposed organic material. The stones used ranged from cobbles > 10 cm to pea gravel, but most were between 3 and 7 cm. With the exception of the cobble surfaces, the deposits were very hard and the gravel matrix very cohesive compacted.

Fig. 96. Road surface, facing east, with interpreted post imprints and to the left. Photo: Museum of Copenhagen.

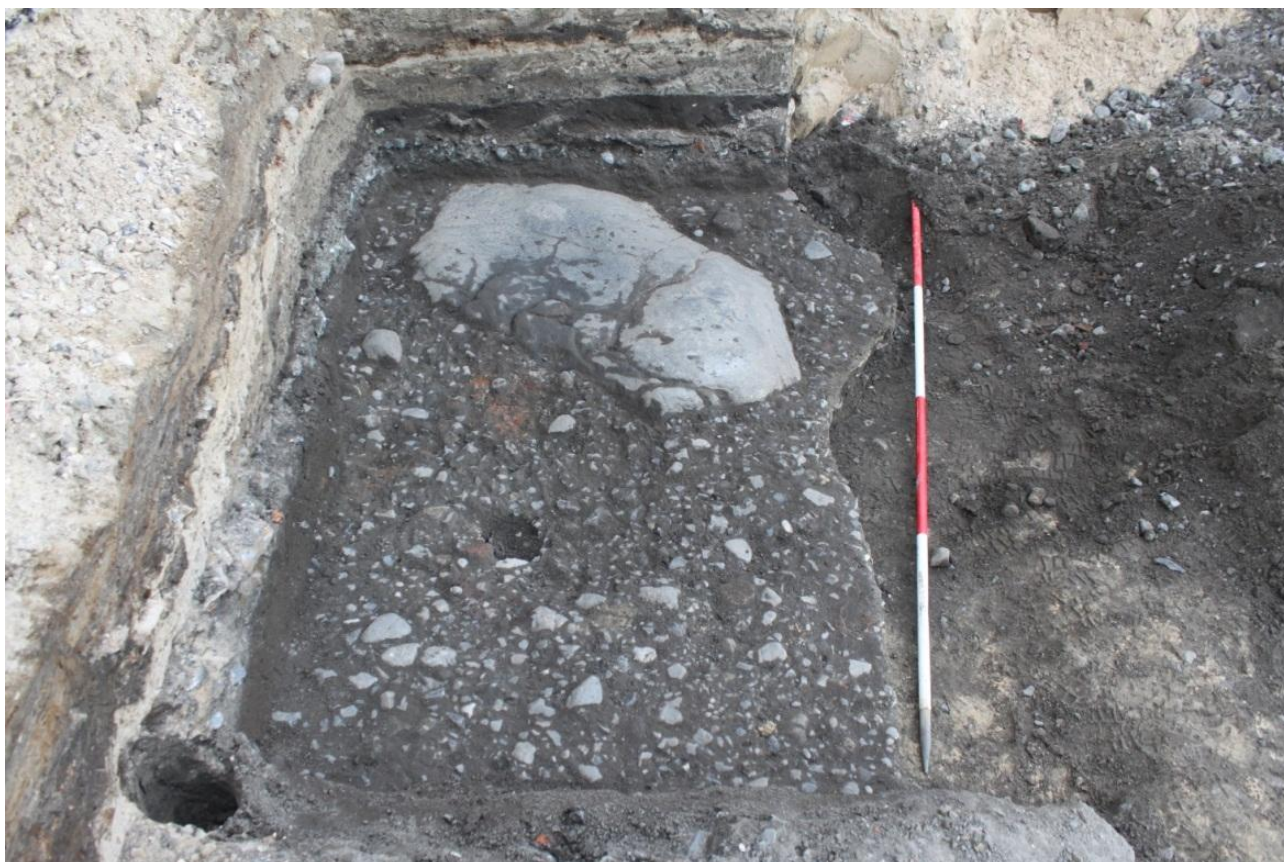
A big boulder was recorded within the road surfaces to the west. Boulders of this type were typically used as foundations in massive masonry structures or at the base of earthen ramparts. This was probably the original use of this boulder, but its surface had been exposed and it formed a part of the lower gravel pavement. The stone was presumably reused from a foundation, perhaps as a northern boundary stone for the entrance, as it was apparent that traffic had polished the surface, and it was presumed to be contemporary with road surfaces (G-821) which are later according to the matrix, although the layers between could amount to levelling and foundation layers for the construction of the road.

Fig. 97. Boulder and road surface, facing NW. Photo: Museum of Copenhagen.

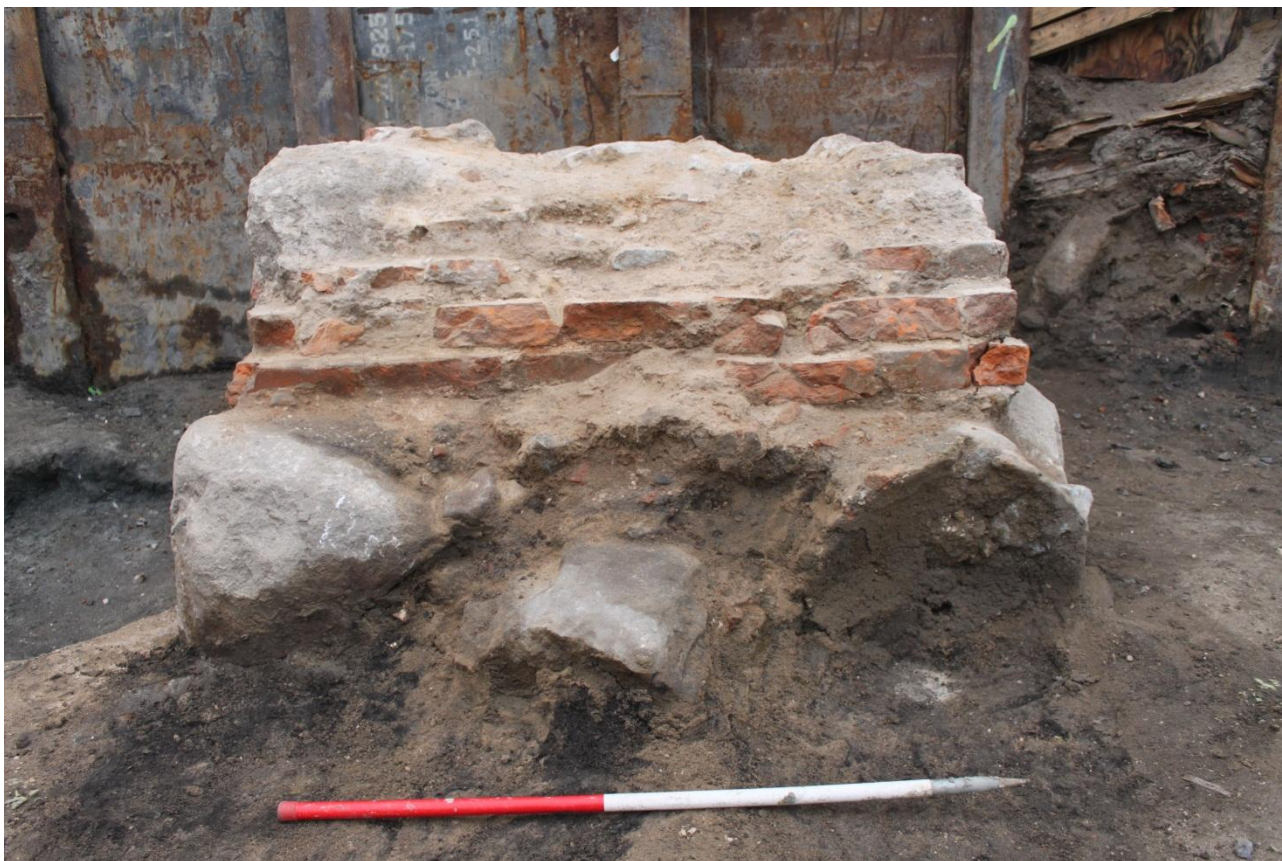
The wall was a mixture of large granite stones (c. 0.8 m) and coursed brickwork, where the bricks had been broken to fit around the larger stones (Fig. 99). The stones built into the faces of the wall were flat and smooth, and flush with the brickwork. At the most – six to seven courses of fully laid fragmentary “munkesten” with smooth and struck mortar were recorded. The middle of the wall consisted of smaller stones and red brick fragments mixed with mortar.

Fig. 99. Cut through brick wall, facing west. Photo: Museum of Copenhagen.

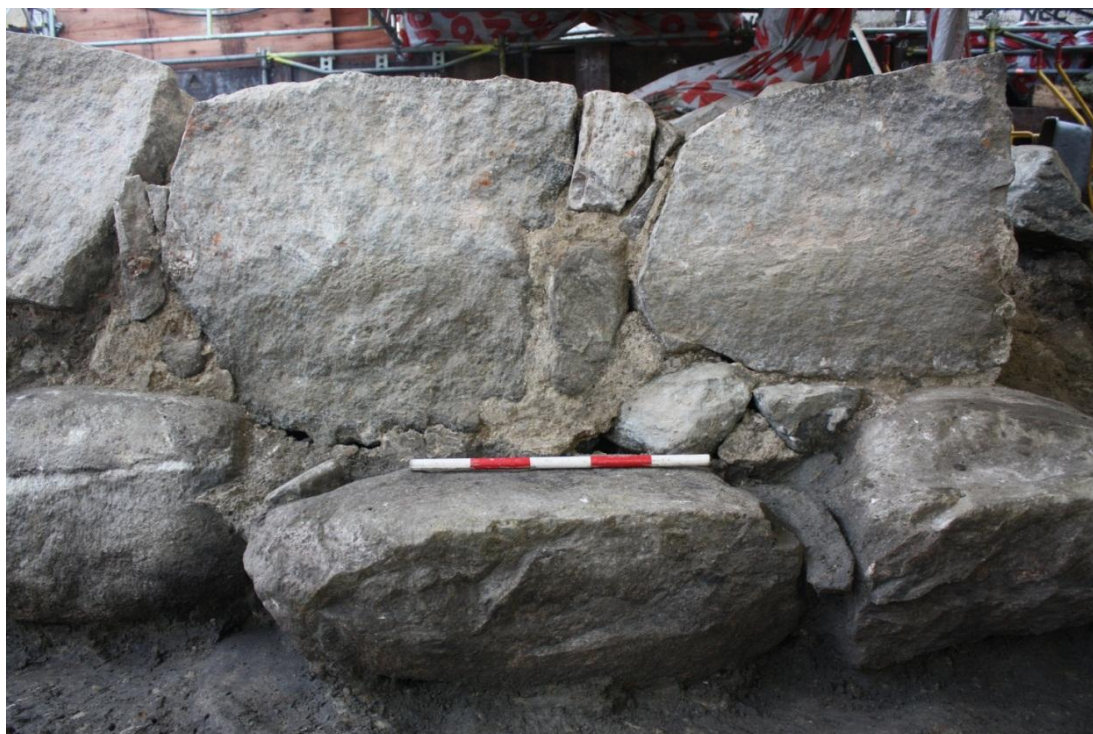
Fig. 100. Extended entrance and rebuilding work in the 1500s? Foundation stones, facing south. Photo: Museum of Copenhagen.

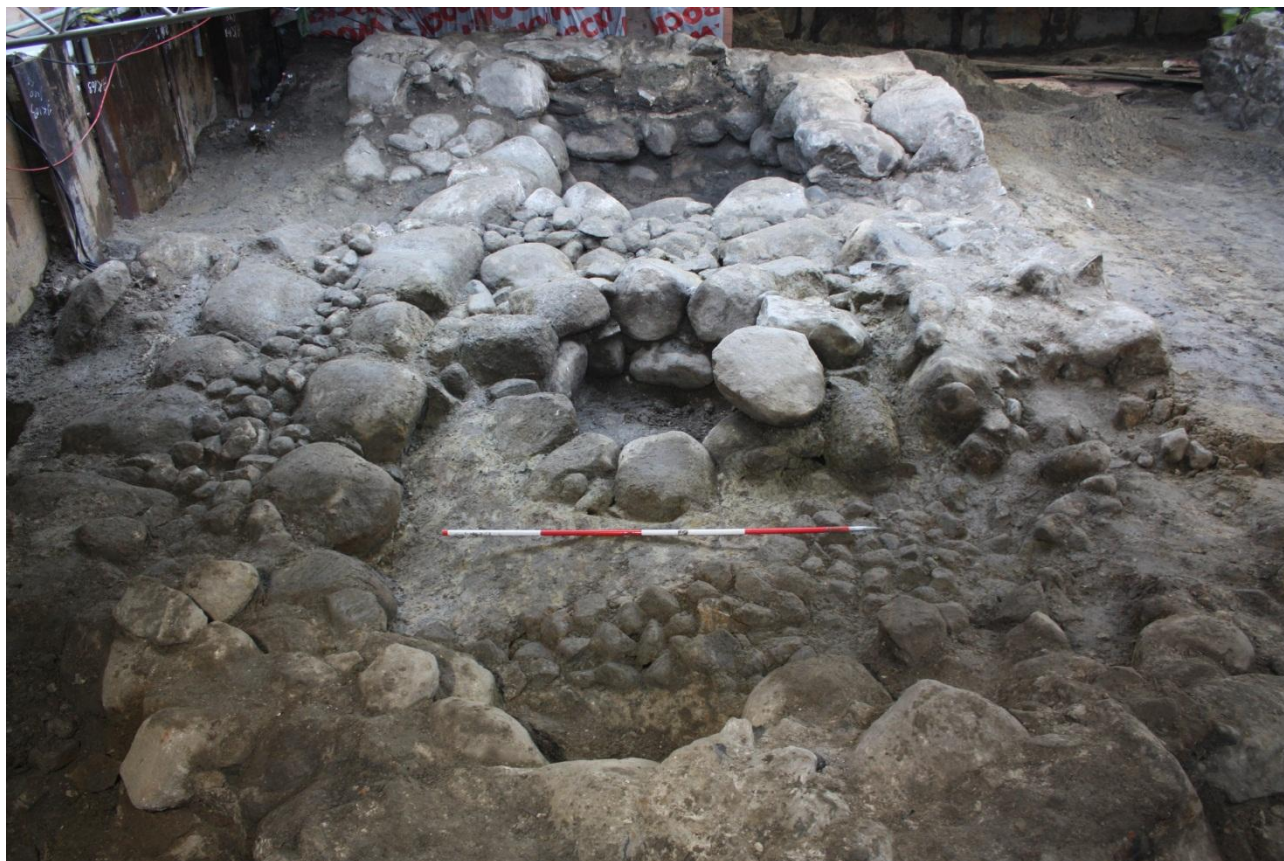
Fig. 101. Overview. The southern part of the gate building with gate walls and well, facing west. Photo: Museum of Copenhagen.

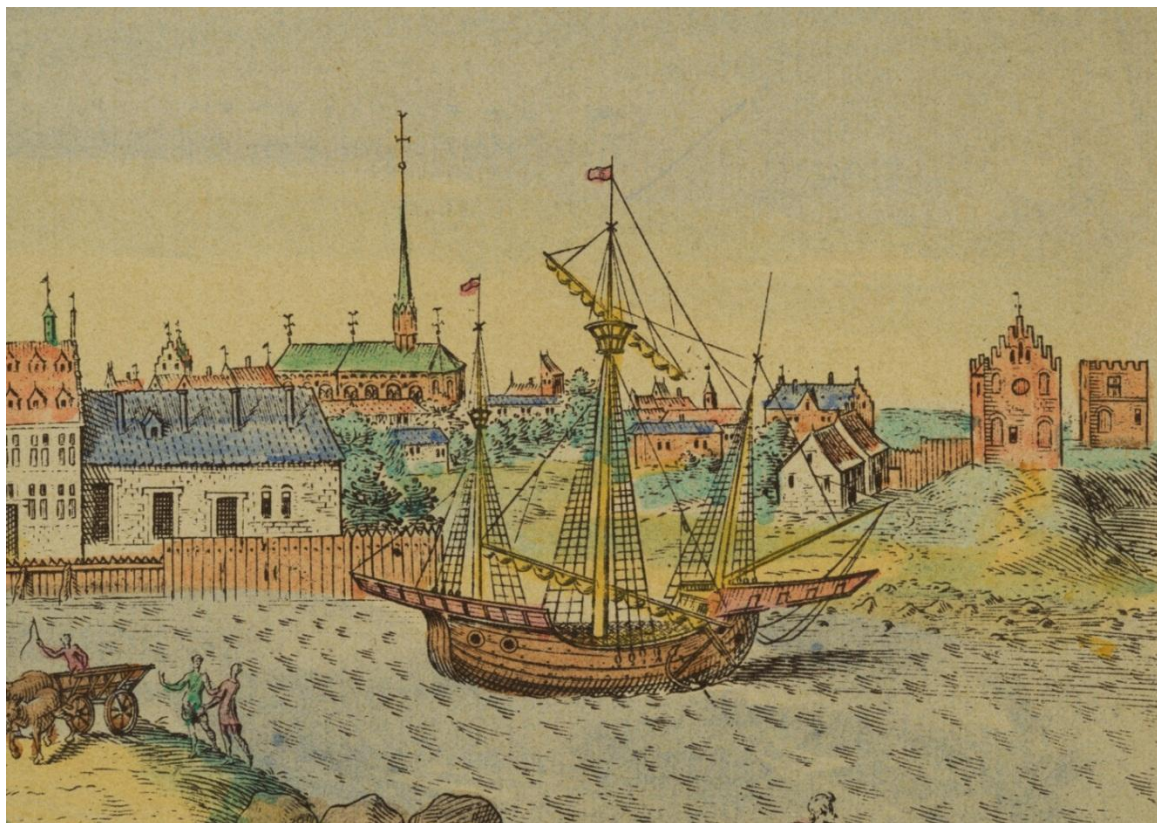
Østerport during the 1400s had probably been a High Gothic building with a pointed arched door. It does not seem to have been equipped with a roof, but with upper parts that formed a platform with surrounding parapet (cf. Thorsen 1926:227). This suggested description differs from the oldest known depiction of the gate building seen on a prospect of Braun and Hogenberg from 1587 and Resen's Atlas from c. 1596 [1677] showing a building with Late Gothic blinds, pointed gables and a circular rose (Fig. 102).

Fig. 102. The eastern part of Copenhagen and the interpreted gate building to the right. The image is cropped. From Braun and Hogenberg 1587.

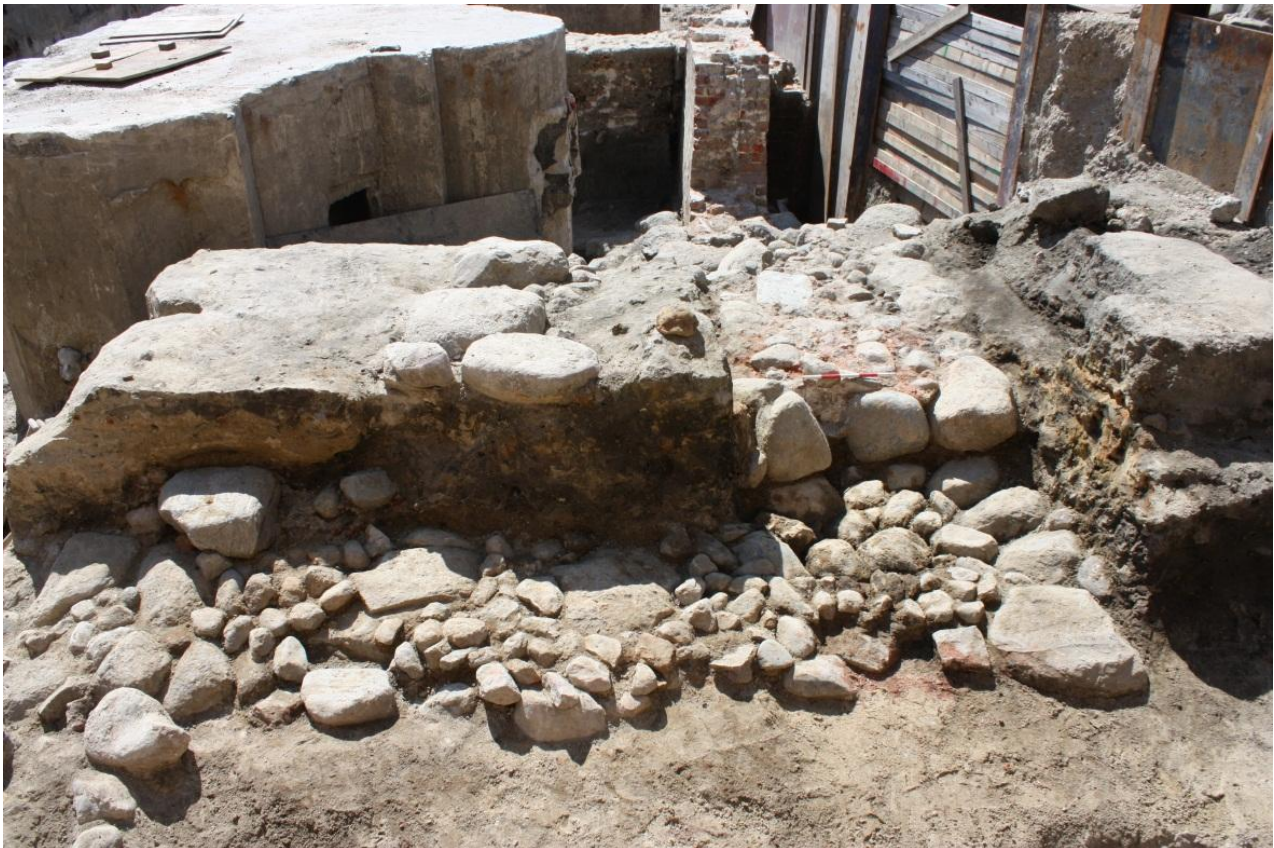
Part of Vesterport was investigated at the Metro excavation at Rådhuspladsen in 2011–2012. The gate itself, based on the foundation remains, measured 9 x 9 m, where the gap between the foundations of the outer gate was 2.75 m, while a projecting wall extended c. 5.1 m to the southwest of the gate's western corner (Fig. 104). The projecting walls would have connected the gate structure to a bridge which spanned the city moat to the gates immediate southwest, possibly preventing the embankment from slumping on to the road. It seems most likely from the way the layers of stone were laid, that the gate and the projecting wall were built at the same time. The building was dated to 1375 AD (Lyne and Dahlström 2015:180-181 and 200).

Fig. 104. Part of medieval Vesterport investigated at Rådhuspladsen, facing SW. Photo: Museum of Copenhagen.

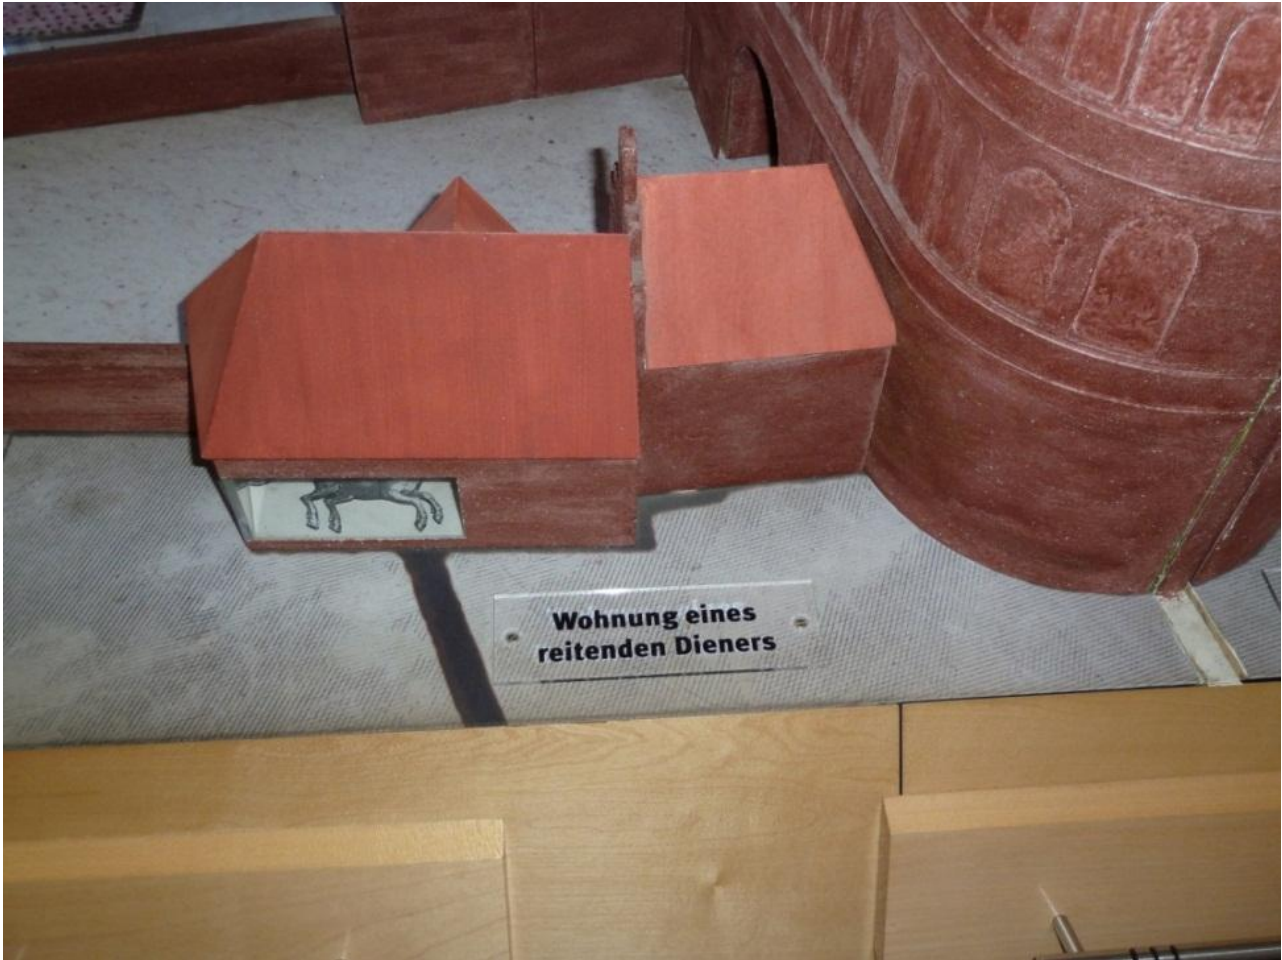
The annex west of the main building is interpreted as a separated customs- or guard house often seen in association with gate buildings in the High Middle Ages (cf. Middle Holsten Gate in Lübeck) (Fig. 106).

Fig. 106. House for riding servants connected to the Middle Holsten Gate in Lübeck from the 15th century. Photo: Morten Steineke.
