Curtain

Moat – construction, usage and deconstruction

Bridge

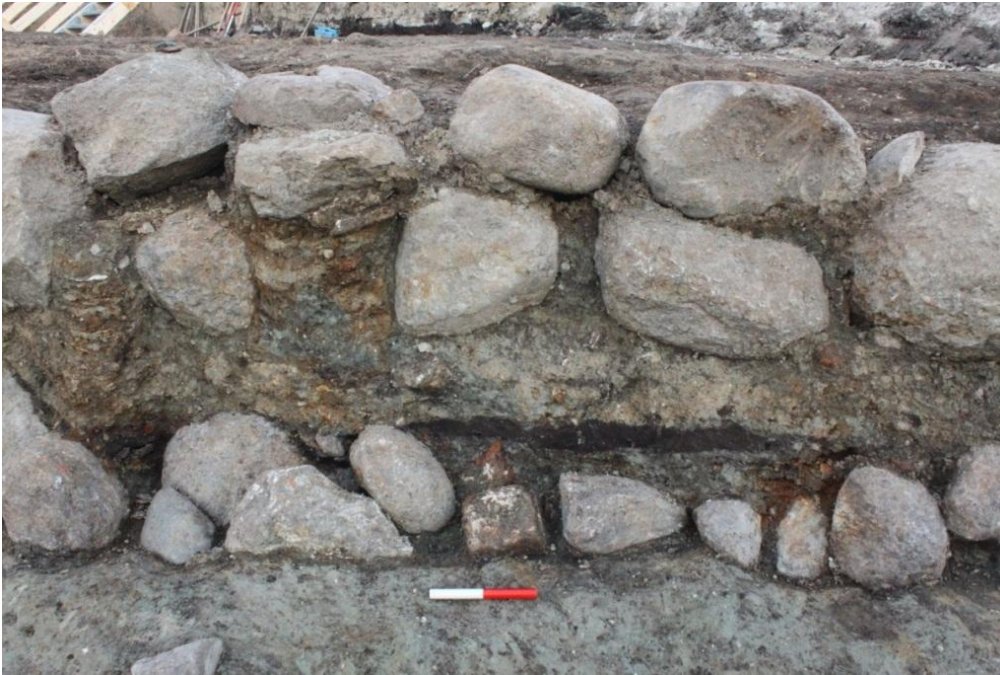
Fig. 159. Bastion foundation stones and construction cut with smaller stones in front used as backfill, facing NW.
Photo: Museum of Copenhagen.

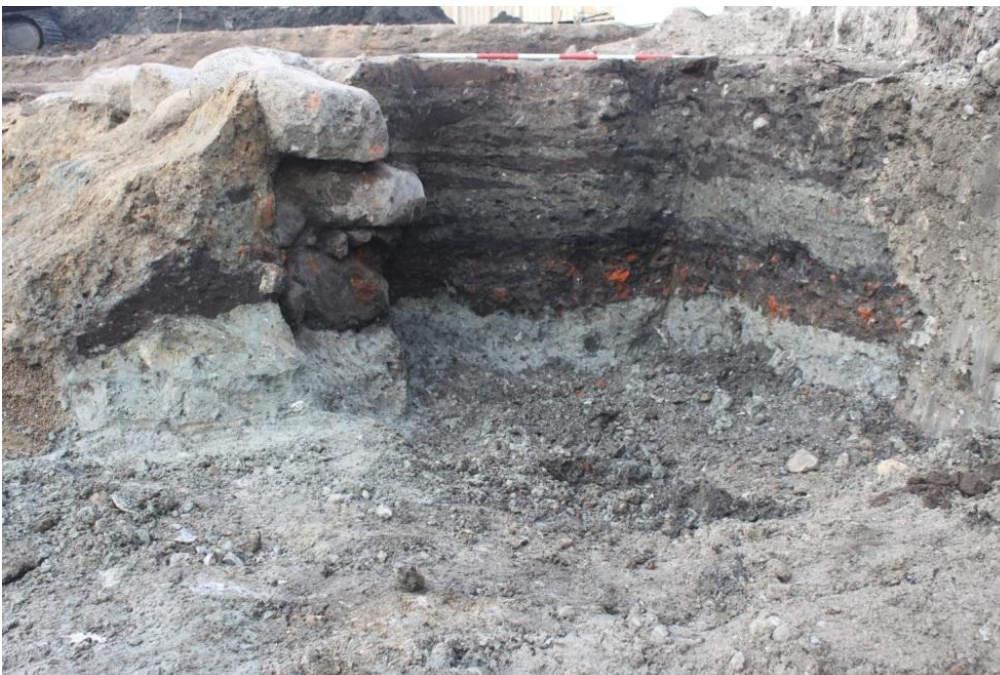
The different courses consisted of mid grey unfinished granite boulders and stones. Some stones had been formed to fit within the bigger structure and a large flat boulder had been placed at the corner of the foundation (Fig. 158). With one exception the internal core of the bastion consisted of redeposited firm light greenish grey sandy clay with inclusions of CBM (red brick fragments) and pebbles (Fig. 160).

Fig. 160. Section, facing SW showing the bastion's core with different types of internal fill of lensed brown clay, firm greenish grey sandy clay and brown deposit with brick fragments at the base above the natural moraine. Photo: Museum of Copenhagen.

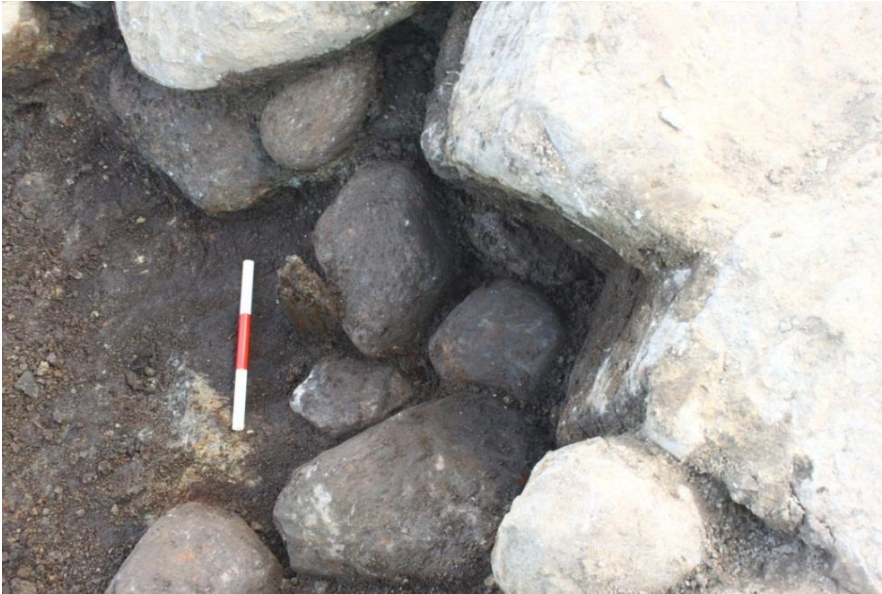
Like the previous bastion line wooden posts were recorded among the stones, suggesting that these were placed in order to mark the outline of the bastion during the building process (Fig. 161).

Fig. 161. Internal corner with vertical post, facing south. Photo: Museum of Copenhagen.

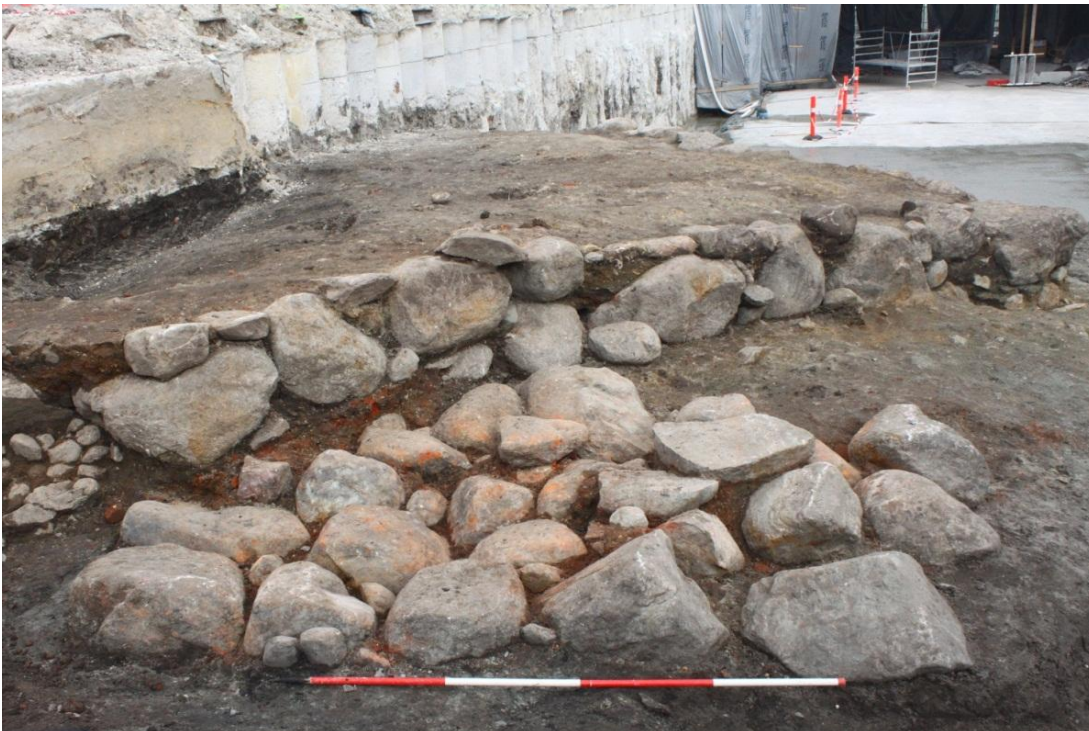
A concentration of smaller stones and large boulders, laid in a rectangular shape of roughly 4.5 x 2.8 m, directly outside the main bastion line (Fig. 162).

Fig. 162. Stones in front of the main bastion line, facing NE. Photo: Museum of Copenhagen.

The stones were evenly deposited and covered by a brick layer. On site the feature was first thought to be separate from the main bastion, perhaps acting as some kind of "helping" construction while building the fortification.

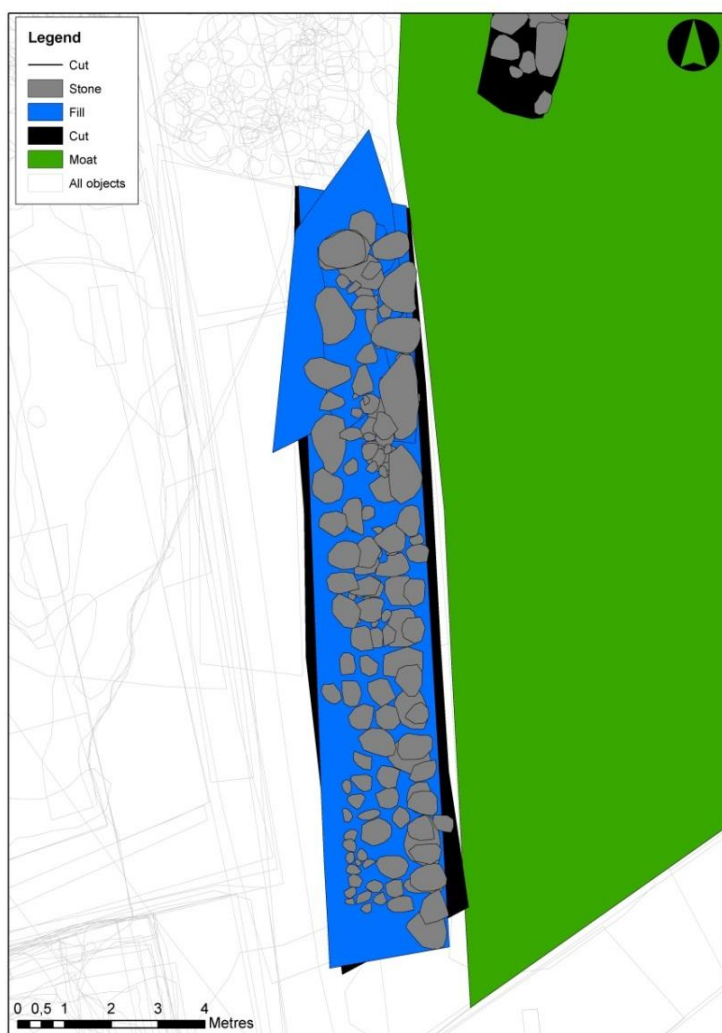
The foundation of the curtain consisted of two courses of boulders, stones and layers running in a N-S direction at a length of 16.5 m. The width varied, but was approximately 2.5 m (Fig. 163). The purpose of the structure was to severely limit the erosion of and to form a solid foundation for the rampart material and structures built on top of it, in the same way as the foundation stones incorporated in the construction of the bastion.

Fig. 163. North-south running curtain with construction cut, two courses of stones and boulders together with foundation layers. Part of the contemporary moat to the right.

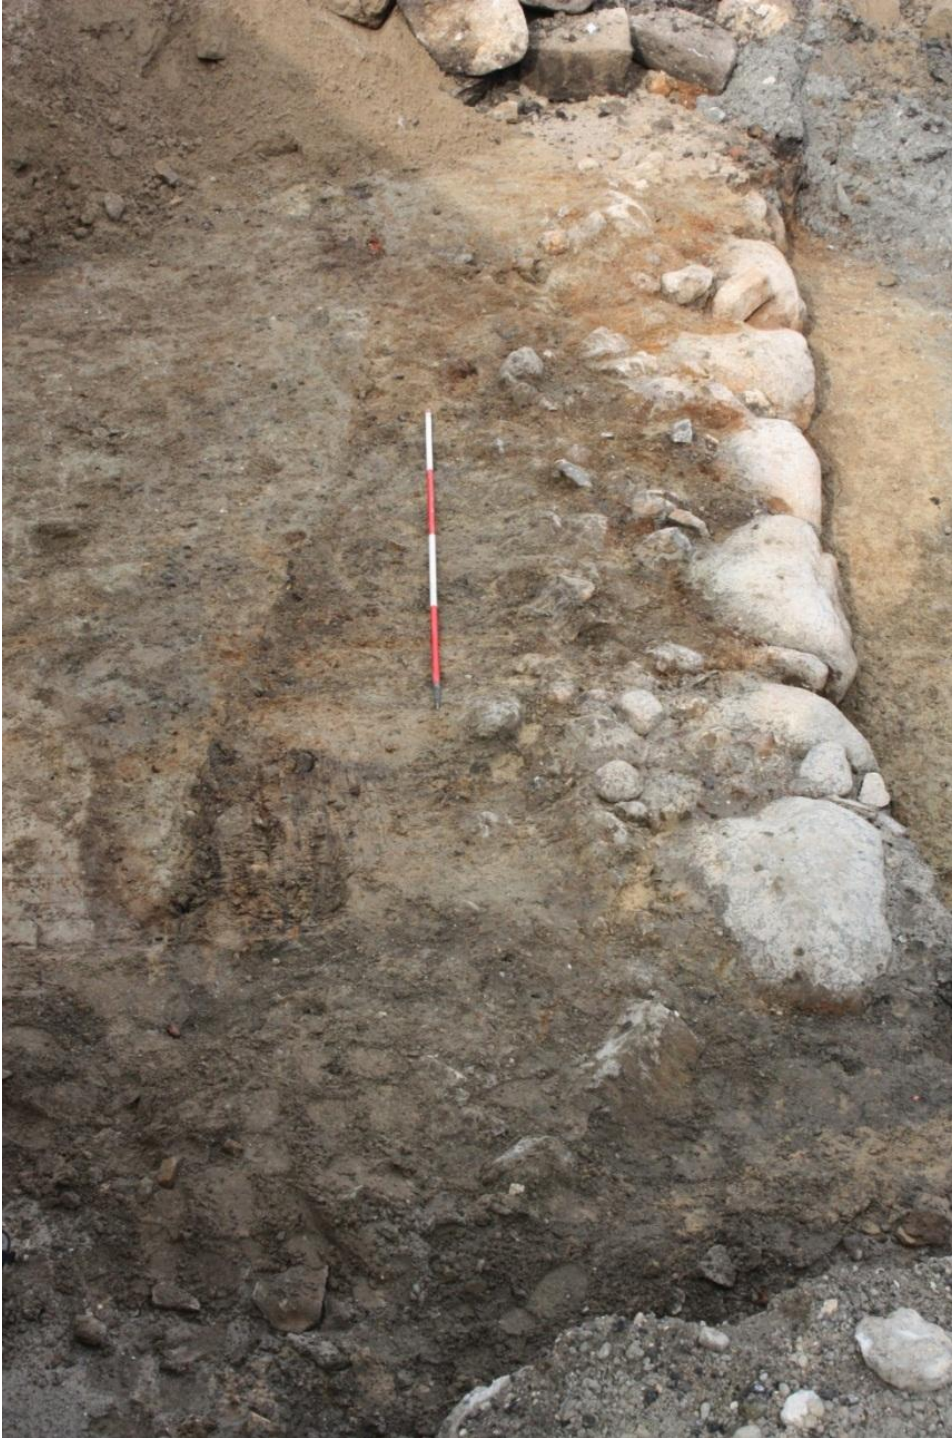
Fig. 164. Upper part of the 17th century curtain. Foundation stones and rubble infill with the inner construction cut to the left, facing north. Photo: Museum of Copenhagen.

The rubble infill and foundation layers were amalgamations of large stones up to 30 cm in diameter, smaller stones with small fractured pieces of CBM, but no identifiable bricks or half bats. The deposits were mixed with yellow/grey sand and natural clay – possibly consisting of removed natural moraine from the original construction cut.

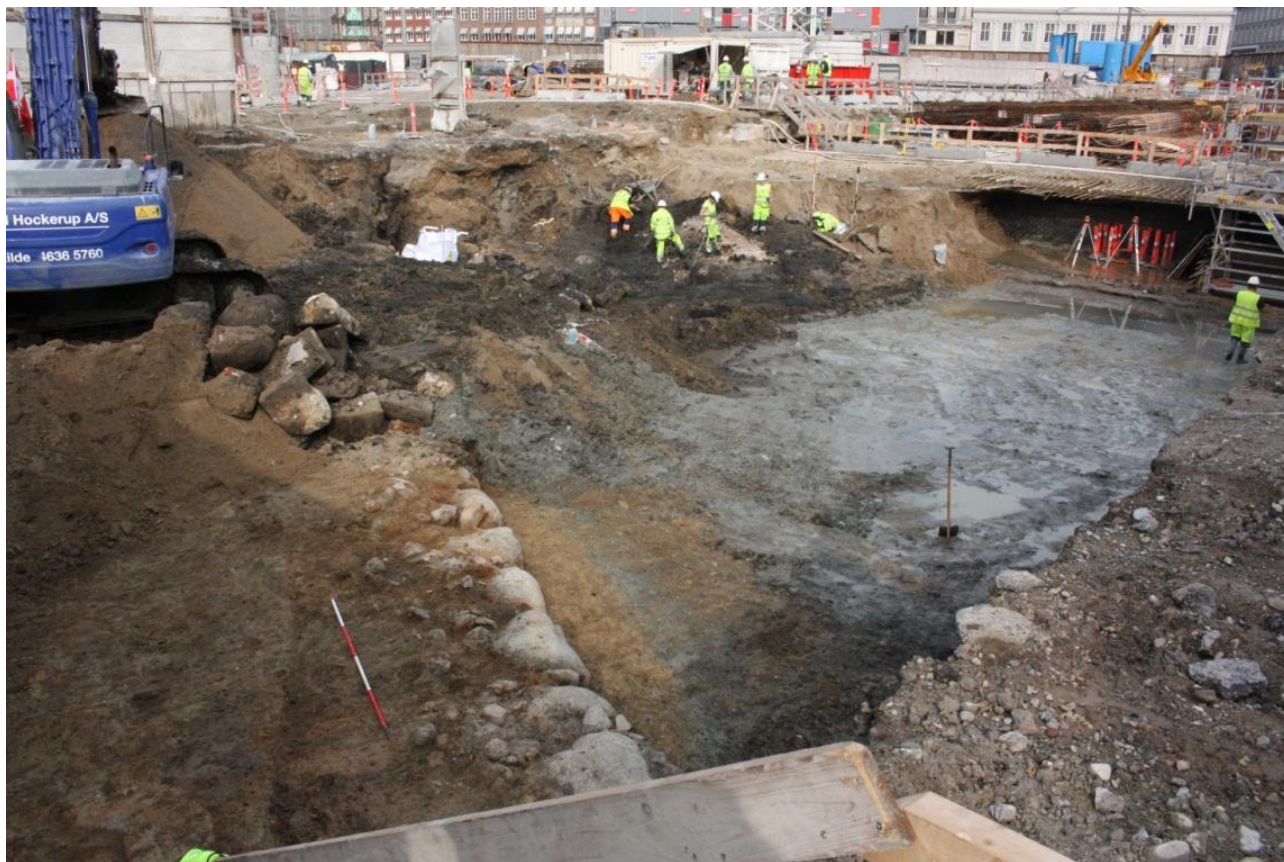
Fig. 165. Investigating the 17th century fortification step by step. Part of the exposed curtain, facing north. In the middle – staff working on one of the bridge pillars. To the right – the excavated 17th century moat. Photo: Museum of Copenhagen.

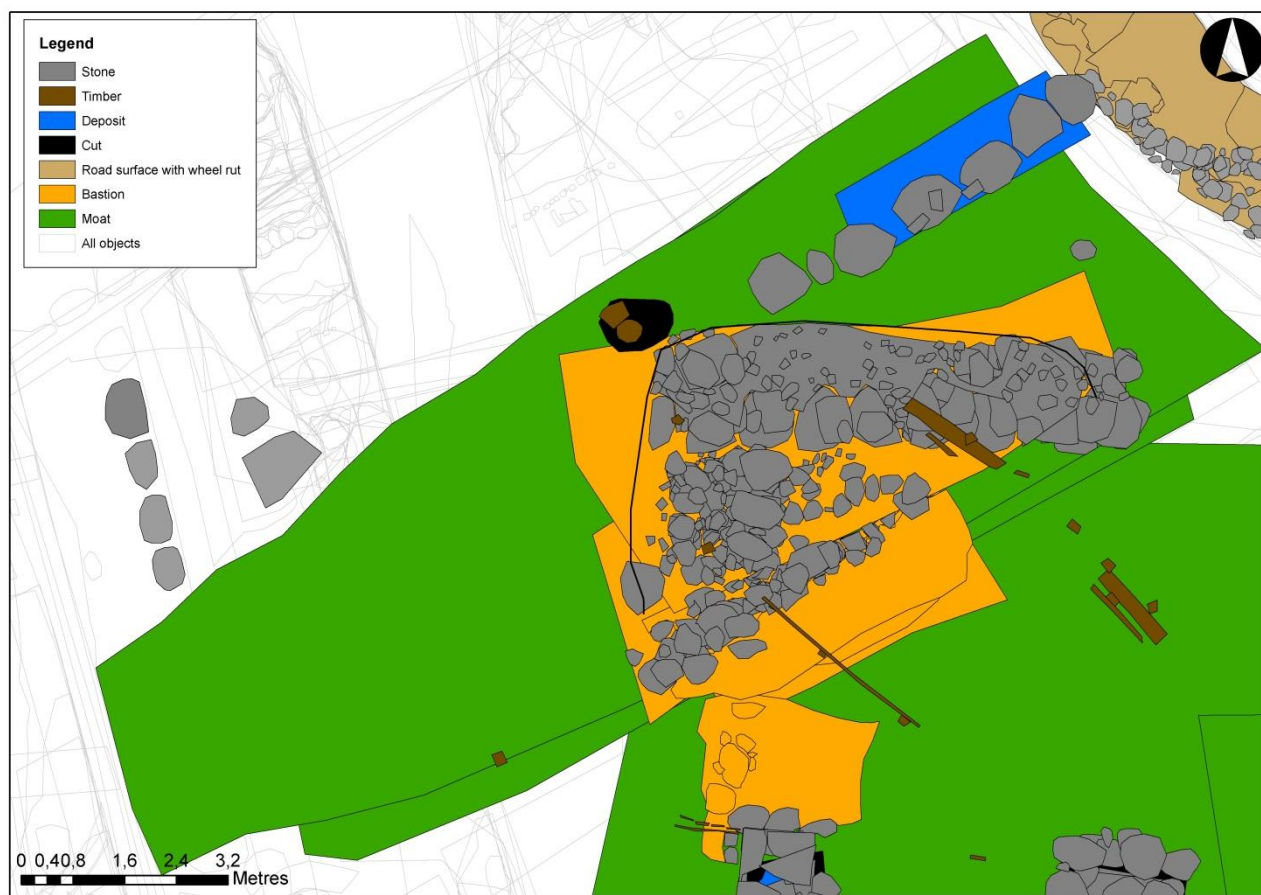
Subgroup (SG-503795) consisted of five mid grey stones with a flat surface facing upwards (Fig. 166). The two separate rows of stones were situated in and covered by rubble fill and the stones might well not have been in situ, but could also have ended up in the rubble layer later. It should also be stressed that the area around the stones had been truncated by modern trenches such as concrete cable boxes and a central heating duct. The stones were approximately 1.0 m higher than the curtain, so the structure is not a continuation of this structure. Group (G-503427) consisted of a row of seven stones running in a NE-SW direction between the road surfaces to the north and the 17th century moat to the south. These were of different sizes and none of them were flattened on top. The shape and surface of the stones showed no signs of wear, suggesting that they were either related to earlier road(s) to hold back soil on top of the slope as a stabilizing structure, or were part of a limit to an unknown stone structure (part of the 16th century roundel? – see Fig. 166 and further discussion below).

Fig. 166. Stones with unclear purpose documented in association with the 17th century fortification. Be aware that the estimated edge of the moat is measured a little far to the north due to machining.

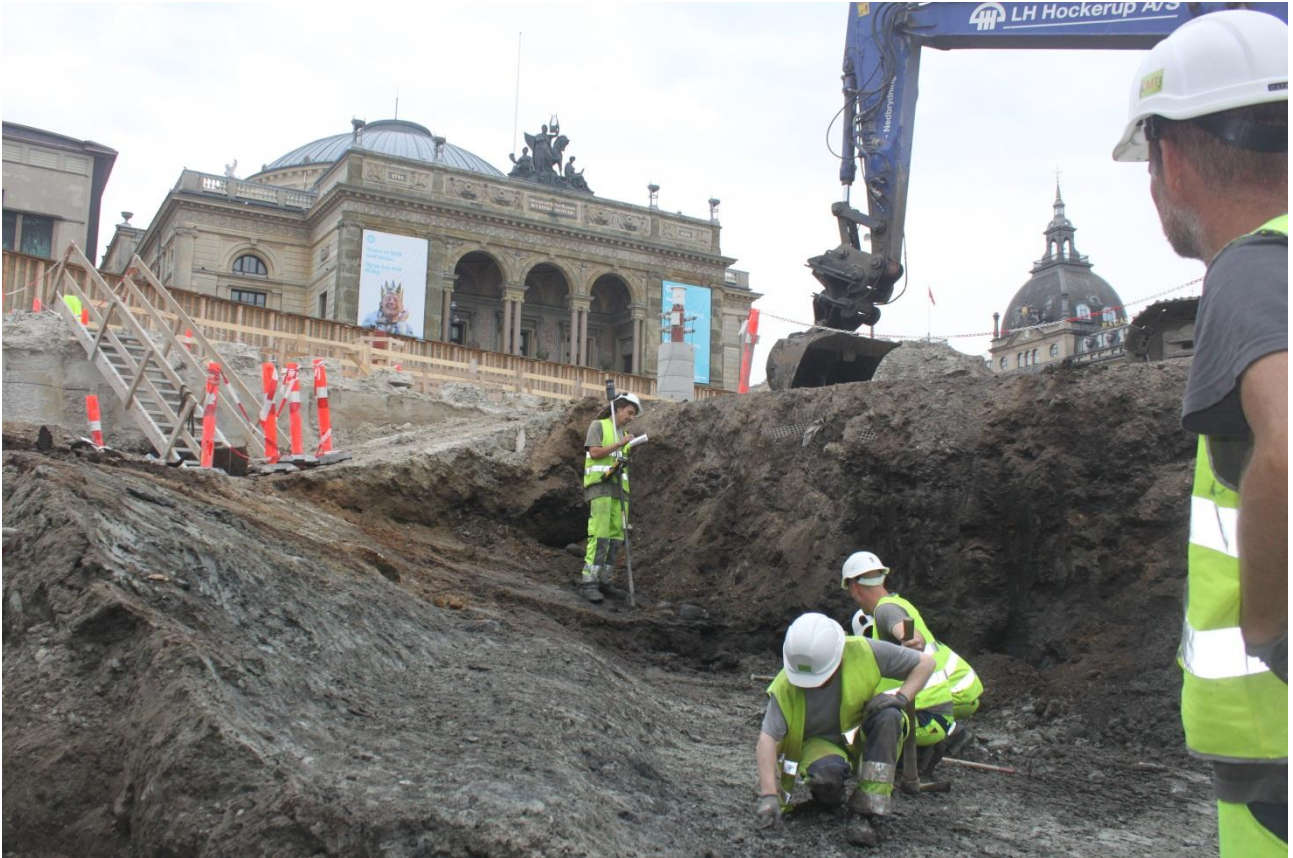
The sides had an angle of 45 degrees and with a gradual break of the slope to the concave and flat base. At the eastern side of the moat a separate step was recorded close to the base (Fig. 168). It is uncertain whether this ledge was created as a pathway while building the fortification or should be seen as part of the defence system.

Fig. 168. Exposing and cleaning the eastern stepped side of the 17th century moat, facing south with the Royal Theatre in the background. Photo: Museum of Copenhagen.

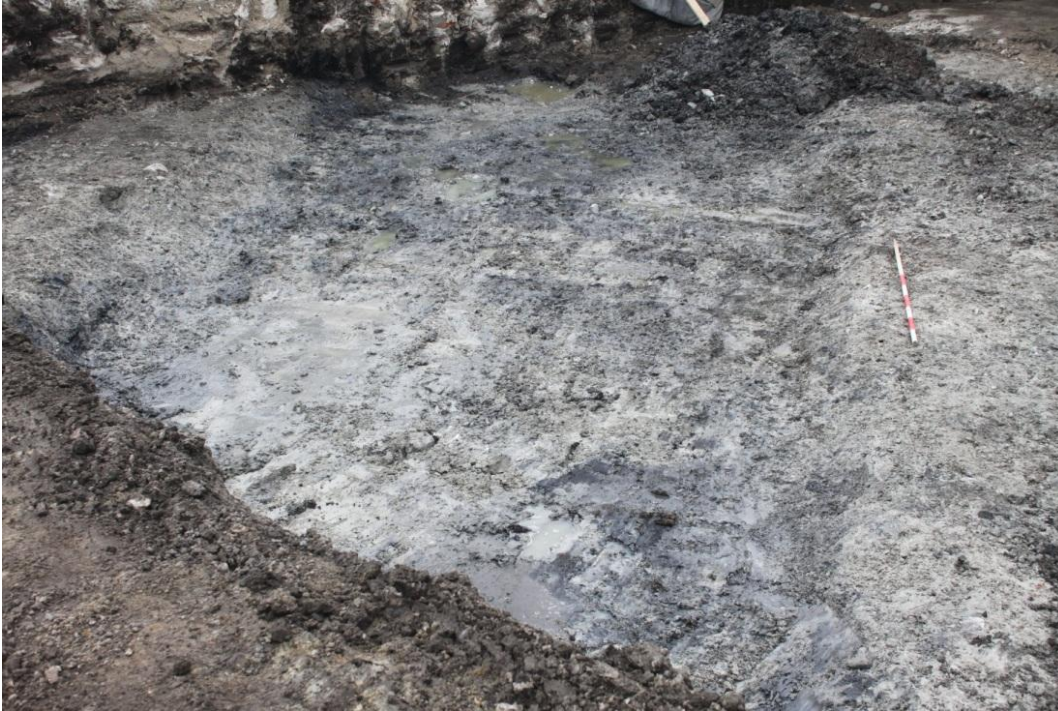
In the middle of the moat a N-S oriented, rectangular construction cut was recorded at the base of the moat cut, into the natural substrate (Fig. 169). This was interpreted as a cunette (a trench dug in the moat to allow drainage, or as an extra obstacle for attackers). The width varied from 5.2-6.6 m with a depth of 0.15 m. The base was flat and the sides steep.

Fig. 169. Part of interpreted cunette in the 17th century moat, facing NE. Photo: Museum of Copenhagen.

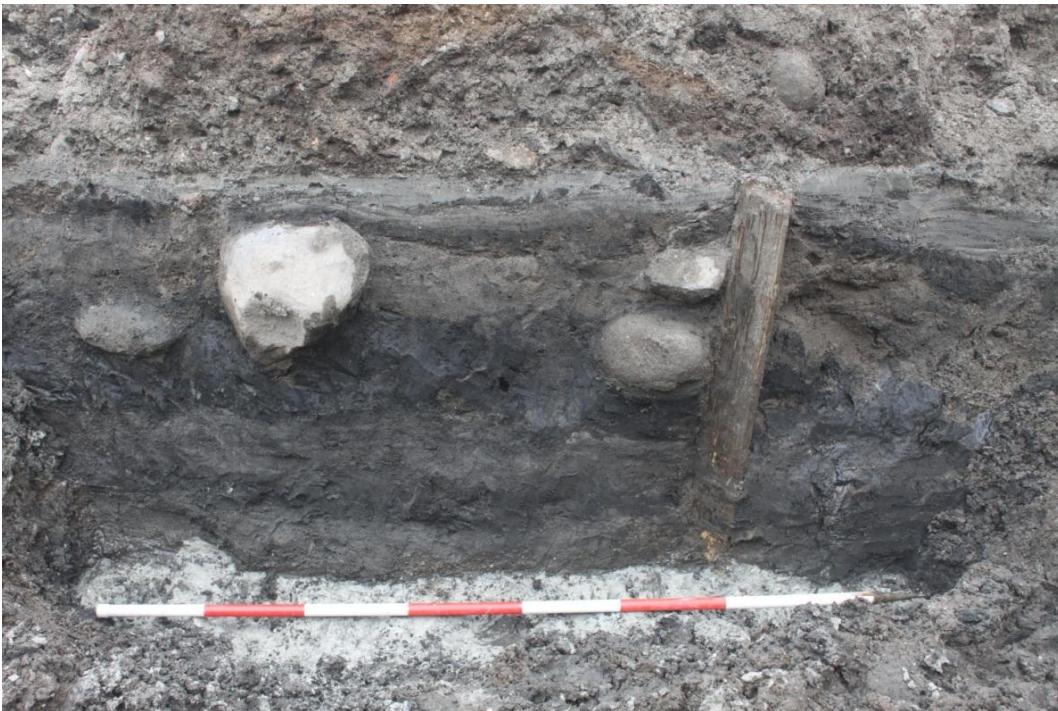
The sedimentation in the moat varied in thickness from 0.1-0.5 m and consisted of lensed dark brown and black decomposed peat with lenses of white sand and different types of finds (Fig. 170). Some of the finds must be connected to the later deconstruction phase pressed into the underlying soft deposits, but overall this assumption does not affect the dating of the deconstruction phase to the mid 17th century.

Fig. 170. Trench cut showing darker alluvial sedimentation at the base of the moat, facing west. The white layer represents natural moraine and the post is part of timber structure (G-240090). Photo: Museum of Copenhagen.

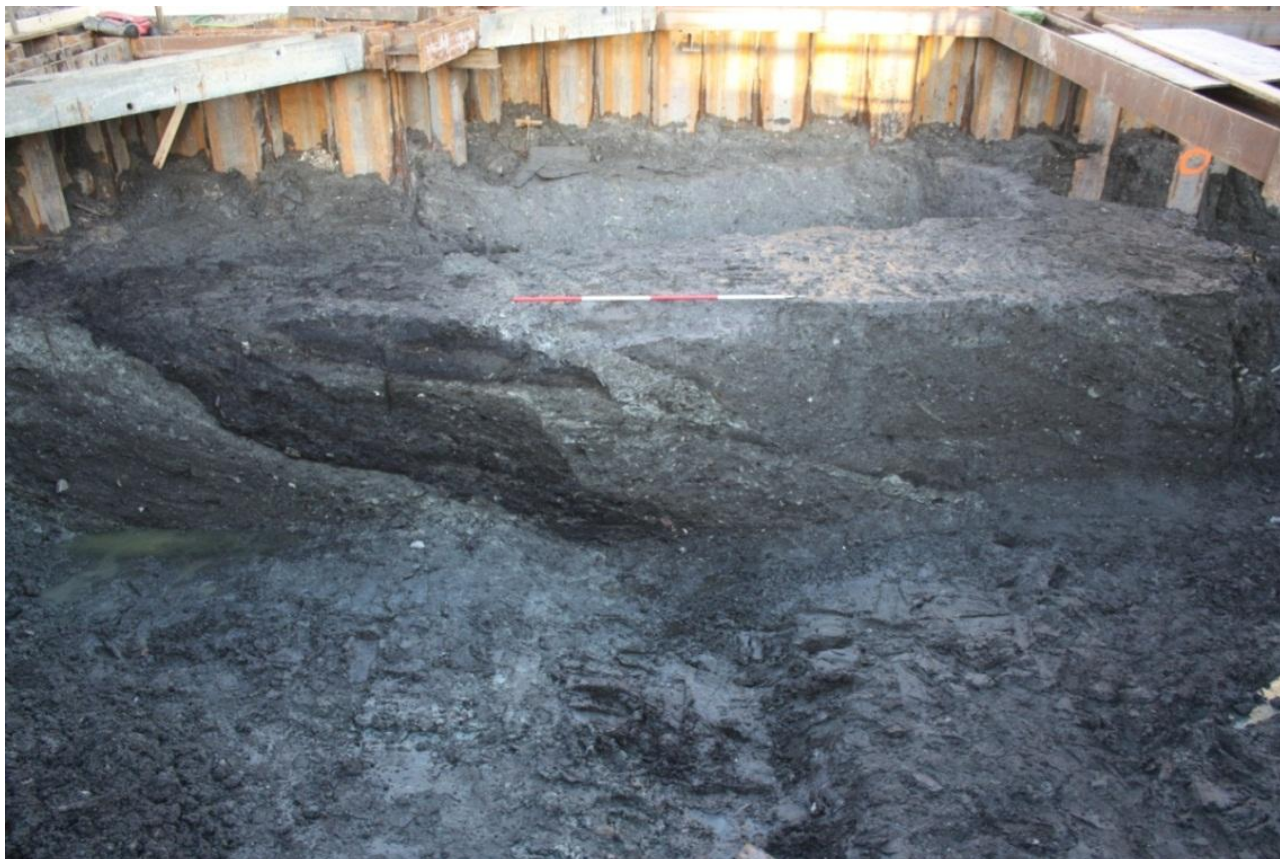
In the mid 17th century the fortification was demolished and the moat filled up mainly from the curtain side (south and SW) (Fig. 171). The dumped material consisted of several deposits of different colour, composition and homogeneity. Some layers contained large amounts of urban, household waste (animal bones), decomposed, organic material (manure) and demolition material (CBM). No clear evidence of industrial activity can be seen within the dumped material, except for a significant number of leather off cuts and concentrations of horn at some places. However, the moat was excavated by watching brief only (machined), so the finds retrieval is far from being as detailed as that in a full excavation (e.g. compared with the moat and finds from other Metro investigations such as Rådhuspladsen).

Fig. 171. Excavation of the Transformer Station in 2010. Different dumps and moat backfills seen in section, facing SW. Photo: Museum of Copenhagen.

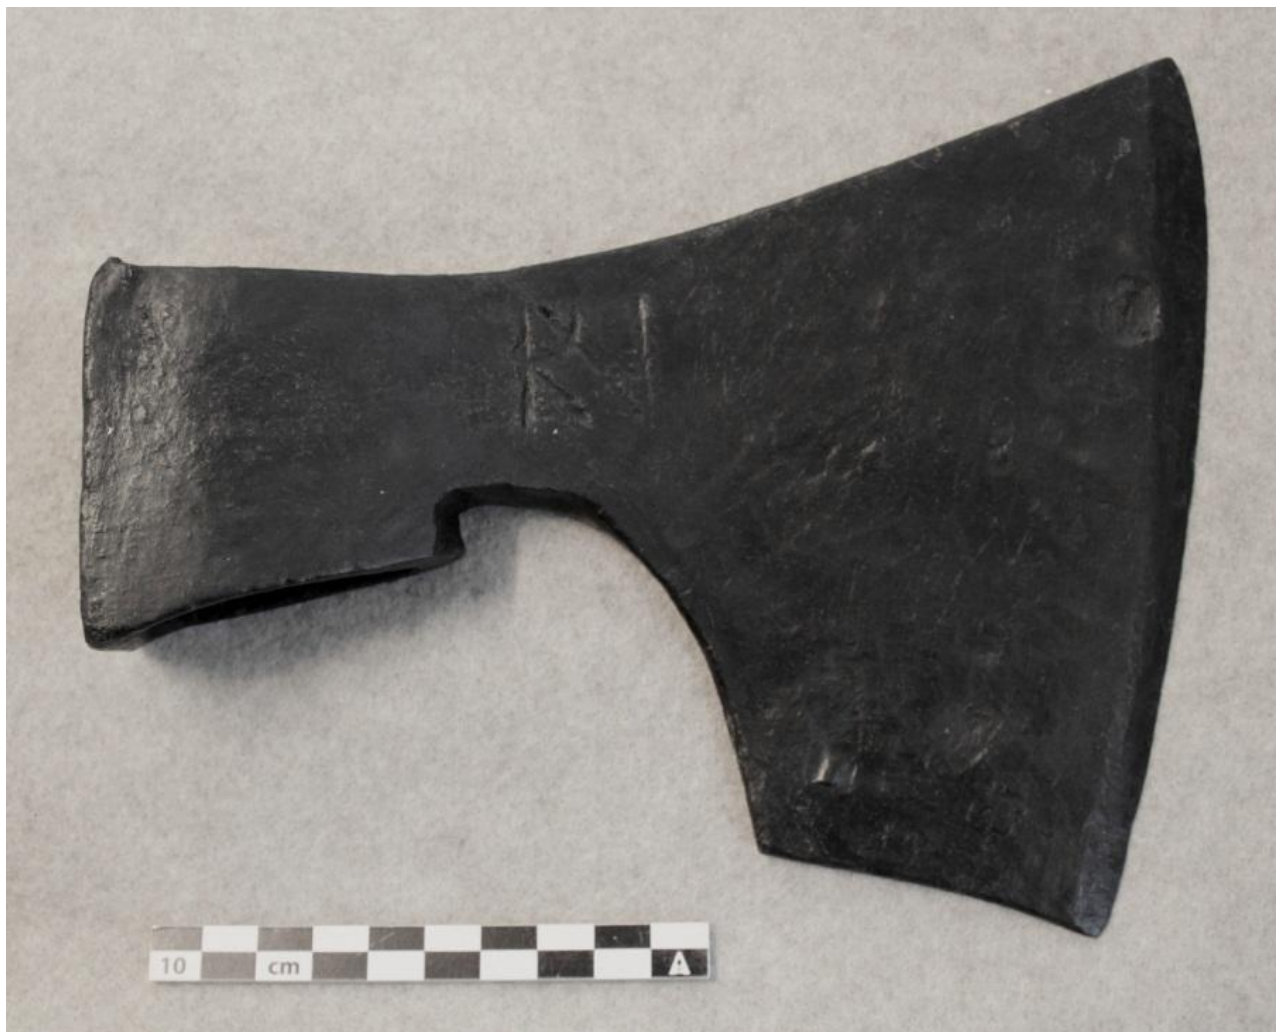
An axe found in the natural accumulation in the 17th century moat is a broad axe with asymmetrical bevelled edge (Melin 2014:12-13). Axes with an asymmetrical bevelled edge are sometimes called single bevel and/or side axes. Since these types of axes more correctly have one clear bevel and one less clear, the author prefers to call them asymmetrical. As the name side axe implies they are specialized tools to be used for hewing the sides of timbers, etc. to accomplish a smooth surface. The axe is made for a right handed craftsman who stands with his left leg close to the timber when hewing. The owner's initials (KI) can be seen on the blade (Fig. 172).

Fig. 172. Broad axe from the original sedimentations in the 17th century moat, after conservation. Photo: Museum of Copenhagen.

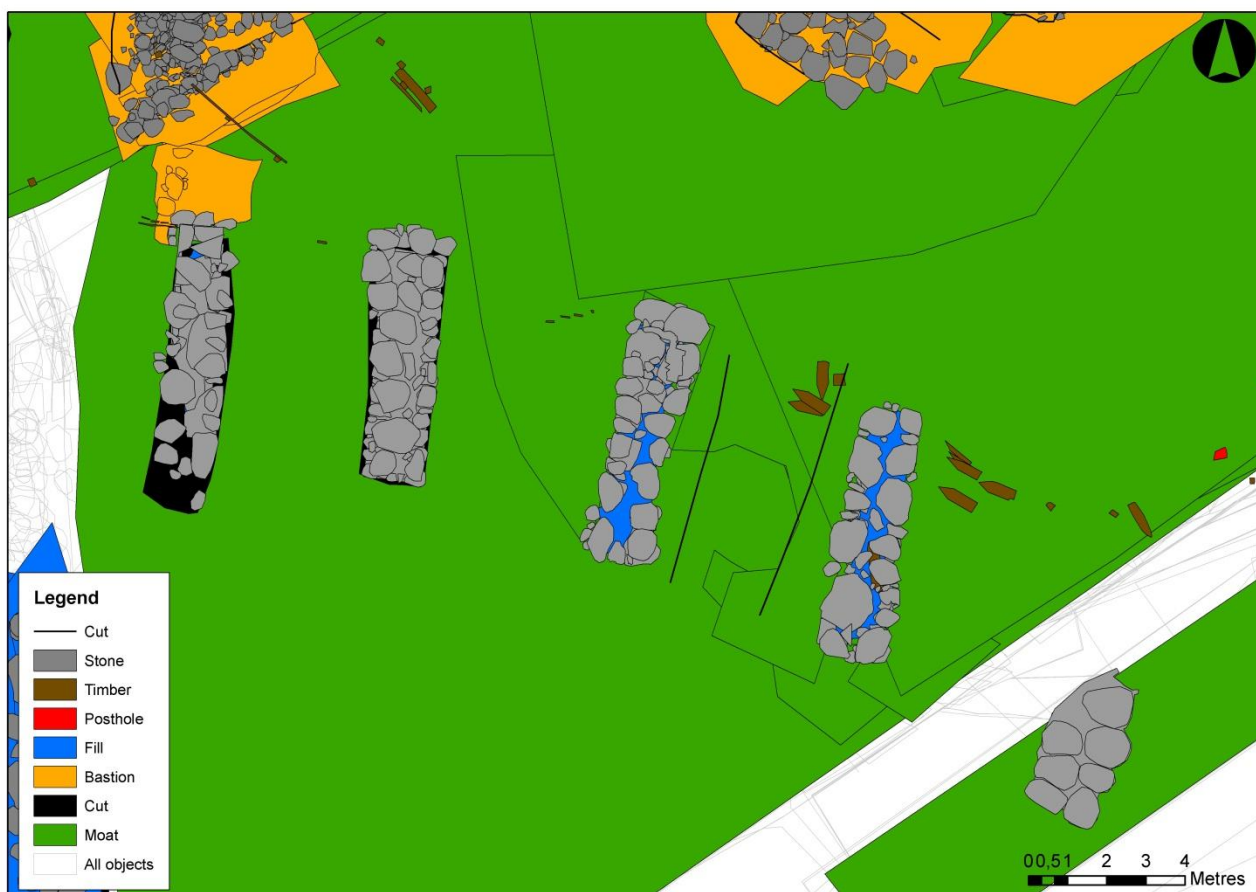
The bridge in the moat consisted of five NNE-SSW orientated bridge pillars, slightly curving to the south (G-500892) (Fig. 173). The length and width of each were roughly equivalent (L: 6-7 m and W: 1.5-1.8 m), and the distance between the pillars was between 3.5 and 4.5 m.

Fig. 173. Bridge pillars in the 17th century moat starting with pillar No. 1 to the left. Notice the weak curve between bridge pillars Nos. 1 and 2 and bridge pillars Nos. 3, 4 and 5, probably done for defence considerations. Compare with bridge in prospect Fig. 200, below.

Five vertical brick pillars or bridge piers were investigated in the moat. Part of this bridge structure was also recorded in 1994 consisting of a dressed stone plinth with three dressed stones and masonry of medieval bricks and lime mortar on a foundation of boulders and demolition material from the 16th century or later, revealed in the street outside Kongens Nytorv No. 21. The dressed stones were sloping 15-20 degrees (Skaarup 1994).

The width was c. 7 m, similar to the 17th century bridge investigated at Vesterport (cf. Lyne and Dahlström 2015:208) and details/construction method compare closely with later versions outside Østerport (Fig. 200).

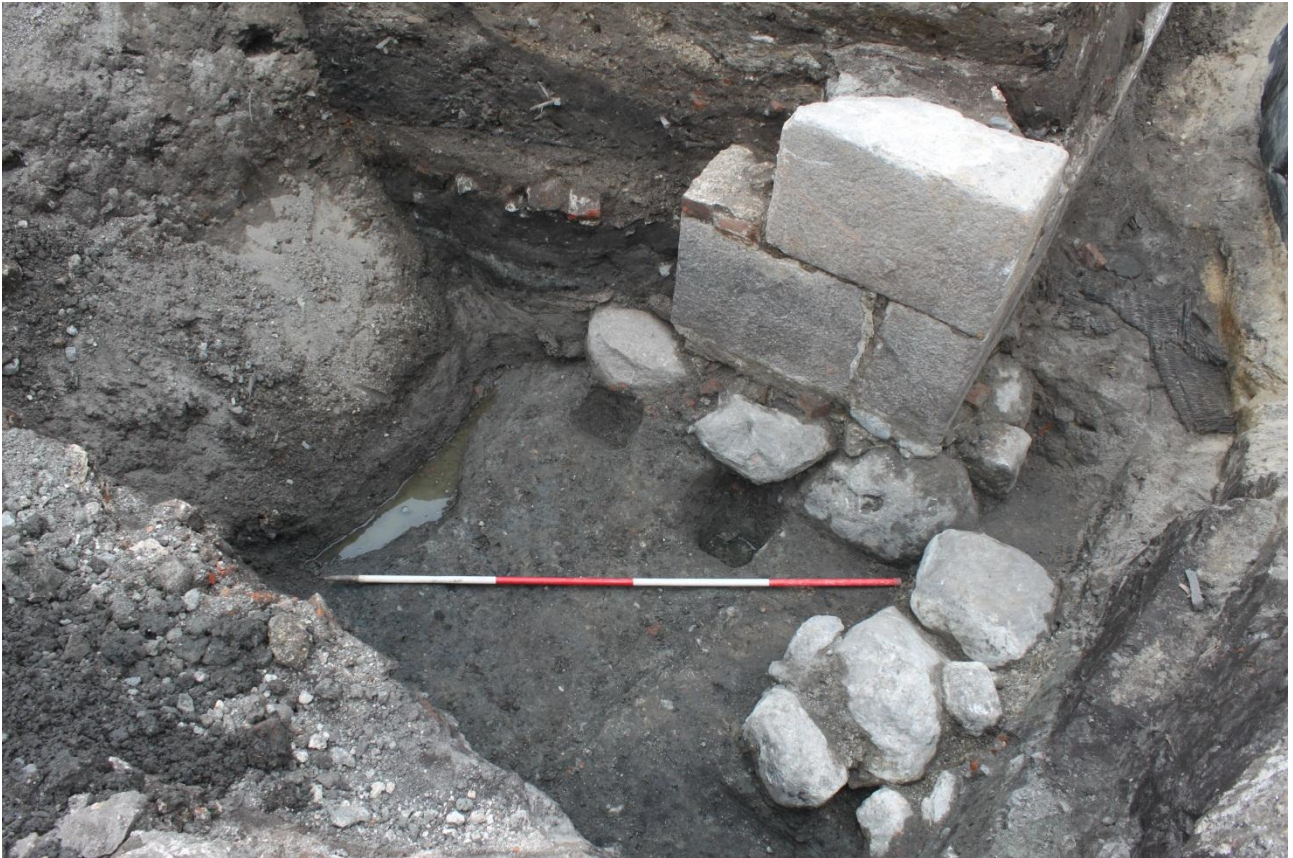
The foundation consisted of two uneven courses of mid grey, unfinished boulders and medium size stones (Fig. 174). The structure was two stones wide and the gaps in between were filled with grey clay and yellow compact and coarse mortar, red brick material, red tiles and minor grey smooth stones of 10-20 cm. It appeared that the 1st stone layer was much longer north to south, so the stones had been placed so as to create a stepped foundation. The foundation stones/boulders all had a smooth surface on every side and had not been cut or shaped. The northern extent of the boulders was covered with blue clay related and belonging to the nearby bastion foundation (SG-813).

Fig. 174. Foundation stones and ashlar stones documented in part of the Guide Wall trench 2012, facing SE. In the middle – a test pit to investigate the depth of the stone structure. Photo: Museum of Copenhagen.

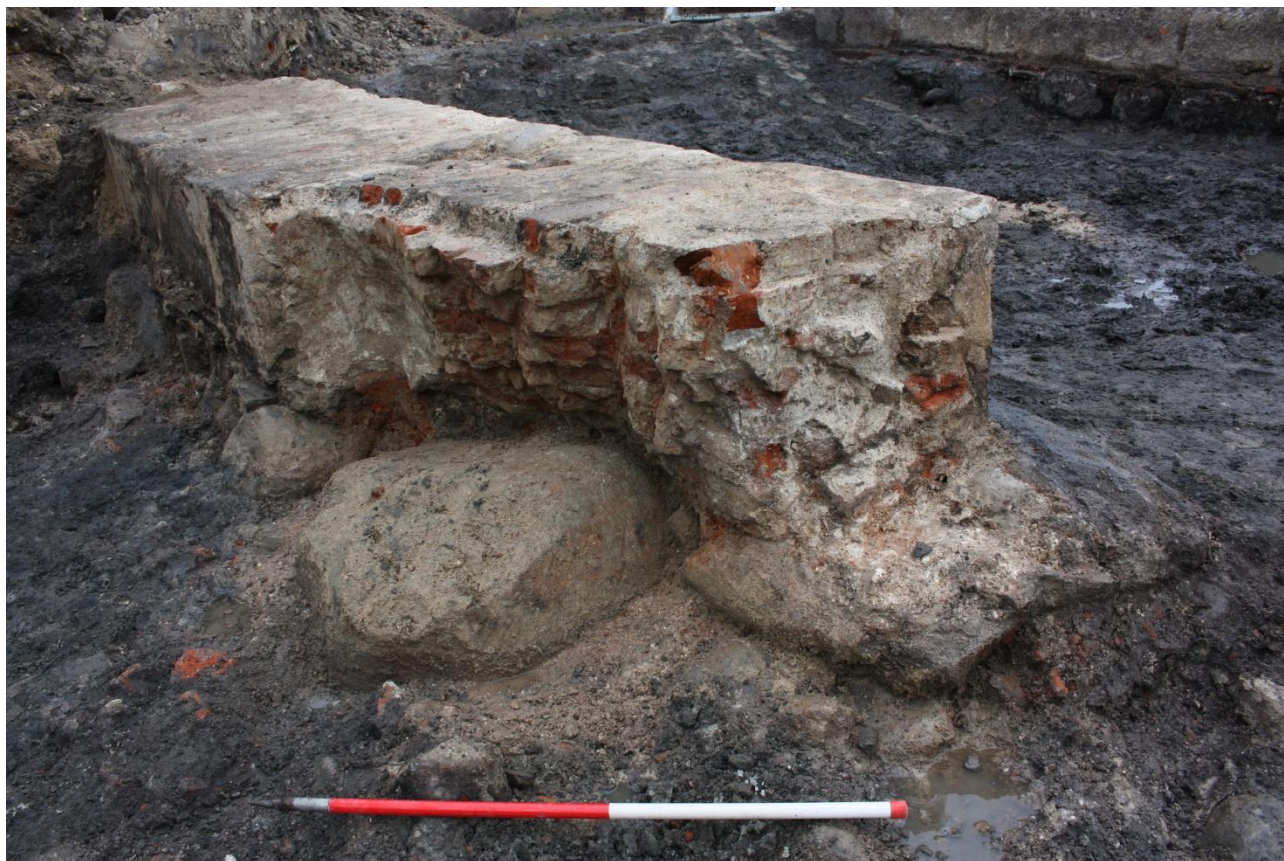
The upper part of the core consisted of strongly cemented yellow and white mortar and lime with inclusions of stones, bricks, charcoal, shell and possibly volcanic ash as a binder. The rest of the core consisted of bricks bonded with cemented mortar and placed in rows (Fig. 176). There was a structure in the placement of the bricks – yet the coursing was uneven and the main purpose had been to fill the gaps in a suitable way. Mortar was later poured into fill any remaining gaps/spaces. Furthermore it appeared that a significant amount of mortar had been poured on top of the 2nd row of foundation stones prior to placing the faced stones and bricks, probably to create an even platform and to hold the structure together. Like the ashlar stones, the south and SW corner was missing and had been probably robbed out.

Fig. 176. Exposed bridge pillar No. 1 with foundation, cemented brick and mortar core together with ashlar stones, facing NE. Photo: Museum of Copenhagen.

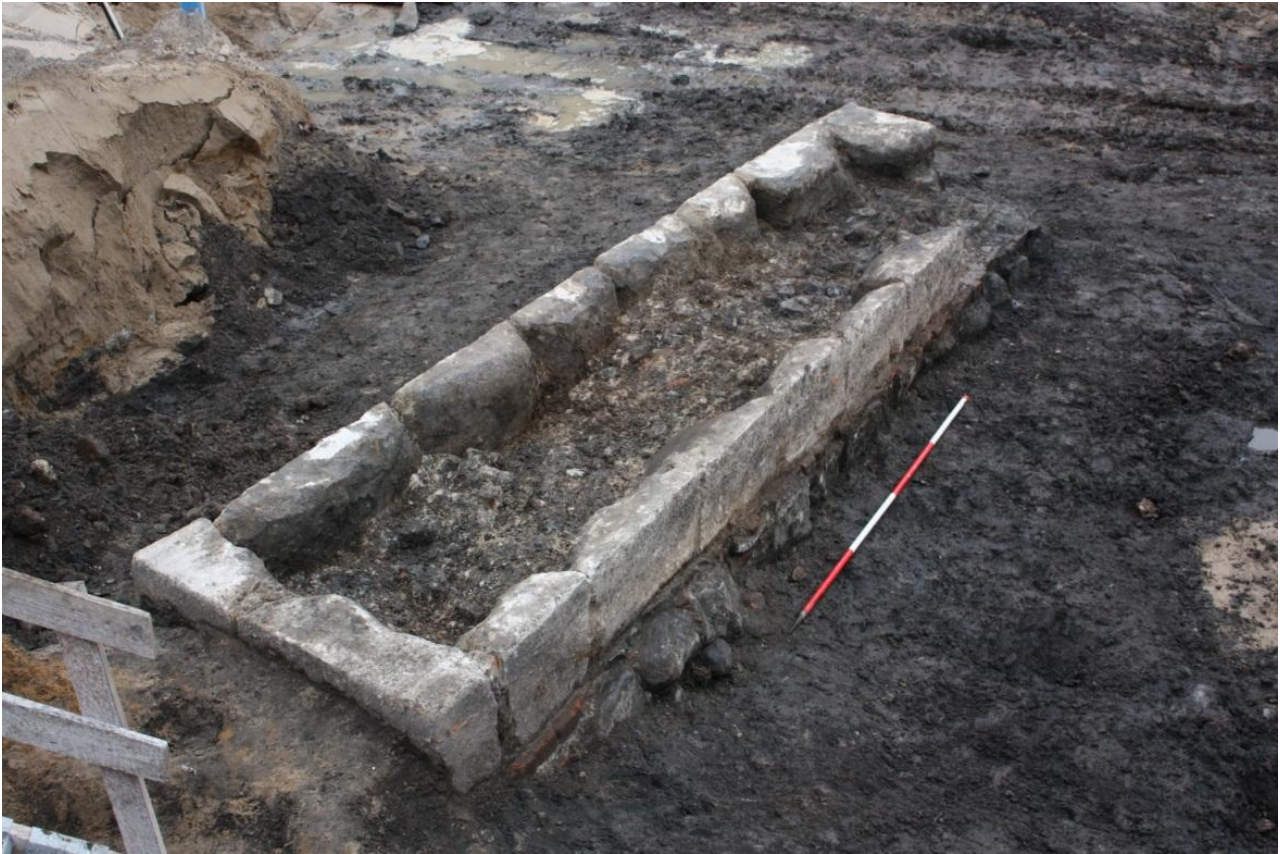
The upper part of the bridge consisted of well finished upright, rectangular light grey ashlar and regular blocks with a length from 0.5 m to 1.0 m (Fig. 177). The rectangular structure had a well laid outside face and a solid core of red brick fragments and smaller stones, bricks and mortar in between. The bricks were probably reused medieval bricks ("munkesten") as also seen in pillar No. 1. The joints of the stone and brick elements were rendered over to give a smooth finish. This was light grey, without inclusions, and very hard. The SW part was missing and probably had been robbed out.

Fig. 177. Upper part of bridge pillar No. 2 represented by ashlars and infill, facing SE. Photo: Museum of Copenhagen.

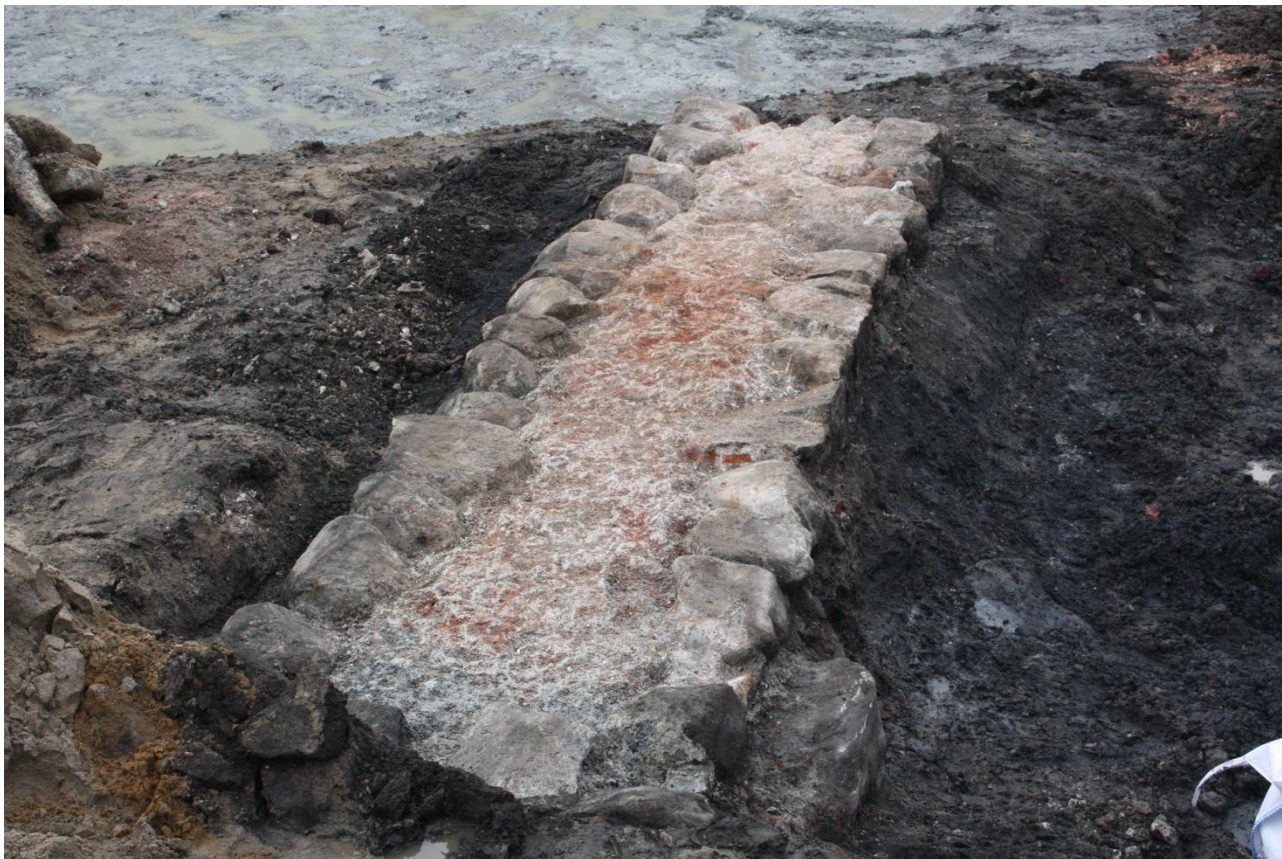
The core consisted of 3 separate layers of mid yellow white cemented sandy silt with inclusions of red brick fragments, stones, pebbles, wood and mortar. The bricks did not lie in order, but had been pushed and jumbled together. The bricks varied in size (0.08 x 0.06 x 0.04 m) representing medieval so-called “munkesten”. One layer had parts where the bricks had been deliberately placed intact in position – in other parts the bricks had been mixed with stones and mid yellow smooth mortar. The upper part of the core consisted of a rectangular box of red bricks (“munkesten”), with cemented grey/yellow mortar with inclusions of charcoal (from burning limestone) and pebbles (Fig. 178). The bricks were placed as a header course above the first layer of foundation stones to create a smooth surface for the next level of ashlar stones. The lower part of the context (not separated on site) consisted of cemented white/yellow mortar with crushed brick fragments between and above the foundation stones.

Fig. 178. Foundation stones and mortar core, facing south. Photo: Museum of Copenhagen.

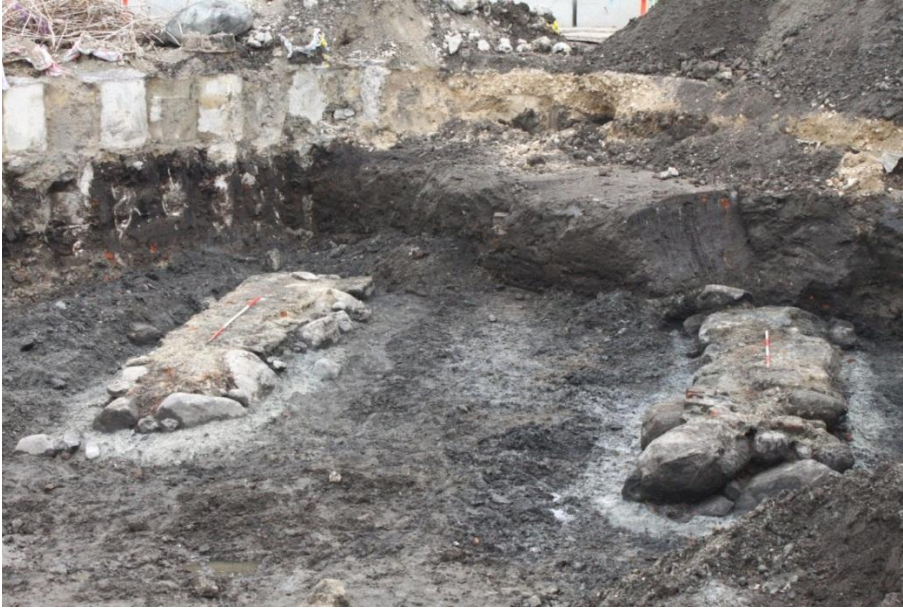
The rectangular foundation was built of natural grey stones and boulders of very varied size with the smallest stones in the middle. The structure seemed to have been built as two uneven rows of stones, east and west, with only the outside faces at all straight. At the south end, the gap between the two rows was filled with a short western line of stones. At the north end, this was not needed as the two northern stones were big enough to fill the full stretch of the northern face. The bridge pillar was not as well preserved as pillars No. 1 and 2 with only one course of systematically placed boulders, although there were a few stones in a lower layer (separated with two different context numbers) (Fig. 179). As noted, the boulders were uneven in size and shape. They consisted of unworked, natural boulders, either beach stones or glacial erratics. The boulders' heights were quite uneven, and there may once have been another course of boulders atop the shortest of these (or dry stone flags, on bridge pillar No. 4 (see below), but if so, this was not preserved.

The core consisted of mortar and two short courses of bricks, registered separately from those in the brick structure. The mortar was mixed with crushed and broken bricks and placed atop the foundation.

Fig. 179. Overview. Bridge pillar Nos. 3 and 4 surrounded by dark waterlogged moat sedimentation, facing SW. Photo: Museum of Copenhagen.

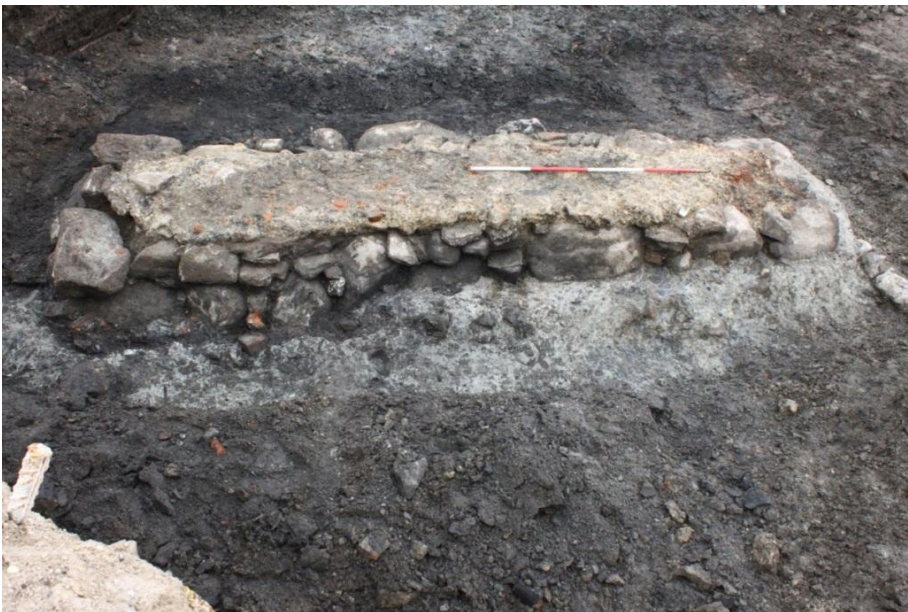
As with bridge pillar No. 3 the structure was heavily robbed of its building material, but the principle of construction seemed to be that two rows of boulders were laid, running roughly north-south, with smaller stones in the middle and with straight outer faces (Fig. 180).

Fig. 180. Bridge pillar No. 4 with foundation and mortar core surrounded by dark waterlogged moat sedimentation, facing west. Photo: Museum of Copenhagen.
