Curtain

Moat – construction, usage and deconstruction

Bridge

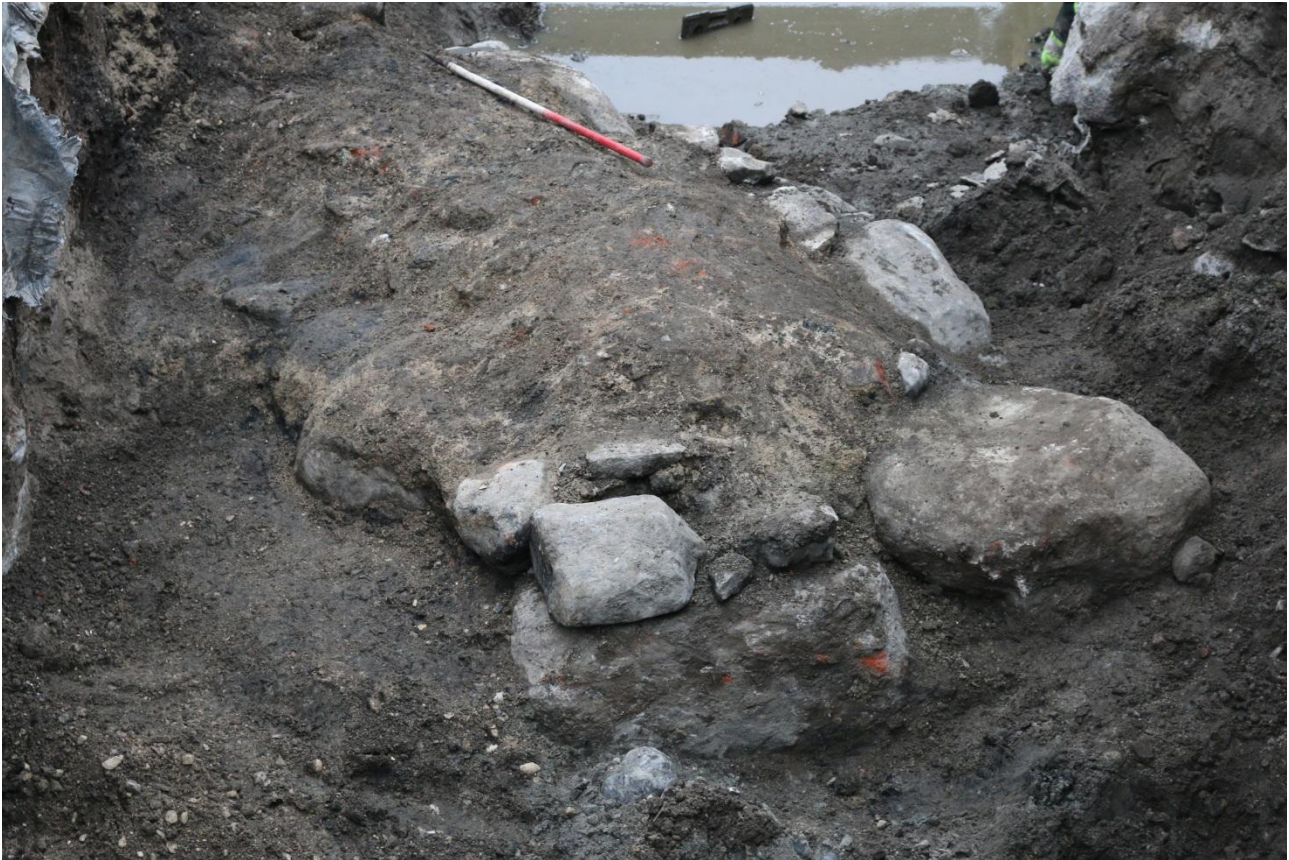
Bridge pillar No. 5 was exposed approximately 5 metres east of pillar No. 4 and consisted of a rectangular foundation built of natural grey stones and boulders of very varied size, where the smallest stones had been used in the core. The structure (c. 4.0 x 2.2 m) was built as two uneven rows of stones, running NE-SW, with only the outside faces straight (Fig. 181). There seemed to be only one course of systematically placed boulders, although there were a few stones in a lower layer (recorded on site before machining). The boulders were uneven in size and shape and varied from 0.7-1.4 m. Some smaller stones could be seen on top of the boulders making the surface on top flatter. The building material was unworked, natural boulders, either beach stones or glacial erratics. A total of seven boulders were recorded, but there were more, since the structure continued beyond the trench to the north. Due to measuring problems (the bridge pillar was exposed deep down in a narrow Ventilation Shaft) records for all stones and boulders were created later in IntraSiS based on measurements on site and from images.

Fig. 181. Bridge pillar No. 5 with foundation stones and mortar/brick core, facing NE. Photo: Museum of Copenhagen.

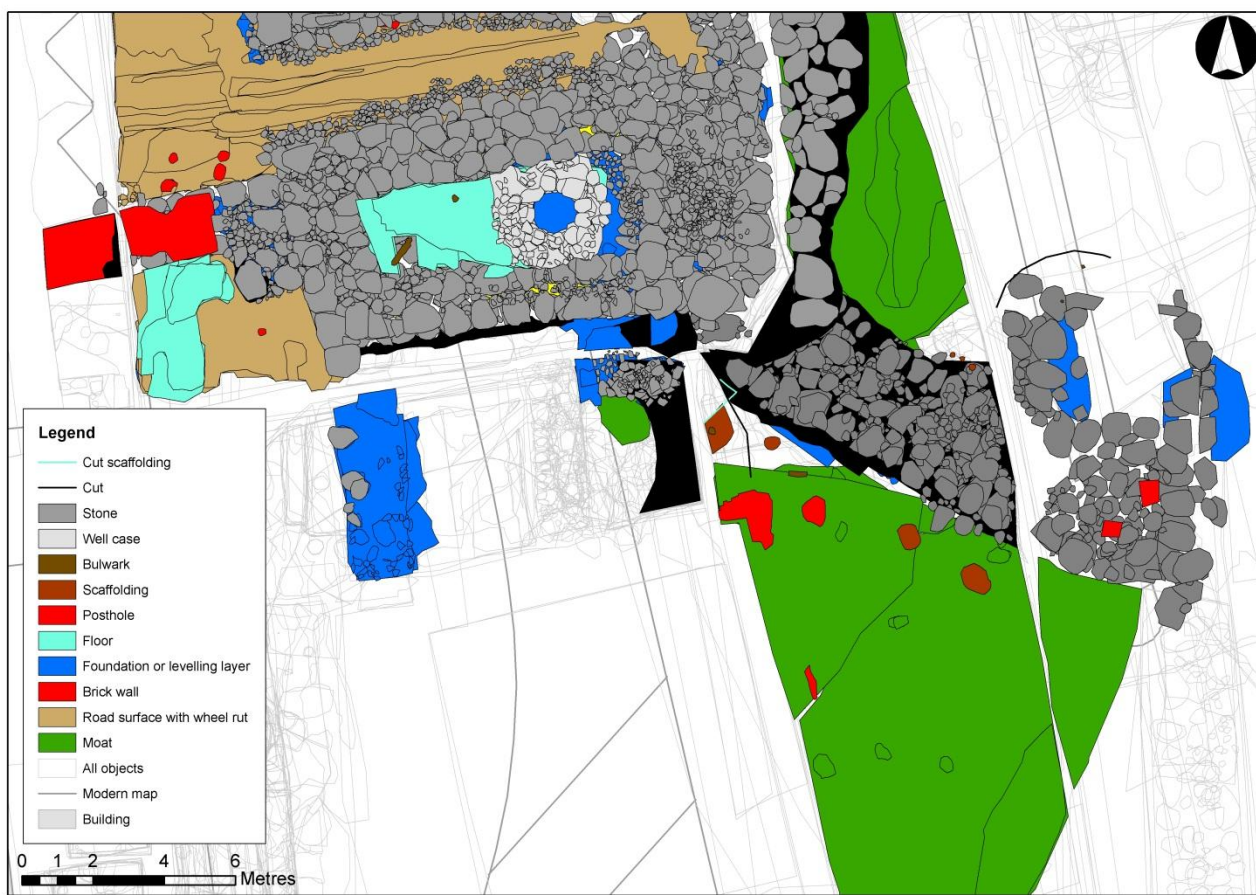
Fig. 182. Dam with semicircular barrier tower placed SW of the gate building in the Late medieval moat. The lack of stones in the middle and within the tower is due to the modern shoring and a concrete pillar erected in conjunction with the new Guide Wall. The measured moat cut to the left, inside the building should be moved two metres to the right based on later re-interpretations.

Attached to the eastern end of the dam a semicircular or B-shaped structure was investigated. This was interpreted as part of a barrier tower to prevent access into the city over the dam. The tower consisted of a brick wall, deposits, stones and construction cuts (see Fig. 182 above). Some of the recorded stones and boulders in the structure were a continuation of dam structure (SG-296) to the west. However, part of this structure was placed beneath a curved brick wall which had obvious similarities with the tower to the north, and is therefore integrated and grouped with the main tower construction. Some of the stones in foundation were also probably part of the northern end of the curtain (SG-503797). This uncertainty and interpretation is due to missing stratigraphical relationships obscured by modern shoring in 2010 and by machining in 2014. One should also be aware that this is the place where three different structures were interconnected – the 17th century bridge, the curtain and the dam.

The tower was heavily disturbed by a couple of modern disturbances (Fig. 182 and 185). A cable box ran straight through the structure in a N-S direction and a big concrete pillar for the Guide Wall had been drilled down through the middle and probably moved some of the boulders aside. A wooden water pipe, dated to the 19th century, had been placed straight across the feature from NW-SE. The gap resulting from missing boulders/stones (triangle) close to the modern shoring is due to machining and for safety reasons which prevented a complete survey.

Finds from the surrounding deposits and the stone structures date the dam and barrier tower to first half of the 17th century. There is also clear evidence that the two features cut sedimentations and usage layers in the Late medieval moat which reinforces this dating (cf. Fig. 182). Dutch or English cross bond used in the tower has a Flemish origin and

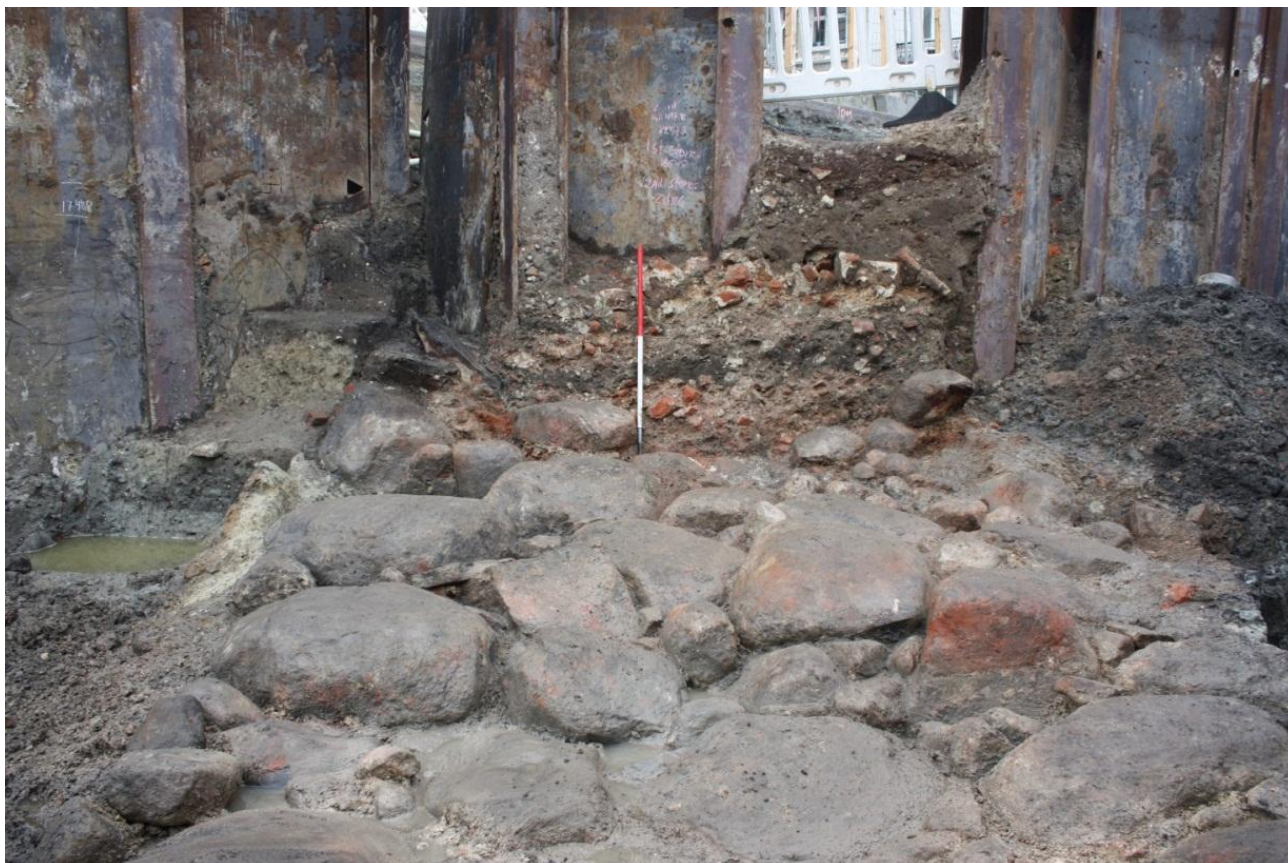
Like the gate building and bridge pillars, the dam had been plundered for building materials. The demolition deposits consisted of light and mid yellowish brown, grey and white sandy mortar with inclusions of charcoal, pebbles, stones and fragments of red brick (Fig. 184). The CBM consisted of large medieval brick fragments ("munkesten") and a few bricks of Renaissance size; small Dutch, from the 17th century.

Fig. 184. Part of dam structure with overlying demolition material and rubble, facing NW. Photo: Museum of Copenhagen.

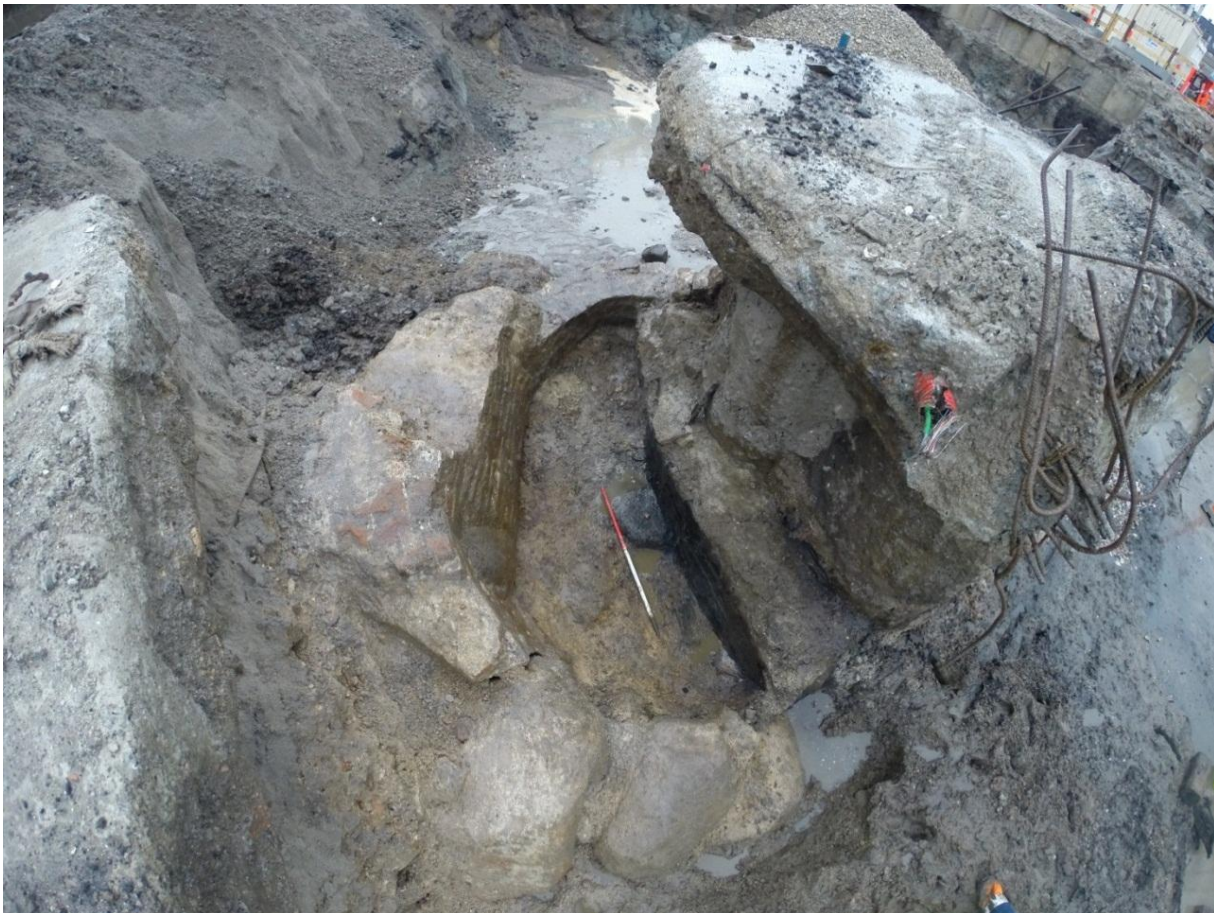
In 2014 the rest of the barrier tower was fully exposed (Fig. 185). Foundation consisted of a semicircular structure of unfinished mid grey granite boulders and stones with infill of mortar and CBM. Two of the stones, facing east, had worked surfaces similar to the worked stones seen in the bridge pillars further to the east.

Fig. 185. Barrier tower from above pierced by a modern concrete pillar to the east. Photo: Museum of Copenhagen.

The construction and foundation layers consisted of mortar and firm greyish blue clay mixed with a large amount of CBM. Levelling layer in the interior of the tower structure was disturbed by a modern concrete pillar in the centre (see Fig. 185 above), so only a small portion of the layer was visible and preserved.

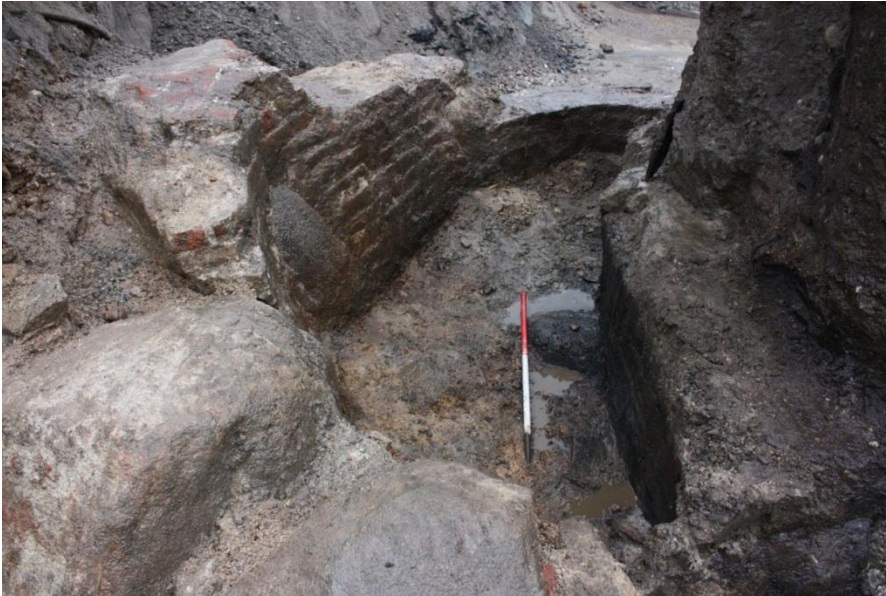
The brickwork consisted of a curved part of a well laid brick wall where parts had been laid in Dutch coursing (Fig. 186 and 187). The wall was thicker towards the base, probably for stabilization. With the exception of the northern part, consisting of a single, 0.44 m thick brick wall, the bricks had been placed on top of and between the large foundation stones, and the wall structure was recorded in a couple of separate sections. The brick construction had an L-shaped form, but the main direction of the structure was north-south. It was first associated with the 17th century curtain which ran in the same direction, but was later grouped with the tower as part of SG-809 investigated in 2012 (see above). The exposed part of the wall consisted of a header course where the bricks had been laid flat either side on, or end on to the face of the wall.

Fig. 186. Remains of the barrier tower with foundation stones and curved brick wall, facing north. To the right – section through dark alluvial deposits inside the structure. Photo: Museum of Copenhagen.

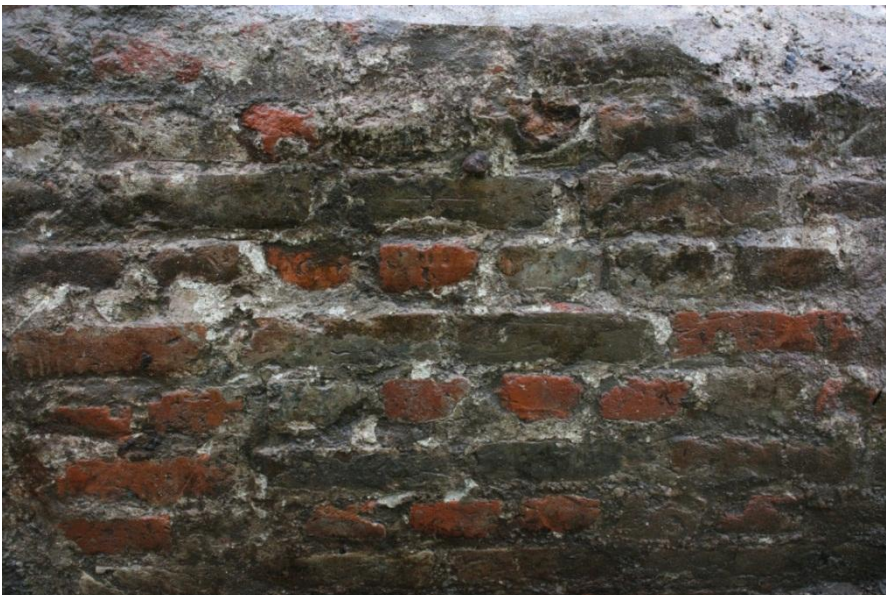
Fig. 187. Close up of brick wall of Dutch or English cross bond, facing NW. This bond has alternating stretcher and header courses, with the headers centred over the midpoint of the stretchers, and perpends in each alternate course aligned. Photo: Museum of Copenhagen.

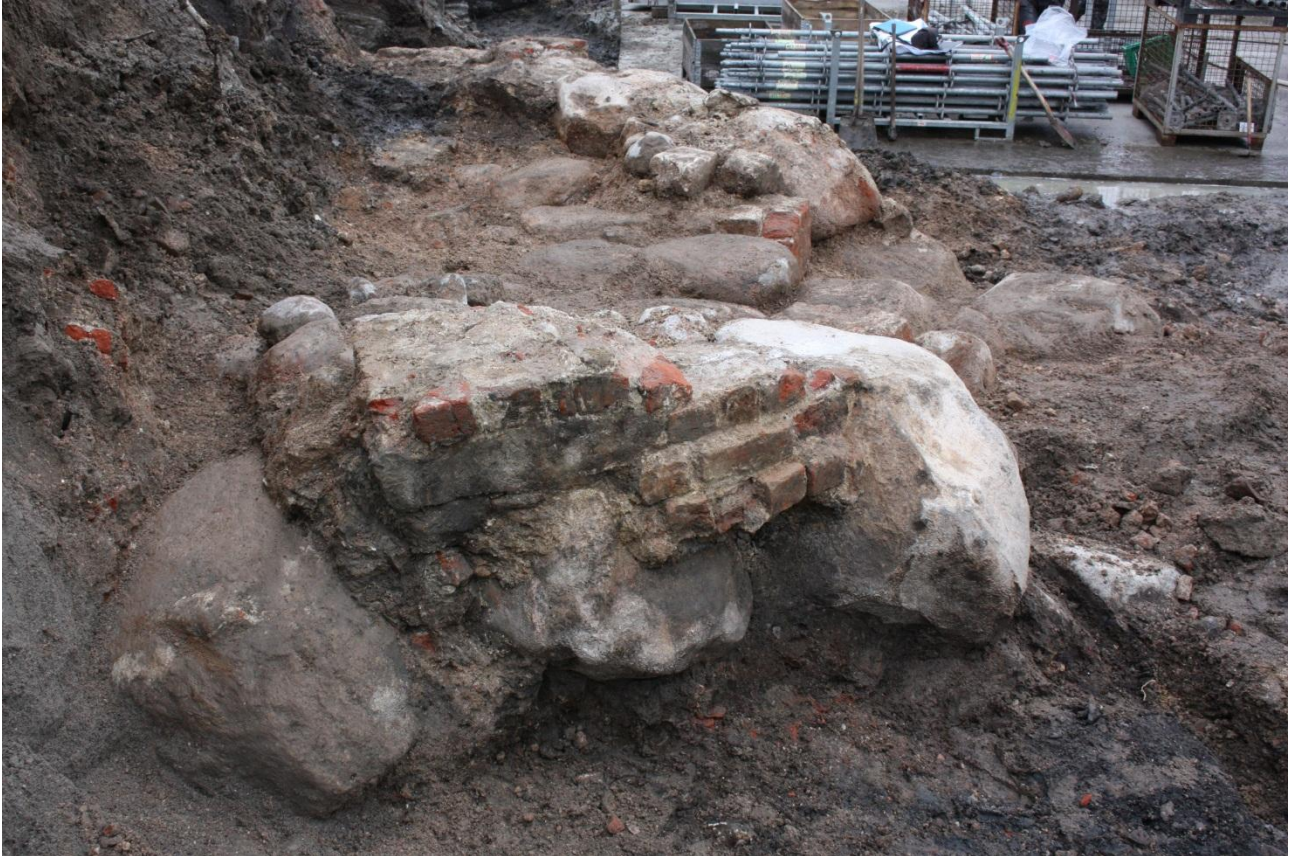
Structure (SS311742) consisted of a curving wall of fully laid medieval bricks and a single rectangular ashlar. The brick wall was 1.2 m long, 0.4 m wide and 0.5 m high with mid red bricks (“munkesten”) and yellow/white tuck mortar. The bricks had been placed stepwise (5 cm) in the lower part (Fig. 188), and one got the impression that the structure sloped slightly to the NE, but this probably was done to stabilize the construction. The brickwork consisted of both headers and stretchers, but no coursing technique could be determined on site. The bricks and ashlar stone had been placed on and matched to the foundation stones.

Fig. 188. Curved brick wall placed on and matched to boulders, facing NW. Photo: Museum of Copenhagen.

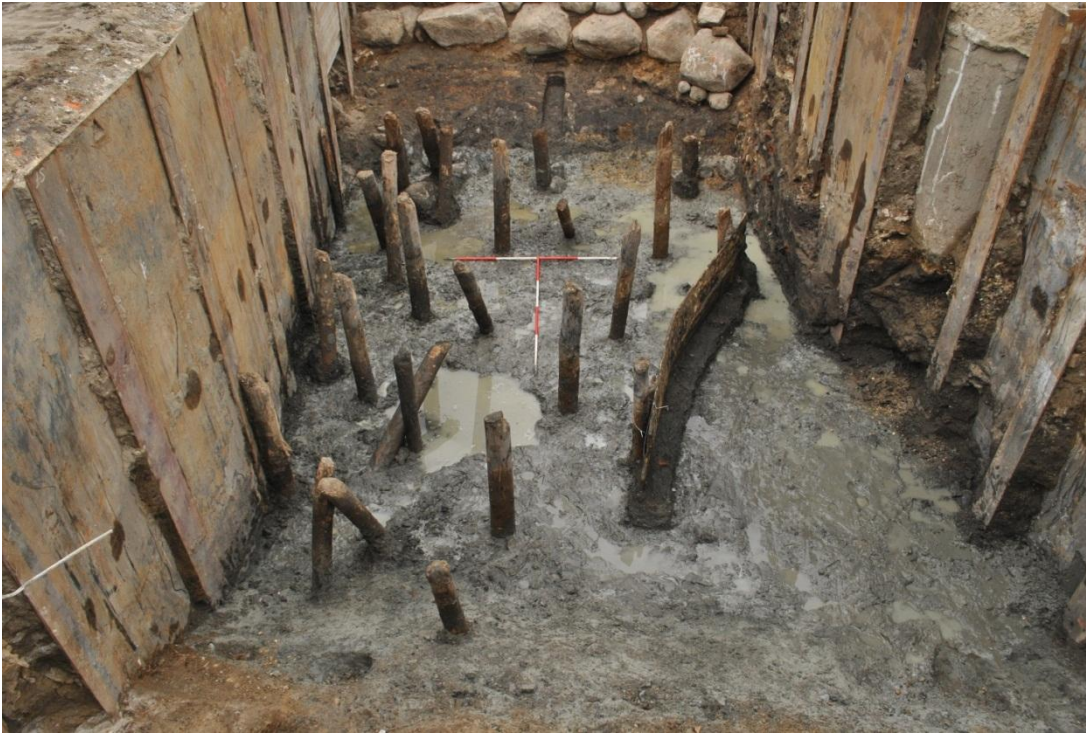
Fig. 191. Bridge structure, facing west. Photo: Museum of Copenhagen.

Parts of the bridge consisted of a sharp slender post and two planks, both of which showed evidence of earlier use for another purpose (Fig. 191). The structure was orientated in a rough east-west direction. The post had been created by splitting a round timber with an axe creating a tangentially faced post with a narrow tapered point up to 0.29 m in length. The post might have been used in a roof construction (Melin 2013:21). Two substantial iron nails were noted on the exterior of the post, which had been bent downwards and upwards after they had been hammered through. They may have been used to fasten the post to the two timber planks adjoining it to the north.

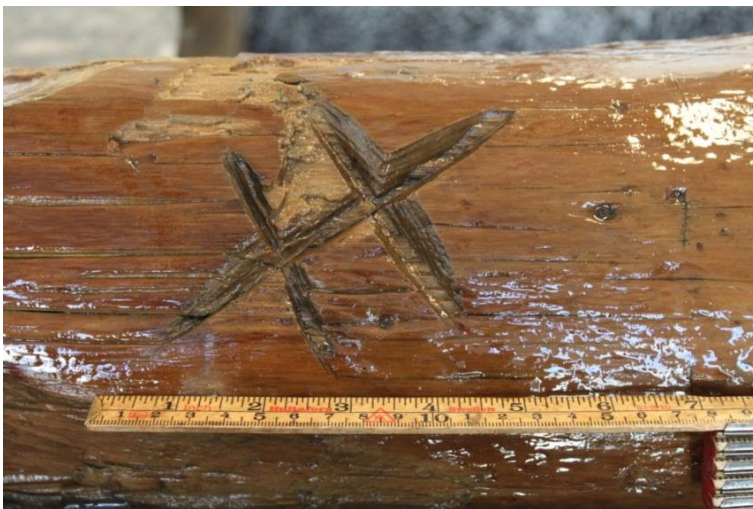
Some of the posts were related to a cut, due to variations in the soil around the posts, and were initially thought to be cuts with fill differing from the surrounding layers. One of the timbers had a producer's mark consisting of a double cross (Fig. 192).

Fig. 192. Producer's mark on one of the posts in the 17th century bridge. Photo: Museum of Copenhagen.

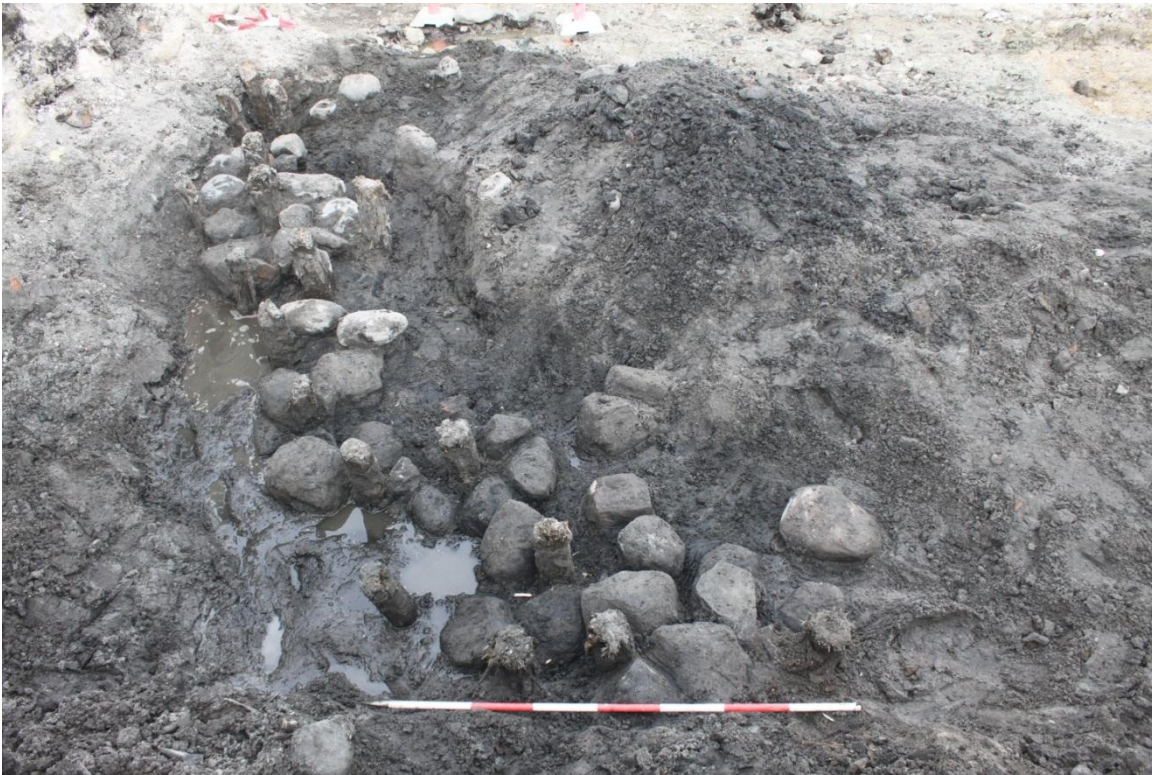
The vertically set posts were 0.75-1.37 m long with four sided tips. As a continuation of this, N-S running group (G-6571) was later recorded representing an alignment of a total of 82 vertical postholes with tapered bases. The overall length was c. 22.0 m and width 1.0 m (Fig. 194).

Fig. 194. Part of revetment. Wooden posts and stones, facing NW. Photo: Museum of Copenhagen.

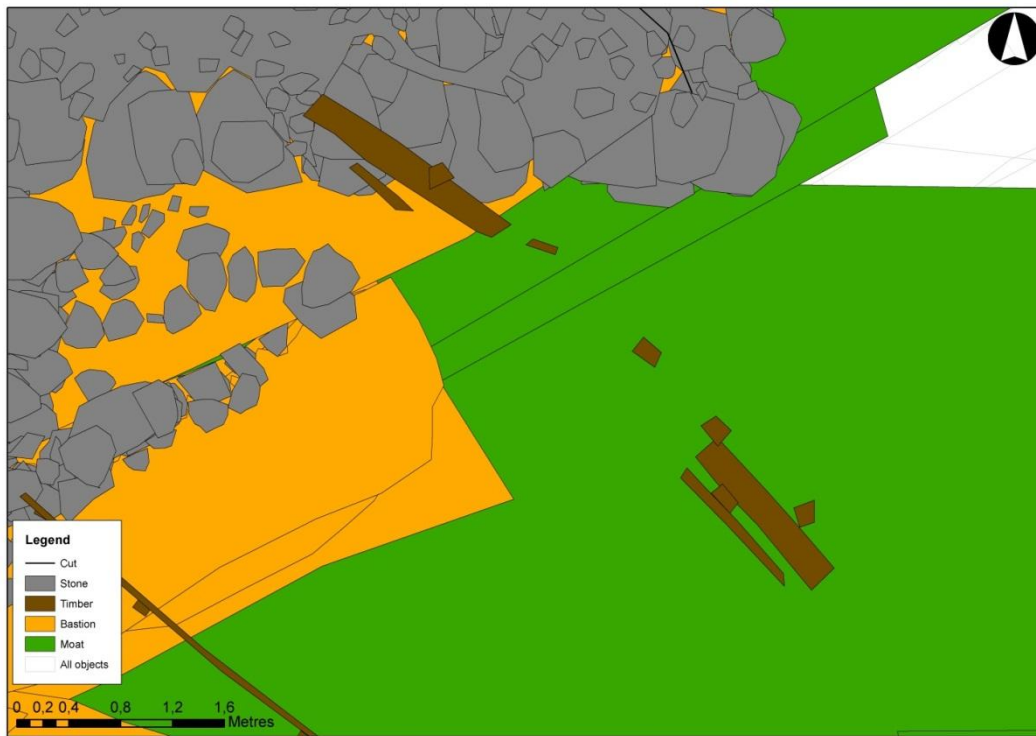
Group (G-503381) represents part of a 5.4 m long and 4.0 m wide wooden structure consisting of eight vertically set box hearted posts and five planks of different size and depth/thickness recorded close to stone structure SG-503400 and bridge pillars (G-500892) at the base of the 17th century moat (Fig. 195).

Fig. 195. Interpreted sluice of timber posts and planks partly underlying the 17th century bastion.

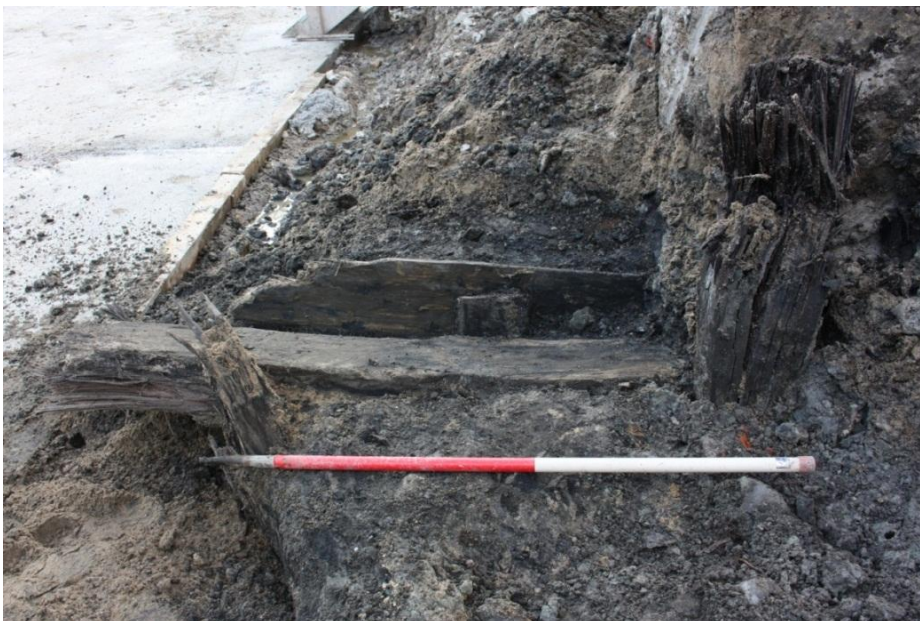
Horizontal plank was 5.4 m long and 0.2 m wide and placed parallel to a planking in a NW-SE direction. The NW end was clean, sawn cut, whereas the SE end was broken – possibly the result of a modern break. The timber structure was destroyed in the middle by modern concrete forming the Guide Wall. A plank further to the west had the same orientation, was 3.12 m long, worn and slightly ripped at the ends. The plank was placed right up against two upright posts, but no fixings were visible (Fig. 196).

Fig. 196. SE part of wooden structure (G-503381) consisting of vertical posts and horizontal planks at the base of the moat, facing SW. Photo: Museum of Copenhagen.

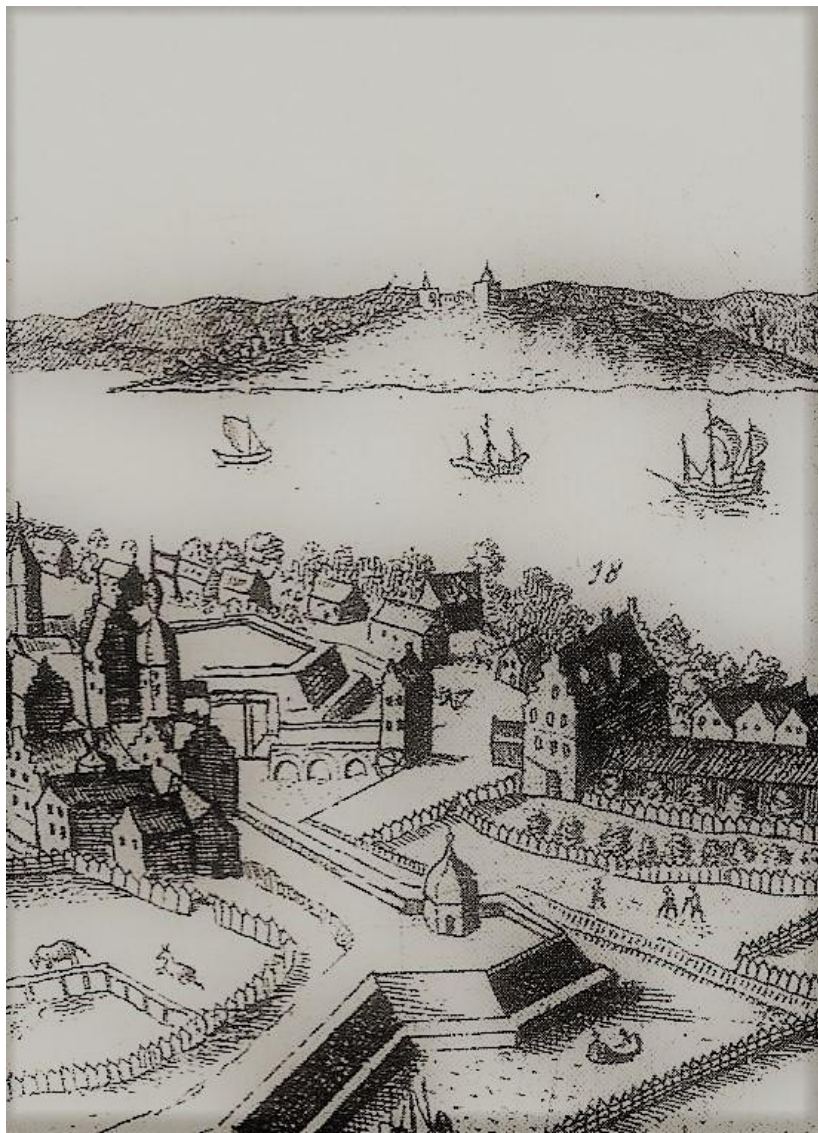
Fig. 198. Part of Johan van Wijck's painting and prospect from 1611 showing Østerport including inner- and outer gate buildings and drawbridge. The Spangenberg's characteristic bastion just north of Østerport is just visible behind the new gate building and is shown as a large, earth-filled plateau with surrounding parapets. A berm is shown by the moat.

In tandem with the construction of the new moat, an outer gate was also constructed. This faced to the south-southeast, approximately at a right-angle to the main gate building, in itself a defensive layout (Fig. 198).

Jan Dirksen's prospect of Copenhagen from 1611 based on van Wijck's painting is the only source that suggests that the city's fortifications might have been covered with bricks (Fig. 198). No brick structure could be traced in connection with the bastion at Kongens Nytorv as was seen at the Metro excavation at Rådhuspladsen (cf. Lyne and Dahlström 2015:206) and nothing in the demolition material from the fortification or the subsequent filling of the moat suggests this. Here, in the southern part of Østervold, from Østerport in the north to Vandporten to the south, the outer slope was almost vertical and it would have been very difficult to maintain this fortification if the works outside were lined with bricks. It is also unclear if the reproduction represents soil or masonry. Since there are no records in the written sources mentioning the purchase of bricks and/or work with masonry, nor later repair around the bastions, it seems clear that it was intended that the fortifications from Vandkunsten in the west to Bremerholm in the east would have been built as earth works in the "Dutch style" (Westerbeek Dahl in press).

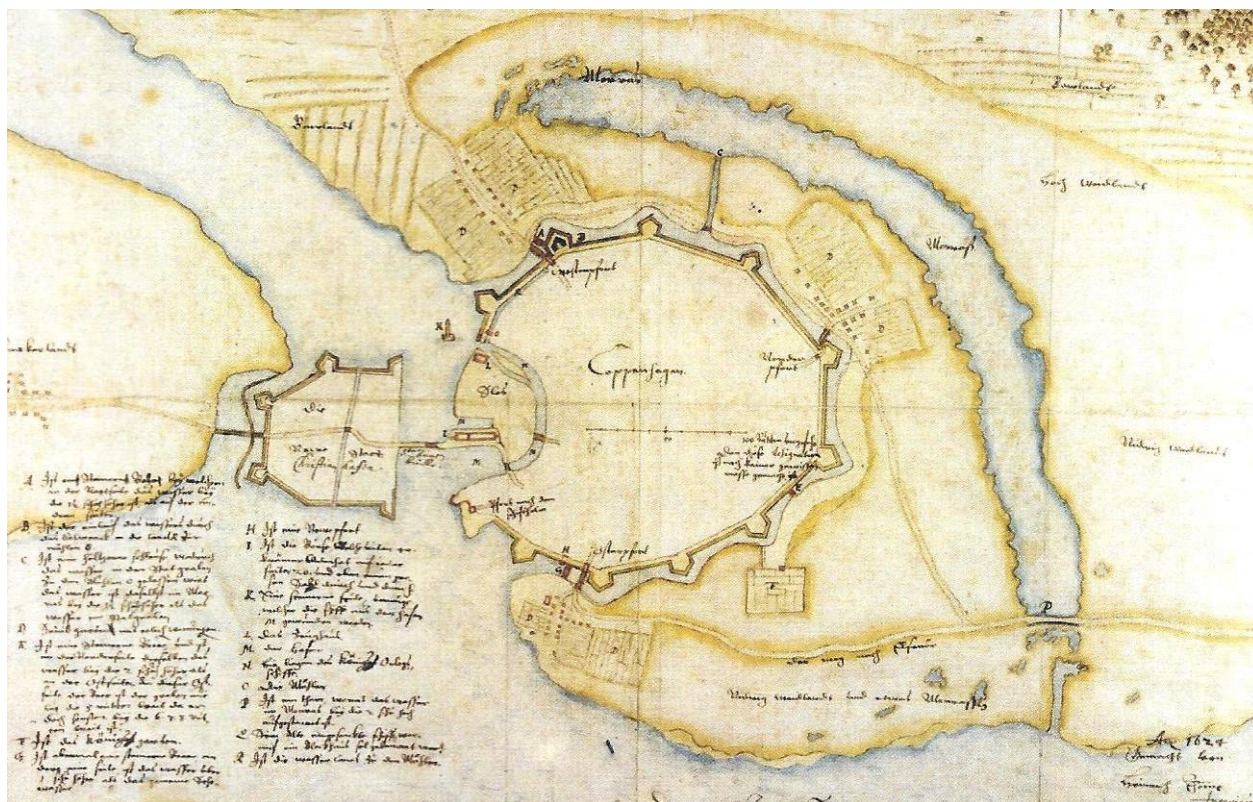
Fig. 199. The new fortification surrounding Copenhagen based on Dutch and Italian models, drawn by Swedish engineer Heinrich Thome in 1624. From Krigsarkivet – War Archives, Stockholm.

In the process of rebuilding the fortification based on Dutch and Italian models, the former roundel north of Østerport was transformed into a spear-edged bastion, physically connected to the rampart in the semicircular fortification. The possible reasons for this – apart from general defensive needs – may relate to a desire to keep up with current trends in urban defence, as well as an increased need for defence. These constructions would again have been organised centrally, either by the king, or by his administration, requiring significant planning and organisation, and a large expenditure of labour, time and money (Westerbeek Dahl in press).

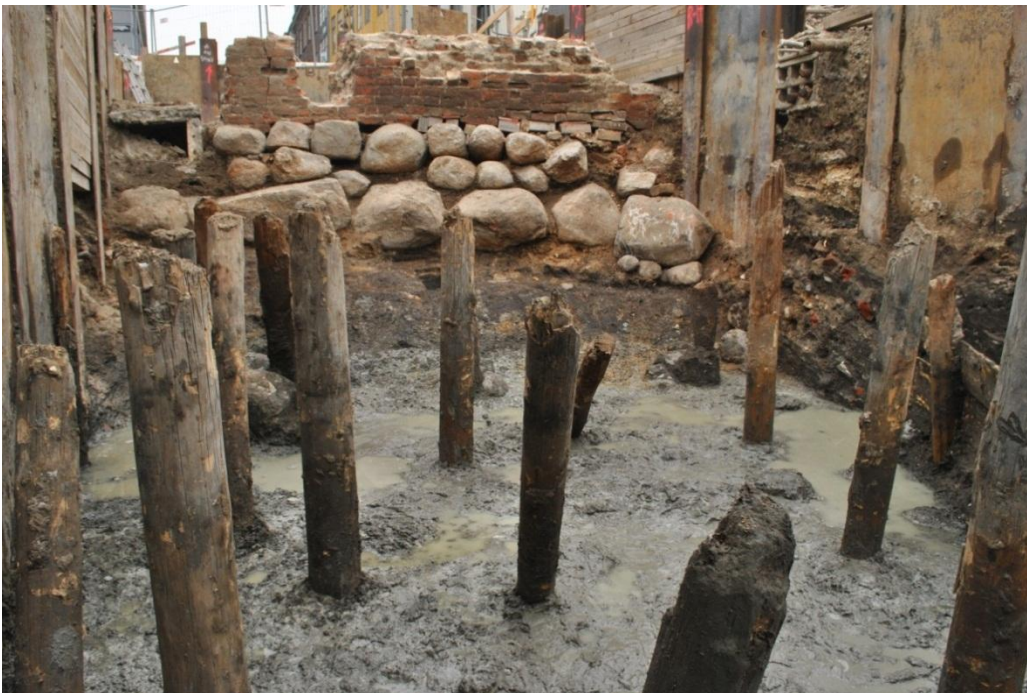
Fig. 201. Overview of the bridge structure in the Late medieval moat, facing west. Photo: Museum of Copenhagen.

Based on dendrochronological dating of horizontal plank and the presence of alluvial deposits, it is assumed that the bridge was built in the early 17th century when the moat went out of use, as a temporary substitute for the eastern gate and related bridge. Part of the medieval city wall was preserved adjacent to Lille Kongensgade as a bridge head while the rebuilding and construction work was ongoing (cf. Fig. 201).

In connection with the new bridge one needed a temporary entrance into the city. In 1618–1619 a 30 fathoms bridge entering through an arch down to the beach opposite Slotsherrens gård at Østerport is mentioned (Thorsen 1926:237 and 247), which is presumably the same bridge investigated at the end of Lille Kongensgade in 2011 (Fig. 201).

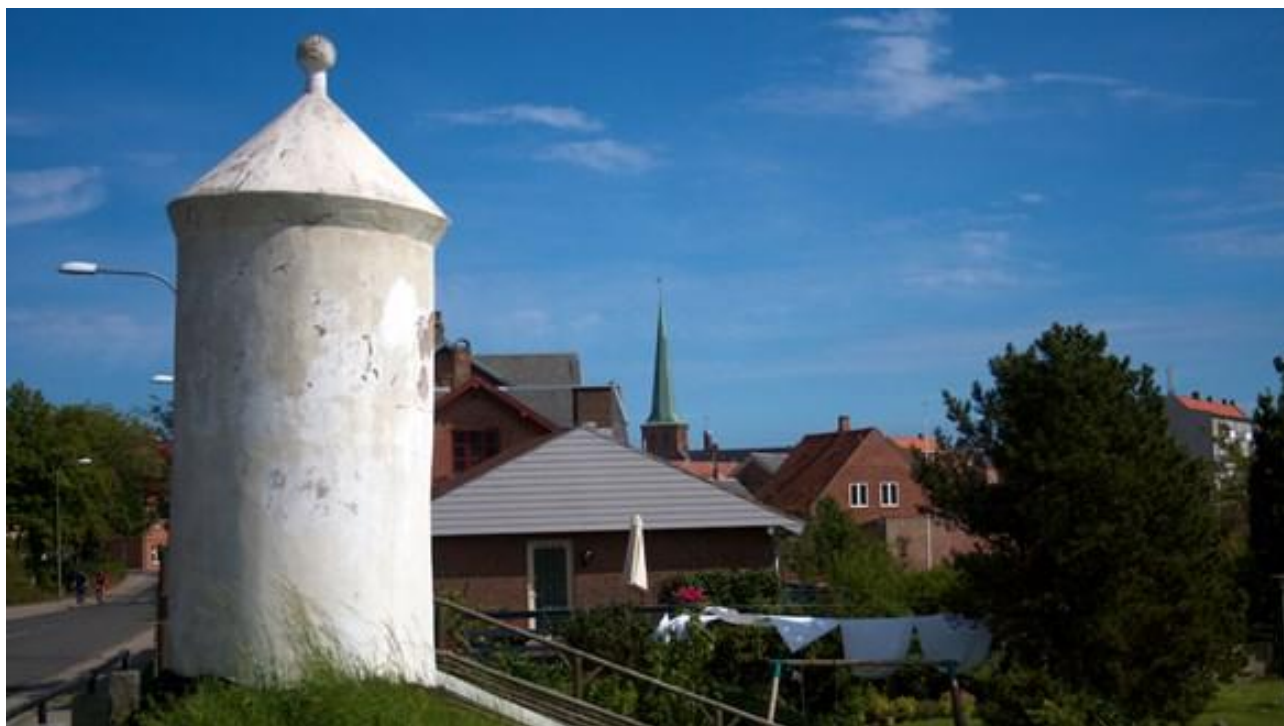
Fig. 202. Small whitewashed tower from c. 1660 AD on top of the dam at "*Kongens Bastion*" in Nyborg. From: Den hvide jomfru 2016.

The barrier tower previously had been documented without any clear interpretation (Skaarup 1994). This brick structure was interpreted as a tower in connection with a dam structure just south of Østerport and dated to 1608–1609 AD. This hurdle is also seen on Thorsen's drawing of Østervold and includes two small towers to prevent passage over the moat (Fig. 280; Lassen 1855:28; Thorsen 1926:246; Westerbeek Dahl 2016; in press). The interpretation as a tower is also based on its internal structure and a similar, still existing tower in Nyborg (Fig. 202).
