15 Phase 4c Eastern gate building 1200–1600 AD

15.1.1 Eastern gate building – building and construction details

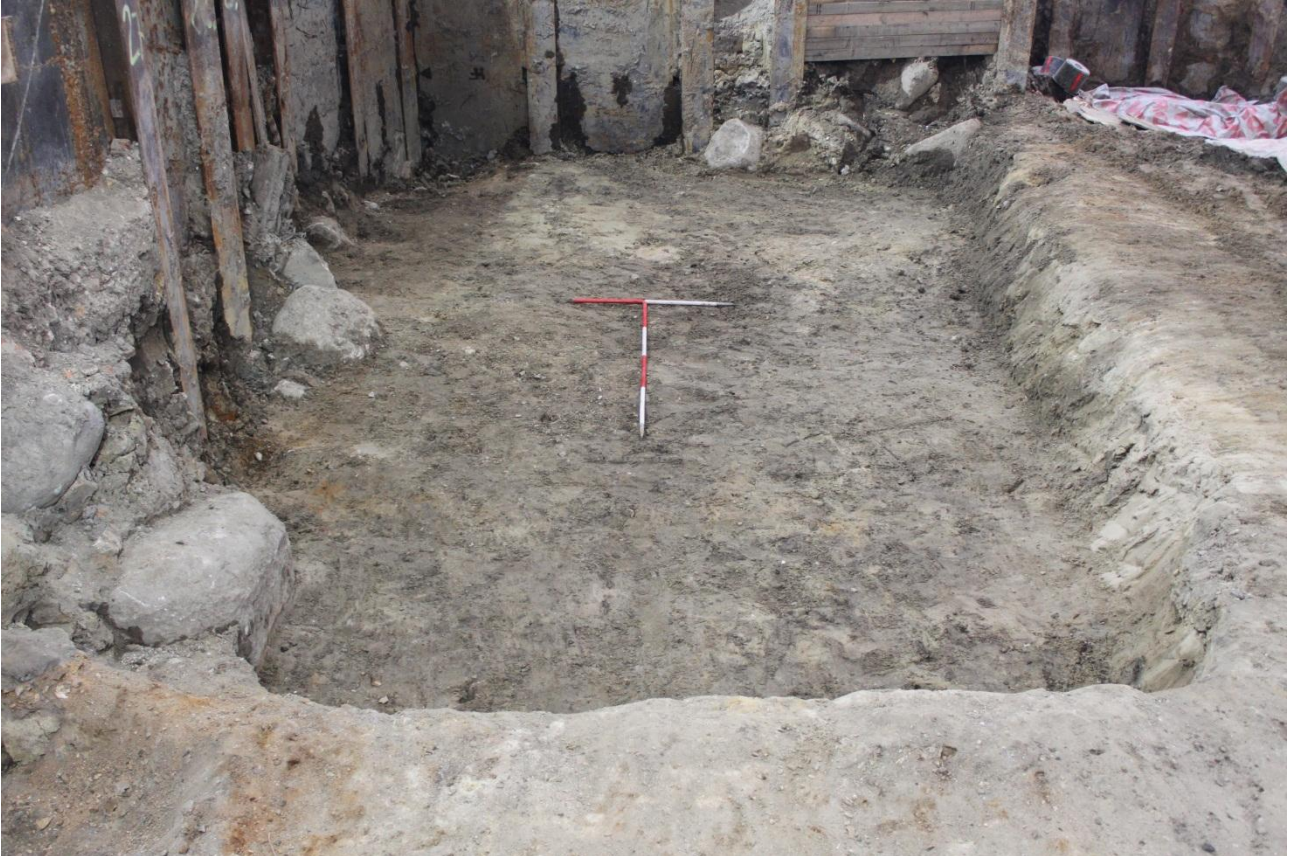
Fig. 99. Post-excavation. Northern construction cut of the gate building without foundation stones, facing east. Photo: Museum of Copenhagen.

The construction cut for the gate building could be followed both in the northern and southern parts of the structure truncating the natural clay and sand. Only half of the northern part of the gate building was investigated where the foundation cut formed four separate L-formed cuts recorded at a distance of 8.4 x 4.4 m. Four cuts surrounded the southern foundation over a total distance of 7.2 x 6.5 x 9.1 m. Both truncations were limited by the excavation area and by the Late medieval moat cut to the west (Fig. 99).

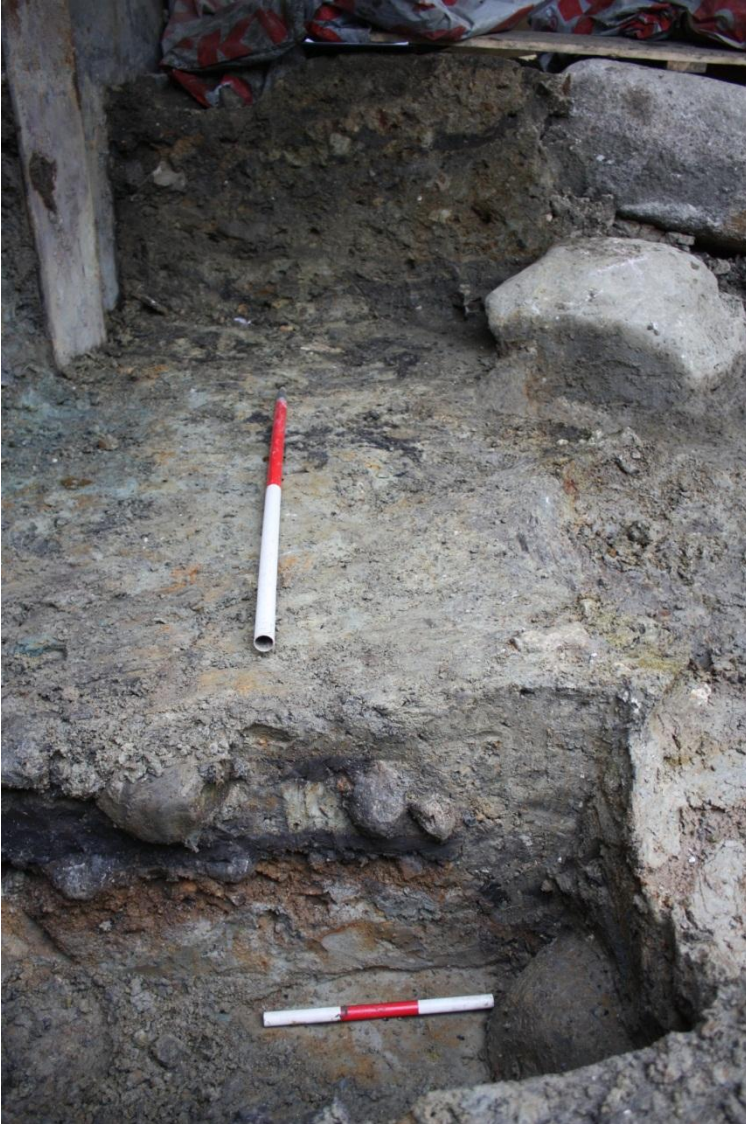
Fig. 100. Close-up photo of construction cut (SC105092) by the southern foundation cutting through darker salt marsh layers, gravelly post-glacial sediments and moraine, facing west. Photo: Museum of Copenhagen.

The cut sides were gradual/straight/steep and the base flat. Depth was 0.5 m at the most. Cuts (SC117039) and (SC117060) were part of a secondary, irregular construction cut, diffuse and only possible to follow in the northern part. A lot of smaller stones were present suggesting that these stones were placed here for some sort of drainage purpose (Fig. 100).

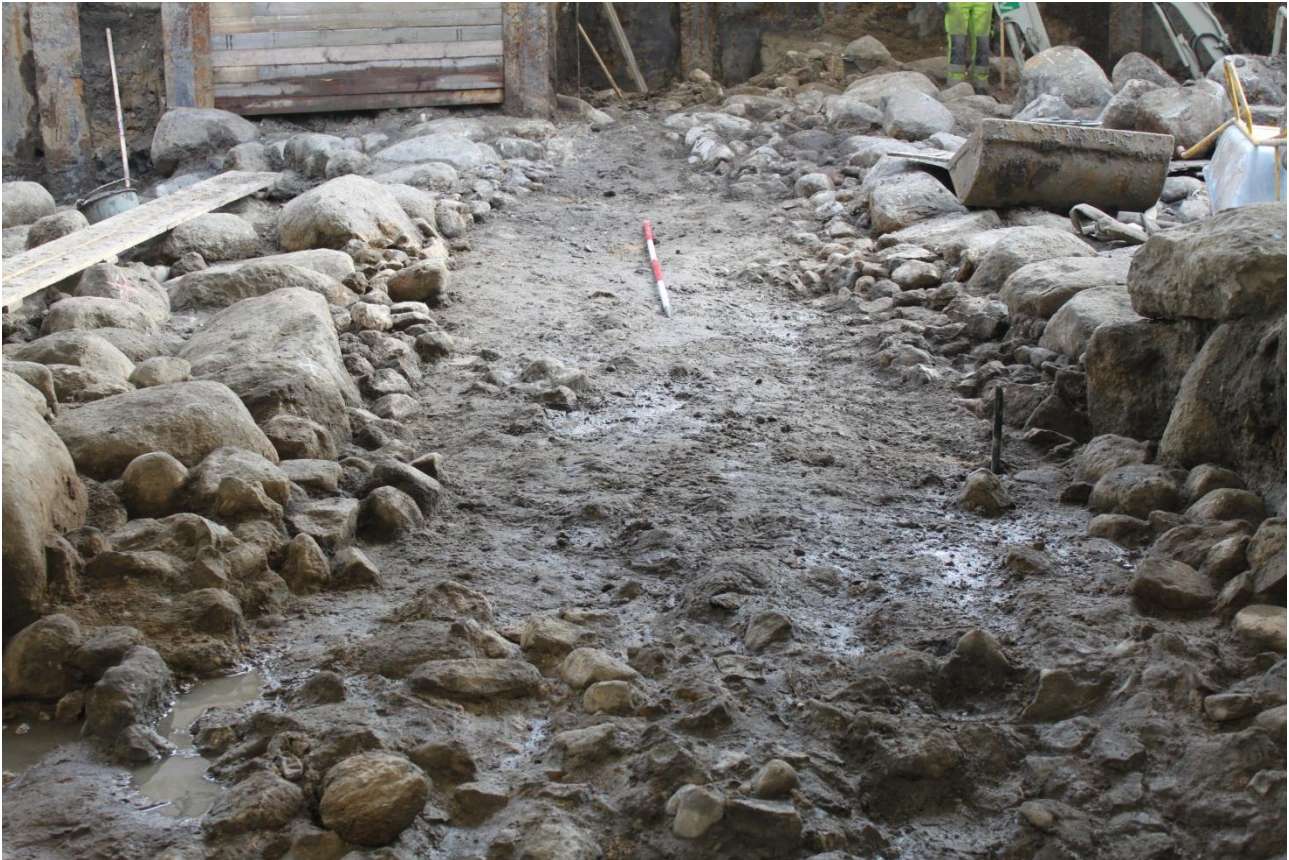
Fig. 101. Backfill and concentration of smaller stones in the construction cut on both sides of the gateway area, facing east. Photo: Museum of Copenhagen.

Stones (SS109482) and (SS111867) consisted of smaller stones within the gateway area extending for a distance of 10.0 m up close to the northern and southern foundation walls. These may have functioned as a stabilizer within the created construction cut and the later backfill (Fig. 101).

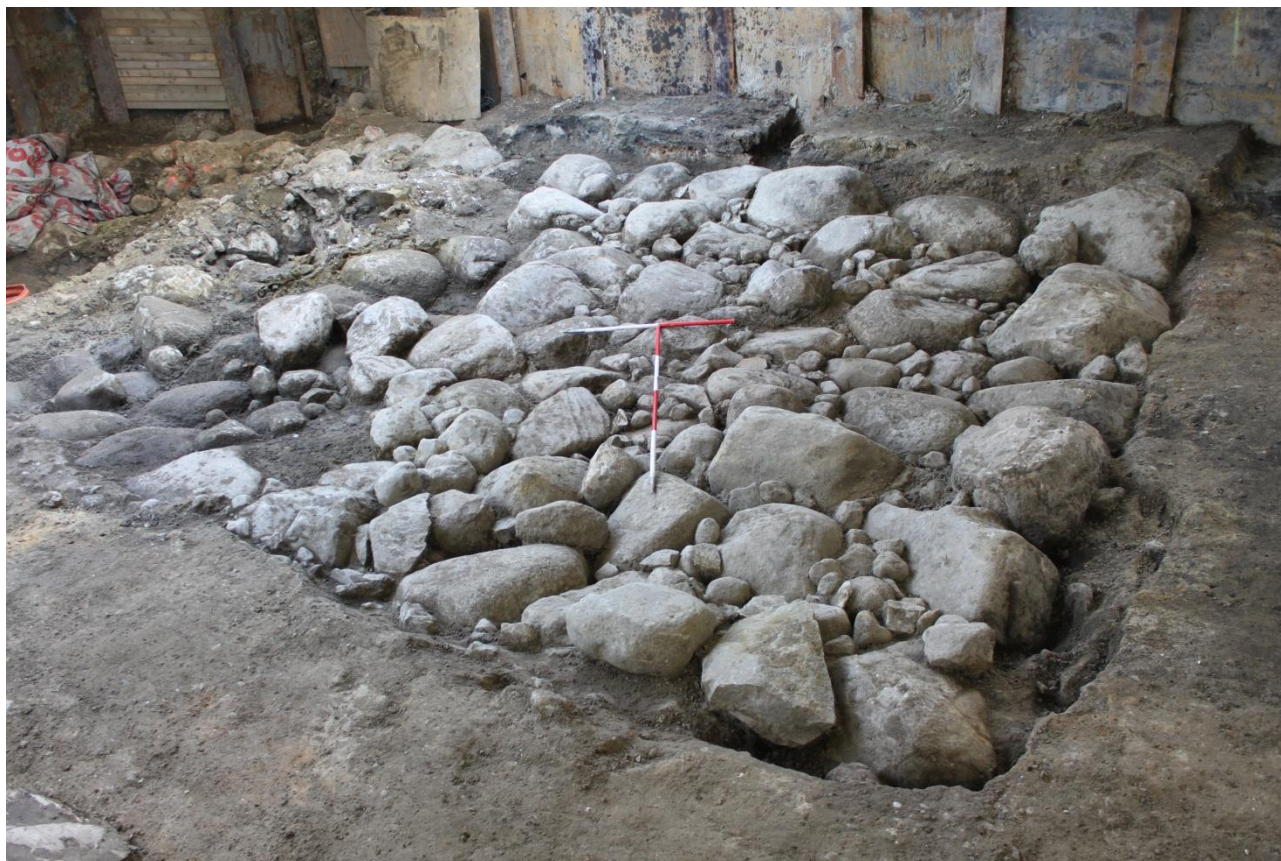
Fig. 102. Southern foundation layer of big boulders and smaller stones (SS130888) dug into natural, facing SE. Photo: Museum of Copenhagen.

The main foundation to the gate building consisted of a dry stone structure comprising of light and mid grey unfinished stones and boulders (Fig. 102). The dimensions varied – the main foundation stones and the outer skin of stones in the foundation had an average of 0.50-1.50 m in diameter, the packing consisted of smaller fill stones with an average of 0.05-0.40 m in diameter. In between, the fill consisted of firm, yellow-brown clay, silt and sand together with smaller stones.

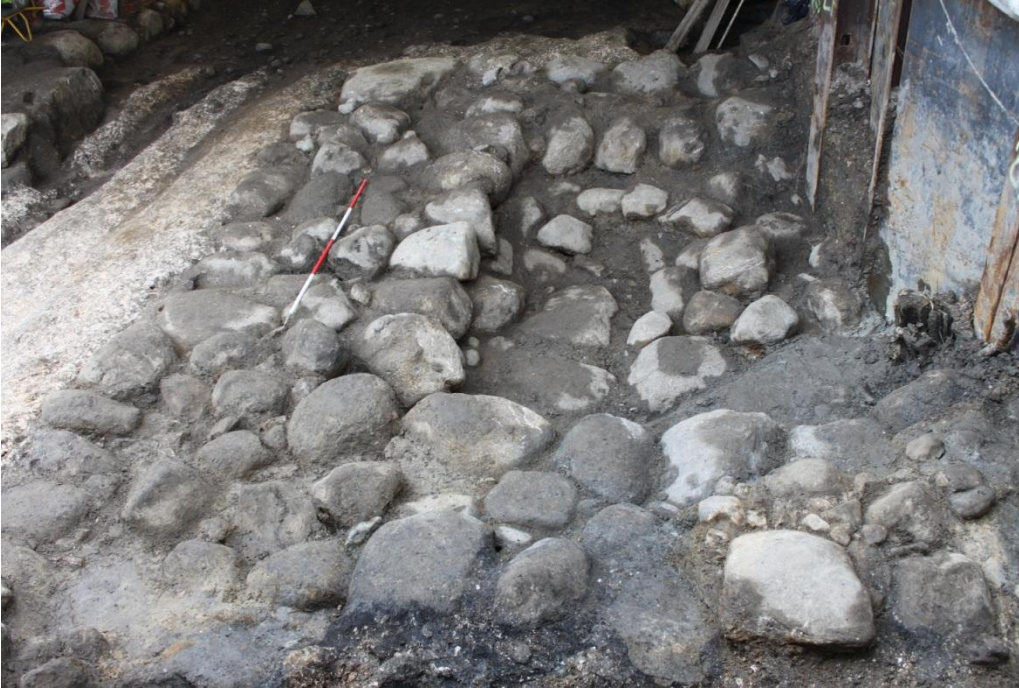
Fig. 103. The NW room (SS107580) in the gate building, facing west. In the foreground – part of the partition wall. Photo: Museum of Copenhagen.

The natural boulders had been carefully placed in relation to each other where flat side(s) were placed out- or upwards, either to achieve a smooth surface or to facilitate the work with the next layer of stones. After placement, the remaining gap was filled with stones and compact light white-yellow mortar and firm brown-grey sand and clay with inclusions of charcoal, pebbles, small stones and red brick fragments. The foundation material between the stones and boulders within the separated rooms consisted of compact and hard silty clay and sand of different colours and inclusions of charcoal, CBM, pebbles and stones. Nothing implies that the upper and exposed stone walls had been plastered, etc. (Fig. 103-105).

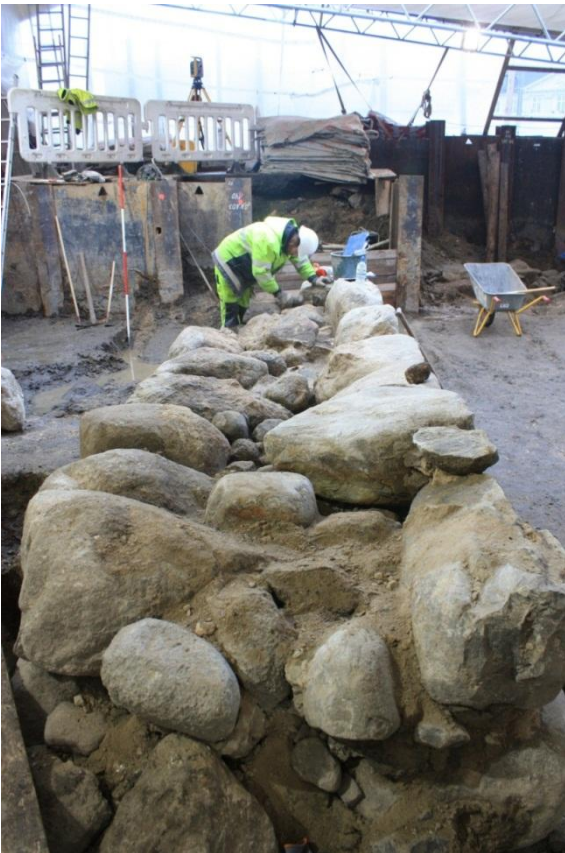
Fig. 104. Investigating the double faced wall in the northern part of the building with infill of mortar and stones, facing east. Photo: Museum of Copenhagen.

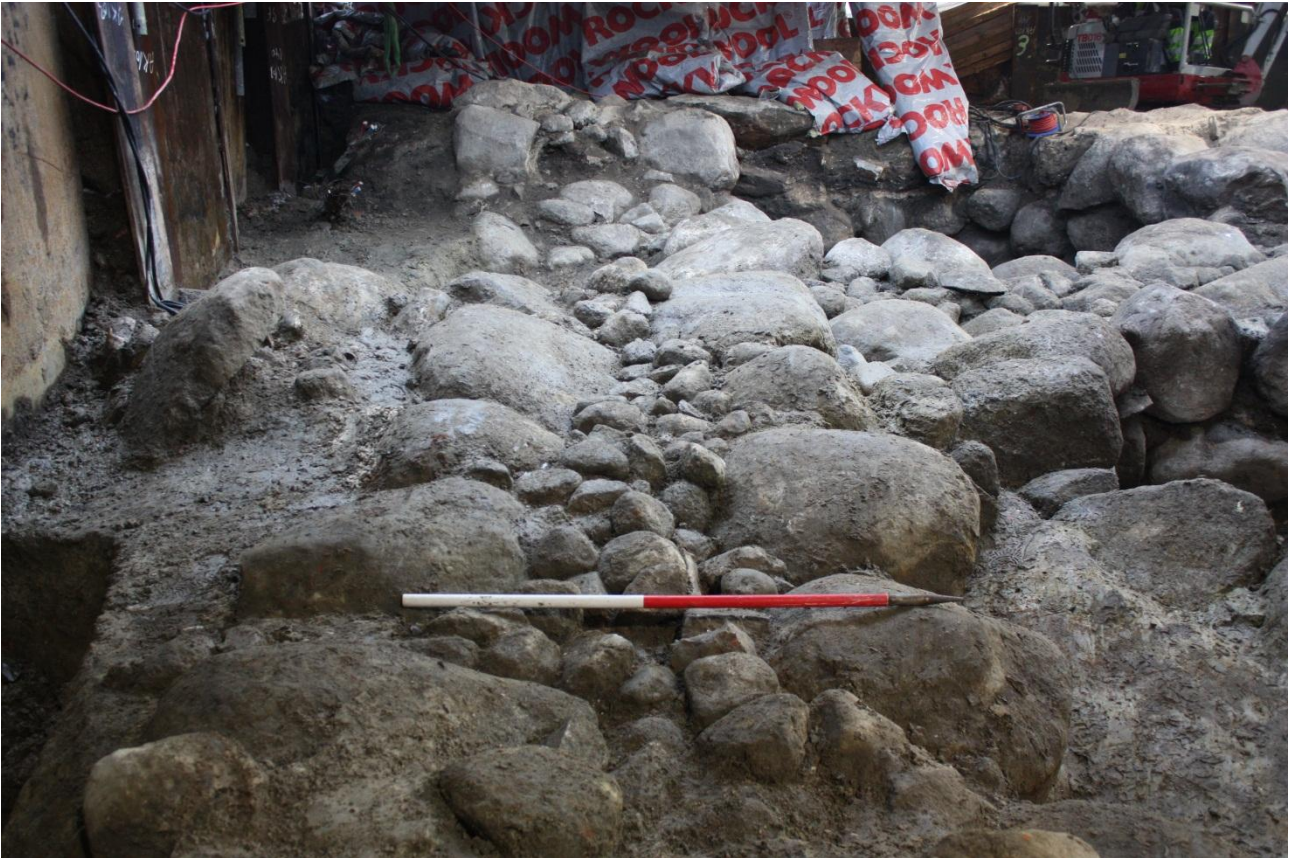
Fig. 105. Construction detail. The southernmost and double faced wall (SS108559) with packing material of smaller stones, facing west. Photo: Museum of Copenhagen.

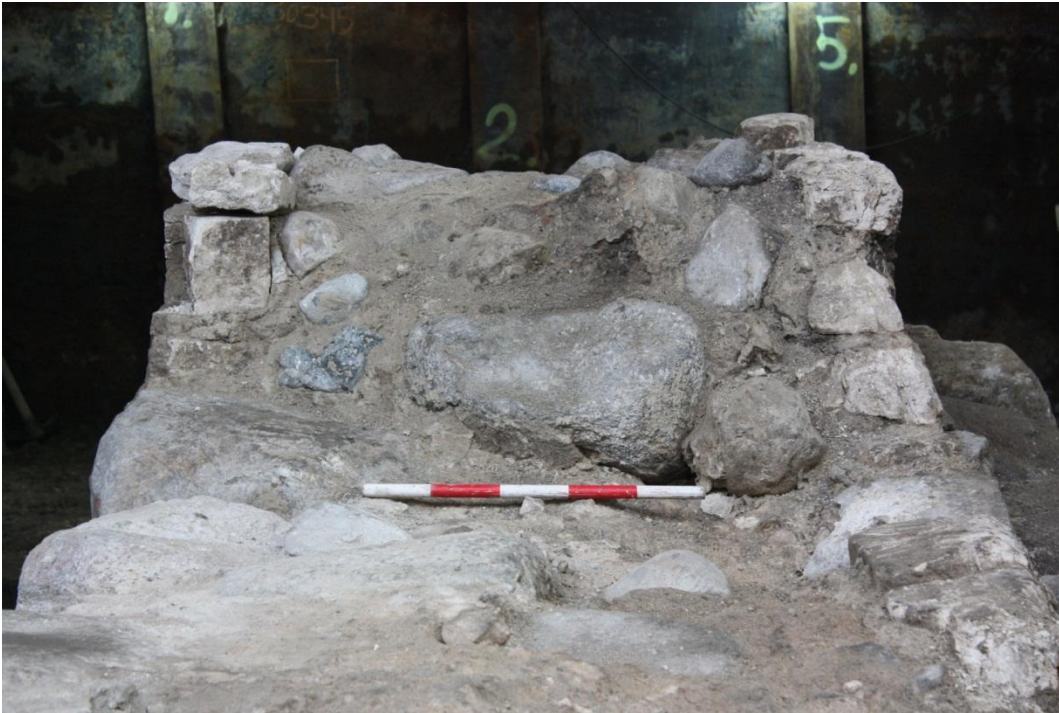
Fig. 106. Cut through the NW gateway showing the two faces of ashlar stones and core consisting of smaller and bigger stones with mortar, facing west. Photo: Museum of Copenhagen.

Context (SS45722) consisted of two lengths of a limestone wall of blocks on top of the northern foundation wall in the gateway area. The length was 0.9 m and 2.4 m respectively (Fig. 106). Despite the fact that only a minor part of the structure was recorded, this sequence of limestones had probably existed on both sides of the gateway in connection with the top section of the foundations.

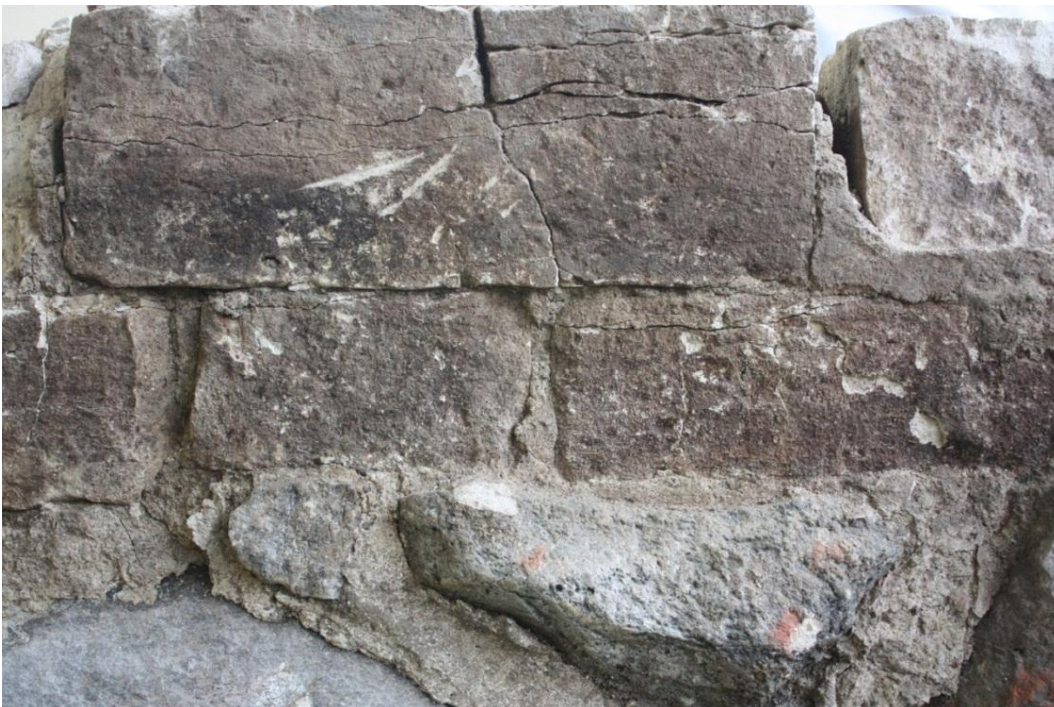
Fig. 107. Detail. Close-up photo of limestones (SS45722), facing north. Photo: Museum of Copenhagen.

The largest limestone block was 0.45 x 0.18 x 0.21 m and the smallest 0.21 x 0.11 x 0.20 m (Fig. 107). The pointing was very varied in thickness – from approximately 0.025 m to 0.010 m. The limestones were in some cases tapered at the back. At the northwest corner of the ashlar structure there was one stone that formed a corner with a wall going in a north-south direction keyed into this part of the wall.

Fig. 137. Limestone ashlars in Absalon's Castle under Christiansborg. Compare with the limestone blocks in the eastern gate building; figure 107. Photo: Morten Steineke.

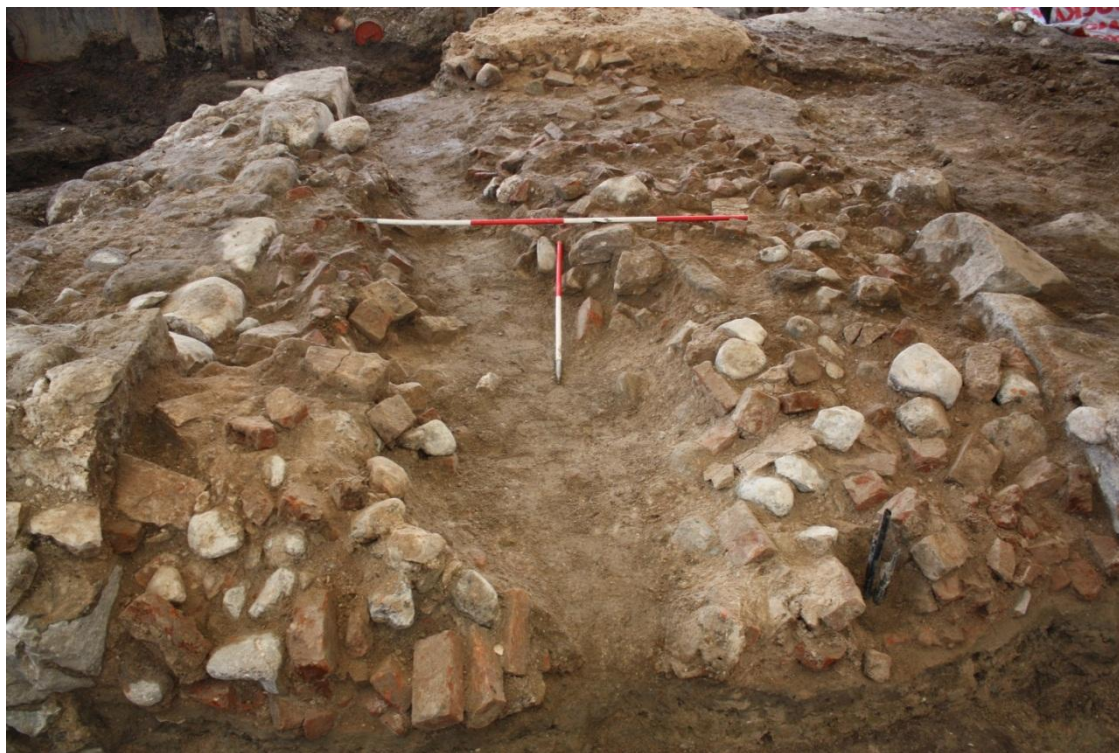
Fig. 108. Demolition material (SD31044) consisting of red bricks, stones, limestone and mortar in the gateway area, facing east. In the middle traces of a modern pipe line cut (SM30245). The truncation in the middle represents a modern disturbance. Photo: Museum of Copenhagen.

The demolition material consisted of mortar and light and mid white, brown, grey and yellow sandy silt and clay with mixed inclusions of charcoal, ash, shell, pebbles, stones and fragments of lime- and “munkesten” (Fig. 108). The cuts were remains of stone imprints and interpreted as robber cuts of different size and depth (for more about the robber cuts; see Chapter 18).

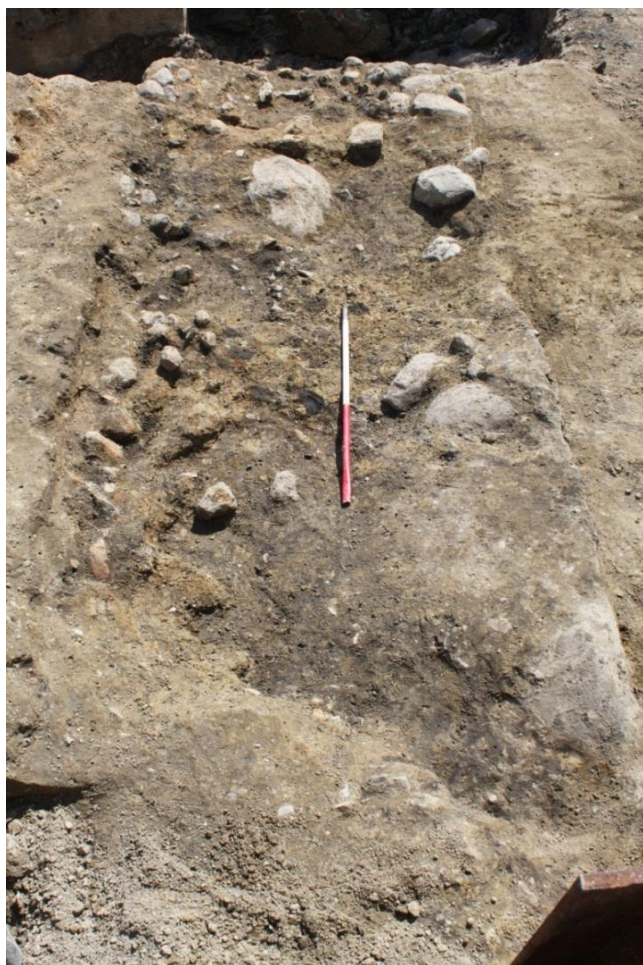
Fig. 109. Foundation layer (SD88059) in connection with the eastern gate building, facing south. Photo: Museum of Copenhagen.

The feature consisted of a very diffuse north-south orientated layer (5.50 x 1.90 x 0.20 m) with a base of greyish sand, big chunks of yellow clay and several stones of different sizes (Fig. 109). The largest stones were 0.86 x 0.47 x 0.15 m, but there was a great variety in sizes – from larger to smaller stones and rubble. Approximately 55 stones were recorded. Yellow lumps of clay indicated traces of removed stones beside the ones surveyed.

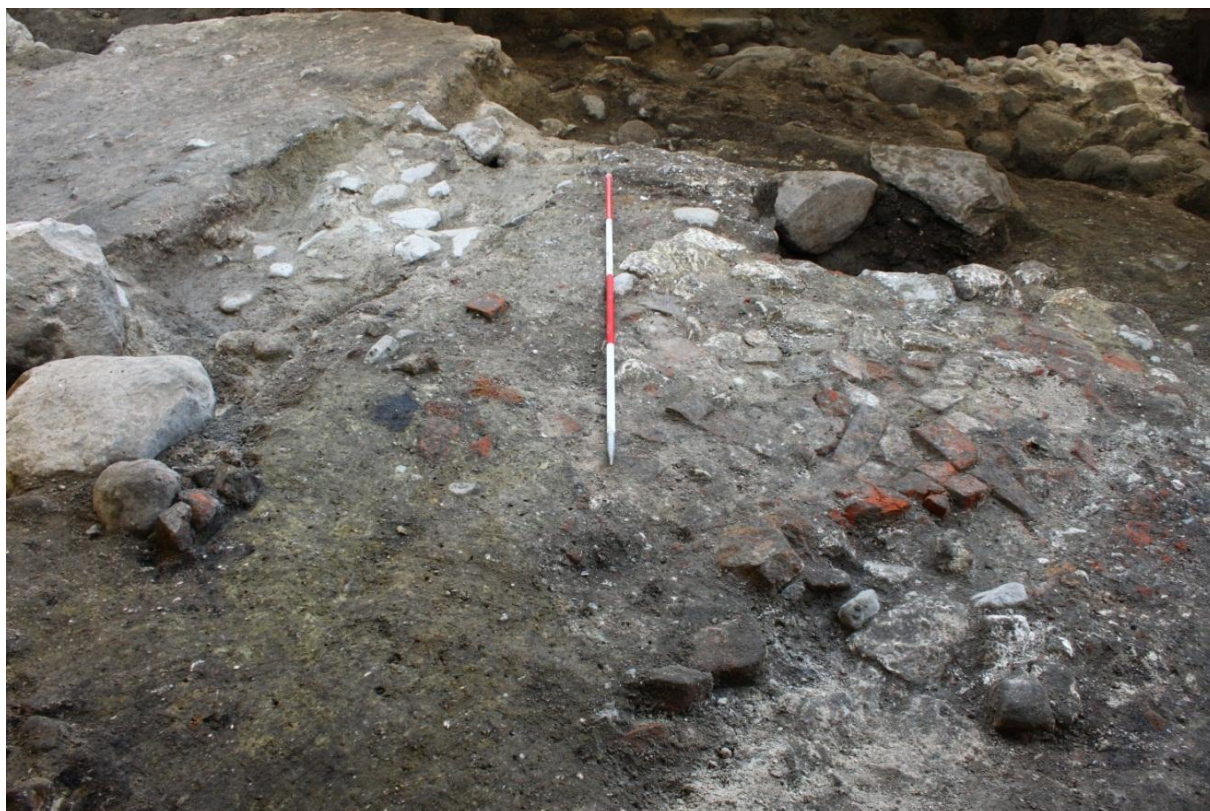
Fig. 110. Part of brick and limestone floor in connection with the well, facing NE. Photo: Museum of Copenhagen.

In the SE room of the building a clay floor was recorded in association with and partly overlying the well, together with foundation layers of mortar with inclusions of pebbles, charcoal and CBM underneath an irregular brick built pavement (SG-265 and SG-500967) (Fig. 110). The irregular brick pavement (2.5 x 4.5 m), laid to provide a dry surface close to the well, consisted of various bricks and large brick fragments (“munkesten”) mixed with worked limestones.

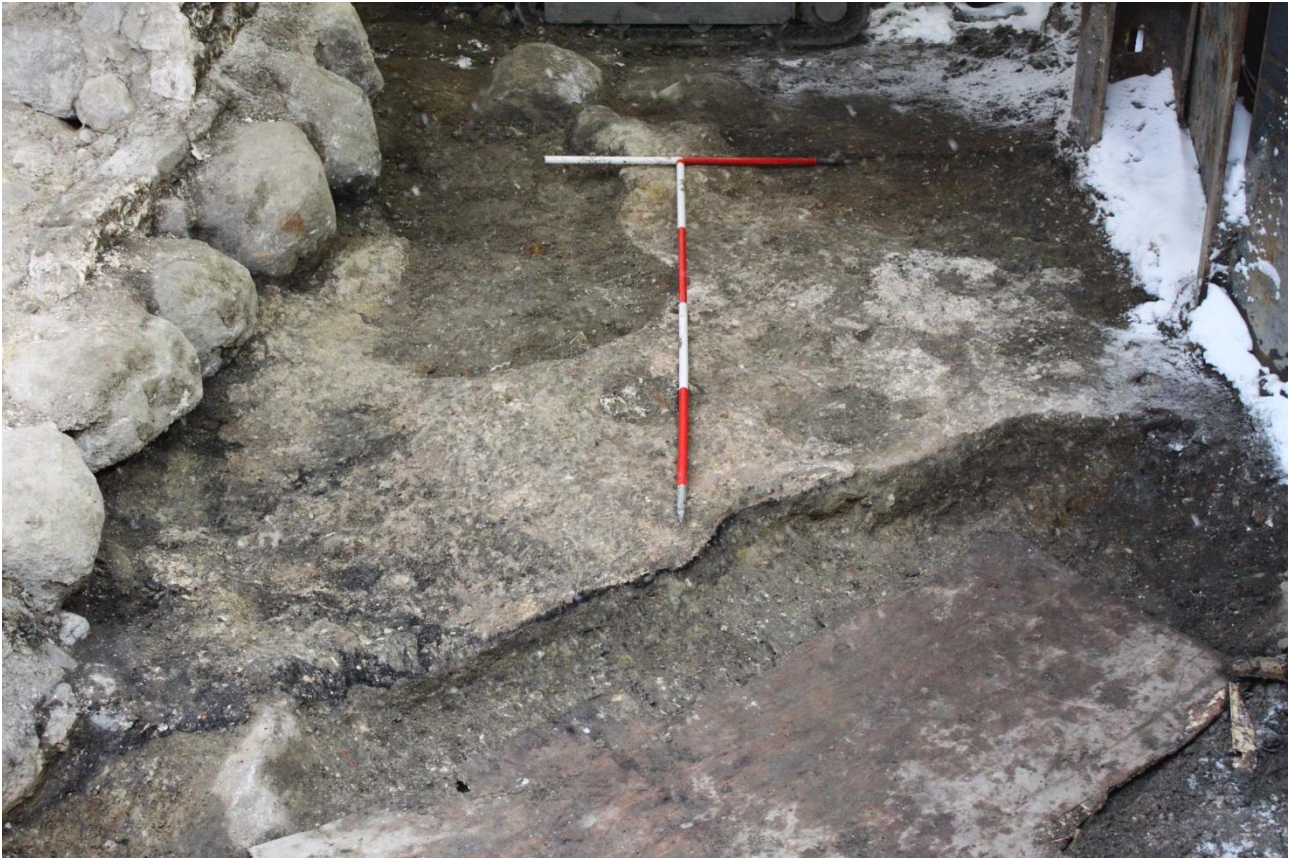
Fig. 111. Part of foundation layer (SD34228) north of the foundation wall, facing west. In front – truncation by a 19th century wooden water pipe not yet exposed. Photo: Museum of Copenhagen.

The foundation and levelling layers consisted of mixed and mottled make-up material of different colour, composition and homogeneity, with inclusions of ash, charcoal, bone, red brick fragments, lime fragments, mortar, wood, peat (salt marshes (?)), pebbles and stones (Fig. 111). The deposits represent mainly construction waste overlying and abutting the foundation stones within the building.

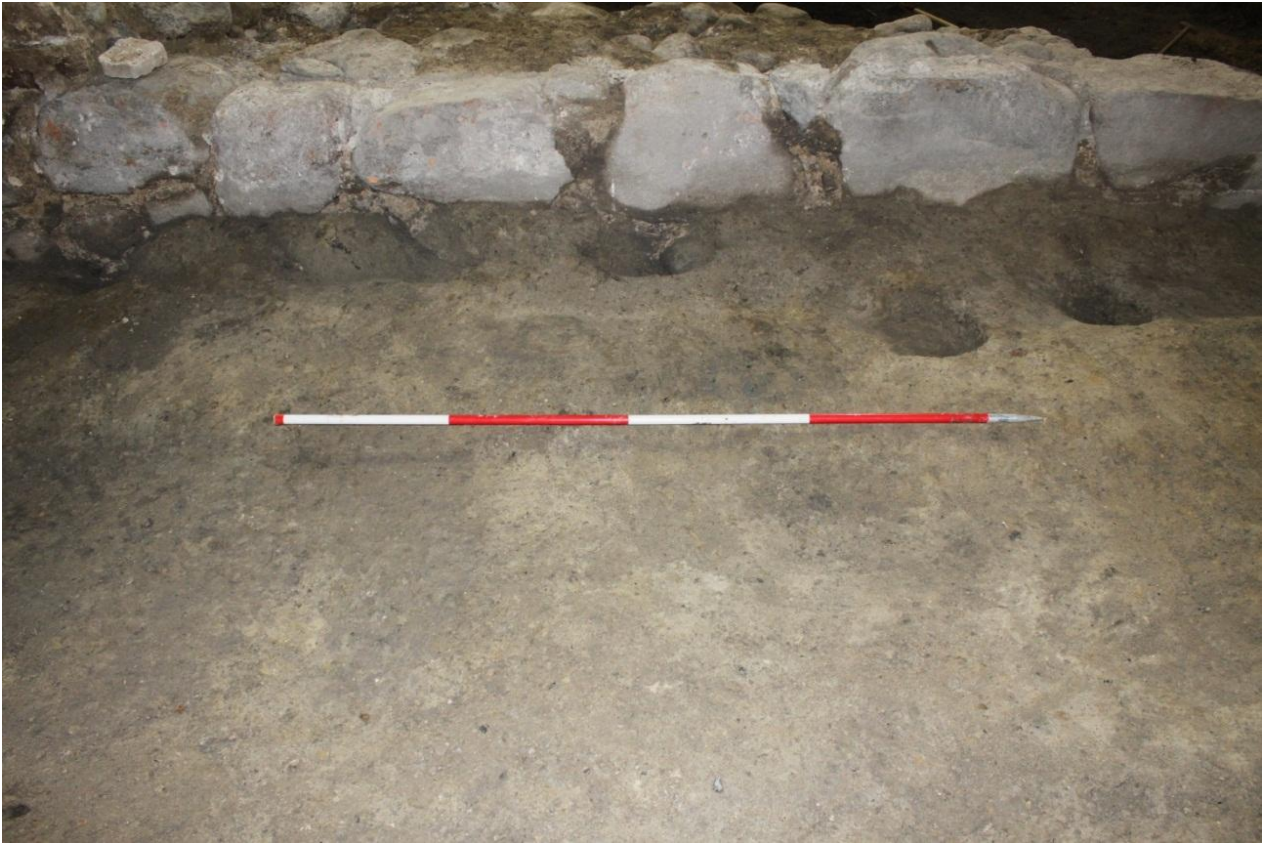
Fig. 113. Post-excavation. Cuts (SC35347) – row of interpreted scaffolding holes within the gateway area, facing north. Photo: Museum of Copenhagen.

In conjunction with the gate building 17 postholes were documented (Fig. 112). Six of these were located close to the northern gateway wall and must be considered as remnants of a scaffold during subsequent work on the gate as these postholes cut through older road surfaces (SD35220) (Fig. 113). This maintenance work cannot be more closely dated than between 1400–1550 AD (see further discussion about this below). In the building's NE part there were three rows of postholes – one running N-S and two running in an EW direction.

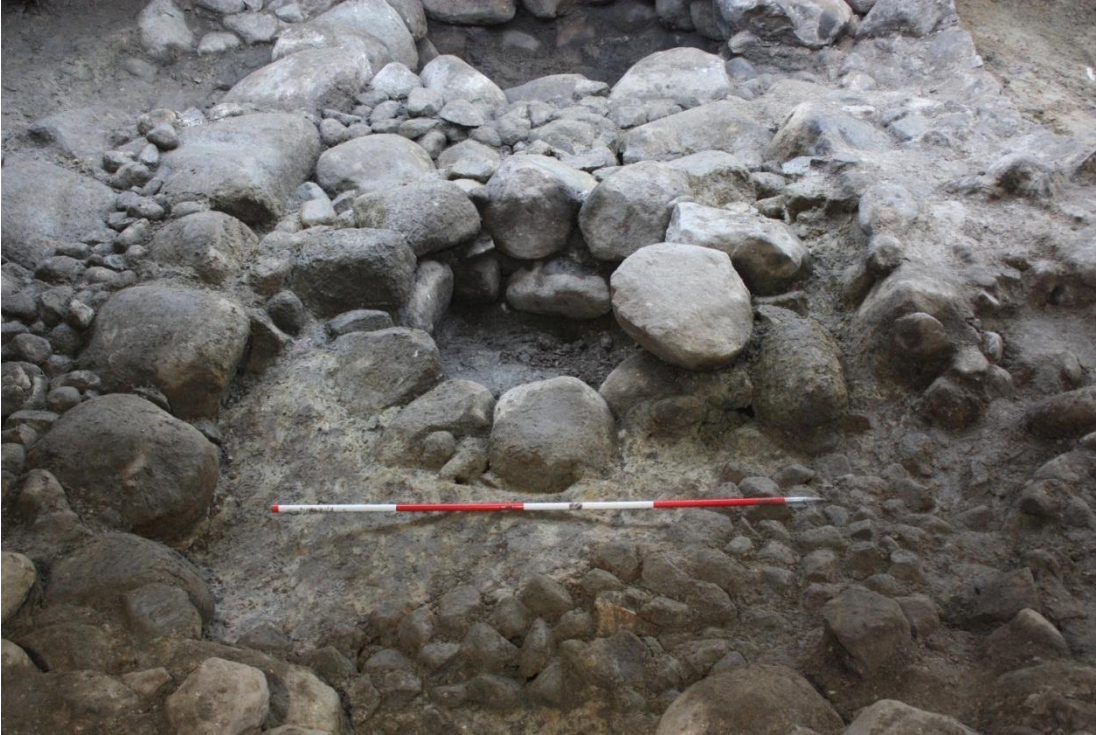
Fig. 114. Top of well case and surrounding packing material, facing west. Photo: Museum of Copenhagen.

In the SE room of the building a well was recorded. This consisted of a circular dry stone structure, approximately 2.5 m in diameter (Fig. 98 and 114). Depth is unknown since the last stones were removed by machine due to time pressure and inflow of ground water, and therefore the bottom was not fully investigated. This should though have been around 4.0 m at the most.

The stones in the well case consisted of a total of seven courses of mid grey, uneven granite stones, with the exception of (SS32959) at the top, consisting of a line of three squared, well finished chalk blocks (Fig. 114). Construction details show that the stones had been gradually built up together with surrounding clay deposits to keep the well tightly sealed. The stones were placed with flat side inwards. Bigger stones were documented at the top, more squared, shaped stones further down in the underlying courses.

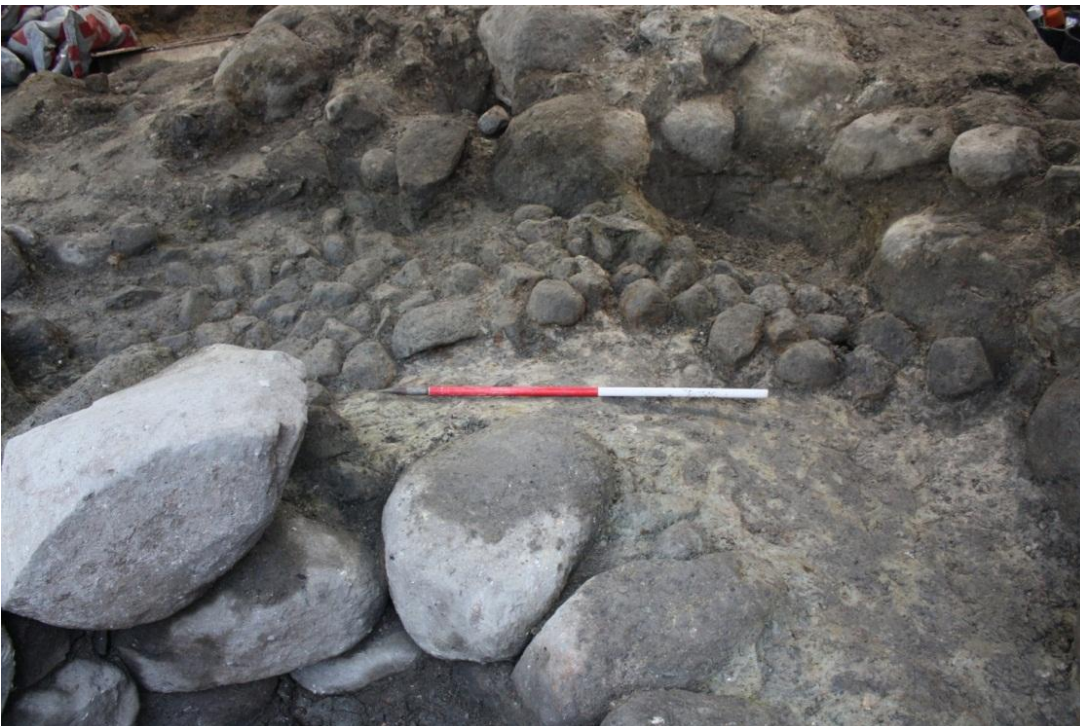
Fig. 115. Packing material of clay and smaller stones, facing E-NE. Photo: Museum of Copenhagen.

The packing material consisted of rubble and smaller stones placed around and butting the larger stones in the well case (SS37290). This was then sealed with bonding material of firm, light and mid yellowish green and grey clay with inclusions of CBM, mortar and bones (SD35476) (Fig. 115).

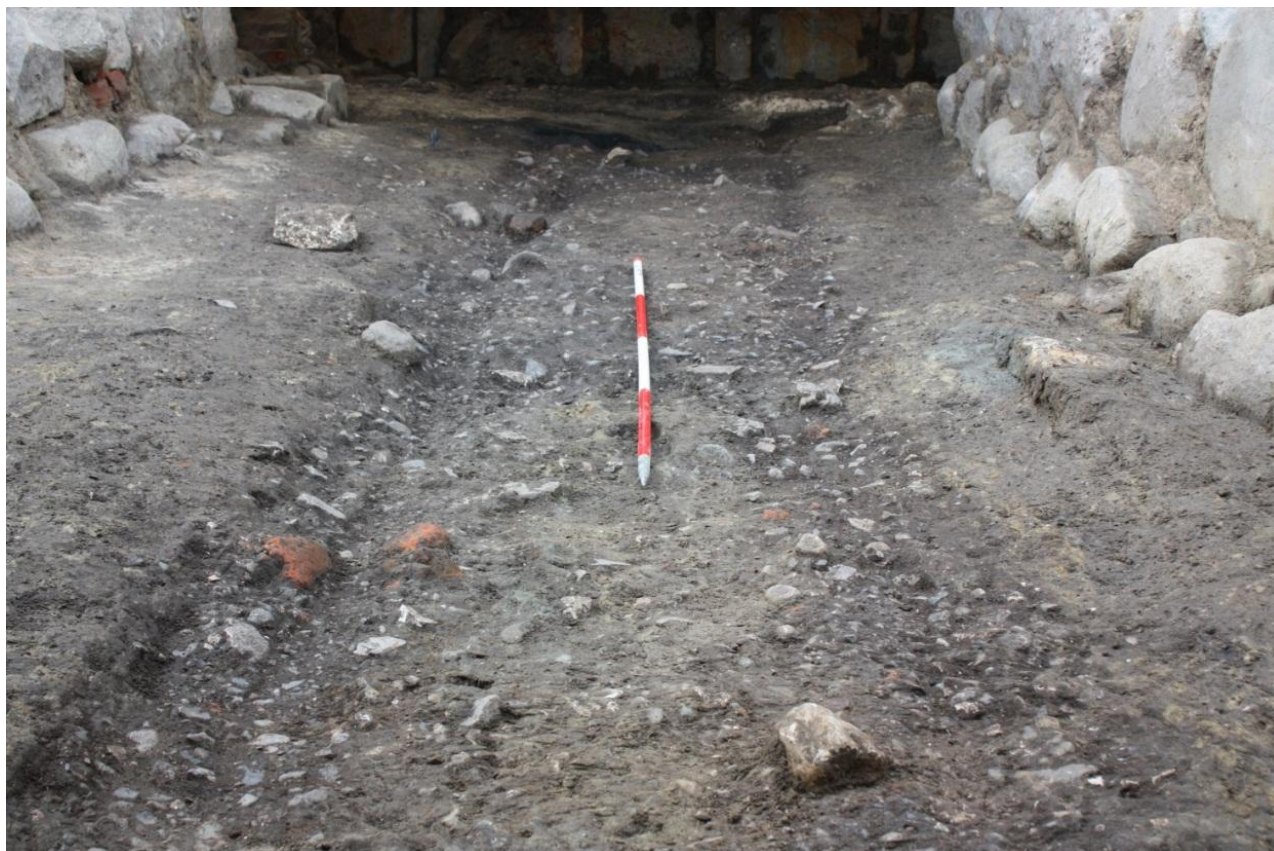
Fig. 116. Road surface (SD42684) with wheel ruts, facing west. Photo: Museum of Copenhagen.

The road surface consisted of brown-grey silty sand and clay with inclusions of soot, charcoal, red brick fragments, pebbles and stones. Some of the deposits had a high content of decomposed organic material and still contained pieces of twig and straw. The average stone fragment size was 2.0-3.0 cm in diameter where in some places the surface had sunk into (or filled) the wheel ruts (Fig. 116).

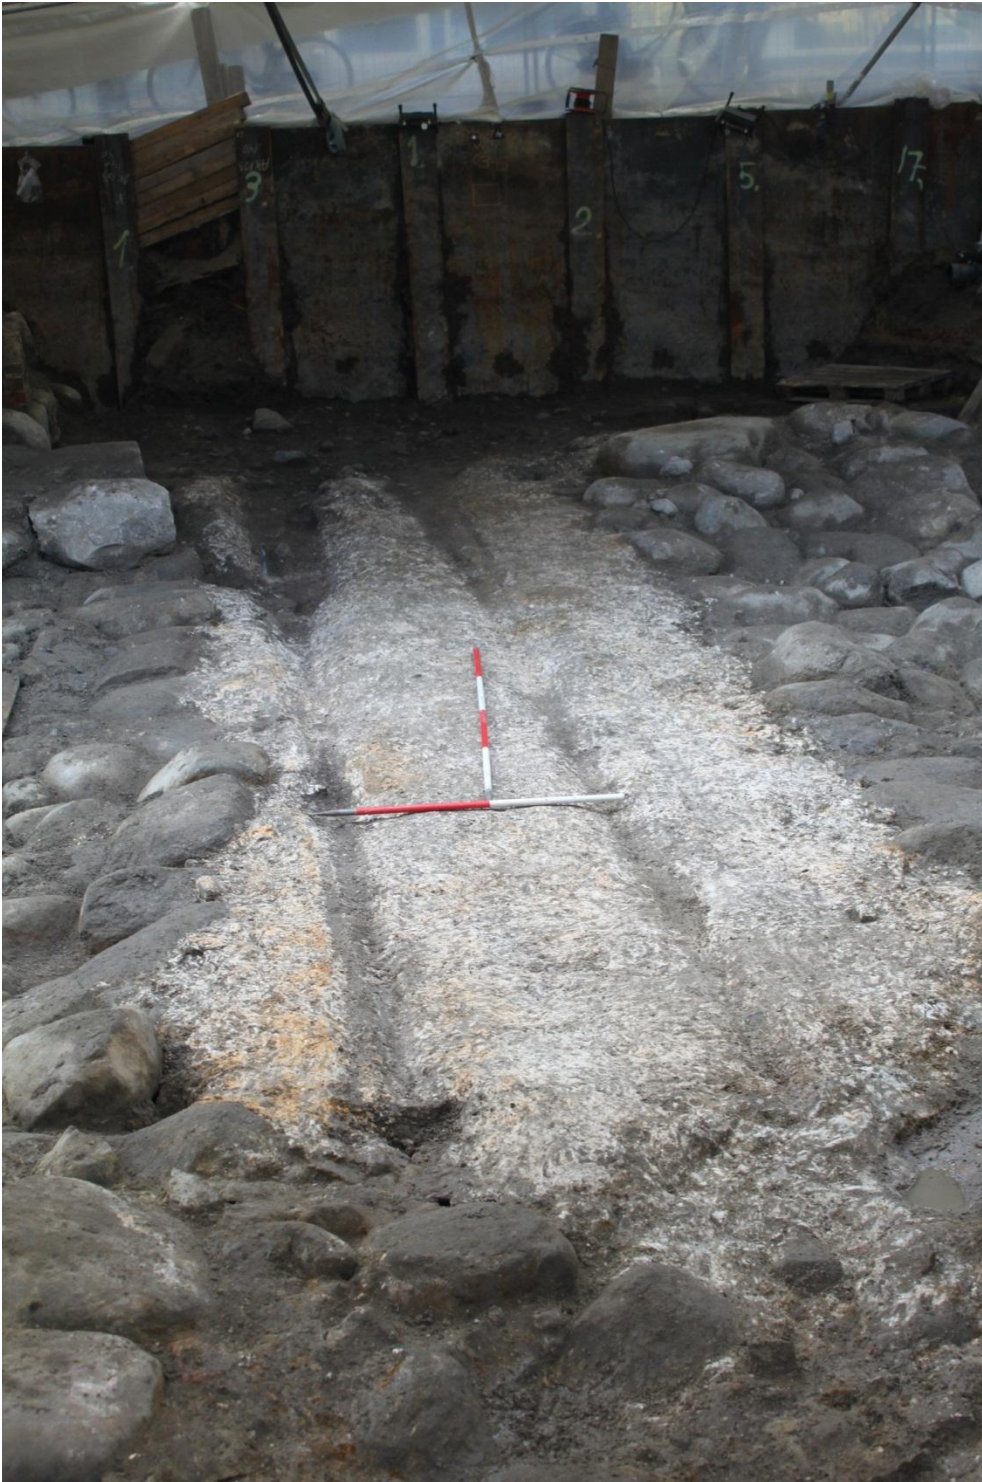
Fig. 117. Road surface (SD105986) with wheel ruts, facing west. Note how the mortar layer overlaps the foundation stones in the wall. Photo: Museum of Copenhagen.

Different wheel ruts were recorded within the gateway area and in the area west of the gate building at a length of c. 13.4 m (Fig. 98). With the exception of (SD117076) represented by four imprints in the direction of the current Østergade and two running in a NE-SW direction, all wheel ruts had an east-west orientation.

The sides of the ruts were irregular/gentle and the depressions had a concave and irregular base. The deepest parts of the ruts were 0.08-0.20 m wide and the maximum depth varied from 0.04 m to 0.18 m. The ruts became much deeper and wider just at the western end of the gate, where they were about 0.15 m deep and 0.60 m wide. The width and

depth indicates heavy loads and wear which had necessitated the subsequent maintenance work filling the depressions with smaller stones and pebbles. The cart wheel spacing varied from 0.9-1.1 m and shows that the spacing had not changed during the time the gate building was in use. In places, it seemed like there were identifiable hoof marks from horses (Fig. 117).

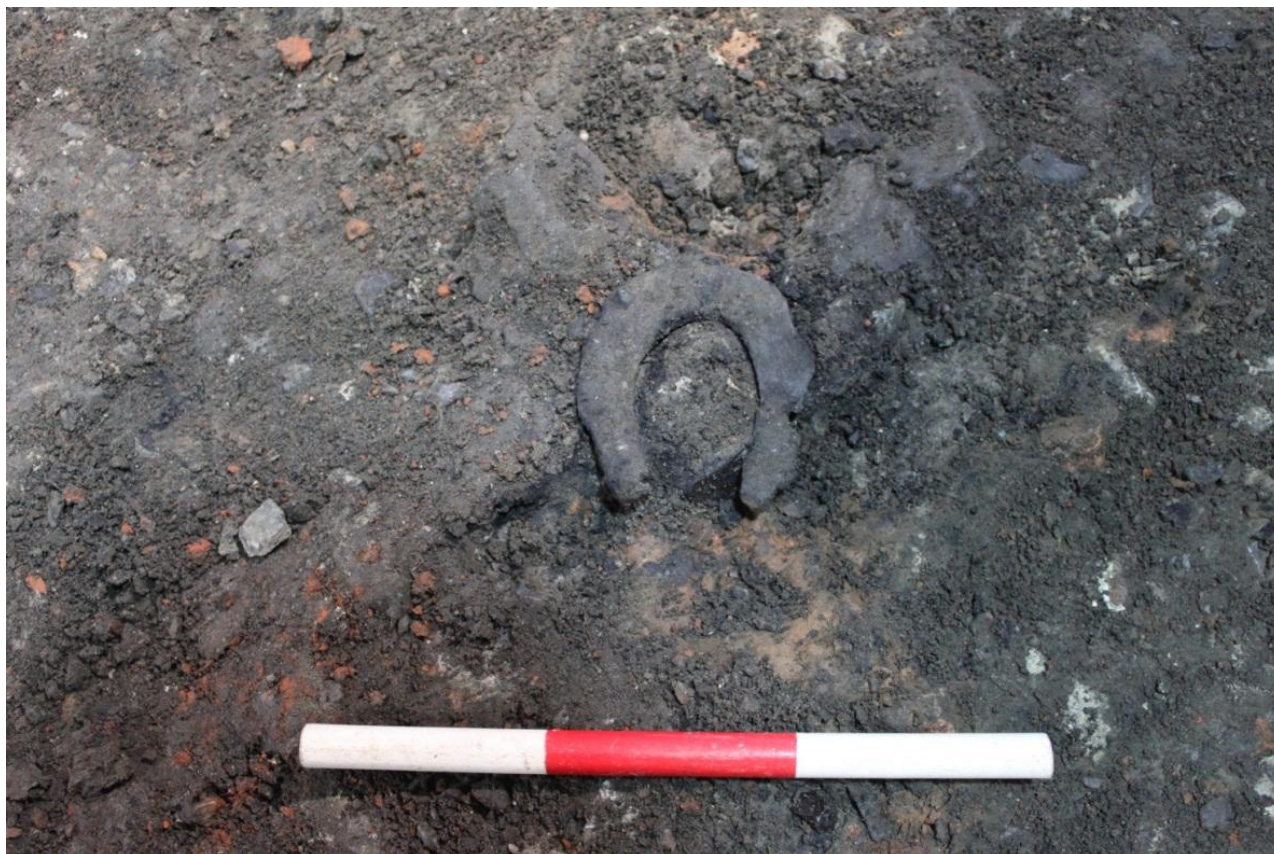
Fig. 118. Horseshoe (FO206684) in situ from above. Photo: Museum of Copenhagen.

No datable material was collected from the foundation layers (roof tiles, part of a button, an iron nail, a flint blade and bones), but finds from the different road surfaces consisted of ceramics (Early redware; 1200–1400 AD and Late greyware: 1200–1400 AD) and an iron horseshoe (FO206684; Fig. 118) from one of the oldest road surfaces was dated to between 1150–1350 AD and most likely between 1200 and 1270 AD (cf. Clark 1995:95-96). Horseshoe (FO206844) was registered as iron waste, but looking at the images this clearly represents a horseshoe, perhaps of the same type as FO206684.

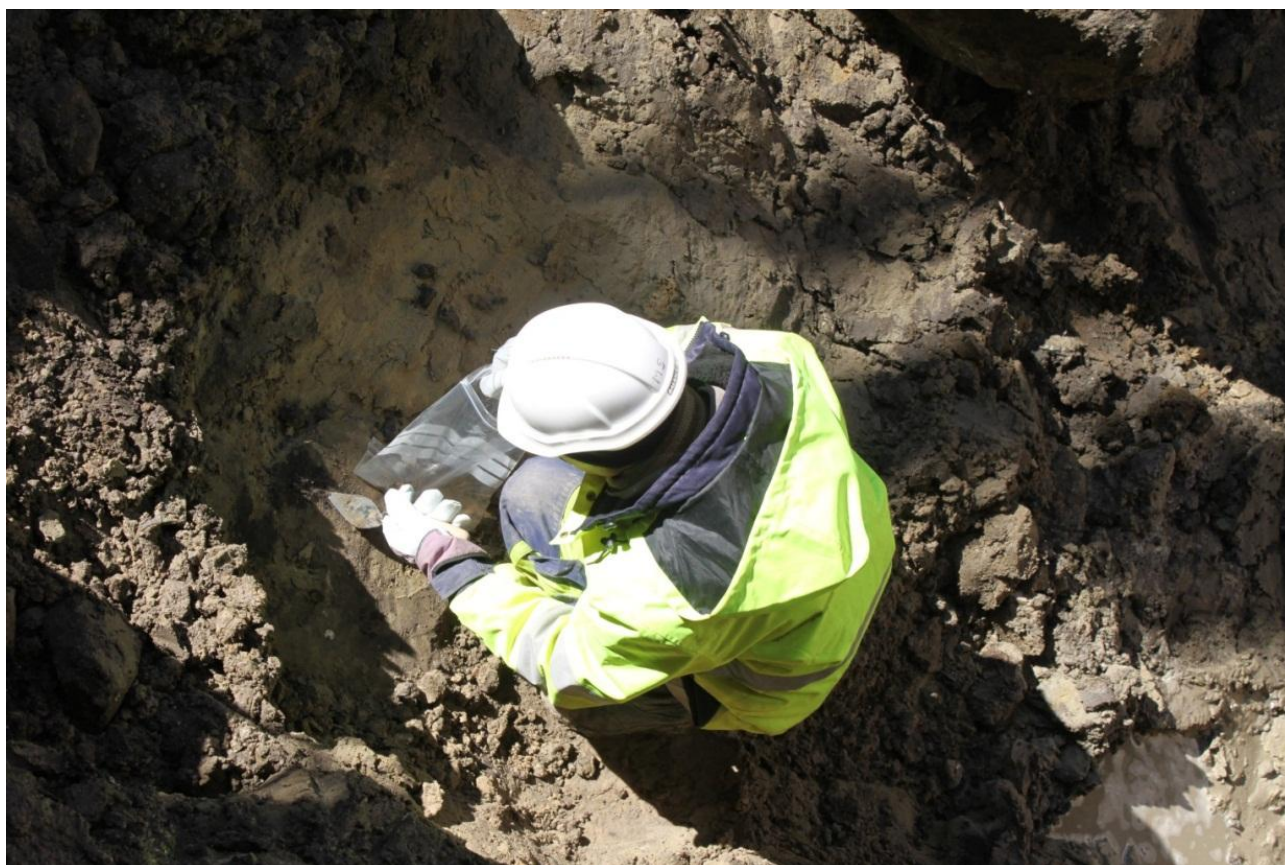
Fig. 119. Imprints in natural after removing (SS123571). Sampling for C14-analysis. Photo: Museum of Copenhagen.

Two AMS-samples collected under foundation stones (SS123571) consisted of mixed seeds and common knotgrass. The first sample represented older seeds on site and did not relate to the construction phase. The same can to a certain part be said for the other sample which dates the structure to the mid 12th century (Tab. 30).

Lab. No.	¹⁴ C year BP	Cal. 1 σ	Cal. 2 σ	Context No.	Negligible own age	Material
LuS 11354	4500±35	3340–3100 BC	3360–3025 BC	SD123571	Y<1	Unidentified mixed seeds
Lus 11355	860±40	1055–1240 AD	1040–1260 AD	SD123571	Y<1	Common knotgrass, <i>Polygonum aviculare</i>
