15 Phase 4c Eastern gate building 1200–1600 AD

15.1.1 Eastern gate building – building and construction details

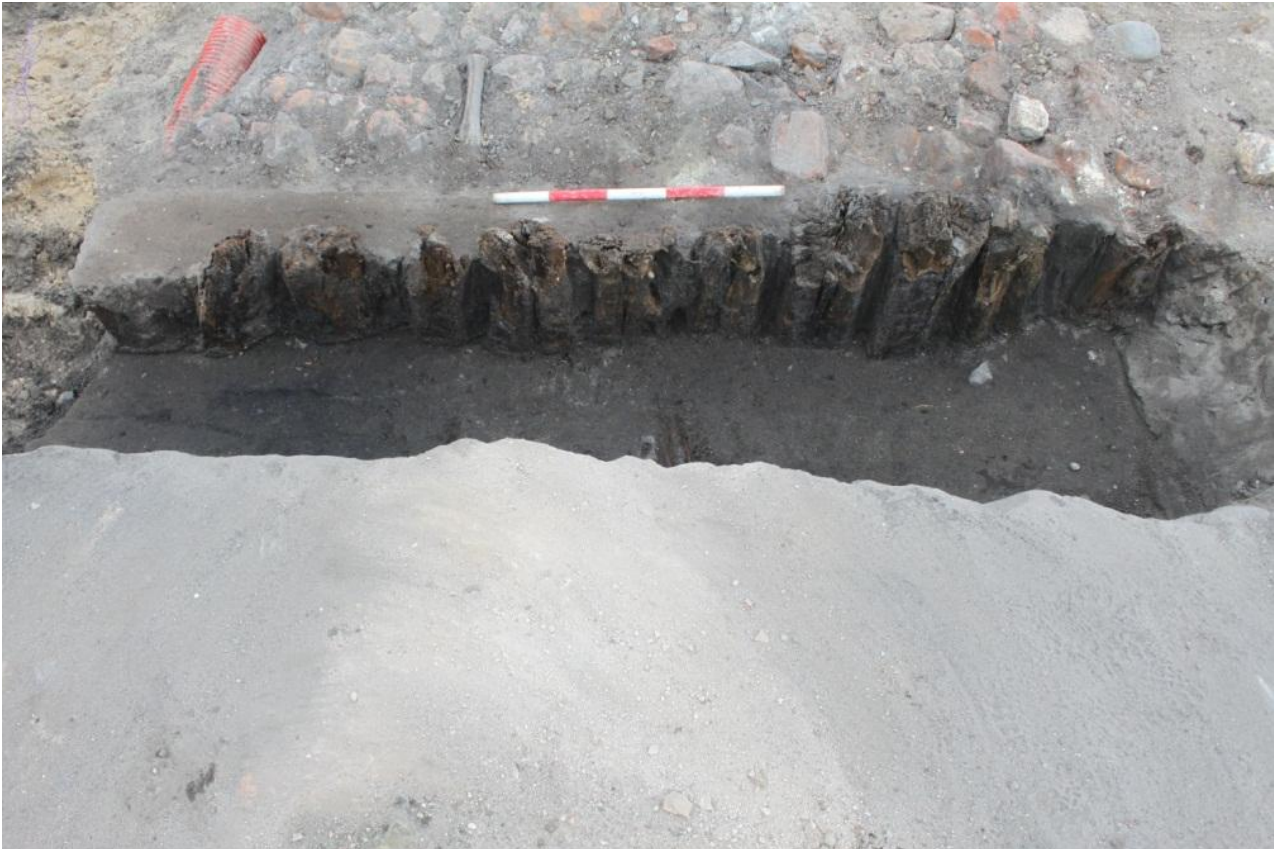
Fig. 121. Partly exposed row of timber posts (ST175883-ST175964) in a created test trench, facing NW. Photo: Museum of Copenhagen.

Two rows of standing timber and postholes were documented east of the gate building. Structure (G-815) consisted of a row of vertically set timber posts running in a NE-SW direction, partly truncated by the central heating trench and not fully exposed due to the excavation limit in 2012. The other row of posts (G-829) was recorded 6.0 m to the north and represented a NE-SW post line consisting of 20 postholes (Fig. 120). Despite the stratigraphical relation being unclear, and the height difference is as much as 0.9 m (kote = +1.8 m and +2.7 m), the spatial location and direction argue respectively that the structure is connected in some way to the road surfaces.

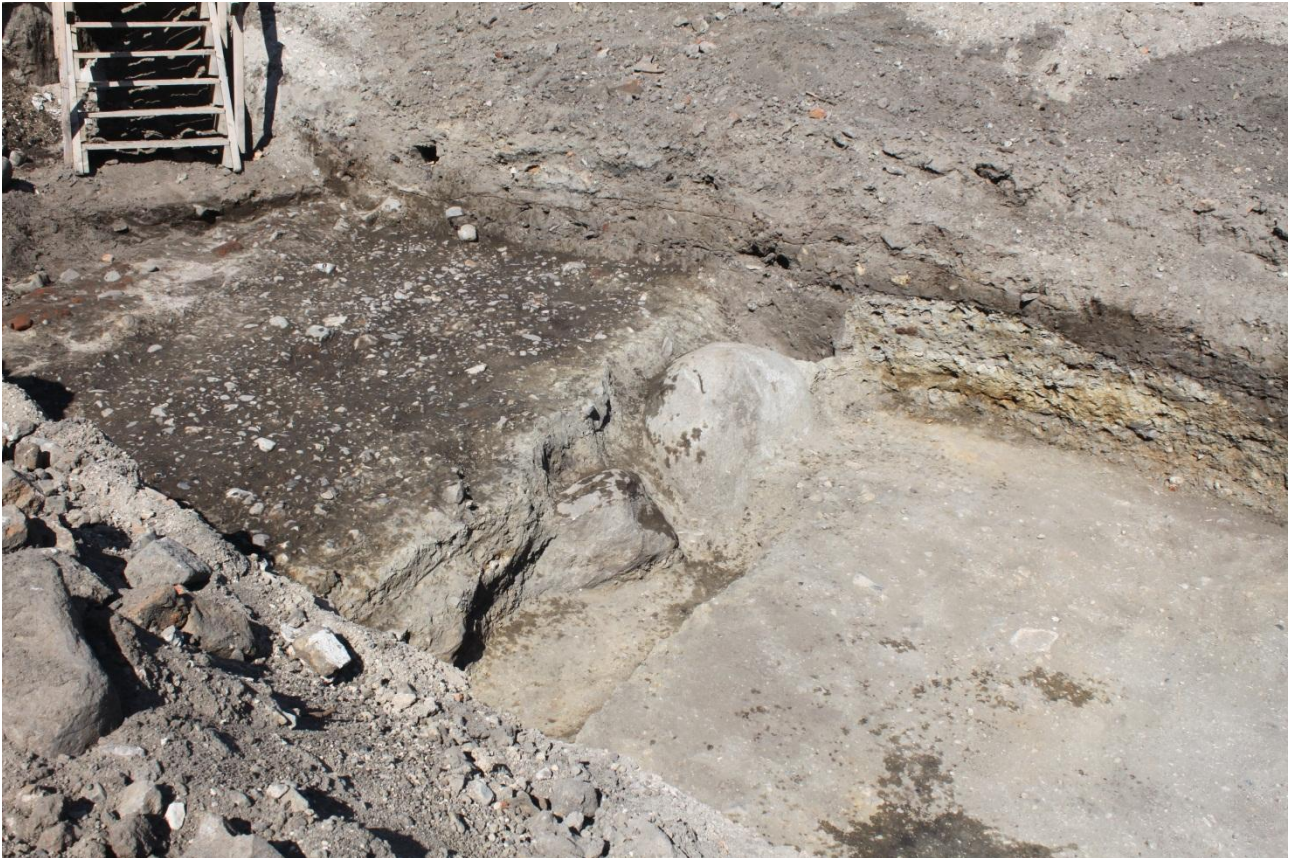
Fig. 122. Stones (SS173669) beneath and up to the road surfaces, facing NE. Photo: Museum of Copenhagen.

South of the identified road surfaces and between the timber structures two lines of NE-SW running, unfinished granite stones was documented. The height above sea level varied between 1.9-2.2 m. The 26 stones were interpreted as part of foundation line for the overlying road surfaces. The gap to the west and some missing stones are related to machining/safety concerns and due to machining it is uncertain whether the stones could have been structural and related to the N-S running stones in fortification group G-503795 (see Fig. 120).

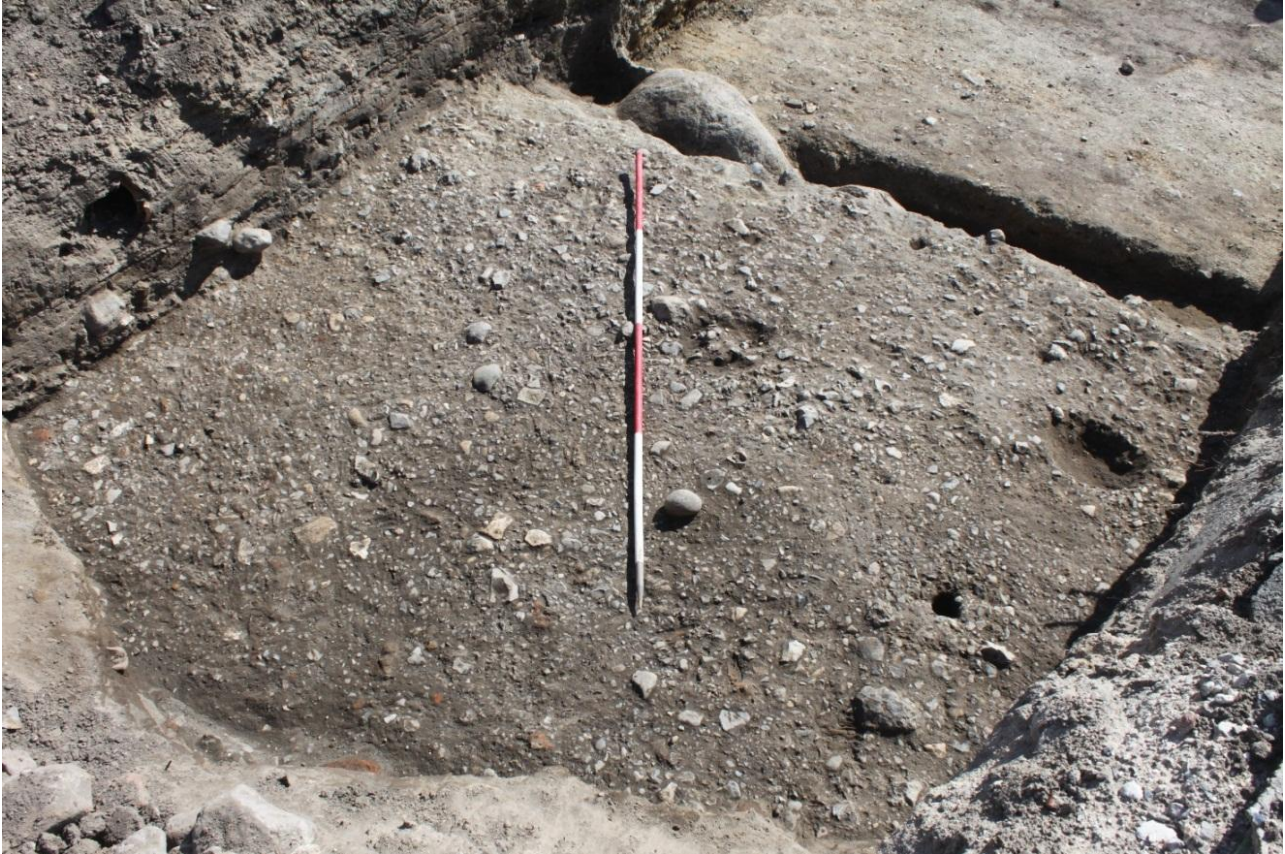
Fig. 123. Road surface (SS173067), facing east, with interpreted post imprints (SC173121) and (SC173134) to the left. Photo: Museum of Copenhagen.

The south-western half of surface (SS175761) was generally intact and smooth, but sloped down to a much more rough uneven and possibly rutted surface with larger cobbles. This north-western sunken portion of the pavement would have continued towards the centre of the road and was probably exposed to more heavy traffic (wagons and horses), while the margin of the road probably carried primarily pedestrians. Despite the generally pitted or uneven character of the NW margin of this road surface no continuous well defined wheel ruts were visible.

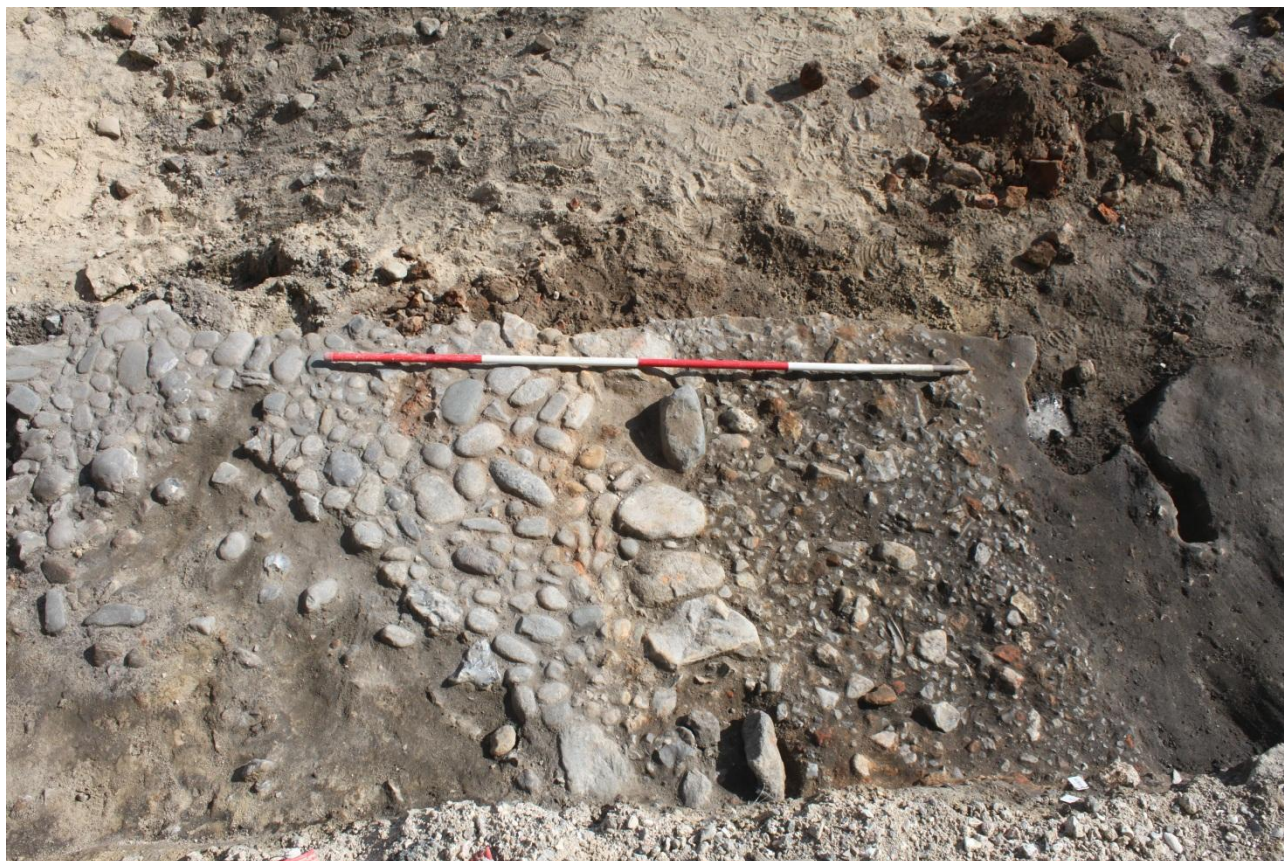
Fig. 124. Paved surface with edge stones (SS173965) together with road surface (SS175184), facing NE. Photo: Museum of Copenhagen.

Cobble surface (SS173965) had been laid along the edge and part of the structure had been robbed. Along the SE side was an edge defined with six bigger stones. The stones in the curb were worn on one surface and could represent some sort of boundary between SS173965 and pebble surface SS175184, though the functional or practical difference between these two surfaces is unclear (median in the middle of the road?).

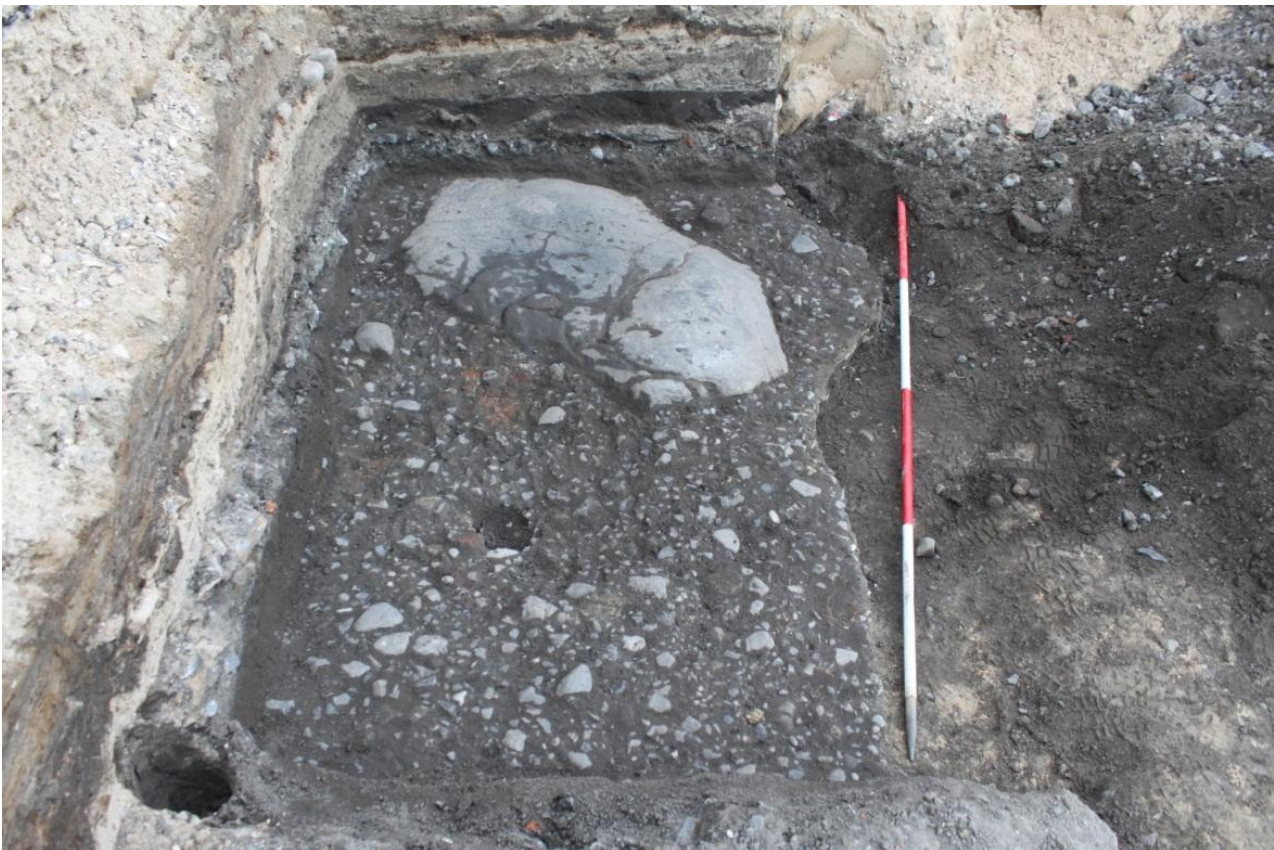
Fig. 125. Boulder (SS176255) and road surface (SS176172), facing NW. Photo: Museum of Copenhagen.

A big boulder was recorded within the road surfaces to the west. Boulders of this type were typically used as foundations in massive masonry structures or at the base of earthen ramparts. This was probably the original use of this boulder, but its surface had been exposed and it formed a part of the lower gravel pavement (SS176172). The stone was presumably reused from a foundation, perhaps as a northern boundary stone for the entrance, as it was apparent that traffic had polished the surface, and it was presumed to be contemporary with road surfaces (G-821) which are later according to the matrix, although the layers between could amount to levelling and foundation layers for the construction of the road.

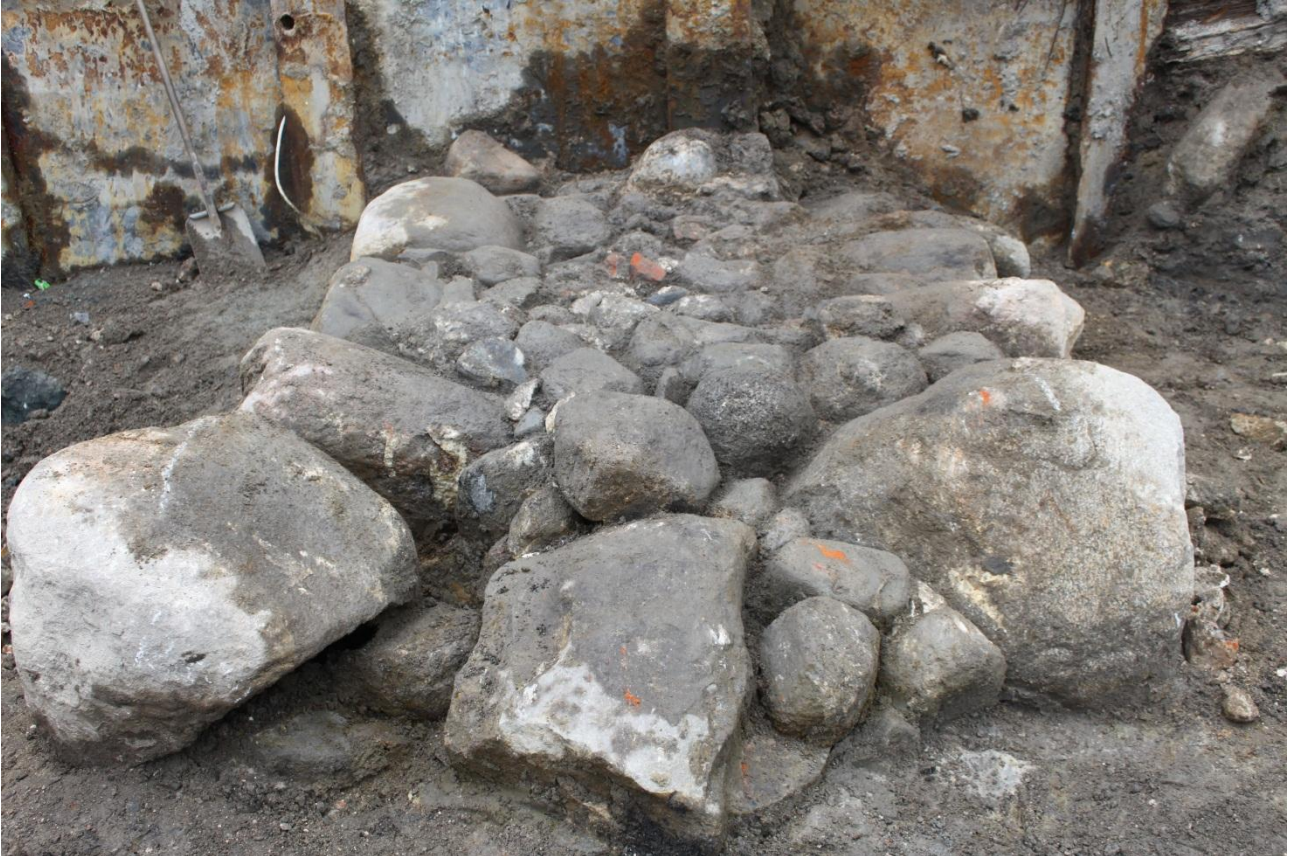
Fig. 127. Foundation stones (SS136525), facing west. Photo: Museum of Copenhagen.

The 1.9 m wide and 4.5 x 3.4 m long foundation consisted of a dry stone structure of unfinished and uncoursed mid grey granite boulders (Fig. 127). The number of courses varied between one and two. The fill between the boulders consisted of smaller stones and loose, brownish and yellowish grey silty sand with inclusions of CBM. On the north side of the brick wall in subarea phase 1N there were two or three stones (SS30556) that could possibly be part of the foundation, however, this relationship remained unclear as no more excavation was carried out in the area (limit of documentation). The boulders had their flat side to the ground.

The wall was a mixture of large granite stones (c. 0.8 m) and coursed brickwork, where the bricks had been broken to fit around the larger stones (Fig. 127-129). The stones built into the faces of the wall were flat and smooth, and flush with the brickwork. At the most – six to seven courses of fully laid fragmentary “munkesten” with smooth and struck mortar were recorded. The middle of the wall consisted of smaller stones and red brick fragments mixed with mortar.

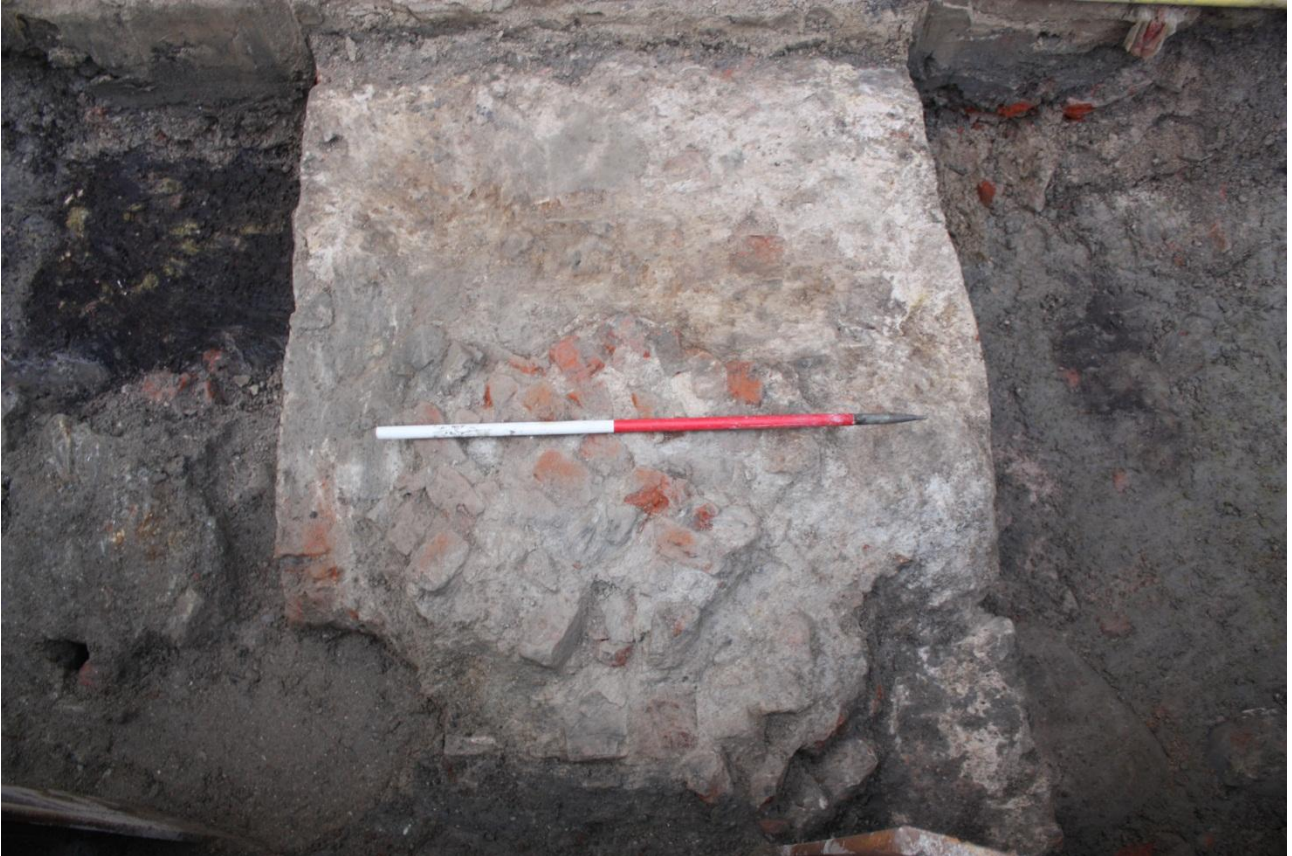
Fig. 128. Brick wall (SS29955) in trench phase 1N consisting of a core of brick fragments and mortar, facing west.
Photo: Museum of Copenhagen.

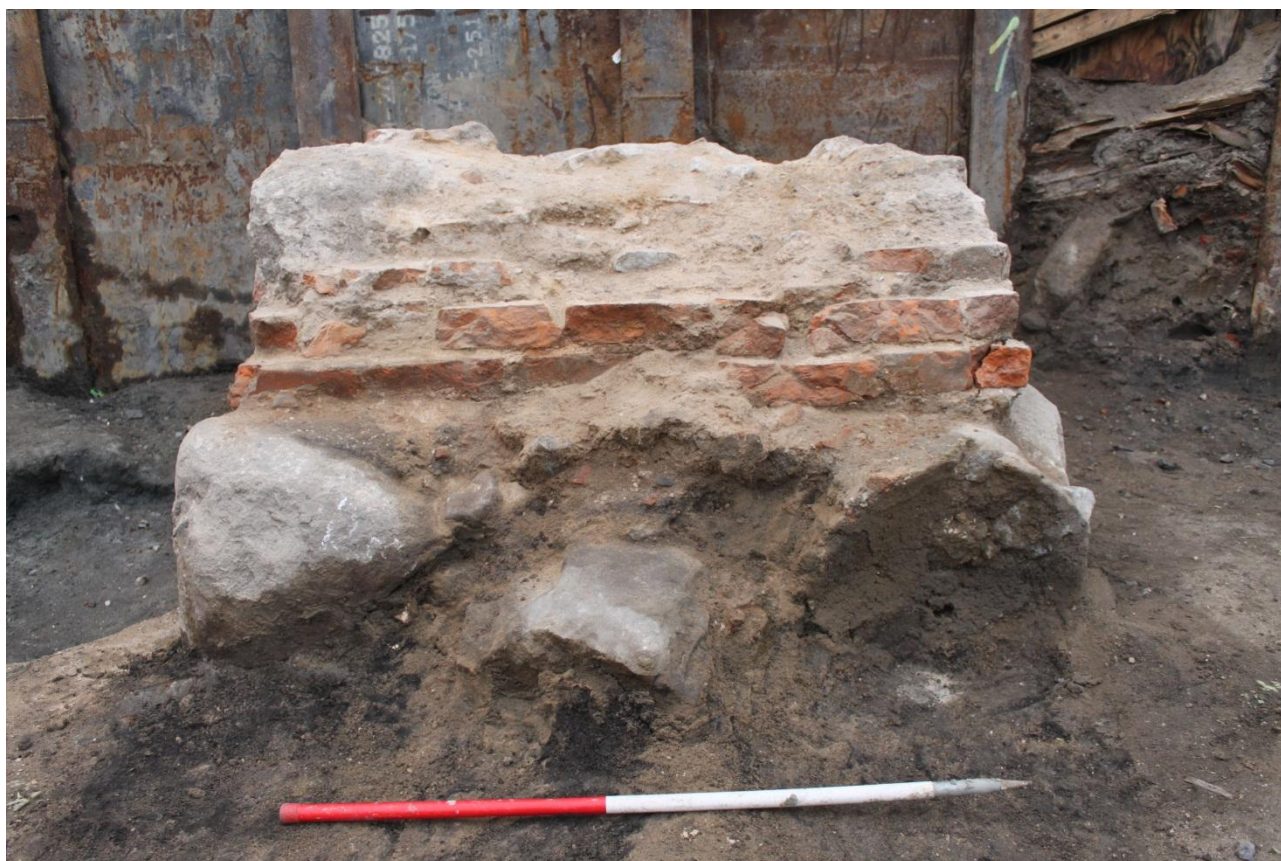
Fig. 129. Cut through brick wall (SS136416), facing west. Photo: Museum of Copenhagen.

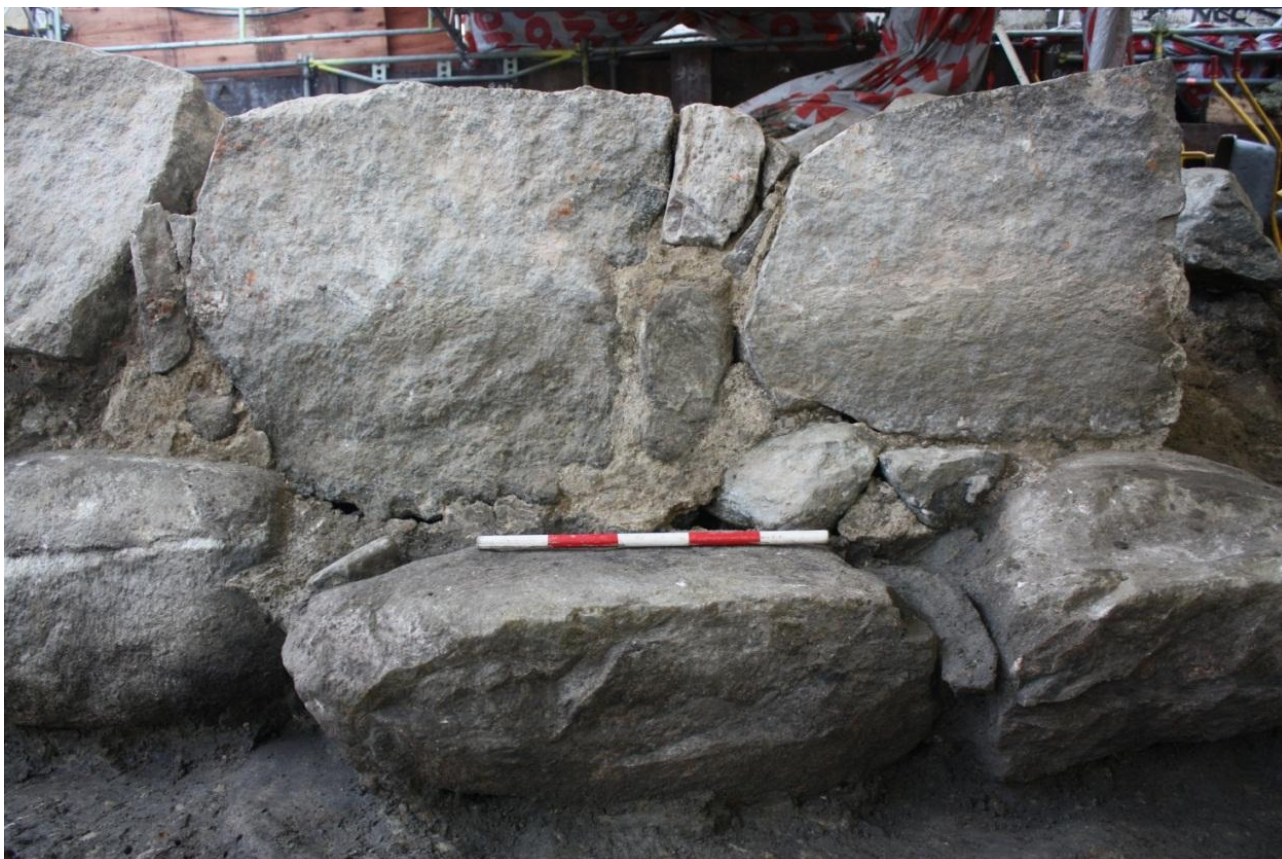
Fig. 130. Extended entrance and rebuilding work in the 1500s? Foundation stones (SS43532) and (SS45115), facing south. Photo: Museum of Copenhagen.

At Kong Hans' last reign considerable work was done on the fortification particularly with respect to the gate; in 1505 a bulwark was built outside Østerport. In 1510 the accounts for the city's amount "*till then bghningh thill Østhre porth*" is mentioned. Since the money mentioned is being used to "*kalck oc stheen*" this must represent masonry, either to an extension and appearance of the present gate building or to a new gate building outside the moat (Thorsen 1926:229-231). In 1511 Mayor Oluf Adersen accounted his outlays spent on the "*then hommeydh weeth Øster porth*" (extension in the wall or entrenchment) at Østerport and in 1512 Alderman Mogens Lavridsen reported the costs for the gate's vault and thatching (Nielsen 1877–1892; Thorsen 1926:229f.). The latter information is of interest since there are several traces of construction work within the gate building – not only the several road and surfaces, traces of scaffolding, but also on the foundation walls themselves. As seen on Figure 130 the second course of foundation stones is placed nearly 0.35 m into the gateway area compared to the uppermost boulders and limestone ashlar.

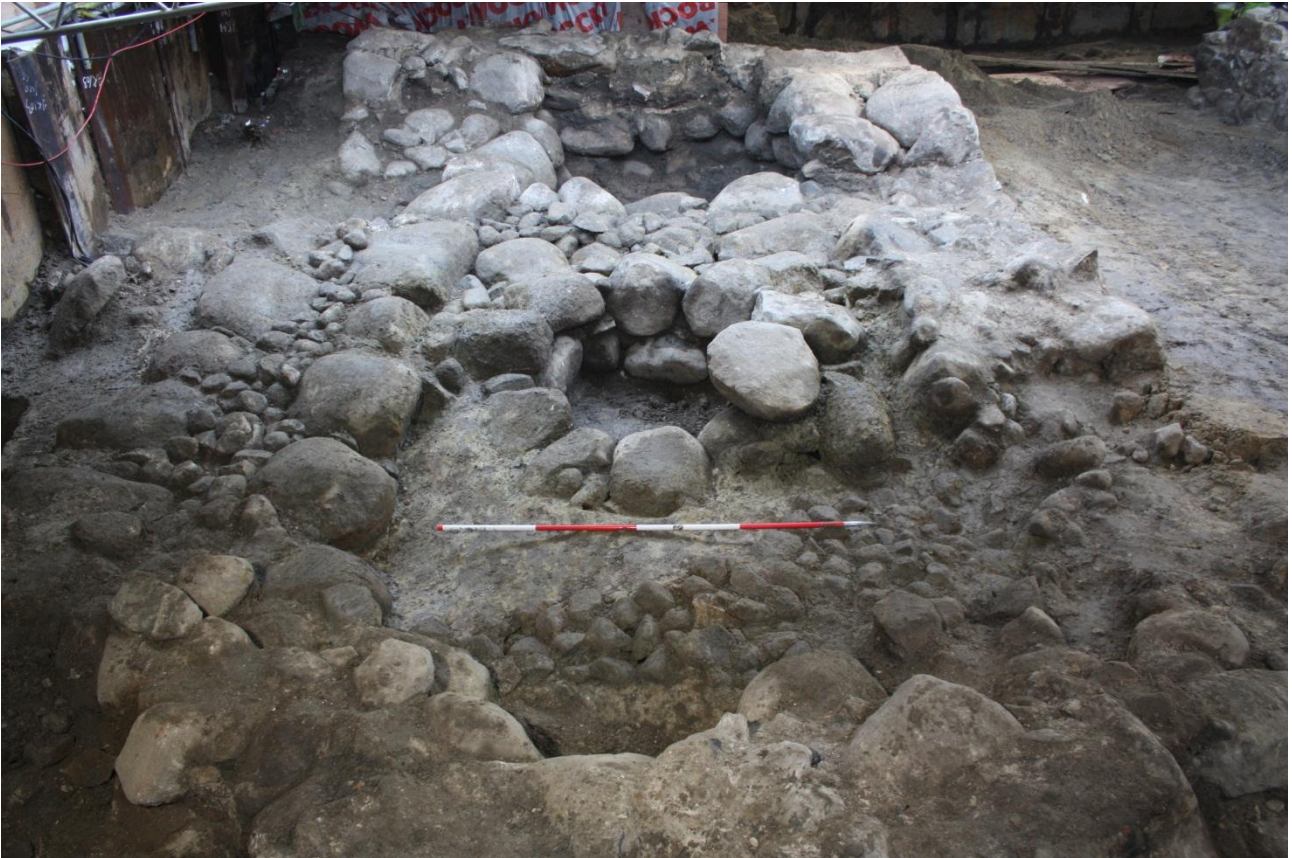
Fig. 131. Overview. The southern part of the gate building with gate walls and well, facing west. Photo: Museum of Copenhagen.

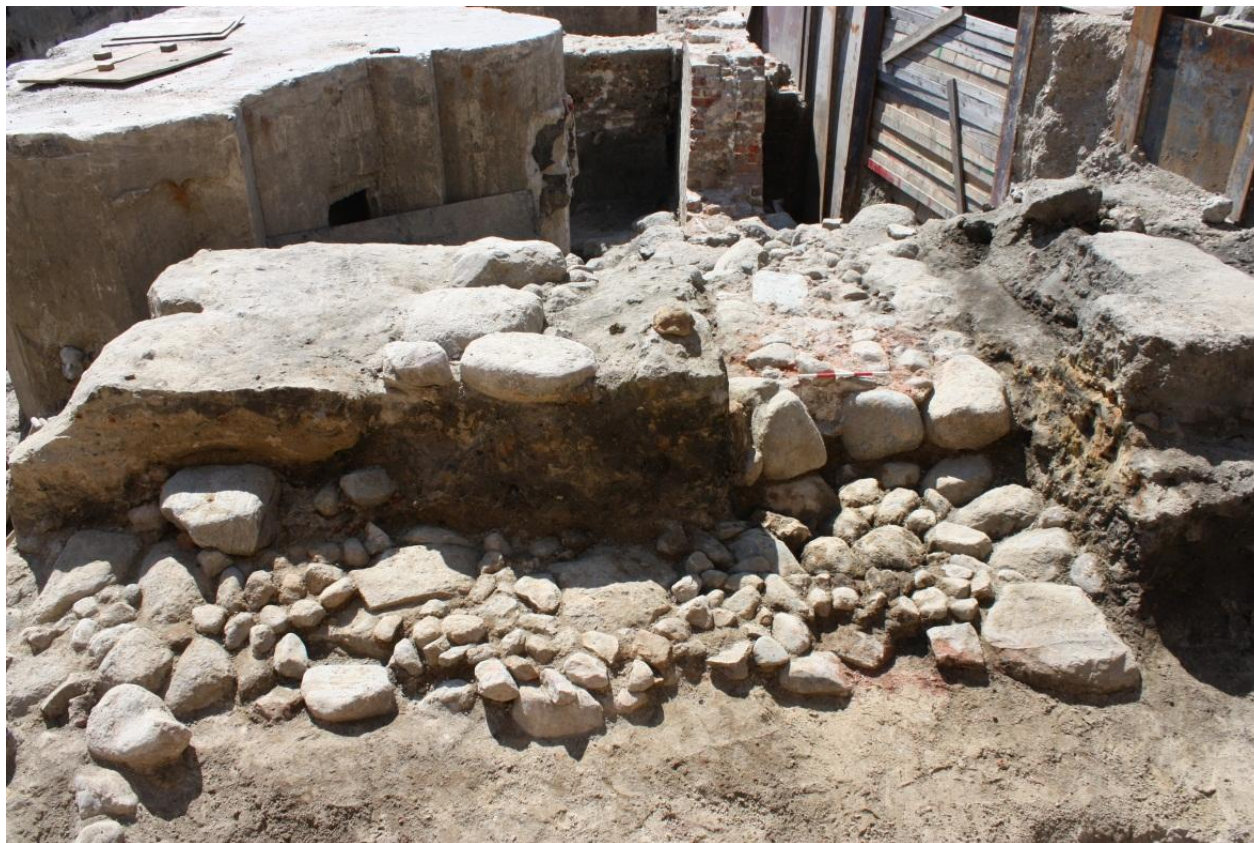
Fig. 136. Part of medieval Vesterport investigated at Rådhuspladsen, facing SW. Photo: Museum of Copenhagen.

Part of Vesterport was investigated at the Metro excavation at Rådhuspladsen in 2011–2012. The gate itself, based on the foundation remains, measured 9 x 9 m, where the gap between the foundations of the outer gate was 2.75 m, while a projecting wall extended c. 5.1 m to the southwest of the gate's western corner (Fig. 136). The projecting walls would have connected the gate structure to a bridge which spanned the city moat to the gates immediate southwest, possibly preventing the embankment from slumping on to the road. It seems most likely from the way the layers of stone were laid, that the gate and the projecting wall were built at the same time. The building was dated to 1375 AD (Lyne and Dahlström 2015:180-181 and 200).

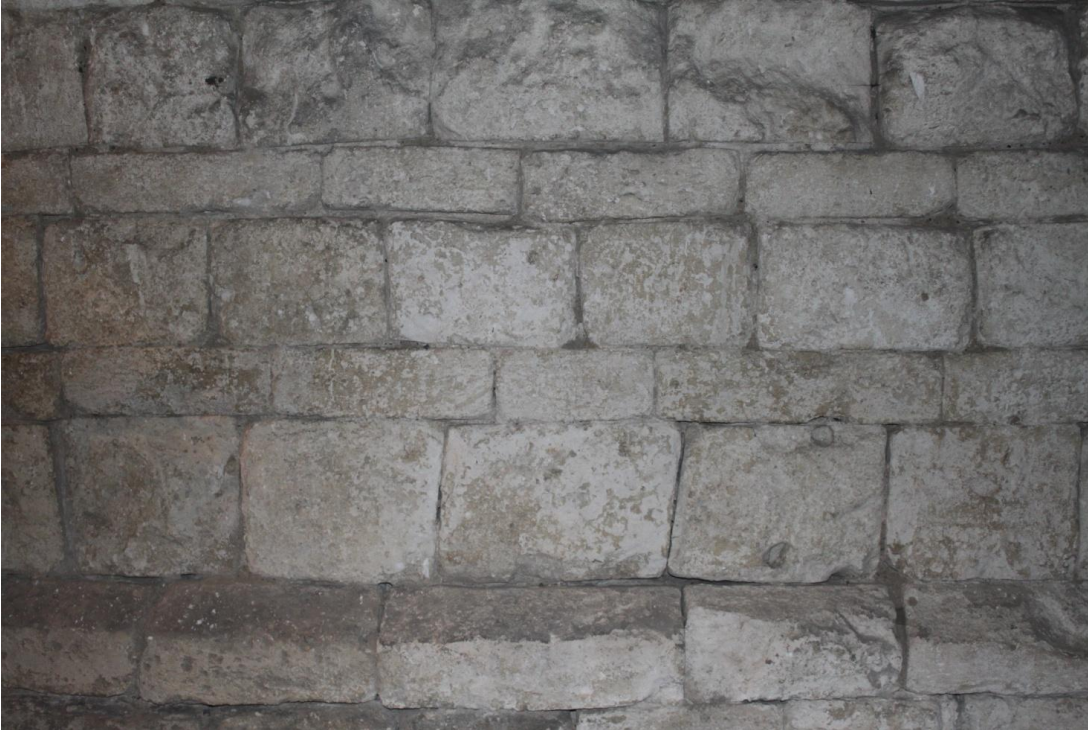
Fig. 137. Limestone ashlars in Absalon's Castle under Christiansborg. Compare with the limestone blocks in the eastern gate building; figure 107. Photo: Morten Steineke.

With a gate building dating to the early 13th century it can be interesting to do comparisons with other similar and dated structures in Copenhagen. The presence of rough hewn stones has similarities to the limestone ashlars seen in Absalon's Castle from the late 12th century (Fig. 137) – though there are also dissimilarities if one compares the wells in the same castle (carefully built with lime ashlars) and the natural granite stones used in the gate building (Fig. 138a and 138b).

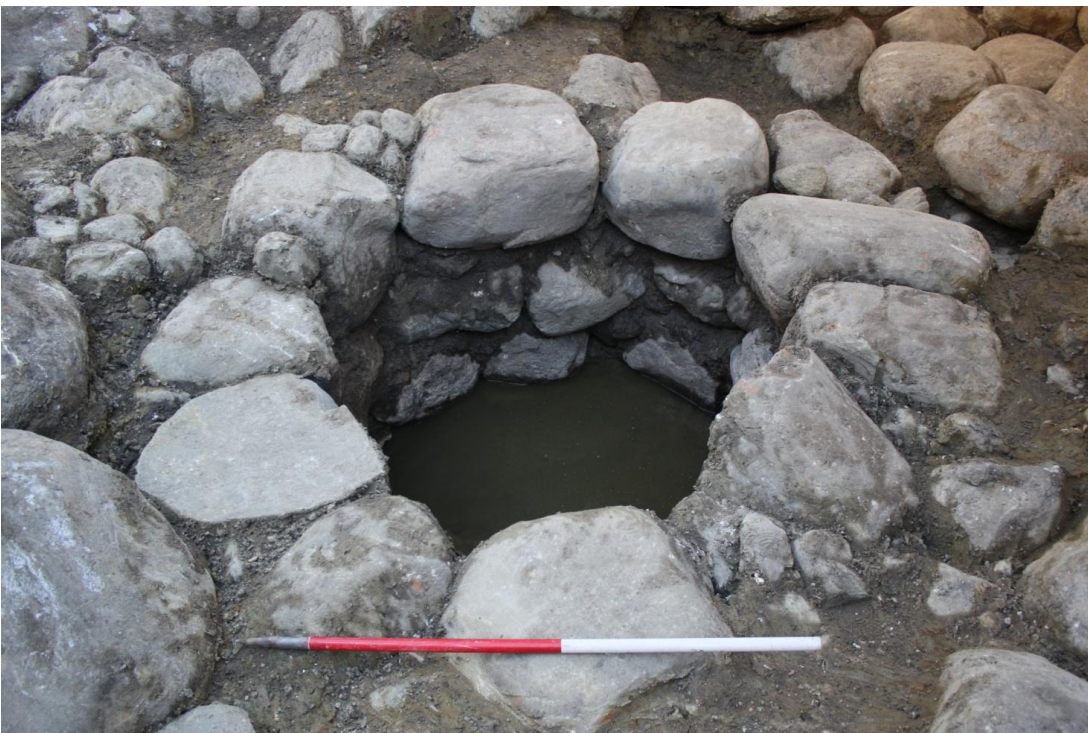
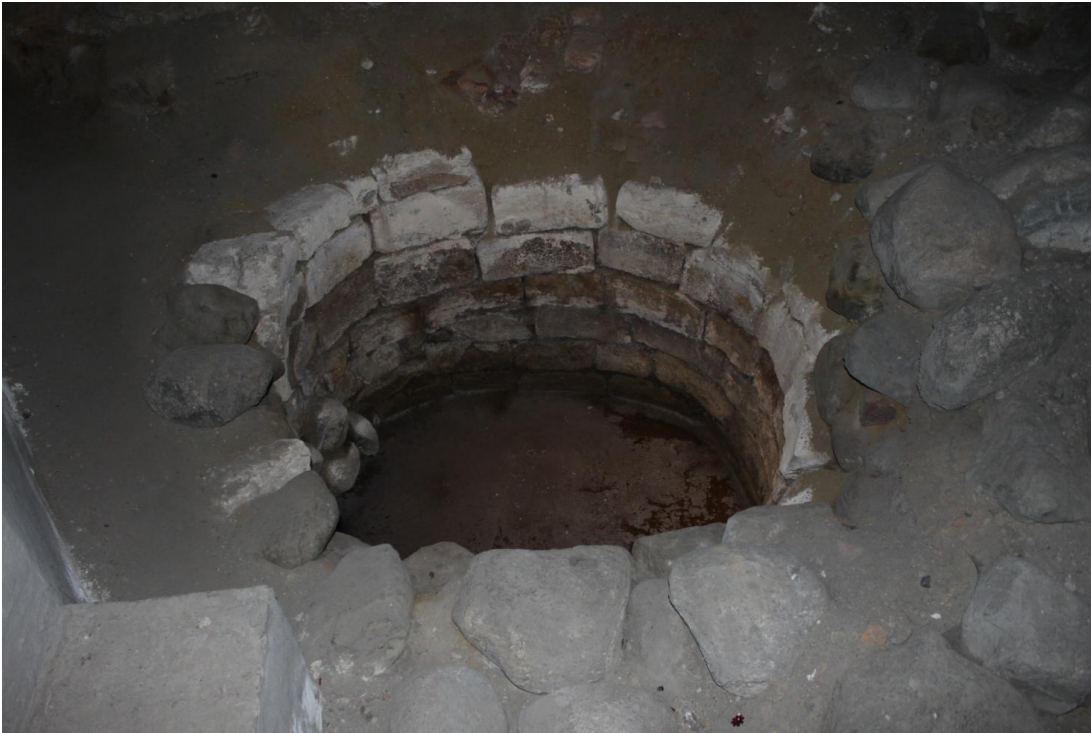
Fig. 138a and 138b. Well in Østerport and well in Absalon's Castle. Photo: Museum of Copenhagen and Morten Steineke.

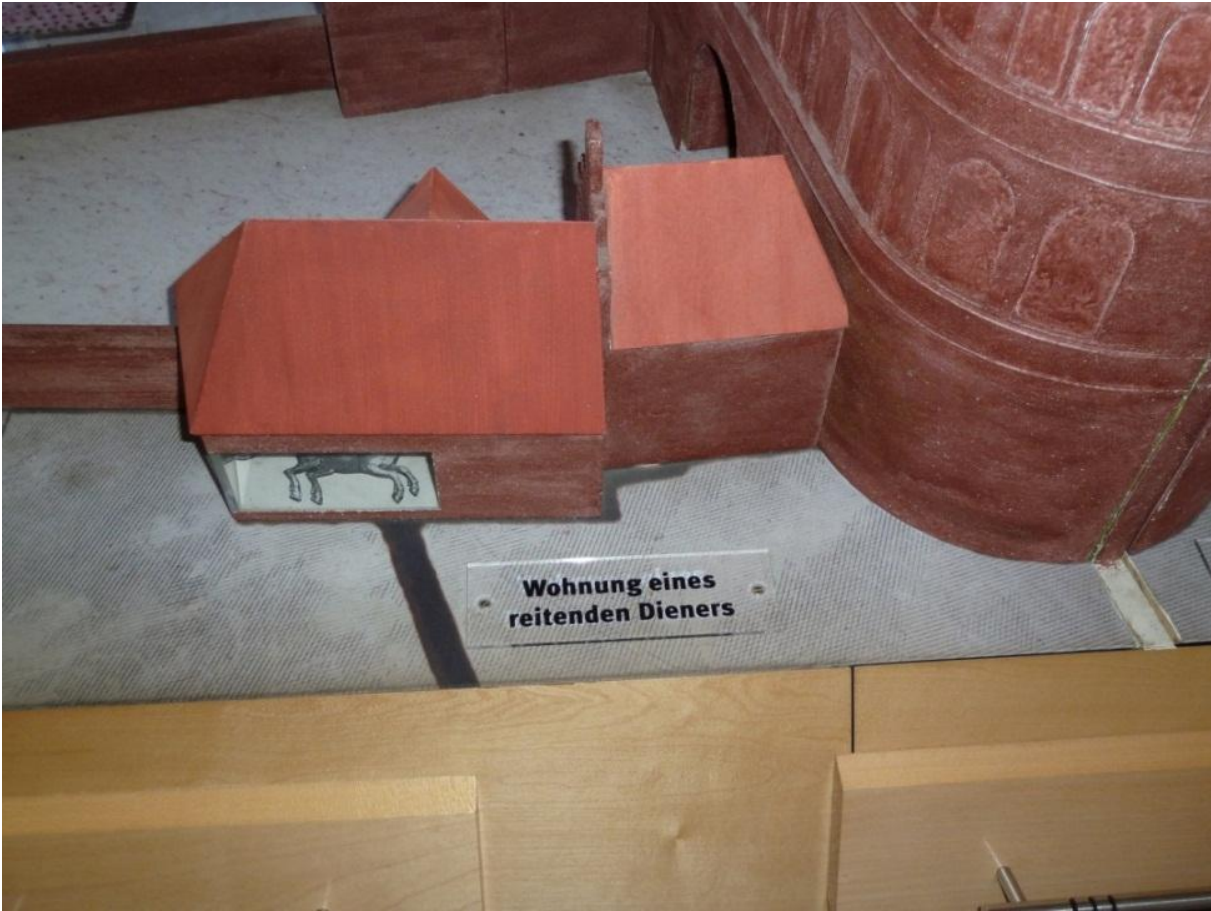
Fig. 139. House for riding servants connected to the Middle Holsten Gate in Lübeck from the 15th century. Photo: Morten Steineke.

The annex west of the main building is interpreted as a separated customs- or guard house often seen in association with gate buildings in the High Middle Ages (cf. Middle Holsten Gate in Lübeck) (Fig. 139).
