18 Phase 6 Eastern gate building and Post medieval fortification 1600–1650 AD

18.1.1 Østerport – additions, activities and deconstruction

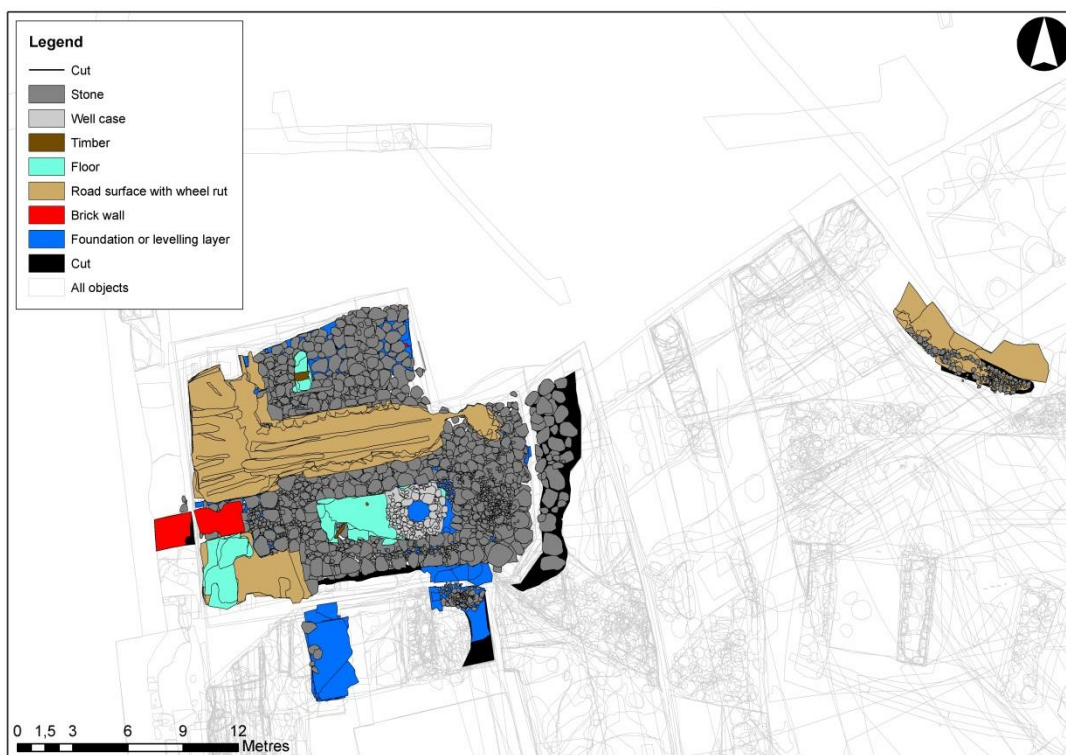
Fig. 195. The new gate building with revetments, road surfaces and bulwark. The expansion and reinforcement of the gate eastwards includes parts of the Late medieval moat and runs on an estimated north-south line about 2 metres east of the well. The void among the foundation stones is caused by modern shoring on the building site.

In connection with the new fortification in the early 17th century Østerport was renovated and expanded further to the east. The foundation for the new gate building included large parts of the Late medieval moat which was filled with boulders and stones to stabilize the subsurface east of the new building (Fig. 195).

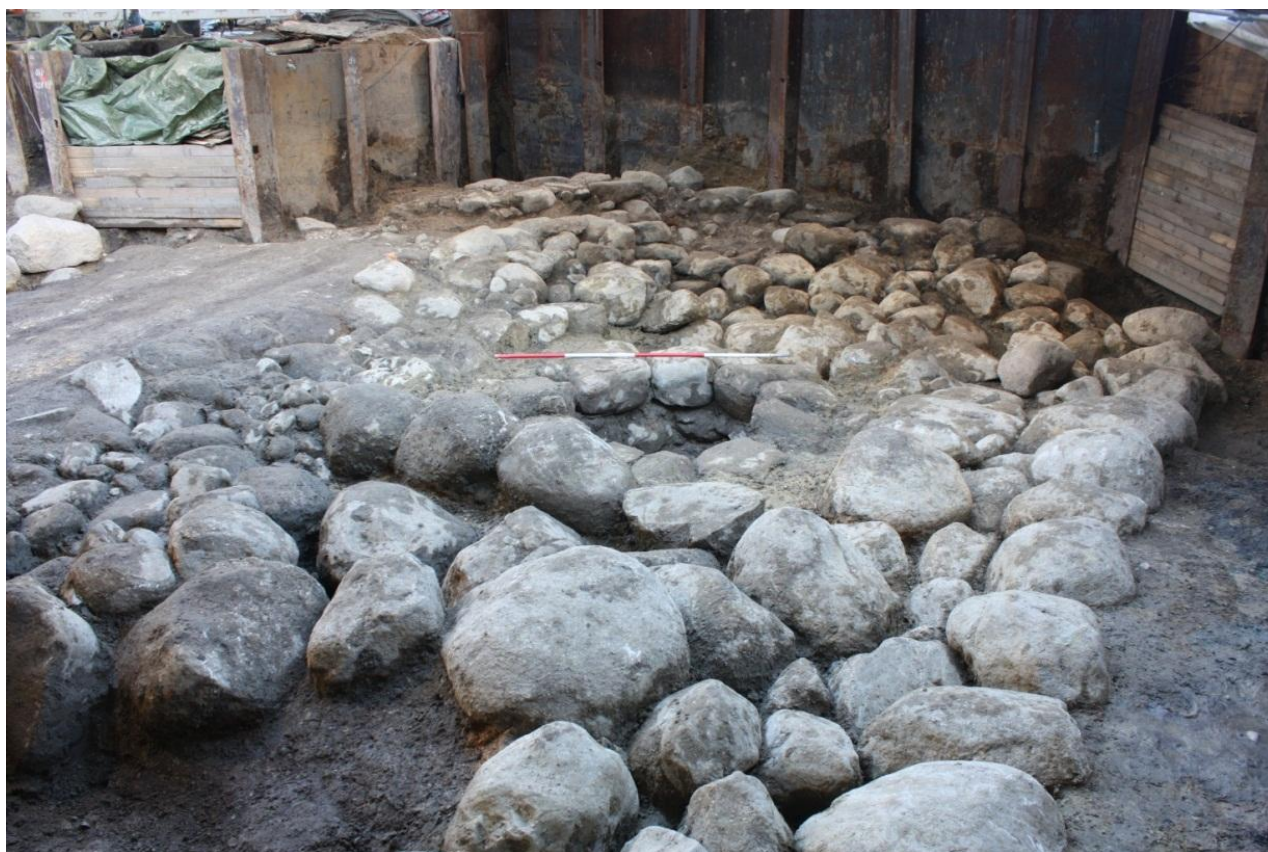
Fig. 196. New additions to the eastern gate building. Boulders and stones (SS103531) in the background and east of the well in the middle, facing NE. Photo: Museum of Copenhagen.

Part of the new foundation covering approximately 63 m² consisted of a dry stone structure of light and mid grey unfinished stones and boulders of different size together with fill and bonding material consisting of smaller stones, light whitish and yellowish grey/brown mortar and silty sand and clay (approximately 40% of the context). Further down the fill became more brown and organic with some inclusions of red brick fragments and charcoal (Fig. 196 and 197).

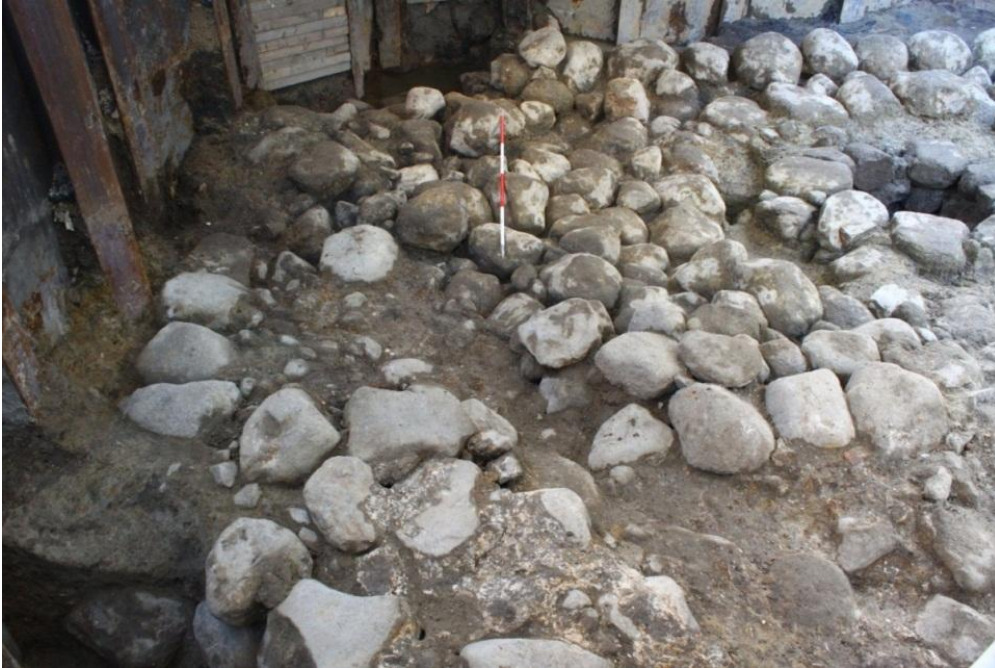
Fig. 197. Additions and foundation layers in front of the original gate building – boulders and fill of smaller stones together with bonding material, facing south. Photo: Museum of Copenhagen.

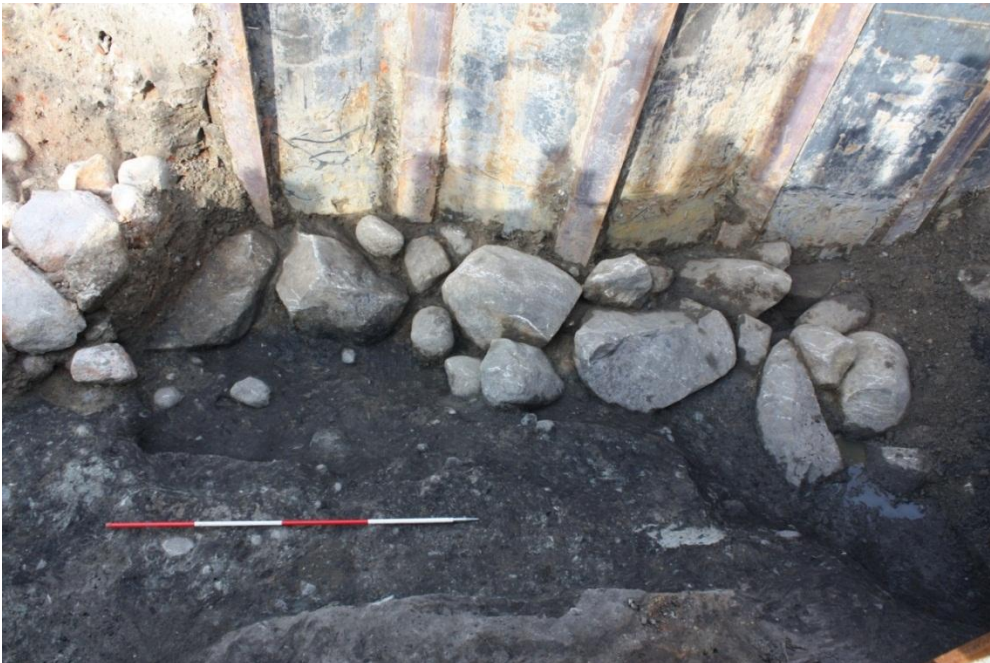
Fig. 198. Row of larger boulders in SS22155, facing SW. To the left – part of dam structure (G-502973). Photo: Museum of Copenhagen.

Context (SS87581) comprised 60-70% part red bricks with the remainder being white limestone and granite lumps. Stones SS88700 represented the lowest level of foundation rubble and were a mixture of part brick, worked limestone, squared blocks and some larger rounded stones. Limestone blocks were predominantly placed to the front while some were found randomly dispersed throughout. Red brick was mostly to the centre and at the back of the structure. Bigger boulders (SS22155) were placed to the east as a constructional fringe (Fig. 198).

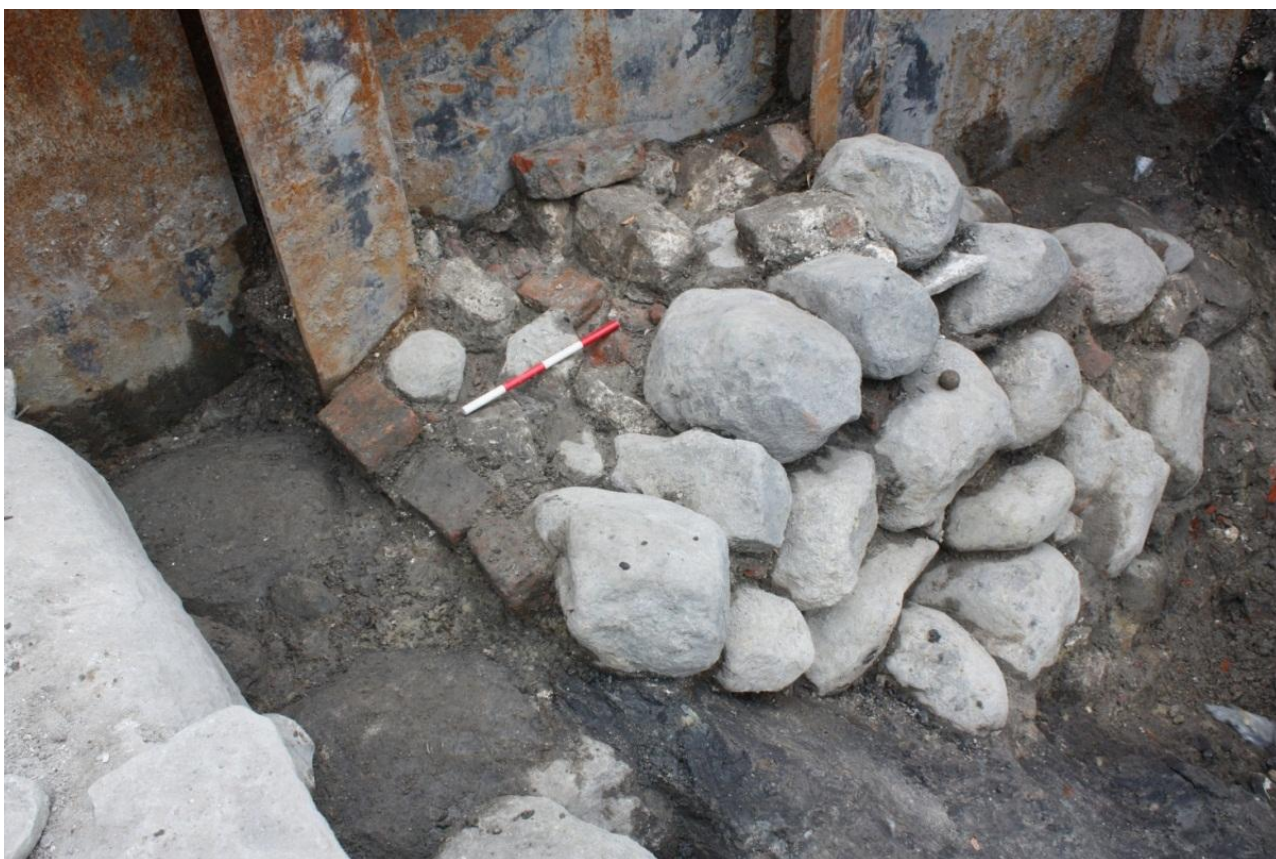
Fig 199. Bricks and stones (SD85806) placed in position behind larger stones and against the city wall foundations, facing NE. Photo: Museum of Copenhagen.

An accumulation of larger stones and reclaimed medieval bricks (SS85806) was documented close to Østerport’s southern boundary and up against the city wall foundation. SC88669 consisted of a linear construction cut oriented in both NE-SW and NW-SE directions just to the south of the gate building and east of the former city wall (Fig. 199). It appeared to be “stepped” and became deeper towards the east, whereby kote 0 was reached and digging could not continue (instructions from the Metro Company). The measured width varied from 1.0 m to 2.5 m, depth to a maximum of 1.05 m. The break of the slope was both sharp (to the south) and moderate (to the west) and the base was flat (to the south) and sloping (to the west).

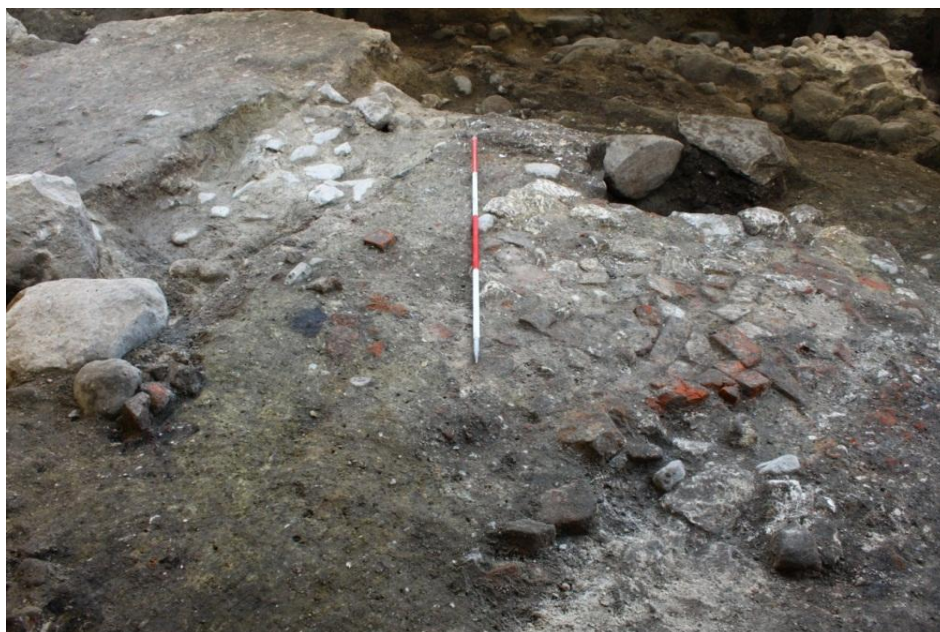
Fig. 200. Part of brick and limestone floor associated with the well, facing NE. Photo: Museum of Copenhagen.

Besides the well there was no clear evidence of indoor activities related to the new gate building presumably as a result of the later destruction and reuse of building materials. The foundation and levelling layers consisted of mixed mortar, CBM and clay including a brick pavement associated with the well (Fig. 200).

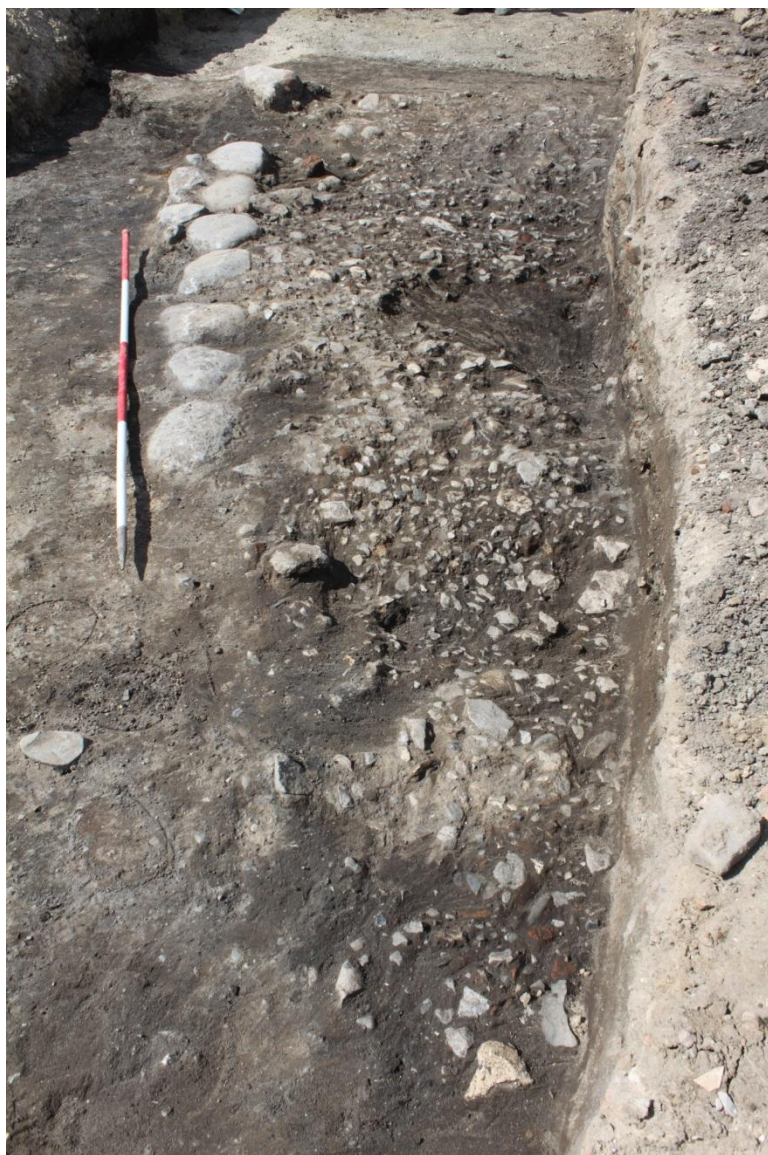
Fig. 201. Road surface SS171977 with curb SS172085 in G-837, facing NW. Photo: Museum of Copenhagen.

Two surfaces recorded outside Østerport have been connected to the new fortification. Road surface or pathway (G-837) consisted of mixed bedding/foundation layers, surfaces of rubble, smaller and bigger stones, layers of large medieval brick fragments (“munkesten”) and granite cobbles, imprints and a dark brown sandy-silt usage layer (Fig. 201). The feature *could* be a continuation of the eastern parts of the older road surfaces in G-821 outside the eastern gate building (see Chapter 15.1.2), either represented by SS173067 or SS173460, but has been placed in this time phase (Phase 6) due to its spatial relationship with G-832 (see below).

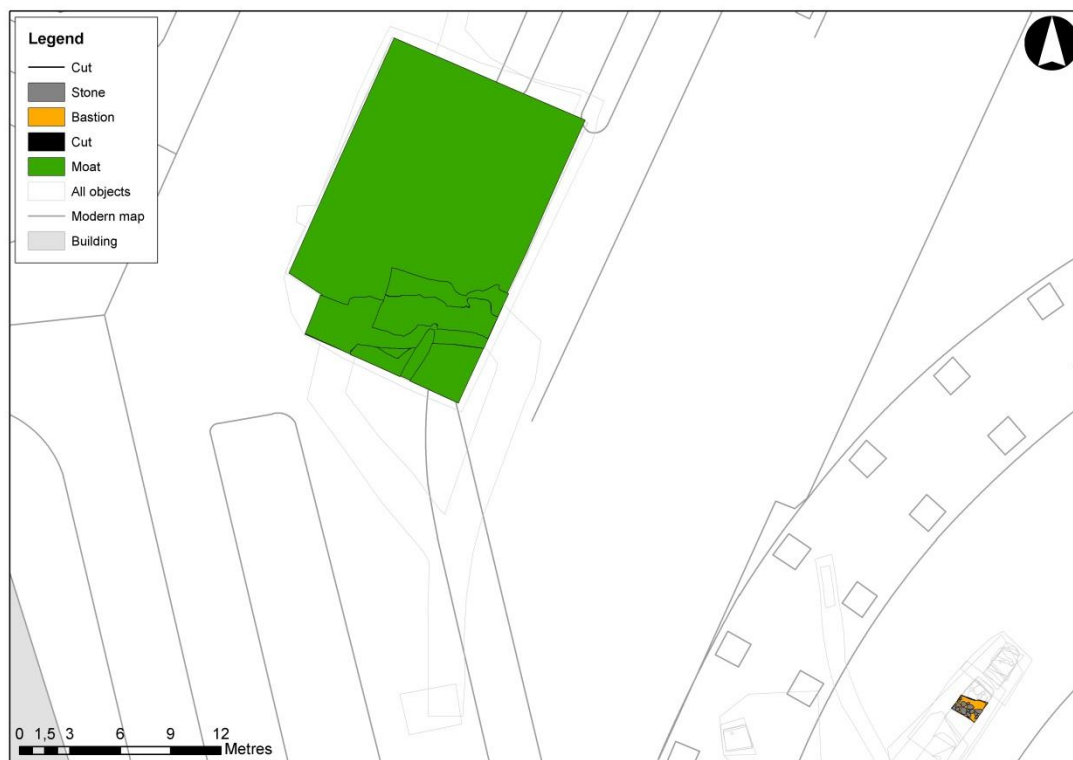
Fig. 202. The 17th century fortification in the NW part of Kongens Nytorv with parts of the moat and bastion line/foundation.

Parts of the 17th century bastion were investigated at two places – in a small trench in the NW part of Krinsen and in the main Station Box further to the south (Fig. 202 and 204).

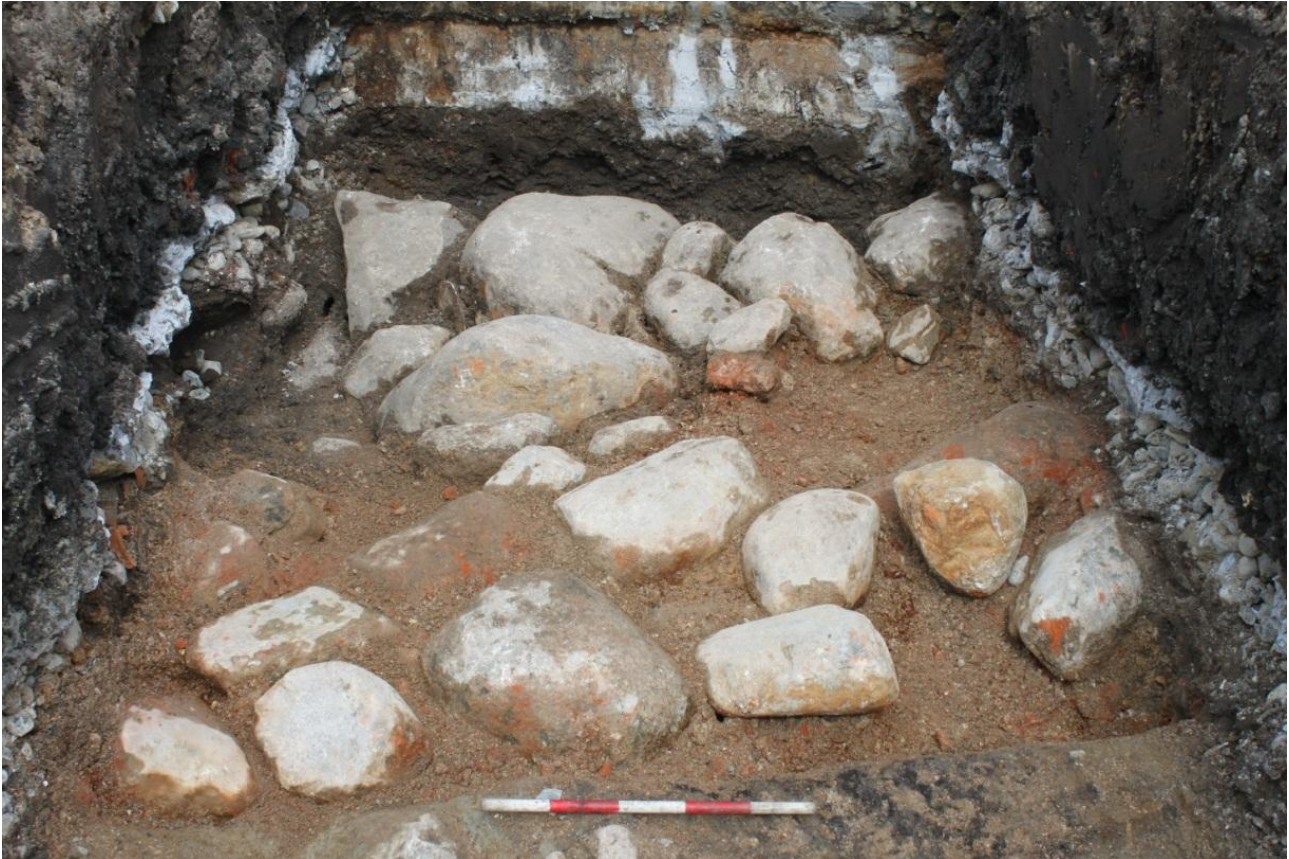
Fig. 203. Foundation stones SS162617 with larger boulders SS162498 moved to establish a 2nd World War bunker in the background, facing NE. Seen in the section – bedding of flint cobbles and part of the concrete floor. Photo: Museum of Copenhagen.

The foundation stones SS162617 consisted of a dry stone structure of at least two courses of mid grey granite boulders and stones, ranging from 0.20-0.60 m in dimension (Fig. 203).

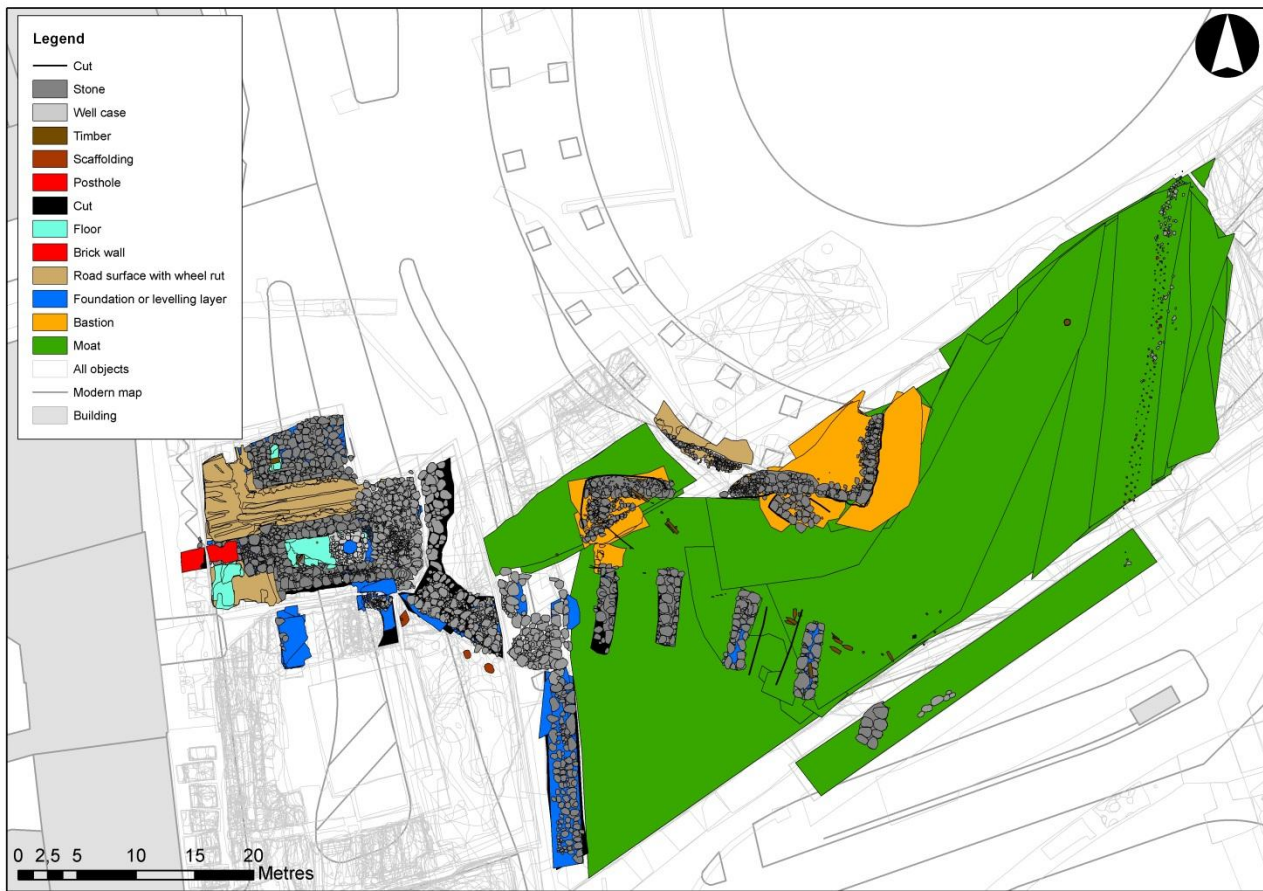
Fig. 204. Overview. The 17th century fortification including the new gate building, bastion, curtain, bridge, dam with barrier tower and moat.

The other and major part of the new fortification was investigated in connection with Østerport and north of the Royal Theatre (Fig. 204).

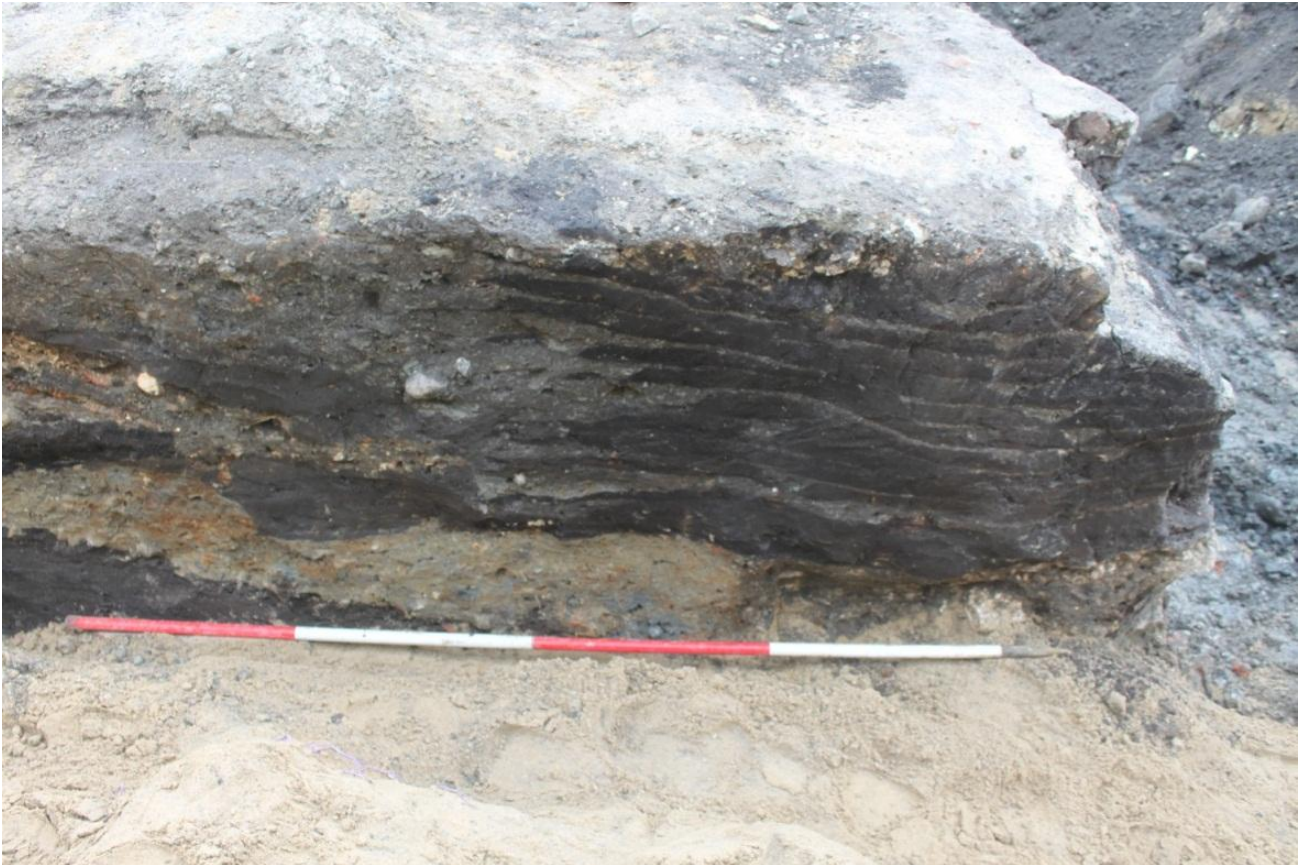
Fig. 205. Peat layer (SD178067) seen in a modern central heating trench, facing east. The context consisted of several turf and sand layers sloping slightly towards the south and covering the core of the 17th century bastion here seen as orange and grey clay at the base. Photo: Museum of Copenhagen.

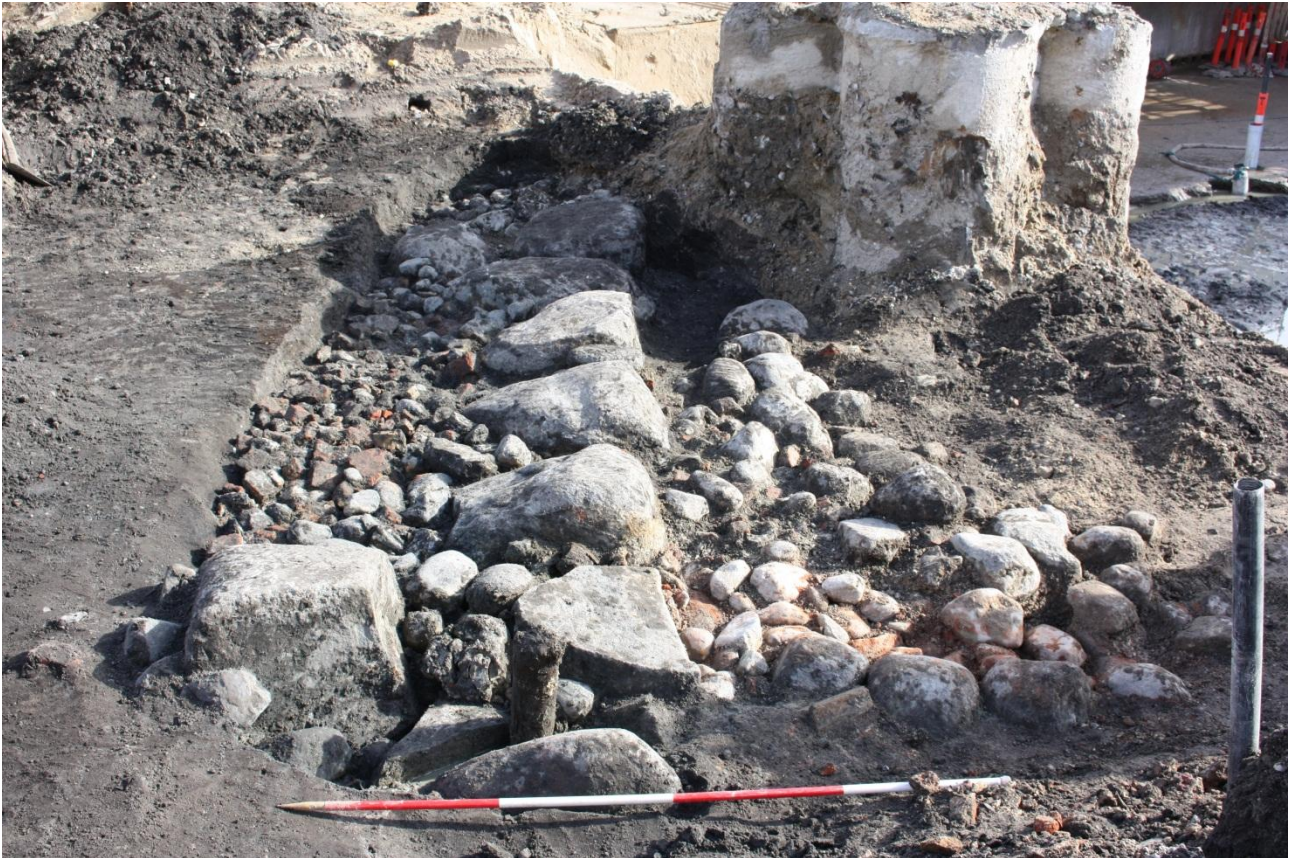
Fig. 206. Stone structure (SG-503400) with big boulders and packing of smaller stones, red bricks and brick fragments exposed in 2014, facing east. In front – part of wooden post (ST306864). Photo: Museum of Copenhagen.

The main stone structure below (SG-503400) consisted of an L- or triangular shaped structure (7.7 x 4.4 m) constructed from at least two courses of large rounded, granite boulders running E-W and some large to medium size boulders running N-S, and a core filled with large and small stones (Fig. 206). The lack of stones in some parts of the structure was partly due to machining. Rubble infill between the stones and between the construction cut and boulders ST307052 and ST307645 consisted of smaller stones, red medieval bricks (“munkesten”) and brick fragments.

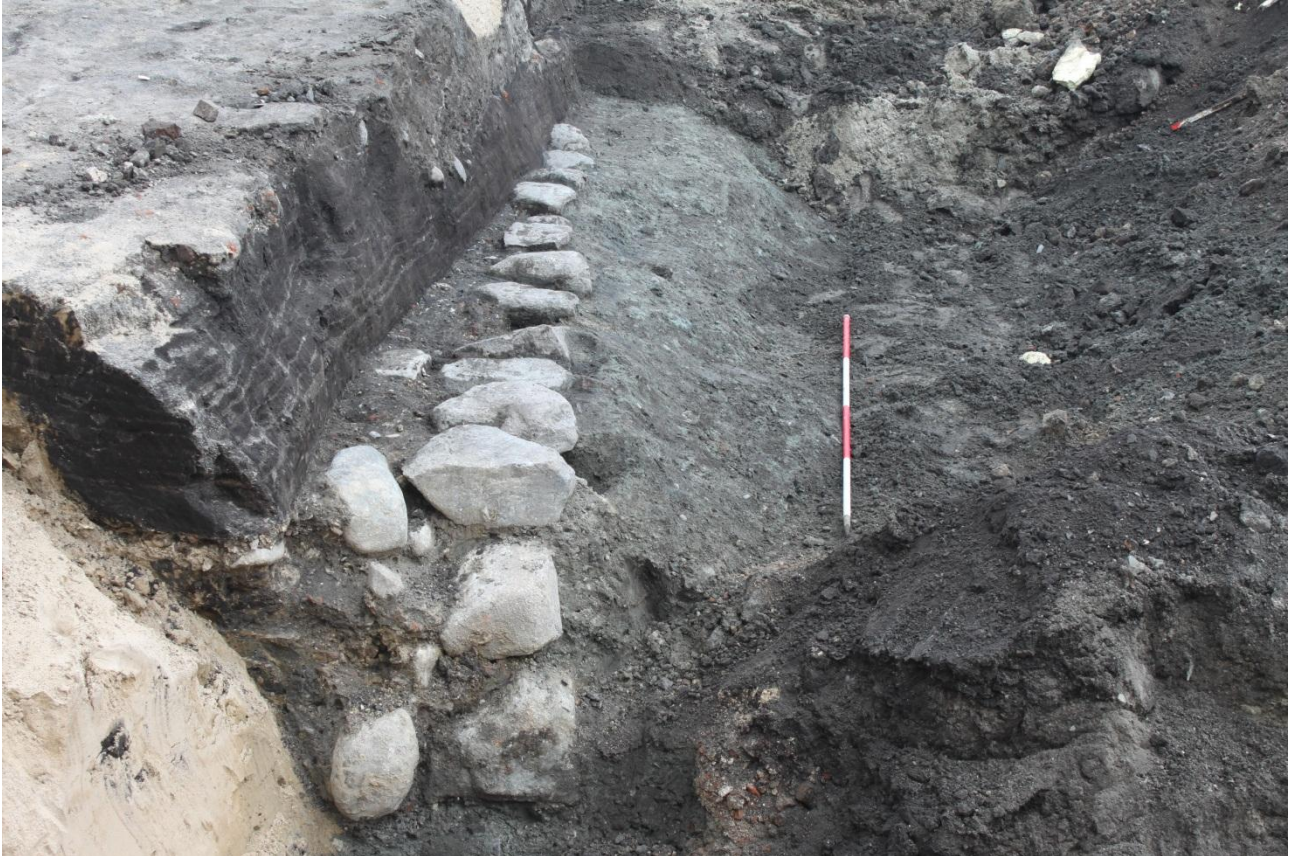
Fig. 207. Southern part of foundation stones SS177220 in the bastion and sealing clay layer SD176814, investigated in 2012, facing NE. Above are multiple layers of peat used as building material in the fortification. Photo: Museum of Copenhagen.

Dry stone structure (SS177220) consisted of four courses of grey, cleaved boulders and rounded stones running in a NE-SW direction (Fig. 207). The lowermost stones in SD176814 were lying more south-east-south and these must be connected to the bridge foundation stones, excavated to the south (see bridge structure below). It is likely that a stone or two were mistakenly not surveyed in the area between these two structures, as it was believed that they were already recorded. Some of the stones were unworked, but others seemed cleft or roughly finished. It was noted that the structure was built from reused stones, since some stones had been worked and some had traces of mortar.

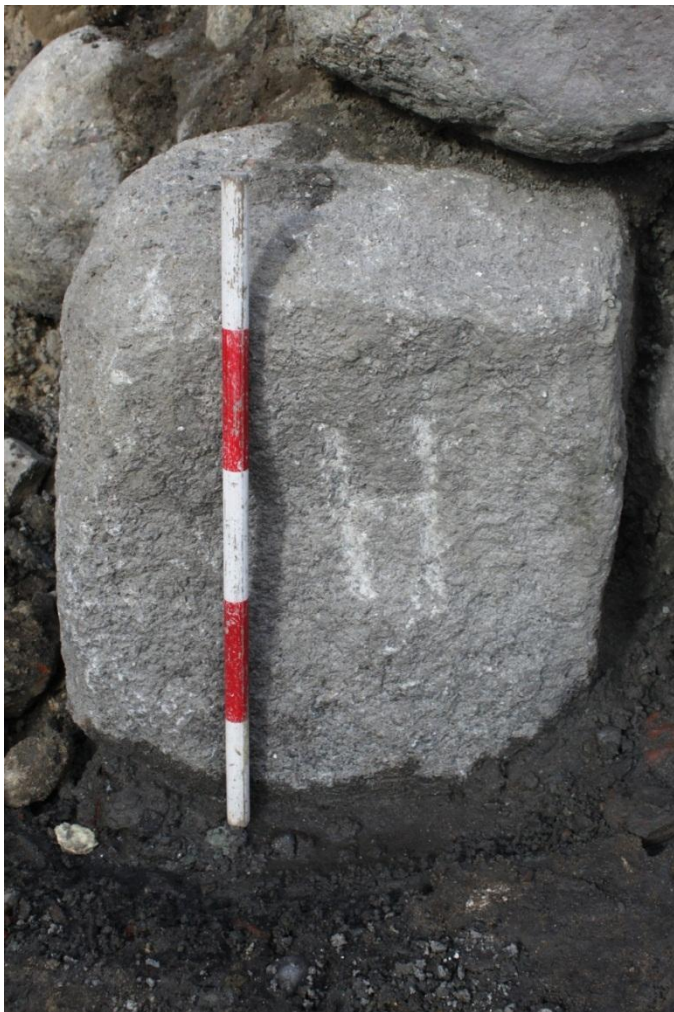
Fig. 208. Signature on one of the western boulders in SS177220, facing NW. Can this be related to Johan Henriksen paid 250 riksdaler “for det Stenhugger-Arbejde til Østerport” and mentioned in a piece work from 1608? (cf. Thorsen 1926:244). Photo: Museum of Copenhagen.

One of the stones had a mason's mark consisting of the letter H (Fig. 208). In this case the letter probably represents a worker or builder signing the completed work.

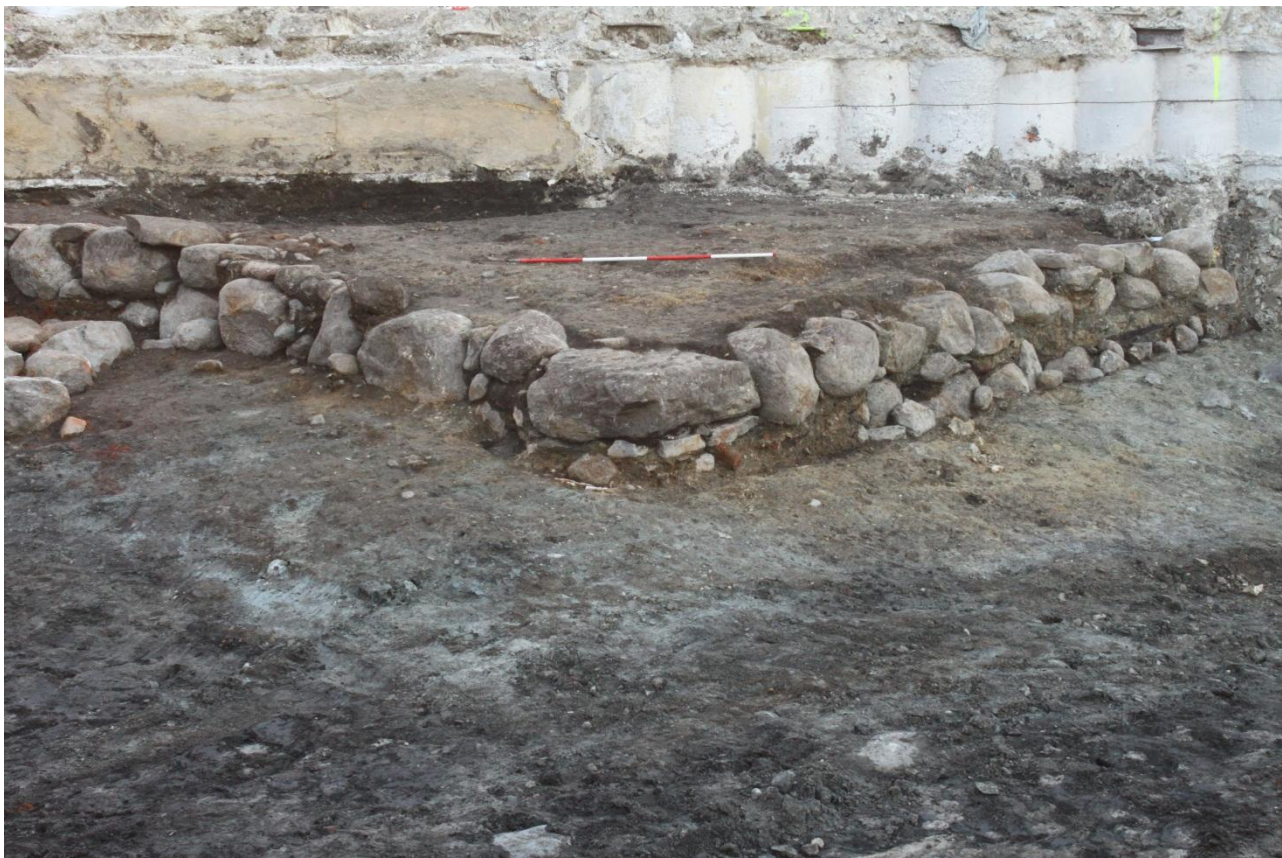
Fig. 209. Overview bastion line, facing NW taken from the former moat with dark and waterlogged sedimentation still on site. Photo: Museum of Copenhagen.

The continuation and the SE corner of the 17th century bastion was investigated c. 20 m to the west of the first recorded foundation stones represented by subgroup (SG-500887). Its outer edge was constructed from four courses of large rounded grey granite boulders and smaller stones forming an L-shape which was then backfilled with redeposited natural grey-yellow clay with some inclusions of CBM, mortar and pebbles (Fig. 209).

The different courses consisted of mid grey unfinished granite boulders and stones. Some stones had been formed to fit within the bigger structure and a large flat boulder had been placed at the corner of the foundation (Fig. 209). Context (SS197574) consisted of a row of stones in the construction cut and backfill, up to the row of big stones in foundation wall SS197445. SS198522 represented a deposit consisting of mainly stones and pebbles.

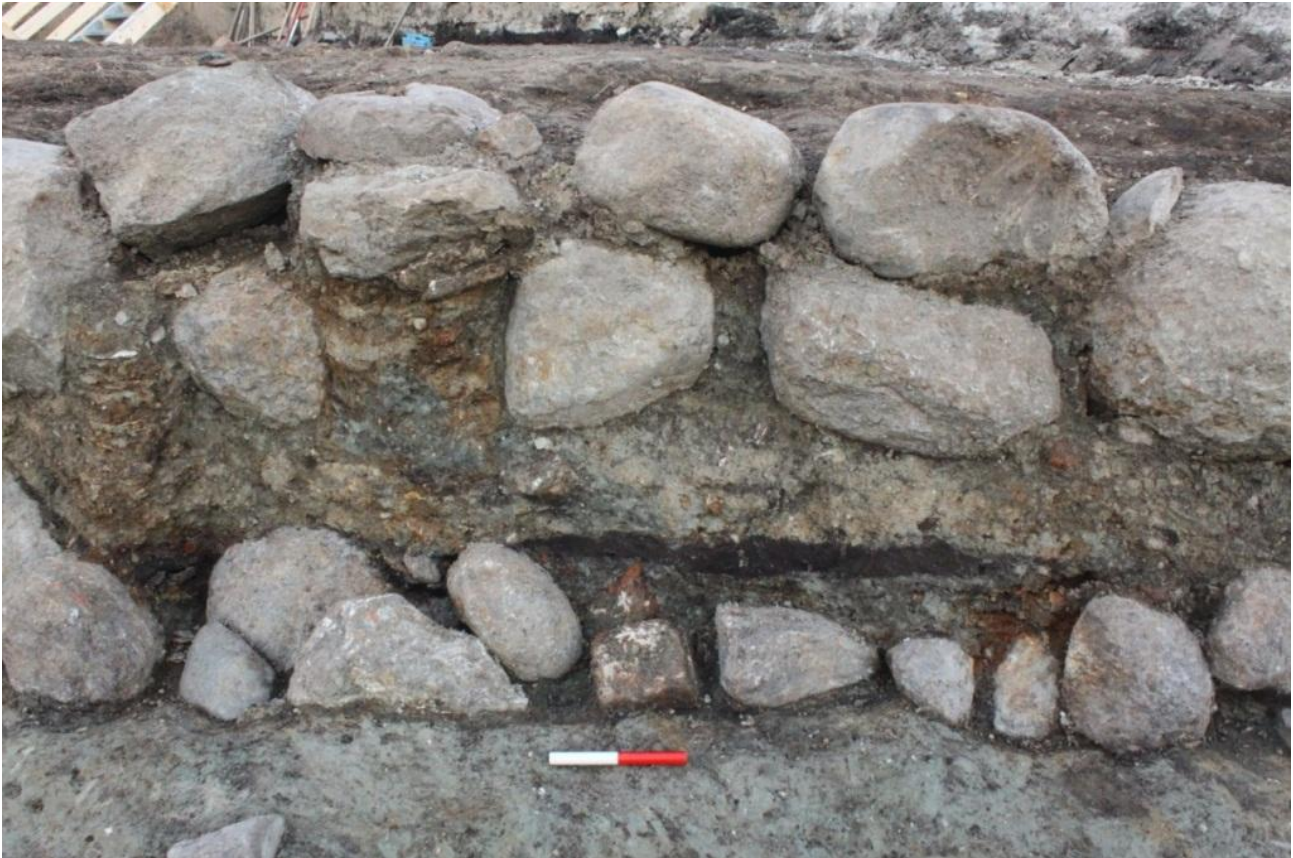
Fig. 210. Bastion foundation stones SS193802 and construction cut SC198471 with smaller stones SS197574 in front used as backfill, facing NW. Photo: Museum of Copenhagen.

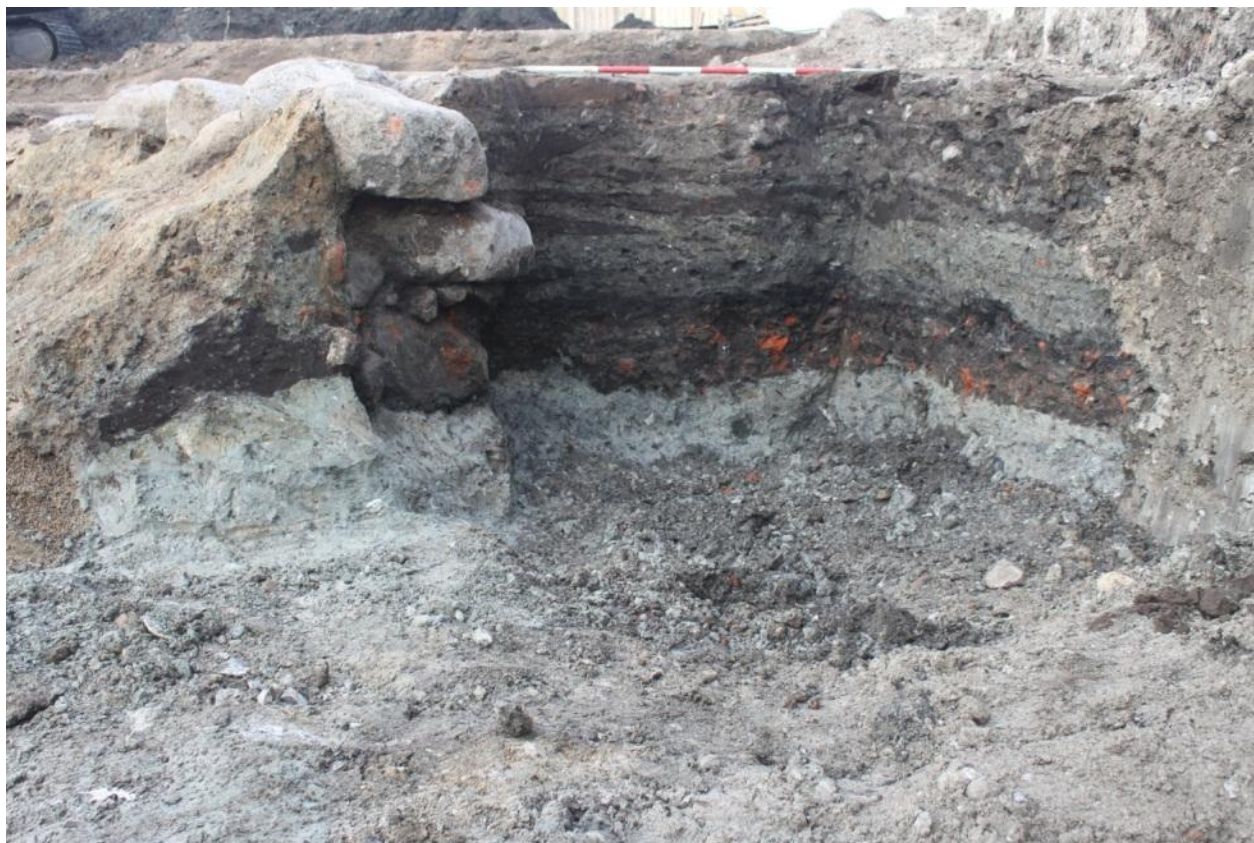
Fig. 211. Section, facing SW showing the bastion's core with different types of internal fill of lensed brown clay, firm greenish grey sandy clay and brown deposit SD197413 with brick fragments at the base above the natural moraine. Photo: Museum of Copenhagen.

With one exception the internal core of the bastion consisted of redeposited firm light greenish grey sandy clay with inclusions of CBM (red brick fragments) and pebbles (Fig. 211).

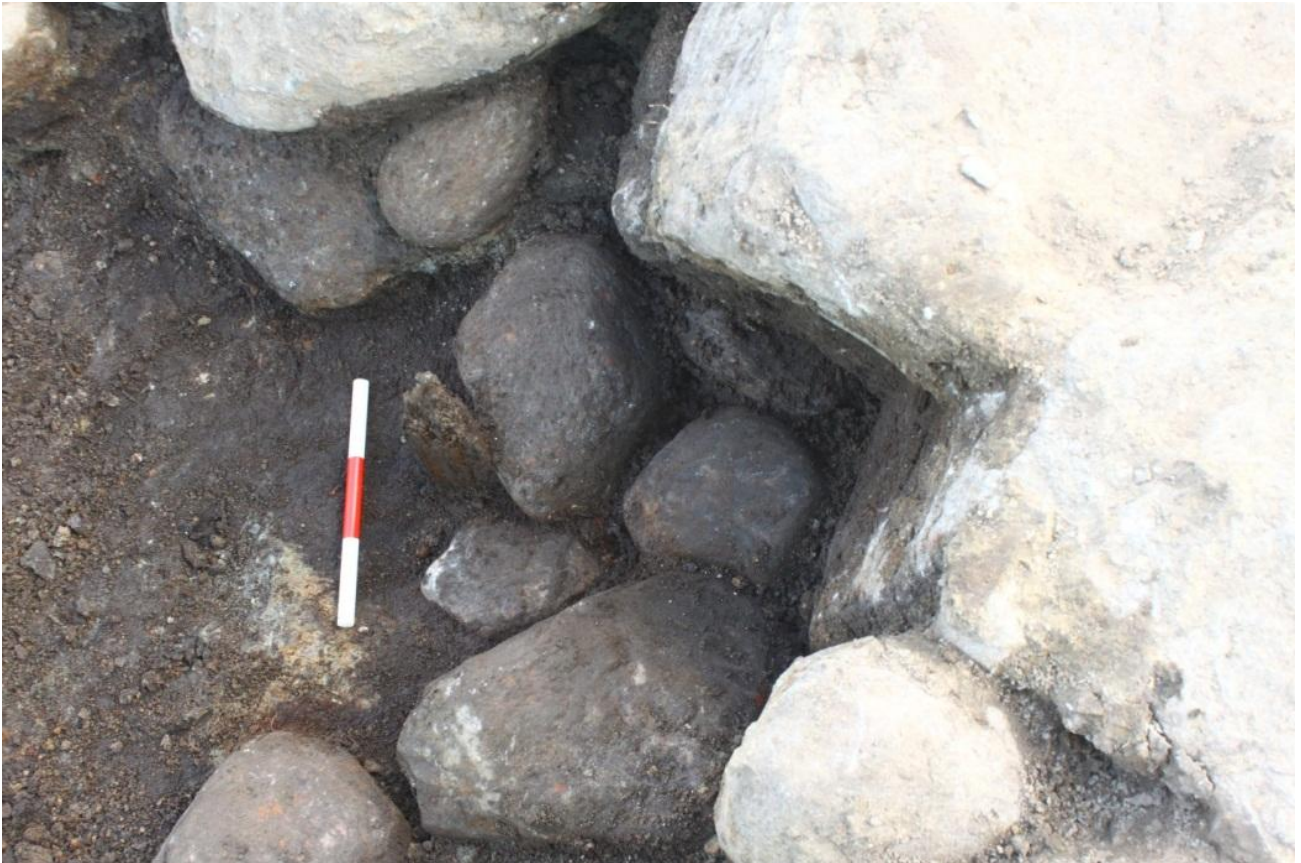
Fig. 212. Internal corner with vertical post (ST197391), facing south. Photo: Museum of Copenhagen.

Like the previous bastion line wooden posts were recorded among the stones. Timber (ST195526) consisted of a vertical, very soft post approximately 0.1 m in diameter and 0.7 m long with a tapered pointed base. ST195526 was situated to the west in one of the upper brick dump layers that filled the interior of the bastion. Post (ST197391), vertical and 0.65 m long, was set in the southern part of the inner side of the stone structure. The position of the posts by the edge of and within the internal fill, suggests that these were placed in order to mark the outline of the bastion during the building process (Fig. 212).

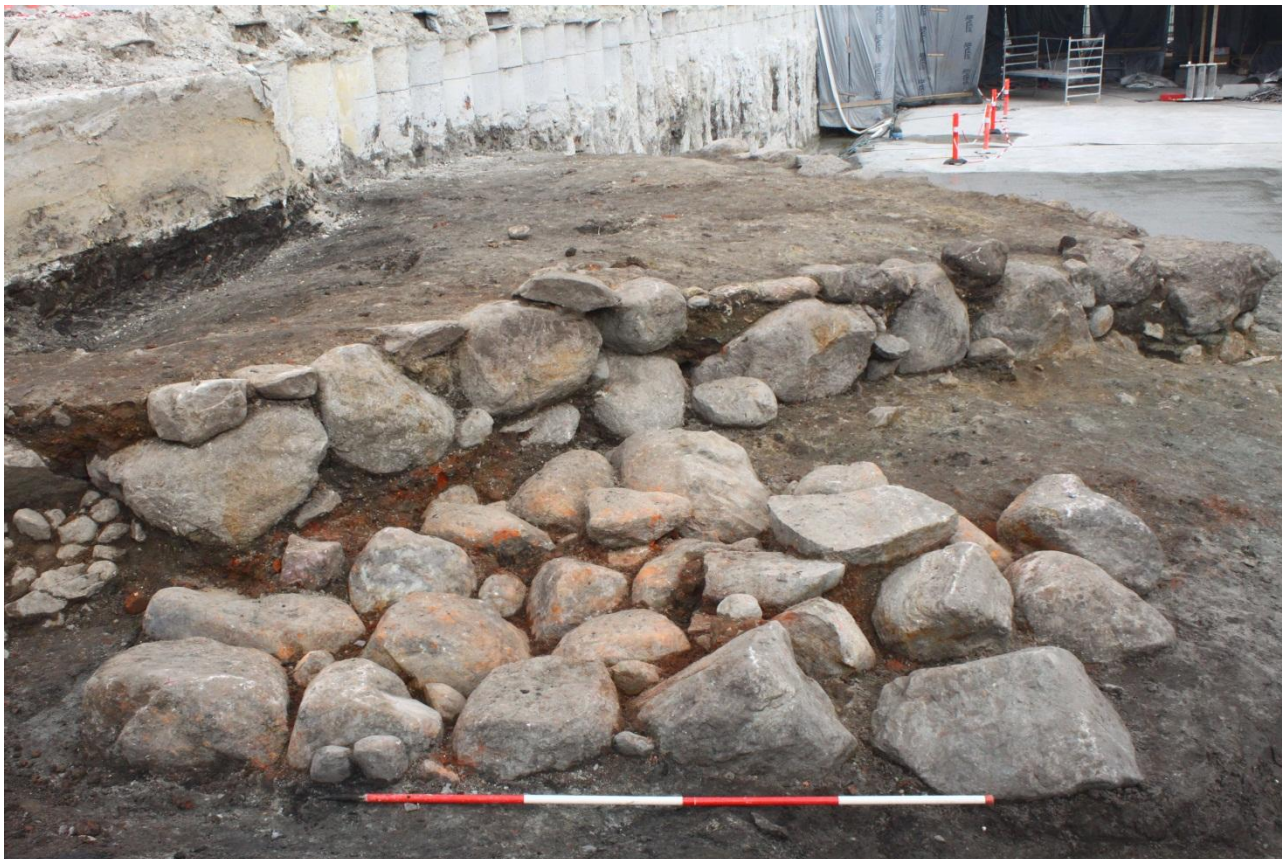
Fig. 213. SS195613 in front of the main bastion line, facing NE. Photo: Museum of Copenhagen.

SS195613 consisted of smaller stones and large boulders, laid in a rectangular shape of roughly 4.5 x 2.8 m, directly outside the main bastion line (Fig. 213).

The stones were evenly deposited and covered by a brick layer (SD195337). On site the feature was first thought to be separate from the main bastion, perhaps acting as some kind of "helping" construction while building the fortification.

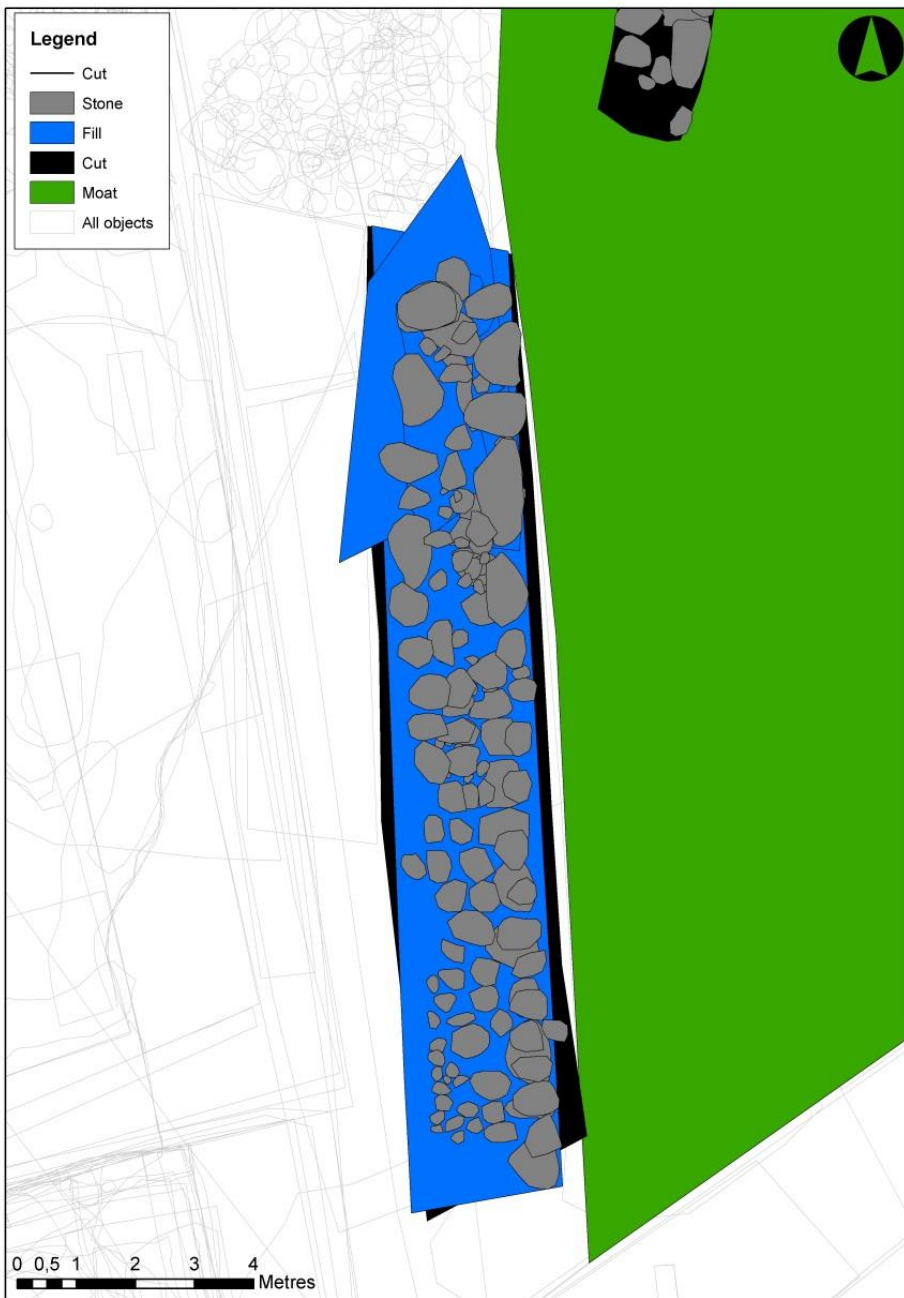
Fig. 214. North-south running curtain with construction cut, two courses of stones and boulders together with foundation layers. Part of the contemporary moat to the right.

The foundation of the curtain consisted of two courses of boulders, stones and layers running in a N-S direction at a length of 16.5 m. The width varied, but was approximately 2.5 m (Fig. 214). The purpose of the structure was to severely limit the erosion of and to form a solid foundation for the rampart material and structures built on top of it, in the same way as the foundation stones incorporated in the construction of the bastion.
