18 Phase 6 Eastern gate building and Post medieval fortification 1600–1650 AD

18.1.1 Østerport – additions, activities and deconstruction

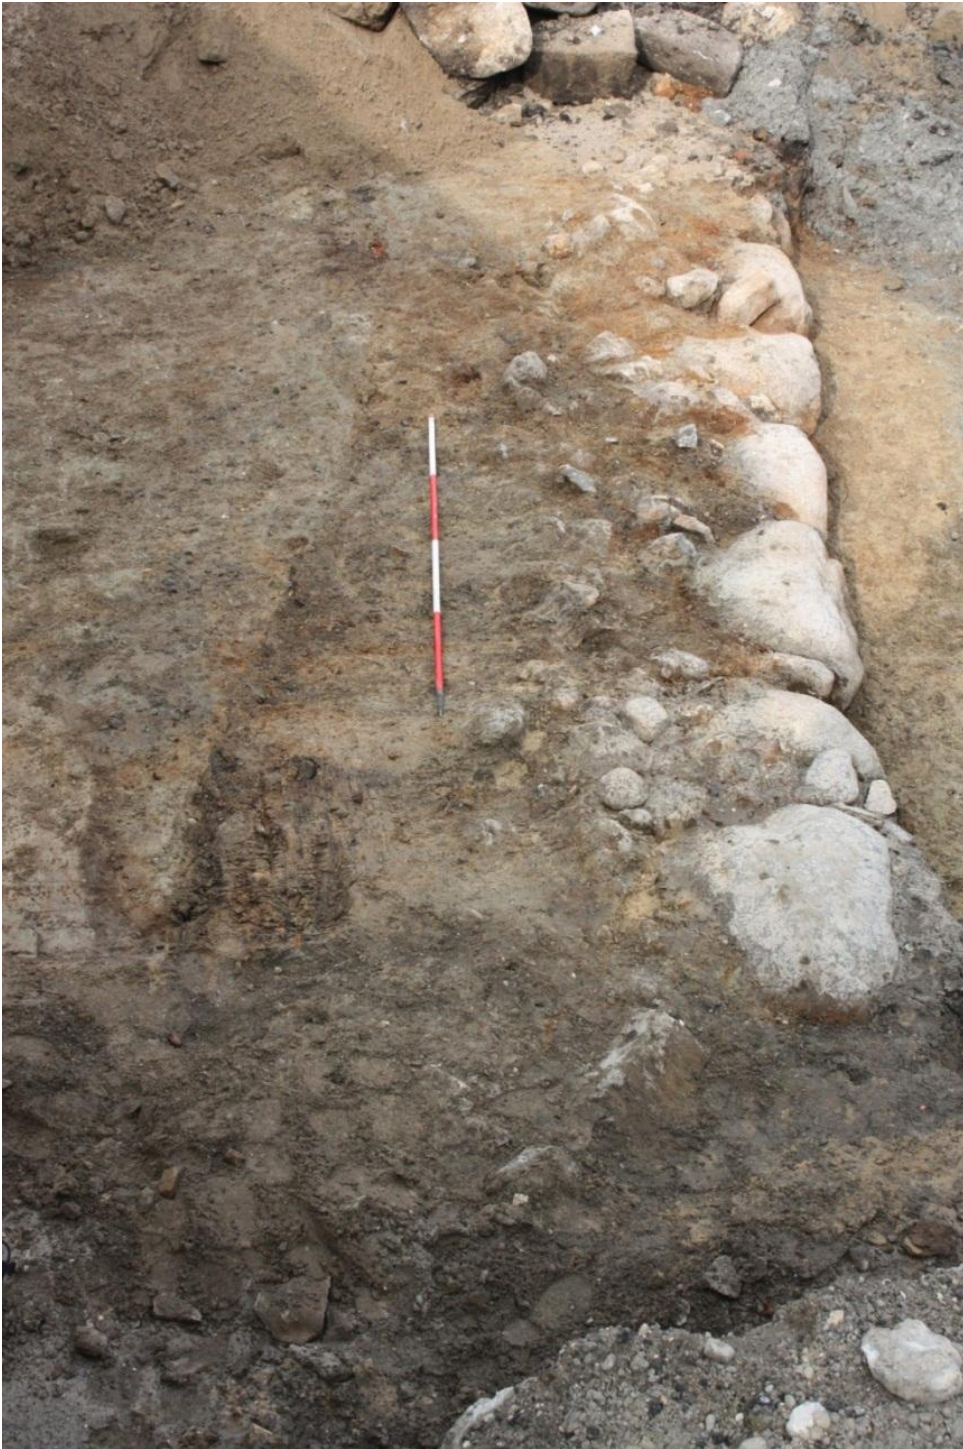
Fig. 215. Upper part of the 17th century curtain. Foundation stones SS305778 and rubble infill SD305863 with the inner construction cut to the left, facing north. Photo: Museum of Copenhagen.

The construction cut for the curtain was rectangular in plan with slightly curvy edges, concave sides and a flat base. It appeared to have been cut into natural moraine on the west side and through excavated moat material (natural clay and sand) on the east side. Context (SS305778) consisted of large rounded and randomly shaped naturally formed foundation boulders. The top course of stones had a rubble/stone mix behind the inner face of the stones (Fig. 215 and 216). The first course of foundation stones SS305955 consisted of a double row of similarly sized boulders as those in SS305778, but also with smaller stones and some CBM infill between the stones.

The rubble infill and foundation layers (SD305863) were amalgamations of large stones up to 30 cm in diameter, smaller stones with small fractured pieces of CBM, but no identifiable bricks or half bats. The deposits were mixed with yellow/grey sand and natural clay – possibly consisting of removed natural moraine from the original construction cut.

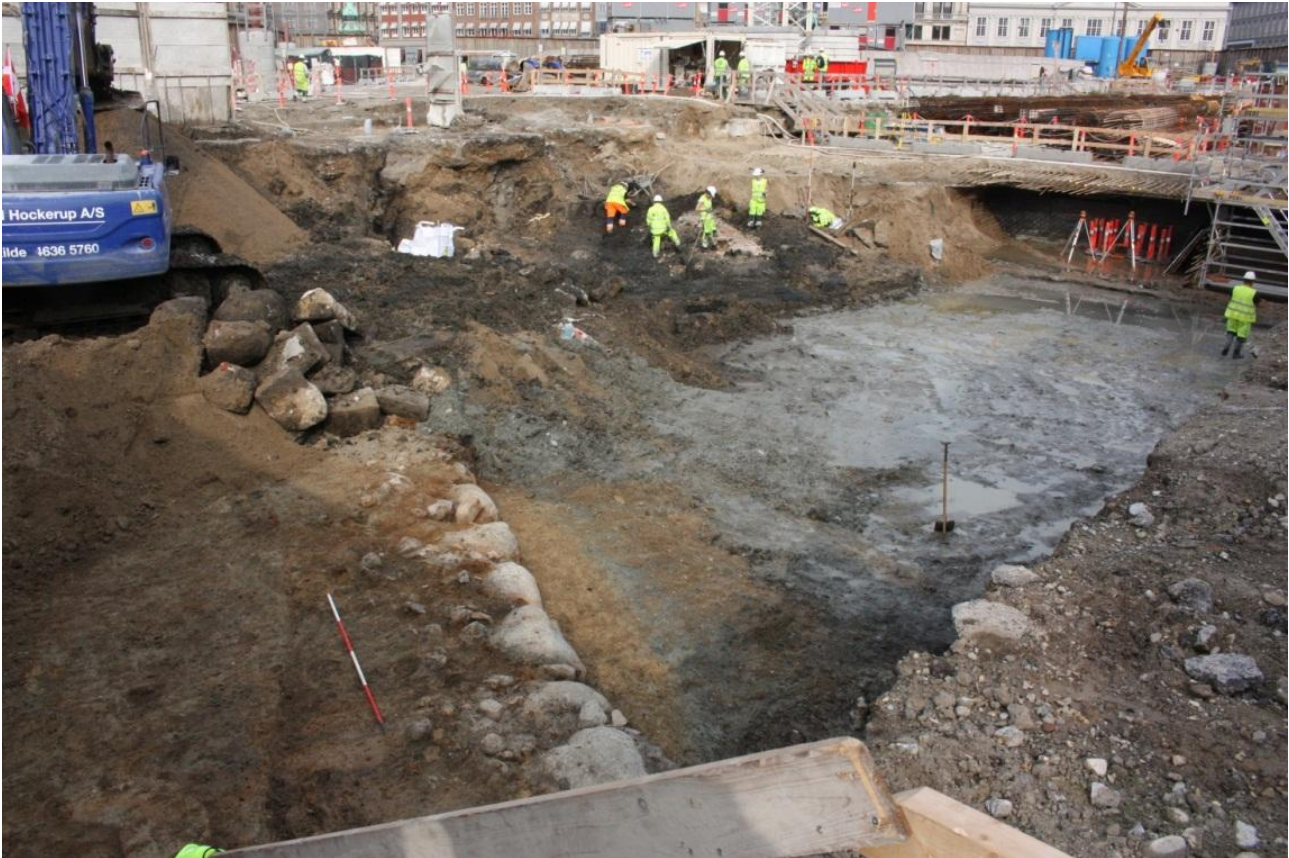
Fig. 216. Investigating the 17th century fortification step by step. Part of the exposed curtain, facing north. In the middle – staff working on one of the bridge pillars. To the right – the excavated 17th century moat. Photo: Museum of Copenhagen.

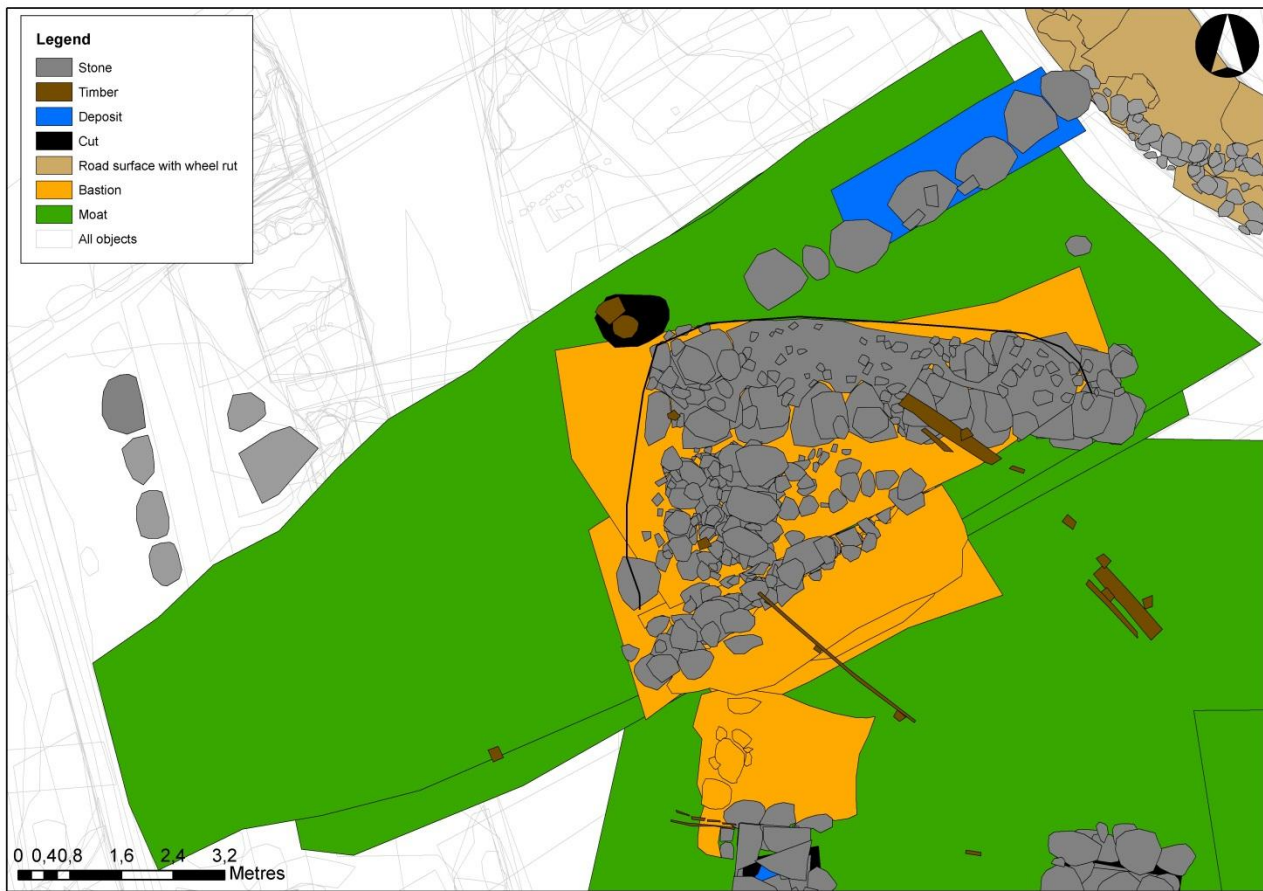
Fig. 217. Stones with unclear purpose documented in association with the 17th century fortification. Be aware that the estimated edge of the moat is measured a little far to the north due to machining.

Subgroup (SG-503795) consisted of five mid grey stones with a flat surface facing upwards (Fig. 217). The two separate rows of stones were situated in and covered by rubble fill and the stones might well not have been in situ, but could also have ended up in the rubble layer later. It should also be stressed that the area around the stones had been truncated by modern trenches such as concrete cable boxes and a central heating duct. The stones were approximately 1.0 m higher than the curtain, so the structure is not a continuation of this structure. Group (G-503427) consisted of a row of seven stones running in a NE-SW direction between the road surfaces to the north and the 17th century moat to the south. These were of different sizes and none of them were flattened on top. The shape and surface of the stones showed no signs of wear, suggesting that they were either related to earlier road(s) to hold back soil on top of the slope as a stabilizing structure, or were part of a limit to an unknown stone structure (part of the 16th century roundel? – see Fig. 152 and further discussion below).

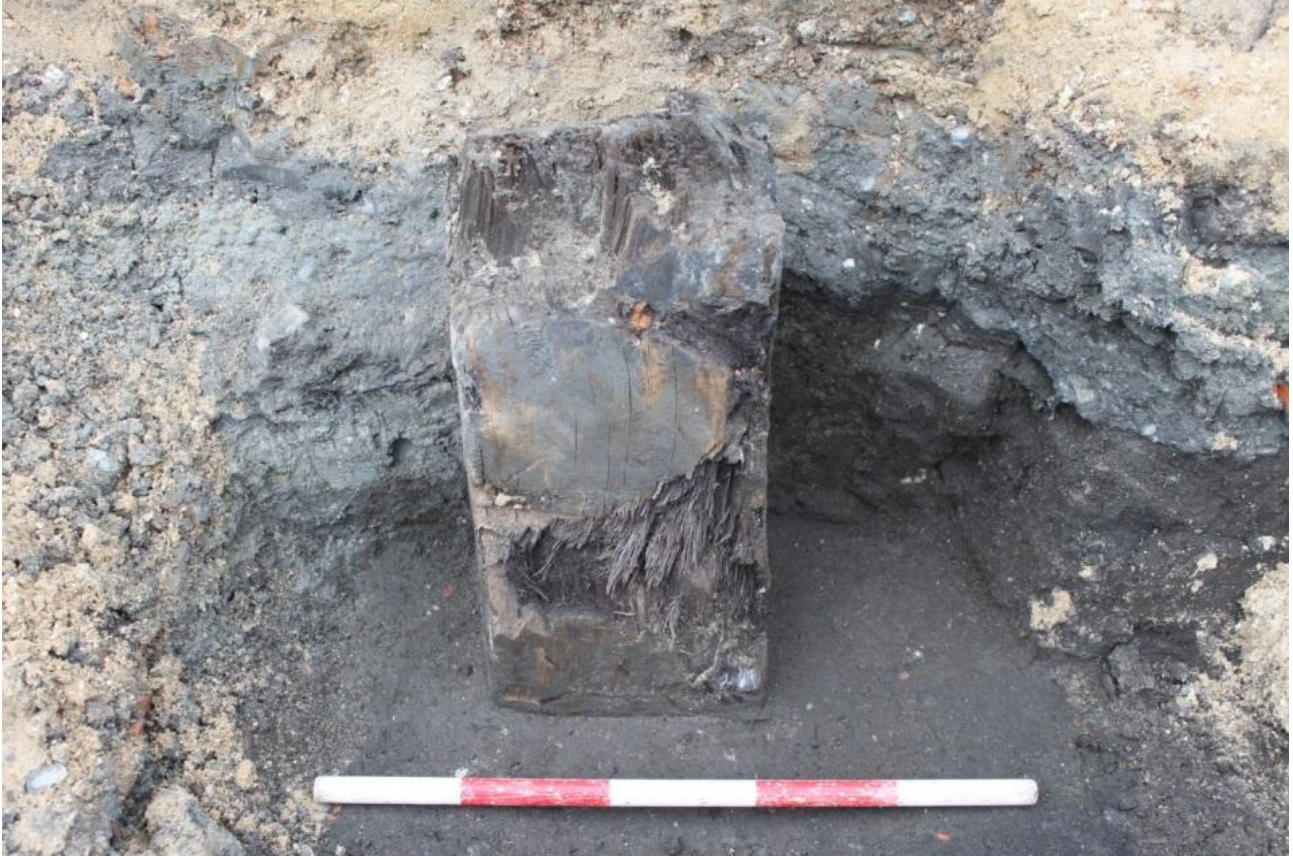
Fig. 218. Box hearted post (ST177435) in situ, facing SE. Photo: Museum of Copenhagen.

ST177435 consisted of a vertical timber partly exposed after removing a central heating pipe with modern backfill (2012). The post had a flat end and its middle section had been worked, with small axe marks around 0.10-0.20 m long (Fig. 218). Its depth was > 0.60 m. Interpretation is unclear, but it was probably part of a bulwark.

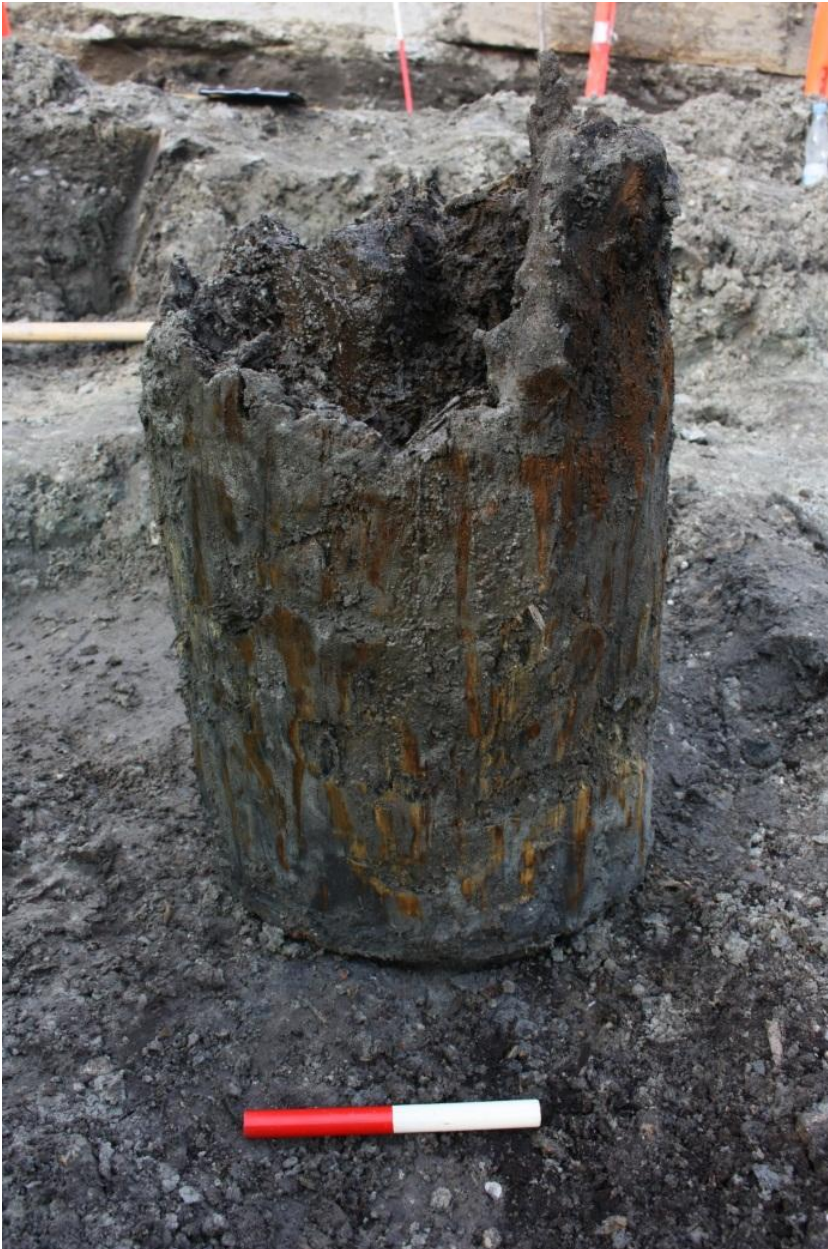
Fig. 219. Timber (ST310935) with a flat base. Photo: Museum of Copenhagen.

Timber ST310929 consisted of a worn upright and squared pine post placed directly up against another cylindrical and upright post ST310935 (Fig. 219). Context (SC310947) was the sub-circular construction cut made for the two posts with a total depth of 0.82 m. The function is unclear, but they could have been part of the 17th century bastion.

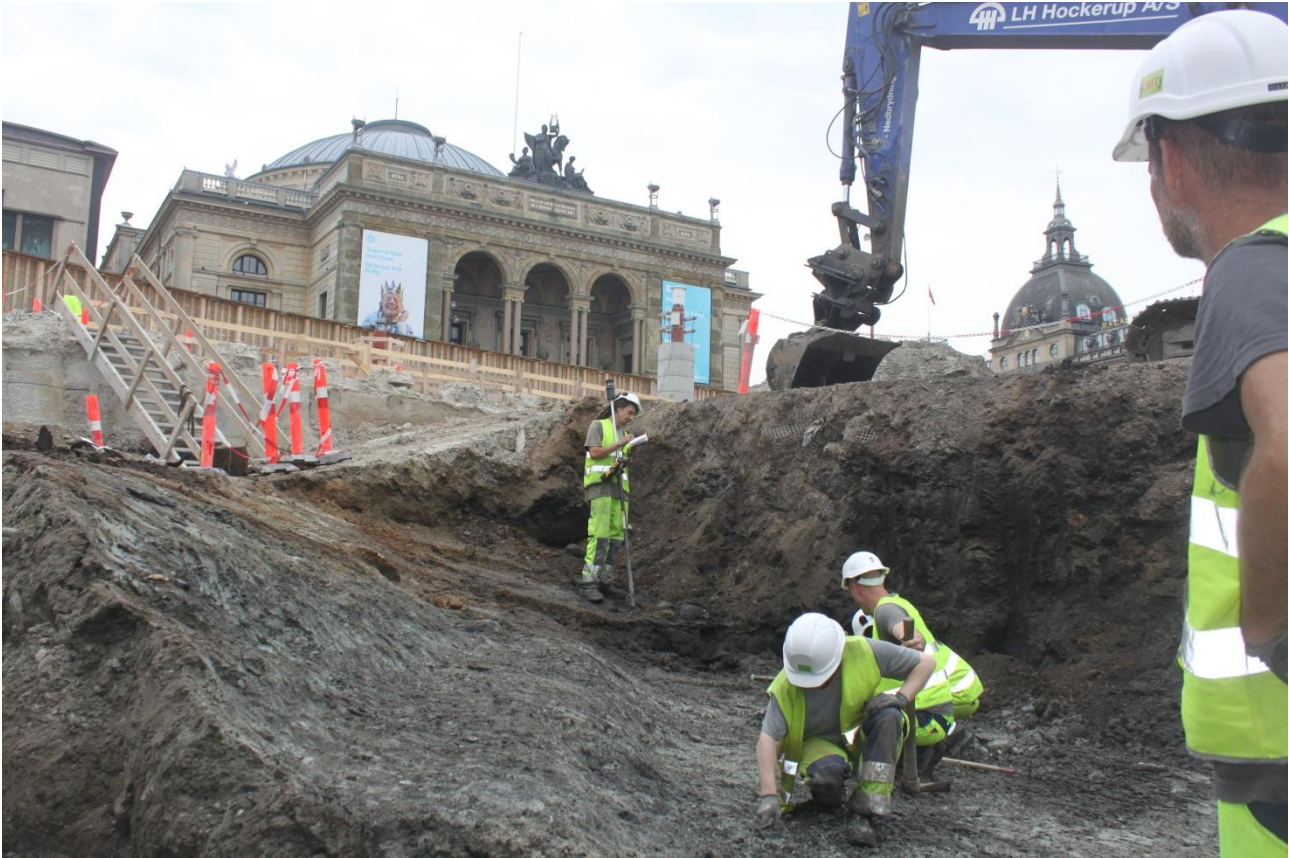
Fig. 221. Exposing and cleaning the eastern stepped side of the 17th century moat, facing south with the Royal Theatre in the background. Photo: Museum of Copenhagen.

The sides had an angle of 45 degrees and with a gradual break of the slope to the concave and flat base. At the eastern side of the moat a separate step was recorded close to the base (Fig. 221). It is uncertain whether this ledge was created as a pathway while building the fortification or should be seen as part of the defence system.

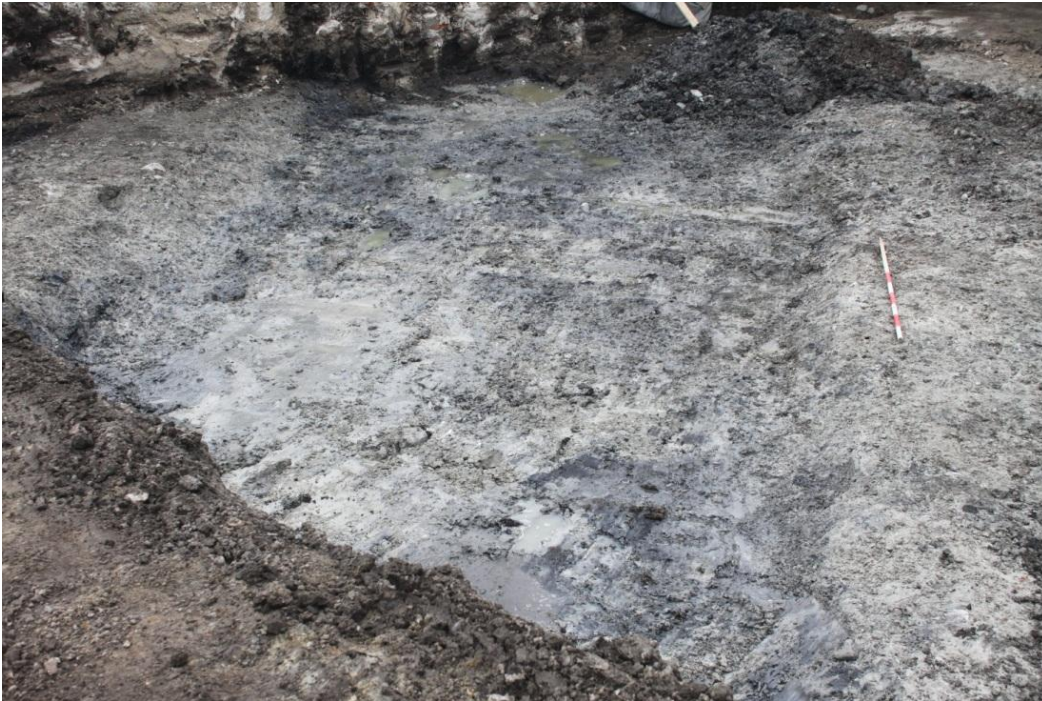
Fig. 222. Part of interpreted cunette in the 17th century moat, facing NE. Photo: Museum of Copenhagen.

In the middle of the moat a N-S oriented, rectangular construction cut was recorded at the base of the moat cut, into the natural substrate (Fig. 222). This was interpreted as a cunette (a trench dug in the moat to allow drainage, or as an extra obstacle for attackers). The width varied from 5.2-6.6 m with a depth of 0.15 m. The base was flat and the sides steep.

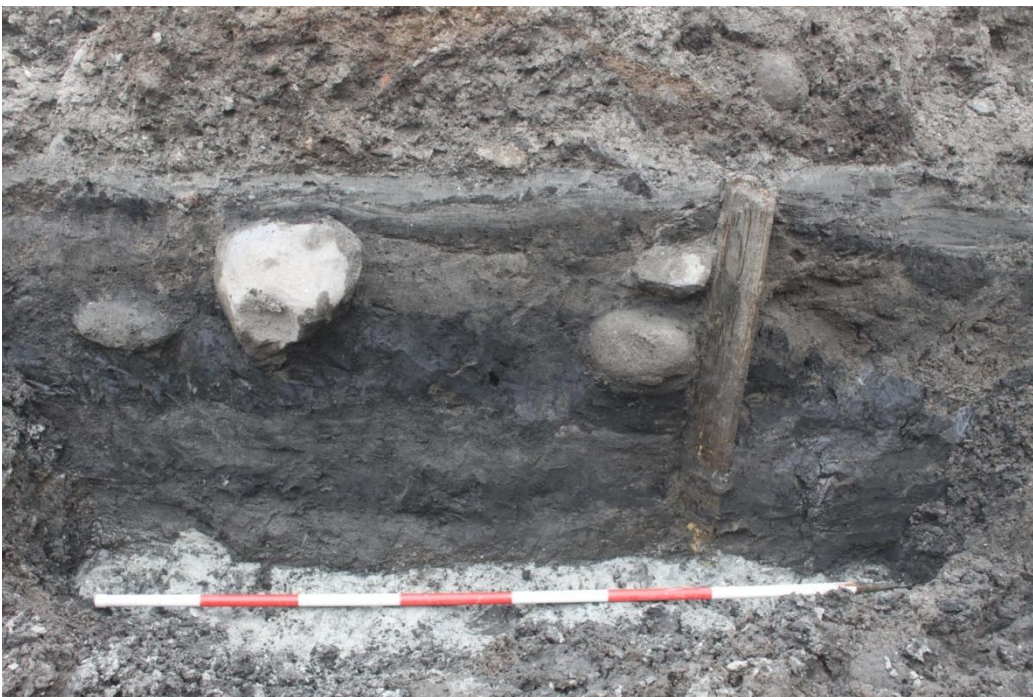
Fig. 223. Trench cut showing darker alluvial sedimentation (SD192275) at the base of the moat, facing west. The white layer represents natural moraine and the post is part of timber structure (G-240090). Photo: Museum of Copenhagen.

The sedimentation in the moat varied in thickness from 0.1-0.5 m and consisted of lensed dark brown and black decomposed peat with lenses of white sand and different types of finds (Fig. 223). Some of the finds must be connected to the later deconstruction phase pressed into the underlying soft deposits, but overall this assumption does not affect the dating of the deconstruction phase to the mid 17th century.

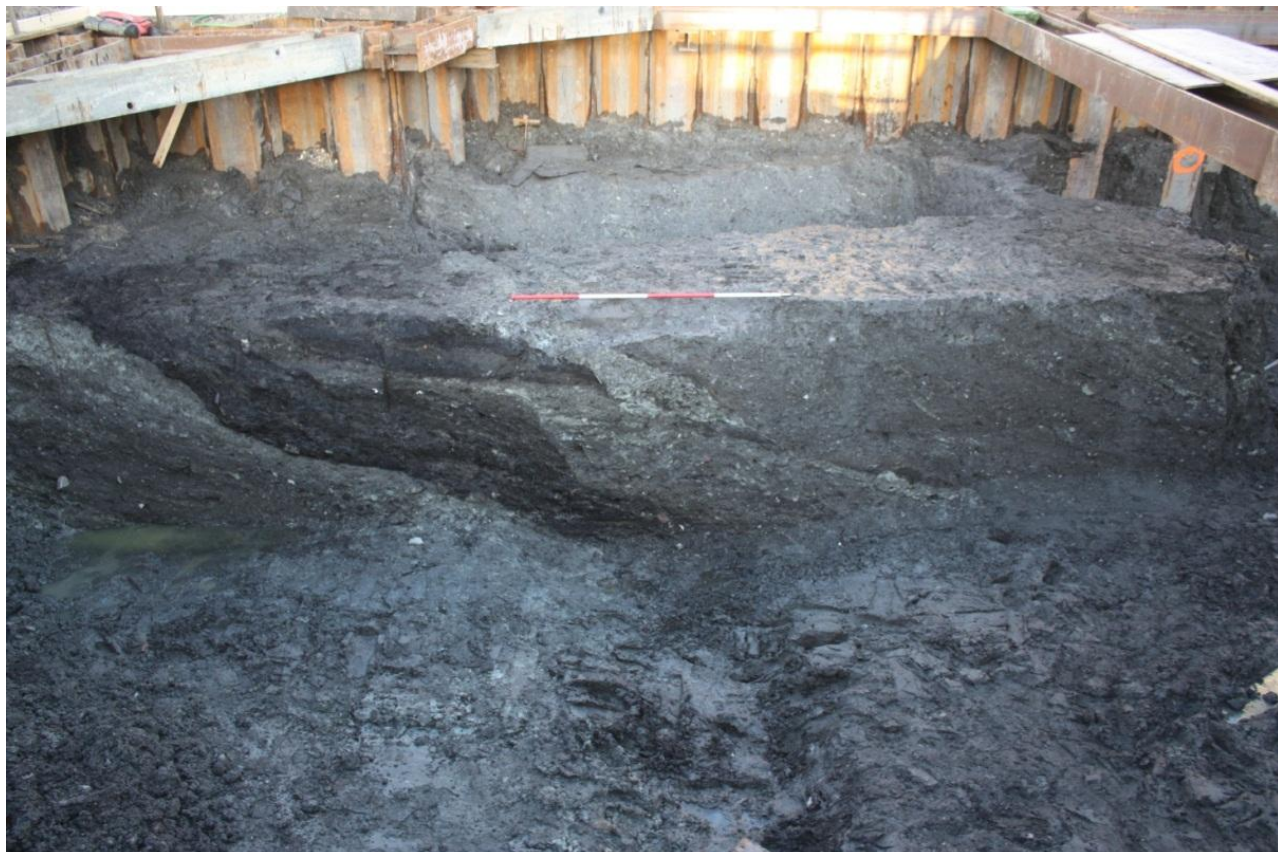
Fig. 224. Excavation of the Transformer Station in 2010. Different dumps and moat backfills seen in section C50254, facing SW. Photo: Museum of Copenhagen.

In the mid 17th century the fortification was demolished and the moat filled up mainly from the curtain side (south and SW) (Fig. 224). The dumped material consisted of several deposits of different colour, composition and homogeneity. Some layers contained large amounts of urban, household waste (animal bones), decomposed, organic material (manure) and demolition material (CBM). No clear evidence of industrial activity can be seen within the dumped material, except for a significant number of leather off cuts and concentrations of horn at some places. However, the moat was excavated by watching brief only (machined), so the finds retrieval is far from being as detailed as that in a full excavation (e.g. compared with the moat and finds from other Metro investigations such as Rådhuspladsen).

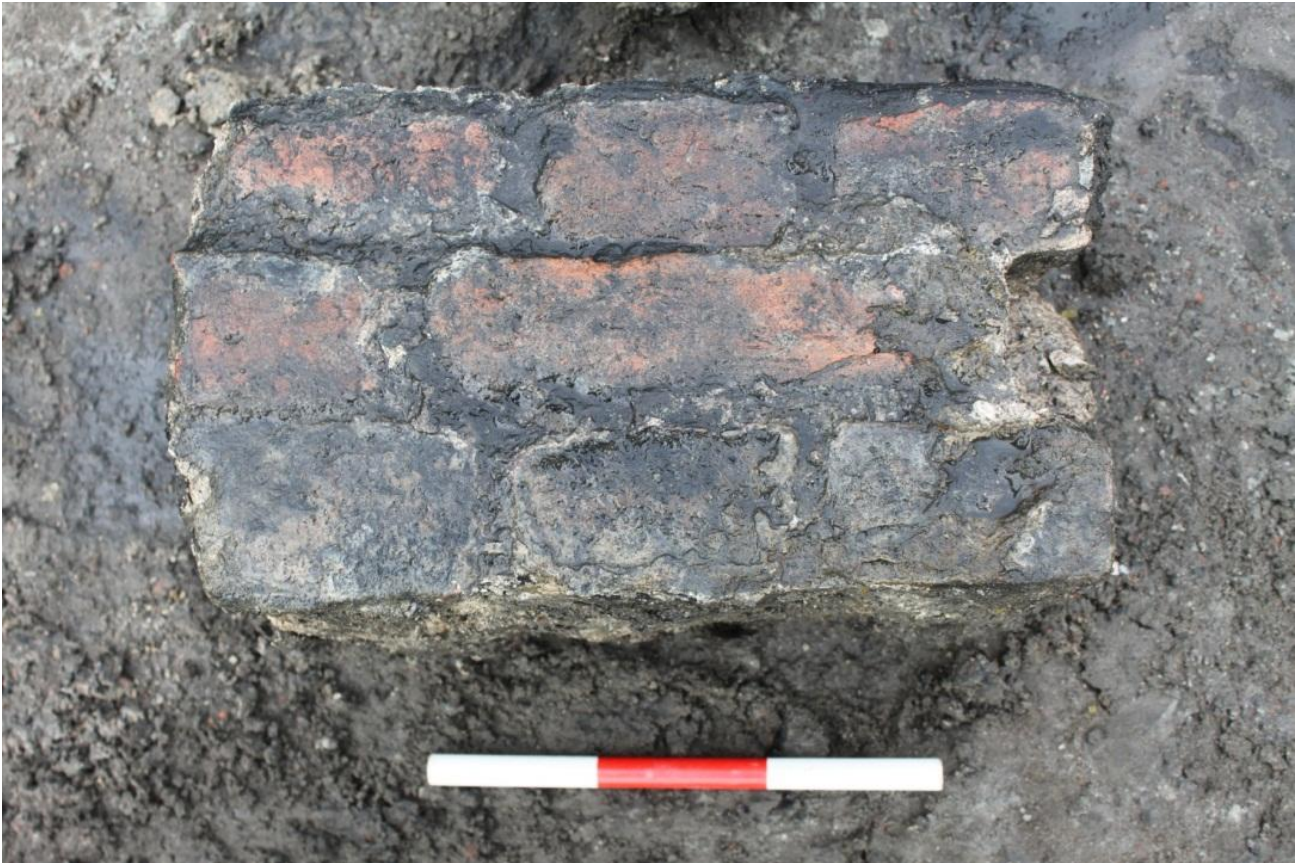
Fig. 225. Building material from the former moat. Masonry (Dutch or English cross bond) from demolished bridge structure, from above. Photo: Museum of Copenhagen.

Some of the deposits in the moat should be mentioned: SG-500893 consisted of demolition material from the bridge piers in G-500892 (Fig. 225). Some of these layers were interpreted as forming a ramp in order to access the bridge piers whilst the overlying deposits of masonry and demolition material derived from the deconstruction of the bridge piers together with urban waste.

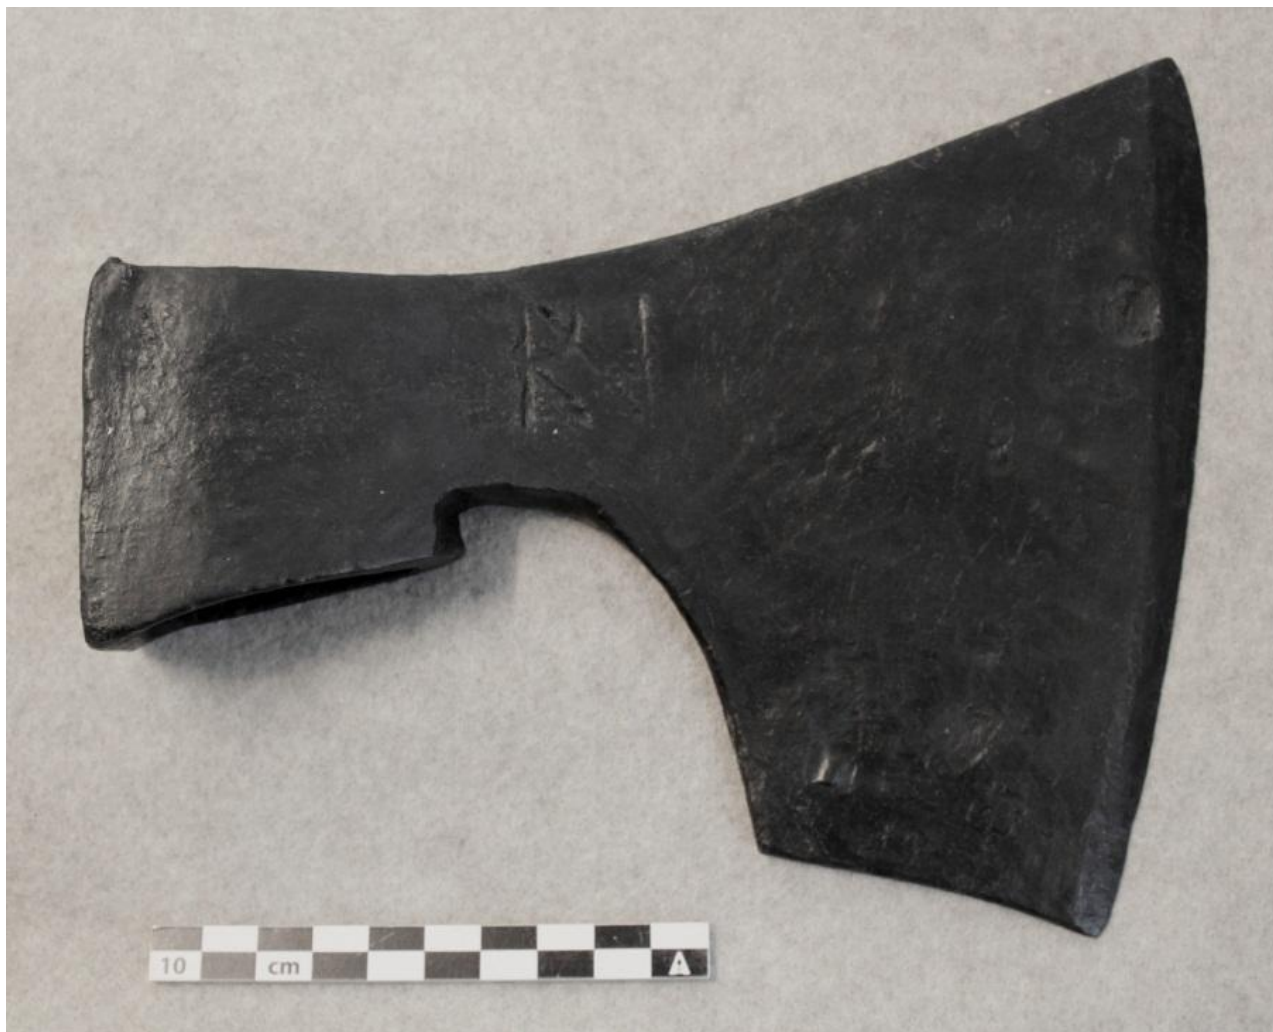
Fig. 227. Broad axe (FO501815) from the original sedimentations in the 17th century moat, after conservation. Photo: Museum of Copenhagen.

A coin (FO500999) from one of the deposits represents a ¼ øre from Sweden; Kristina (1632–1654 AD) and (FO501004); a Frederik III, 1 søsling from 1651. FO501011 is a Wolf Lauer token (1612–1651 AD). Coin (FO501002) consists of a Christian IV, 1 skilling from 1621 AD, FO501009 is a Hans Krauswinckle token, probably from the 1580s and FO501012 is an Alexander Mang token, probably from around 1601 AD. The axe found in (SD190850) is a broad axe with asymmetrical bevelled edge (Melin 2014:12-13). Axes with an asymmetrical bevelled edge are sometimes called single bevel and/or side axes. Since these types of axes more correctly have one clear bevel and one less clear, the author prefers to call them asymmetrical. As the name side axe implies they are specialized tools to be used for hewing the sides of timbers, etc. to accomplice a smooth surface. The axe is made for a right handed craftsman who stands with his left leg close to the timber when hewing. The owner's initials (KI) can be seen on the blade (Fig. 227).

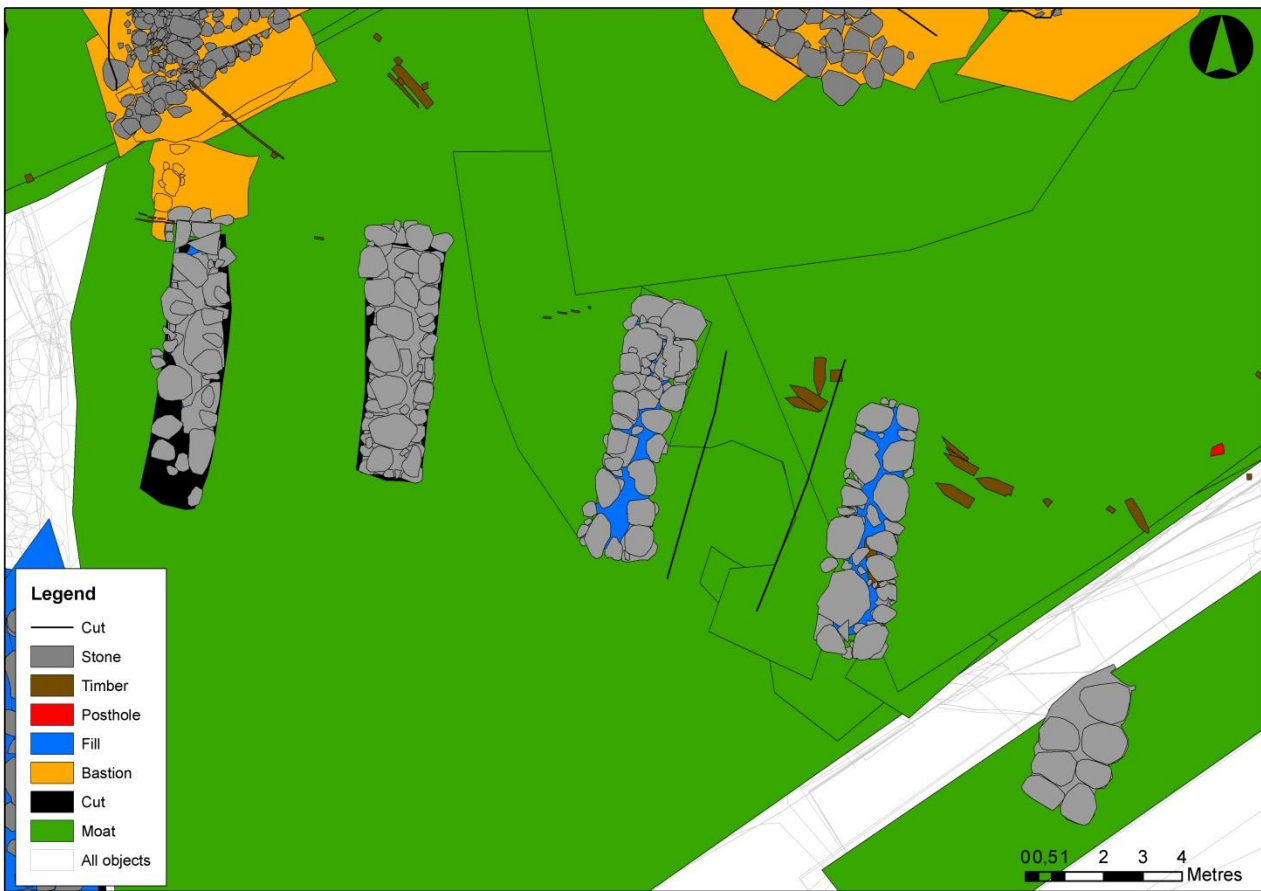
Fig. 228. Bridge pillars in the 17th century moat starting with pillar No. 1 to the left. Notice the weak curve between bridge pillars Nos. 1 and 2 and bridge pillars Nos. 3, 4 and 5, probably done for defence considerations. Compare with bridge in prospect Fig. 268, below.

The bridge in the moat consisted of five NNE-SSW orientated bridge pillars, slightly curving to the south (G-500892) (Fig. 228). The length and width of each were roughly equivalent (L: 6-7 m and W: 1.5-1.8 m), and the distance between the pillars was between 3.5 and 4.5 m.

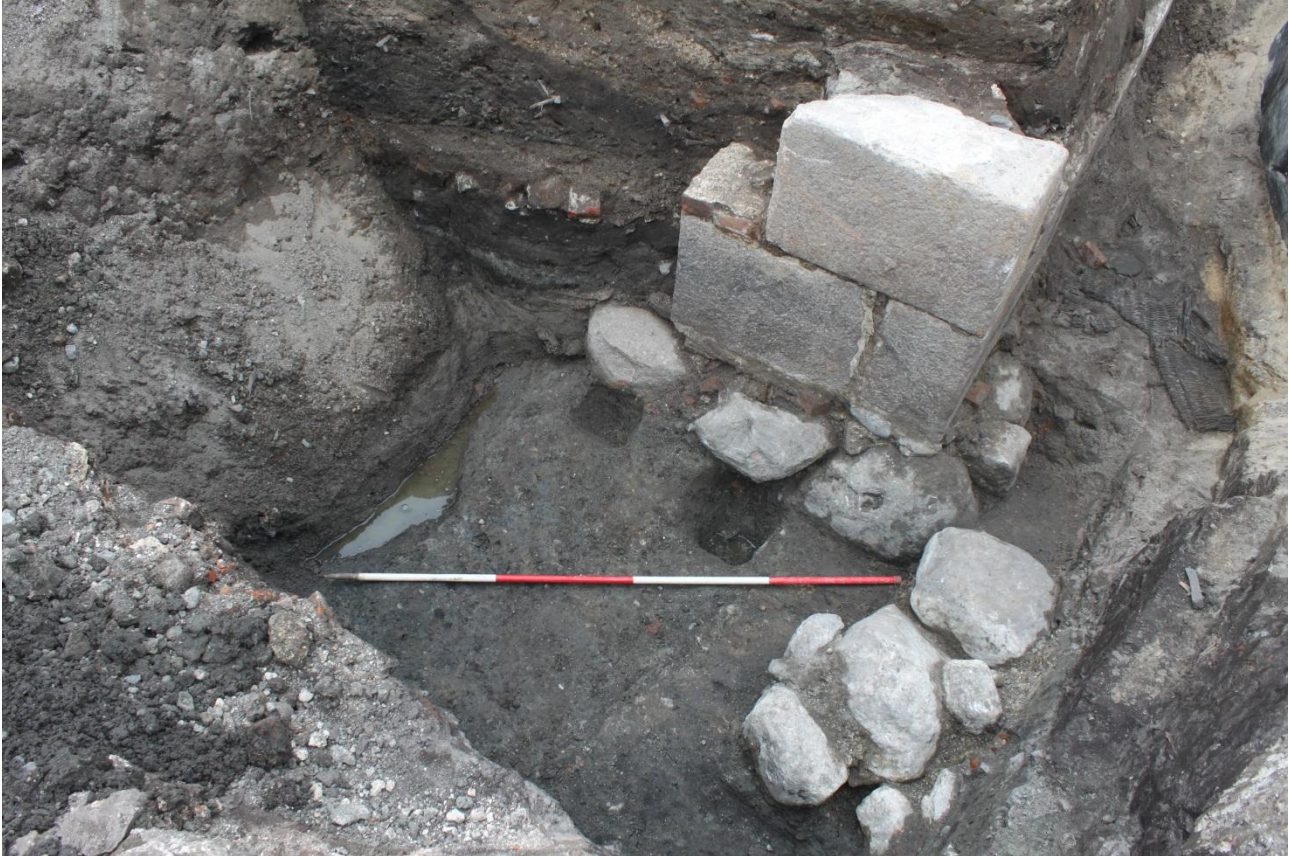
Fig. 229. Foundation stones SS176940 and ashlar stones SS175676 documented in part of the Guide Wall trench 2012, facing SE. In the middle – a test pit to investigate the depth of the stone structure. Photo: Museum of Copenhagen.

The foundation consisted of two uneven courses of mid grey, unfinished boulders and medium size stones (Fig. 229). The structure was two stones wide and the gaps in between were filled with grey clay and yellow compact and coarse mortar, red brick material, red tiles and minor grey smooth stones of 10-20 cm. It appeared that the 1st stone layer (SS305540) was much longer north to south, so the stones had been placed so as to create a stepped foundation. The foundation stones/boulders all had a smooth surface on every side and had not been cut or shaped. The northern extent of the boulders was covered with blue clay related and belonging to the nearby bastion foundation (SD176814; see SG-813).

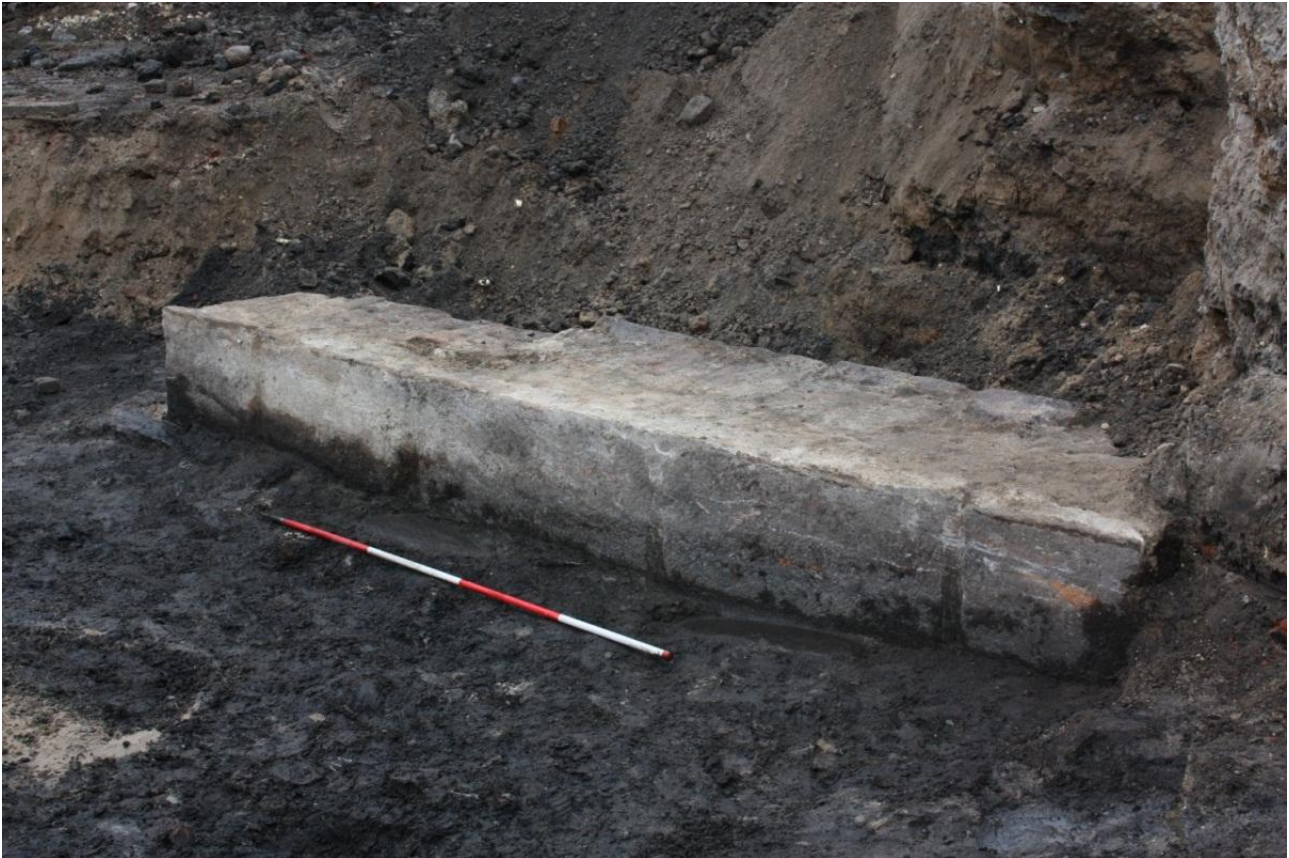
Fig. 230. Continued investigations. Exposed bridge pillar No. 1 (2014) with ashlar stones SS304586 and cemented core of yellow-white mortar, facing SW. NW part not fully exposed due to Station Box limit. Photo: Museum of Copenhagen.

On top of the foundation two courses of well finished, rectangular, upright mid grey ashlar and regular blocks of different size were recorded (Fig. 230). The structure was faced externally and had a solid core of red brick fragments and with smaller stones, bricks and mortar in between. The bricks were probably reused, medieval “munkesten”.

The NW end of the first course was represented by a single stone and two red bricks mortared in position. Mortar on the top of the second course stone showed that the structure was previously at least three courses high. The joints of the stone and brick elements were rendered over to give a smooth finish. This was light grey, without inclusions, and very hard. The SW part of the structure was missing and probably was robbed out in the mid 17th century when the bridge went out of use.

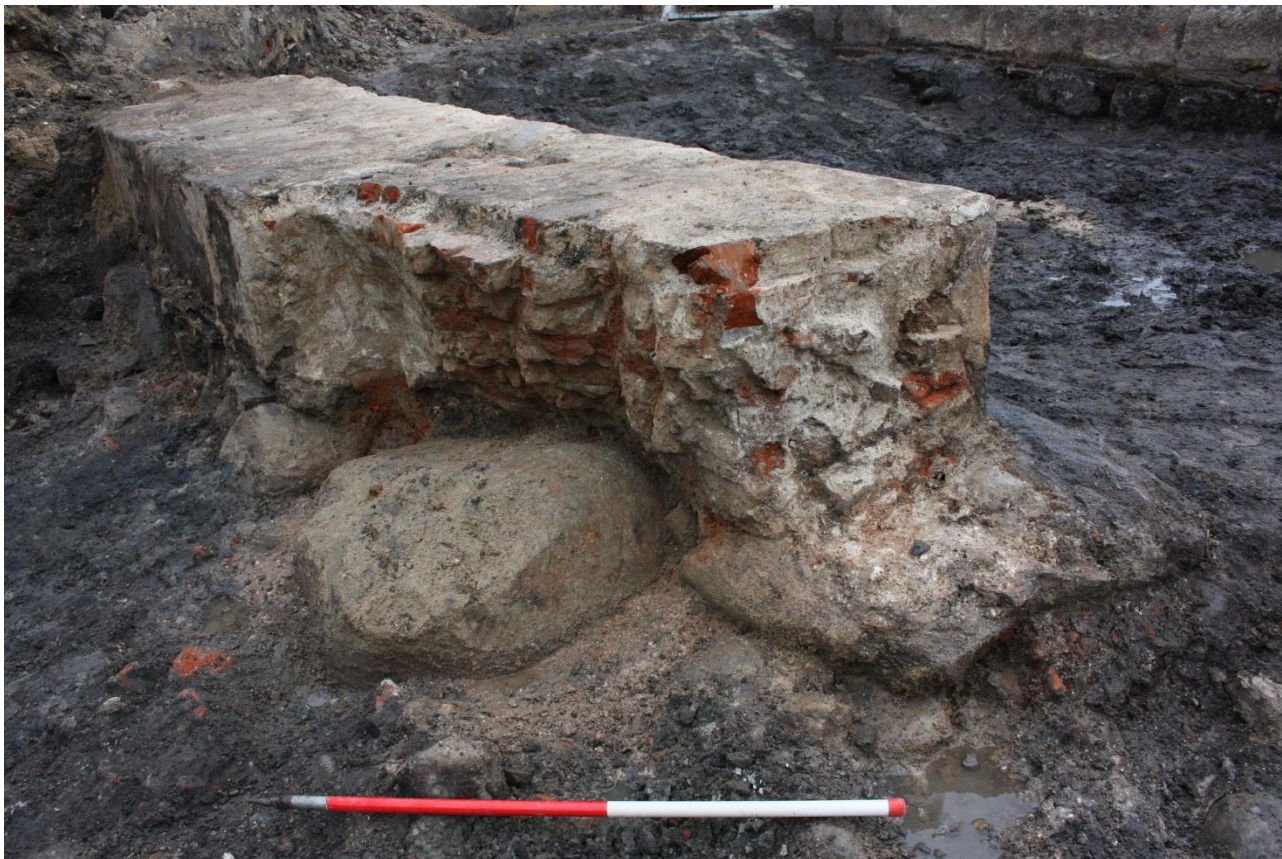
Fig. 231. Exposed bridge pillar No. 1 with foundation, cemented brick and mortar core SS304681 together with ashlar stones, facing NE. Photo: Museum of Copenhagen.

The upper part of the core consisted of strongly cemented yellow and white mortar and lime with inclusions of stones, bricks, charcoal, shell and possibly volcanic ash as a binder. The rest of the core consisted of bricks bonded with cemented mortar and placed in rows (Fig. 231). There was a structure in the placement of the bricks – yet the coursing was uneven and the main purpose had been to fill the gaps in a suitable way. Mortar was later poured into fill any remaining gaps/spaces. Furthermore it appeared that a significant amount of mortar had been poured on top of the 2nd row of foundation stones prior to placing the faced stones and bricks, probably to create an even platform and to hold the structure together. Like the ashlar stones, the south and SW corner was missing and had been probably robbed out.

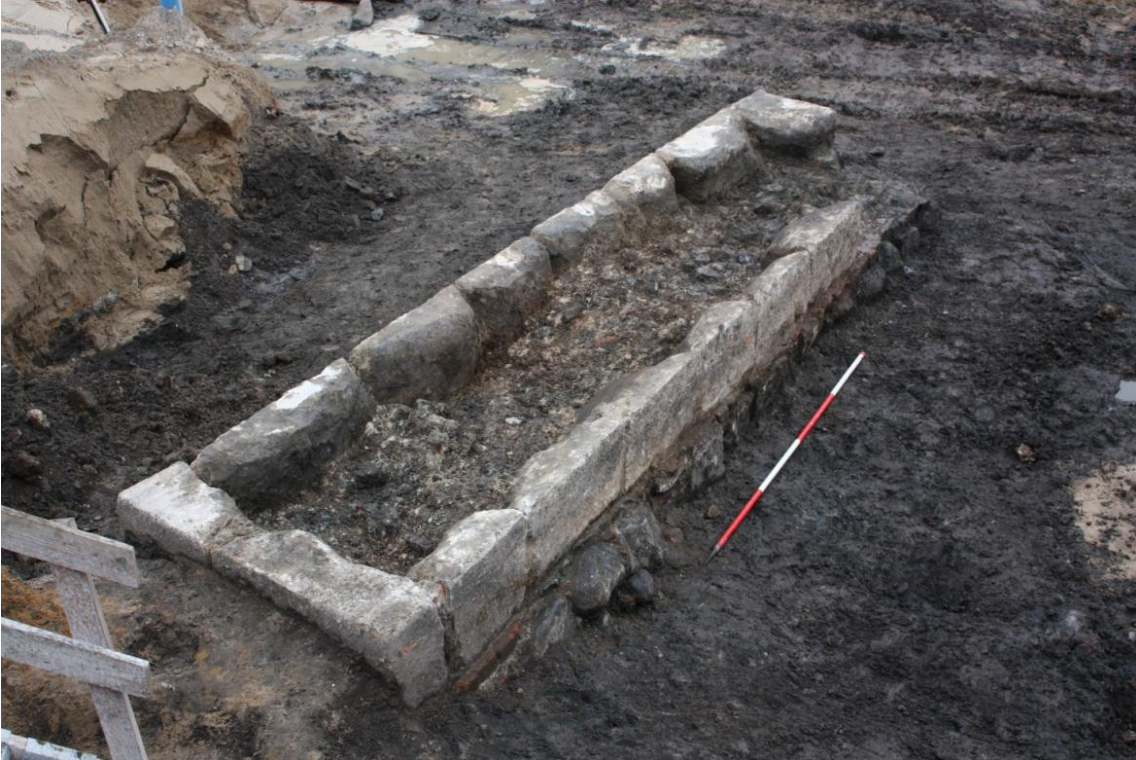
Fig. 232. Upper part of bridge pillar No. 2 represented by ashlars SS304186 and infill SS304582, facing SE. Photo: Museum of Copenhagen.

Context (SS304186) consisted of well finished upright, rectangular light grey ashlar and regular blocks with a length from 0.5 m to 1.0 m (Fig. 232). The rectangular structure had a well laid outside face and a solid core of red brick fragments and smaller stones, bricks and mortar in between. The bricks were probably reused medieval bricks ("munkesten") as also seen in pillar No. 1. The joints of the stone and brick elements were rendered over to give a smooth finish. This was light grey, without inclusions, and very hard. The SW part was missing and probably had been robbed out (Fig. 233).

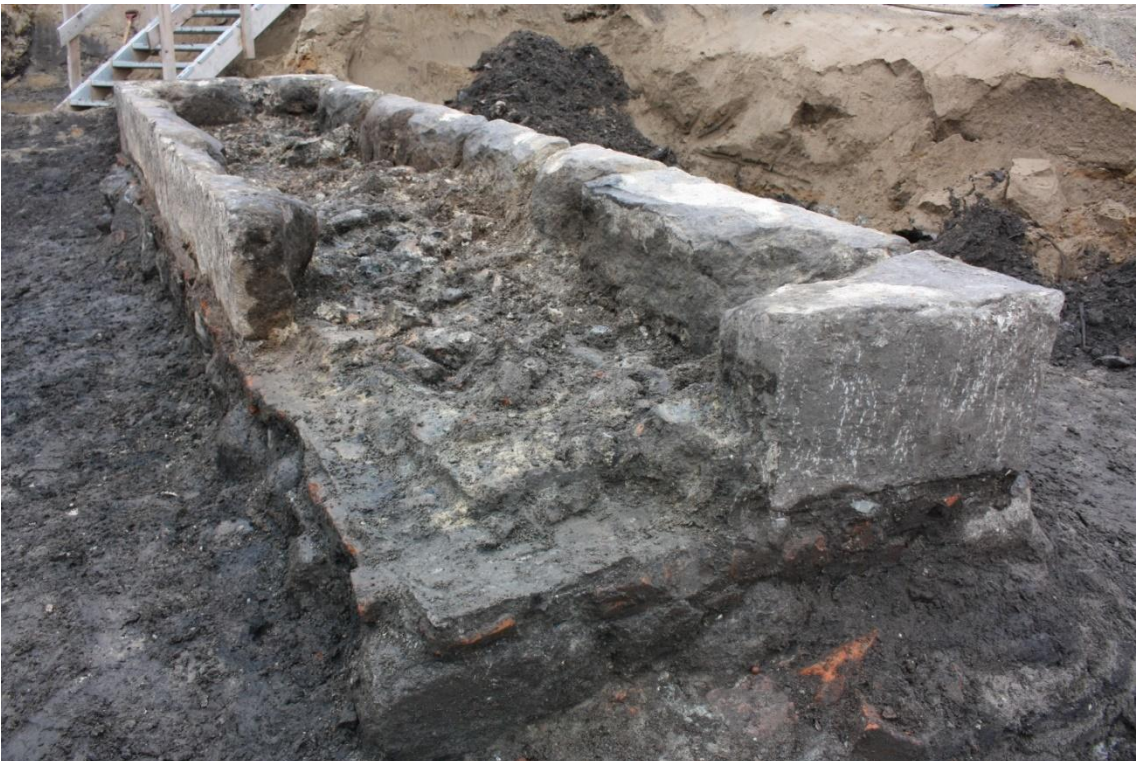
Fig. 233. Bridge pillar No. 2. Part of facing stone wall with ashlar stones SS304186 and rubble infill SS304582, facing north. Photo: Museum of Copenhagen.
