#### 18.1.5 Dam with barrier tower

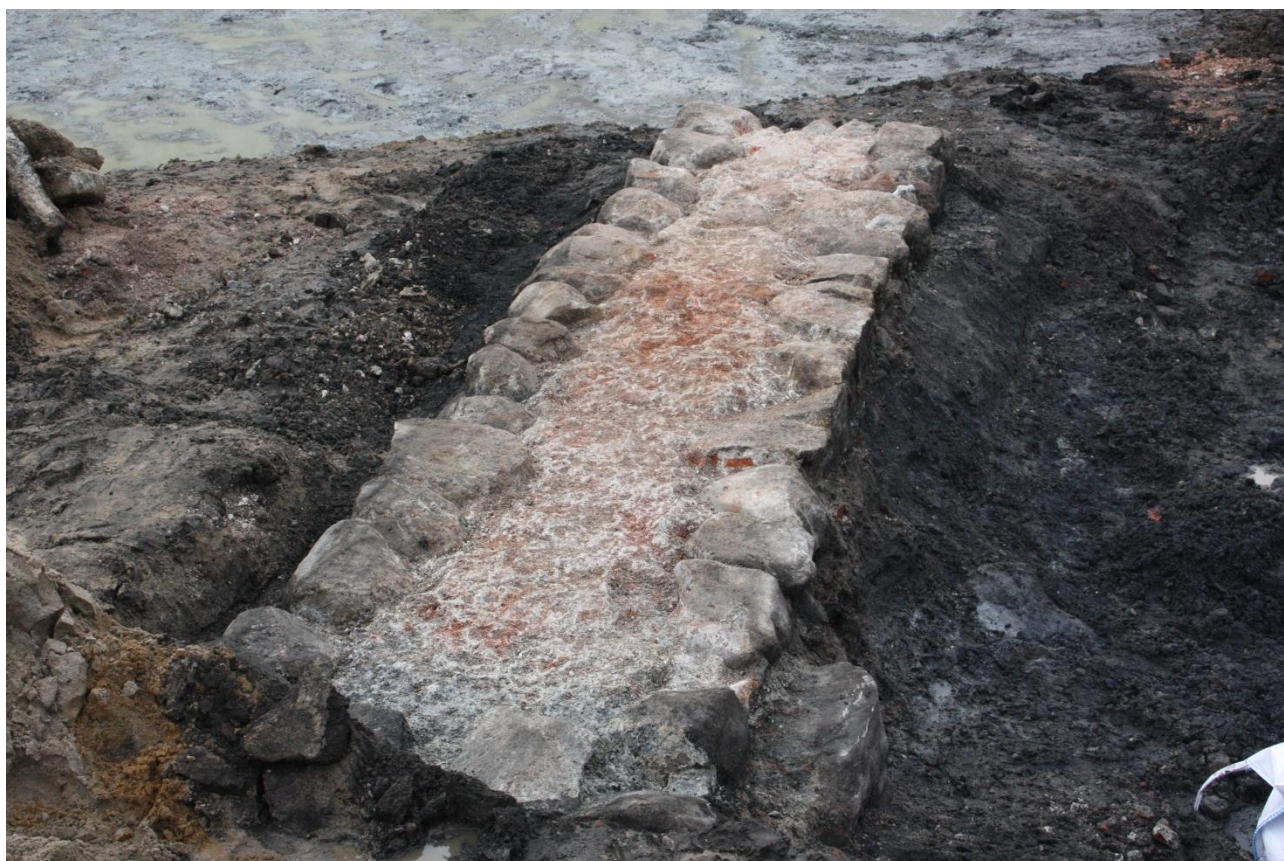
Fig. 234. Foundation stones SS305000 and mortar core SS305876, facing south. Photo: Museum of Copenhagen.

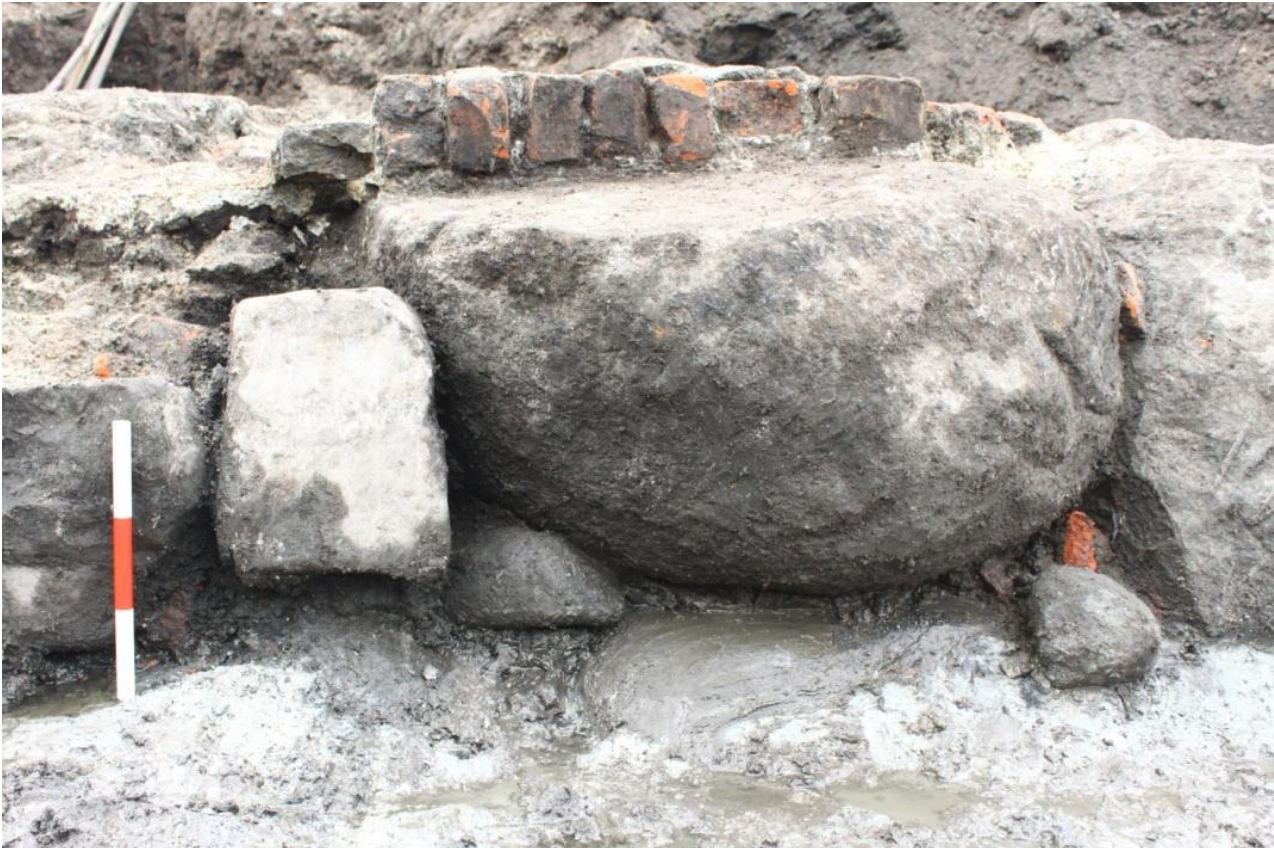
Fig. 235. Close-up photo. Upper part of foundation stones SS301585 with brickwork, facing SW. Photo: Museum of Copenhagen.

SS301458 consisted of a fully laid brick structure on top of the foundation stones (Fig. 235). This had been destroyed while tearing down the bridge and only one course and a few red bricks in the northern end had survived. The red bricks were approximately 0.24 x 0.12 x 0.07 m, placed in headers-rowlock system and of Renaissance type (?). The type of mortar was unclear due to the poor preservation of the brick structure.

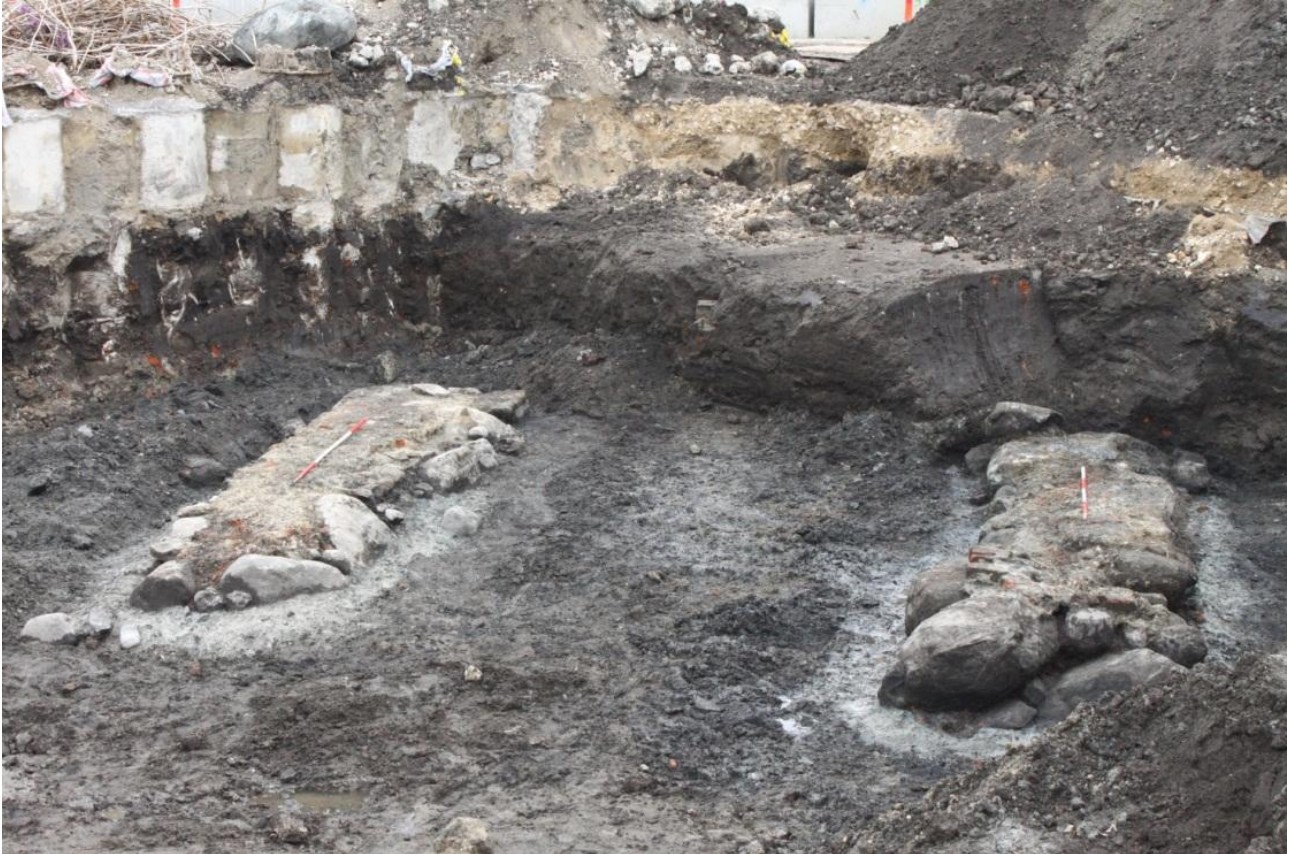
Fig. 236. Overview. Bridge pillar Nos. 3 and 4 surrounded by dark waterlogged moat sedimentation, facing SW. Photo: Museum of Copenhagen.

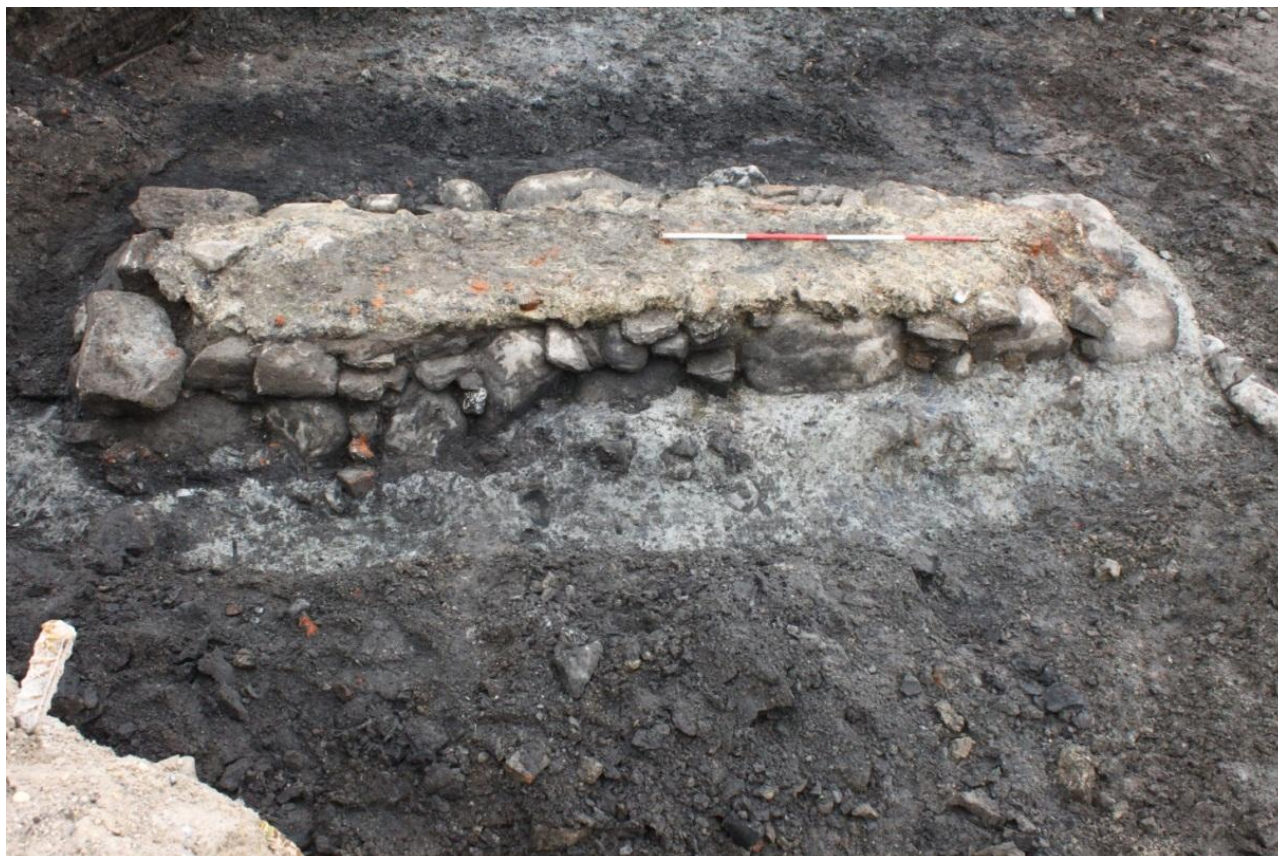
Fig. 237. Bridge pillar No. 4 with foundation and mortar core surrounded by dark waterlogged moat sedimentation, facing west. Photo: Museum of Copenhagen.

As with bridge pillar No. 3 the structure was heavily robbed of its building material, but the principle of construction seemed to be that two rows of boulders were laid, running roughly north-south, with smaller stones in the middle and with straight outer faces (Fig. 237). Stones SS303409 refers to a separate, uppermost layer of stones in the foundation, the southern corner, laid for levelling the foundation, as had two rows of smaller, flat stones, placed along the edges of the rest of foundation towards its northern end.

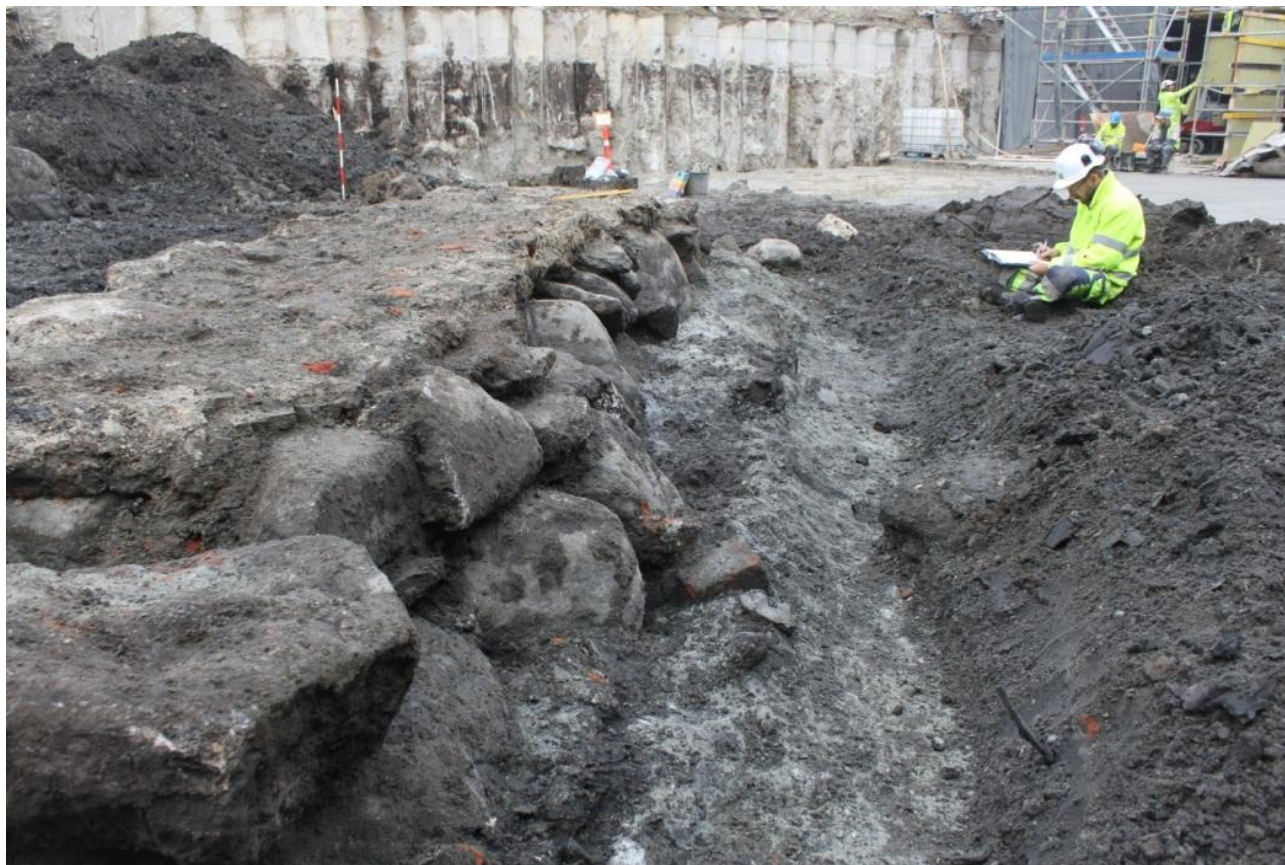
Fig. 238. Documentation of bridge pillar No. 4, facing north. On the right side one can see that the moat itself has been dug deeper around the pillars with the surrounding and natural clay becoming part of the foundation. Photo: Museum of Copenhagen.

Cut SC303632 consisted of a NE-SW oriented, flat depression between bridge pillar Nos. 3 and 4. The distance/width was 2.5-3.0 m but the length was not clarified due to machining. This truncation represents some sort of construction cut in the natural substrate related to the moat and bridge structure. Context (SC228488) was also a landscaping event related to the bridge, but further information and interpretation is unclear. Created cut (SC302799) consisted of some sort of rectangular foundation of natural moraine around bridge pillar Nos. 3 and 4, a leftover when digging the rest of the surrounding moat (Fig. 238).

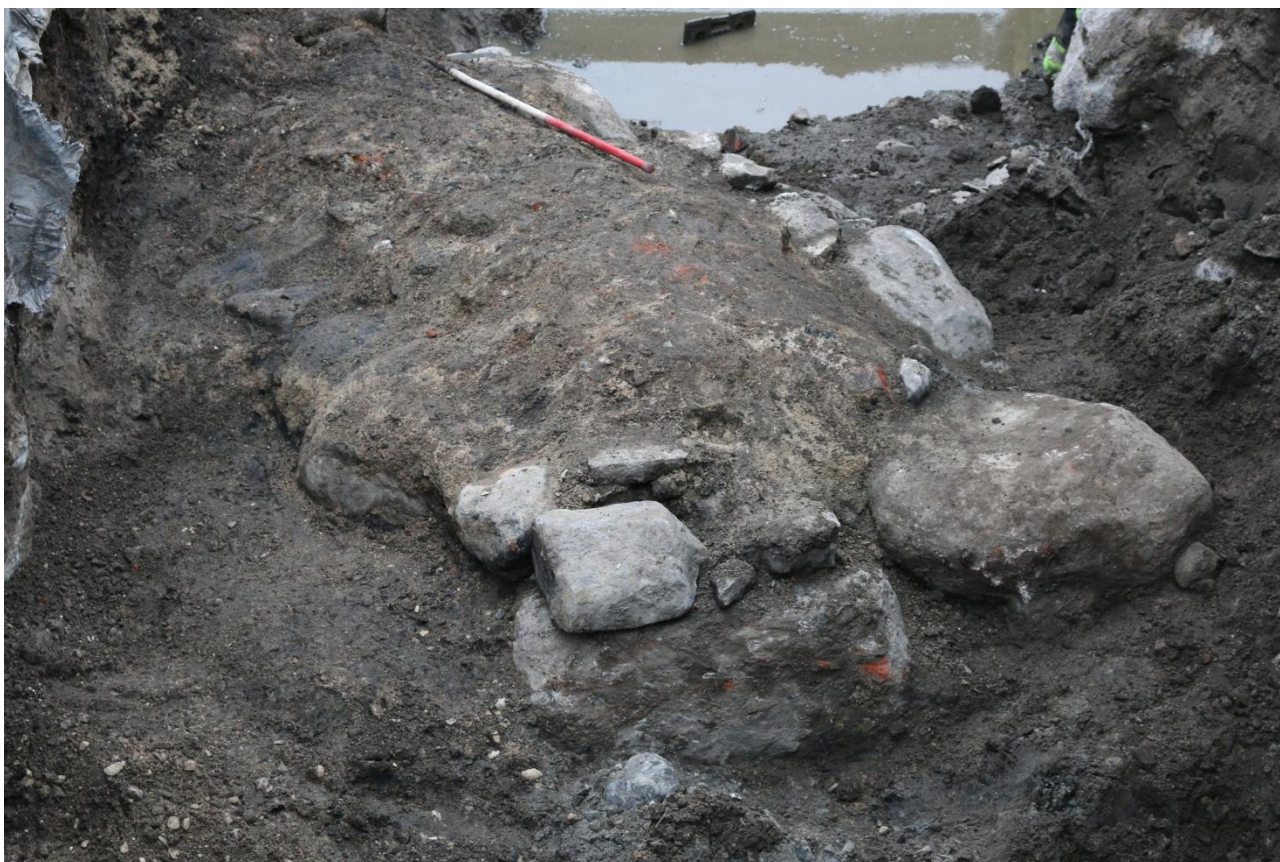
Fig. 239. Bridge pillar No. 5 with foundation stones and mortar/brick core, facing NE. Photo: Museum of Copenhagen.

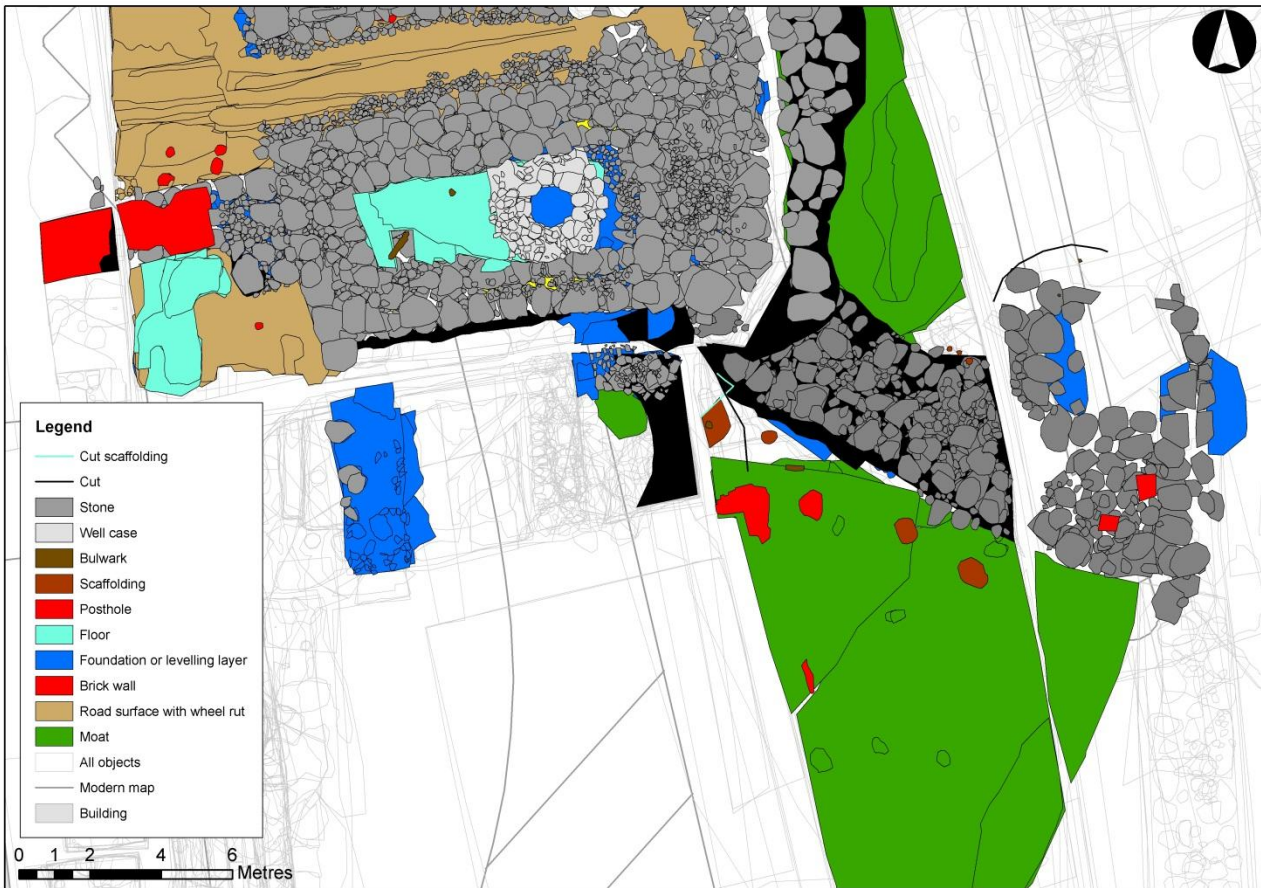
Fig. 240. Dam with semicircular barrier tower placed SW of the gate building in the Late medieval moat. The lack of stones in the middle and within the tower is due to the modern shoring and a concrete pillar erected in conjunction with the new Guide Wall. The measured moat cut to the left, inside the building should be moved two metres to the right based on later re-interpretations.

The dam constructed in association with the gate building regulated the water level in the moat and extended in a NW-SE direction for a length of c. 14 m (G-502973). It consisted of construction cuts, three courses of light, grey unfinished stones and boulders, fills in between the stones, together with foundation- and destruction layers (Fig.

240). The upper part of the stone structure had been destroyed by looting (robber pits) in the 17<sup>th</sup> century and by a modern NW-SE running central concrete heating duct from 1956.

Attached to the eastern end of the dam a semicircular or B-shaped structure was investigated. This was interpreted as part of a barrier tower to prevent access into the city over the dam. The tower consisted of a brick wall, deposits, stones and construction cuts (Fig. 240). Some of the recorded stones and boulders in the structure were a continuation of dam structure (SG-296) to the west. However, part of this structure was placed beneath a curved brick wall (SS311742) which had obvious similarities with the tower to the north, and is therefore integrated and grouped with the main tower construction. Some of the stones in foundation (SS503426) were also probably part of the northern end of the curtain (SG-503797). This uncertainty and interpretation is due to missing stratigraphical relationships obscured by modern shoring in 2010 and by machining in 2014. One should also be aware that this is the place where three different structures were interconnected – the 17<sup>th</sup> century bridge, the curtain and the dam.

The tower was heavily disturbed by a couple of modern disturbances (Fig. 240). A cable box ran straight through the structure in a N-S direction and a big concrete pillar for the Guide Wall had been drilled down through the middle and probably moved some of the boulders aside. A wooden water pipe, dated to the 19<sup>th</sup> century, had been placed straight across the feature from NW-SE. The gap resulting from missing boulders/stones (triangle) close to the modern shoring is due to machining and for safety reasons which prevented a complete survey.

Finds from the surrounding deposits and the stone structures date the dam and barrier tower to first half of the 17<sup>th</sup> century. There is also clear evidence that the two features cut sedimentations and usage layers in the Late medieval moat which reinforces this dating (cf. Fig. 240). Dutch or English cross bond used in the tower has a Flemish origin and was first used late in or after the Middle Ages. The defence tower was short lived and probably was destroyed and replaced with another dam called “*Kammen*” that included a barrier tower in 1629 further to the south (see Chapter 5; Other archaeological observations around Kongens Nytorv above).

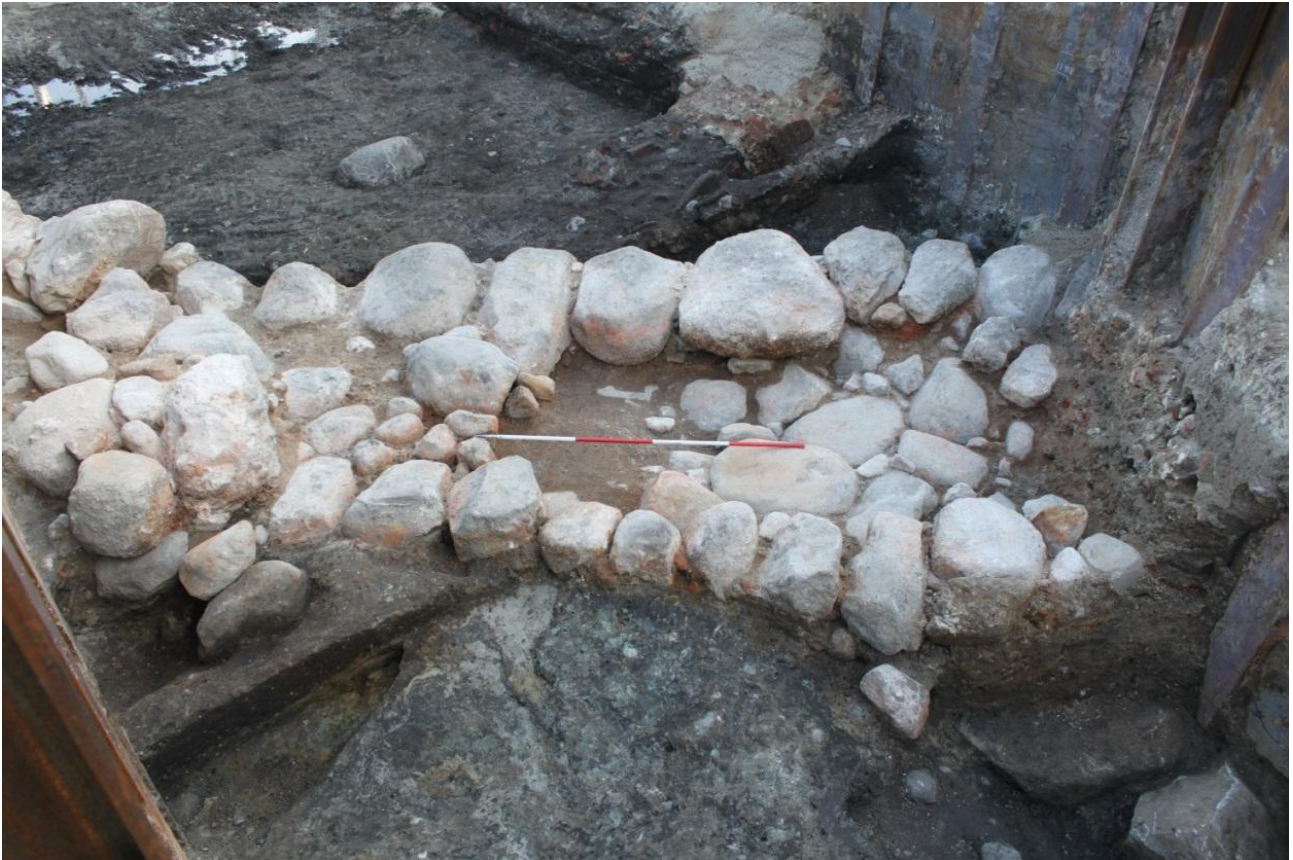
Fig. 241. Dam structure. Excavation of upper course (SS18545), facing SW showing carefully placed boulders to the north and south. Photo: Museum of Copenhagen.

The dam consisted of a double faced dry stone structure with rubble fill (Fig. 241). The dimensions of the stones were not uniform, where the diameter varied from approximately 0.1 m to 1.0 m, of which the largest stones had been placed as a course of outer facade stones, and where the southern course consisted of even larger stones/boulders than the northern walling.

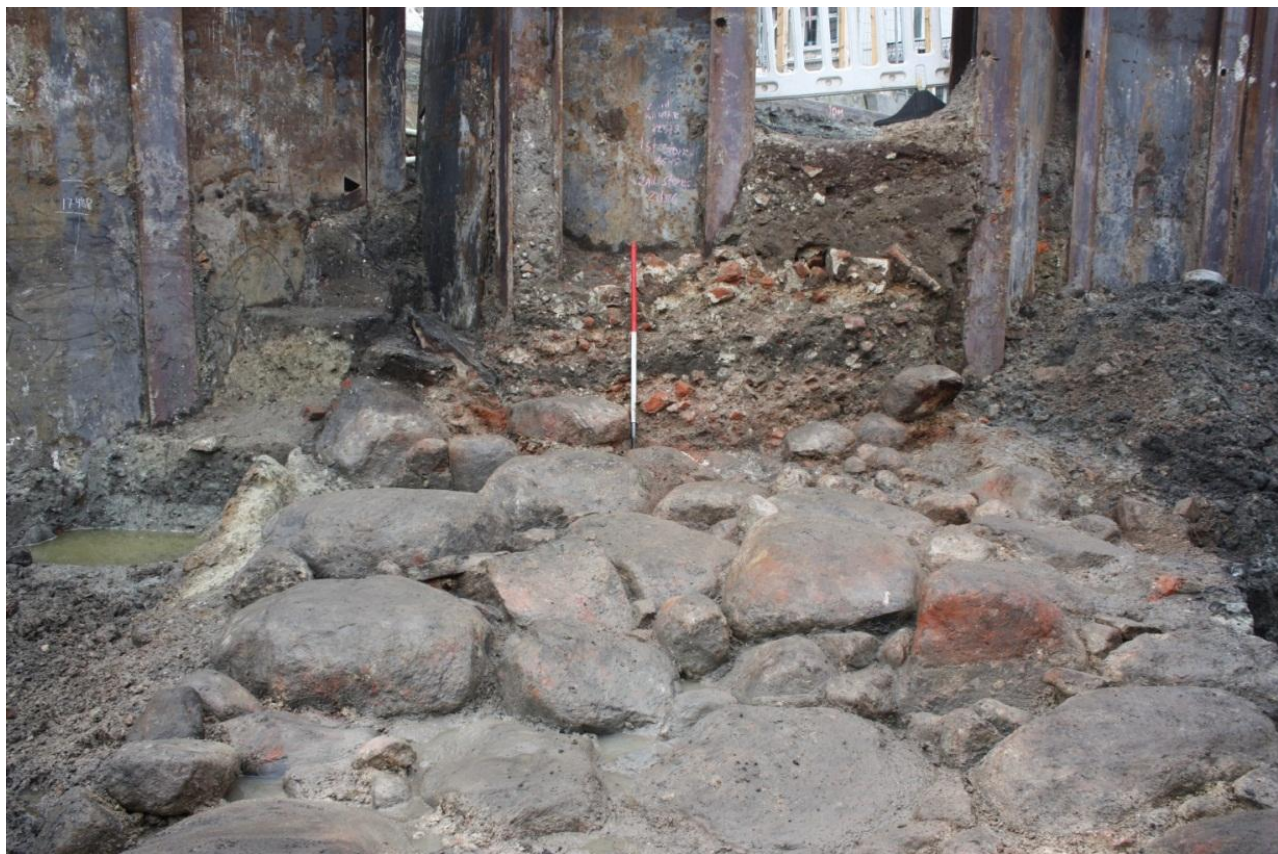
Fig. 242. Part of dam structure and section C204494 with overlying demolition material and rubble, facing NW. Photo: Museum of Copenhagen.

Like the gate building and bridge pillars, the dam had been plundered for building materials. The demolition deposits consisted of light and mid yellowish brown, grey and white sandy mortar with inclusions of charcoal, pebbles, stones and fragments of red brick (Fig. 242). The CBM consisted of large medieval brick fragments (“munkesten”) and a few bricks of Renaissance size; small Dutch, from the 17<sup>th</sup> century.

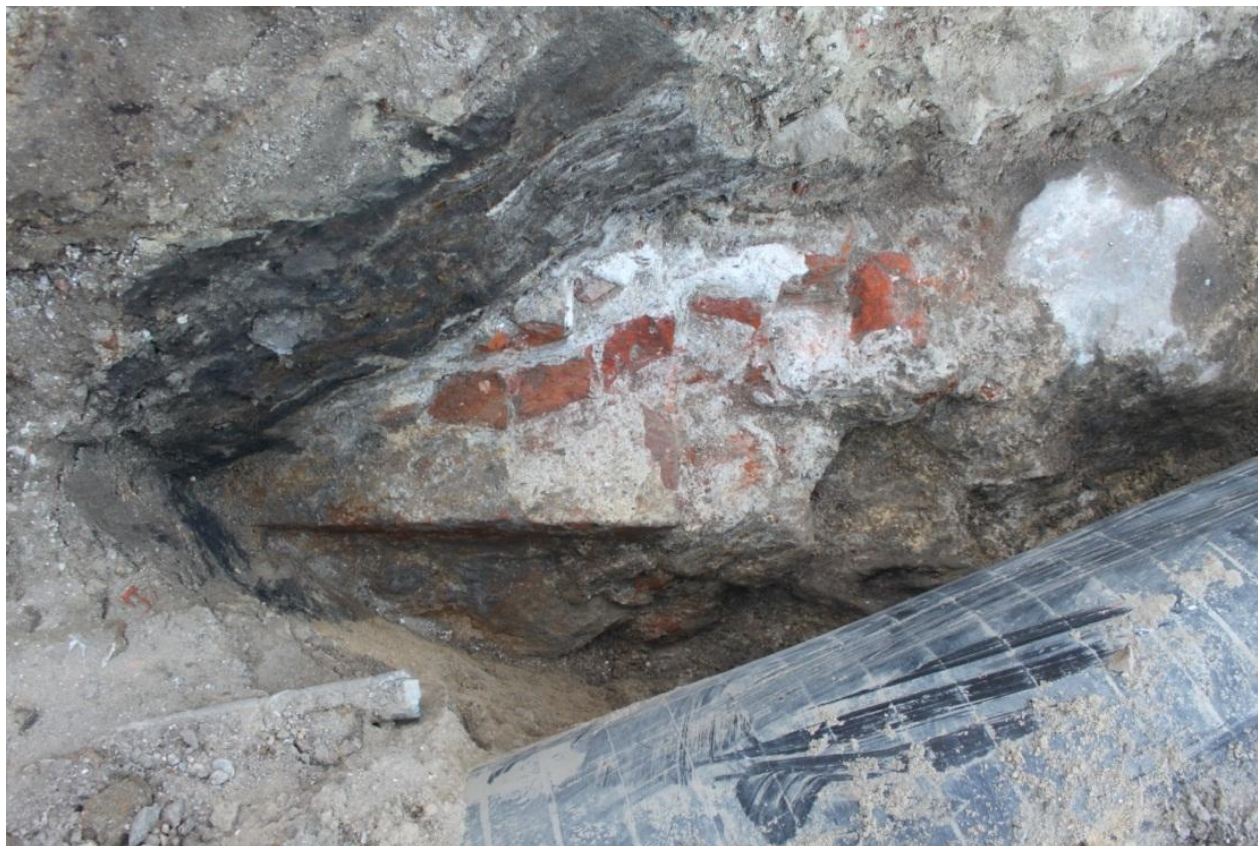
Fig. 243. Exposed part of the barrier tower including a brick wall and foundation (SS177019) covered by lensed deposit (SD177015), facing east. To the right and upper corner – part of interpreted robber cut (SC177008) filled with CBM rubble, mortar and clay. Photo: Museum of Copenhagen.

The tower was first investigated in 2012 and seen in the NW section of a modern central heating pipe trench, truncated to the SE by the latter (Fig. 243).

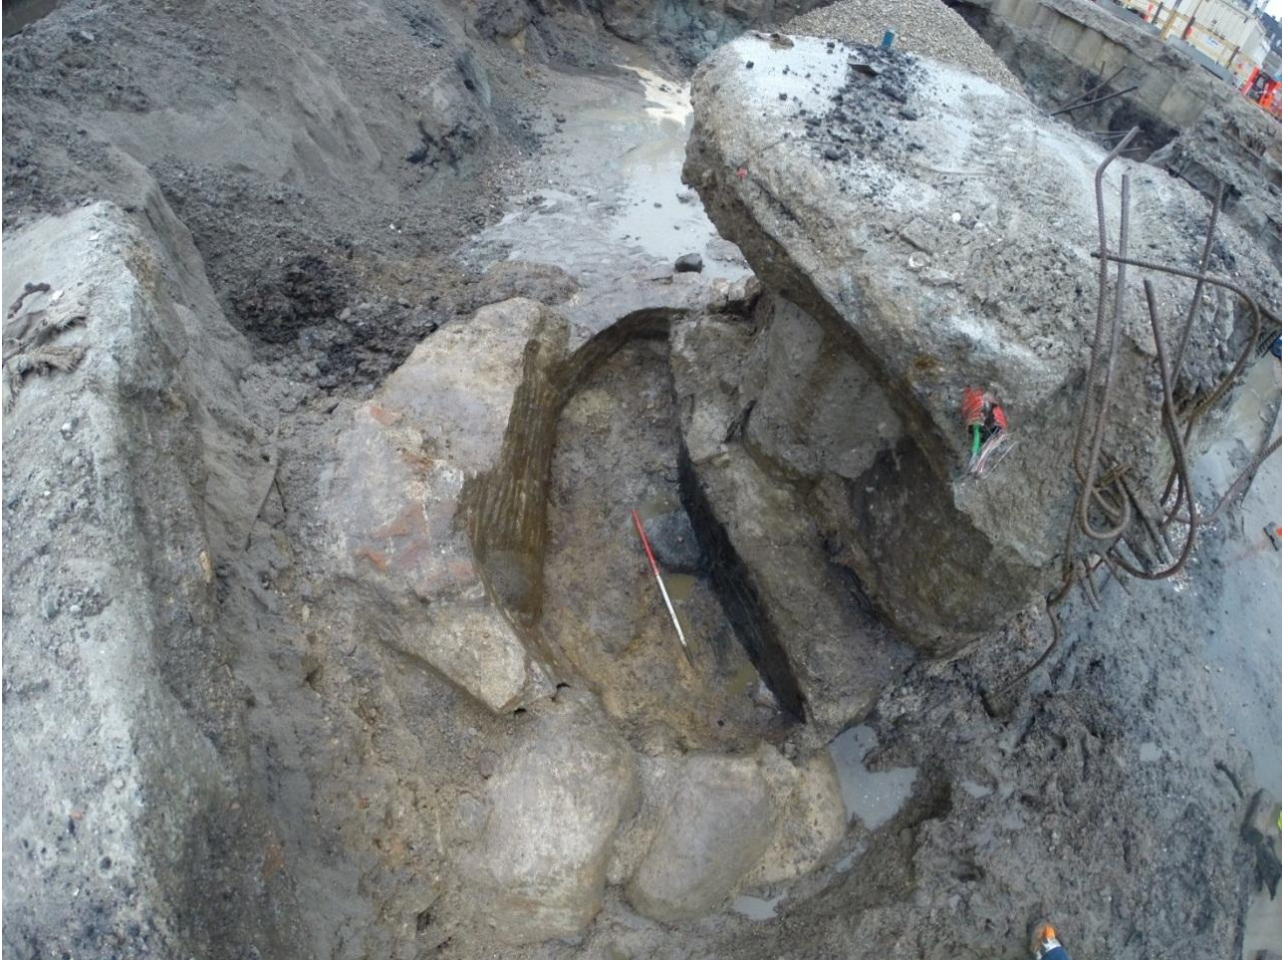
Fig. 244. Barrier tower from above pierced by a modern concrete pillar to the east. Photo: Museum of Copenhagen.

In 2014 the rest of the barrier tower was fully exposed (Fig. 244). Foundation SS311800 and SS503426 consisted of a semicircular structure of unfinished mid grey granite boulders and stones with infill of mortar and CBM. Two of the stones, facing east, had worked surfaces similar to the worked stones seen in the bridge pillars further to the east.

The construction and foundation layers SD309903 and SD310094 consisted of mortar and firm greyish blue clay mixed with a large amount of CBM. Levelling layer (SD313535) in the interior of the tower structure was disturbed by a modern concrete pillar in the centre (Fig. 244), so only a small portion of the layer was visible and preserved.

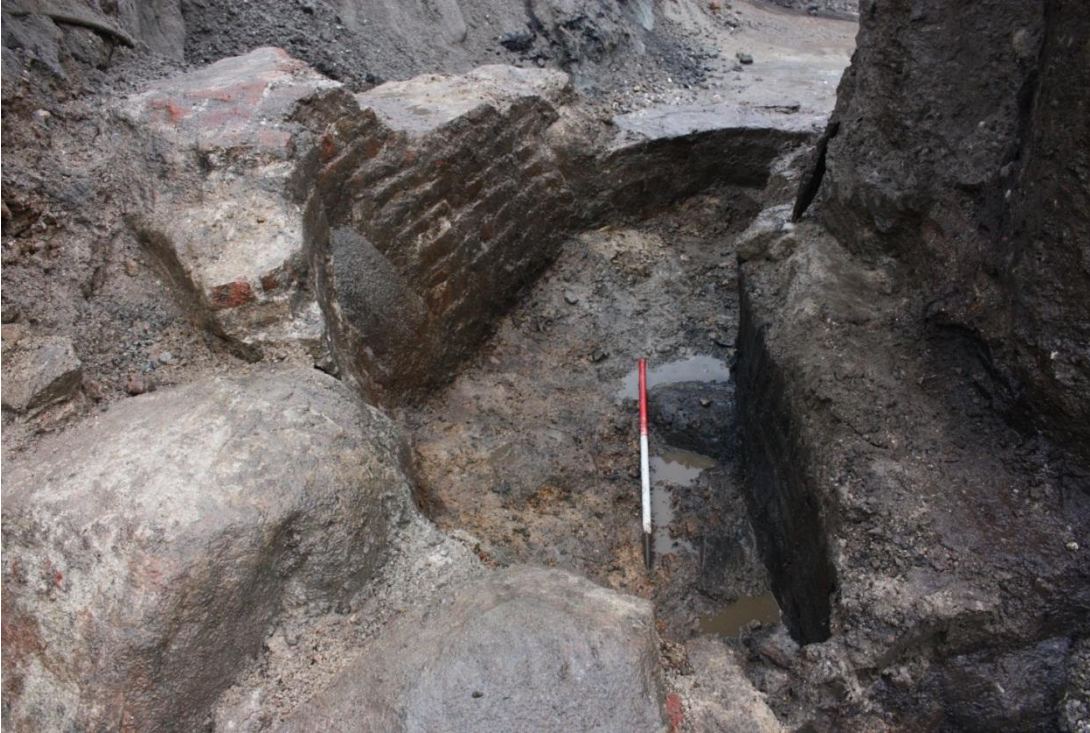
Fig. 245. Remains of the barrier tower with foundation stones and curved brick wall (SS313218), facing north. To the right – section through dark alluvial deposits inside the structure. Photo: Museum of Copenhagen.

Context (SS313218) consisted of a curved part of a well laid brick wall where parts had been laid in Dutch coursing (Fig. 245-247). The wall was thicker towards the base, probably for stabilization. With the exception of the northern part, consisting of a single, 0.44 m thick brick wall, the bricks had been placed on top of and between the large foundation stones in SS311800, and the wall structure was recorded in a couple of separate sections. Brick construction (SS309994) had an L-shaped form, but the main direction of the structure was north-south. It was first associated with the 17<sup>th</sup> century curtain which ran in the same direction, but was later grouped with the tower as part of SG-809 investigated in 2012 (see above). The exposed part of the wall consisted of a header course where the bricks had been laid flat either side on, or end on to the face of the wall.

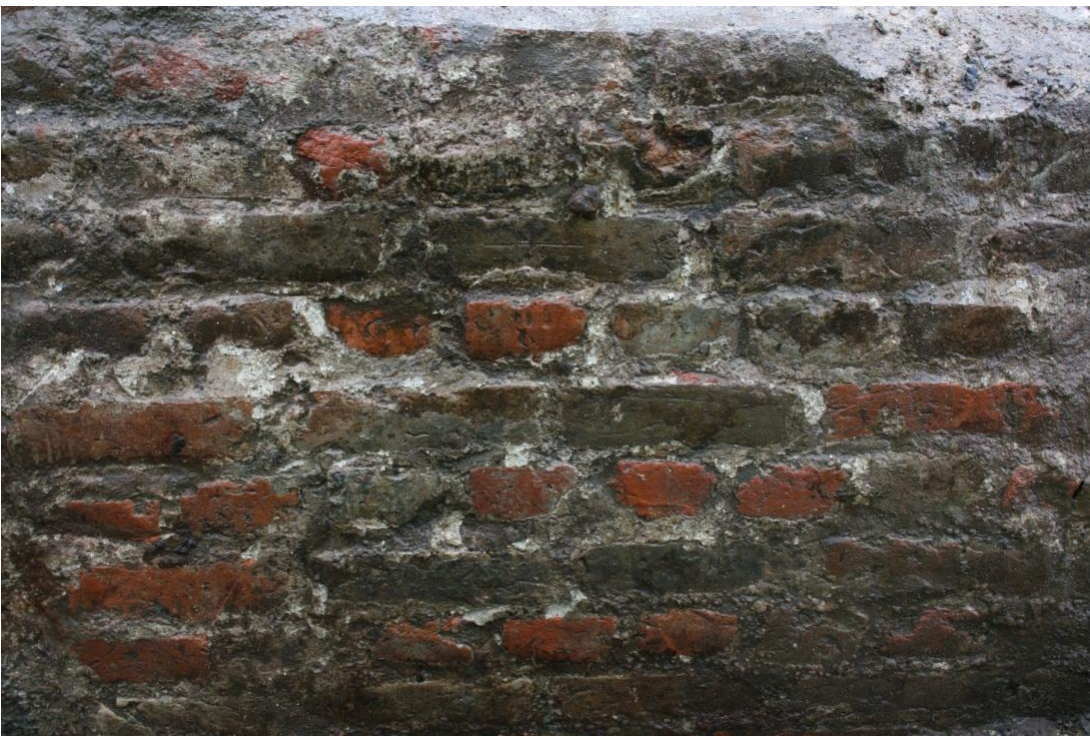
Fig. 246. Close up of brick wall (SS313218) of Dutch or English cross bond, facing NW. This bond has alternating stretcher and header courses, with the headers centred over the midpoint of the stretchers, and perpend in each alternate course aligned. Photo: Museum of Copenhagen.

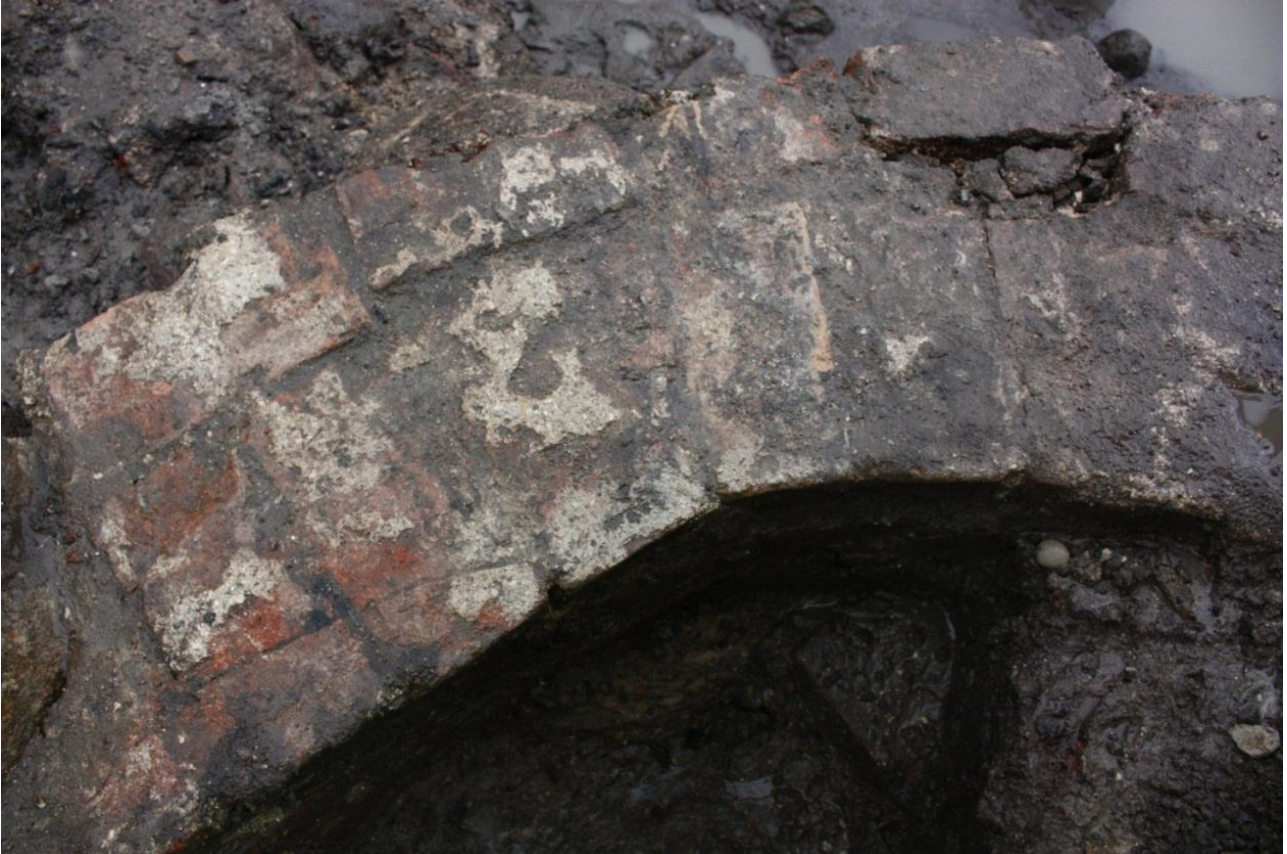
Fig. 247. Detail view of brick wall. The northern and narrower part of brick wall (SS313218) from above. Stretchers exposed and placed against the headers on the inside. Photo: Museum of Copenhagen.

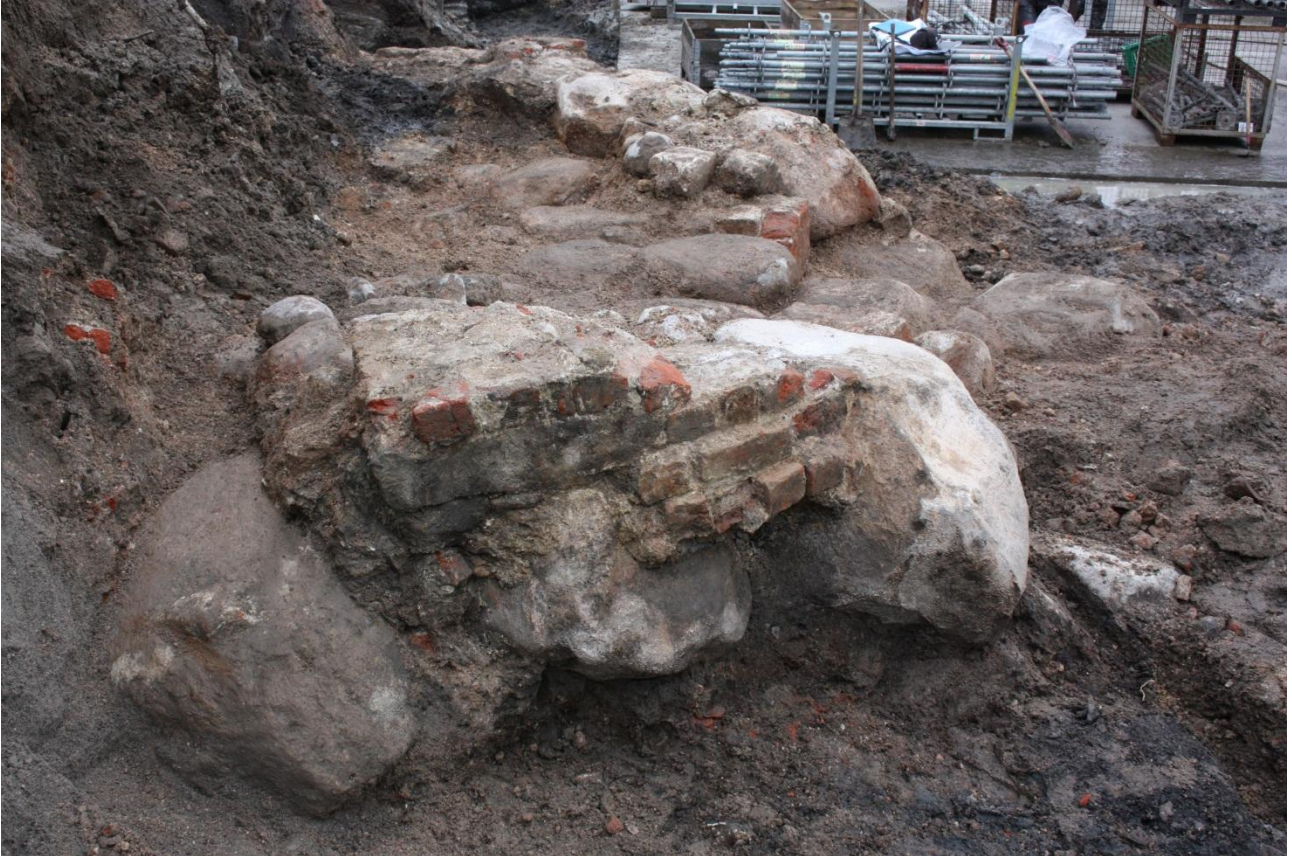
Fig. 248. Curved brick wall (SS311742) placed on and matched to boulders (SS503426), facing NW. Photo: Museum of Copenhagen.

Structure (SS311742) consisted of a curving wall of fully laid medieval bricks and a single rectangular ashlar. The brick wall was 1.2 m long, 0.4 m wide and 0.5 m high with mid red bricks (“munkesten”) and yellow/white tuck mortar. The bricks had been placed stepwise (5 cm) in the lower part (Fig. 248), and one got the impression that the structure sloped slightly to the NE, but this probably was done to stabilize the construction. The brickwork consisted of both headers and stretchers, but no coursing technique could be determined on site. The bricks and ashlar stone had been placed on and matched to the foundation stones in SS503426.

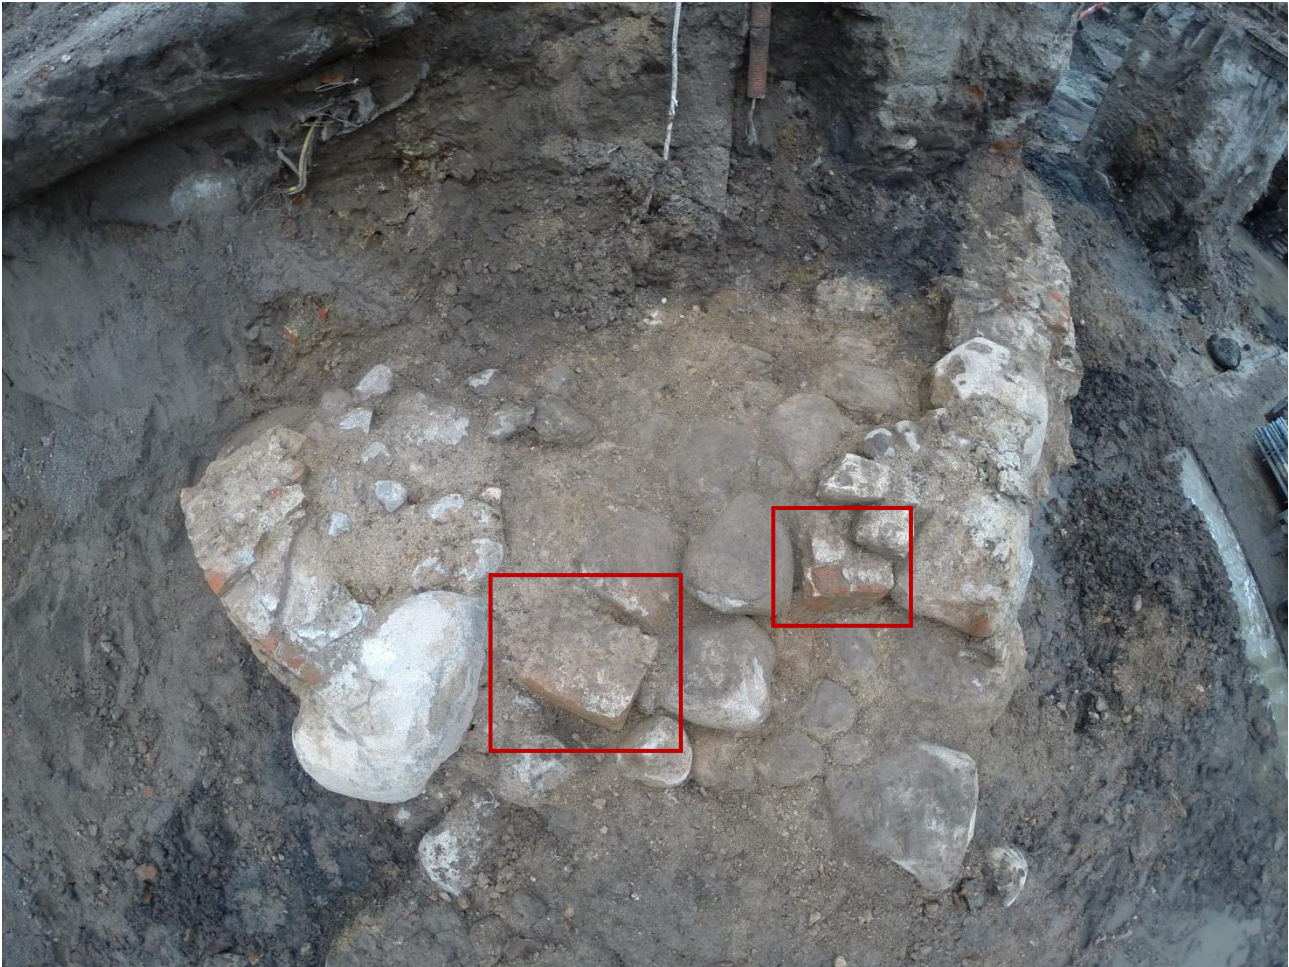
Fig. 249. Overview. Continuation of curved brick wall to the left (SS311742), foundation (SS503426) with reused merlons from the former city wall (SS311725) in the middle (within the red squares) and brick wall (SS309994) to the right. Photo: Museum of Copenhagen.

Square blocks SS311725 and SS311734 consisted of three courses of medieval red bricks (“munkesten”) with white tuck mortar within foundation SS503426 (Fig. 249). The blocks are interesting – the shape and the finished edges suggest that these represent the lower part of merlons, reused as building material when the city wall was demolished in the early 17<sup>th</sup> century. A merlon is the solid upright section of a battlement or crenellated parapet in medieval architecture or fortifications.

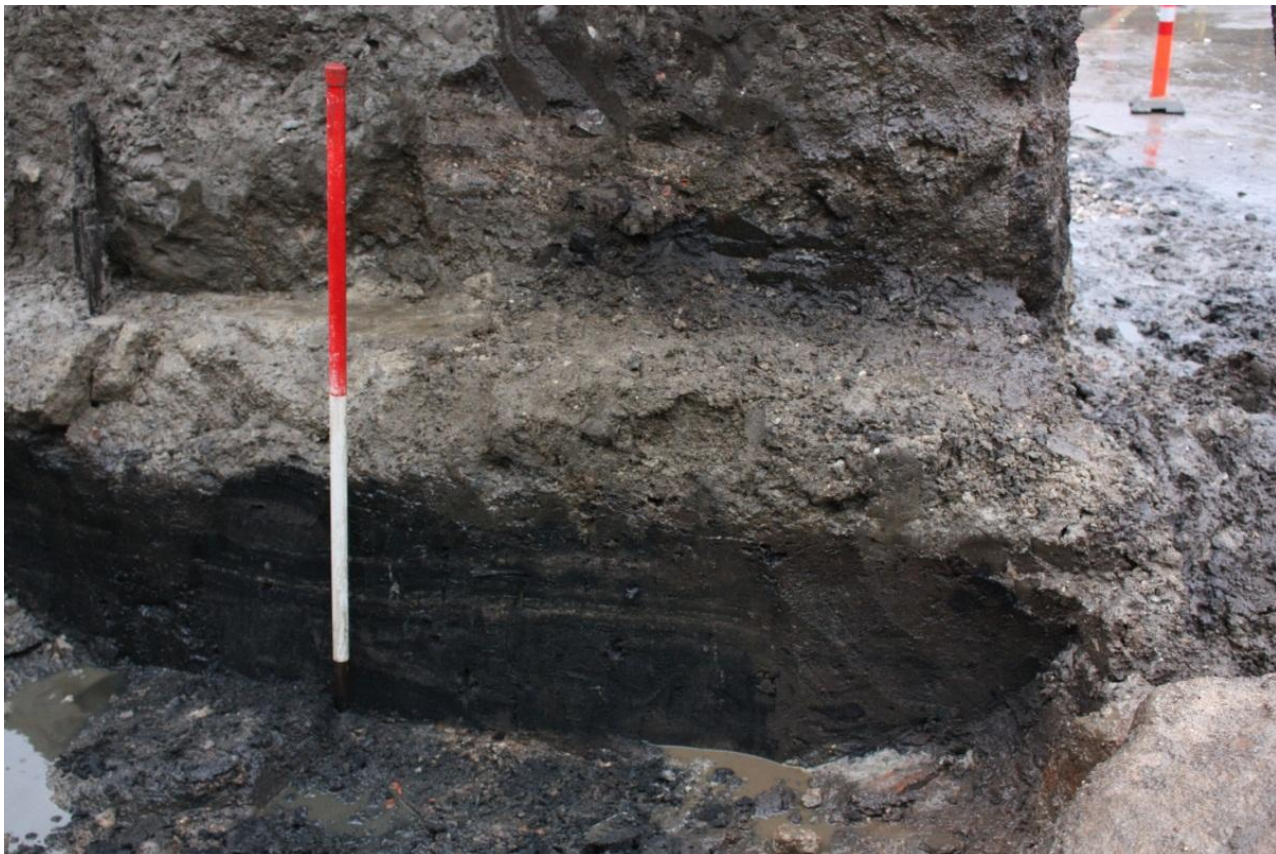
Fig. 250. Dark alluvial deposits (SD310100 and SD313522) within the subcircular structure (SG-503796), facing east. Photo: Museum of Copenhagen.

Fills (SD310100 and SD313522) within the barrier tower consisted of a lensed layer of firm dark blackish brown sandy silt (Fig. 250). Some small fragments of what could have been the remains of a wooden floor were recorded. One side of the wooden plank looked almost polished while the other side was more decomposed and in bad condition. A lot of burnt material; charcoal, burnt wood and soot were recorded in the deposit. Alluvial deposit (SD177015), investigated in 2012, was highly lensed, with lighter grey sandy lenses to the NE, and yellower lenses with iron panning to the SW. The lensing suggested a stepwise, natural accumulation.

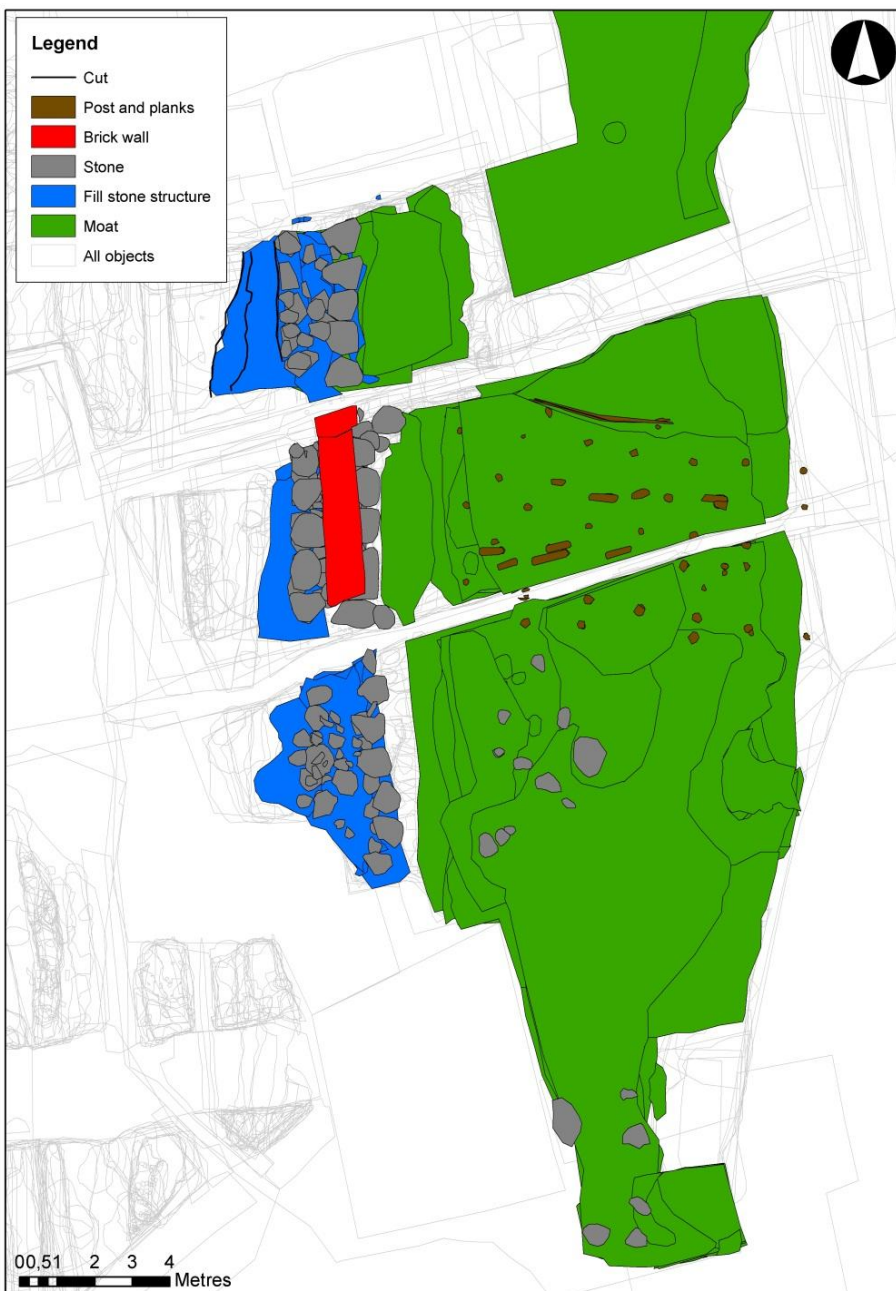
Fig. 251. Temporary bridge in the Late medieval moat with the medieval city wall to the left.

The bridge (G-446) consisted of 44 circular vertically set and tilting posts with removed branches and stripped bark which varied in length from 0.92 m to 2.80 m and horizontal planks laid edge on (Fig. 251-253).

Based on dendrochronological dating of horizontal plank ST70114 and the presence of alluvial deposit SD68352, it is assumed that the bridge was built in the early 17<sup>th</sup> century when the moat went out of use, as a temporary substitute for the eastern gate and related bridge (Tab. 43). Part of the medieval city wall was preserved adjacent to Lille Kongensgade as a bridge head while the rebuilding and construction work was ongoing (Fig. 251).
