#### 18.1.5 Dam with barrier tower

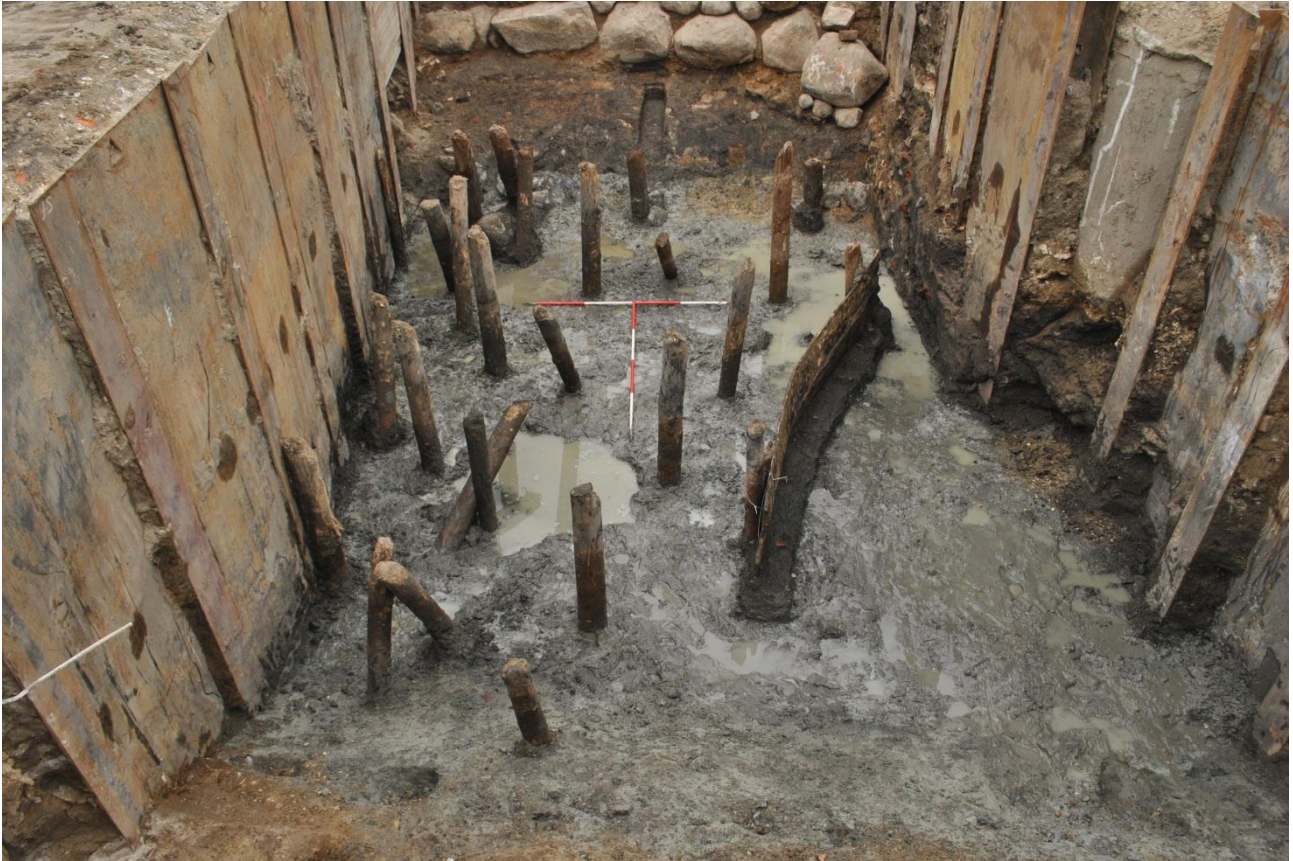
Fig. 252. Bridge structure, facing west. Photo: Museum of Copenhagen.

ST70114 was a timber structure consisting primarily of a sharp slender post and two planks, both of which showed evidence of earlier use for another purpose. The structure was orientated in a rough east-west direction. The post, surveyed as part of ST70114 had been created by splitting a round timber with an axe creating a tangentially faced post with a narrow tapered point up to 0.29 m in length. The post might have been used in a roof construction (Melin 2013:21). Two substantial iron nails were noted on the exterior of the post, which had been bent downwards and upwards after they had been hammered through. They may have been used to fasten the post to the two timber planks adjoining it to the north (Fig. 252 and 253).

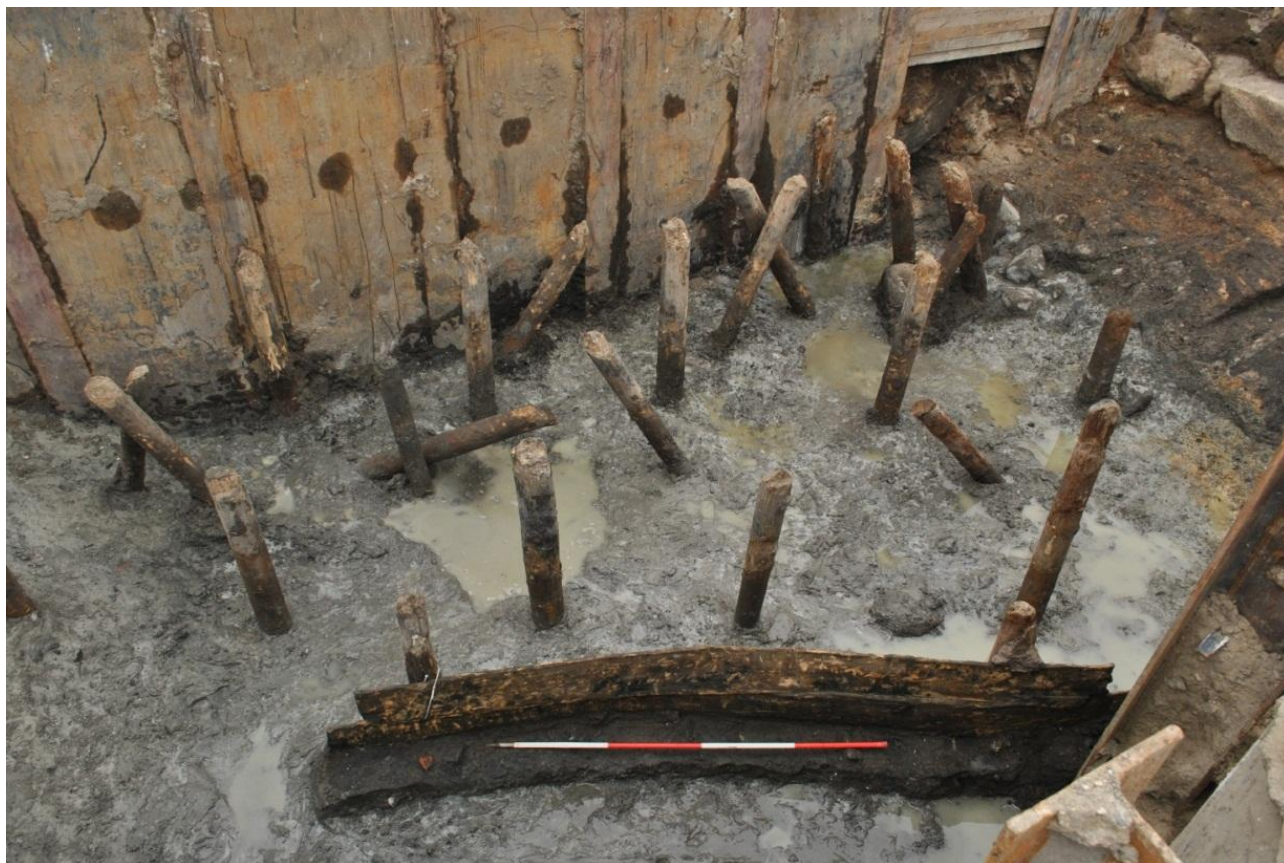
Fig. 253. Bridge structure with planks ST70114, facing SW. Photo: Museum of Copenhagen.

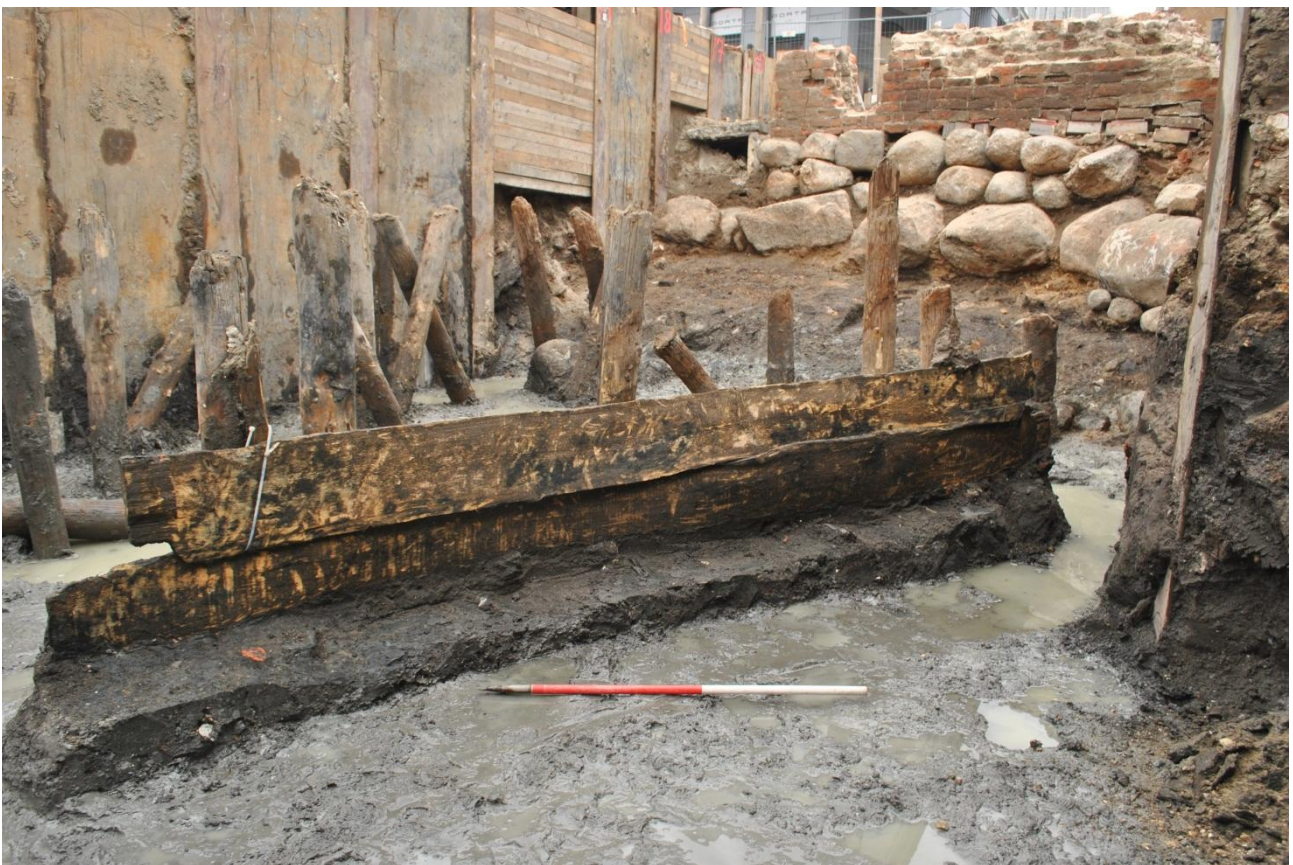
Fig. 254. Upper and lower plank ST70114 on top of alluvial deposit SD68352 in the former moat. Photo: Museum of Copenhagen.

The upper plank was roughly the same width as the lower plank, but clearly shorter (Fig. 254). The upper plank had a length of 3.87 m and a width of 0.29 m. It was set back approximately 0.21 m east of the outside edge of the lower plank and set back approximately 0.26 m west of the outside edge of the lower plank. The upper plank had a raised wooden joint worked into it. It was present at the western end facing south and measured 0.12 m by 0.16 m. In addition, both ends of the upper plank had peculiar wood cuts which suggested reuse. Both ends had angular pieces cut from them leaving the plank with projecting ends on top. The sawn cuts beneath had been made at an angle of approximately 50 degrees.

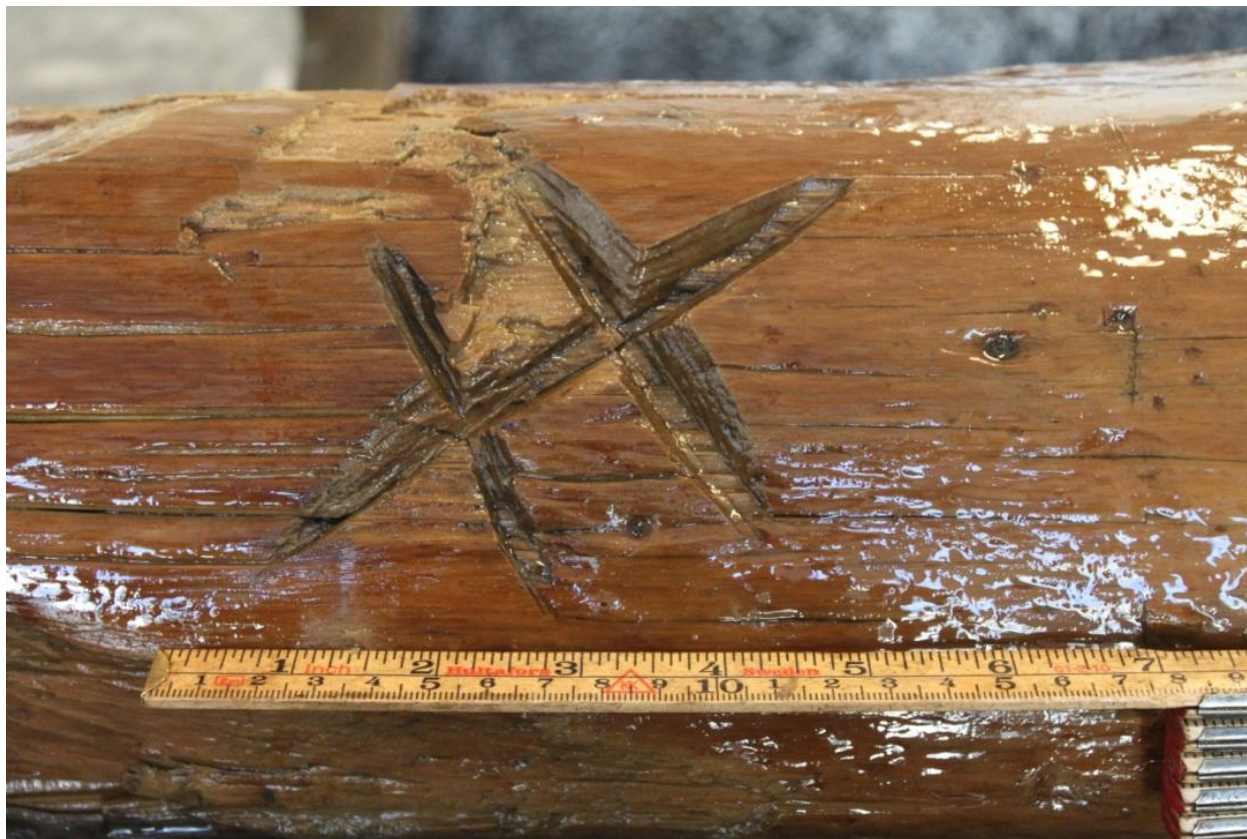
Fig. 255. Producer’s mark on one of the posts (ST65486) in the 17<sup>th</sup> century bridge. Photo: Museum of Copenhagen.

The lower relationship for all posts in subarea phase 5B-2 was SD143984, because this was one of the lowest deposits in the moat and equivalent to SD68352 in phase 5B-1. Some of the posts were related to a cut, due to variations in the soil around the posts, and were initially thought to be cuts with fill differing from the surrounding layers. One of the timbers had a producer’s mark consisting of a double cross (Fig. 255).

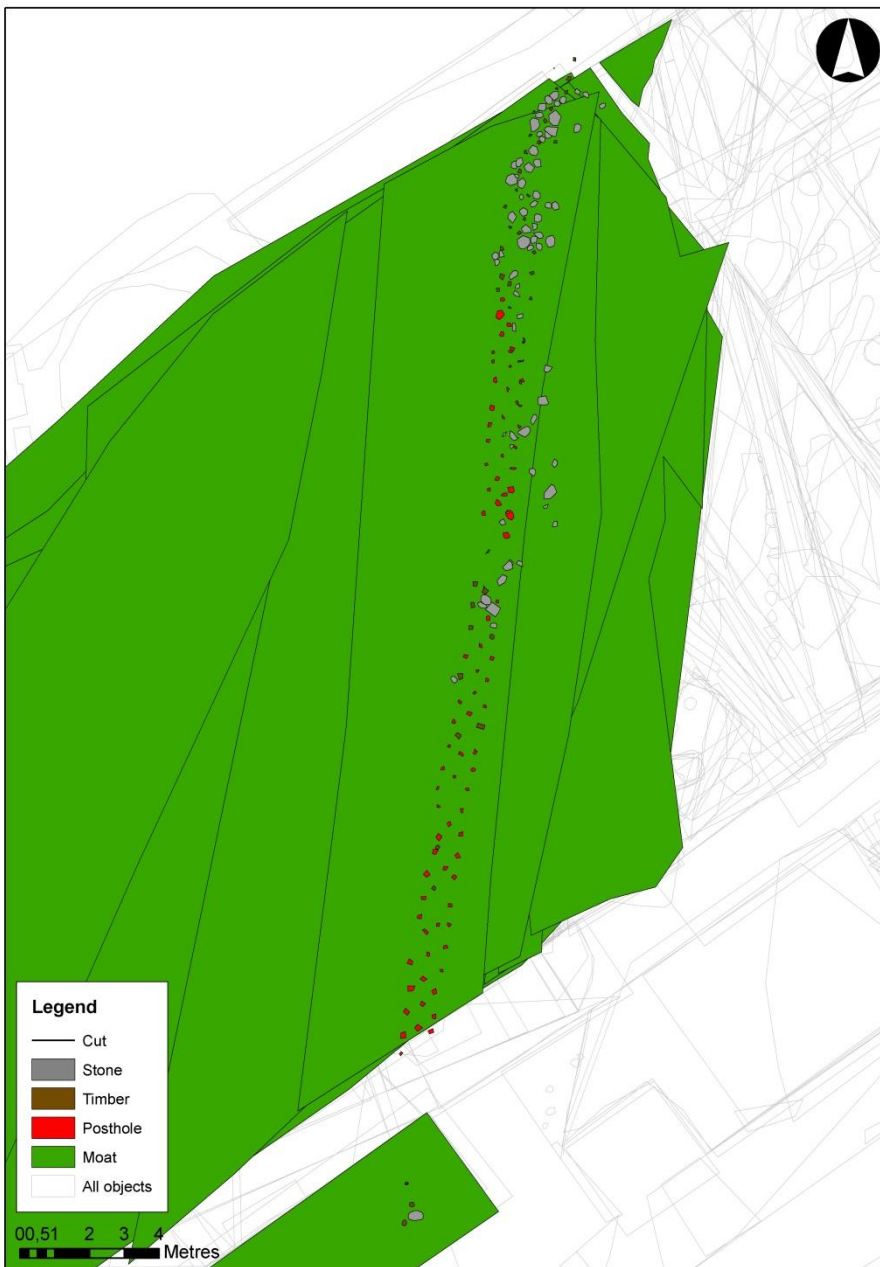
Fig. 256. Alignment of wooden poles, stones and postholes running N-S along the edge of the 17<sup>th</sup> century moat.

Group (G-240090) represents an alignment of several wooden posts (ST191422) with stones (ST191511) running N-S along the eastern side/slope of the moat with the purpose of stabilizing the edge. Most of the structure was recorded in the Station Box in 2013 with a few additions in the Ventilation Shaft in 2016 – although the stones and posts in the southern part (ST503891 and SS503892) were to some degree machined away and reconstructed in IntraSiS based on observations on site (Fig. 256).

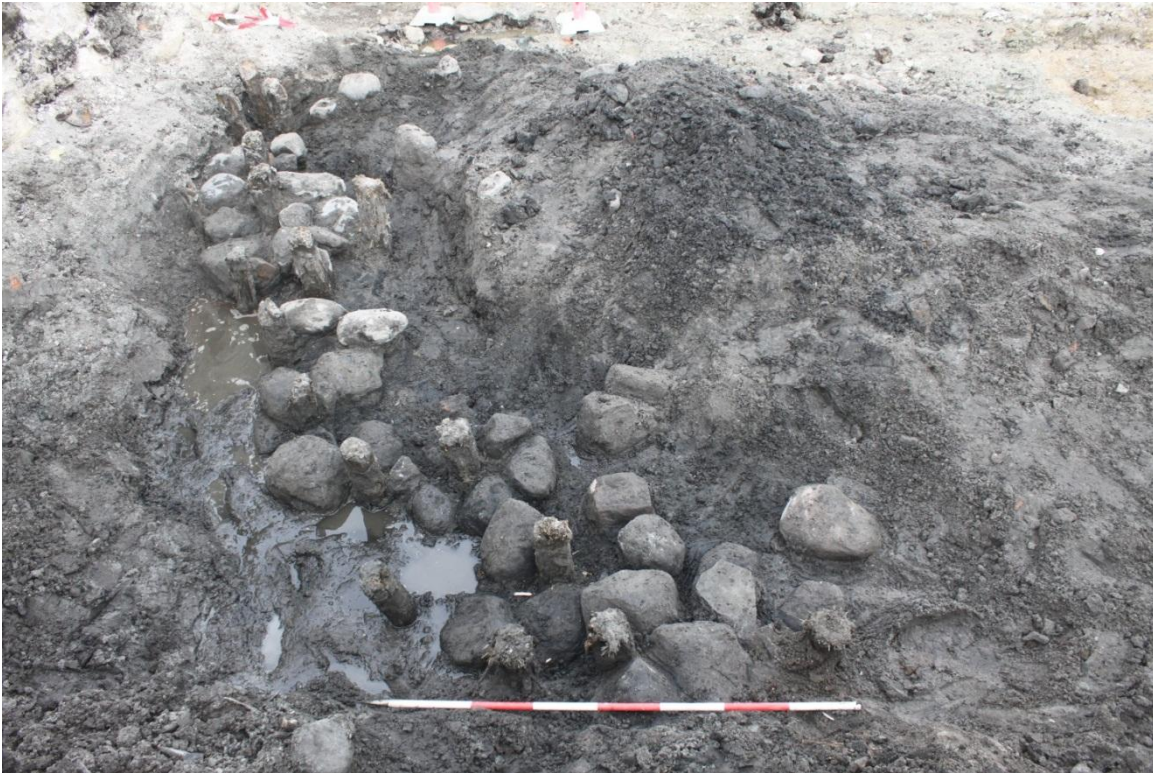
Fig. 257. Part of revetment. Wooden posts (ST191422) and stones (SS191511), facing NW. Photo: Museum of Copenhagen.

The vertically set posts were 0.75-1.37 m long with four sided tips. As a continuation of this, N-S running group (G-6571) was later recorded representing an alignment of a total of 82 vertical postholes with tapered bases (ST192561). The overall length was c. 22.0 m and width 1.0 m (Fig. 257 and 258).

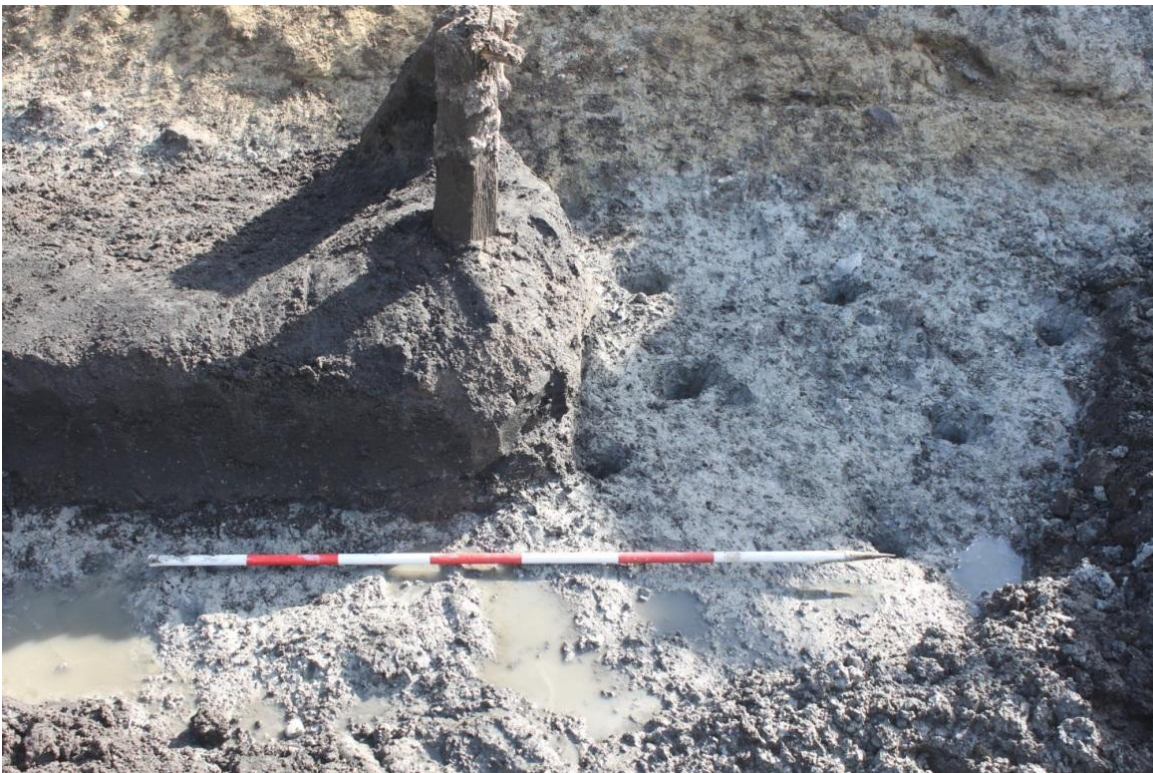
Fig. 258. Part of posts ST191422 with continuing postholes ST192561 (G-6571), facing east. Photo: Museum of Copenhagen.

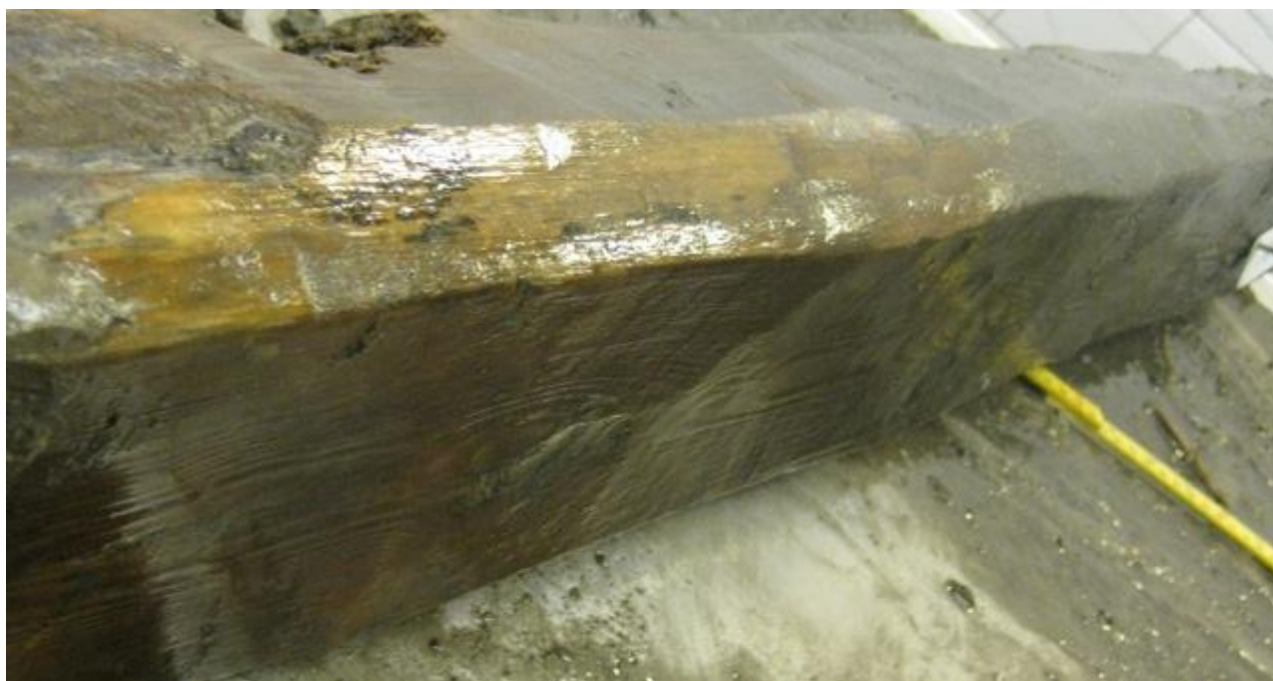
Fig. 259. Post No. 40 with big facets that might have been made with an axe of the same type as the broad axe found in the moat (see FO501815; Fig. 227 above). From Melin 2014:15.

Some of the timber from timber structure (ST191422; G-240090) was analysed with respect to woodworking techniques (Melin 2014). The greater part of the posts had been made of fast grown spruce using the top timbers, where the timber logs closest to the ground had been used for something else – although some of the posts might have been made of young fast grown spruce with an overall small diameter (Fig. 259).

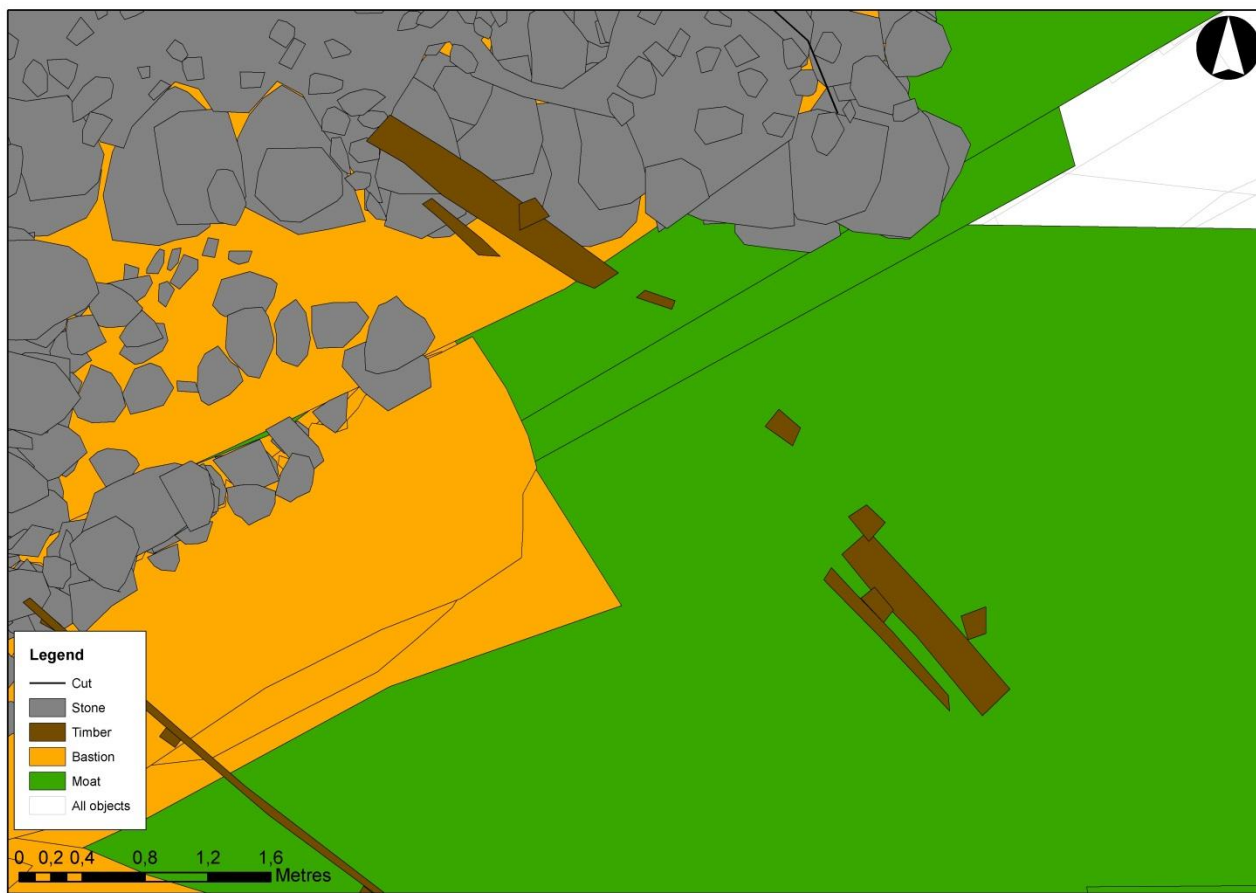
Fig. 260. Interpreted sluice of timber posts and planks partly underlying the 17<sup>th</sup> century bastion.

Group (G-503381) represents part of a 5.4 m long and 4.0 m wide wooden structure consisting of eight vertically set box hearted posts and five planks of different size and depth/thickness recorded close to stone structure SG-503400 and bridge pillars (G-500892) at the base of the 17<sup>th</sup> century moat (Fig. 260).

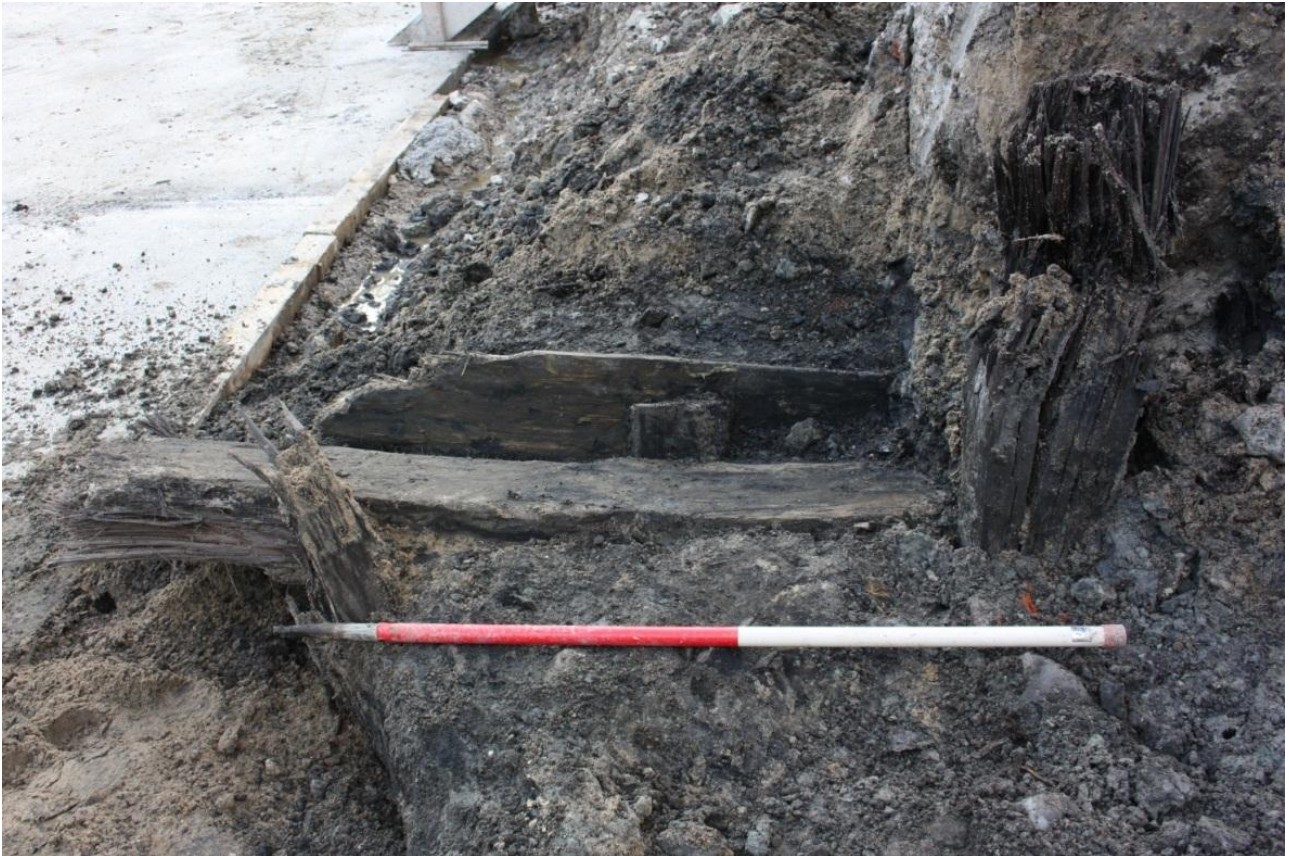
Fig. 261. SE part of wooden structure (G-503381) consisting of vertical posts and horizontal planks at the base of the moat, facing SW. Photo: Museum of Copenhagen.

Horizontal plank (ST310171) was 5.4 m long and 0.2 m wide and placed parallel to planking (ST310200) in a NW-SE direction. The NW end was clean, sawn cut, whereas the SE end was broken – possibly the result of a modern break. The timber structure was destroyed in the middle by modern concrete forming the Guide Wall. Plank (ST311593) further to the west had the same orientation, was 3.12 m long, worn and slightly ripped at the ends. The plank was placed right up against two upright posts (ST311599 and ST311603), but no fixings were visible (Fig. 261).

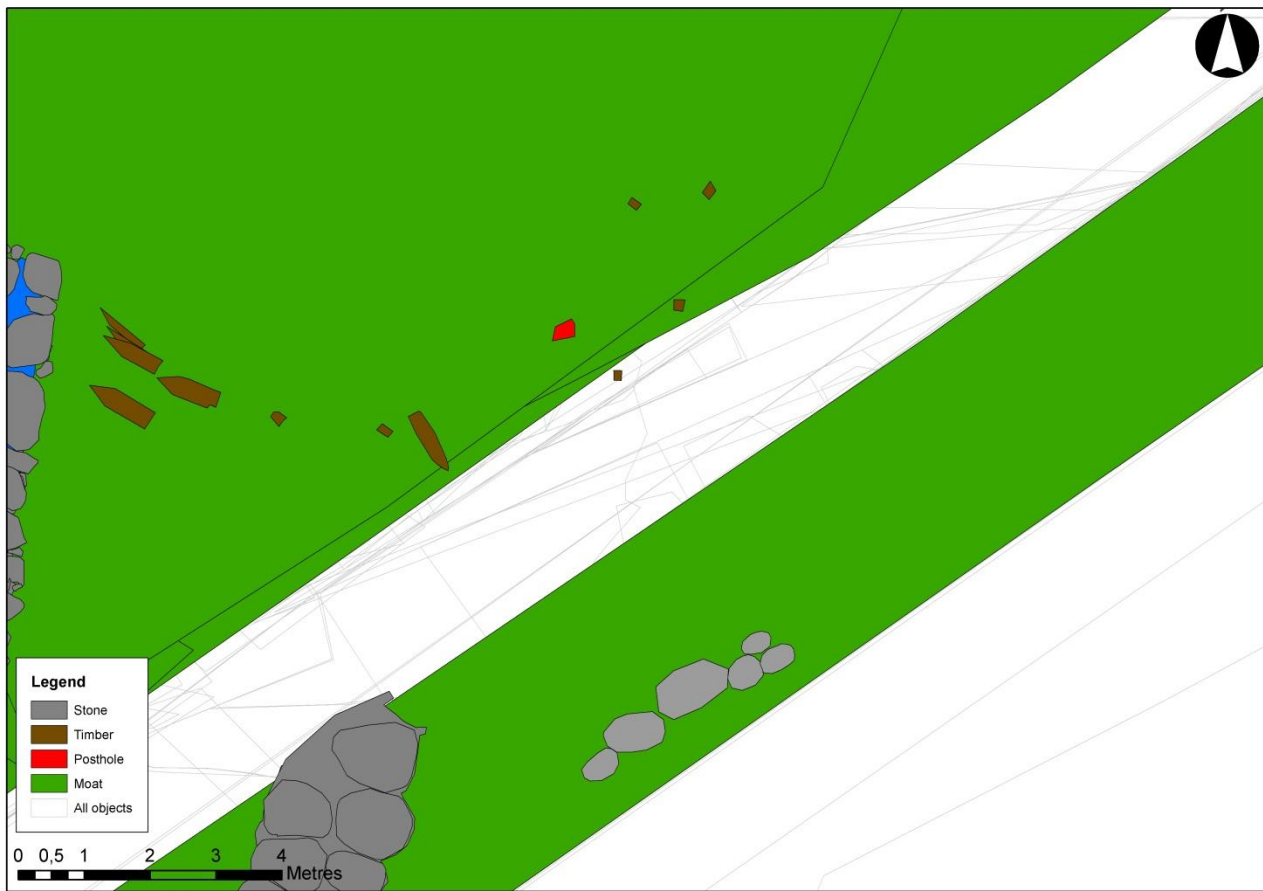
Fig. 262. Vertical posts and bulwark for a larger nearby structure (?) documented at the base of the moat in the natural substrate. The horizontal planks belong to later robber activities; G-810 (see above).

Bulwark (G-500891) was recorded in connection with the bridge and consisted of eight rectangular and vertical beams and one deconstructed posthole (Fig. 262).

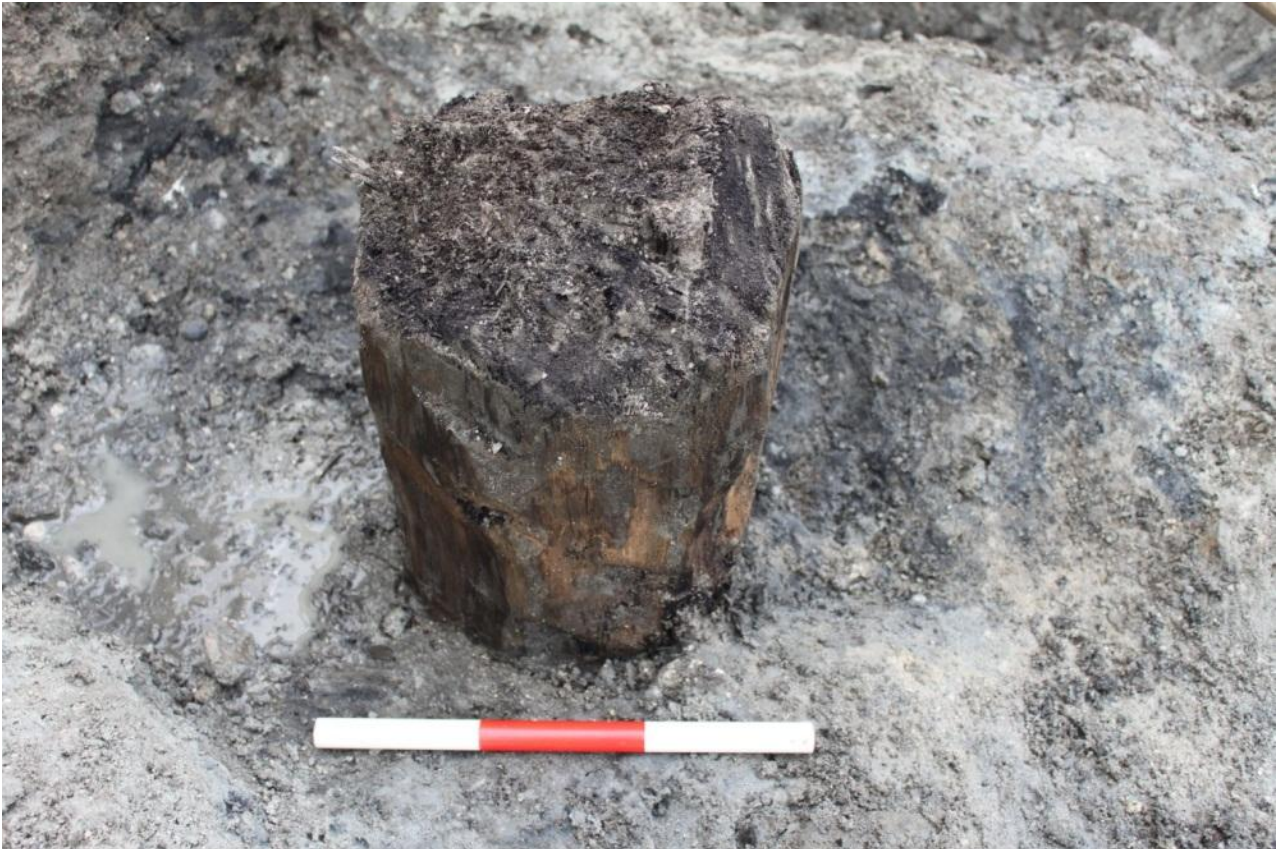
Fig. 263. Post No. 2 (ST198467) driven into the natural substrate, facing north. Photo: Museum of Copenhagen.

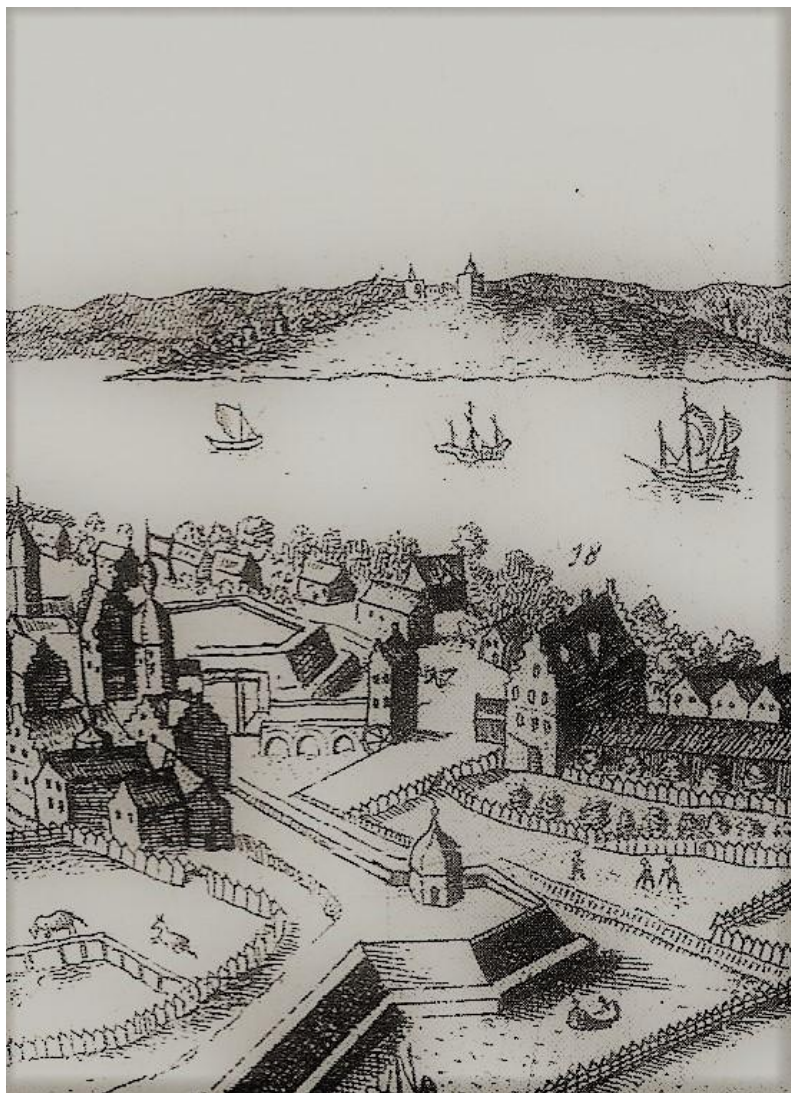
Fig. 264. Part of Johan van Wijck's painting and prospect from 1611 showing Østerport including inner- and outer gate buildings and drawbridge. The Spangenberg's characteristic bastion just north of Østerport is just visible behind the new gate building and is shown as a large, earth-filled plateau with surrounding parapets. A berm is shown by the moat.

In tandem with the construction of the new moat, an outer gate was also constructed. This faced to the south-southeast, approximately at a right-angle to the main gate building, in itself a defensive layout (Fig. 264).

Jan Dirksen's prospect of Copenhagen from 1611 based on van Wijck's painting is the only source that suggests that the city's fortifications might have been covered with bricks (Fig. 264). No brick structure could be traced in connection with the bastion at Kongens Nytorv as was seen at the Metro excavation at Rådhuspladsen (cf. Lyne and Dahlström 2015:206) and nothing in the demolition material from the fortification or the subsequent filling of the moat suggests this. Here, in the southern part of Østervold, from Østerport in the north to Vandporten to the south, the outer slope was almost vertical and it would have been very difficult to maintain this fortification if the works outside were lined with bricks. It is also unclear if the reproduction represents soil or masonry. Since there are no records in the written sources mentioning the purchase of bricks and/or work with masonry, nor later repair around the bastions, it seems be clear that it was intended that the fortifications from Vandkunsten in the west to Bremerholm in the east would have been built as earth works in the "Dutch style" (Westerbeek Dahl in press).

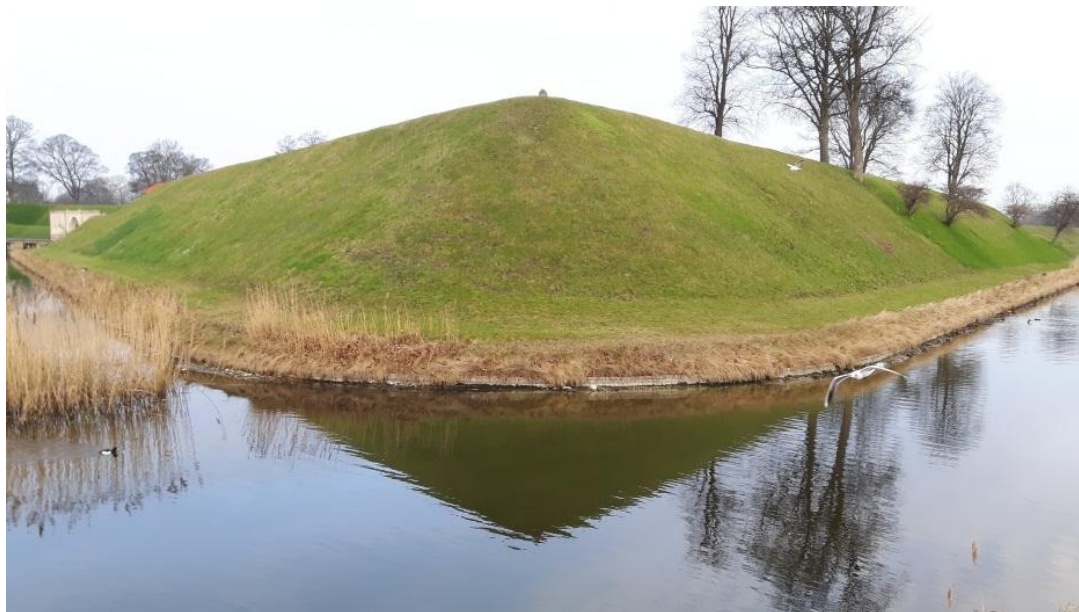
Fig. 266. Bastion and berm facing the moat at the Citadel in Copenhagen. Photo: Morten Steineke.

*Rentemesterregnskaberne* mentions the ramparts and roundels to be 7 cubits high, the parapet 3 cubits high with a cannon bench inside, the embankments width – without parapets and berm facing the moat – should have been 20 cubits (Fig. 266). The written sources also mention that a person named Corneliussen was required to place stones along the inside of the moat, and he should even pay for supplies of turf for the rampart. Only by Nørreport did the

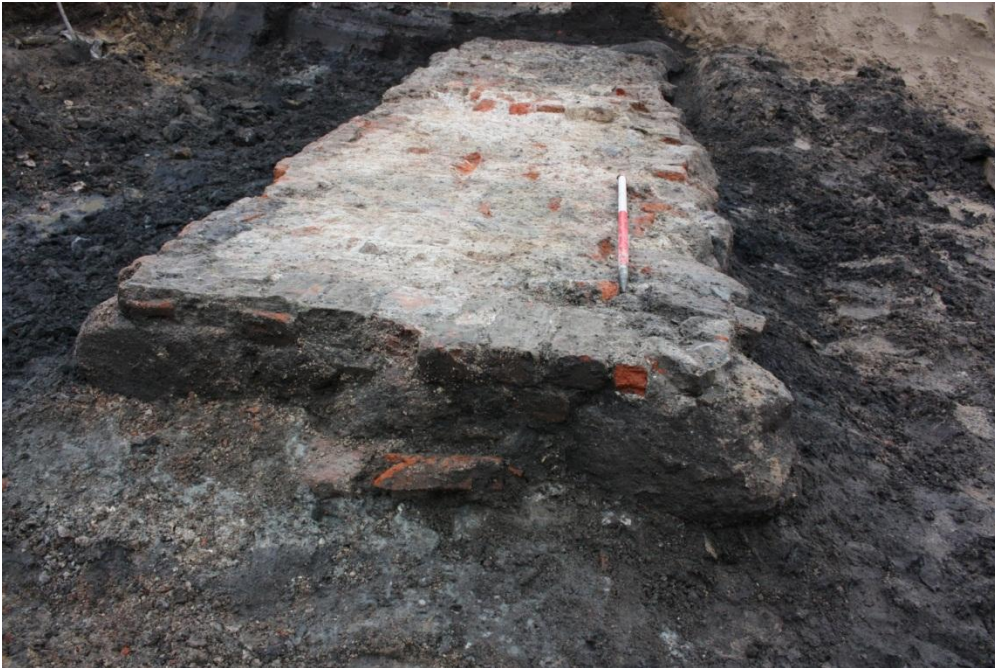
Fig. 267. One of the bridge pillars in the moat. Brick core (SS305876) with header coursing, facing north. Photo: Museum of Copenhagen.

Five vertical brick pillars or bridge piers were investigated in the moat (Fig. 267). Part of this bridge structure was also recorded in 1994 consisting of a dressed stone plinth with three dressed stones and masonry of medieval bricks and lime mortar on a foundation of boulders and demolition material from the 16<sup>th</sup> century or later, revealed in the street outside Kongens Nytorv No. 21. The dressed stones were sloping 15-20 degrees (Skaarup 1994).

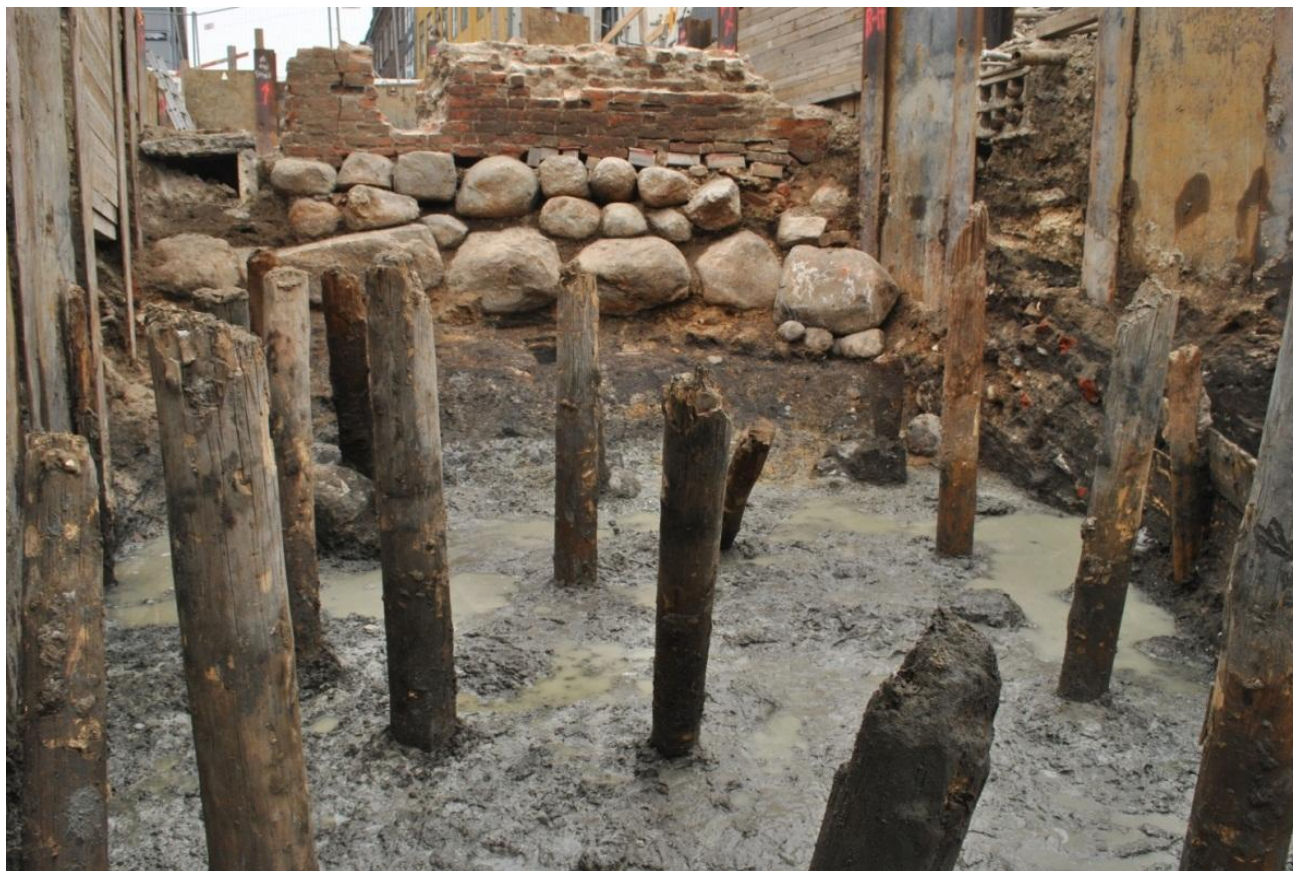
Fig. 269. Overview of the bridge structure in the Late medieval moat, facing west. Photo: Museum of Copenhagen.

In connection with the new bridge one needed a temporary entrance into the city. In 1618–1619 a 30 fathoms bridge entering through an arch down to the beach opposite Slotsherrens gård at Østerport is mentioned (Thorsen 1926:237 and 247), which is presumably the same bridge investigated at the end of Lille Kongensgade in 2011 (Fig. 269).

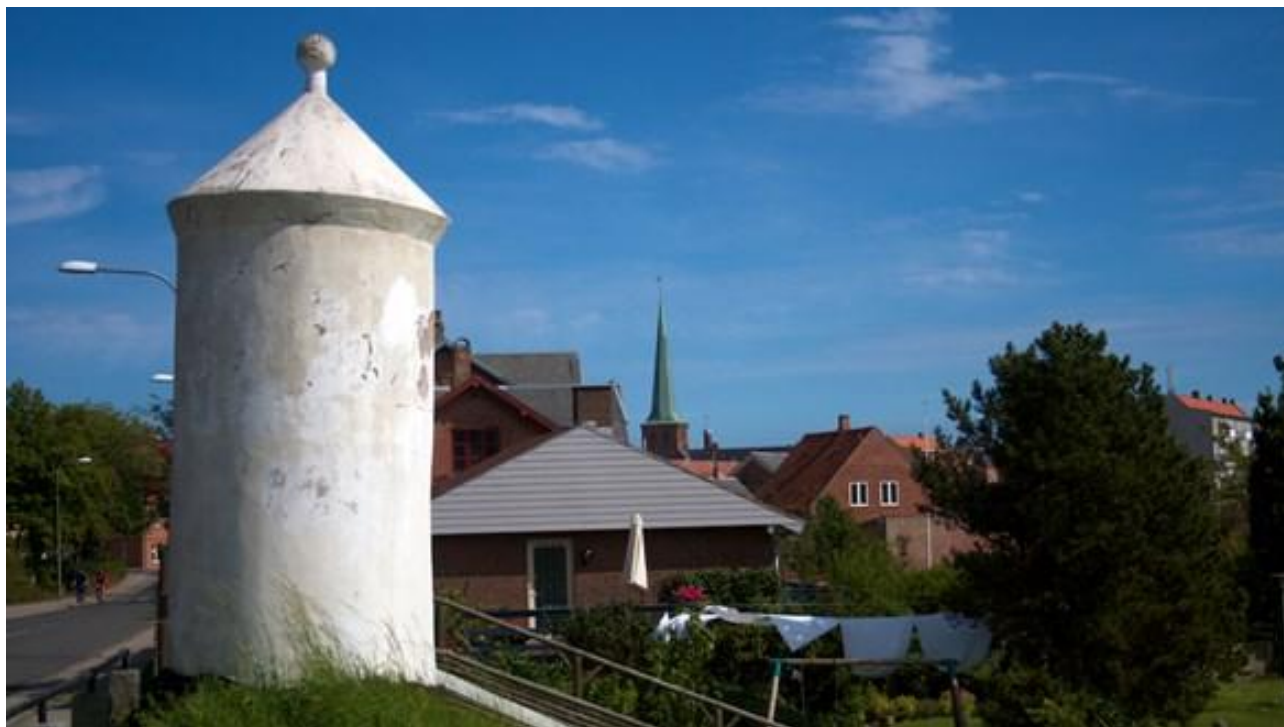
Fig. 270. Small whitewashed tower from c. 1660 AD on top of the dam at "Kongens Bastion" in Nyborg. From: Den hvide jomfru 2016. Photo: Kristian Lilholt, VisitNyborg.

The barrier tower previously had been documented without any clear interpretation (cf. Skaarup 1994). This brick structure was interpreted as a tower in connection with a dam structure just south of Østerport and dated to 1608–1609 AD. This hurdle is also seen on Thorsen's drawing of Østervold and includes two small towers to prevent passage over the moat (Fig. 152; cf. Lassen 1855:28; Thorsen 1926:246; Westerbeek Dahl 2016; In press). The interpretation as a tower is also based on its internal structure and a similar, still existing tower in Nyborg (Fig. 270).

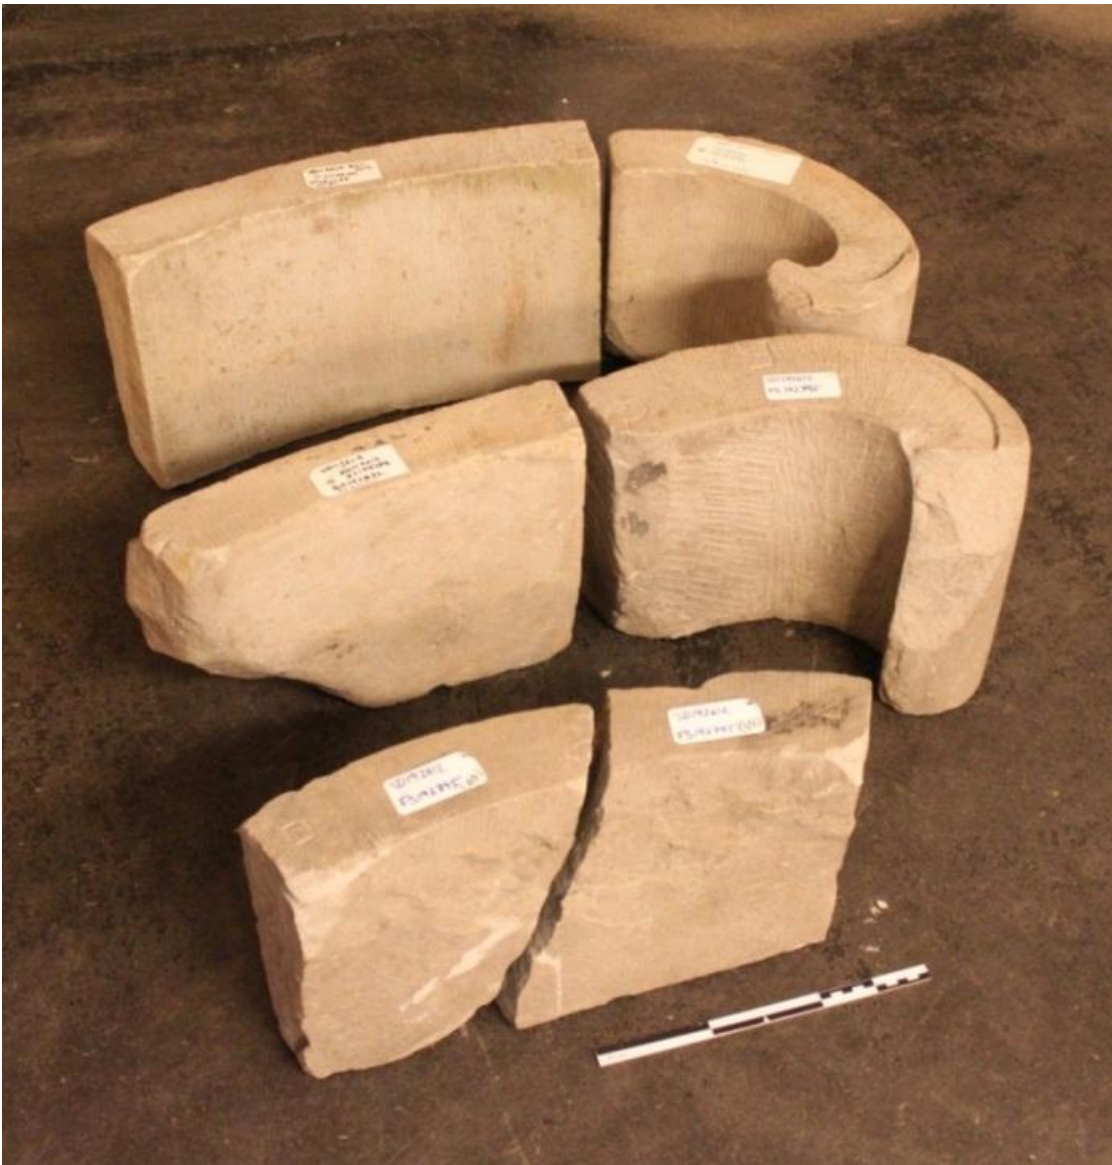
Fig. 271. Parts from former Østerport? Early post medieval sandstone ashlars from the 17<sup>th</sup> century moat. Photo: Museum of Copenhagen.

the 17<sup>th</sup> century moat originates from the same building (Fig. 271). The dating is early 17<sup>th</sup> century and the ashlars could represent destruction material from the former Østerport, although this proposal is highly uncertain.
