Kongens Nytorv 1650-1950 AD

Results

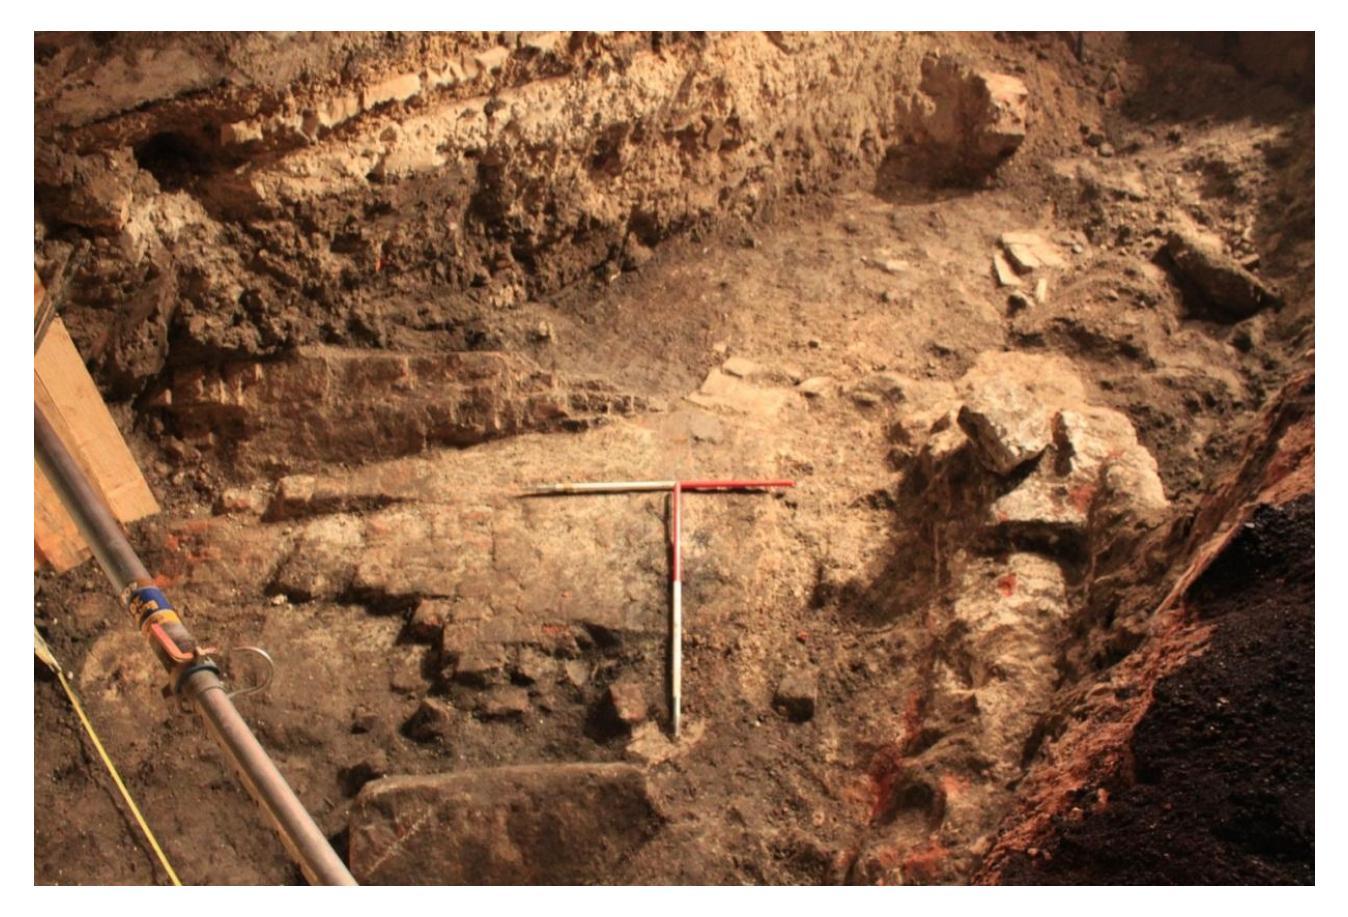
Fig. 247. Night work. Floor of square bricks and brick walls (SS53028 investigated in current Holmens Kanal, facing south. Photo: Museum of Copenhagen.

Part of a building was recorded in a watching brief trench during night work in current Holmens Kanal (Fig. 247).

The building included several structures such as a brick floor in several phases, wooden planks, boulders, various types of masonry, a collection of ten vertical piles in an area of approximately 1.7 x 0.8 m, and parts of a foundation consisting of three parallel wooden beams together with demolition material containing brick fragments and mortar. The piles had a diameter of 0.2 m and had been used to stabilize the building (Fig. 248). The building remains can be connected to and interpreted as part of the Lille Gjethus from 1698; the city's former cannon foundry, magazine or storage shed for the finished moulded cannons.

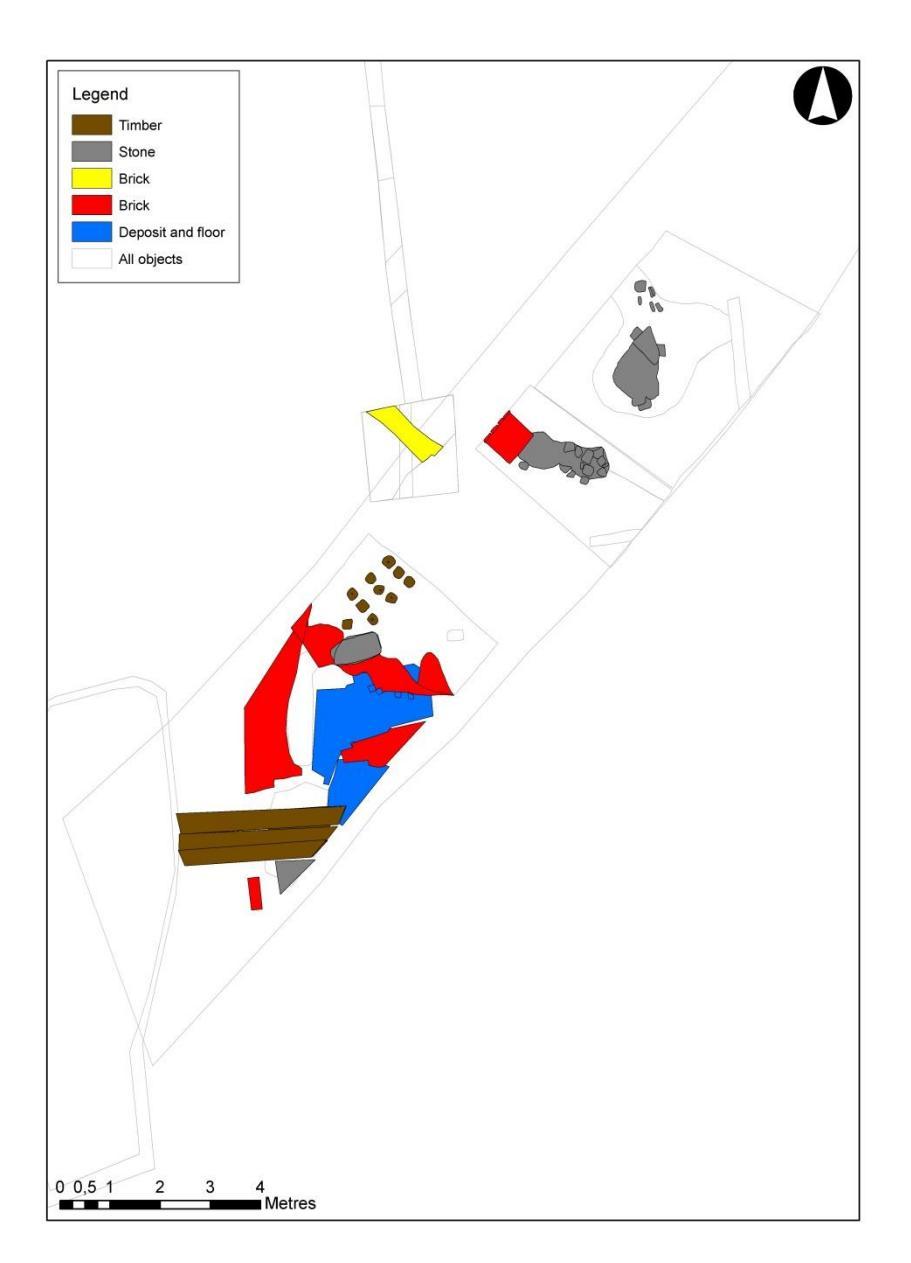
Fig. 248. Features belonging to Lille Gjethus excavated in Holmens Kanal.

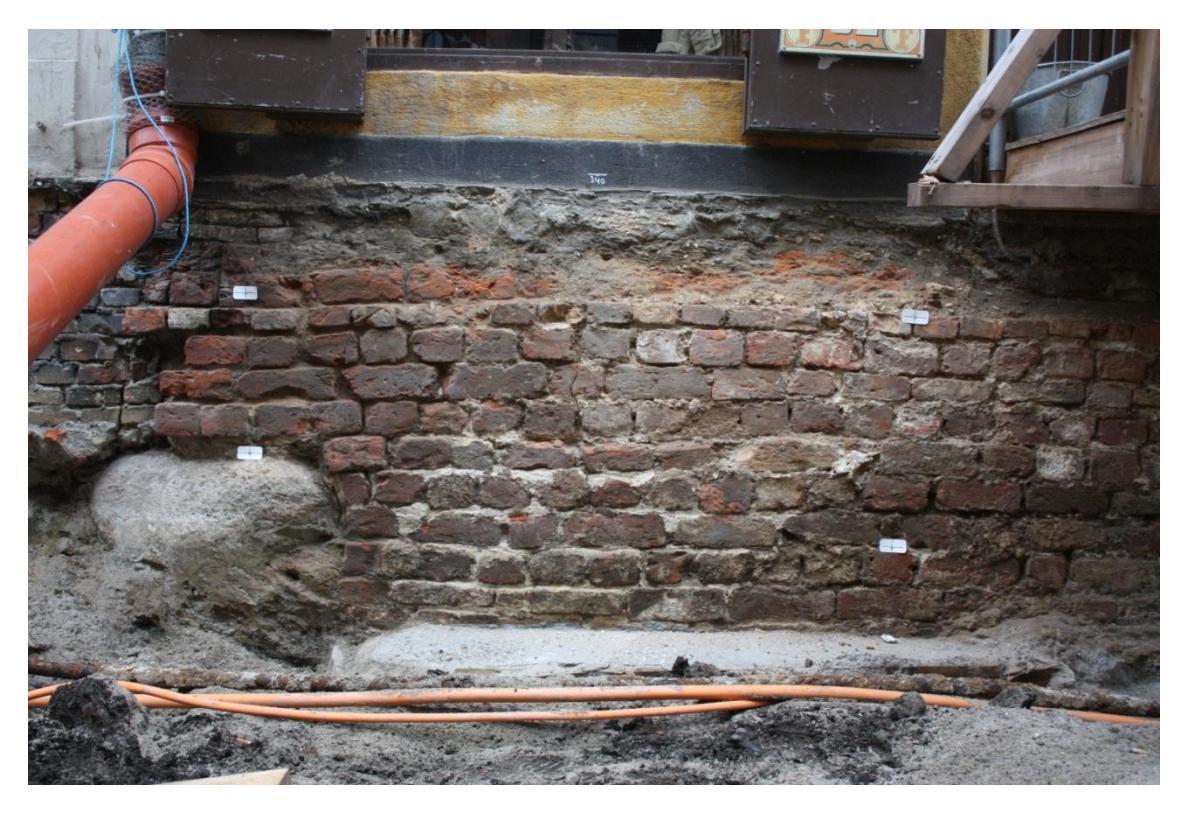
Fig. 249. Exposed brick wall and foundation stone at Hviids Vinstue, facing north. Photo: Museum of Copenhagen.

With the establishment of the new Metro Cityring it was necessary to underpin the foundations of Hviids Vinstue and other nearby buildings in order to provide additional support. Larger parts of the facade were therefore exposed and excavated, which enabled archaeological documentation of the brickwork together with foundation stones (Fig. 249).

The recording showed the different phases of maintenance work and interventions in the brick wall foundations that have happened during the years after the building was constructed in the early 1700s.

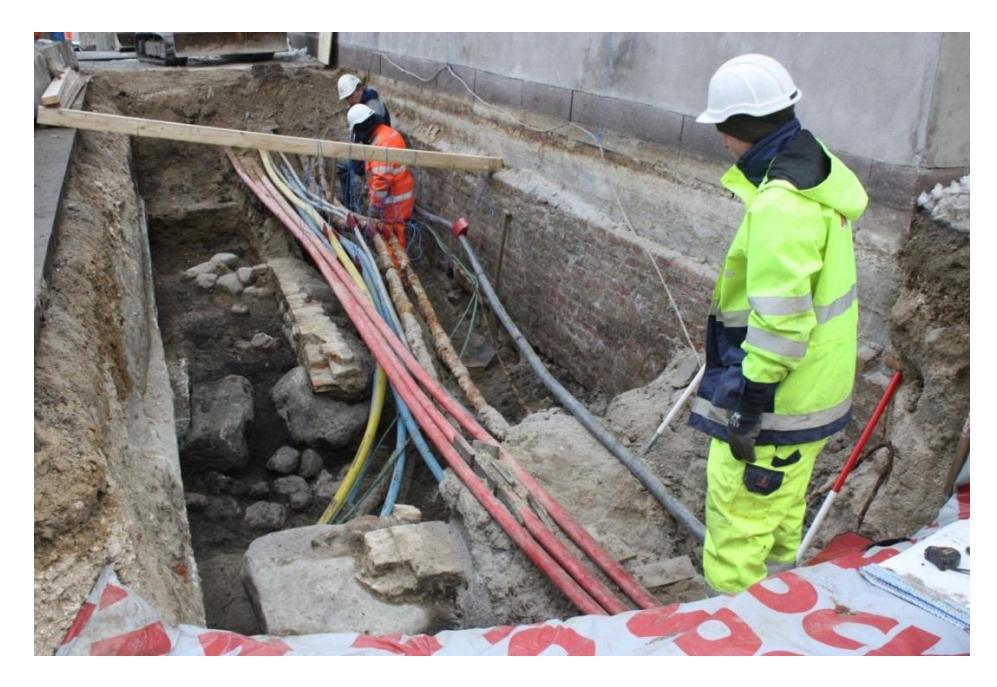
Fig. 250. Overview trench outside Danske Bank with exposed boulders, stones and brick wall, facing east. Photo: Museum of Copenhagen.

Part of a building was investigated north of Danske Bank's facade (Fig. 250).

Besides the remains of a floor (?) in the western part of the trench, seven large boulders arranged in at least two courses forming a U-shape were documented in an area of approximately 2.7 x 1.4 m surrounding an open area with a buried bucket (Fig. 251).

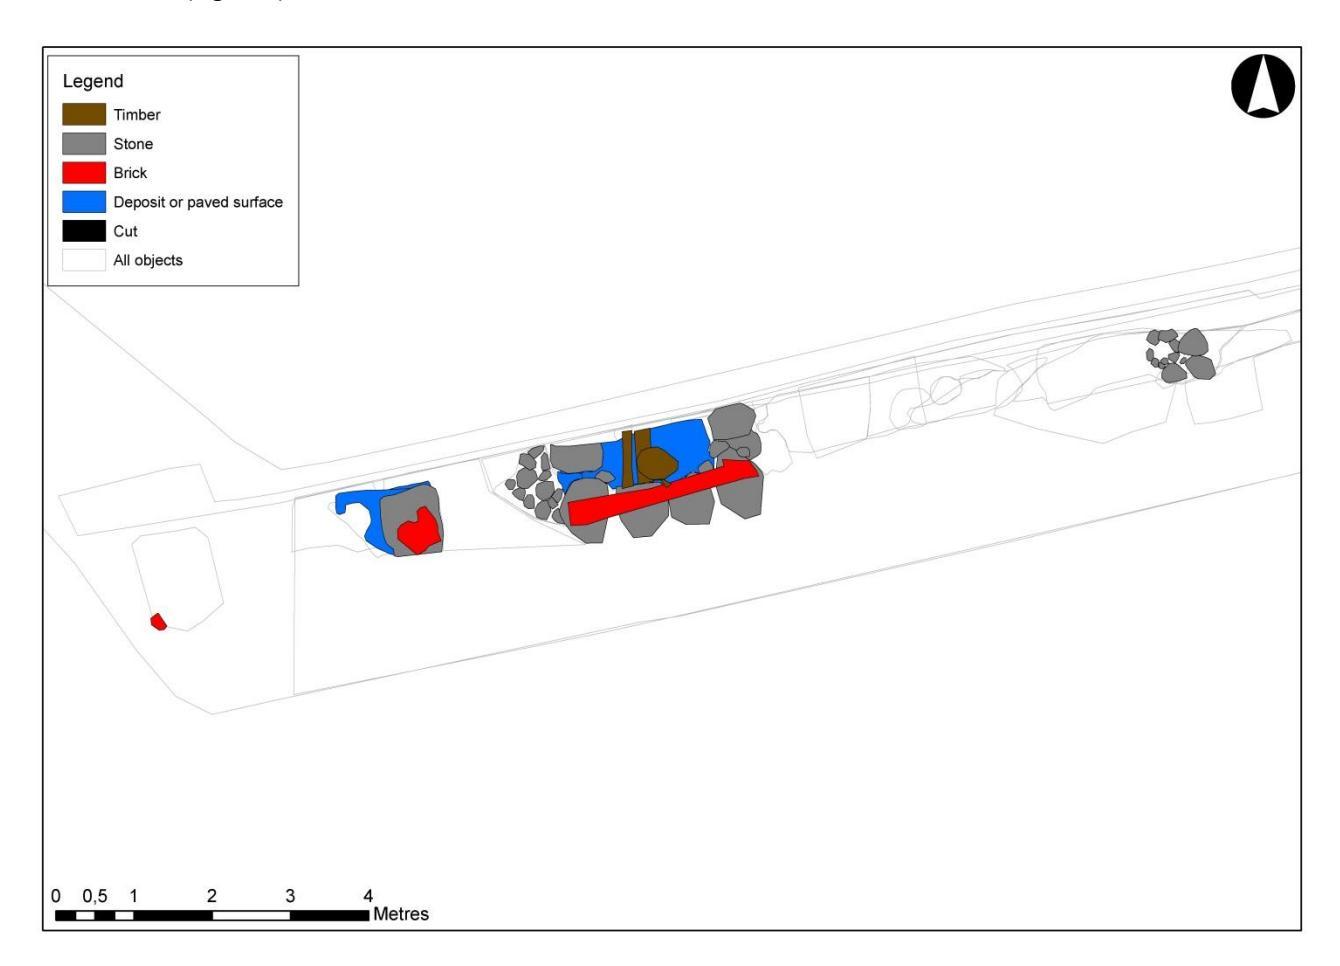
Fig. 251. Part of brick wall belonging to a former building outside the northern facade of the present Danske Bank. In the middle – part of a bucket with unknown purpose.

The bucket contained different types of waste, such as brick fragments, tiles, glass and ceramics. Below the bucket two wooden 0.7 m log logs of uncertain function was recorded. Up against the boulders an accumulation of 20 smaller stones were recorded (G-202). The southern row of boulders and a large stone to the west had served as the foundation for a later NE-SW running wall of red and yellow bricks in three courses.

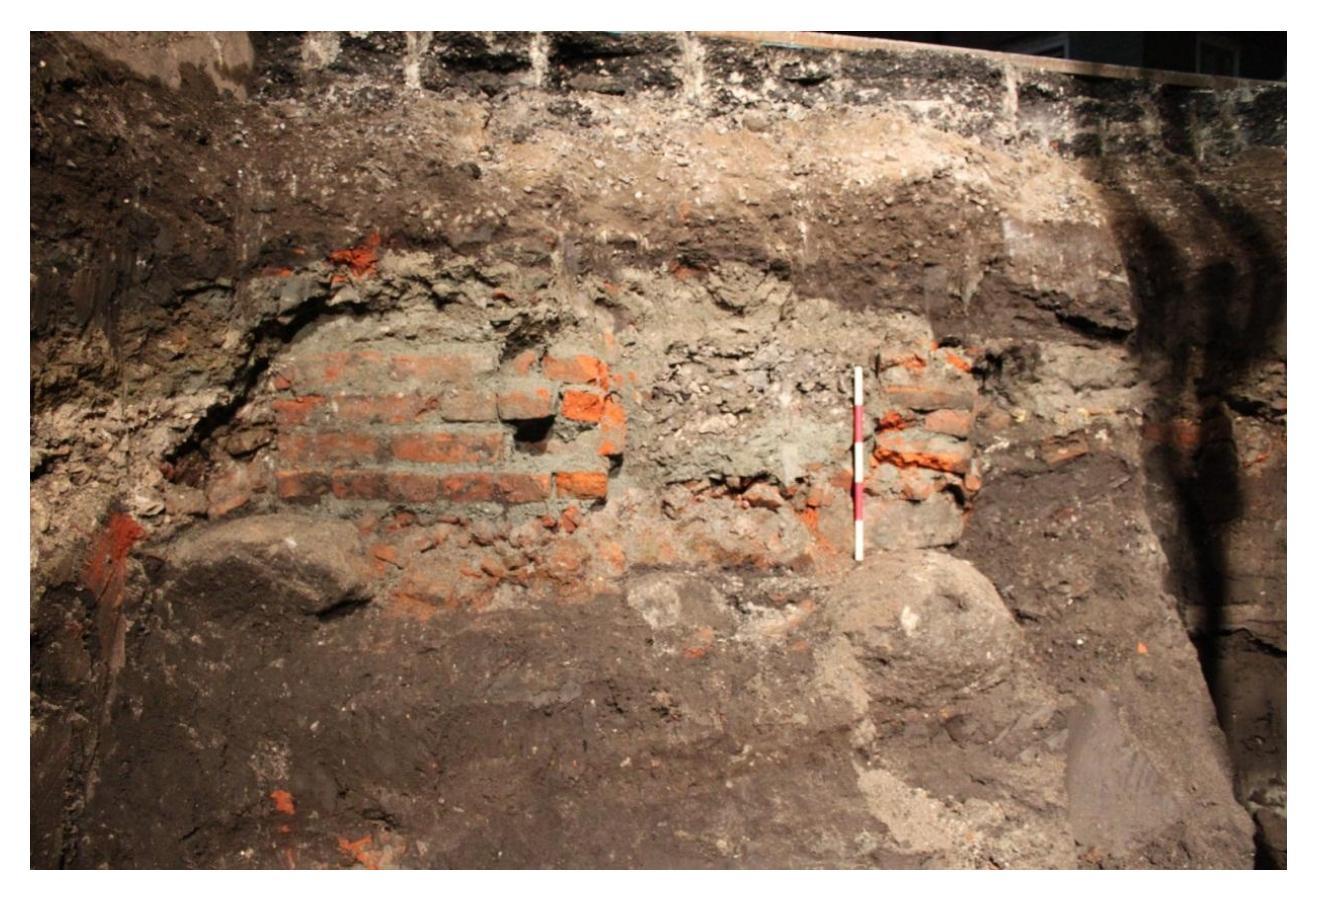
Fig. 252. Foundation stones and brick wall exposed during night work in trench ZT52627, facing SE. Photo: Museum of Copenhagen.

In a watching brief trench across Bredgade from Krinsen to Nyhavn parts of a building were investigated (Fig. 252).

The brickwork and foundation stones belong to an earlier building with a Post medieval date. An accumulation of bricks recorded in the north could have a similar origin. Beams were revealed in the northern part of the trench and this construction may be the remnants of a bulwark and parts of a ground anchor. Similar structures have been encountered in previous surveys in the area. The structure could represent part of the guard building seen on Marcelius prospect from c. 1720 AD (see Fig. 261 below).

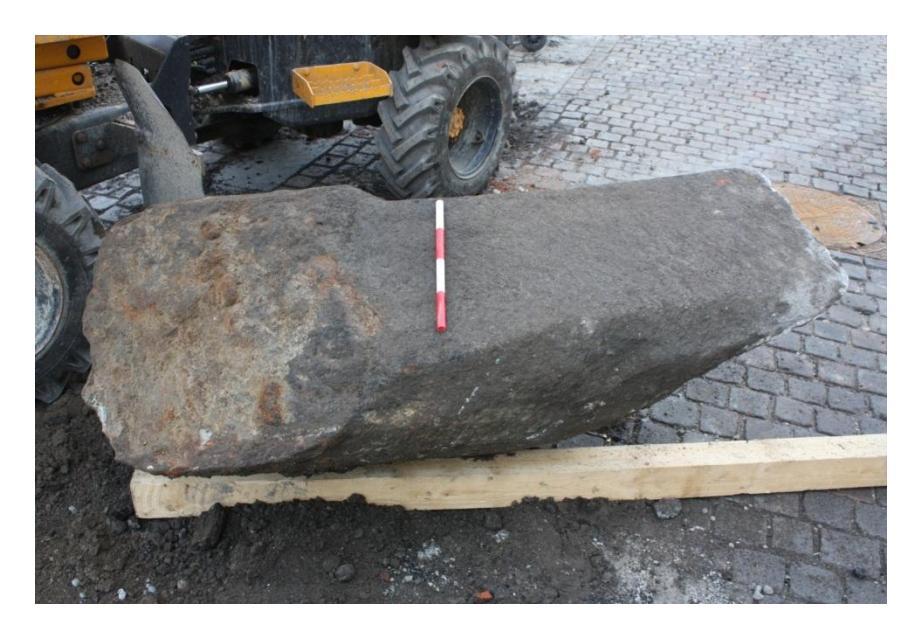
Fig. 253. Boulder interpreted as an "entrance stone" (Danish: afviser) from dump and levelling layers outside the Royal Theatre. Photo: Museum of Copenhagen.

In a trench extending from August Bournonvilles Passage to the SW corner of the Royal Theatre some stones were recorded and interpreted as remnants of an older building, but probably represent destruction material. Part of a wattle and daub wall (?) could be remains of a timber building seen between Store Gjethus and Lille Gjethus on a drawing from 1698 (cf. Elling 1940; Fleischer 1985). A large boulder exposed and removed from a watching brief trench outside the theatre represented an "entrance stone", perhaps from the former Harsdorff's Theatre (1774) west of the current theatre (Fig. 253).

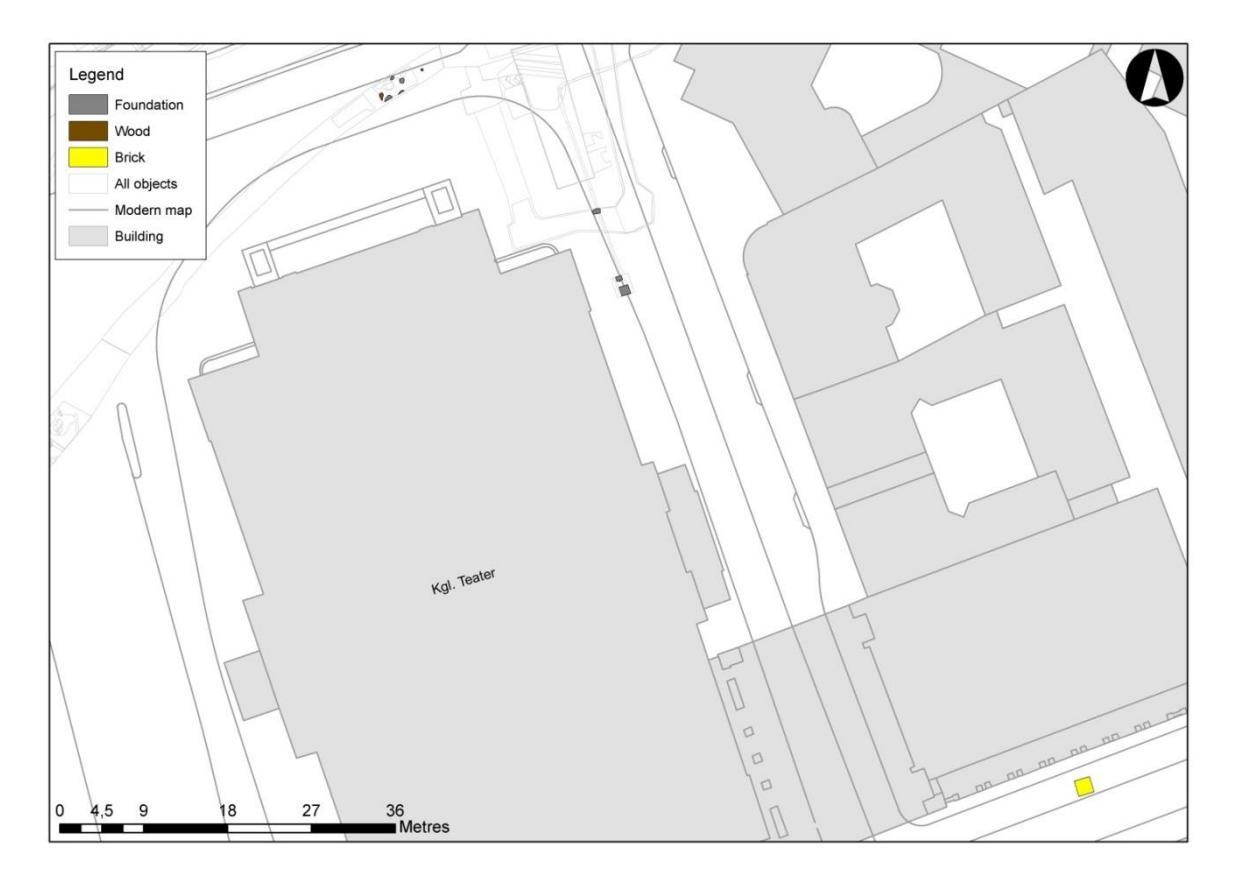
Fig. 254. Four foundation stones and lower parts of a brick wall (2.5 x 1.0 x 0.5 m) running in NE-SW direction together with brickwork and foundation layers in Heibergsgade and August Bournonvilles Passage.

In the northern part of a trench between the Royal Theatre and August Bournonvilles Passage No. 1 a brick foundation of so-called Flensborg bricks was documented (see Fig. 254 below). The width was estimated to be about 1.0 m, with the foundation continuing beyond the edge based on the location of the trench to the north. The brickwork may have belonged to Store Gjethuset built on the site in 1672 AD.

Part of a stone pavement was investigated in August Bournonvilles Passage. In a monitoring trench in Heibergsgade outside No. 7 an uncertain Late post medieval brick wall in the SW corner was recorded (1.2 m down), although without further interpretation.

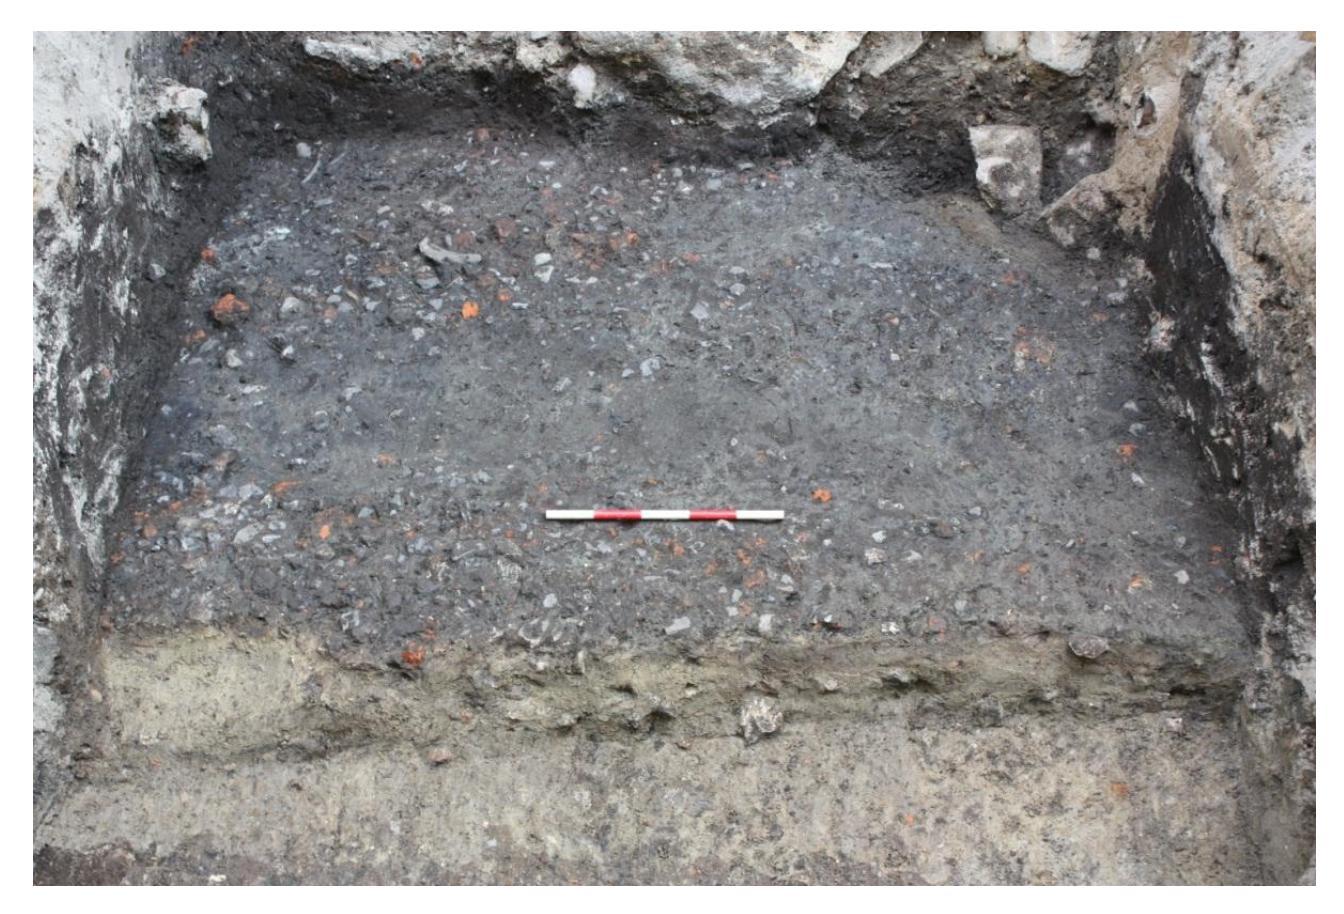
Fig. 255. Street surface in Lille Kongensgade, facing north. Photo: Museum of Copenhagen.

Five different road and street surfaces dated to this time phase were recorded at Kongens Nytorv and adjacent streets (Fig. 255). The surfaces did not differ remarkably from the already reported medieval and Post medieval road and street surfaces and consisted of brown-grey silty sand and clay with inclusions of soot, charcoal, red brick fragments, pebbles and stones. The average stone fragment size was 2.0-3.0 cm in diameter where in some places the surface had sunk into (or filled) the wheel ruts. The street surfaces recorded in Lille Kongensgade consisted of pebbles, flint and brick fragments and were in many ways similar to the road surfaces documented outside Østerport dated to the 16th and 17th centuries.

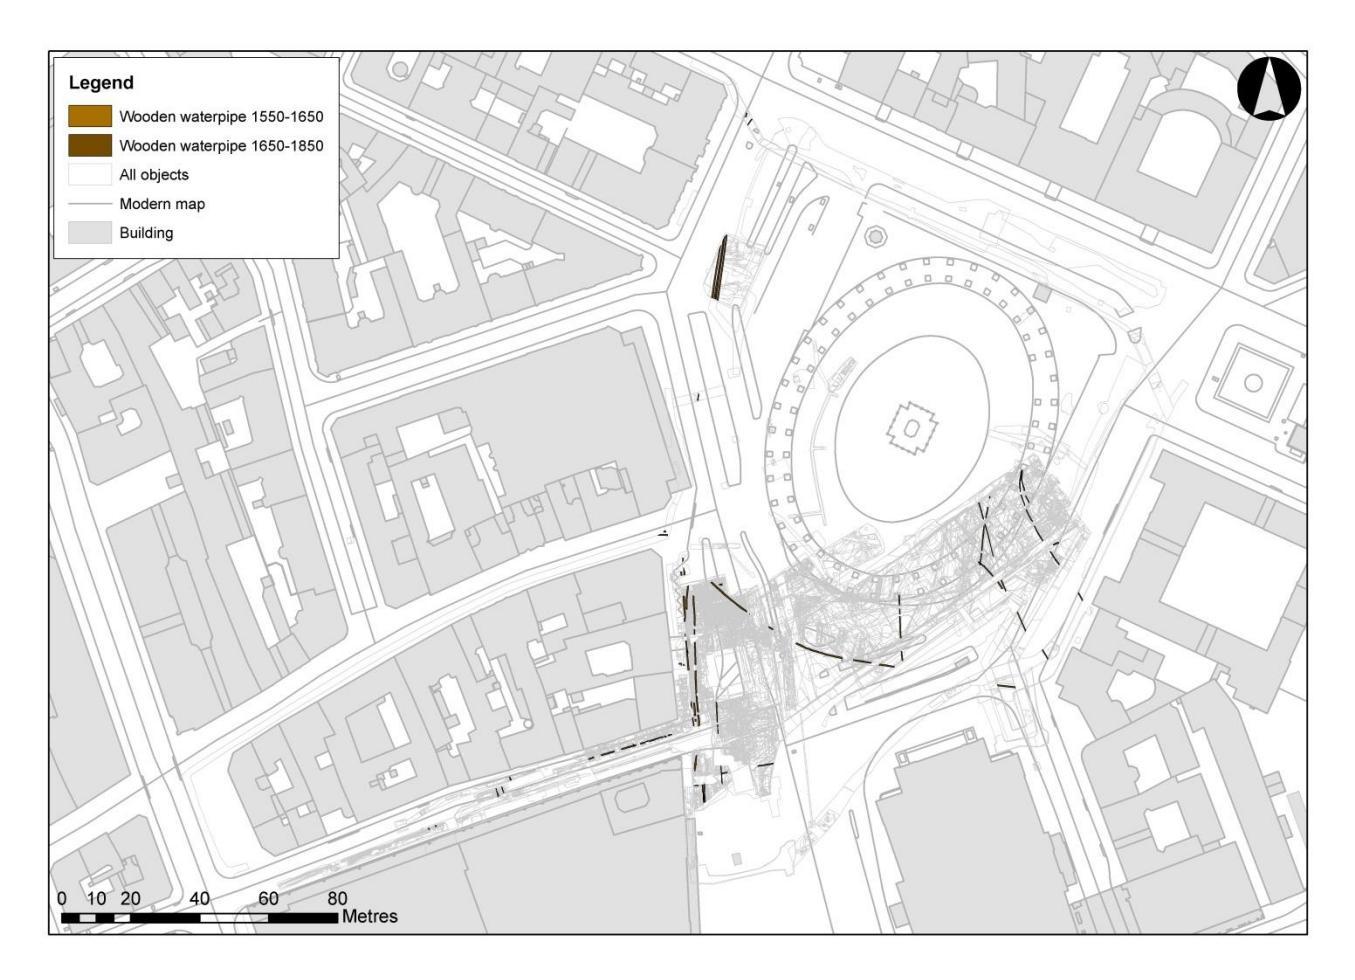
Fig. 256. Overview. Wooden water pipe lines at Kongens Nytorv and in Lille Kongensgade.

Several wooden water pipes were documented both in Lille Kongensgade and at Kongens Nytorv (Fig. 256). The pipes were made of pine, had a diameter of between 0.20 m and 0.50 m, where the drilled core was from 0.10-0.20 m in diameter. Some of the pipes had joints made of metal and a covering of lead plate (Fig. 257). In some cases the pipes had been stabilized with wood blocks or bricks.

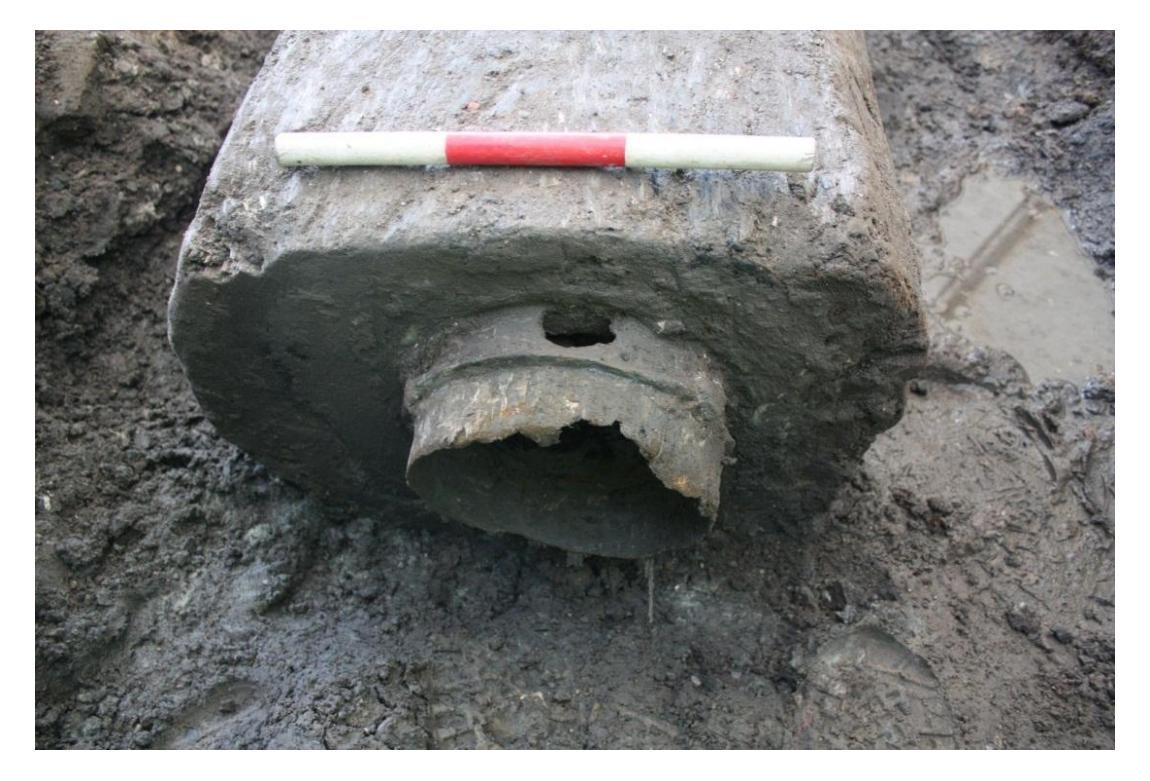
Fig. 257. Iron bolt in one of the recorded wooden water pipe. Photo: Museum of Copenhagen.

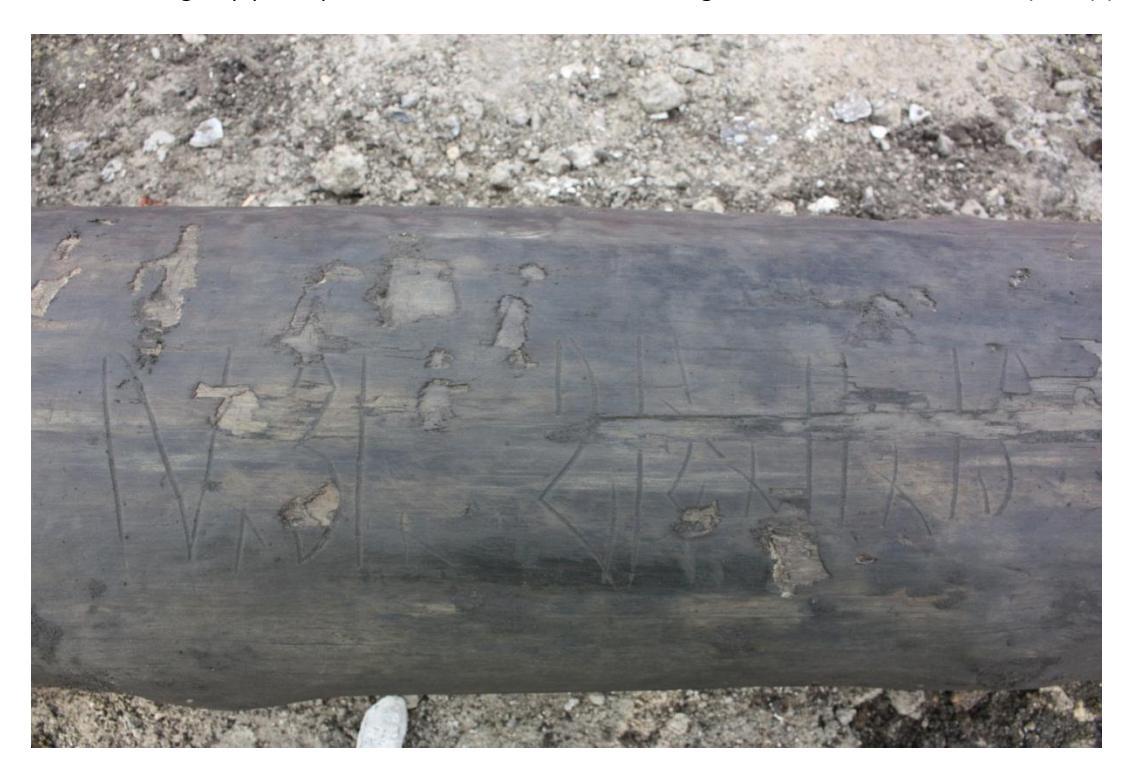
One of the largest pipes exposed in the Station Box had writing on it: N x 31 x 21¹/₂ x 11 x 13 (or 15) (Fig. 258).

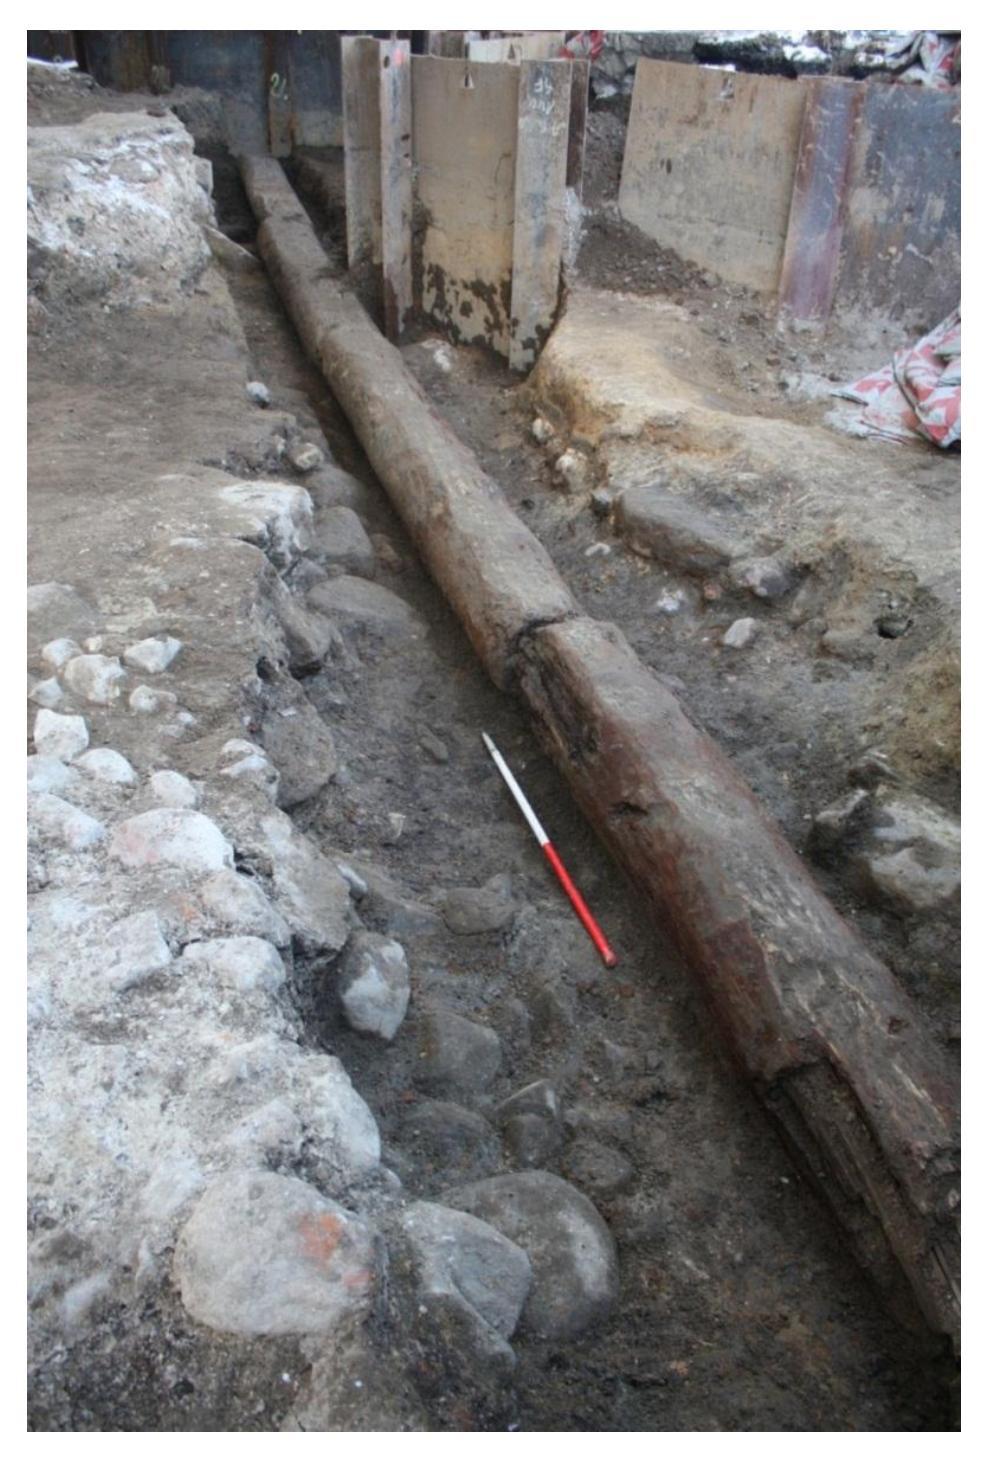
Fig. 262. One of the main pipelines at Kongens Nytorv. Wooden water pipe with construction cut through the foundations of 17th century Østerport, facing SW. Photo: Museum of Copenhagen.

(customers who had paid for a water supply). The timber species used for the water pipes was pine and the wooden trunks were connected by lead and by iron bolts (Fig. 262).

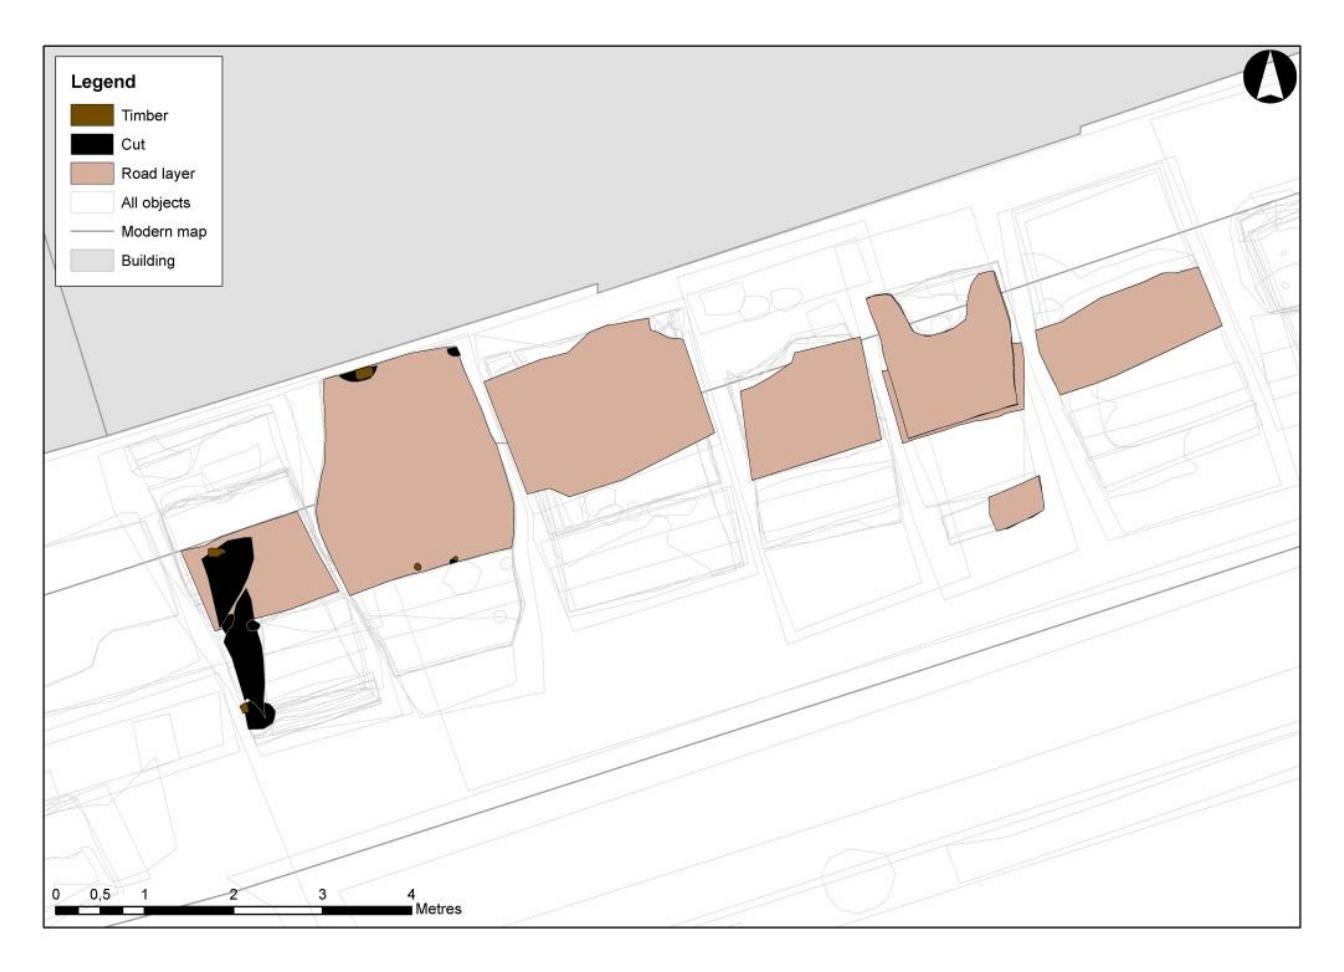
Fig. 268. Remains of probable horse stable excavated in Lille Kongensgade.

The remains of a stable were also excavated to the west of Lille Kongensgade (Fig. 268).

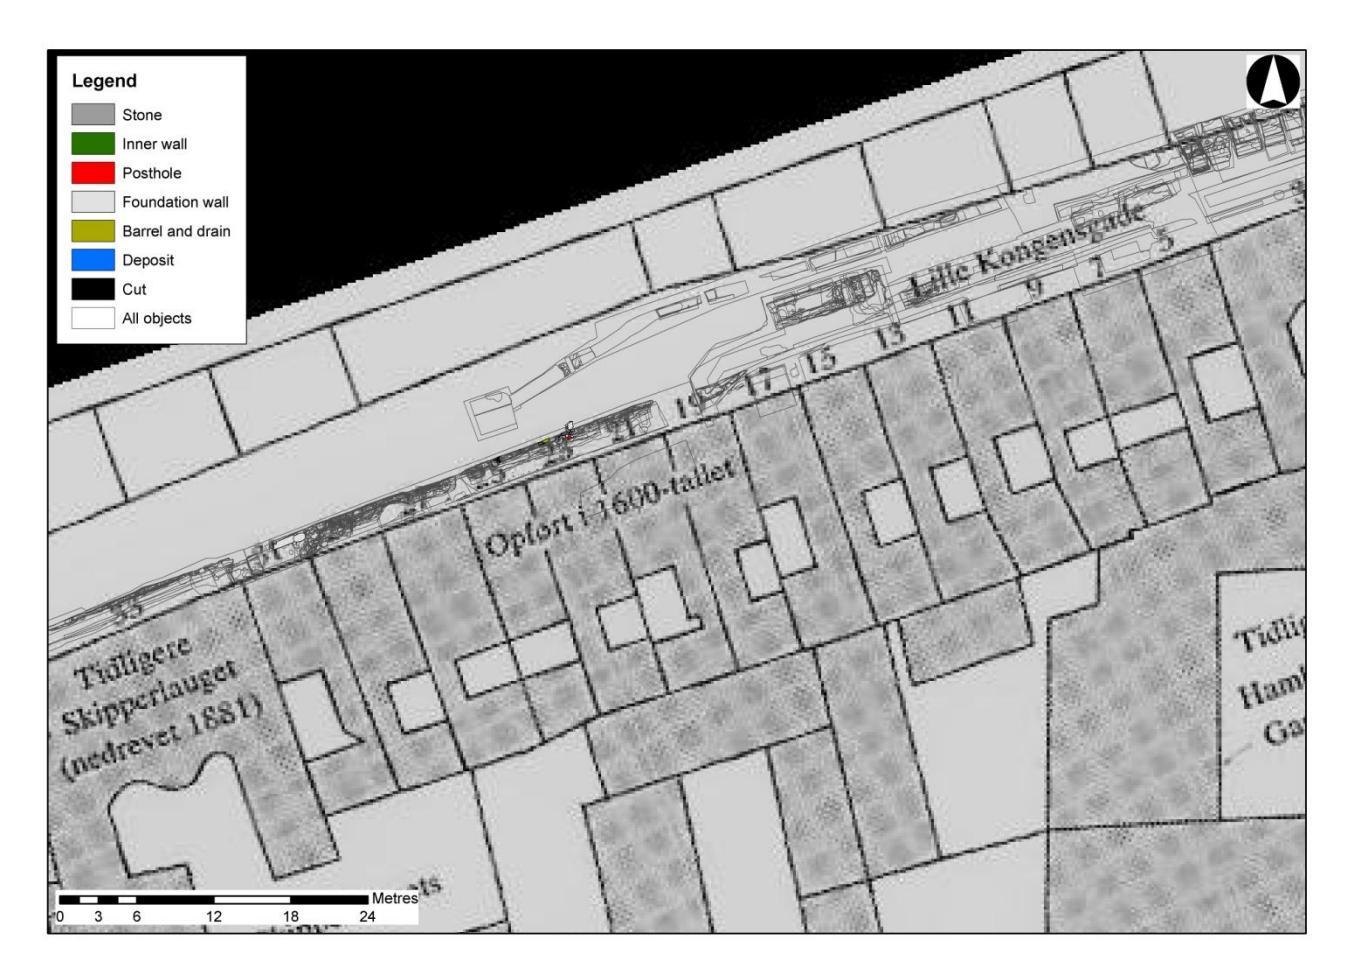
Fig. 269. Archaeological findings of the King's Booths/Kongens Boder – see plot No. 21-29. Outside plot No. 23 was the location of the barrel and other remains that are interpreted as a type of workshop.

The King's Booths in Lille Kongensgade are most likely originally to have been high quality brick buildings and this is probably one of the reasons why some of the buildings still survived into the 1930s before they were torn down (Fig. 269). The buildings that were still standing in the 20th century must have been rebuilt/restored on more than one occasion. The excavations in Lille Kongensgade revealed remains up to three buildings that stratigraphically belonged in the latest level before the present time. This corresponds well with the fact that they were – at least some of the nemins of buildings torn down only some 90 years ago. The dating of finds also puts the remains in the range of the Post medieval period. The best preserved building could indicate a function as some kind of workshop. A barrel was set in the floor with an adjoining wooden drainage. There was no indication of which kind of work had been carried out. It could also have had the function of a front shop at the same time. This would be very likely in this urban setting of booths along the street with different functions and inhabitants.

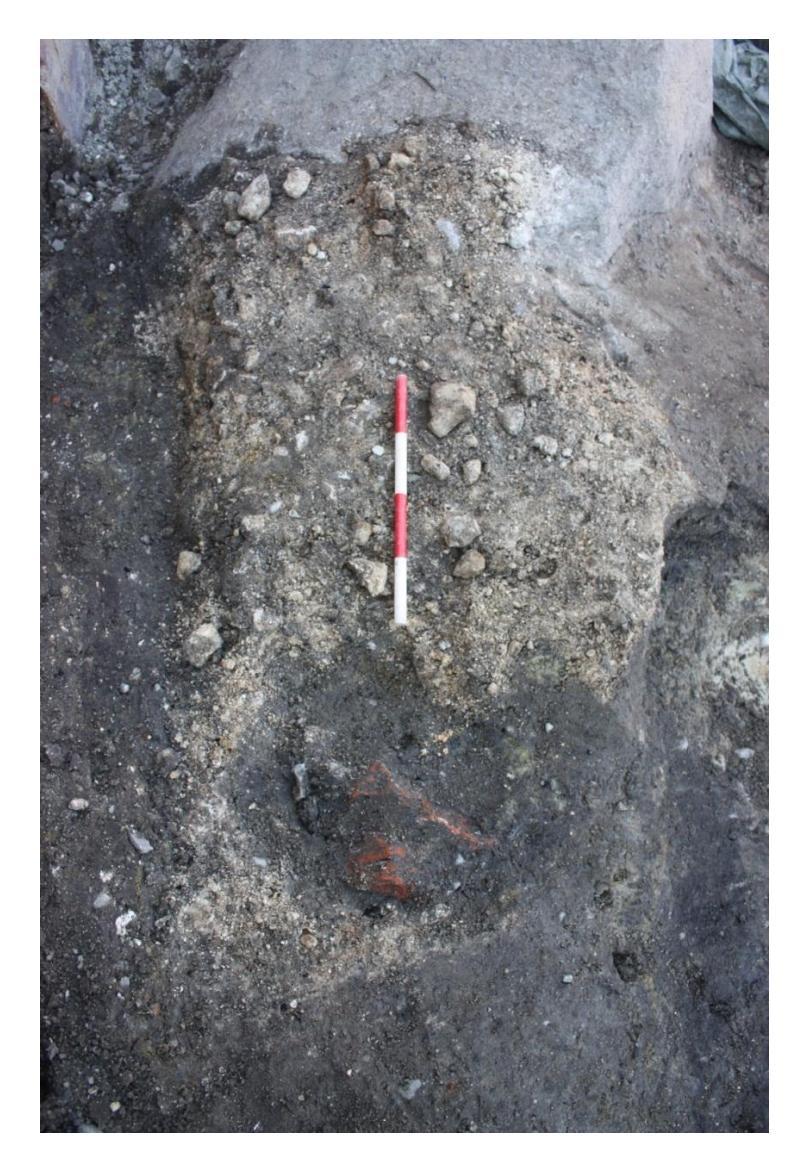
Fig. 270. Mortar production area. Photo: Museum of Copenhagen.

Just south of Lille Kongensgade a work area with traces of mortar production was located (Fig. 270). This could have been a smaller local production site, because large scale production probably would take up a lot of space. The production area was placed near the medieval forge building and indicates an industrial area in this part of the city – also confirmed by the fact that no definite domestic evidence exists from the same area.

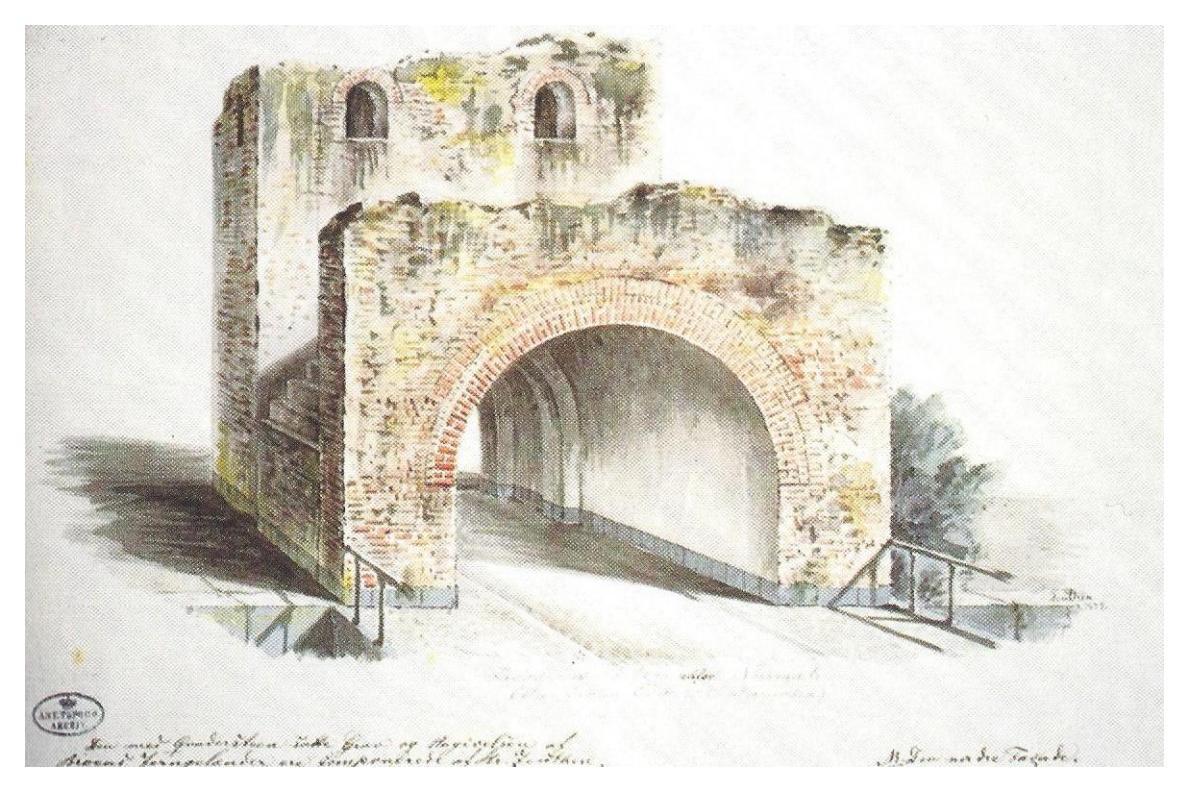
Fig. 272. Nørreport's gate building outside Nørregade in Nørre Voldgade. A similar row of limestone ashlars at the base has been documented in Østerport. Drawing by C. O. Zeuthen. From National Museum of Denmark.

The Late medieval version of Østerport is significantly larger than both Nørreport and the remains of Vesterport. The contemporary Nørreport was squared (c. 7.0 x 7.0 m) with a gateway width of 4.0 m and with a round arched vault (Fig. 272 and 273). The southern wall was 1.0 m wide and the north and east wall 1.26 m (cf. Lassen 1855:Planche III; Thorsen 1926:239).

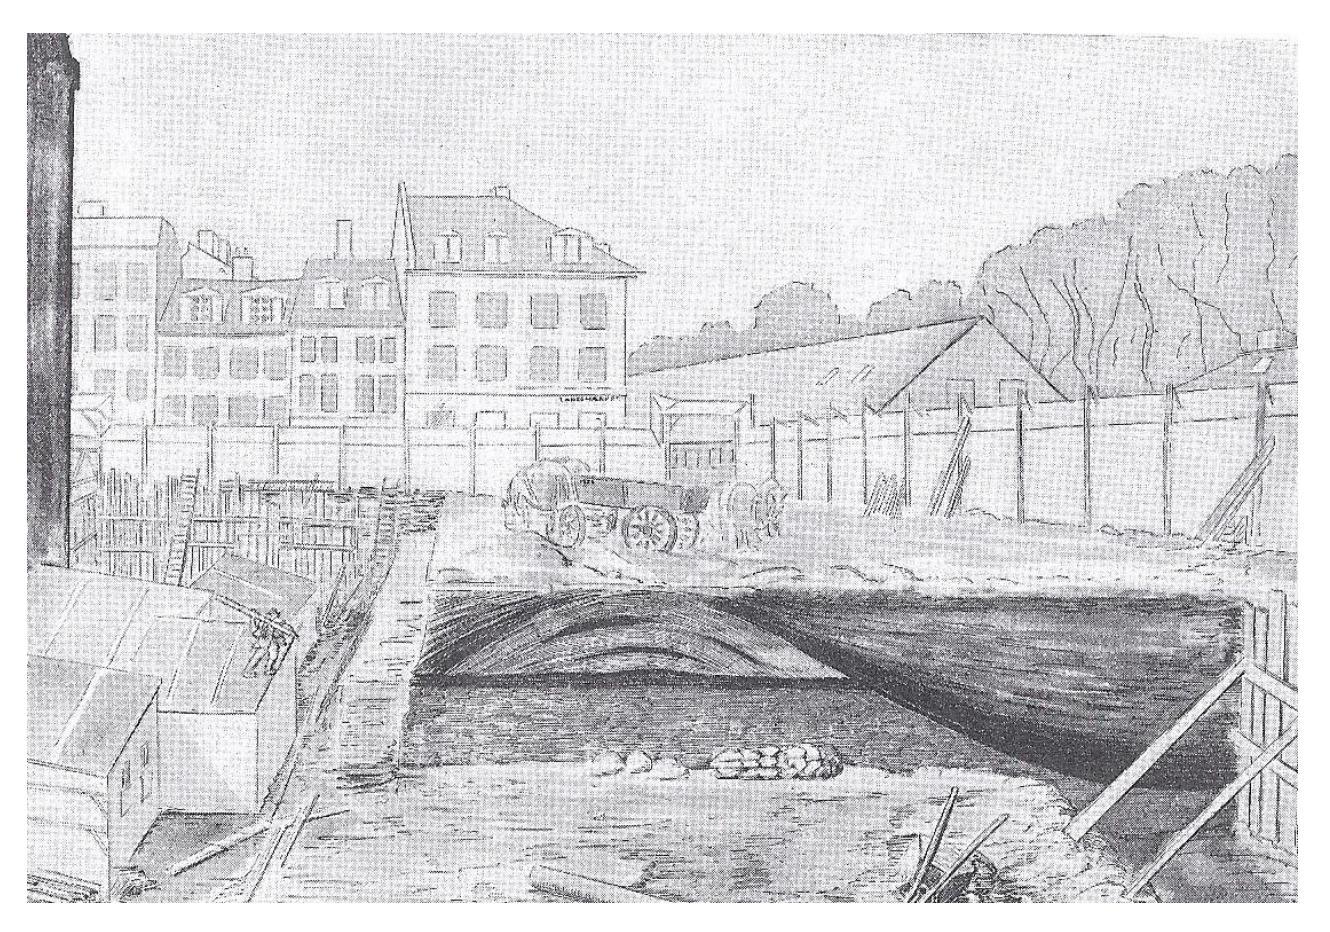
Fig. 274. The medieval rampart and moat exposed at the corner of Gothersgade and Landemærket in 1926. The natural salt marshes can be seen as a horizontal line in the middle of the section. Drawing by Peter Linde. Museum of Copenhagen.

Through archaeological studies the medieval rampart has been proven between Vartov Grønnegård, Nørreport and Kongens Nytorv (Jensen 1934; Ramsing 1940, Vol. III:4; Kristiansen 1998:63 et seq.; Skaarup 1998a:39; Fabricius 1999:117 et seq.). The fortification has on several occasions been identified at Løngangsstræde (Thorsen 1926:205 and Fig. 274) and at an excavation in 1992 a rampart or dam was recorded along the former beach in Lille Kirkestræde and dated to the 1220s (KBM 775).
