Kongens Nytorv 1650-1950 AD

Results

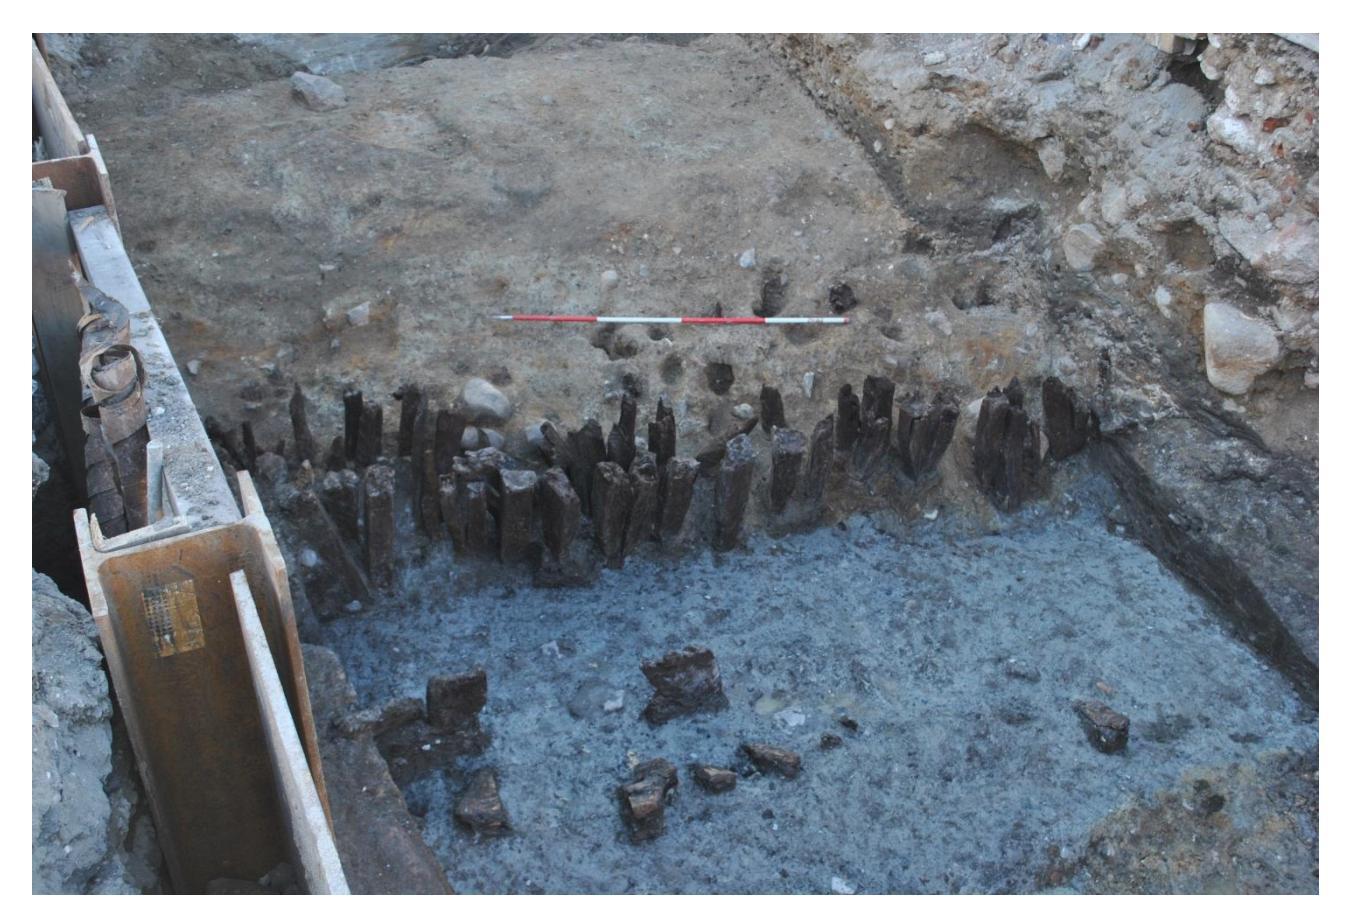
Fig. 275. Bulwark, rampart and moat (blue), facing NW. Photo: Museum of Copenhagen.

standardized to 10-12 m and the height between 1.5-3.5 m, while the moat was 12.0-14.5 m wide with a depth of 2.0-2.5 m. The size varies between the different locations, but the building material is always natural moraine dug from the moat in front of the embankment and placed directly on top of the natural salt marshes, and finally covered with topsoil and/or turf. The outer edge has at some places been strengthened with a wooden bulwark or stone settings (Fig. 275).

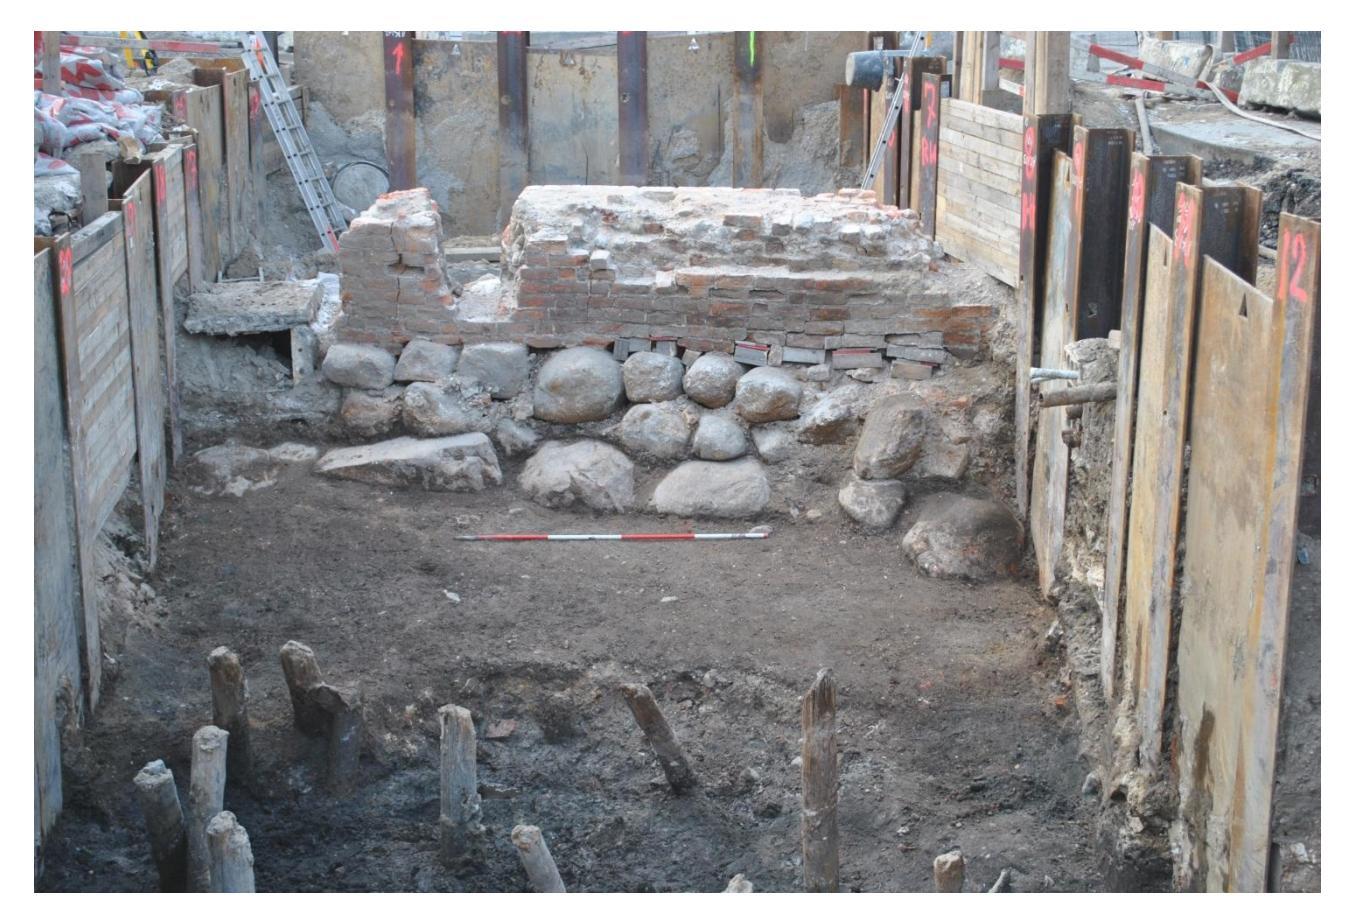
Fig. 277. Overview of the city wall with stone foundation, facing west. In front – the Late medieval moat with part of a later and temporary 17th century bridge structure. Photo: Museum of Copenhagen.

The width of the documented brick wall outside Lille Kongensgade varied from 0.86 m to 1.20 m placed on 2-3 courses of large granite boulders where the width of the foundation was 1.1-2.2 m (Fig. 277). The construction cut truncated both the original rampart and the salt marshes, within which the stones had been placed step-wise. Limestone ashlars had later been placed at the base of the wall to level the masonry built with medieval coursing ("munkeskifte") using bricks with the size of 27.0 x 12.5 x 9.0 cm.

The wall had probably been 9 cubits high (5-6 m) with a watchman's gallery or top coronation of stone to avoid frost damage on the top courses. During Frederik the $1^{st's}$ reign the fortification was straightened with an inner embankment as high as the city wall and with a width of 16 cubits (cf. Thorsen 1926:226 and 234) – although it is uncertain if the latter is valid for the area south of Østerport and the area excavated, since this would in large degree affect the access through the rampart street. In comparison the city wall in Malmö, Scania from the early 15^{th} century is believed to have been 9 cubits high – c. 5.5 m with a width of "three stones" (c. 0.9 m) standing on a one metre high foundation of natural boulders (Rosborn 1984:37; Reisnert 1998:32 et seq.; Olsson och Ödman 2009).

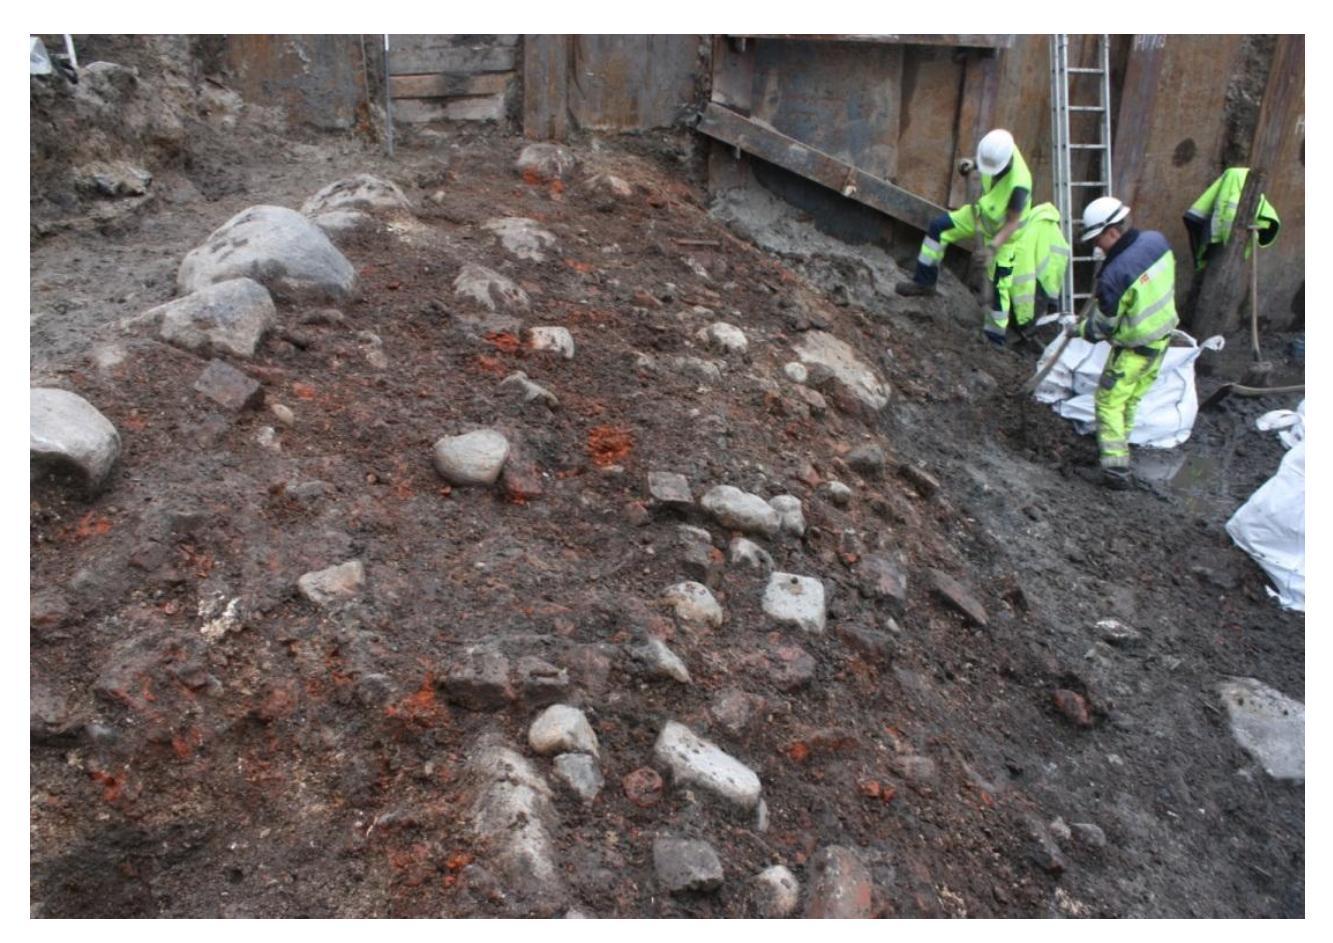
Fig. 278. The final destruction. Discarded bricks and demolition material in the Late medieval moat, facing north. Photo: Museum of Copenhagen.

The final demolition of the city wall was completed in connection with the Østervold bastion in the early 17th century when the Late medieval moat was backfilled with rubbish including a large amount of demolition material from the wall itself together with the excavated soil from the new and larger moat (Fig. 278).

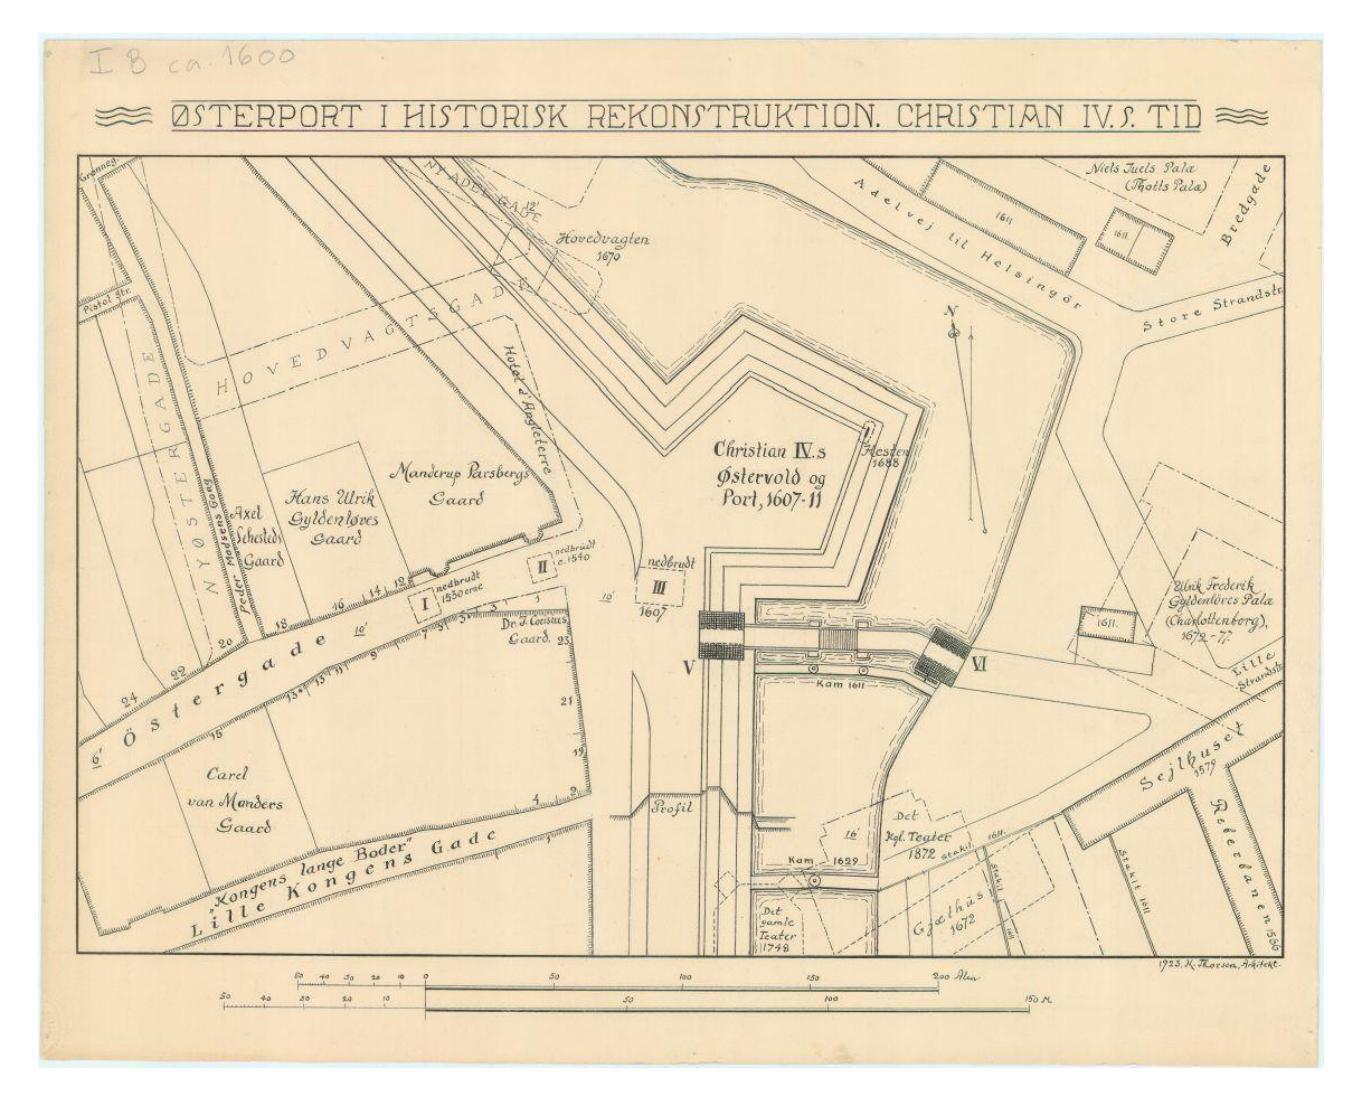
Fig. 280. Reconstruction proposal for the early 17th century fortification at Østervold with earthworks, moat, gate buildings and dams with barrier towers. Drawing by K. Thorsen 1923 and printed in Thorsen 1926. From Copenhagen City Archives.

In tandem with the construction of the new moat, an outer gate was also constructed. This faced to the southsoutheast, approximately at a right-angle to the main gate building, in itself a defensive layout (Fig. 280).

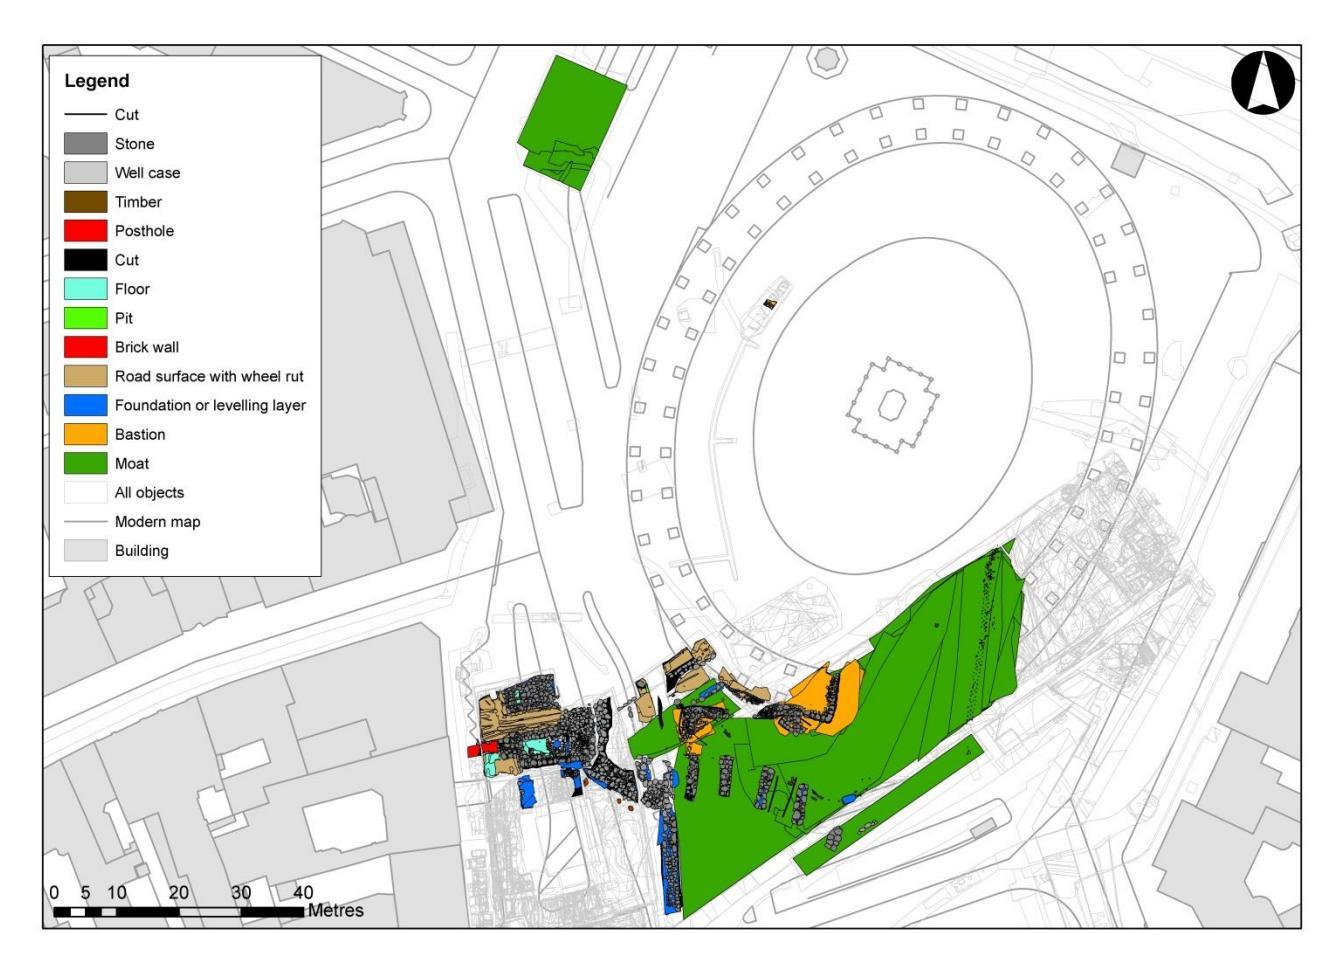
Fig. 282. Investigated parts of the 17th century fortification with the inner gate building and Østervold.

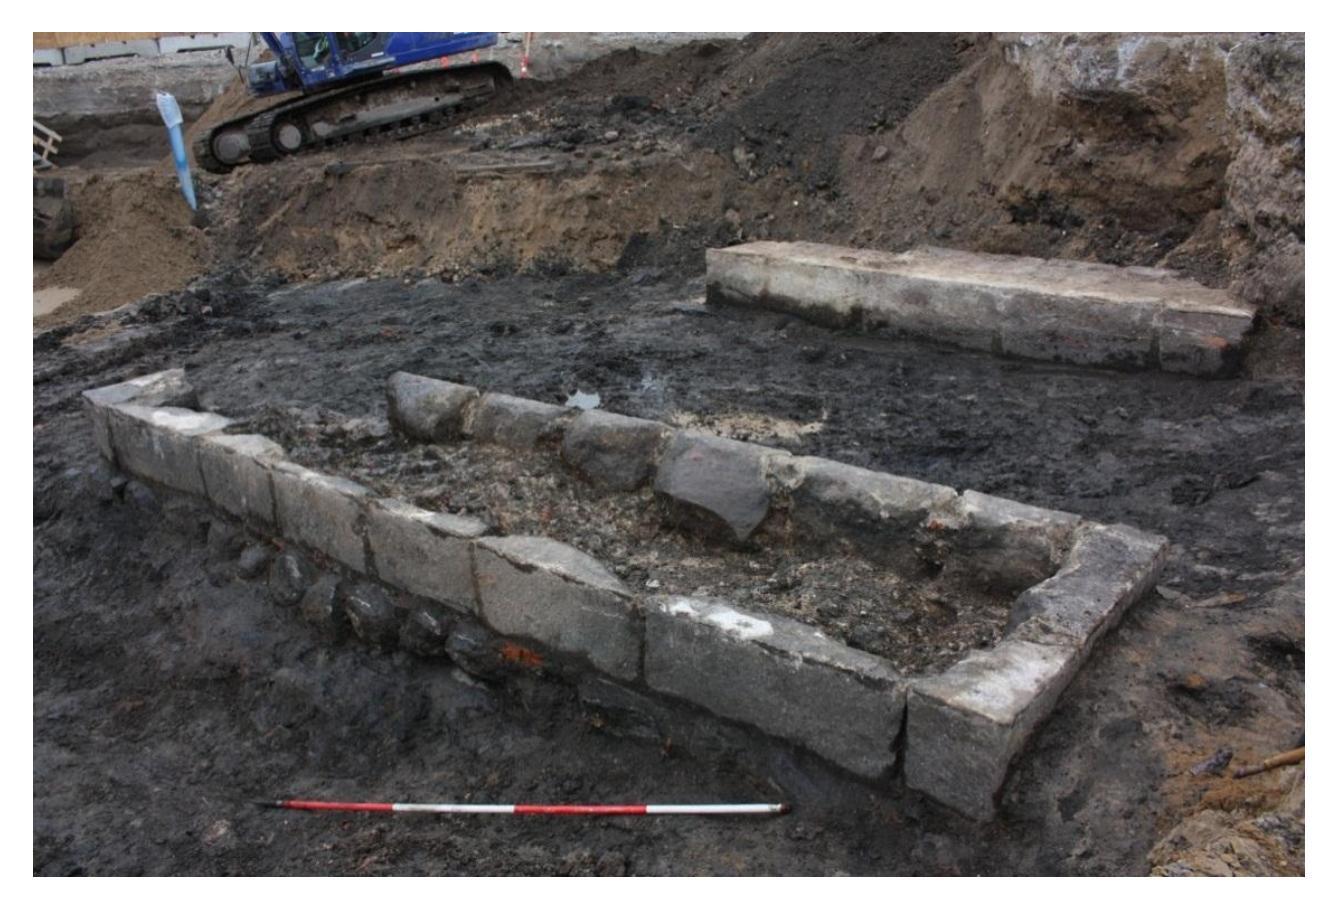
Fig. 283. Overview and upper part of bridge pillar Nos. 1 and 2, facing SW. Photo: Museum of Copenhagen.

Five of these vertical brick pillars or bridge piers were investigated in the moat (Fig. 283). Part of this bridge structure was also recorded in 1994 in the street outside Kongens Nytorv No. 21. This consisted of a dressed stone plinth with three dressed stones and masonry of medieval bricks and lime mortar on a foundation of boulders and demolition material from the 16th century or later. The dressed stones sloped at 15-20 degrees (Skaarup 1994).
